LKK Auto Consultants Pte Ltd

ADJUSTMENT ON REPAIR COST FOR VEHICLE NO. SHD 4573X

PHOTOGRAPHS FOR VEHICLE NO. SHD 4573X

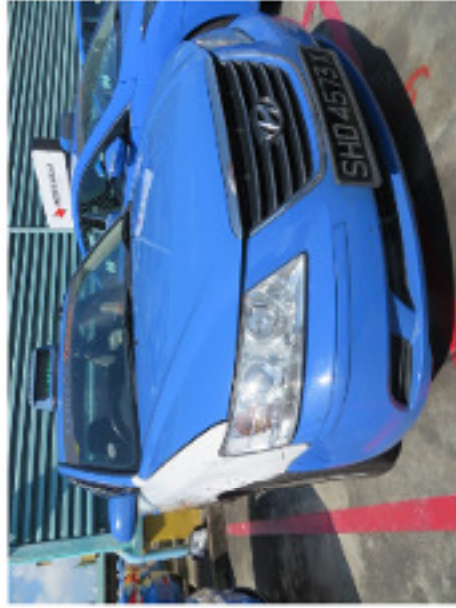
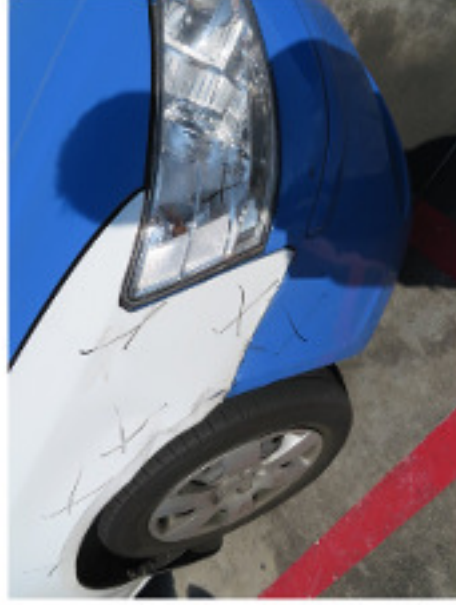
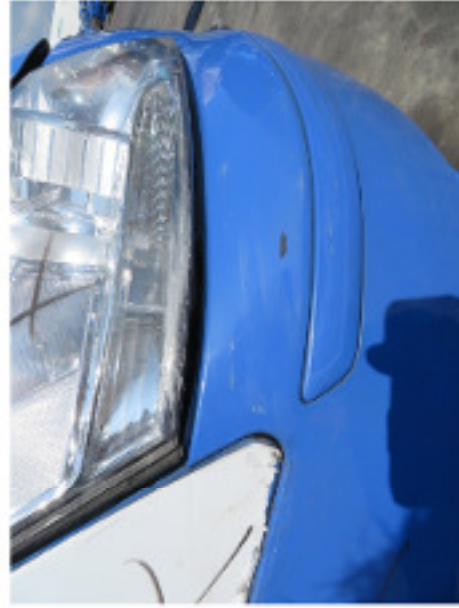
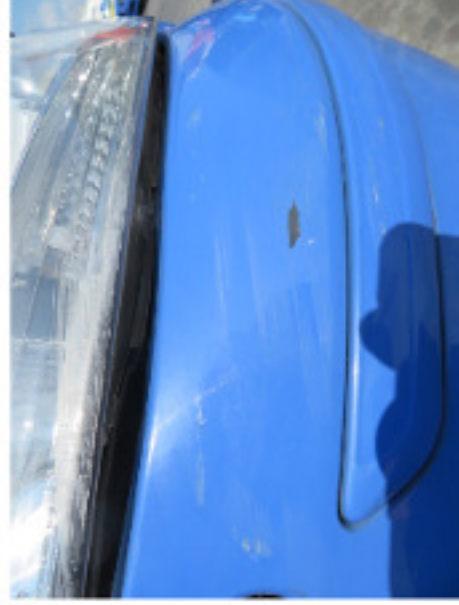
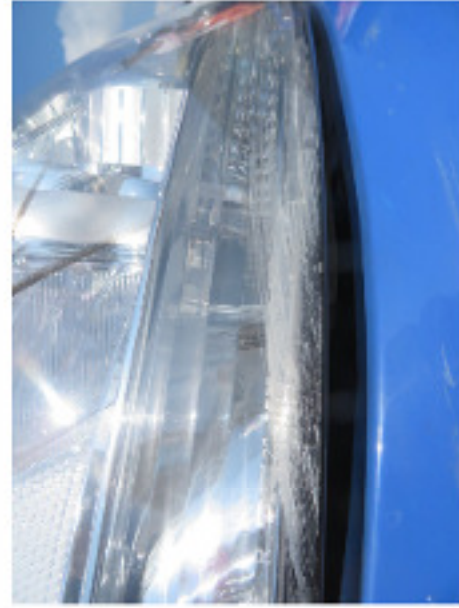
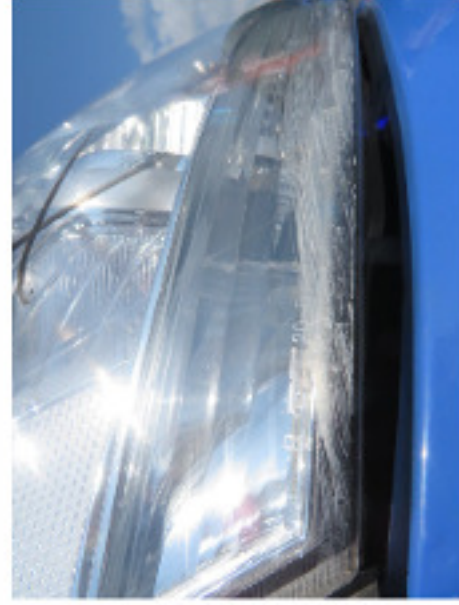
INSPECTION

THE VEHICLE SUSTAINED DAMAGES AT THE O/S FRONT PORTION. DAMAGES SEE DETAILS.
