Your Ref: S8300950
Our Ref : CS/ASM18003398/N

**TECHNICAL INVESTIGATION REPORT OF FIRE INCIDENT INVOLVING THE
INSURED VEHICLE GY 830G ON 16 FEBRUARY 2018**

Vehicle Registration No.	: GY 830G
Make / Model	: KIA FRONTIER SC
Chassis No	: KNCSE011257049147
Year of Registration	: December 2004
Mileage	: N.A (battery melted)

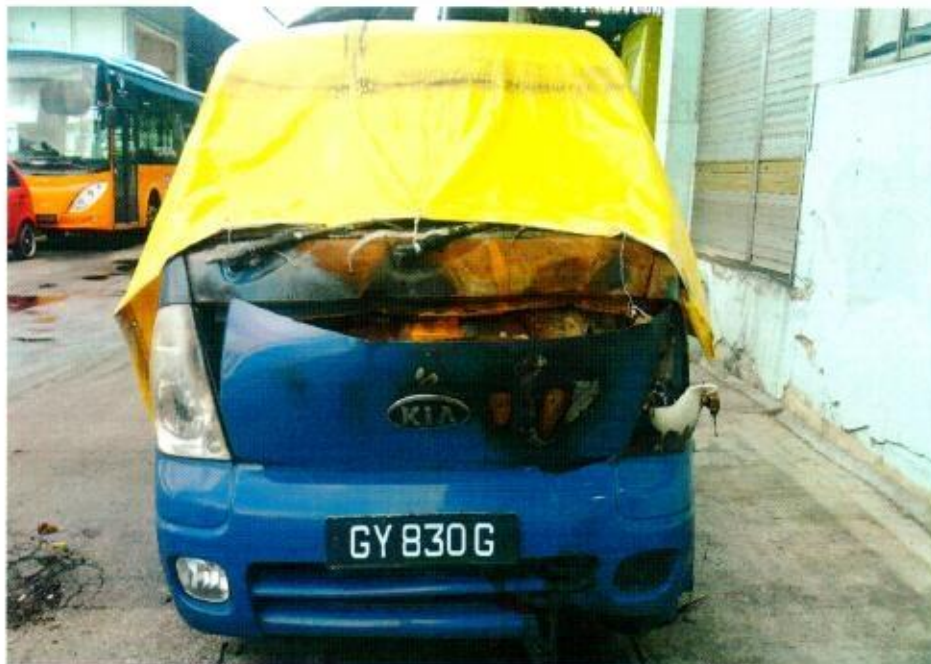
Photo 1 shows the general view of the front portion of the Insured Vehicle at the time of our inspection. The Insured Vehicle was observed to have sustained extensive fire damage all around. Its engine compartment and interior compartment were completely burnt. Rust had accumulated all over the Insured Vehicle as a result of exposure to environmental condition for a period of time.

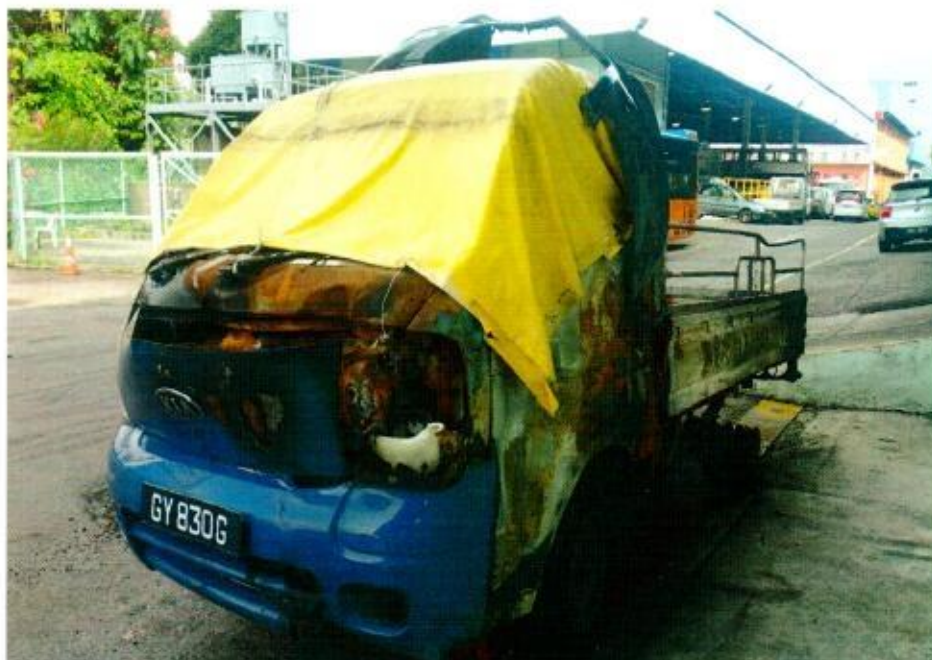
Photo 2 shows the general view of the left body of the Insured Vehicle at the time of our inspection. The Insured Vehicle was observed to have sustained extensive fire damage all around. Rust had accumulated all over the Insured Vehicle as a result of exposure to environmental condition for a period of time.

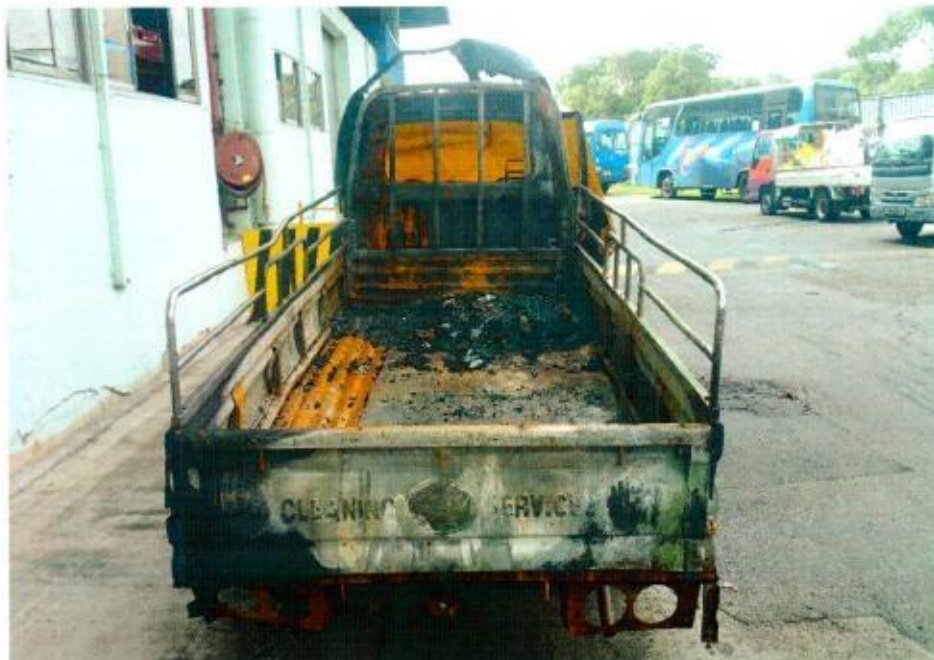
Photo 3 shows the general view of the rear body of the Insured Vehicle at the time of our inspection. The Insured Vehicle was observed to have sustained extensive fire damage all around. Rust had accumulated all over the Insured Vehicle as a result of exposure to environmental condition for a period of time.

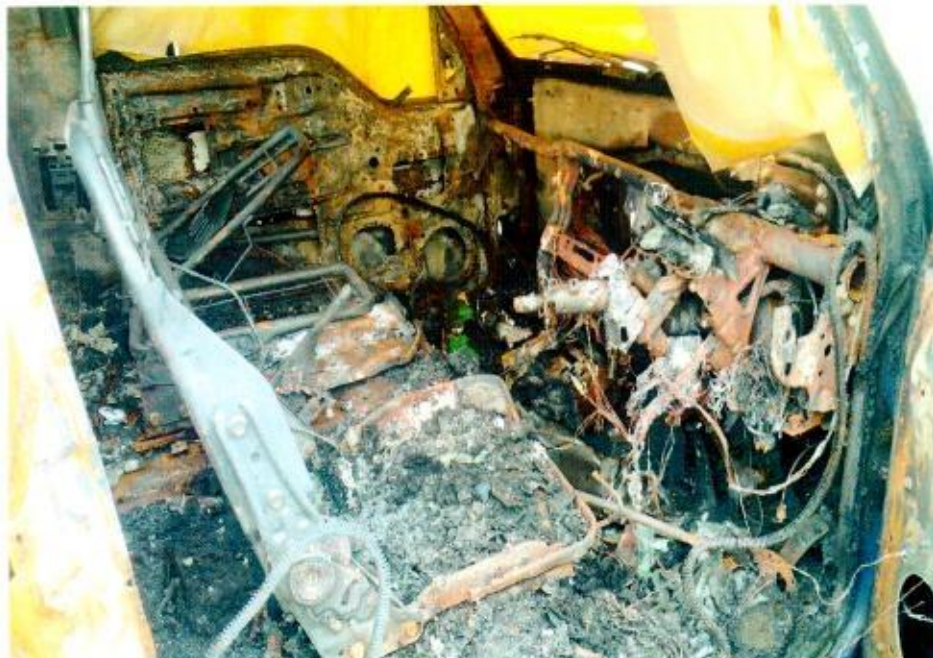
Photo 4 shows the general view of the interior compartment of the Insured Vehicle at the time of our inspection. Its interior compartment was completely burnt as a result of the fire.

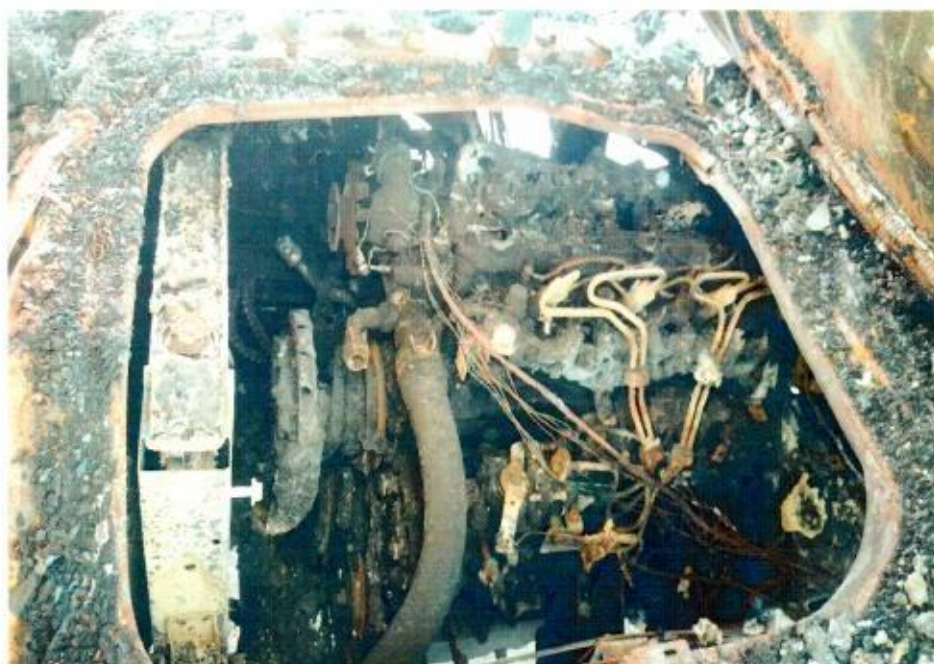
Photo 5 shows the engine compartment of the Insured Vehicle at the time of our inspection. The entire engine compartment of the Insured Vehicle was observed to be severely burnt. Most of the parts inside the engine compartment were found to be burnt and/or melted as a result of the fire.

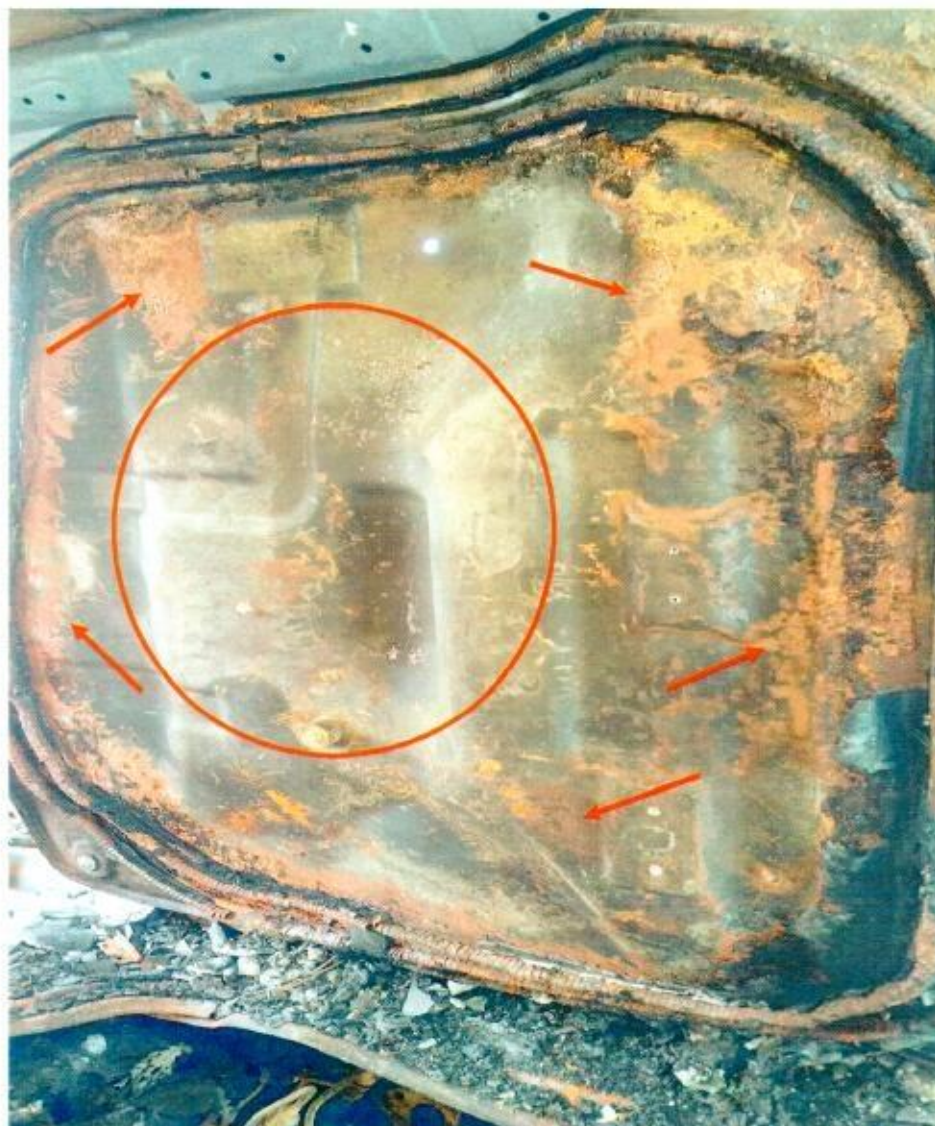
7. For this particular case, the fire appears to have originated within the engine compartment of the Insured Vehicle. This can be determined from the burn pattern and the high heat intensity burn marks (whitish burn marks) found as well as the rust that had developed on the underside of the passenger side engine access panel of the Insured Vehicle.
8. The whitish burn marks are a result of exposure to prolonged heat intensity. Rust would normally start to develop around these areas soon after a fire as prolonged exposure to high heat intensity usually causes steel/metal material body parts to be exposed to natural environmental condition. The rust that had developed on the underside of the passenger side engine access panel of the Insured Vehicle is an indication that the engine compartment had sustained exposure to prolonged high heat intensity. See photo 6 below.

Photo 6 shows the whitish burn marks that were found on the underside of the passenger side engine access panel of the Insured Vehicle (circled). Such whitish burn marks are a result of exposure to prolonged heat intensity. Rust would also begin to develop on these areas soon after the fire. The development of rust is an indication that the area was exposed to prolonged exposure to high heat intensity, which had caused the steel/metal material of the passenger side engine access panel to be exposed to natural environmental condition. Hence the rust that had developed around the underside of the passenger side engine access panel of the Insured Vehicle (arrowed) is an indication that the fire to the Insured Vehicle had originated from the engine compartment.

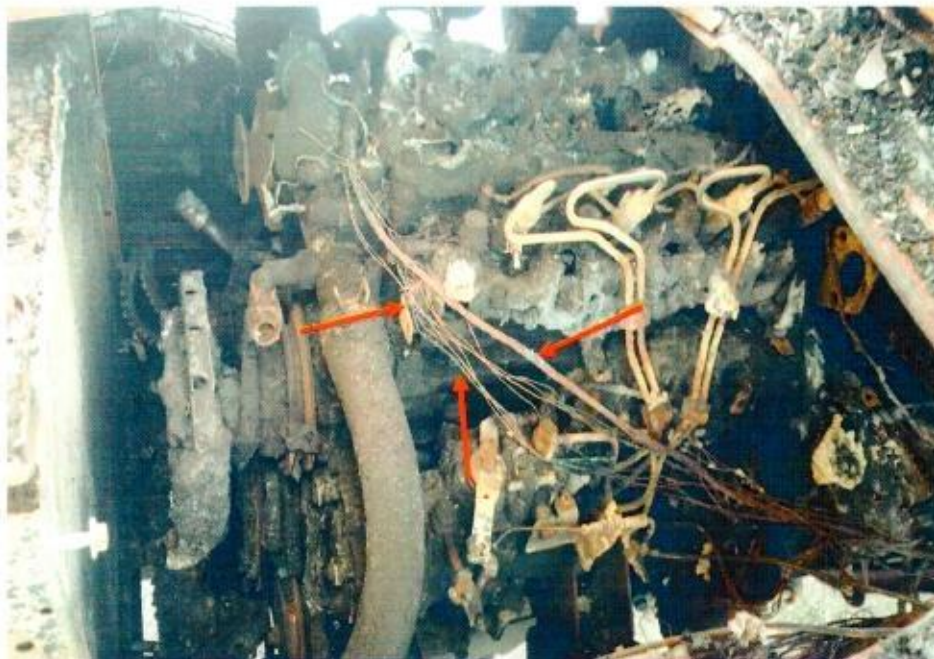
9. Upon closer examination of the engine compartment, which was where the fire to the Insured Vehicle had likely started, we had found several stretches of wiring with green residue. These wirings were original factory fitted wirings that were around the centre portion of the engine compartment. We also found greenish residue on several stretches of wirings leading from the battery of the Insured Vehicle. The presence of greenish residue indicates internal heating of copper wires, a sign of an electrical short circuit occurring. The greenish residue is normally left behind from oxidation as a result of chemical reaction involving the copper wires. These physical evidences would appear to suggest that the cause of fire to the Insured Vehicle could have possibly been due to electrical in nature. See photos 7 - 11 below.

Photo 7 shows the wirings around the centre portion of the engine compartment which is near to the vicinity where the fire to the Insured Vehicle had likely started. We observed greenish residue on the wirings at the centre portion of the engine compartment (arrowed).

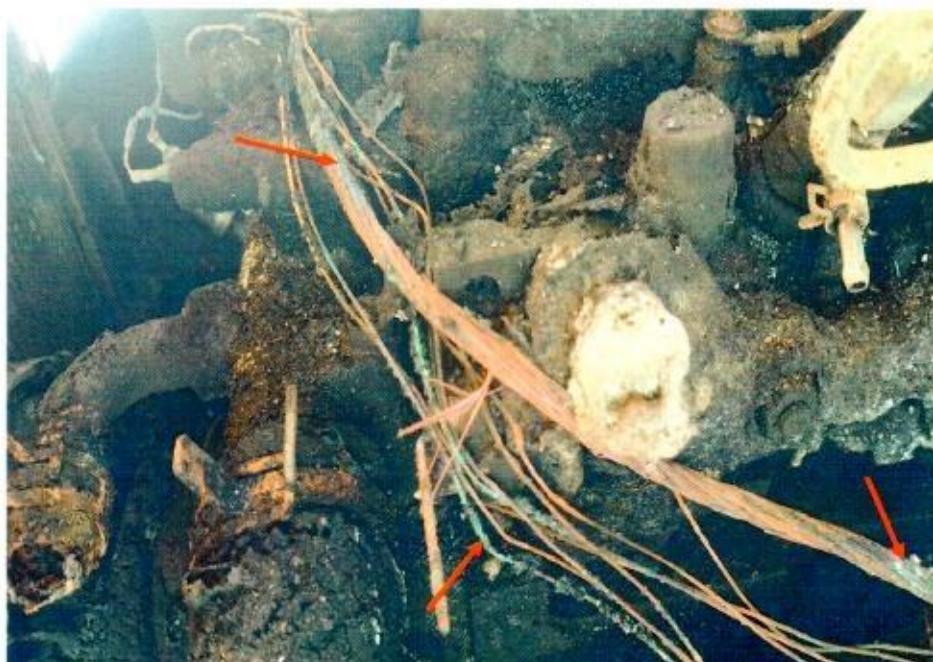
Photo 8 shows a closer view of the greenish residue found on the wirings at the centre portion of the engine compartment (arrowed). This seems to suggest the occurrence of an electrical short circuit.

30. The possibility of the fire being due to electrical in nature is also possible. The fire being due to electrical in nature is also supported by the condition of the wirings that were found in the engine compartment of the Insured Vehicle, which was earlier discussed in paragraph 9 above.

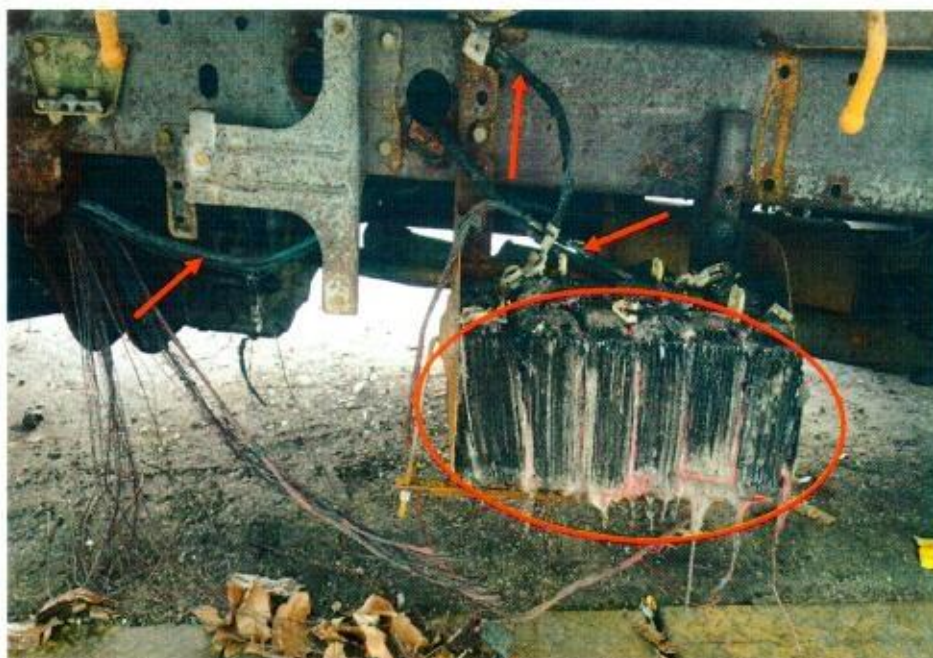
Photo 9 shows the wirings leading from the battery (circled) of the Insured Vehicle. We observed greenish residue on these wirings (arrowed).

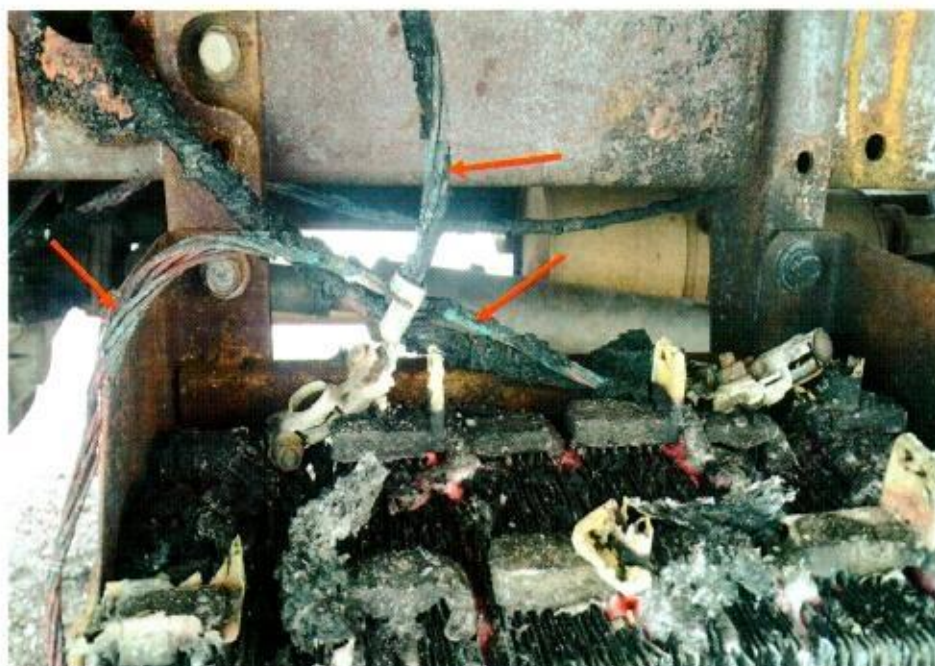
Photo 10 shows a close up view of the greenish residue found on the wirings leading from the battery of the Insured Vehicle (arrowed). This seems to suggest the occurrence of an electrical short circuit.

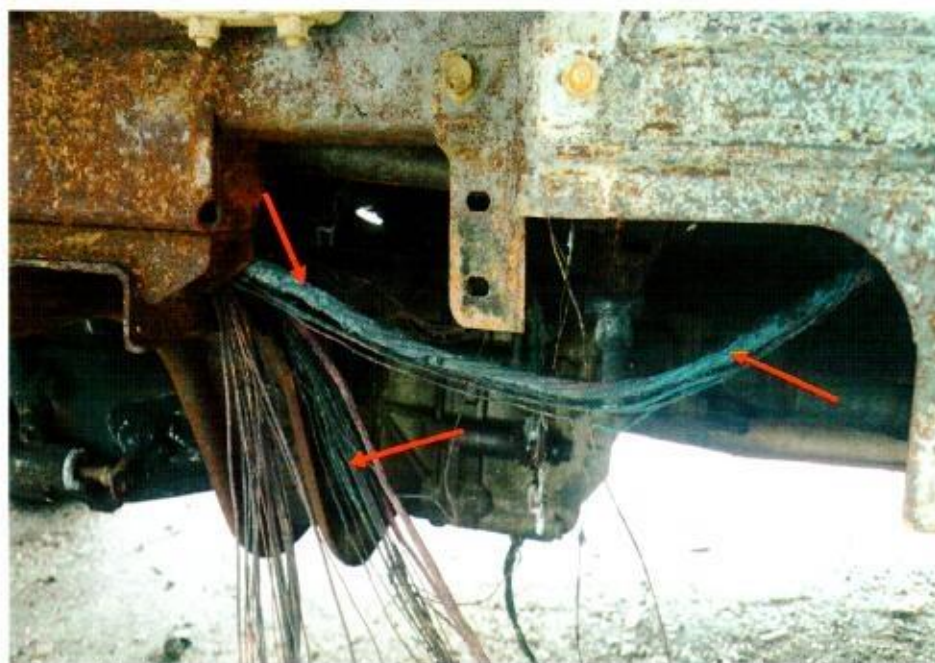
Photo 11 shows a close up view of the greenish residue found on the wirings leading from the battery of the Insured Vehicle (arrowed). This seems to suggest the occurrence of an electrical short circuit.

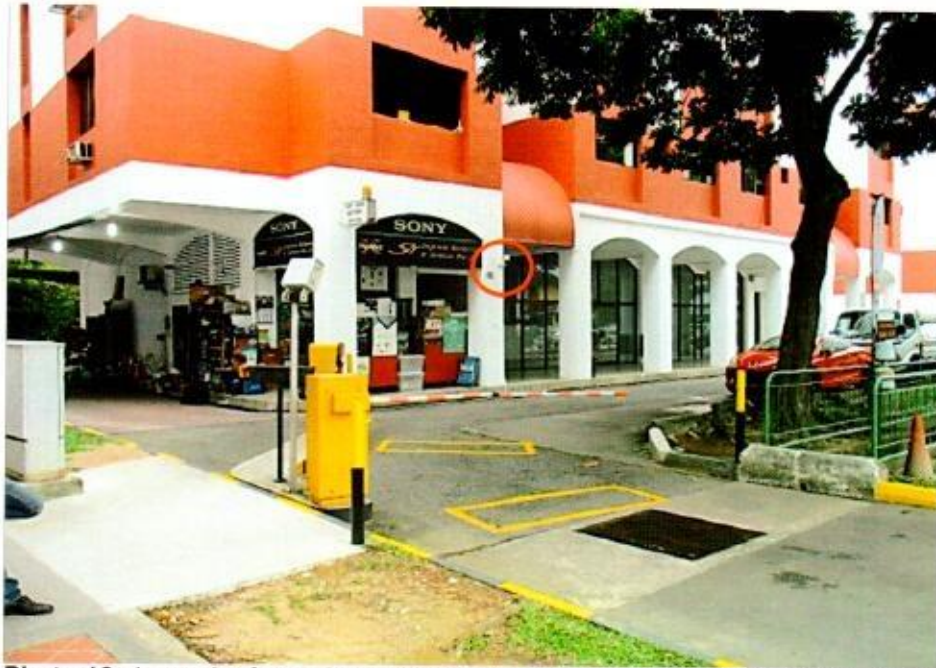
Photo 12 shows the front of the SAR office located at 541 Balestier Road. There is a CCTV camera affixed on the wall at the front left side of the office building, facing the carpark exit (circled). However there is no camera affixed at the rear of the office building.

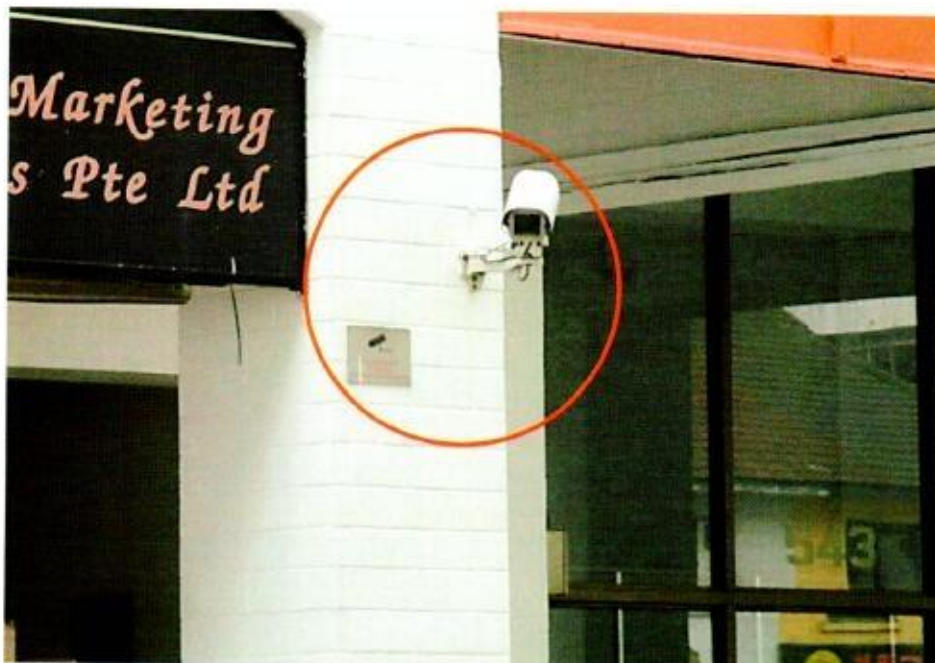
Photo 13 shows a closer view of the CCTV camera affixed on the wall at the front left side of the office building, facing the carpark exit (circled).

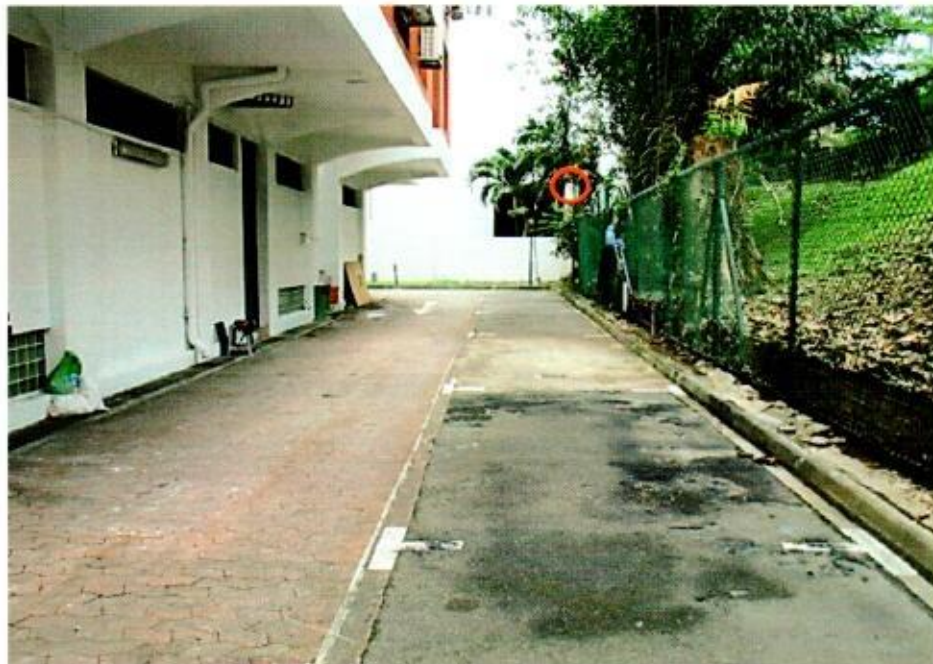
Photo 14 shows the open carpark at the back of the SAR office located at 541 Balestier Road. We did notice that there was a CCTV camera facing the open carpark where the incident occurred which is affixed on the wall of the hotel located next to the office building (circled).

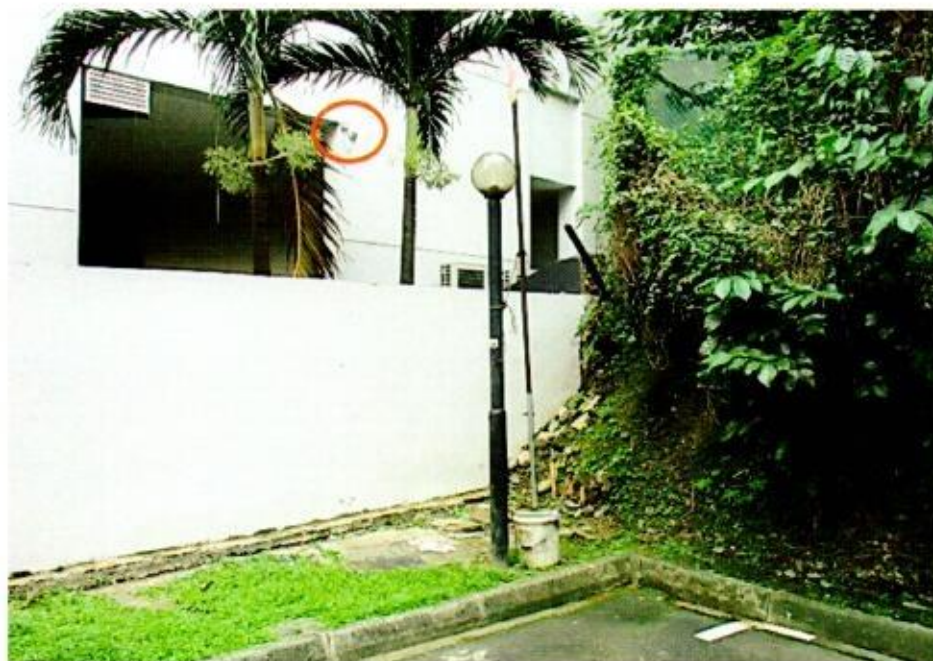
Photo 15 shows a closer view of the CCTV camera facing the open carpark where the incident occurred which is affixed on the wall of the hotel located next to the office building (circled). However we were unable to view or obtain the footage for security reasons.

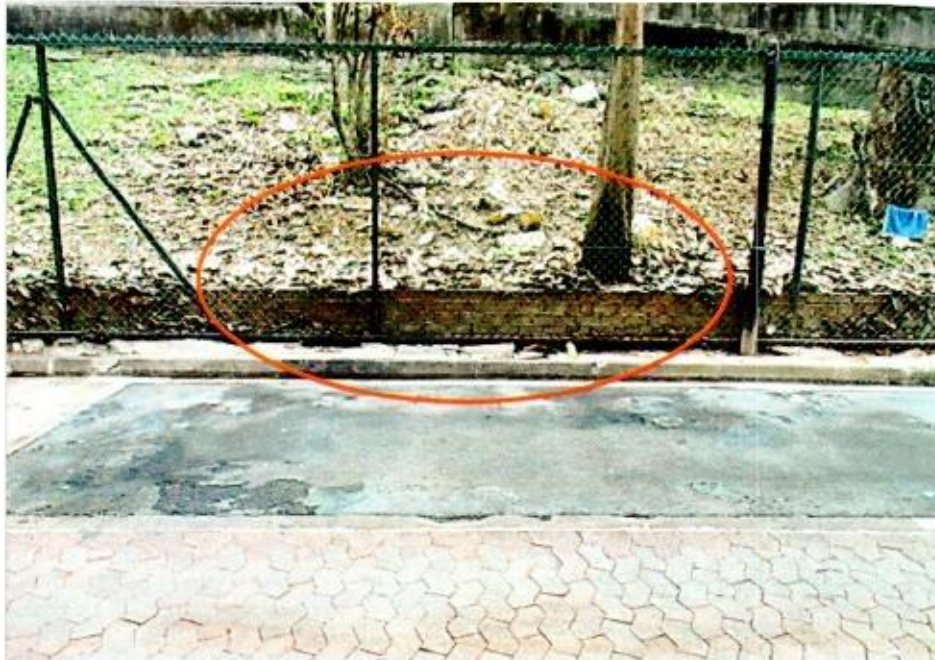
Photo 16 shows a closer view of the burnt marks and/or burnt residual remains on the ground where the Insured Vehicle was parked at the time of incident. We also found burn marks on the kerb, fence and trunk of a tree nearest to where the Insured Vehicle was parked when the fire occurred (circled).

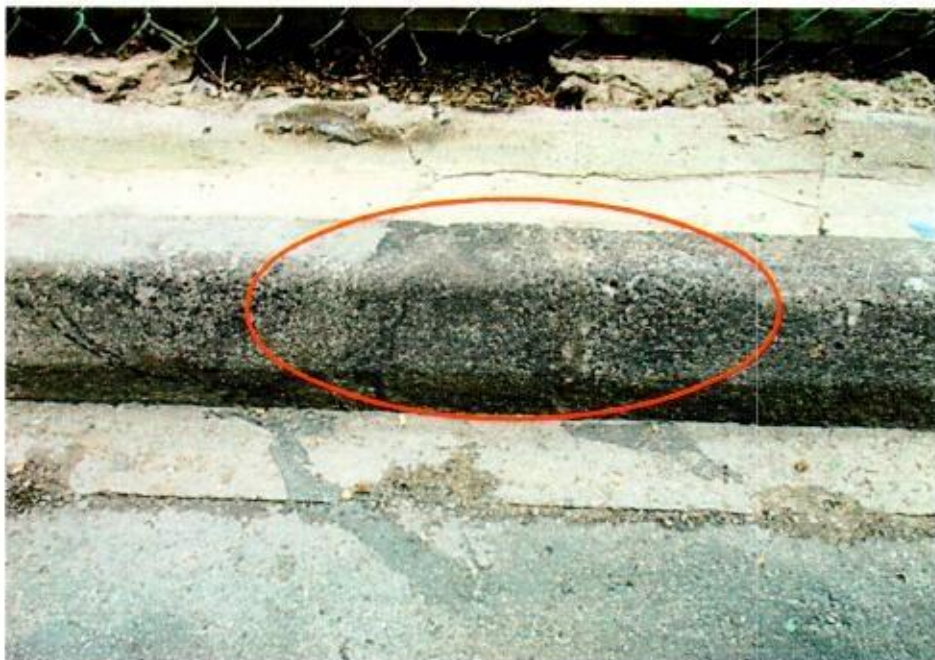
Photo 17 shows a close up view of the burn marks on the kerb nearest to where the Insured Vehicle was parked when the fire occurred (circled).

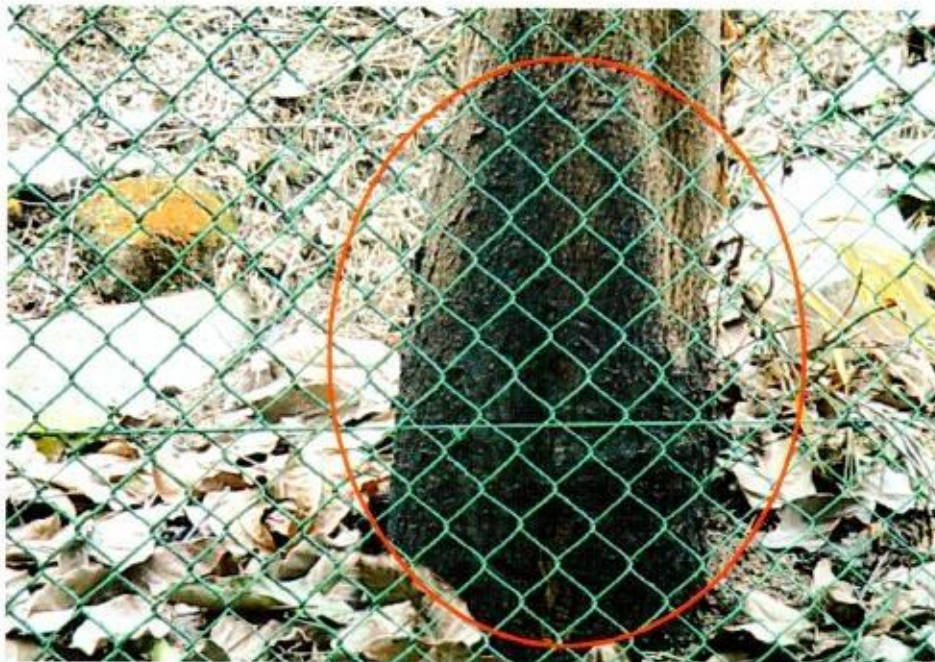
Photo 18 shows a close up view of the burn marks on the fence and trunk of a tree nearest to where the Insured Vehicle was parked when the fire occurred (circled).

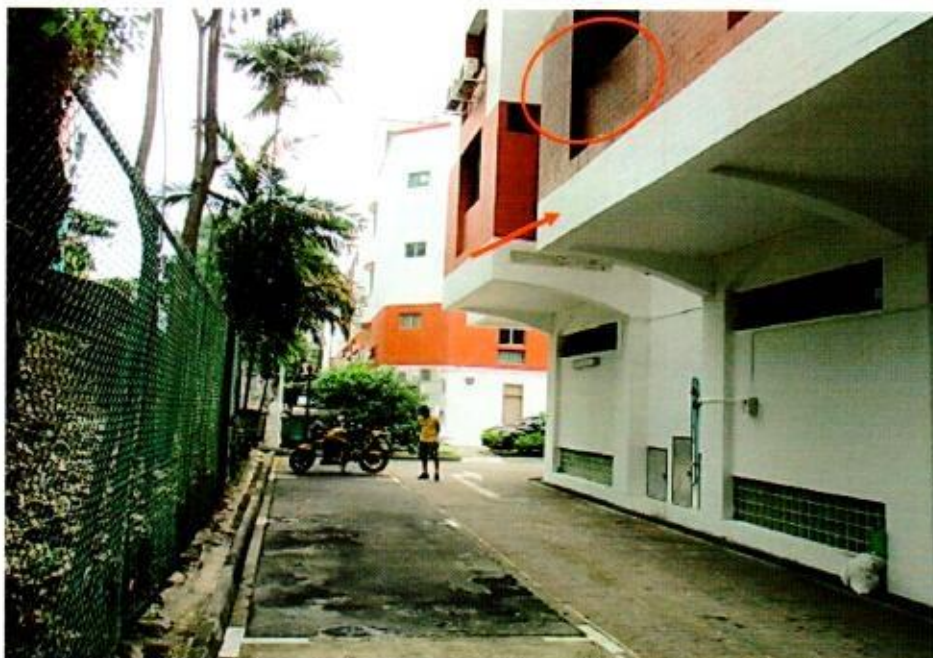
Photo 19 shows although the lower portion of the outer walls of the office building above where the Insured Vehicle was parked had been repainted (arrowed), the upper portion of the outer walls were still covered in soot (circled).

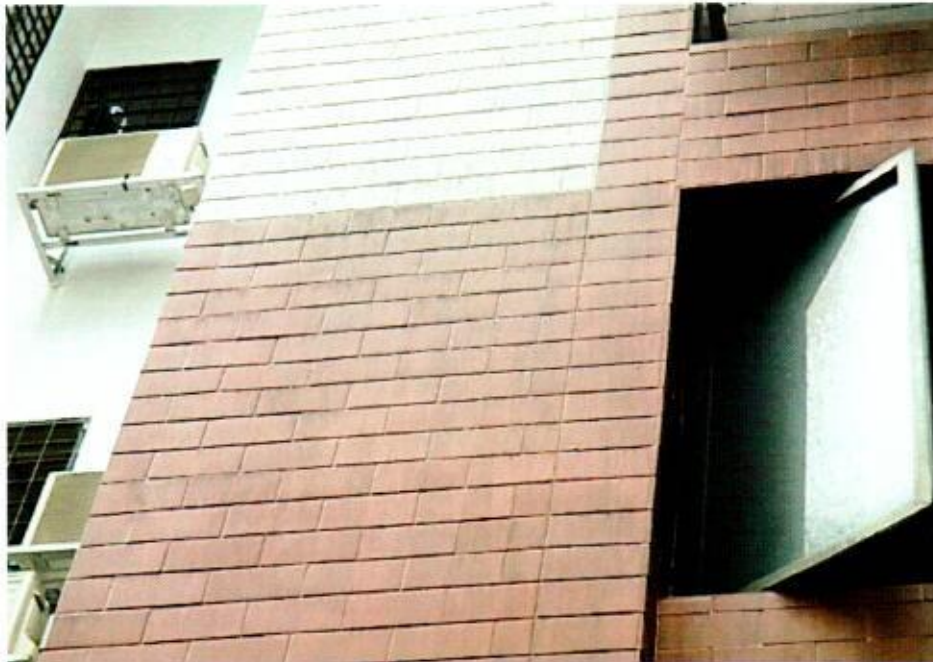
Photo 20 shows a close up view of the upper portion of the outer walls of the office building that were still covered in soot as a result of the fire.

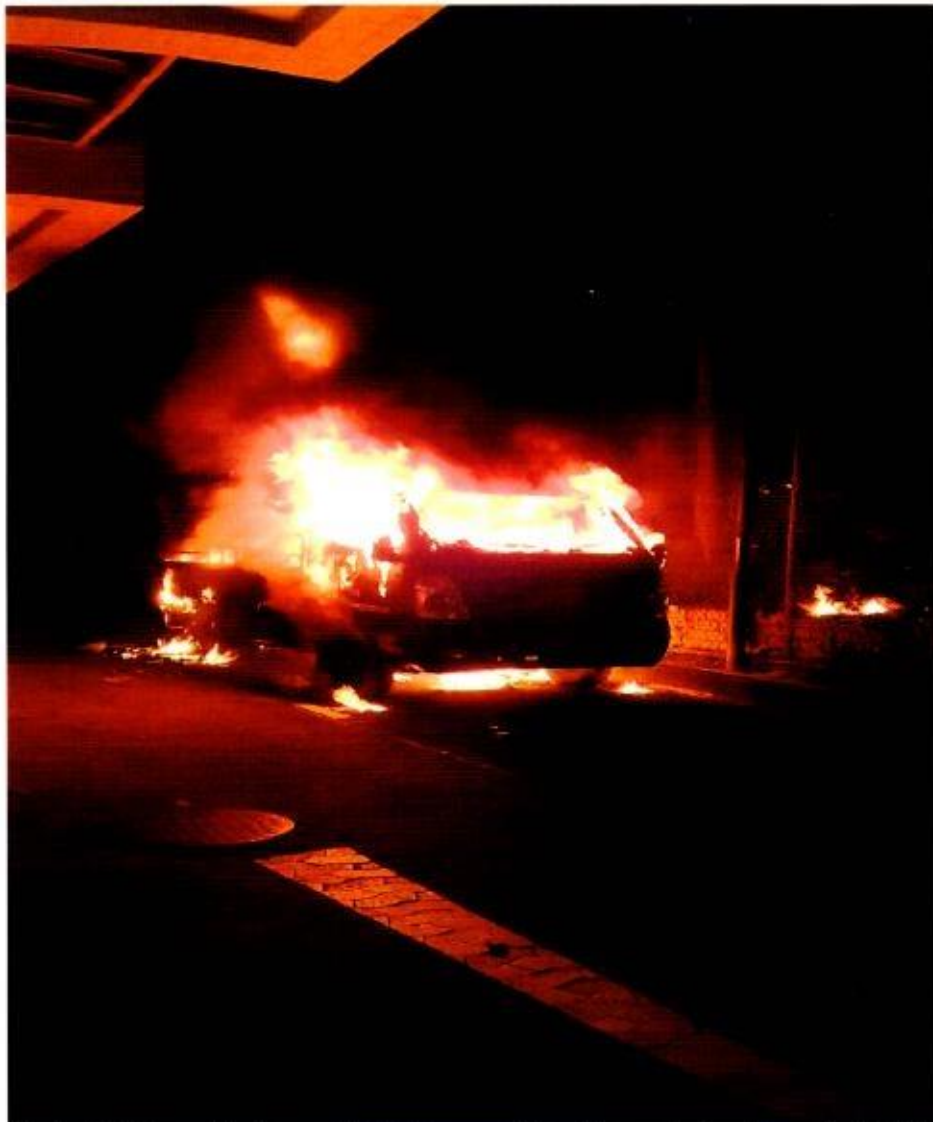
Photo 21 shows the Insured Vehicle engulfed in flames before the arrival of the SCDF.

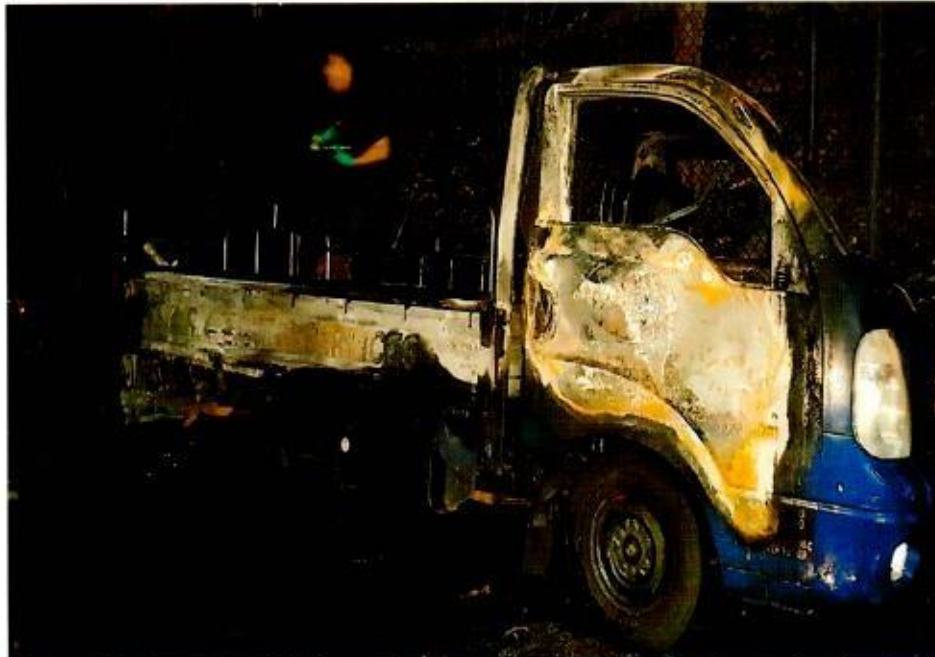
Photo 22 shows the SCDF conducting preliminary investigations after the fire to the Insured Vehicle was extinguished.

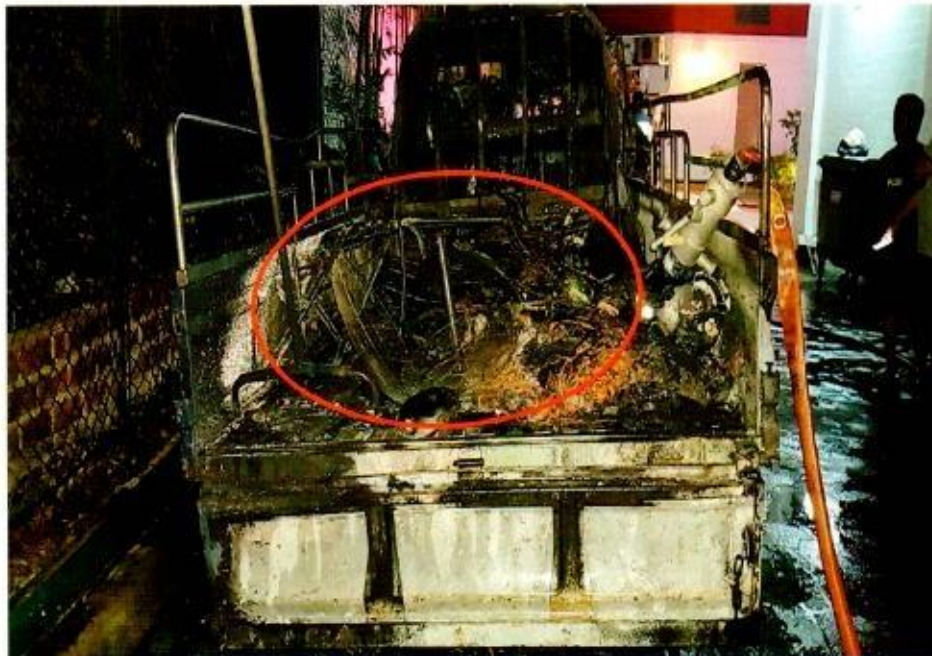
Photo 23 shows the rear portion of the Insured Vehicle after the fire was extinguished. In general, the information gathered from this photograph had corresponded to Ms Sharifah's statement, which is there was old furniture placed at the rear carriage deck of the Insured Vehicle when the fire started (circled).
