**INVESTIGATION REPORT:**

Our Ref : CS/EQI18003509/N  
Policy No : DMPPHQ17-003878  
Insured : SJS 533K  
Date of Accident : 9 February 2018  
Location : Jalan Bukit Merah

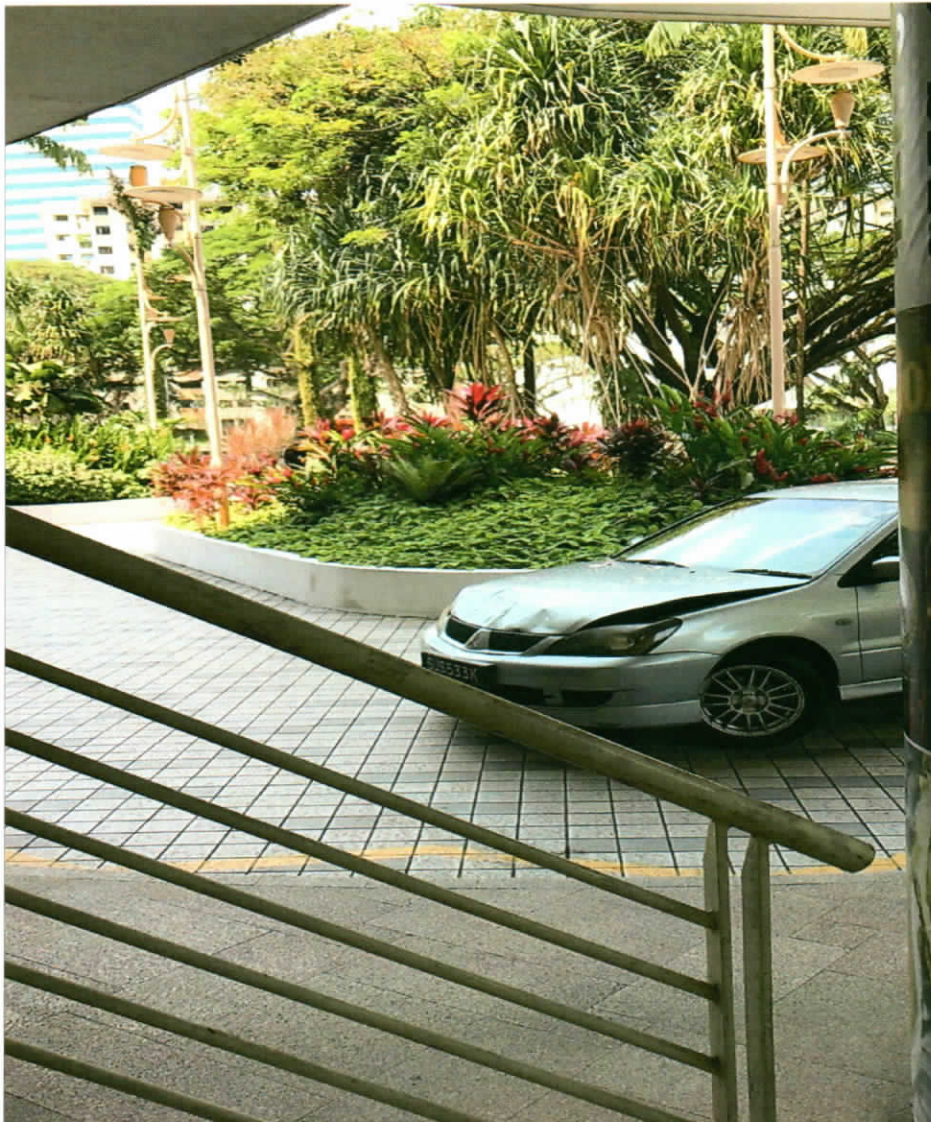
**Photo 1** shows the Insured Vehicle after Ms Kaur stopped near the SingPost Popstation located at SAFRA Mount Faber. Our observation of Ms Kaur's ability to be able to still drive the Insured Vehicle to another location after the accident as well as take clear post- accident photographs would suggest that there was no drink driving involved in this particular accident.

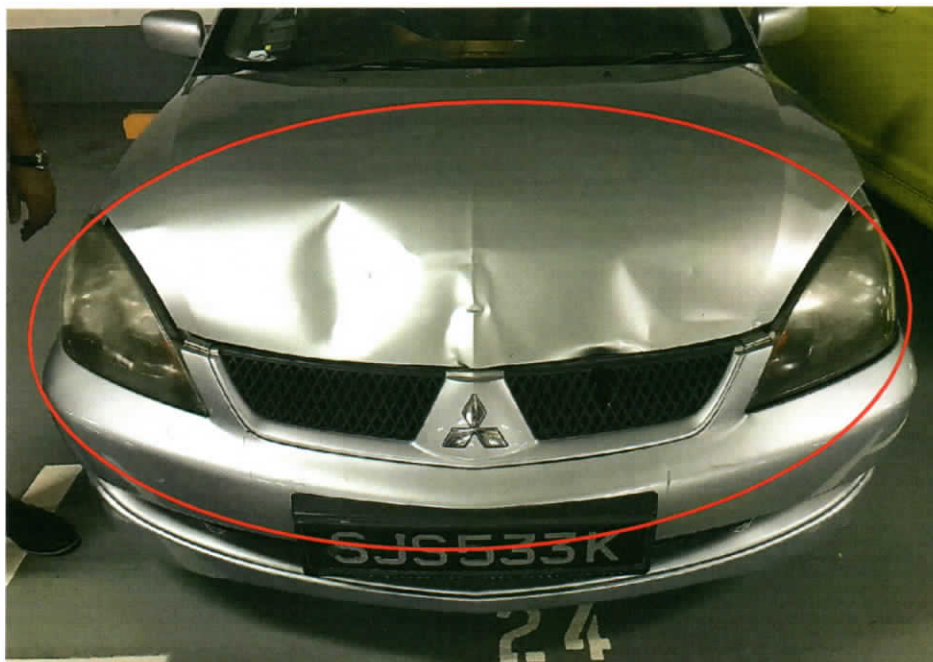
**Photo 2** shows the Insured Vehicle at the basement carpark of SAFRA Mount Faber before Ms Kaur's mother drove the Insured Vehicle to Tekka Market. Our review of this photograph which showed the damaged front portion of the Insured Vehicle seemed to correlate with the circumstances of the accident in which she had rear-ended the Lorry (circled).

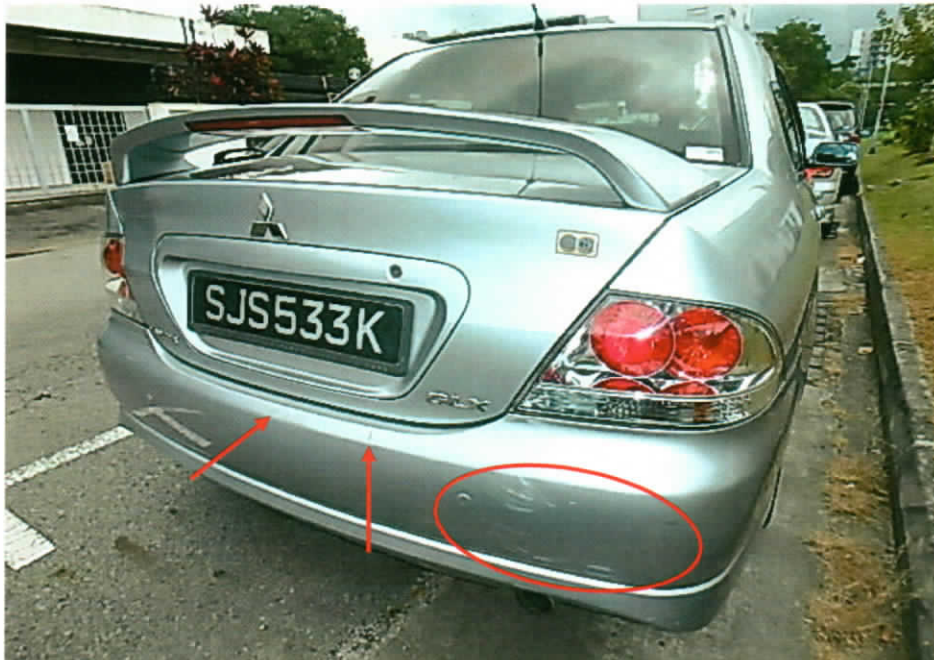
**Photo 3** shows the general rear view of the Insured Vehicle during the physical inspection at CHM. Paint graze marks were found at the centre portion of the rear bumper (arrowed) and paint cracks were found at the right portion of the rear bumper. (circled).

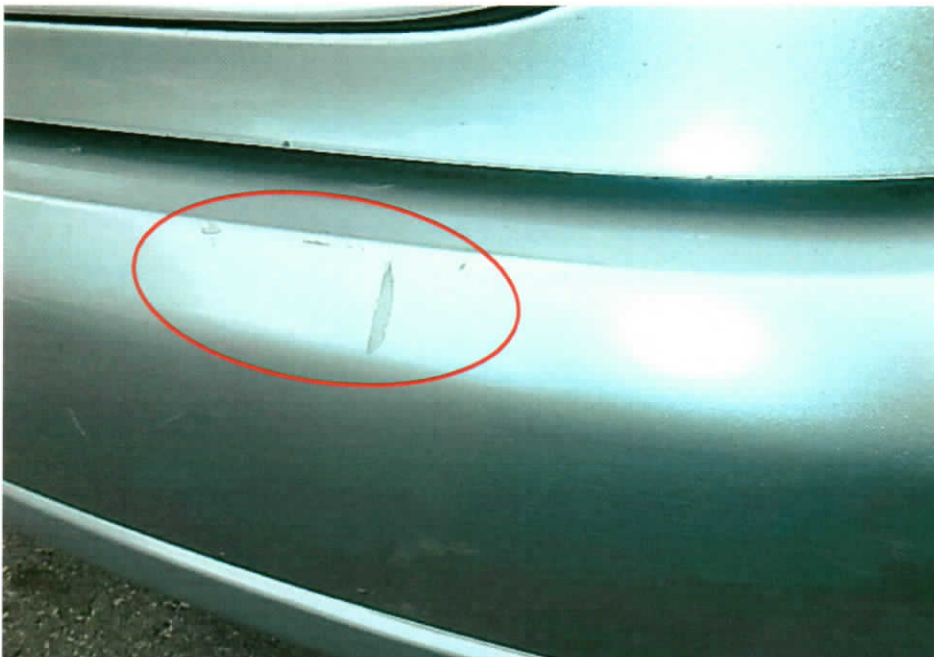
**Photo 4** shows a close up view of the paint graze marks found at the centre portion of the rear bumper of the Insured Vehicle (circled), suggesting that the Insured Vehicle might have been rear-ended by another vehicle.

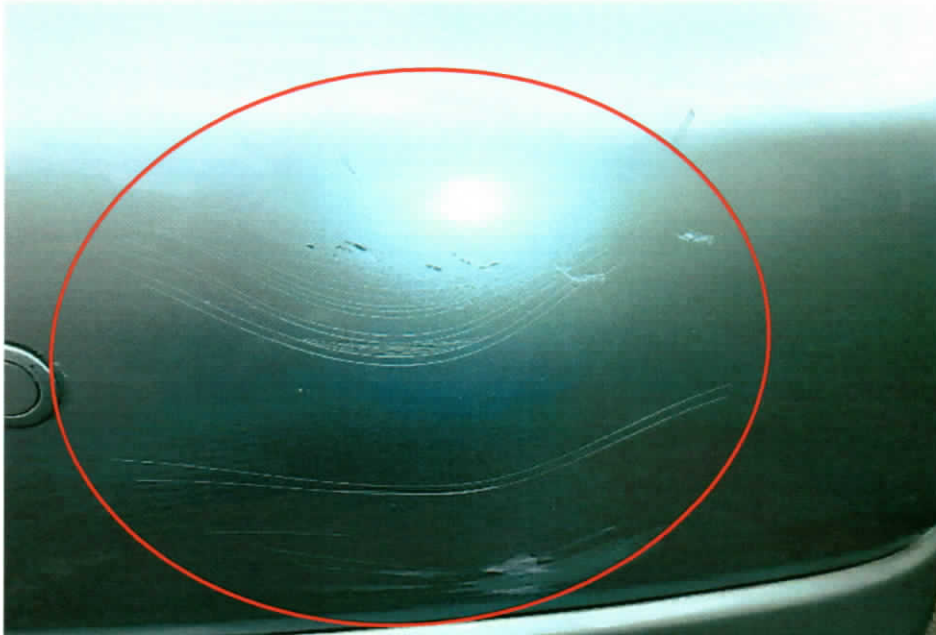
**Photo 5** shows a close up view of the paint cracks found at the right portion of the rear bumper of the Insured Vehicle (circled), suggesting that the Insured Vehicle might have been rear-ended by another vehicle.

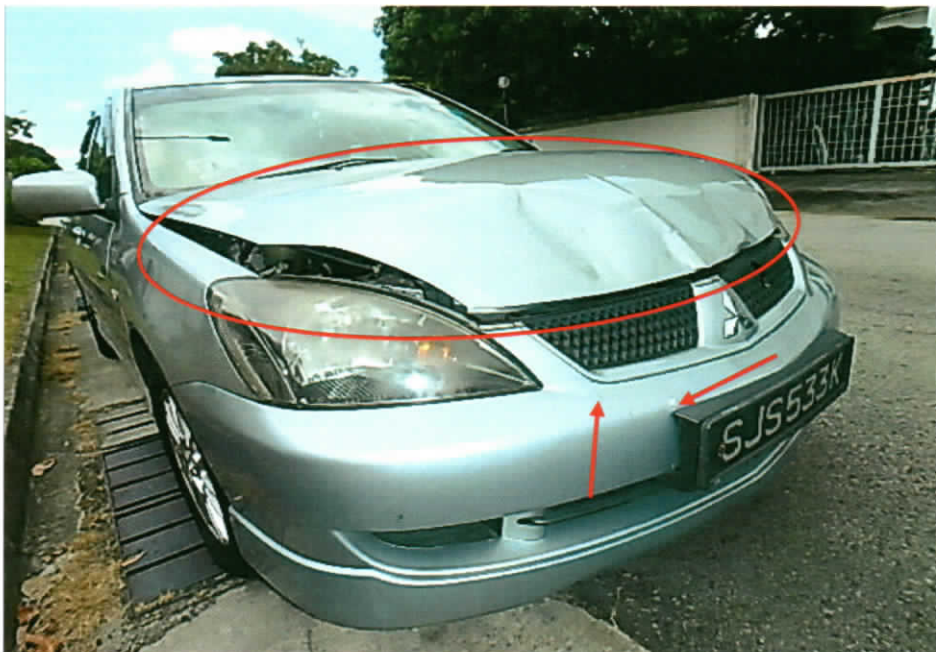
12. Based on the post- accident photographs provided to us by Ms Kaur, the Insured Vehicle had sustained damages to its front portion as a result of the accident.
13. Our physical inspection of the Insured Vehicle at CHM revealed that the Insured Vehicle had sustained damages to its front bumper, front bonnet and rear bumper. The front bonnet was observed to be buckled. Paint graze marks were found at the centre portion of the rear bumper and paint cracks were found at the right portion of the rear bumper. These damages seemed to corroborate with Ms Kaur's statement in which she might have been rear-ended by another vehicle, causing her to panic and accidentally stepping on the accelerator which resulted in the front portion of the Insured Vehicle going under the rear portion of the Lorry. See photos 3 - 6 below.

**Photo 6** shows the general front view of the Insured Vehicle during the physical inspection at CHM. The Insured Vehicle had sustained damages to its front bumper (arrowed) and front bonnet. The front bonnet was observed to be buckled (circled). These damages seemed to corroborate with Ms Kaur's statement in which she might have been rear-ended by another vehicle, causing her to panic and accidentally stepping on the accelerator which resulted in the front portion of the Insured Vehicle going under the rear portion of the Lorry
