INVESTIGATION REPORT:

Our Ref : CS/EQI18003509/N
Policy No : DMPPHQ17-003878
Insured : SJS 533K
Date of Accident : 9 February 2018
Location : Jalan Bukit Merah

Interview Summary of the Driver of the Insured Vehicle SJS 533K

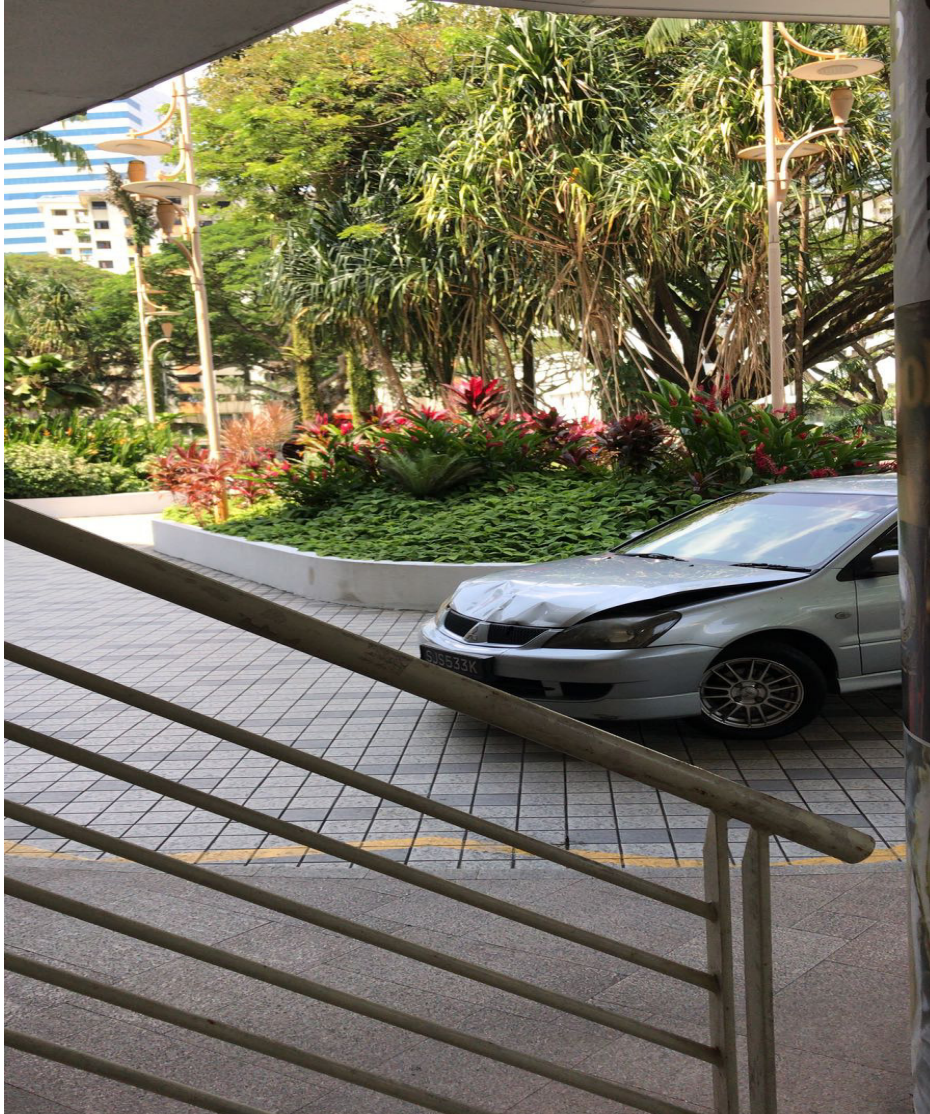
Photo 1 shows the Insured Vehicle after Ms Kaur stopped near the SingPost Popstation located at SAFRA Mount Faber. Our observation of Ms Kaur's ability to be able to still drive the Insured Vehicle to another location after the accident as well as take clear post- accident photographs would suggest that there was no drink driving involved in this particular accident.

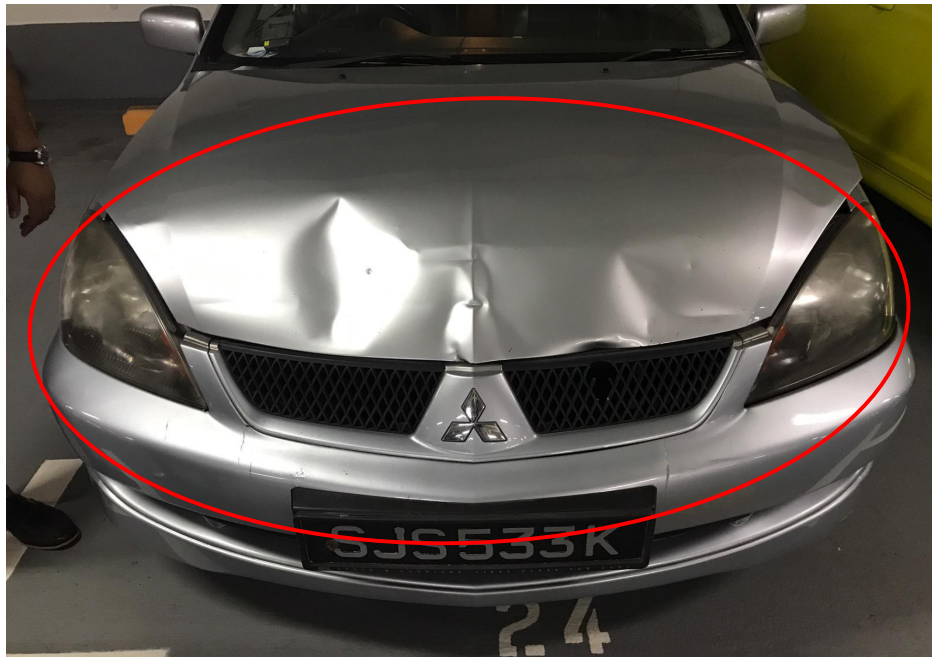
Photo 2 shows the Insured Vehicle at the basement carpark of SAFRA Mount Faber before Ms Kaur's mother drove the Insured Vehicle to Tekka Market. Our review of this photograph which showed the damaged front portion of the Insured Vehicle seemed to correlate with the circumstances of the accident in which she had rear-ended the Lorry (circled).

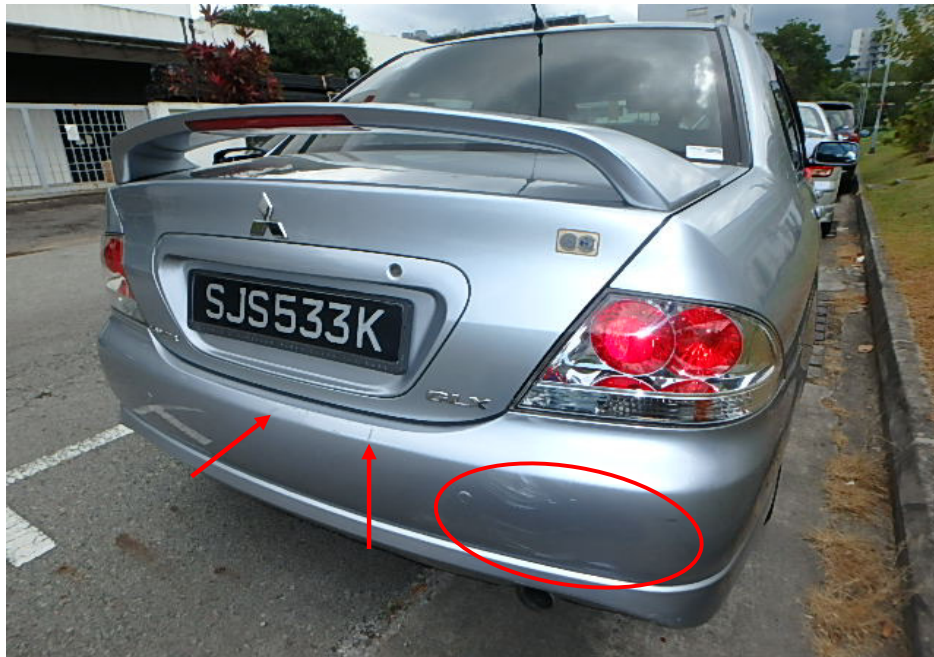
Photo 3 shows the general rear view of the Insured Vehicle during the physical inspection at CHM. Paint graze marks were found at the centre portion of the rear bumper (arrowed) and paint cracks were found at the right portion of the rear bumper. (circled).

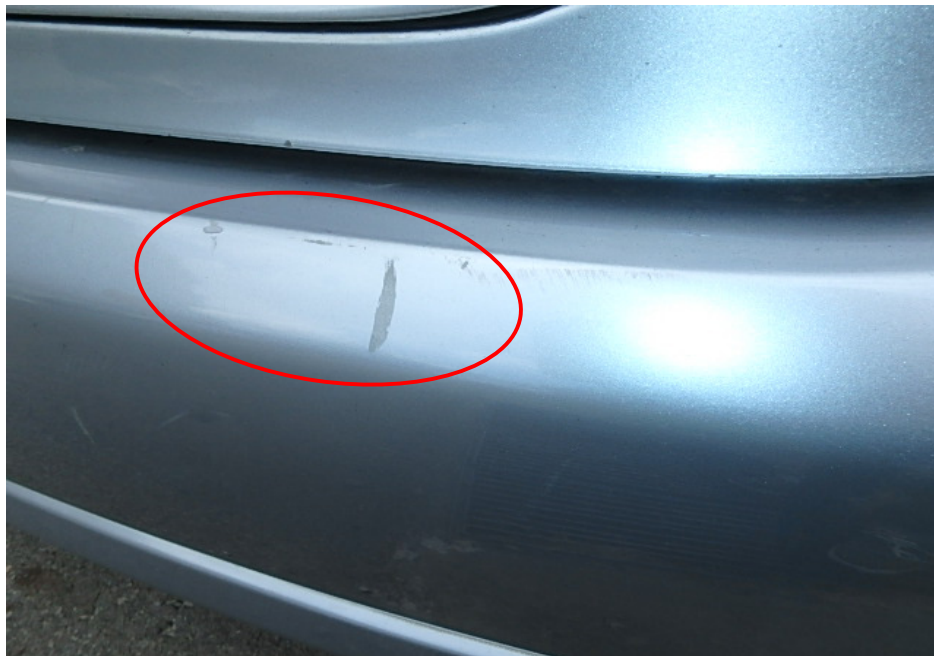
Photo 4 shows a close up view of the paint graze marks found at the centre portion of the rear bumper of the Insured Vehicle (circled), suggesting that the Insured Vehicle might have been rear-ended by another vehicle.

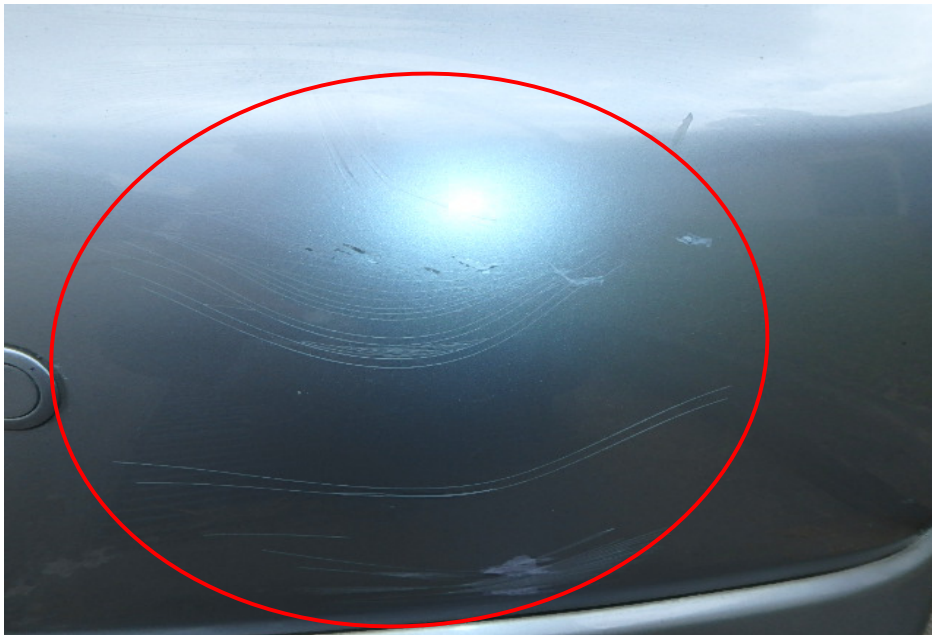
Photo 5 shows a close up view of the paint cracks found at the right portion of the rear bumper of the Insured Vehicle (circled), suggesting that the Insured Vehicle might have been rear-ended by another vehicle.

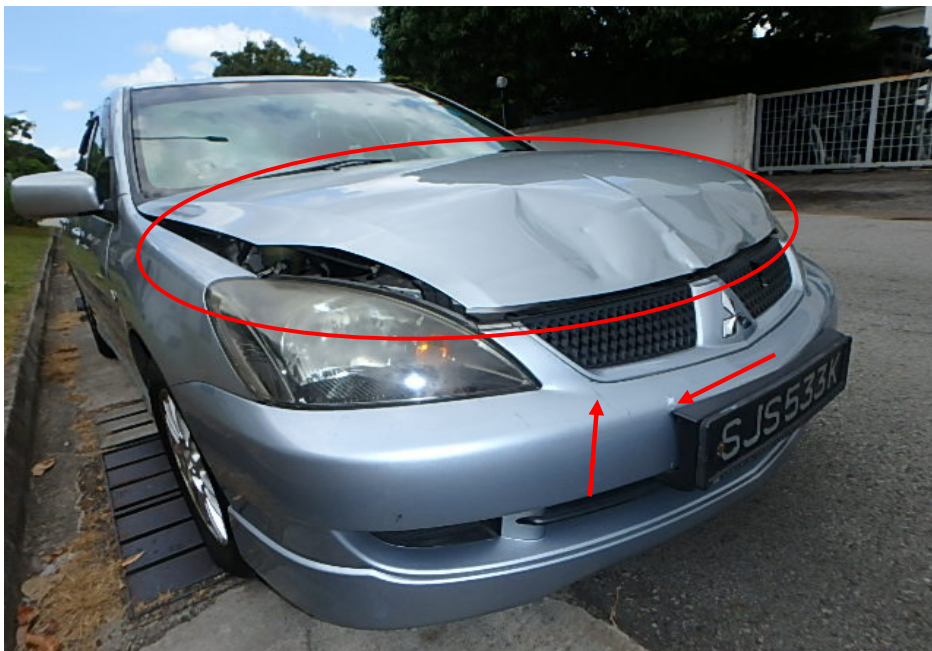
12. Based on the post- accident photographs provided to us by Ms Kaur, the Insured Vehicle had sustained damages to its front portion as a result of the accident.
13. Our physical inspection of the Insured Vehicle at CHM revealed that the Insured Vehicle had sustained damages to its front bumper, front bonnet and rear bumper. The front bonnet was observed to be buckled. Paint graze marks were found at the centre portion of the rear bumper and paint cracks were found at the right portion of the rear bumper. These damages seemed to corroborate with Ms Kaur's statement in which she might have been rear-ended by another vehicle, causing her to panic and accidentally stepping on the accelerator which resulted in the front portion of the Insured Vehicle going under the rear portion of the Lorry. See photos 3 - 6 below.

Photo 6 shows the general front view of the Insured Vehicle during the physical inspection at CHM. The Insured Vehicle had sustained damages to its front bumper (arrowed) and front bonnet. The front bonnet was observed to be buckled (circled). These damages seemed to corroborate with Ms Kaur's statement in which she might have been rear-ended by another vehicle, causing her to panic and accidentally stepping on the accelerator which resulted in the front portion of the Insured Vehicle going under the rear portion of the Lorry

18. Basing on the available evidence gathered during the course of our investigations, we are of the view that the damages to the Insured Vehicle SJS 533K are consistent to the circumstances of the accident, where it was reported that while waiting behind the Lorry at a traffic junction along Jalan Bukit Merah, Ms Kaur may have been hit at the rear by another vehicle, which caused her to accidentally step on the accelerator, resulting in the front portion of the Insured Vehicle going under the Lorry.

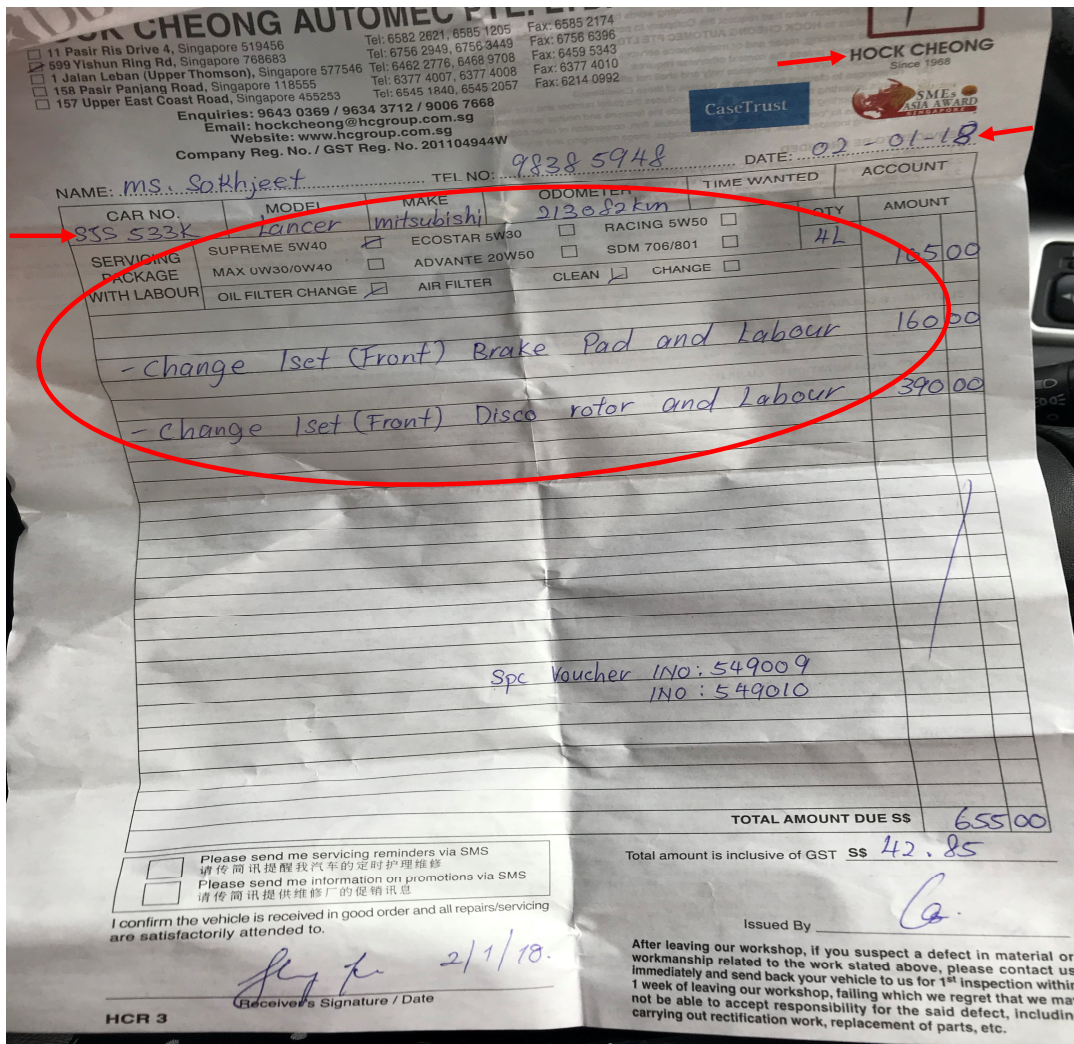
Invoice 1 shows the document relating to the latest servicing that was carried out to the Insured Vehicle on 2 January 2018 at HCA (red arrows). The job scope of this servicing had included changing of the engine oil and oil filter, cleaning of the air filter as well as replacement of the front brake pads and front brake rotors (circled).
