REF: CS/FCI18003695/Krd3ez

Veh No: SHC 5589A Yr Regn: 09, 14

**INITIAL INSPECTION REPORT OF VEHICLE NO. SHC 5589A**

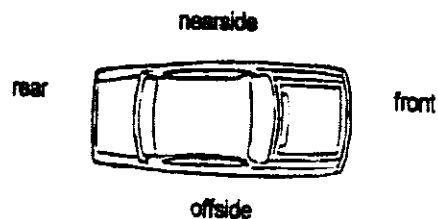
The vehicle sustained damages at the rear n/s portion

**Comments/Present Status:**  
Damages Consistent
