Your ref: D18001301MFSH

Our ref: CS/FCI18003782/Kvd3

**INITIAL INSPECTION REPORT OF VEHICLE NO. SLH 6315T**

## ADJUSTMENT ON REPAIR COST FOR VEHICLE NO. SLH 6315T

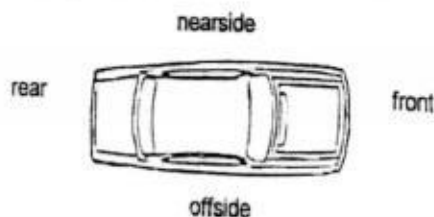
The vehicle sustained damages at the o/s front portion

**Comments/Present Status:**  
Damages Consistent
