Your Ref: SLD 321K
Our Ref : CI/TP18004034/D

01 March 2018

**AUTOMOBILE INSPECTION REPORT OF A LEXUS RX 200T MOTOR CAR
WITH REGISTRATION NUMBER SLD 321K**

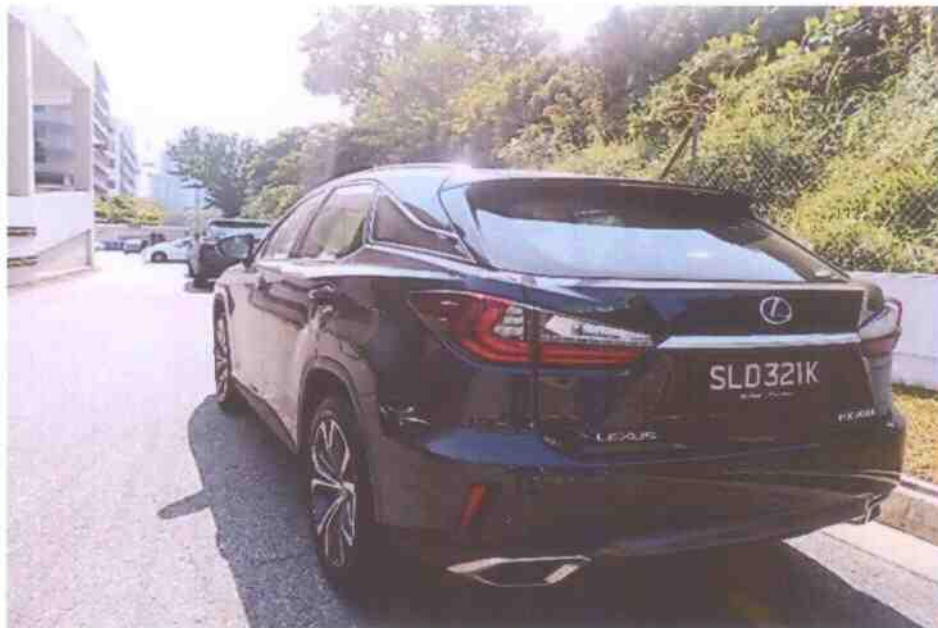
Photo 1 shows the rear left body of the motor car. The motor car was observed to be in good general condition with no loose exterior fittings observed.

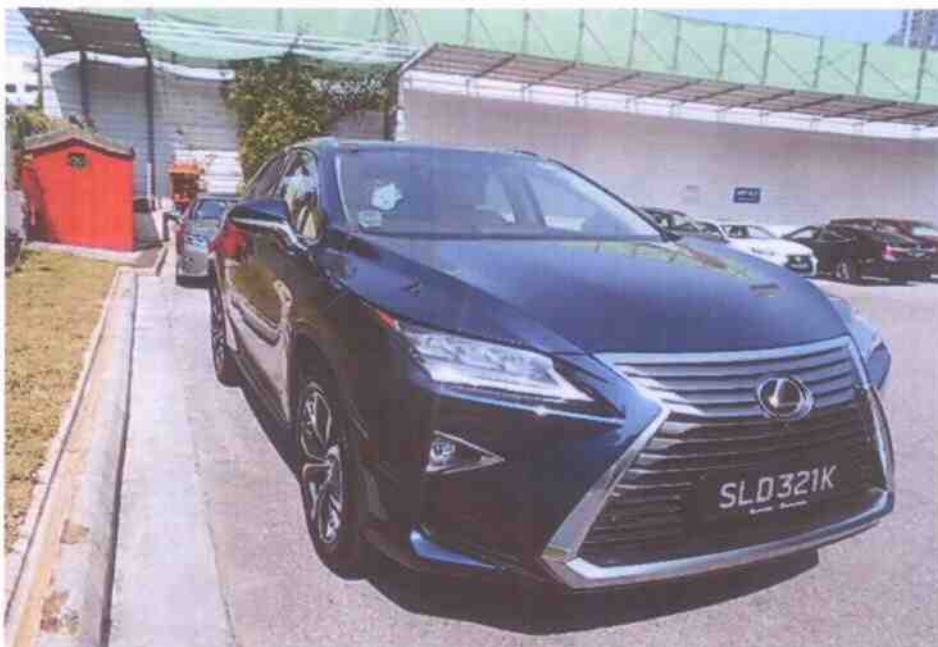
Photo 2 shows the front right body of the motor car. The motor car was observed to be in good general condition with no loose exterior fittings observed. There was also no visible damage observed on its exterior body. The mileage of the motor car at the time of my inspection was 15,131km.

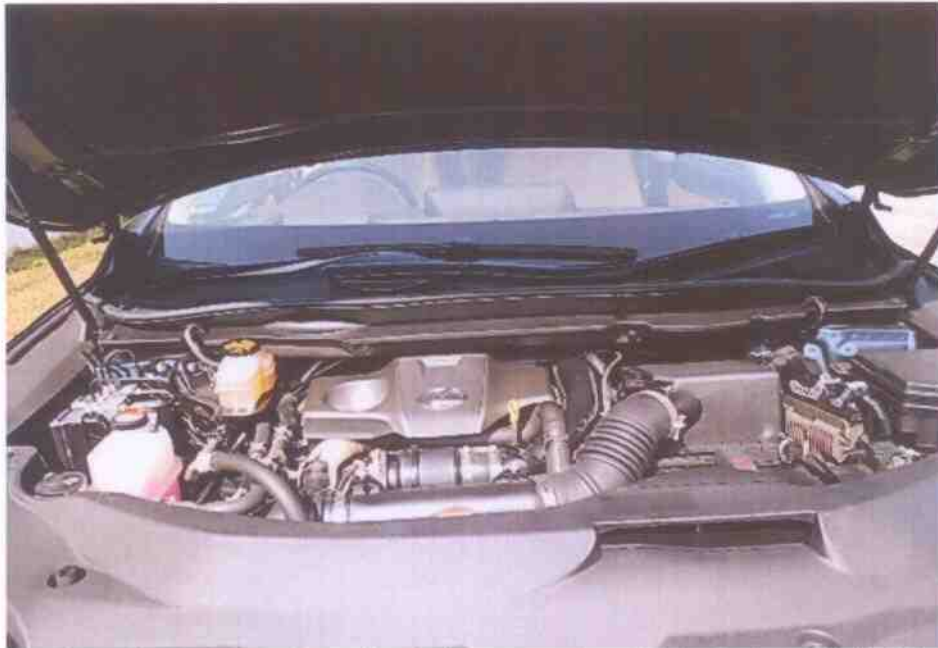
5. Upon checking the engine compartment of the motor car, I had observed that the various mechanical components, hoses and sensors were all intact and securely fitted/attached. This had included the air intake housing, air duct, engine top cover, engine coolant hoses, air con pipes and wiring harness amongst others.

Photo 3 shows the motor car's engine compartment. I had observed that the various mechanical components, hoses and sensors were all intact and securely fitted/attached. This had included the air intake housing, air duct, engine top cover, engine coolant hoses, air con pipes and wiring harness amongst others. The engine compartment was also observed to be relatively clean with no fluid stain(s) and/or fluid leak(s) found.

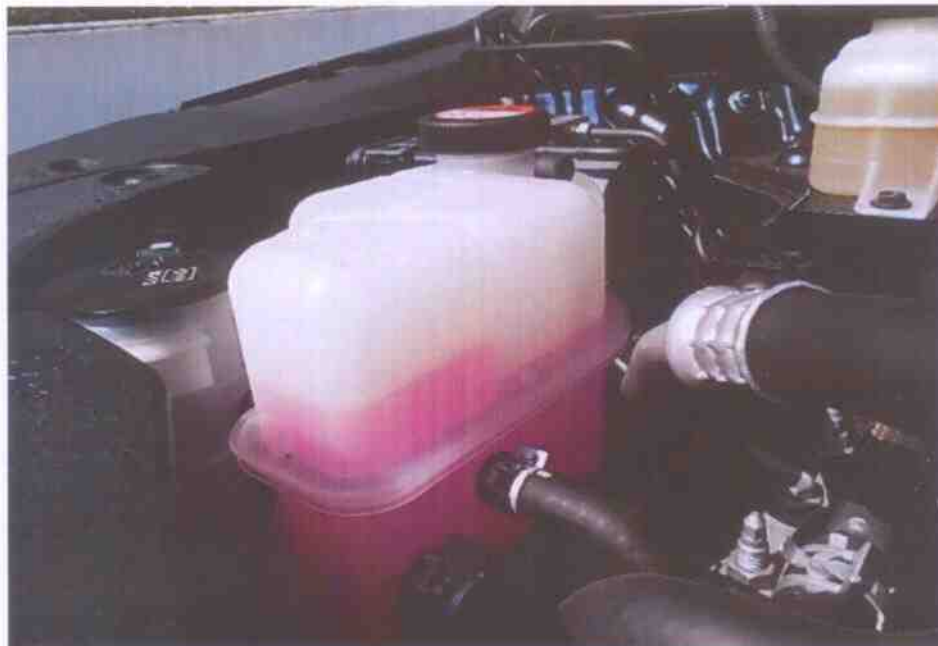
Photo 4 shows the engine coolant reservoir of the motor car at the time of my inspection. The engine coolant was observed to be of sufficient level and without any visible contamination.

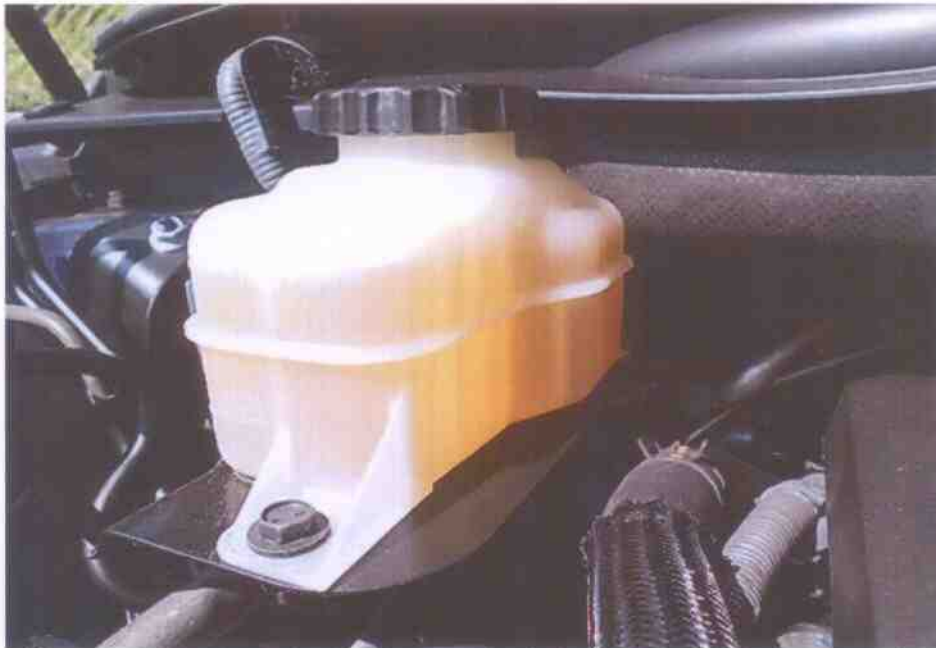
Photo 5 shows the brake fluid reservoir of the motor car at the time of my inspection. The brake fluid was observed to be of sufficient level for operating purposes and without any visible contamination.

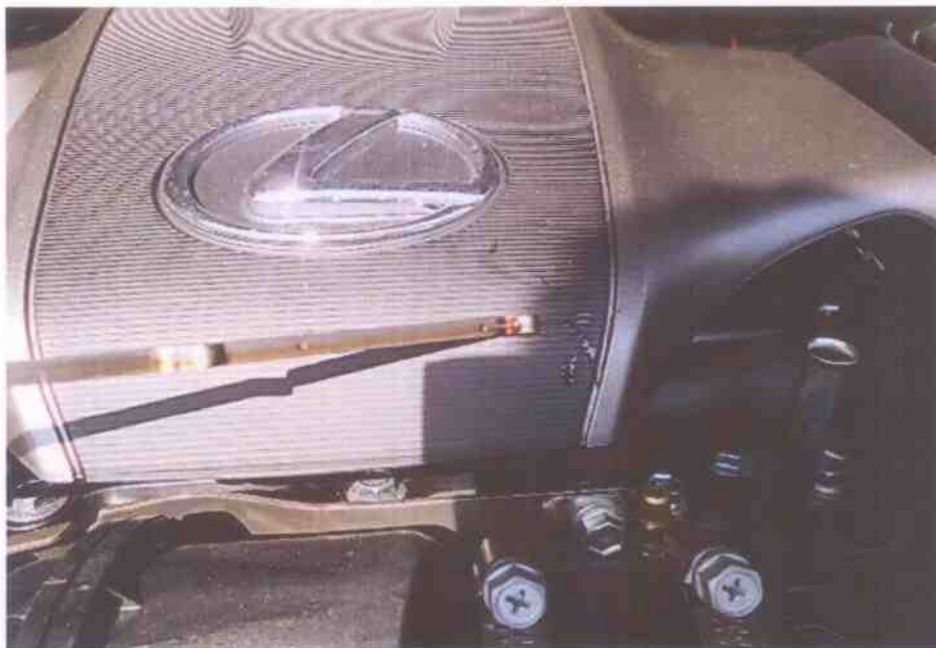
Photo 6 shows the engine oil dip stick of the motor car at the time of my inspection. The engine oil was observed to be of sufficient level and without any visible contamination.

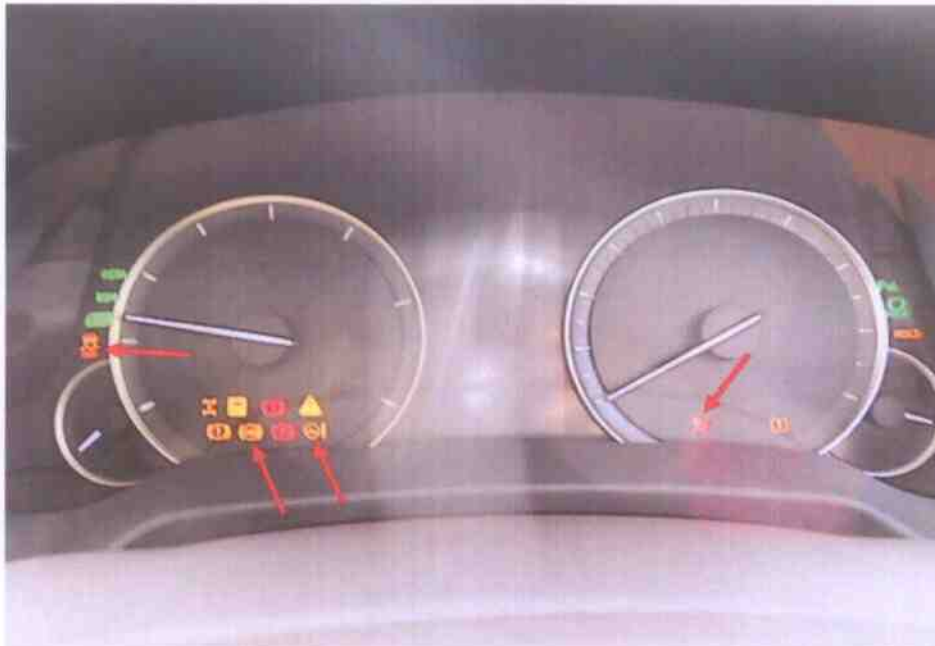
Photo 7 shows the warning light for Anti-Lock Brake System (ABS), Electric Power Steering System (EPS), Traction Control (TC) and Supplemental Restraint System (SRS) appearing on the instrument panel of the motor car during the self-test of its various electronic operating systems when its engine was cranked.

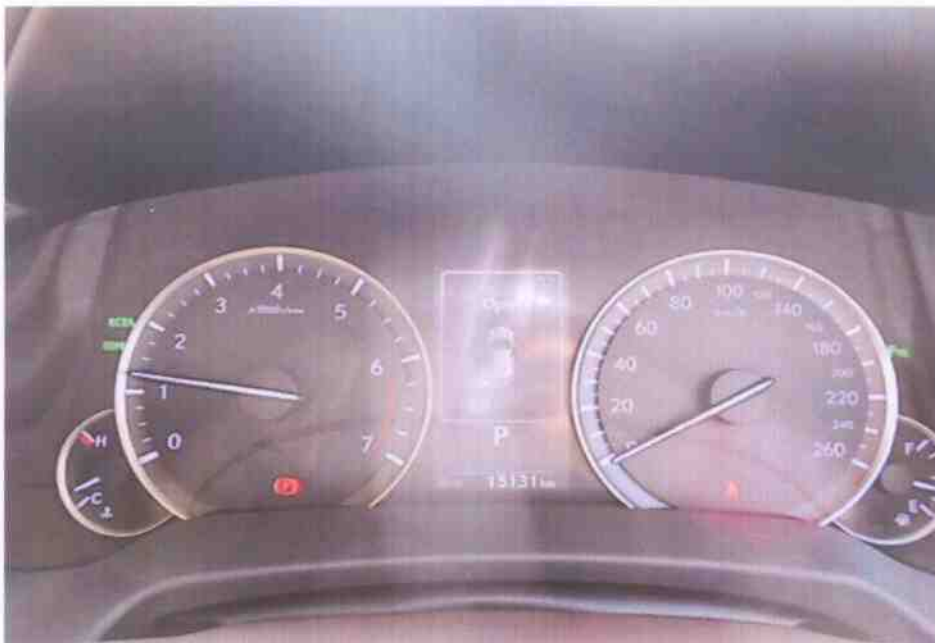
8. The motor car's automatic self-test of the functionality of its various electronic operating systems like the Anti-Lock Brake System (ABS), Electric Power Steering System (EPS), Traction Control (TC) and Supplemental Restraint System (SRS) during cranking of the engine had indicated that these electronic operating systems were in working condition and without abnormality. This can be established from the warning lights disappearing from the instrument panel after the self-test.

Photo 8 shows no warning lights illuminated on the instrument panel of the motor car after the engine was cranked. This would suggest that there was no abnormality to the various electronic operating systems of the motor car, like the ABS, EPS, TC and SRS etc.

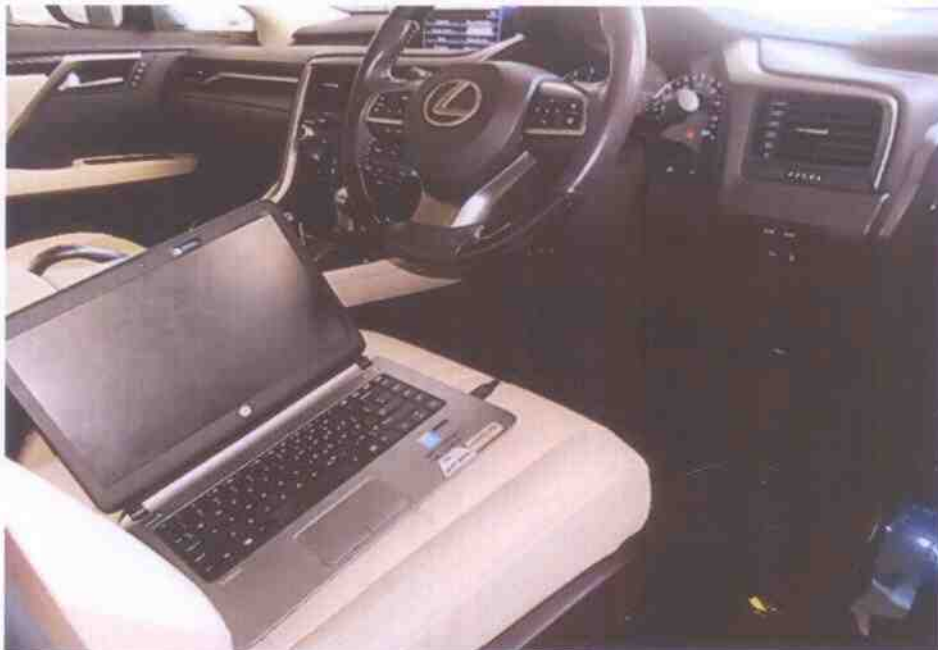
Photo 9 shows an electronic scan being carried out to the motor car to primarily check whether there was any electronic fault recorded in the various control modules of the motor car like the engine control module and transmission control module amongst others.

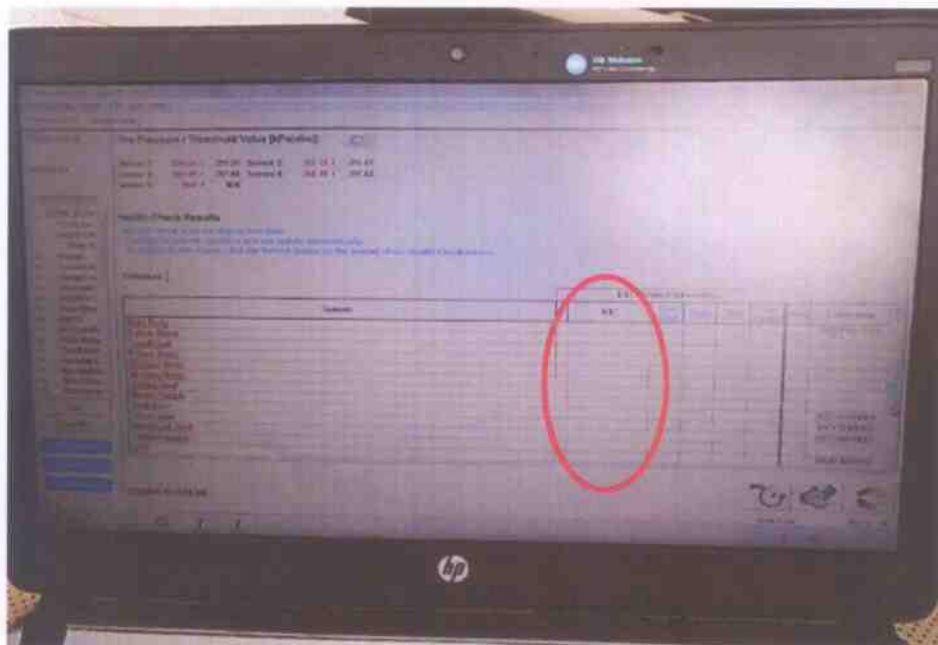
9. Upon my request, an electronic scan was carried out to the motor car to primarily check whether there was any electronic fault recorded in the various control modules of the motor car like the engine control module and transmission control module amongst others. The result after the scan had indicated that there was no electronic fault recorded in the various control modules of the motor car at the time of my inspection.

Photo 10 shows the result after the scan. There was no electronic fault reflected in the fault column (circled), indicating that there was no electronic fault recorded in the various control modules of the motor car at the time of my inspection.
