Your Ref: TP/IP/09681/2017  
Our Ref : CI/TPD18004126/Z

05<sup>th</sup> March 2018

### **MECHANICAL INSPECTION REPORT OF MOTOR CAR SKA 2010Y**

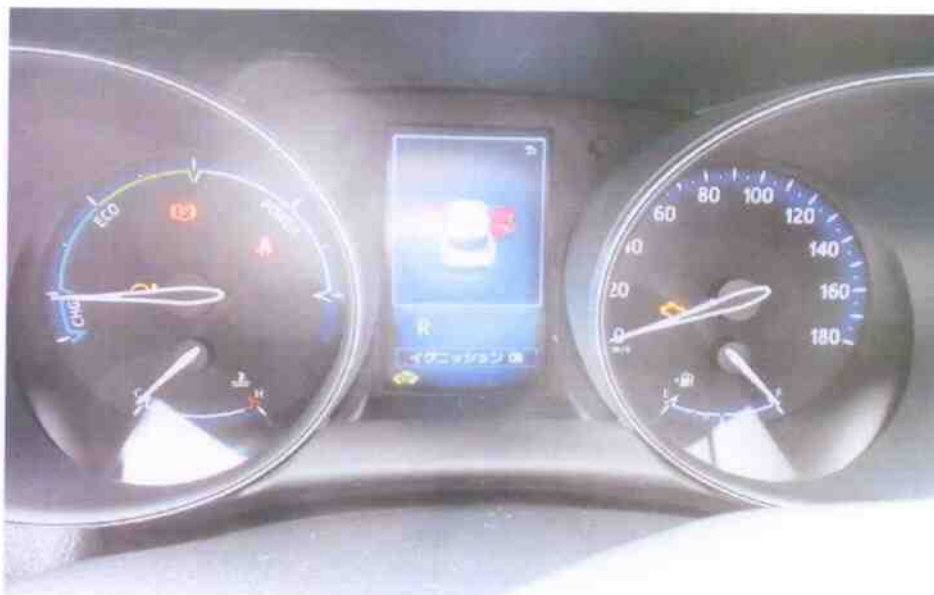
**Photo 1** shows the mileage of the Motor Car at the time of our inspection was not recorded due to the Motor Car's system malfunction likely due to the accidents collision impact.

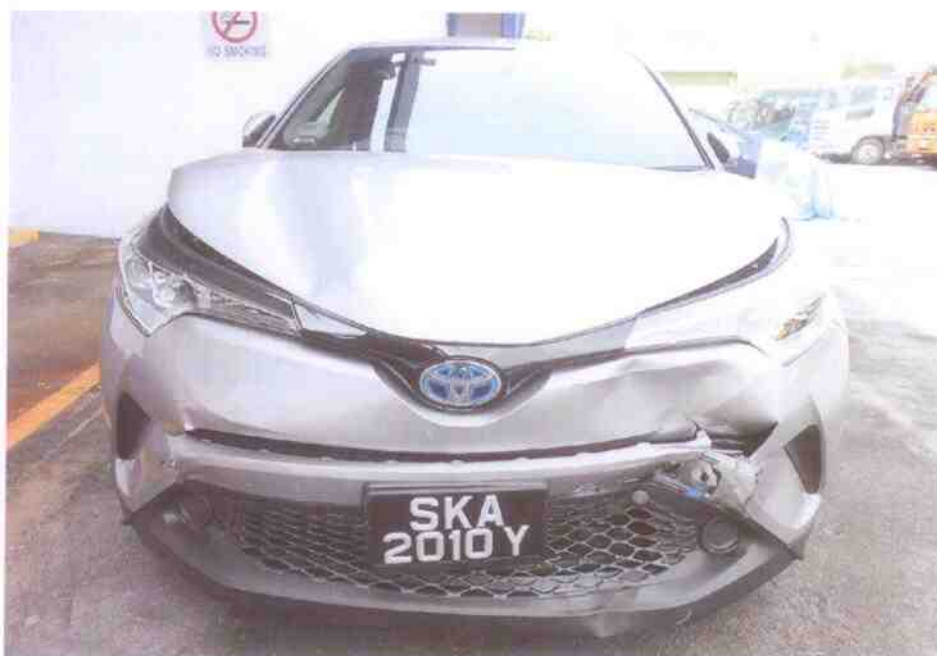
**Photo 2** shows a general view of the front body of the Motor Car at the time of our inspection. The Motor Car was observed to have sustained relatively minor damages at the frontal, front left & front right portion.

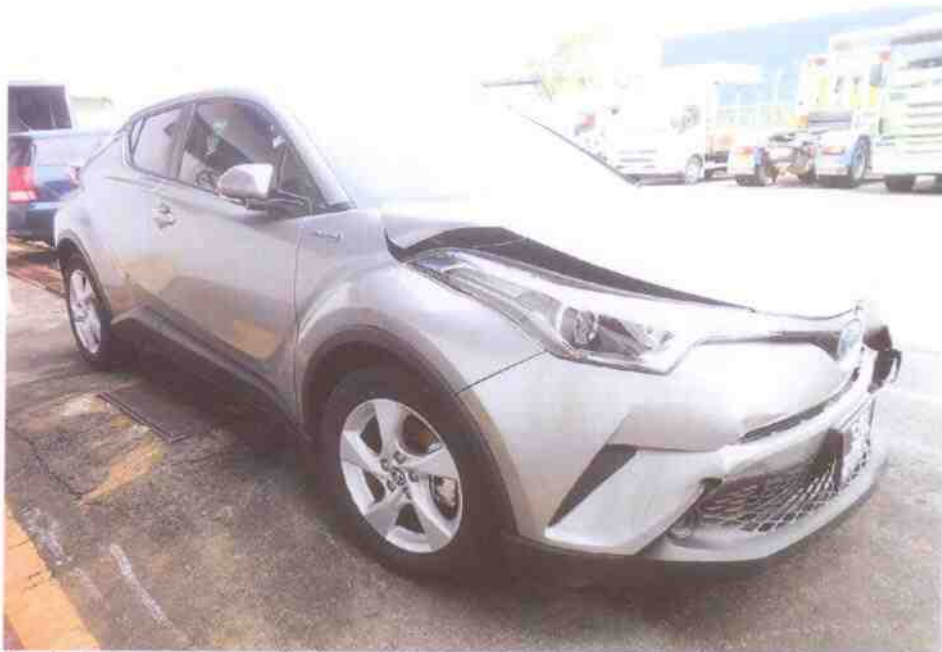
**Photo 3** shows a general view of the front right body of the Motor Car at the time of our inspection. The Motor Car was observed to have sustained relatively minor damages at the frontal, front left & front right portion.

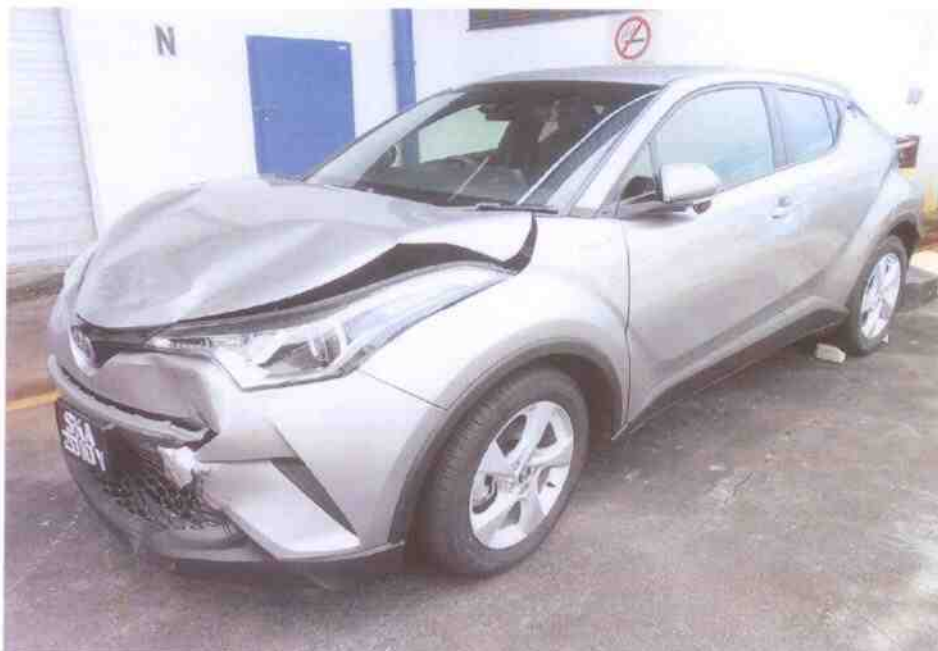
**Photo 4** shows a general view of the front left body of the Motor Car at the time of our inspection. The Motor Car was observed to have sustained minor damages at the left frontal portion.

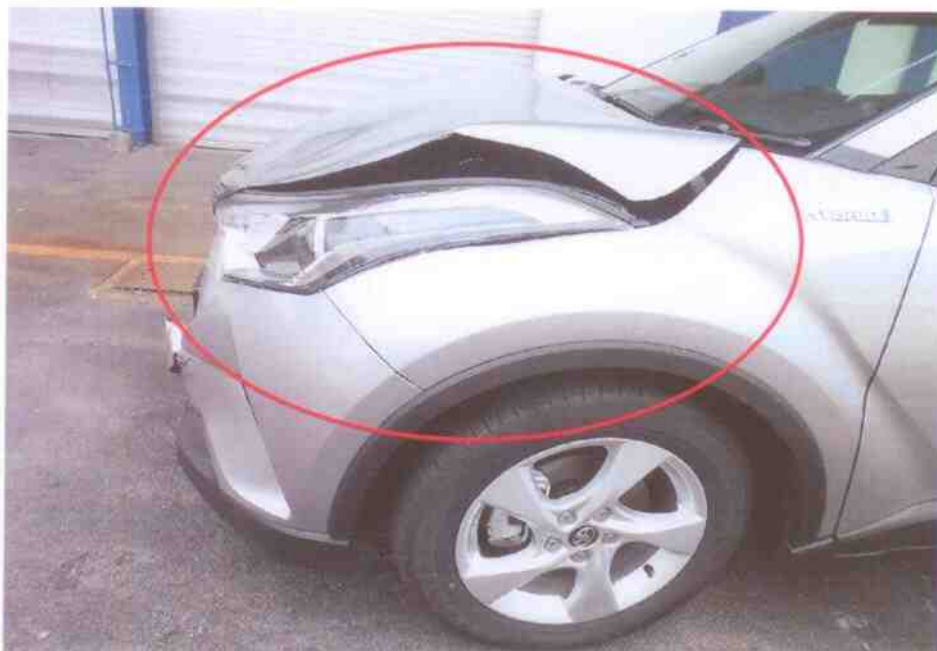
**Photo 5** shows a close up view of the front left side fender of the Motor Car at the time of our inspection. It had sustained damages likely due to the accident.

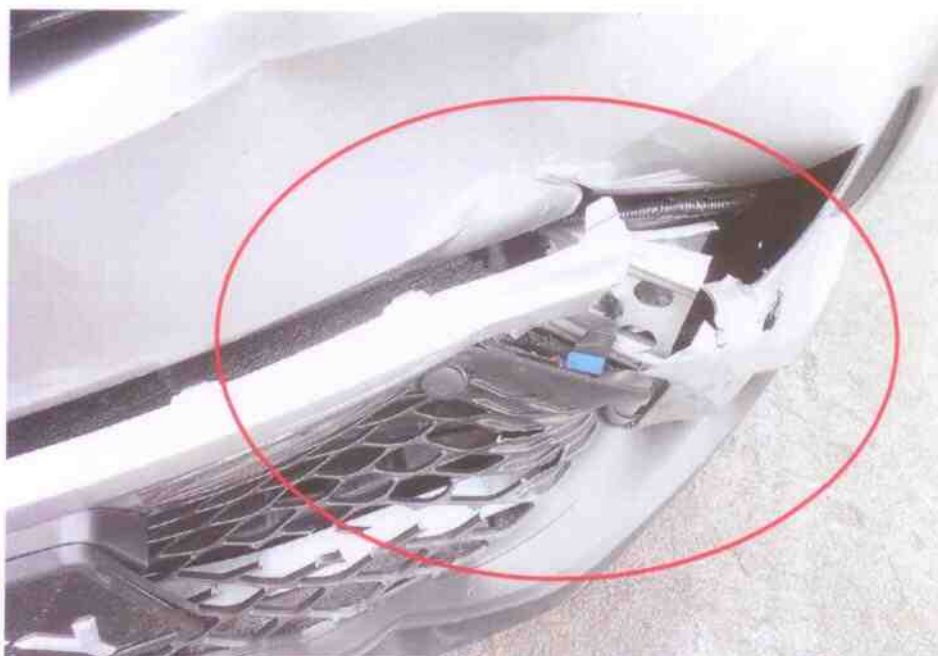
**Photo 6** shows a close up view of the front left lower bumper of the Motor Car at the time of our inspection. It had sustained damages likely due to the accident.

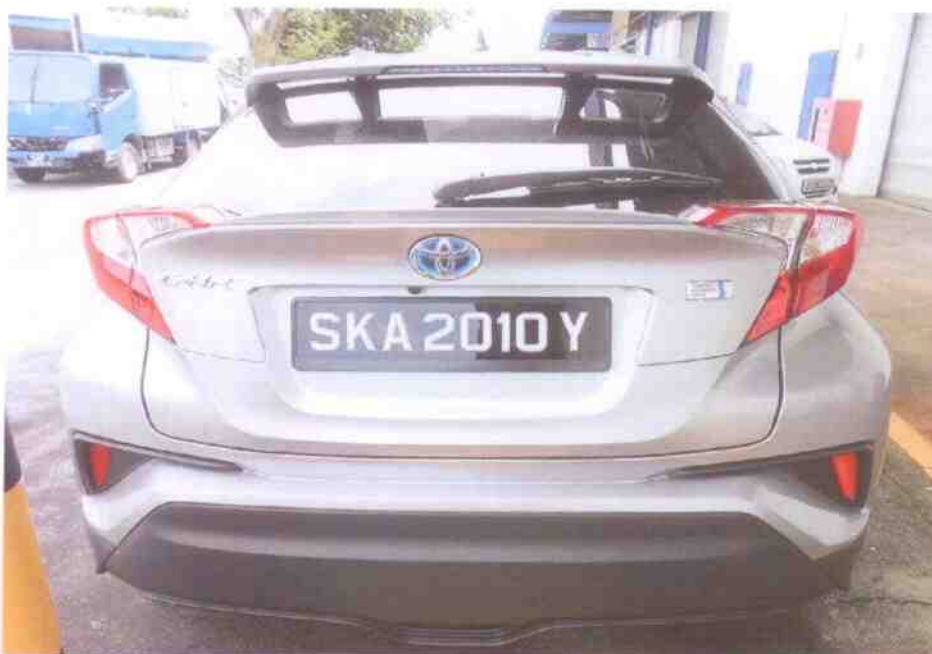
Photo 7 shows a general view of the rear body of the Motor Car at the time of our inspection. The Motor Car was observed to be in good general condition.

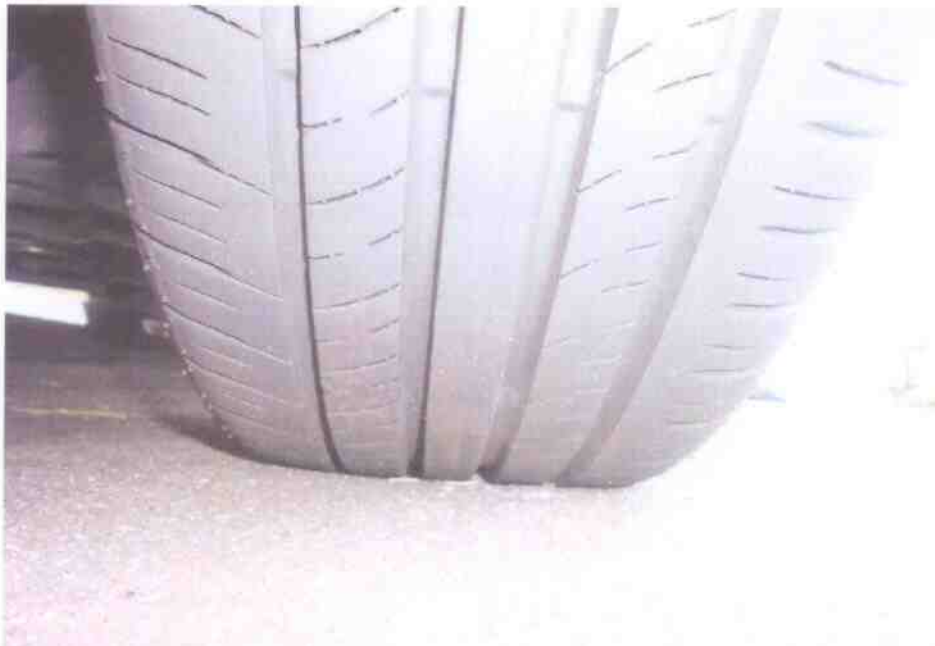
**Photo 8** shows the condition of the front left tyre of the Motor Car, which was observed to be in serviceable condition with remaining tread depth of approximately 7mm. The tyre was also observed to be sufficiently inflated for vehicular operation.

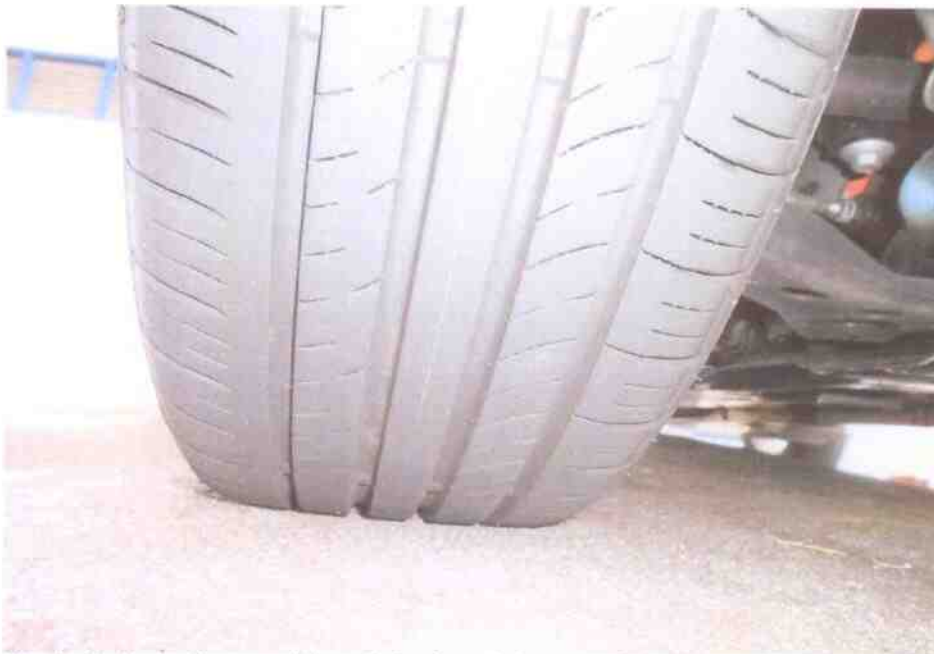
**Photo 9** shows the condition of the front right tyre of the Motor Car, which was observed to be in serviceable condition with remaining tread depth of approximately 6mm. The tyre was also observed to be sufficiently inflated for vehicular operation.

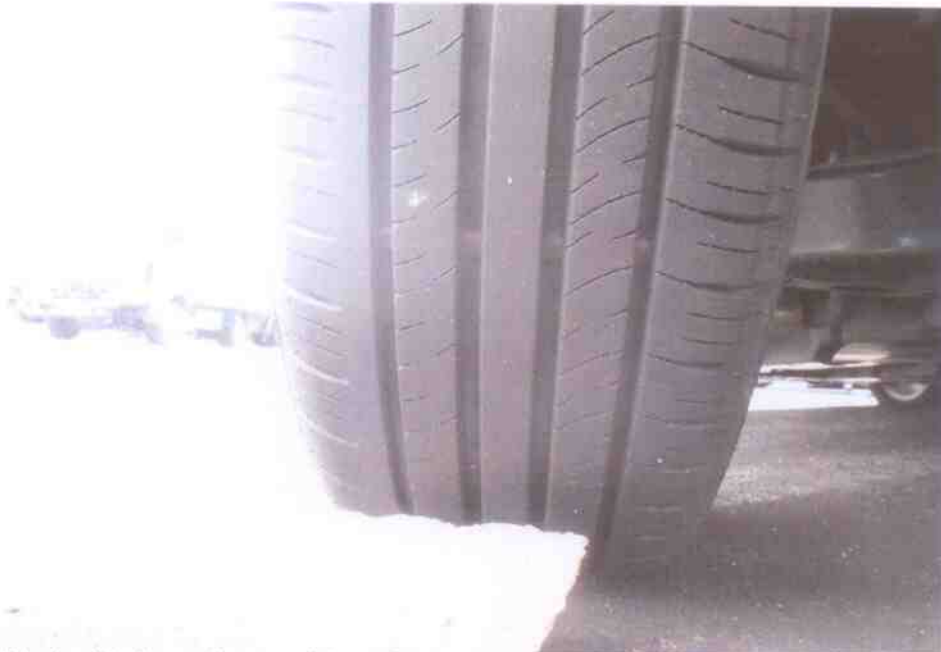
**Photo 10** shows the condition of the rear left tyre of the Motor Car, which was observed to be in serviceable condition with remaining tread depth of approximately 7mm. The tyre was also observed to be sufficiently inflated for vehicular operation.

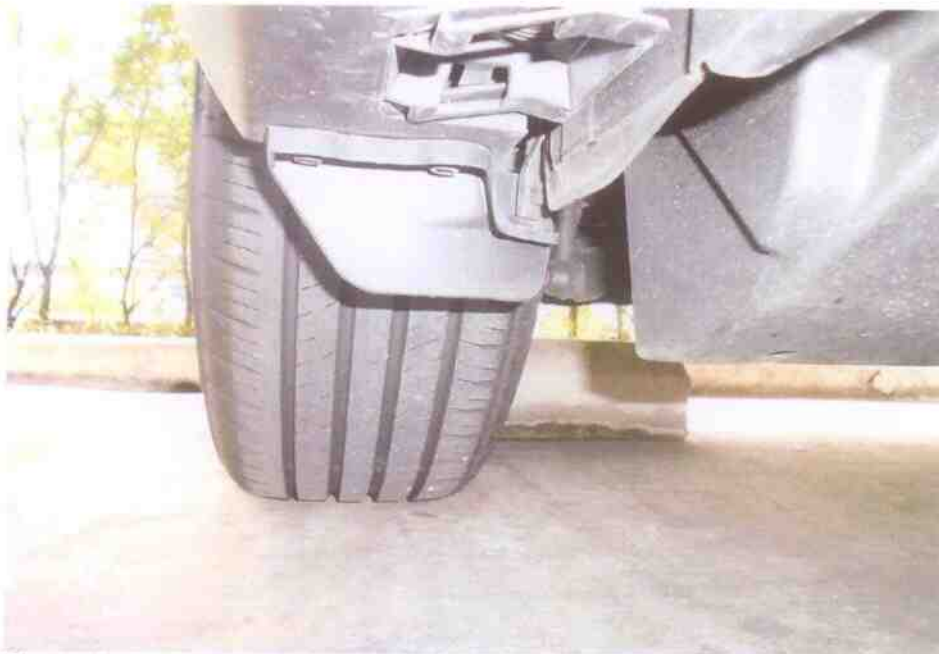
**Photo 11** shows the condition of the rear right tyre of the Motor Car, which was observed to be in serviceable condition with remaining tread depth of approximately 7mm. The tyre was also observed to be sufficiently inflated for vehicular operation.

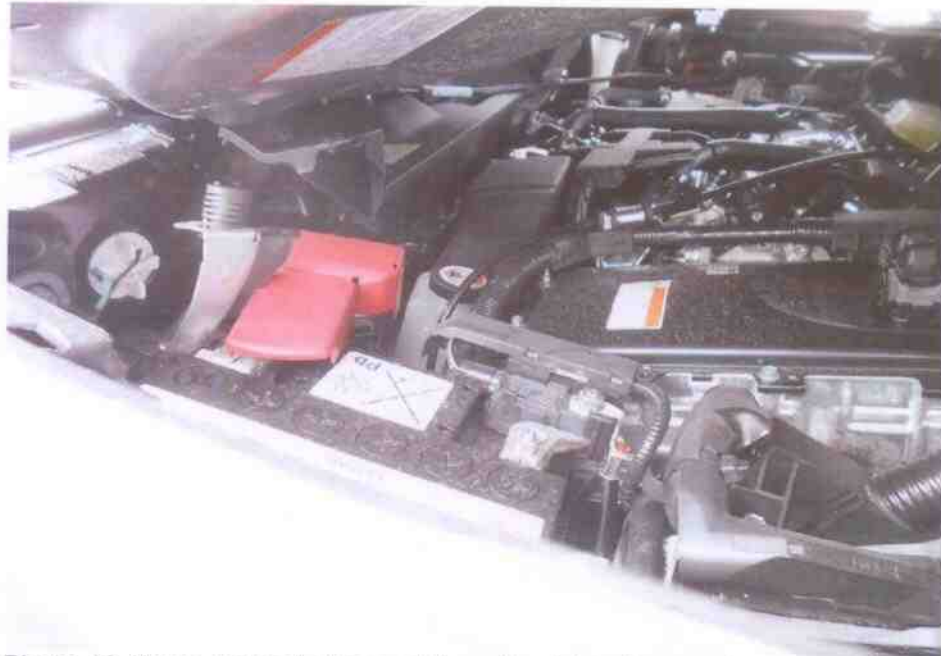
**Photo 12** shows we had observed from the right side opening caused by the accident's impact that some visible parts and components inside the engine compartment to be intact and unaffected by the accident.

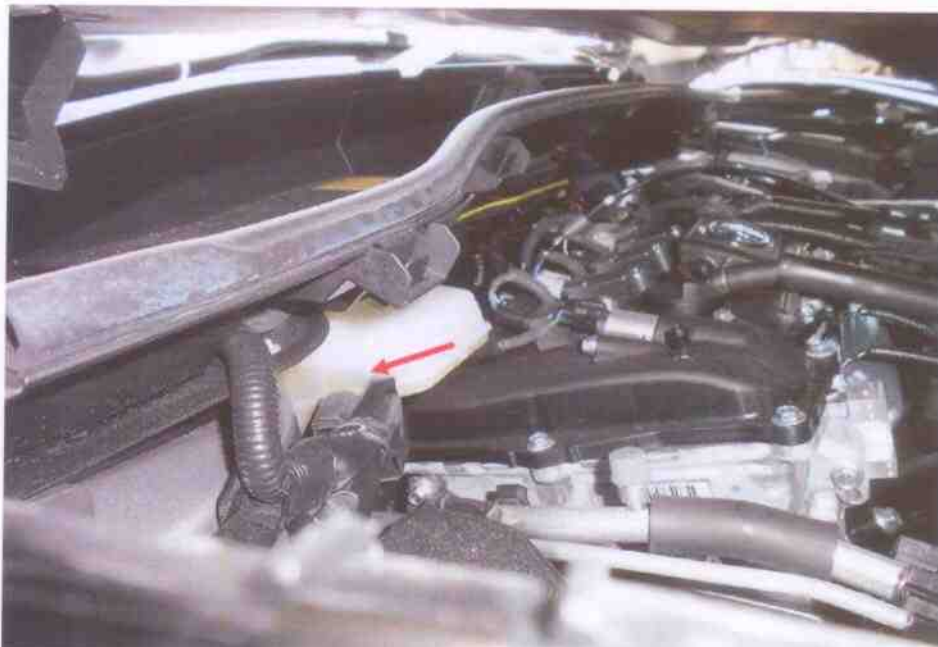
**Photo 13** shows we had observed from the left side opening caused by the accident's impact that some visible parts and components inside the engine compartment to be intact and unaffected by the accident. Fluid component such as brake fluid was visible and found to be of sufficient level for operating purposes. Visually, there was also no contamination found to this fluid.

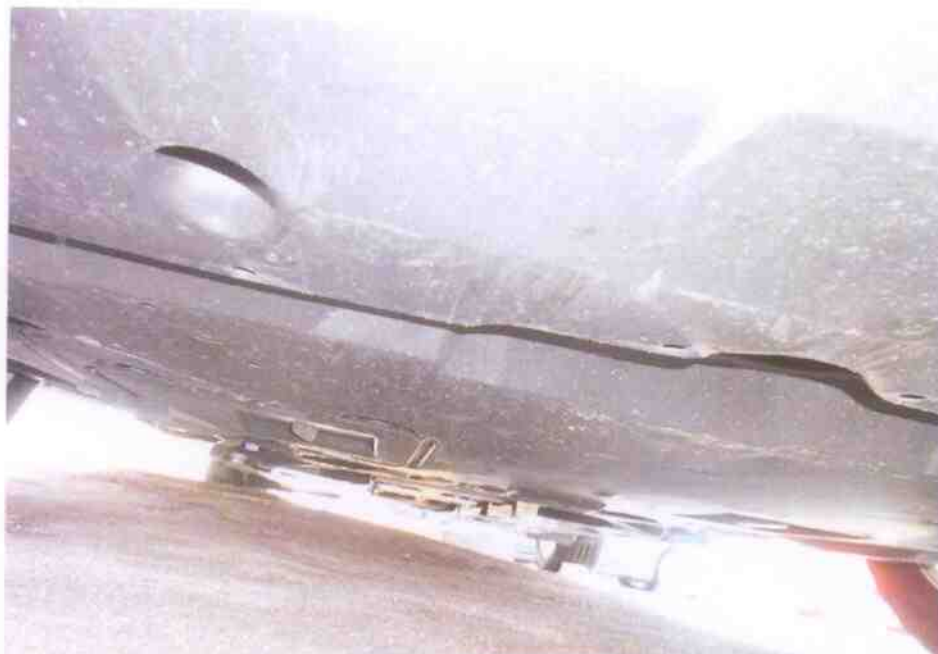
**Photo 14** shows our subsequent checks on the underside of the Motor Car also revealed no fluid stain. Visually, the various undercarriage components of the Motor Car were all observed to be intact and without any visible damage.

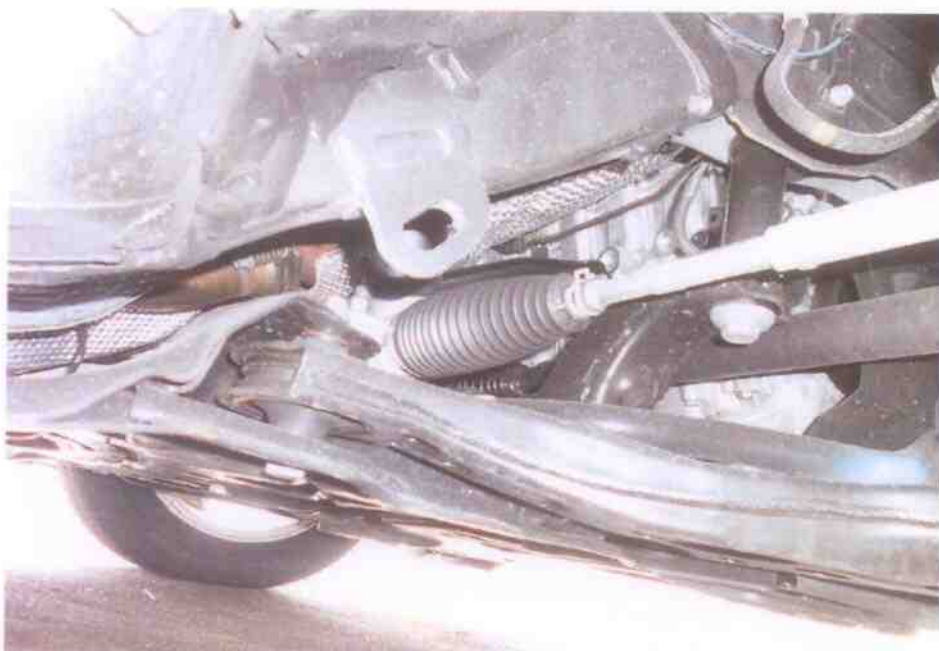
**Photo 15** shows our subsequent checks on the underside of the Motor Car also revealed no fluid stain. Visually, the various undercarriage components of the Motor Car were all observed to be intact and without any visible damage.

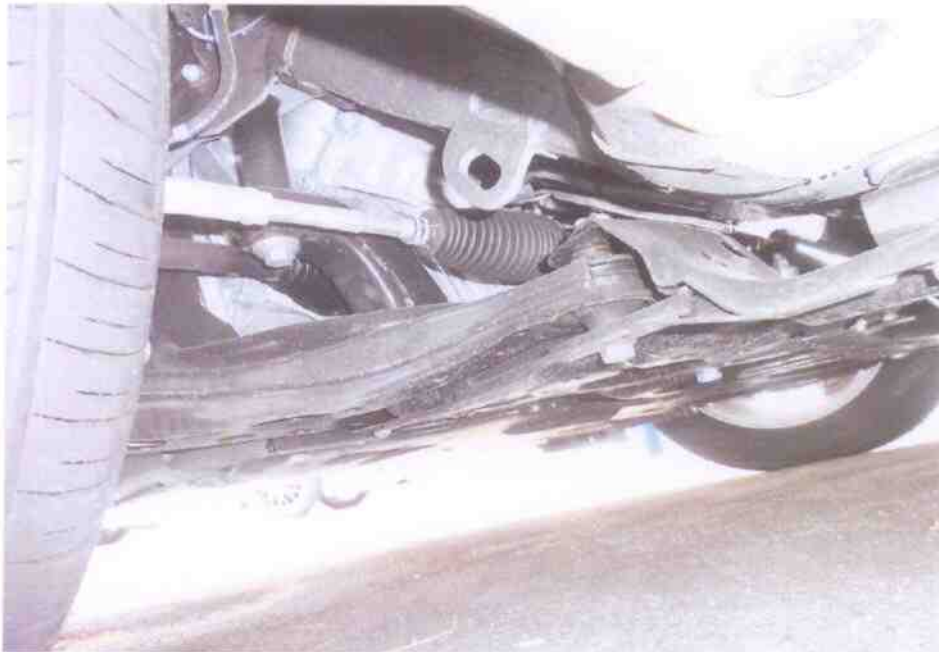
**Photo 16** shows our subsequent checks on the underside of the Motor Car also revealed no fluid stain. Visually, the various undercarriage components of the Motor Car were all observed to be intact and without any visible damage.

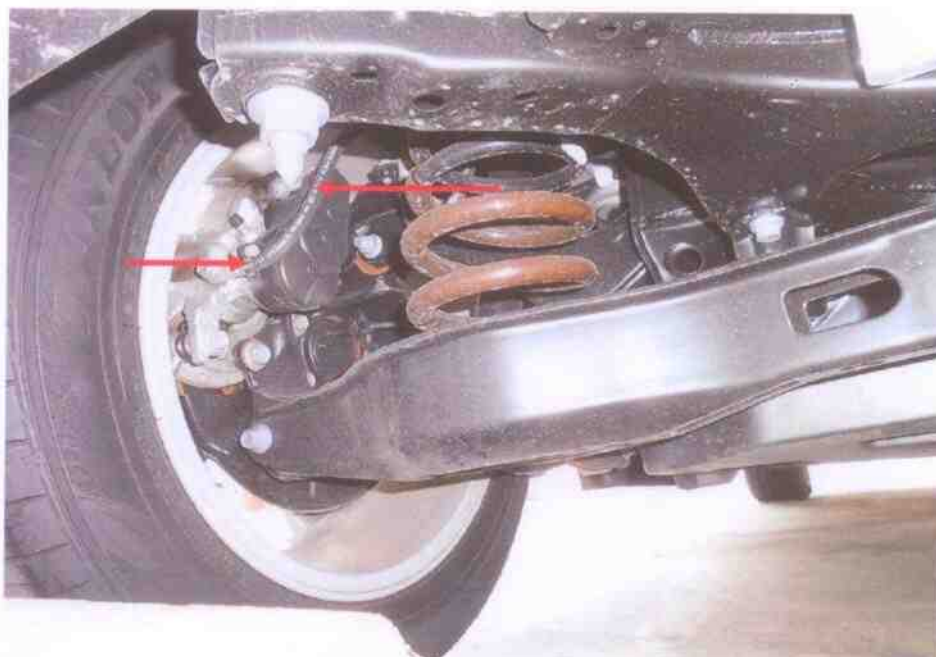
**Photo 17** shows the brake hose (arrowed) at the rear left wheel of the Motor Car. Our visual inspection of the various mechanical components of the Motor Car's braking system revealed all to be intact and without visible damage, indicating that the braking system was likely to be in serviceable condition at the material time of accident.

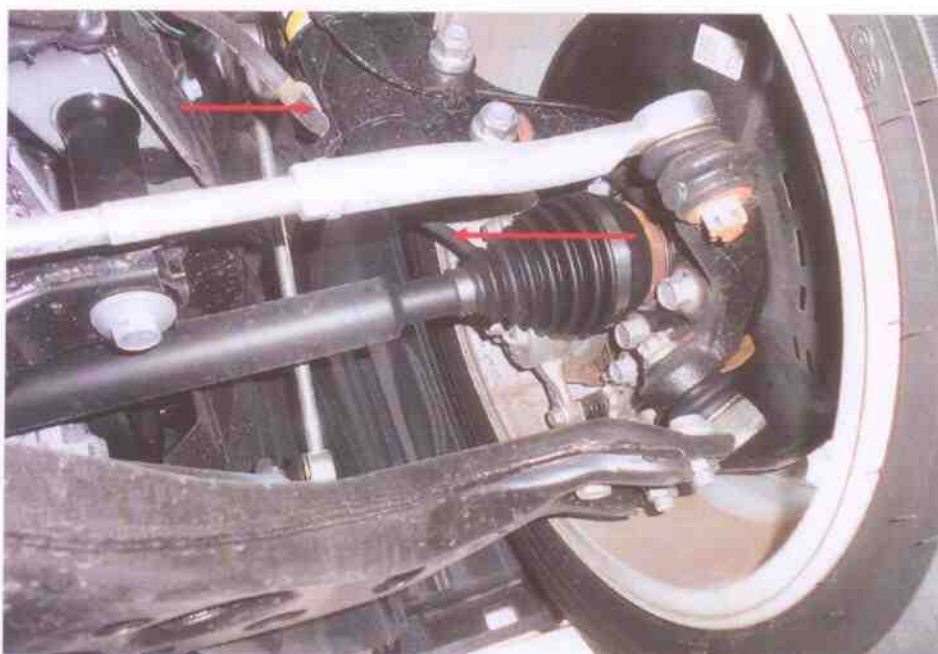
**Photo 18** shows the brake hose (arrowed) at the front right wheel of the Motor Car. Our visual inspection of the various mechanical components of the Motor Car's braking system, including its brake calliper, revealed all to be intact and without visible damage, indicating that the braking system was likely to be in serviceable condition at the material time of accident.

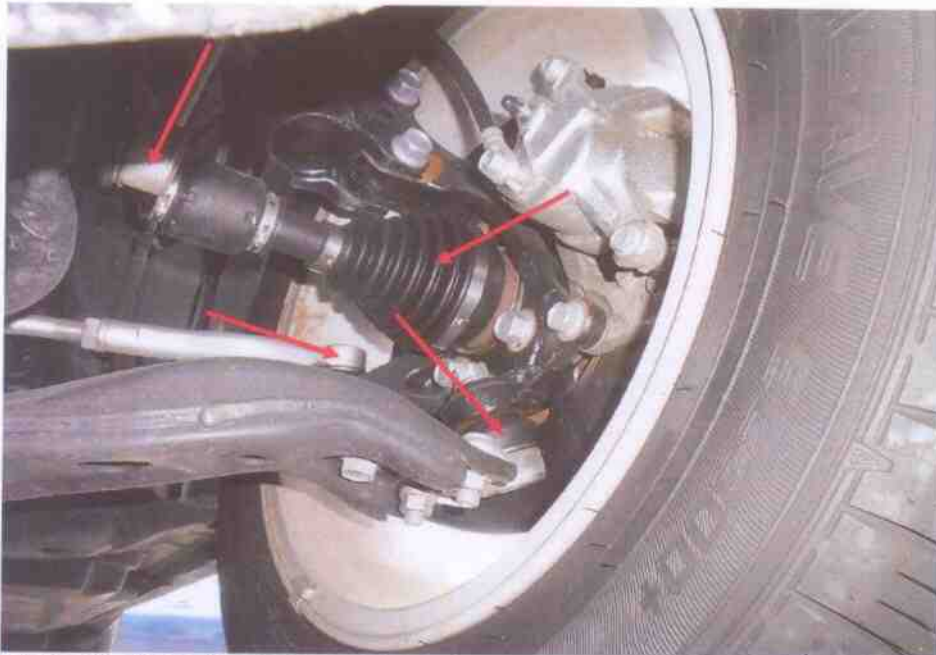
**Photo 19** shows the various undercarriage components at the front left wheel of the Motor Car, in particular the steering tie rod (arrowed). The various steering components were all found to be intact, suggesting that the steering system of the Motor Car was likely to be in serviceable condition.

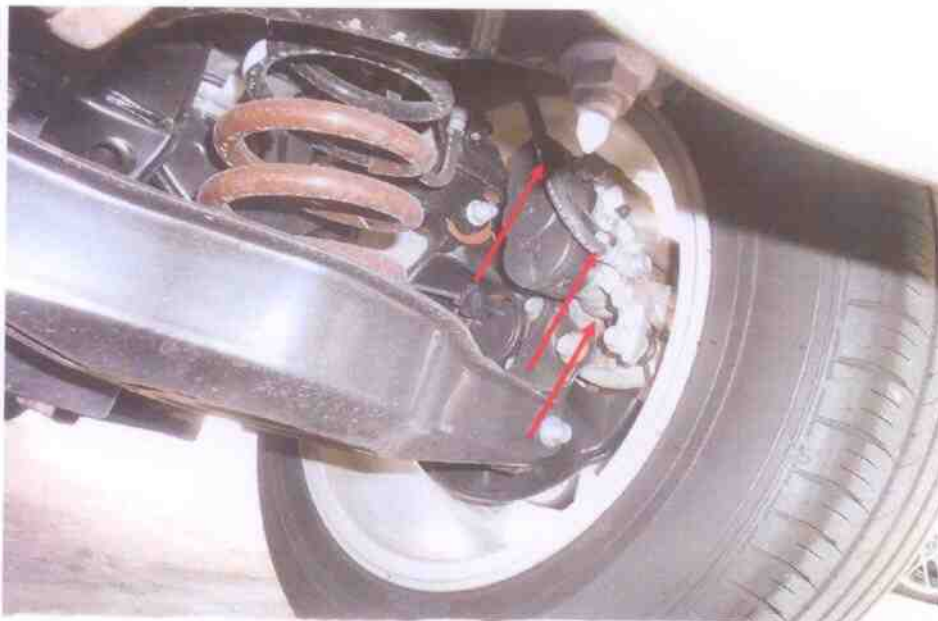
**Photo 20** shows the various undercarriage components at the rear right wheel of the Motor Car. We did not observe any leakage of brake fluid at the time of our inspection of the Motor Car. Our visual inspection of the various mechanical components of the Motor Car's braking system revealed all to be intact and without visible damage, indicating that the braking system was likely to be in serviceable condition at the material time of accident.

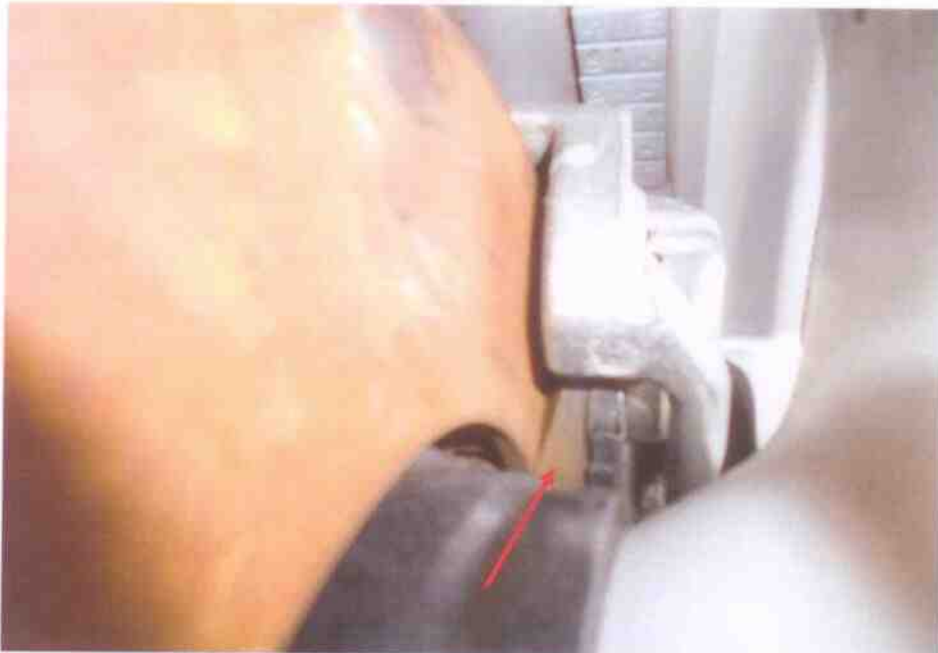
**Photo 21** shows the front right brake pad of the Motor Car. It was observed to be in serviceable condition looking at the thickness of the brake pad at time of our inspection.

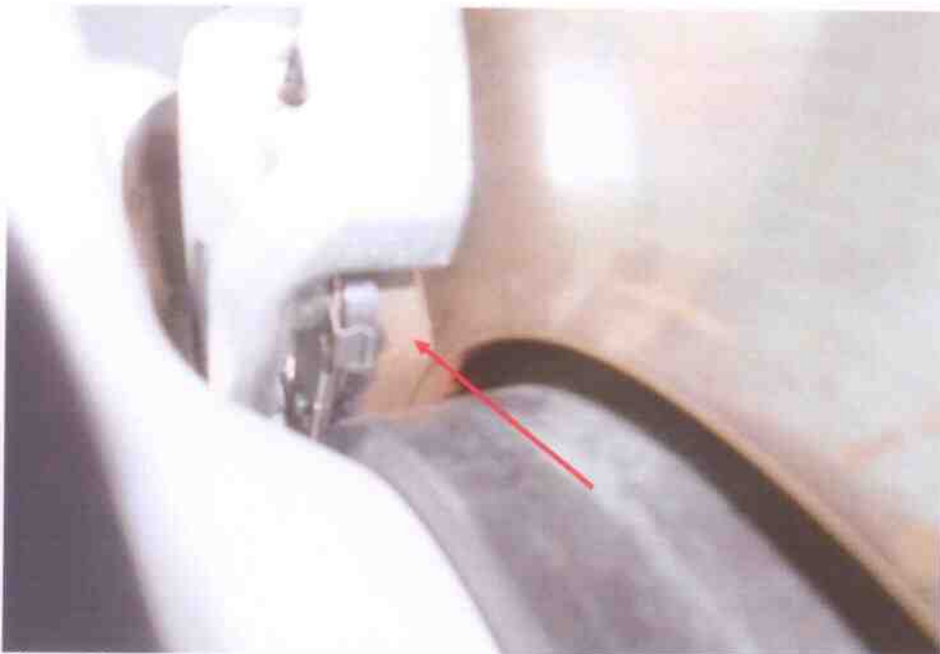
**Photo 22** shows the front left brake pad of the Motor Car. It was observed to be in serviceable condition looking at the thickness of the brake pad at time of our inspection.

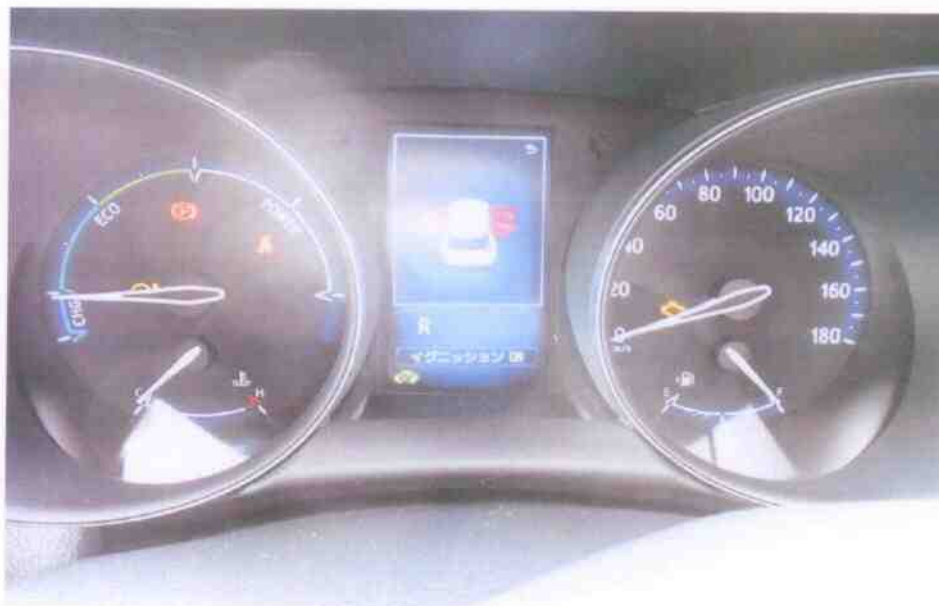
**Photo 23** shows the warning indicators were observed to be lighted up upon pressing on the start button but no cranking of engine was observed. It was observed to be stuck to the 'Reverse Mode' even after we shifted to other modes. This indicates that the Motor Car electronic systems were malfunction likely due to the accident's collision impact.

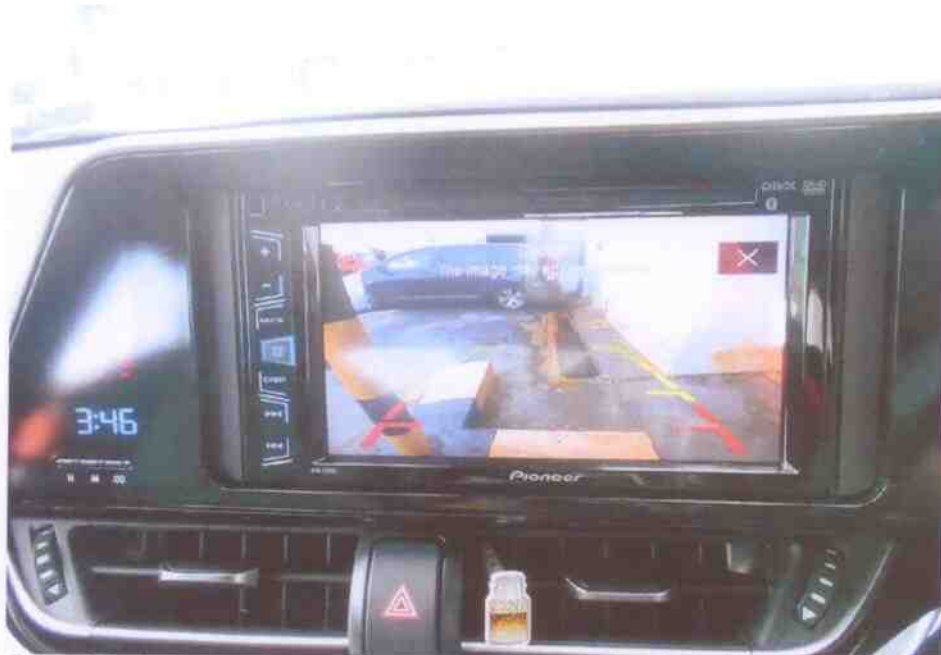
**Photo 24** shows the reverse camera showed the rear view upon pressing on the start button but no cranking of engine was observed. It was observed to be stuck to the 'Reverse Mode' even after we shifted to other modes. This indicates that the Motor Car electronic systems were malfunction likely due to the accident's collision impact.

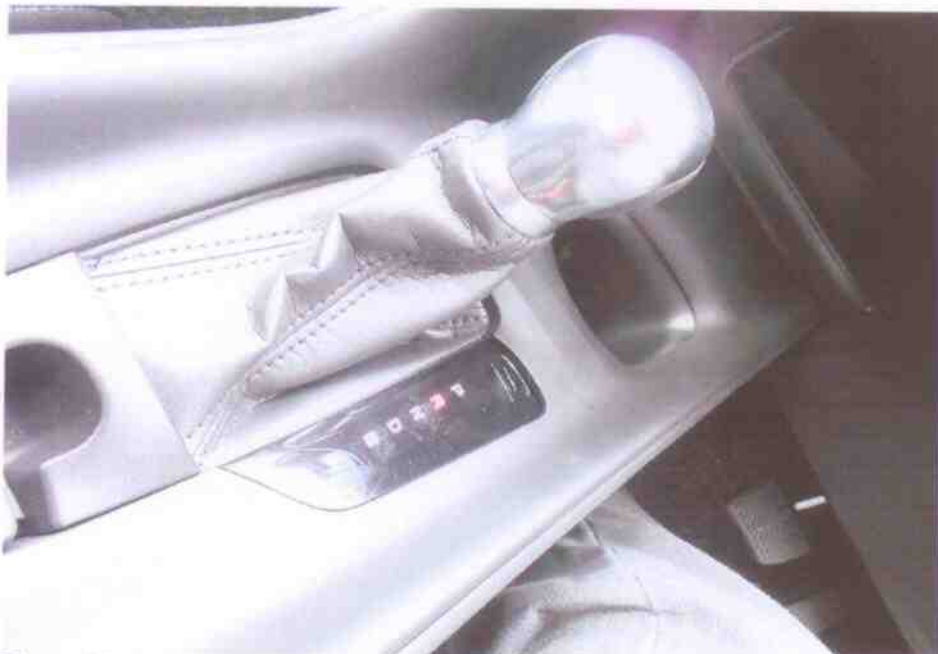
**Photo 25** shows the gear knob was shifted to the 'Parking Mode' but the indicator still showed the 'Reverse mode'. Upon pressing on the start button but no cranking of engine was observed. It was observed to be stuck to the 'Reverse Mode' even after we shifted to other modes. This indicates that the Motor Car electronic systems were malfunction likely due to the accident's collision impact.
