Your Ref: M1801211
Our Ref :CS/TMI18004268/D

02 April 2018

**TECHNICAL INVESTIGATION REPORT OF FIRE INCIDENT INVOLVING THE
INSURED VEHICLE XD 1815D ON 02 MARCH 2018**

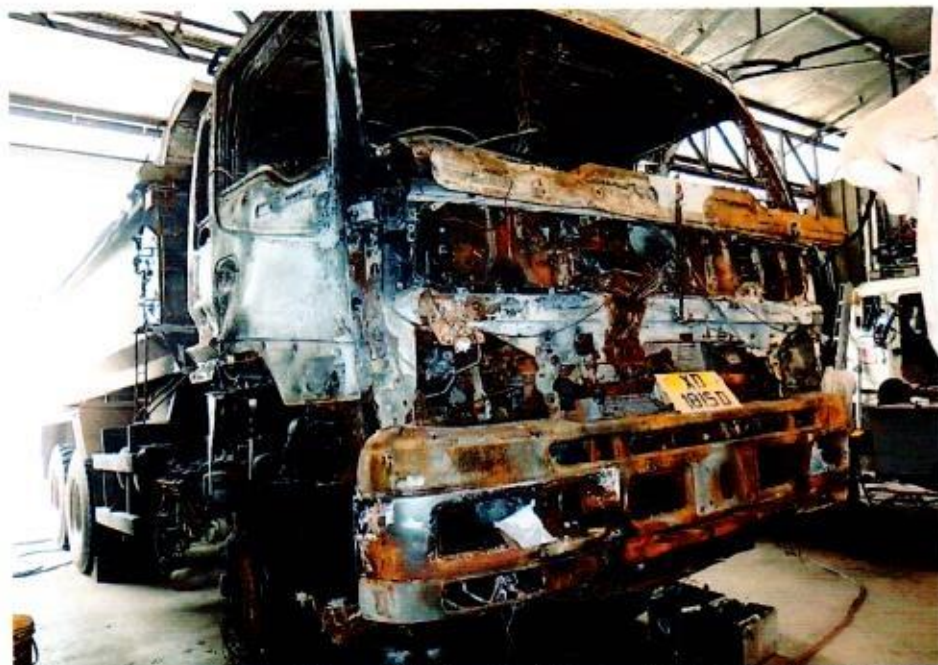
Photo 1 shows a general view of the front right body of the Insured Vehicle at the time of inspection. The Insured Vehicle was observed to have sustained extensive fire damage at its frontal portion. The body panels at the frontal portion and the undercarriage components at the front underside were found to have been burnt to char.

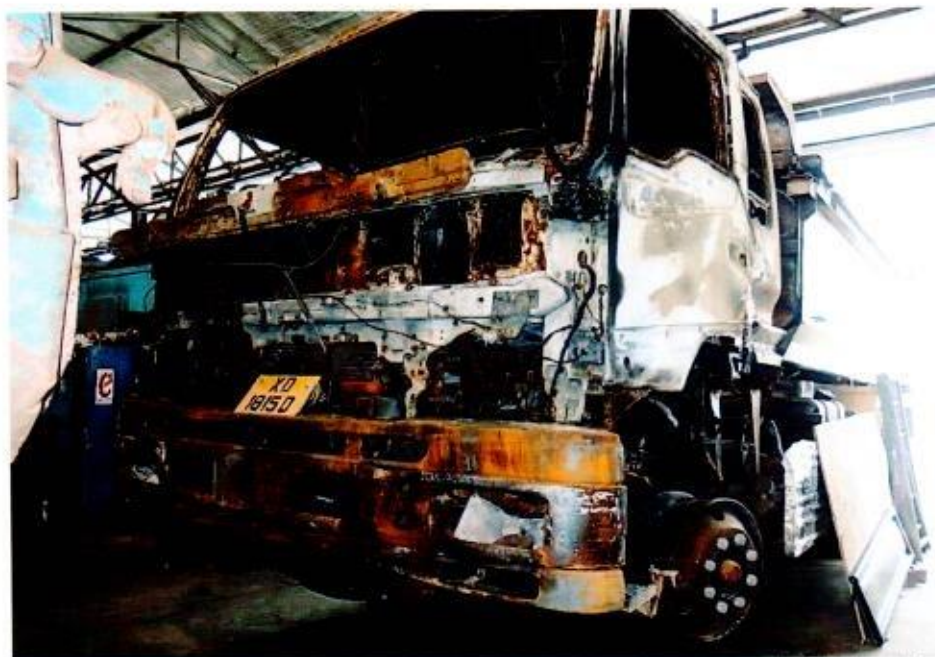
Photo 1 shows a general view of the front left body of the Insured Vehicle at the time of inspection. The Insured Vehicle was observed to have sustained extensive fire damage at its frontal portion. The body panels at the frontal portion were found to have been burnt to char.

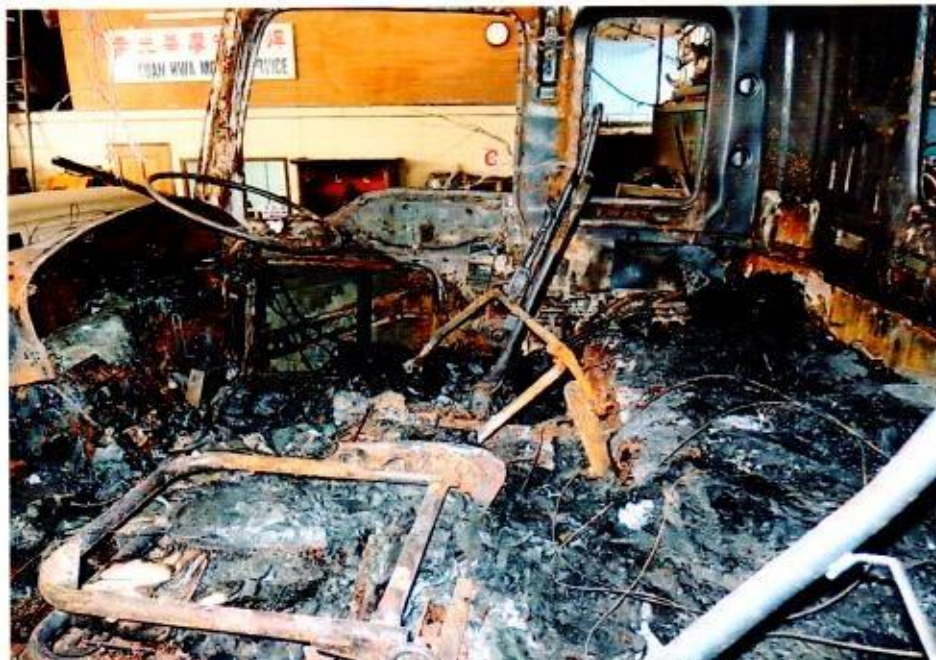
Photo 3 shows the interior compartment of the Insured Vehicle. All the parts inside the interior compartment were found to be burnt and/or melted. Its front seats, rear seats, roof upholstery, carpet and various trims were all burnt and/or melted as a result of the fire.

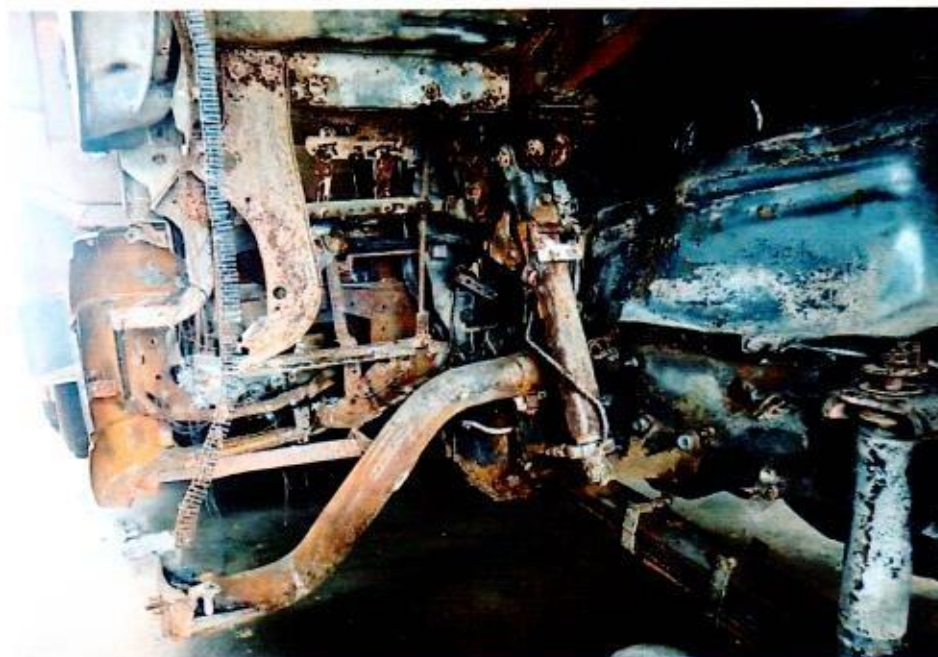
Photo 4 shows the underside of the Insured Vehicle, at its front left area. The various undercarriage components at the front underside of the Insured Vehicle was observed to be affected. This had included components of the braking system and steering system.

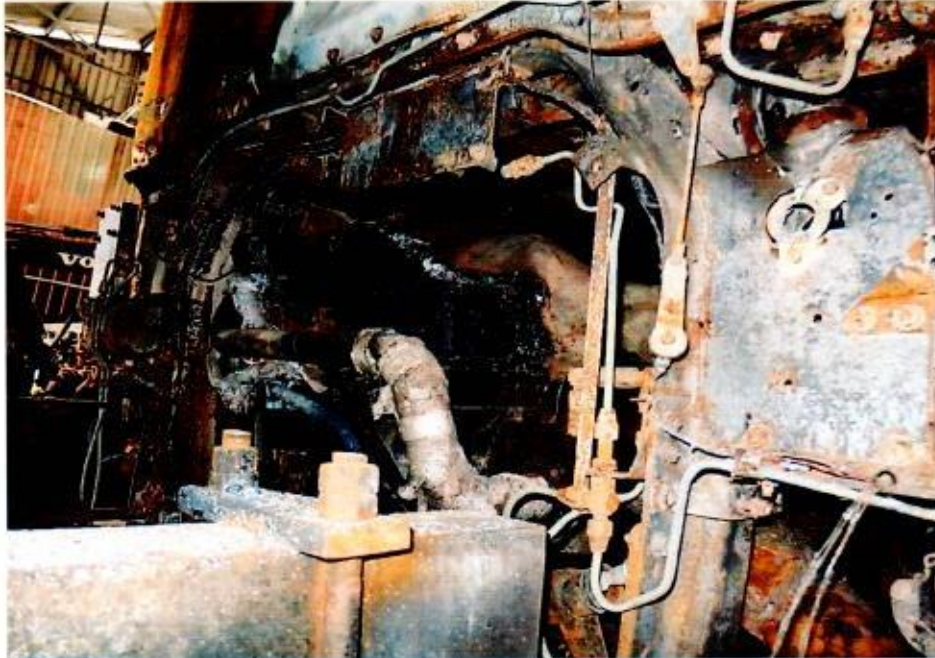
Photo 5 shows the engine compartment, which was located at the back of the Insured Vehicle's front cabin. The various parts and components within the engine compartment of the Insured Vehicle were all affected by the fire. This had included the engine of the Insured Vehicle.

19. Furthermore, the engine was located at the back of the Insured Vehicle's front cabin (refer to photograph 5 below). As seen from the photographs, the area was not a covered area. Heat generated from engine operation would have been easily dissipated out whilst the Insured Vehicle was moving, hence fire resulting from an engine overheat is also unlikely.

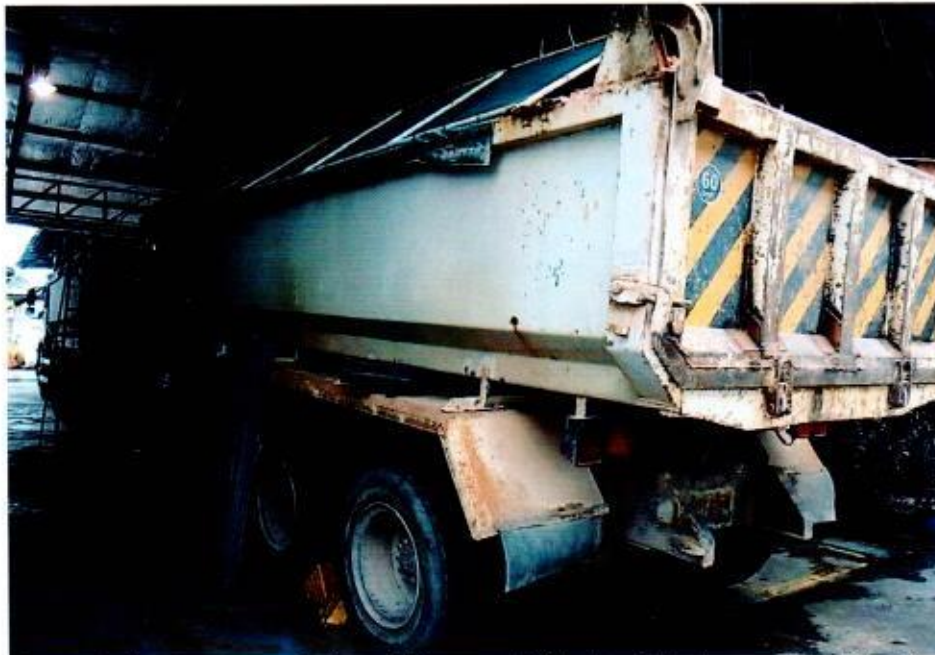
Photo 6 shows a general view of the rear left body of the Insured Vehicle. The rear portion was observed to be relatively unaffected by the fire.

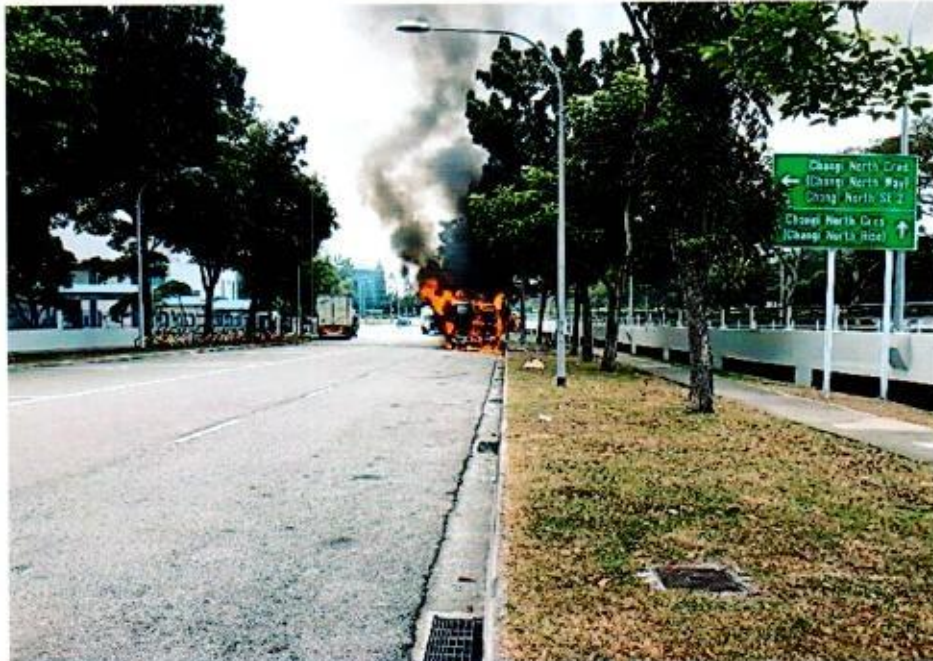
Photo 7 shows a general view of the Insured Vehicle with its frontal portion engulfed in flames. The Insured vehicle could be seen parked along the side of a roadway, in the vicinity of Changi North Crescent. Generally, the information that could be gathered from the incident scene photographs provided by Mr Goh had corresponded to the events that he had related to me.

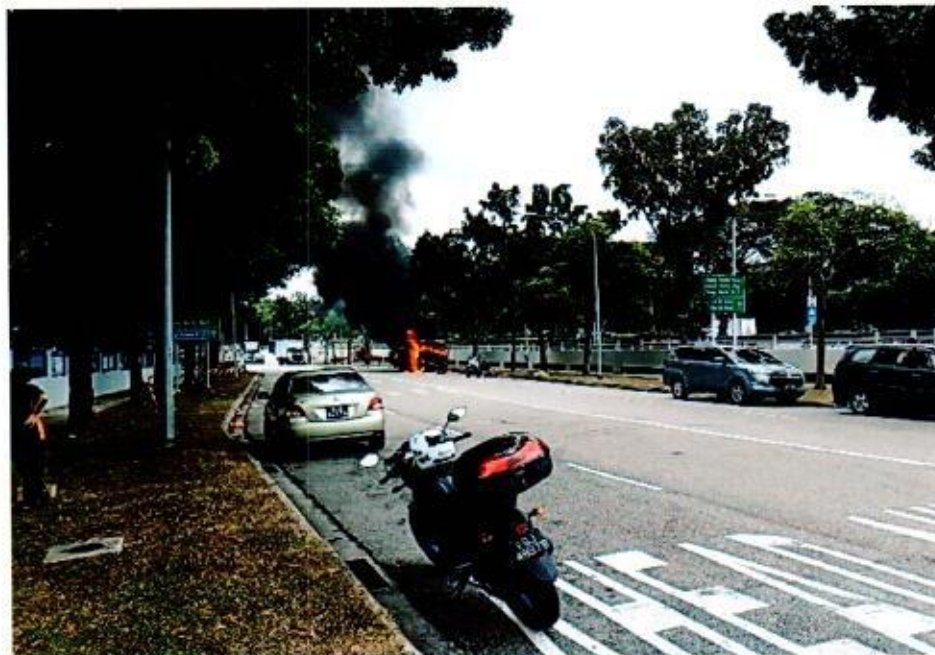
Photo 8 shows a general view of the Insured Vehicle with its frontal portion engulfed in flames. The Insured vehicle could be seen parked along the side of a roadway. The information that could be gathered from the incident scene photographs had corresponded to the events that Mr Goh had related to me

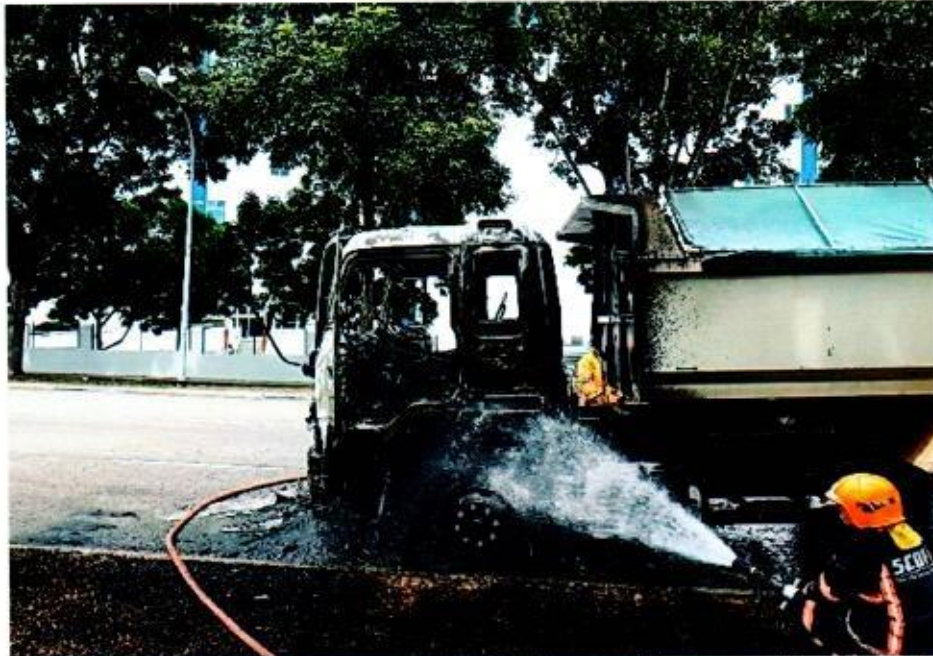
Photo 9 shows a general view of the front left body of the Insured Vehicle at the incident scene. SCDF officers could be seen spraying water onto the front underside of the Insured Vehicle, directly beneath the front cabin of the Insured Vehicle.

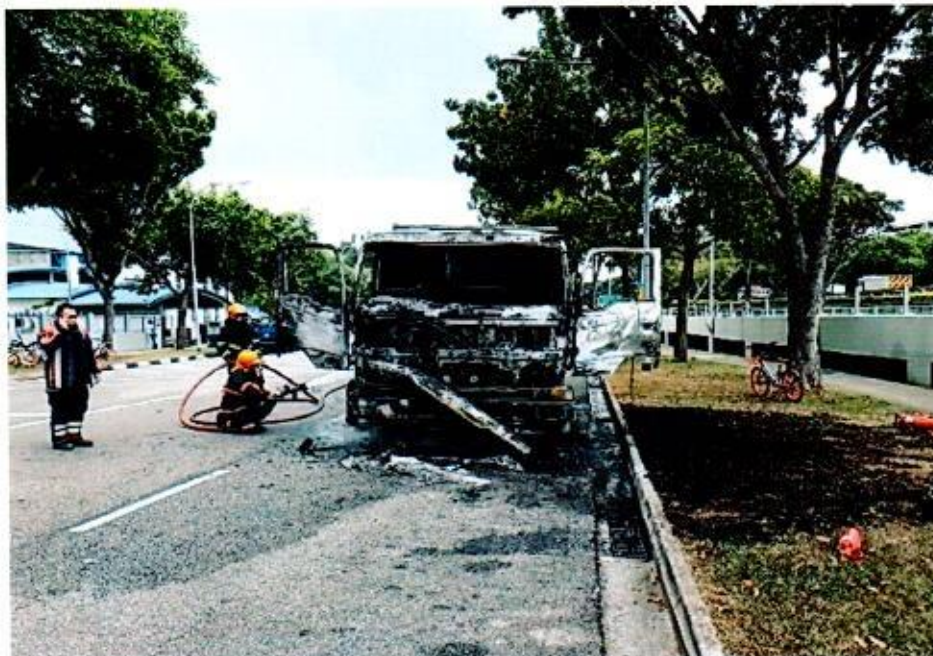
Photo 10 shows a general view of the Insured Vehicle at the incident scene. SCDF officers could be seen spraying water onto the front underside of the Insured Vehicle, directly beneath the front cabin of the Insured Vehicle. Burnt residual remains were observed on the road surface. A patch of grass on the left side of the Insured Vehicle was also observed to be burnt as a result of the fire.
