Your Ref: M1801211  
Our Ref :CS/TMI18004268/D

**Tokio Marine Insurance Singapore Ltd**

**TECHNICAL INVESTIGATION REPORT OF FIRE INCIDENT INVOLVING THE INSURED VEHICLE XD 1815D ON 02 MARCH 2018**

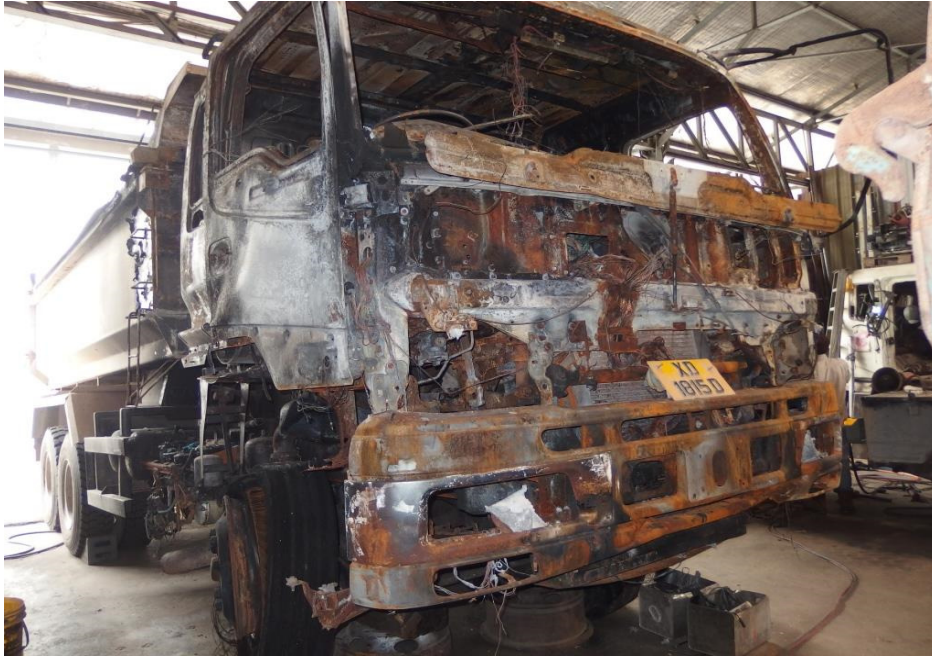
**Photo 1** shows a general view of the front right body of the Insured Vehicle at the time of inspection. The Insured Vehicle was observed to have sustained extensive fire damage at its frontal portion. The body panels at the frontal portion and the undercarriage components at the front underside were found to have been burnt to char.

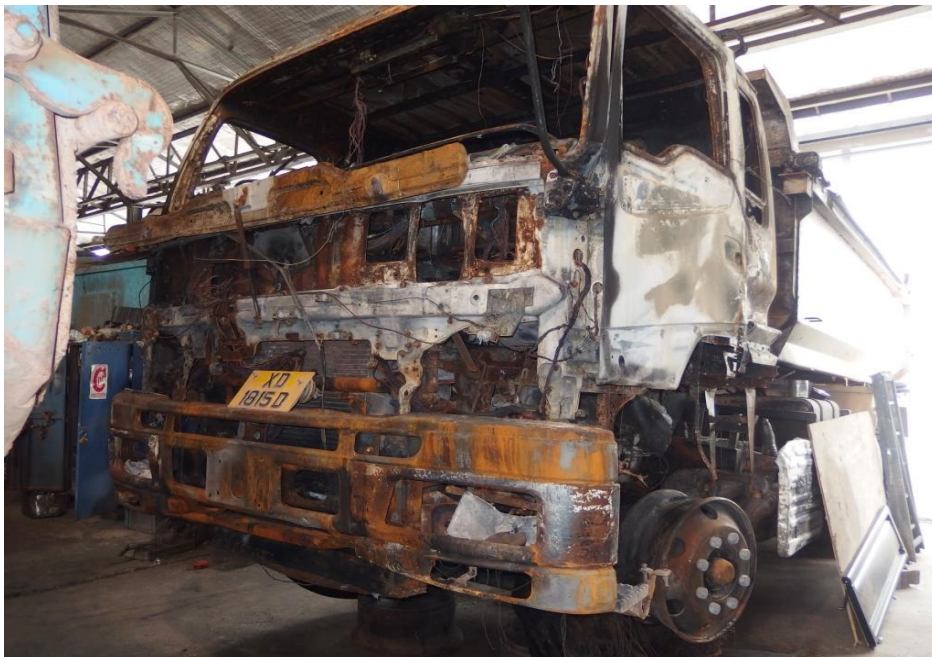
**Photo 1** shows a general view of the front left body of the Insured Vehicle at the time of inspection. The Insured Vehicle was observed to have sustained extensive fire damage at its frontal portion. The body panels at the frontal portion were found to have been burnt to char.

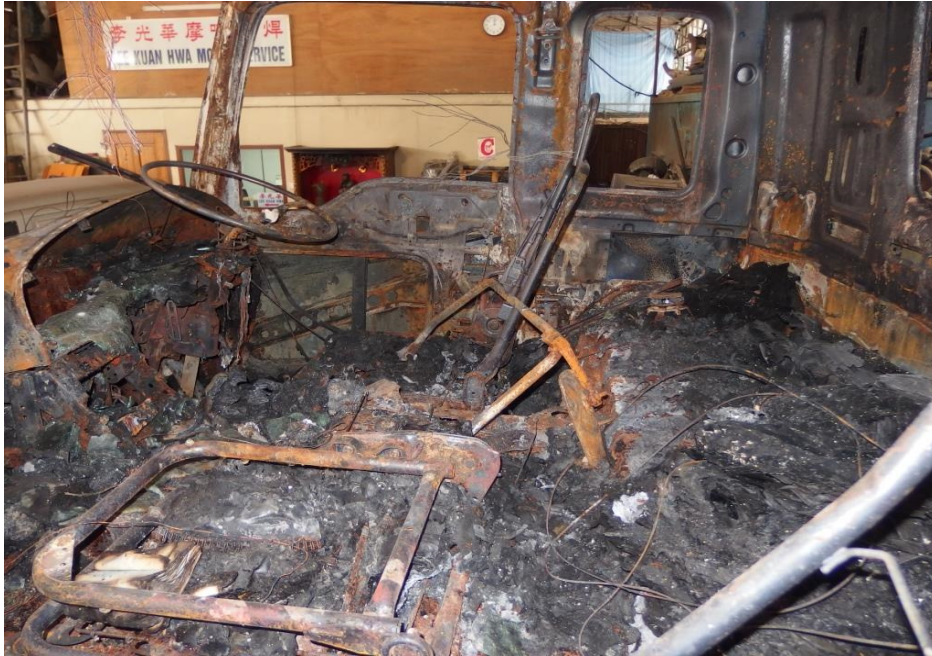
**Photo 3** shows the interior compartment of the Insured Vehicle. All the parts inside the interior compartment were found to be burnt and/or melted. Its front seats, rear seats, roof upholstery, carpet and various trims were all burnt and/or melted as a result of the fire.

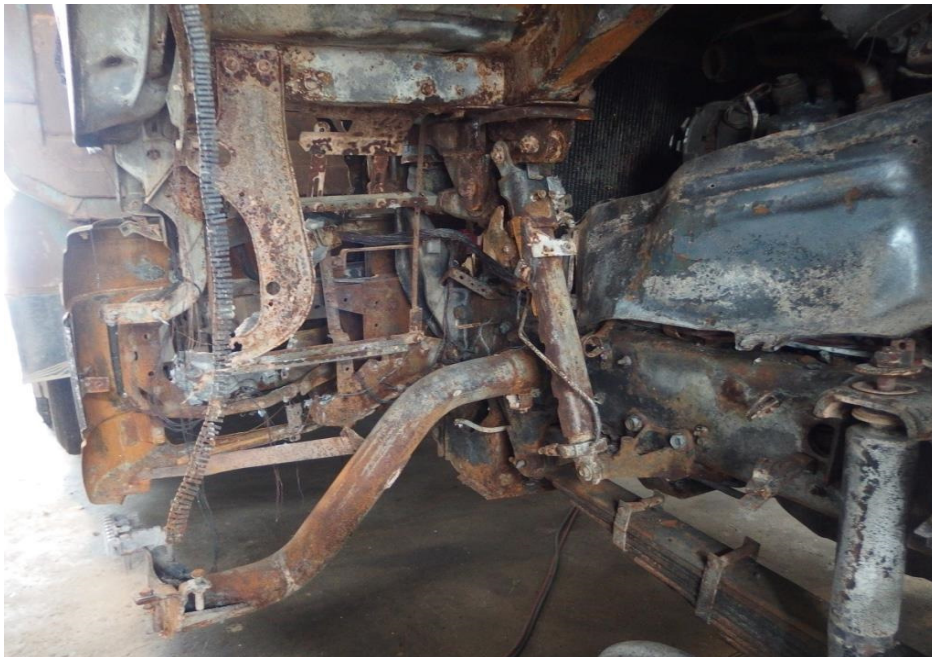
**Photo 4** shows the underside of the Insured Vehicle, at its front left area. The various undercarriage components at the front underside of the Insured Vehicle was observed to be affected. This had included components of the braking system and steering system.

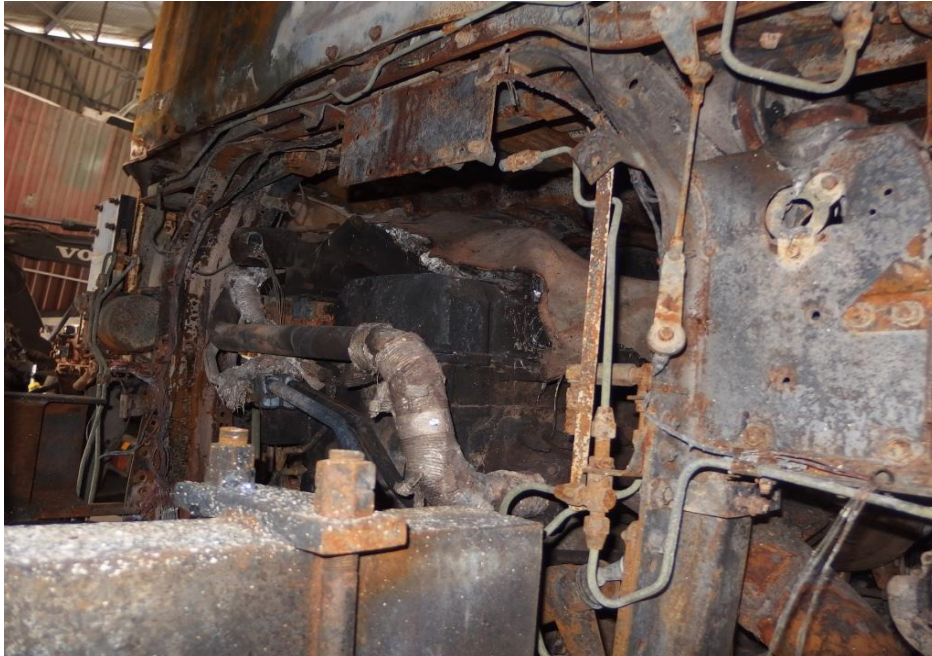
**Photo 5** shows the engine compartment, which was located at the back of the Insured Vehicle's front cabin. The various parts and components within the engine compartment of the Insured Vehicle were all affected by the fire. This had included the engine of the Insured Vehicle.

19. Furthermore, the engine was located at the back of the Insured Vehicle's front cabin (refer to photograph 5 below). As seen from the photographs, the area was not a covered area. Heat generated from engine operation would have been easily dissipated out whilst the Insured Vehicle was moving, hence fire resulting from an engine overheat is also unlikely.

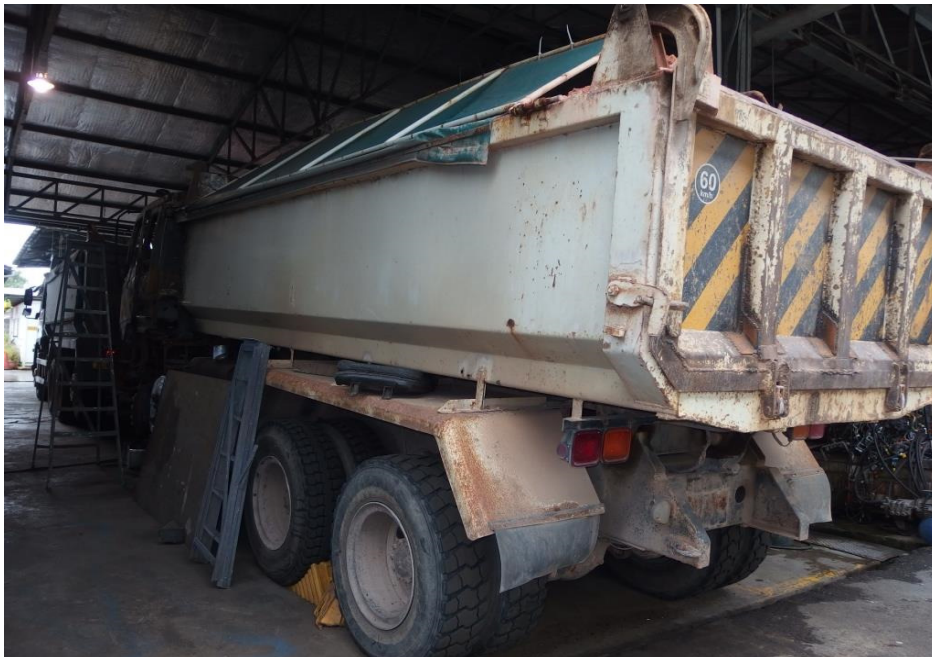
**Photo 6** shows a general view of the rear left body of the Insured Vehicle. The rear portion was observed to be relatively unaffected by the fire.

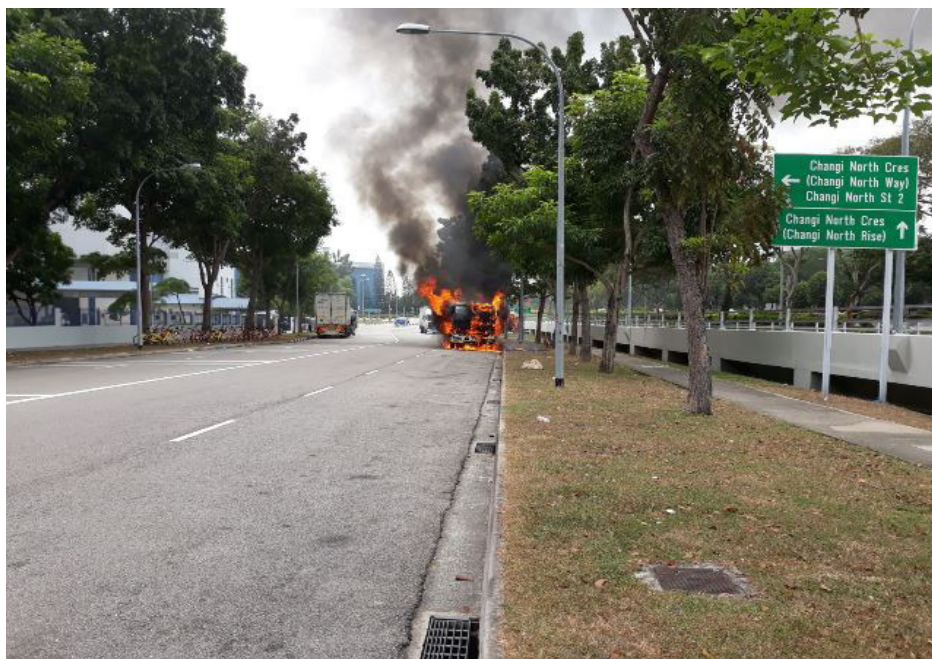
**Photo 7** shows a general view of the Insured Vehicle with its frontal portion engulfed in flames. The Insured vehicle could be seen parked along the side of a roadway, in the vicinity of Changi North Crescent. Generally, the information that could be gathered from the incident scene photographs provided by Mr Goh had corresponded to the events that he had related to me.

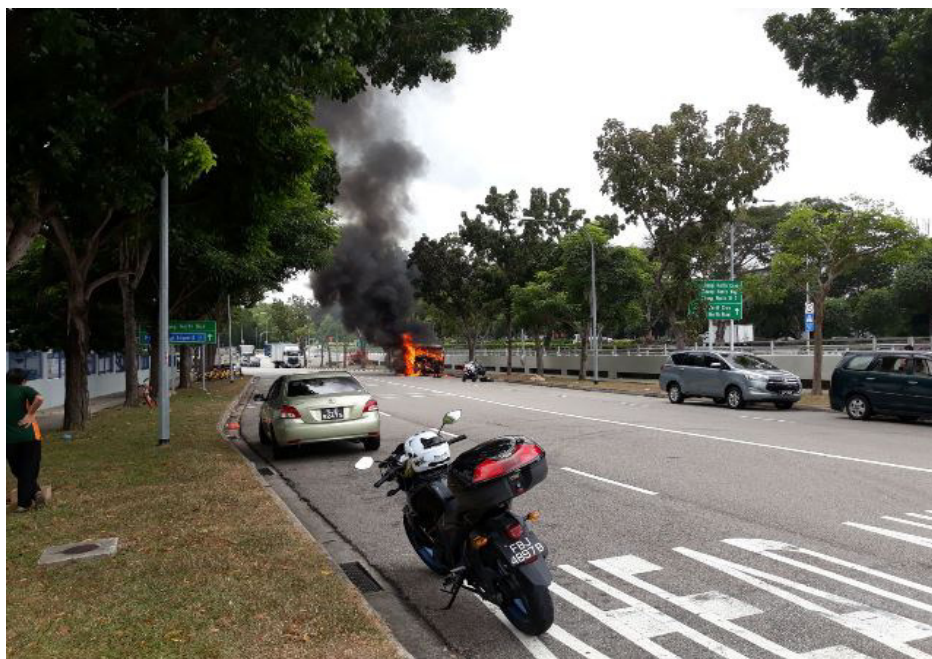
**Photo 8** shows a general view of the Insured Vehicle with its frontal portion engulfed in flames. The Insured vehicle could be seen parked along the side of a roadway. The information that could be gathered from the incident scene photographs had corresponded to the events that Mr Goh had related to me

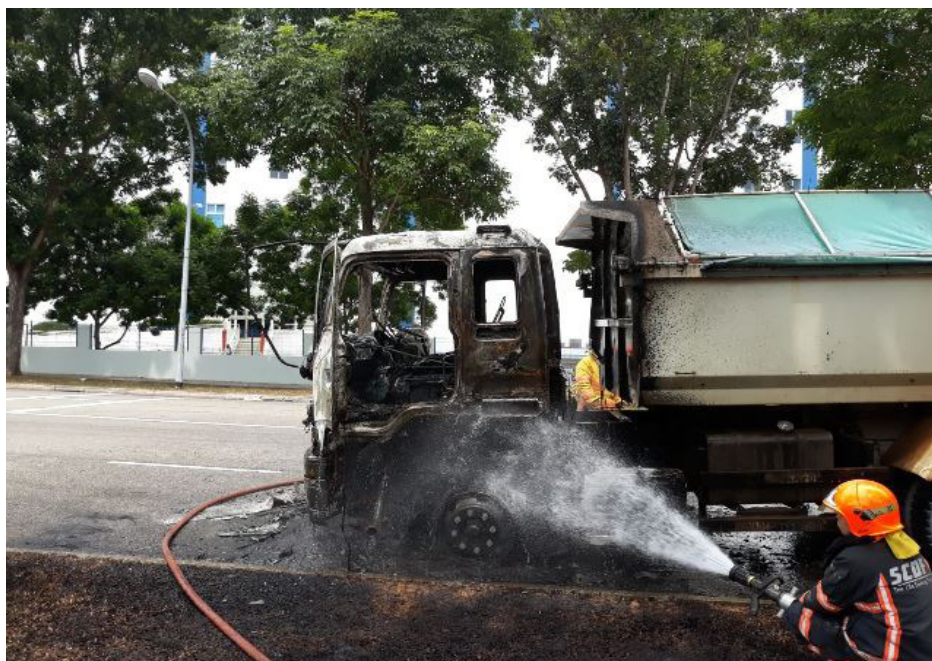
**Photo 9** shows a general view of the front left body of the Insured Vehicle at the incident scene. SCDF officers could be seen spraying water onto the front underside of the Insured Vehicle, directly beneath the front cabin of the Insured Vehicle.

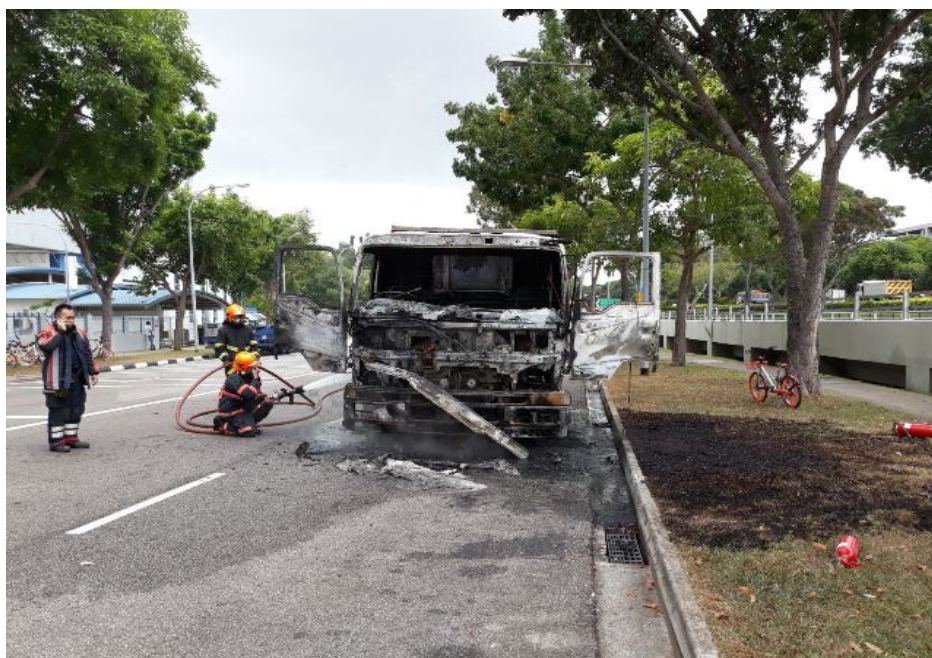
**Photo 10** shows a general view of the Insured Vehicle at the incident scene. SCDF officers could be seen spraying water onto the front underside of the Insured Vehicle, directly beneath the front cabin of the Insured Vehicle. Burnt residual remains were observed on the road surface. A patch of grass on the left side of the Insured Vehicle was also observed to be burnt as a result of the fire.
