Your Ref: C0397877  
Our Ref : CI/AXA18004280/D

### **AUTOMOBILE INSPECTION REPORT OF INSURED VEHICLE SKD 6002D**

1. I refer to your request dated 28 February 2018 to carry out an inspection of the insured vehicle SKD 6002D.
2. The objective of the inspection was to check whether the insured vehicle was fitted with any modification(s), in particular during the period 28 April 2016 to 27 August 2016.

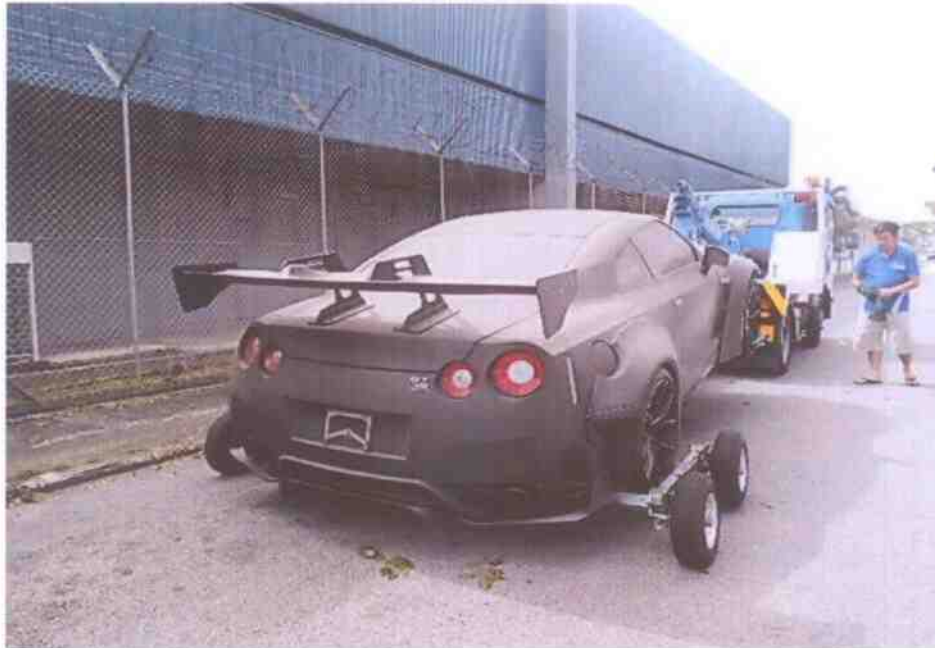
**Photo 1** shows the insured vehicle at Traffic Police Pound prior to being towed to Teamwork Garage Pte Ltd. The method of towing was by, what is commonly referred to as king dolly method. Such method of towing is usually used when the towed vehicle is an all-wheel drive vehicle or rear wheel drive vehicle. The 4 wheels of the towed vehicle are lifted off ground during the towing.

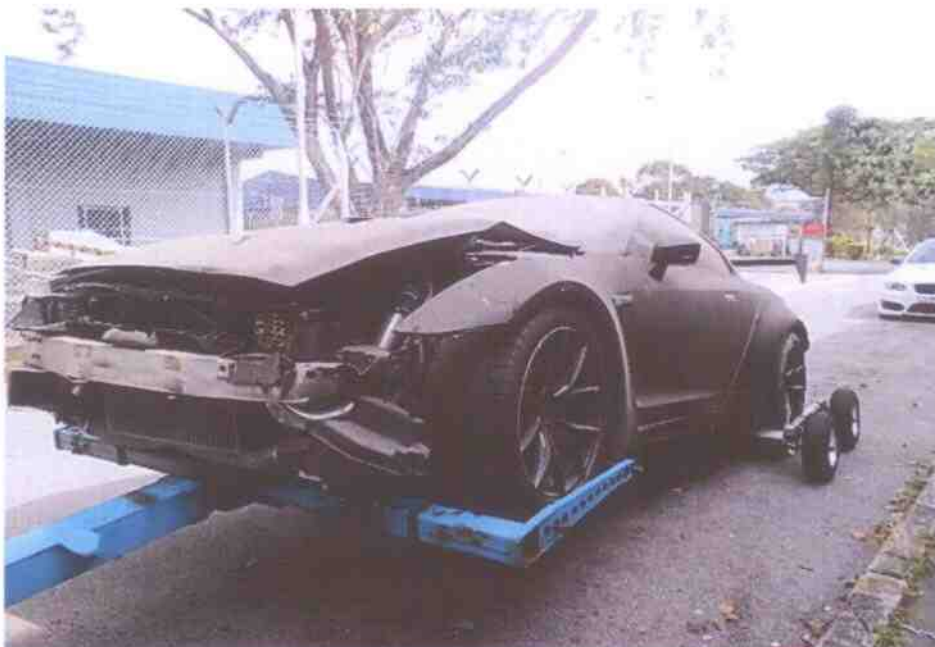
**Photo 2** shows the insured vehicle at Traffic Police Pound prior to being towed to Teamwork Garage Pte Ltd. The method of towing was by, what is commonly referred to as king dolly method. Such method of towing is usually used when the towed vehicle is an all-wheel drive vehicle or rear wheel drive vehicle. The 4 wheels of the towed vehicle are lifted off ground during the towing.

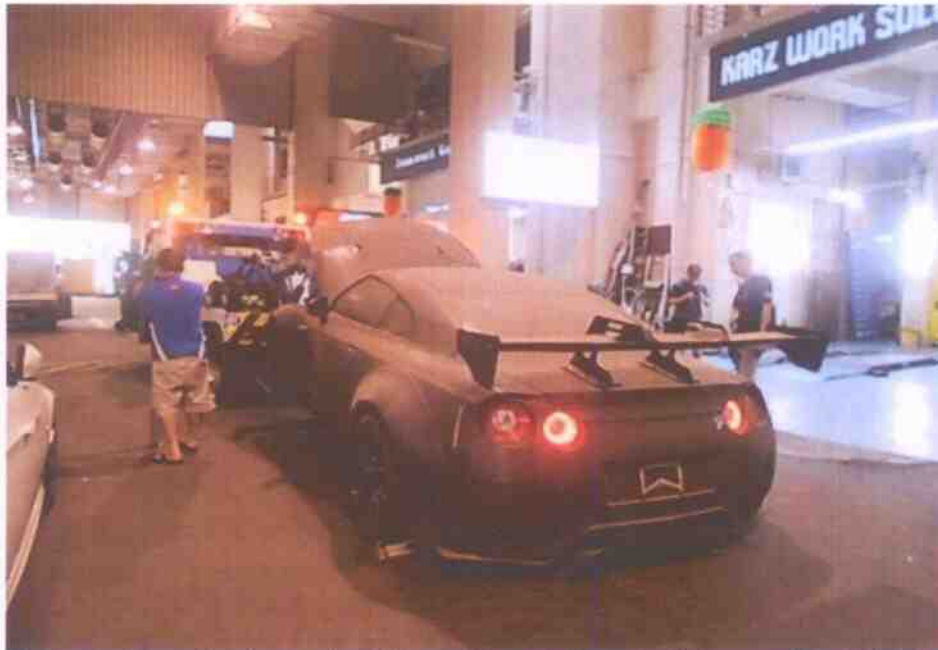
**Photo 3** shows the insured vehicle arriving at Teamwork Garage Pte Ltd. The owner of the insured vehicle, who was present at Traffic Police Pound earlier, was also present when the insured vehicle had arrived at Teamwork Garage Pte Ltd.

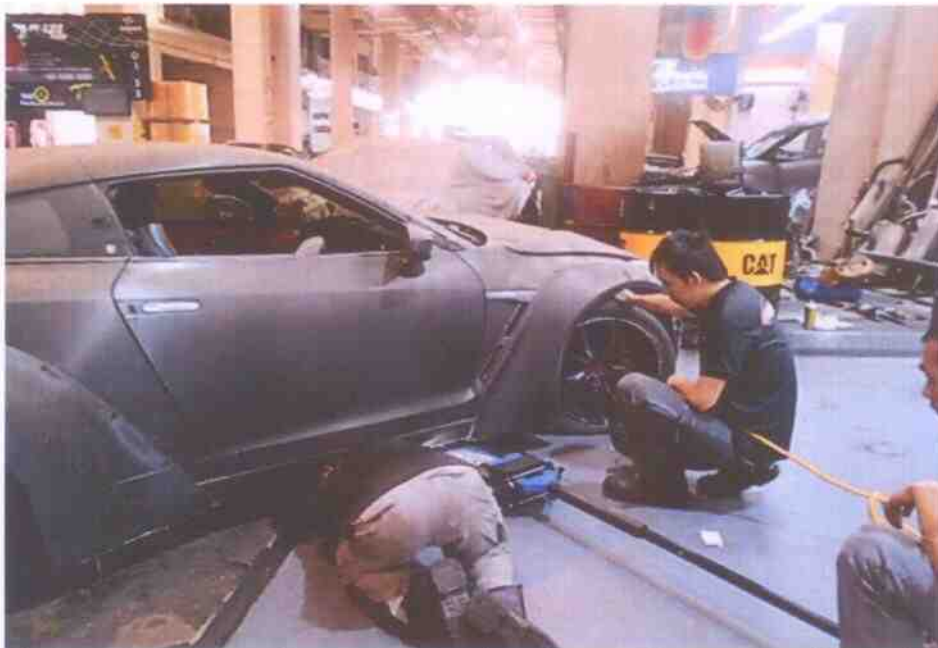
**Photo 4** shows preparation works being done to move the insured vehicle onto a hoist for a detailed inspection.

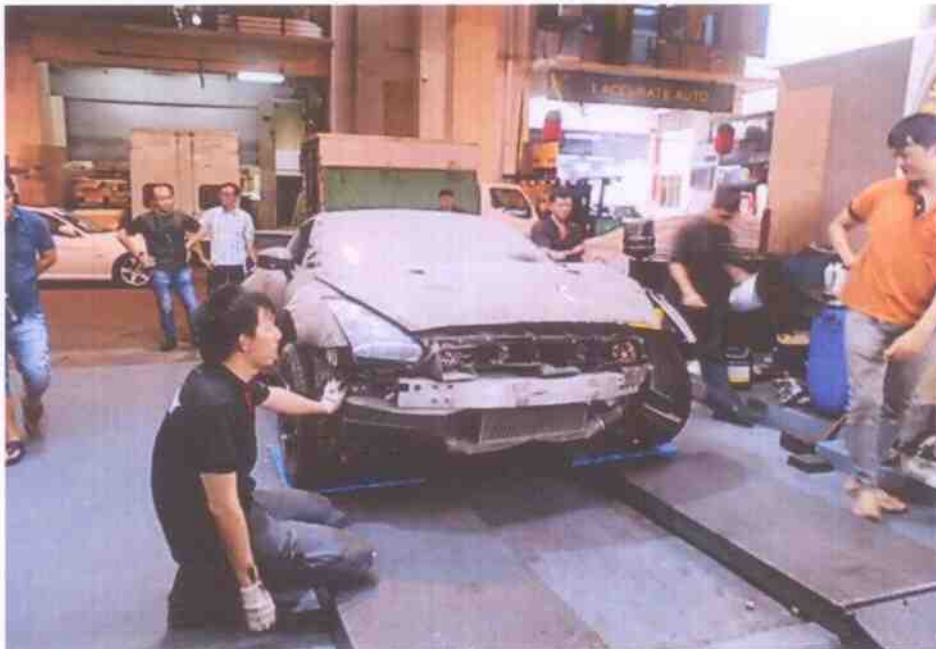
6. Generally, the insured vehicle was observed to be in good condition. It had sustained impact damages that were confined to its frontal portion. Its front bumper, front bonnet, front fenders and front headlamps were amongst the body parts that were observed to have been damaged. Its front right wheel rim was dented, leading to air loss from the front right tyre. Its driver's airbag and front left passenger airbag were both activated, along with the respective seat belts. See photo 1 – 6 below.

**Photo 5** shows the insured vehicle being moved onto a hoist for a detailed inspection. Generally, the insured vehicle was observed to be of good condition. It had however sustained impact damages that were confined to its frontal portion. Its front bumper, front bonnet, front fenders and front headlamps were amongst the body parts that were observed to have been damaged.

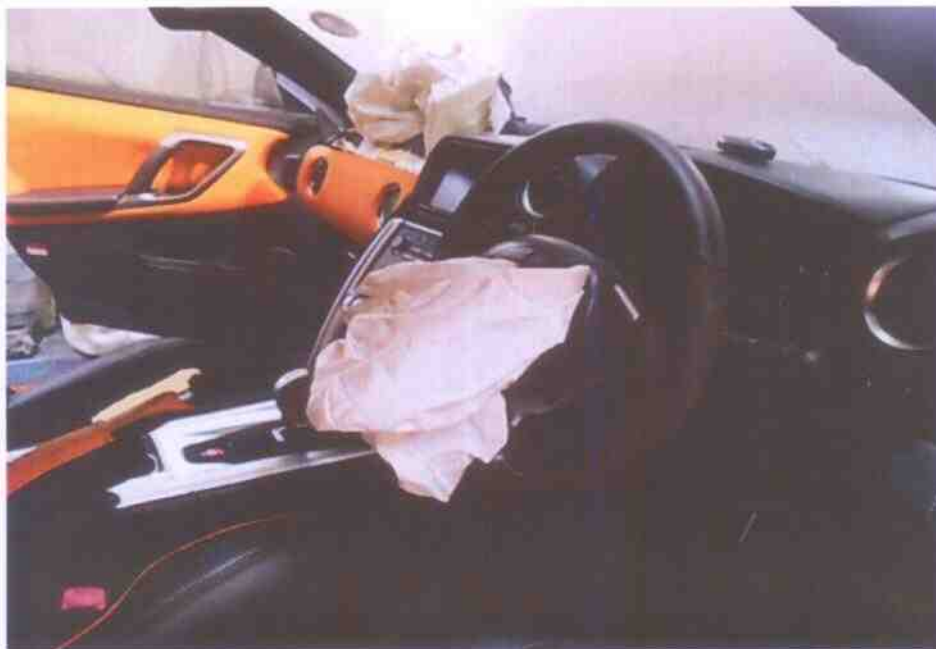
**Photo 6** shows the driver's airbag and front left passenger airbag of the insured vehicle activated.

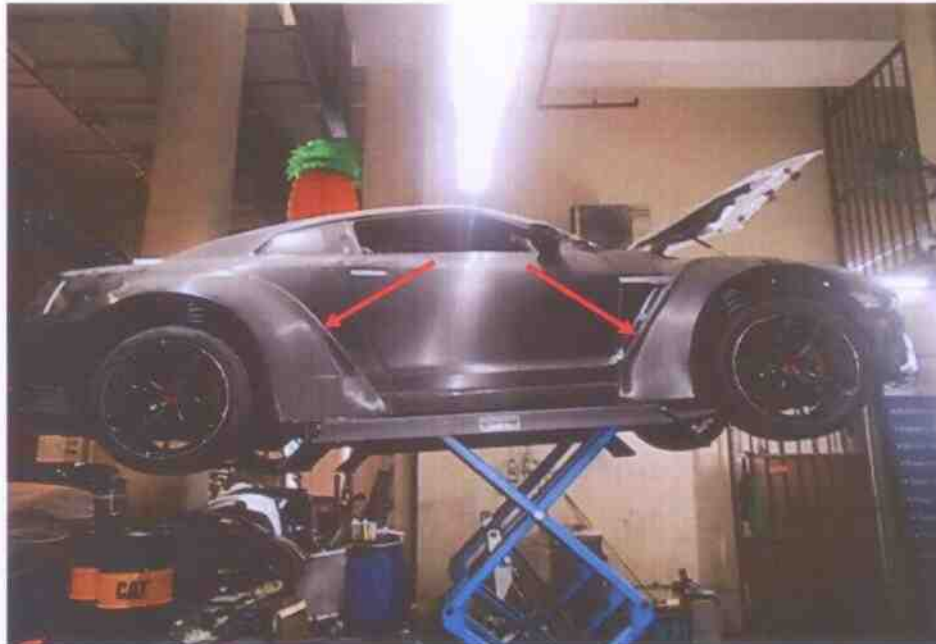
7. Exteriorly, the insured vehicle was fitted with a set of aftermarket bodykit. The type of bodykit fitted was observed to be, what is commonly referred to as "wide body" type, where an additional body panel is fabricated and attached by bolts onto the main body of the insured vehicle, at the wheel arc area above the 4 wheels. Fitting such type of bodykits causes the insured vehicle to be wider laterally. See photo 7 below.

**Photo 7** shows the insured vehicle hoisted during my inspection. Exteriorly the insured vehicle was observed to be fitted with a set of wide body type of bodykit. For such bodykits, an additional body panel (arrowed) is fabricated and attached by bolts onto the main body of the insured vehicle, at the wheel arc area above the 4 wheels. Fitting such type of bodykits causes the insured vehicle to be wider laterally.

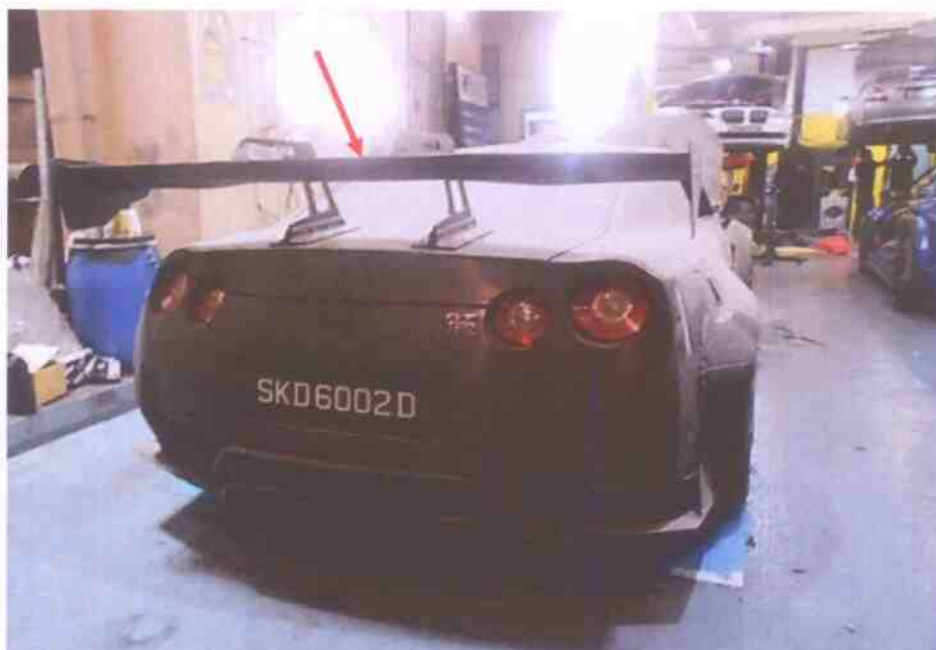
8. The rear spoiler that is fitted on the insured vehicle is an aftermarket type that is commonly referred to as "GT wing". The overall length of the rear spoiler was observed to have laterally protruded out of the insured vehicle's main body. See photo 8 - 10 below.

**Photo 8** shows the rear spoiler (arrowed) fitted on the insured vehicle. The type of rear spoiler is commonly referred to as "GT wing". The overall length of the rear spoiler was observed to have laterally protruded out of the insured vehicle's main body.

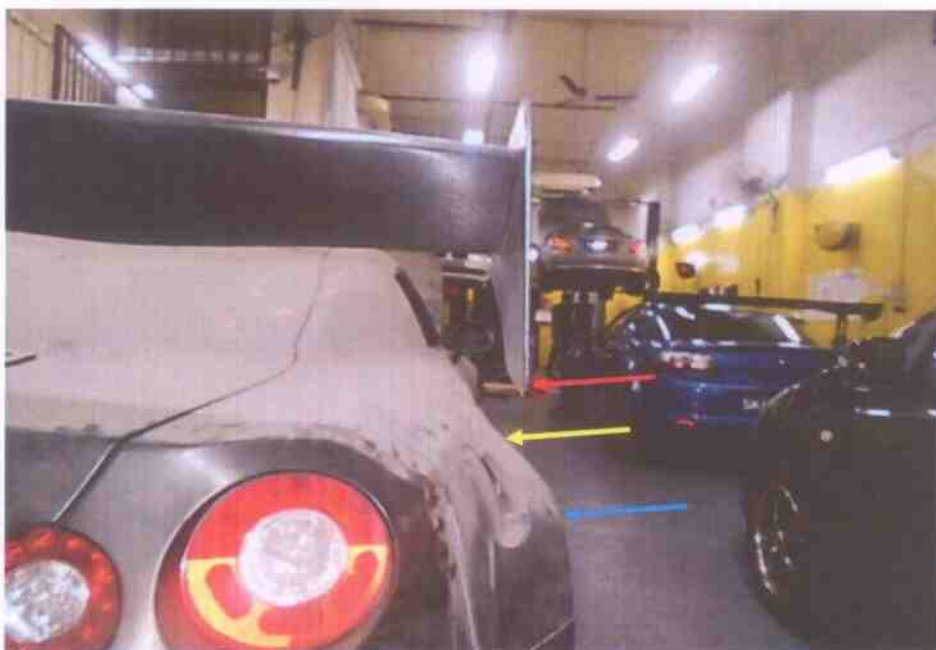
**Photo 9** shows the rear spoiler (red arrow) protruding laterally out of the insured vehicle's main body (yellow arrow). This was at the rear right side of the insured vehicle. The additional body panel (blue arrow) for the wide body type of bodykit is fabricated and attached by bolts onto the main body of the insured vehicle, at the wheel arc area above the 4 wheels. Fitting such type of bodykits causes the insured vehicle to be wider laterally.

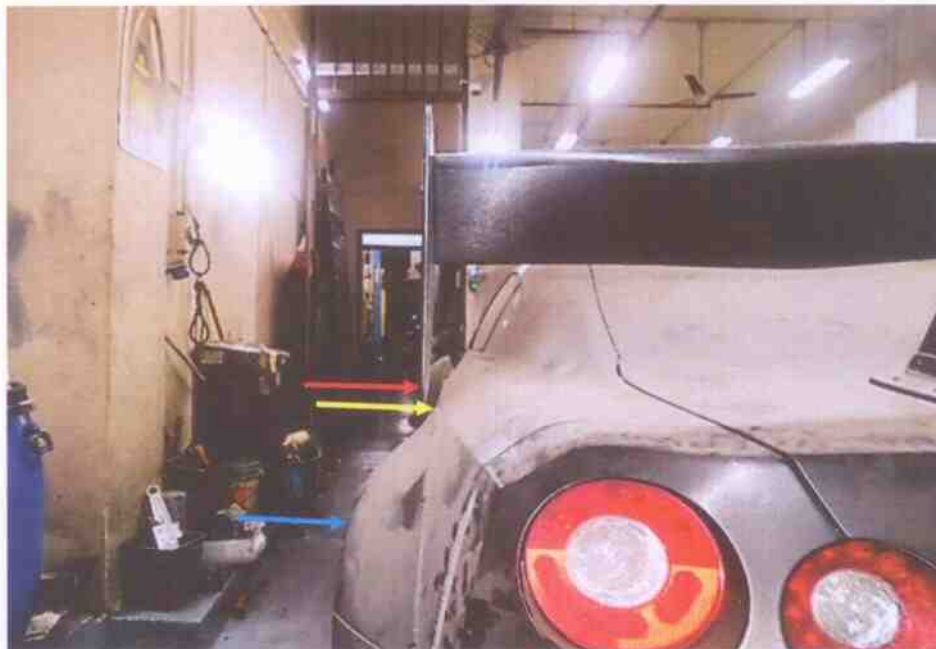
**Photo 10** shows the rear spoiler (red arrow) protruding laterally out of the insured vehicle's main body (yellow arrow). This was at the rear left side of the insured vehicle. The additional body panel (blue arrow) for the wide body type of bodykit is fabricated and attached by bolts onto the main body of the insured vehicle, at the wheel arc area above the 4 wheels. Fitting such type of bodykits causes the insured vehicle to be wider laterally.

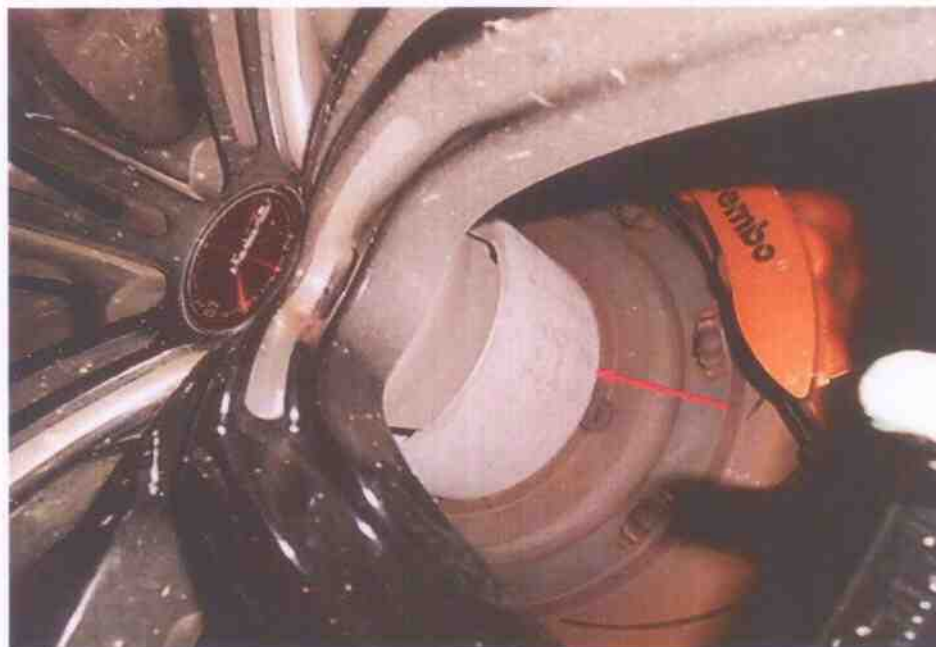
9. In order to accommodate the protruded side body of the insured vehicle that was caused by the fitting of the "wide body" type of bodykit, wheel spacers were added to all the 4 wheels so that the wheels of the insured vehicle were "pushed" outwards, becoming flush with the protruded body line of the insured vehicle. Such wheel spacers are not a standard feature of the insured vehicle and is an additionally fitted part. See photo 11 & 12 below.

**Photo 11** shows the wheel spacer (arrowed) that was additionally fitted at the rear right wheel. Such wheel spacer was found to be fitted on all the 4 wheels of the insured vehicle, "pushing" the 4 wheels of the insured vehicle outwards, becoming flush with the protruded body line of the insured vehicle.

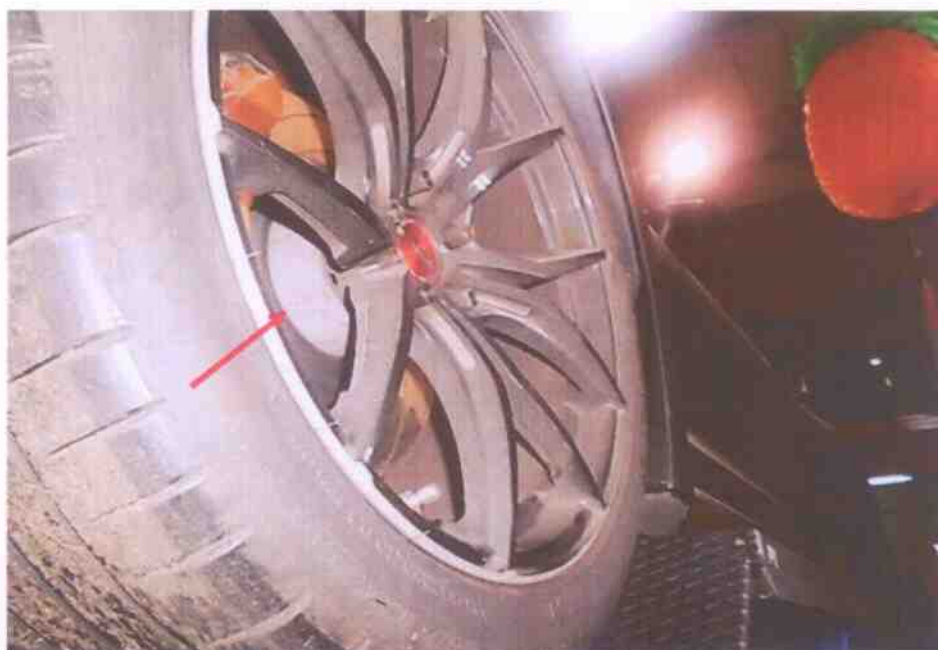
Photo 12 shows the wheel spacer (arrowed) that was additionally fitted at the front left wheel. Such wheel spacer was found to be fitted on all the 4 wheels of the insured vehicle, "pushing" the 4 wheels of the insured vehicle outwards, becoming flush with the protruded body line of the insured vehicle.

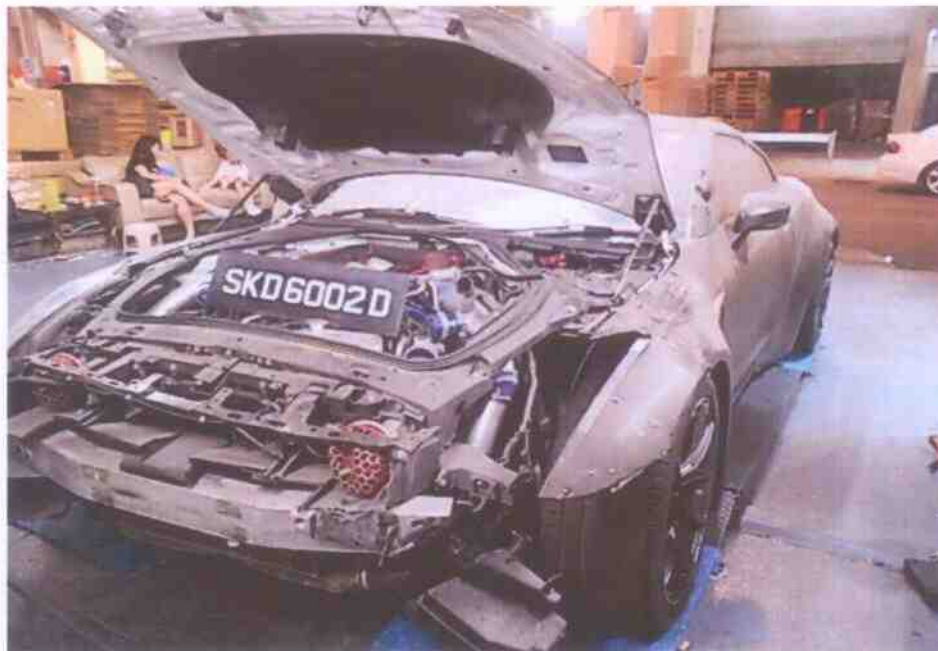
10. Upon checking the engine compartment of the insured vehicle, I had found several modifications fitted. This includes an aftermarket air intake system with all piping; an aftermarket intercooler; a non-original engine coolant reservoir tank; and some non-original fluid carry hoses. See photo 13 – 16 below.

**Photo 13** shows a general view of the engine compartment of the insured vehicle. Several modifications were found fitted in the engine compartment. This had included an aftermarket air intake system with all piping; an aftermarket intercooler; a non-original engine coolant reservoir tank; and some non-original fluid carry hoses.

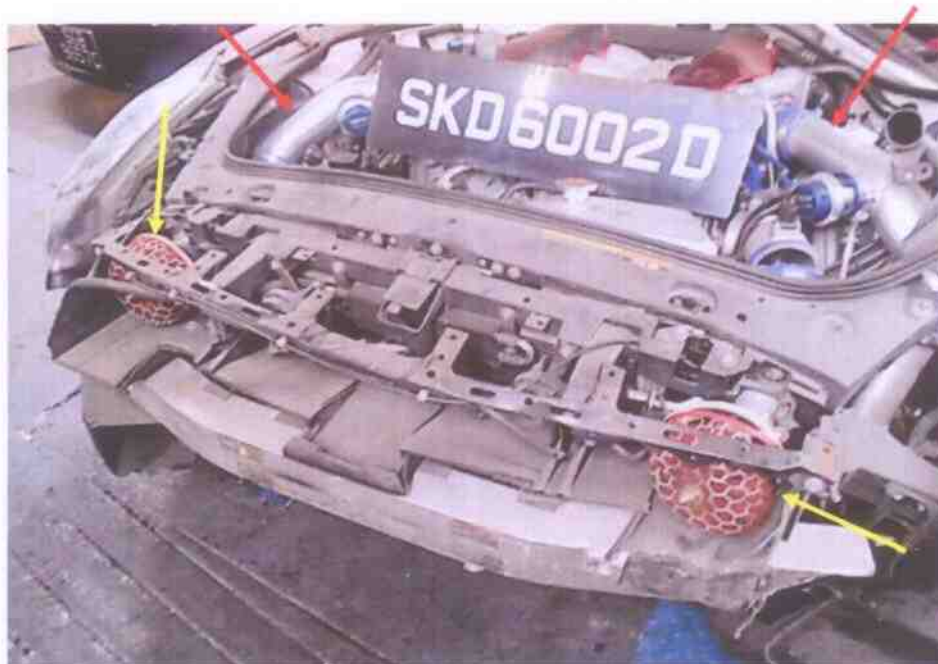
**Photo 14** shows the engine compartment of the insured vehicle. An aftermarket air system was observed to be fitted on the insured vehicle. This had included non-original air filters (yellow arrow) and piping (red arrow).

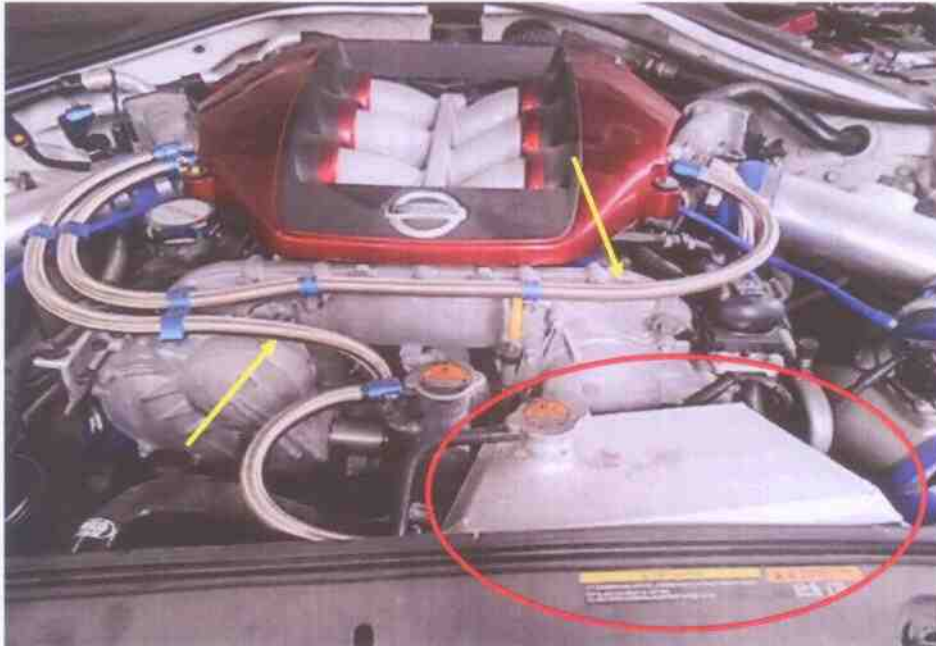
Photo 15 shows the engine compartment of the insured vehicle and the non-original engine coolant reservoir tank (circled) and some various non-original fluid carry hoses (yellow arrow).

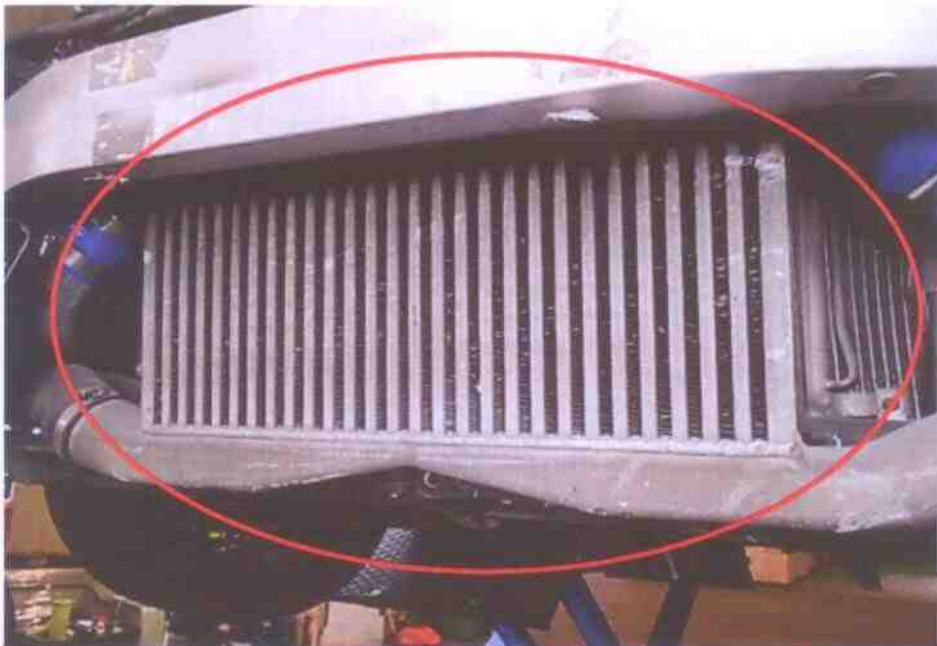
Photo 16 shows the aftermarket intercooler (circled) that was observed on the insured vehicle.

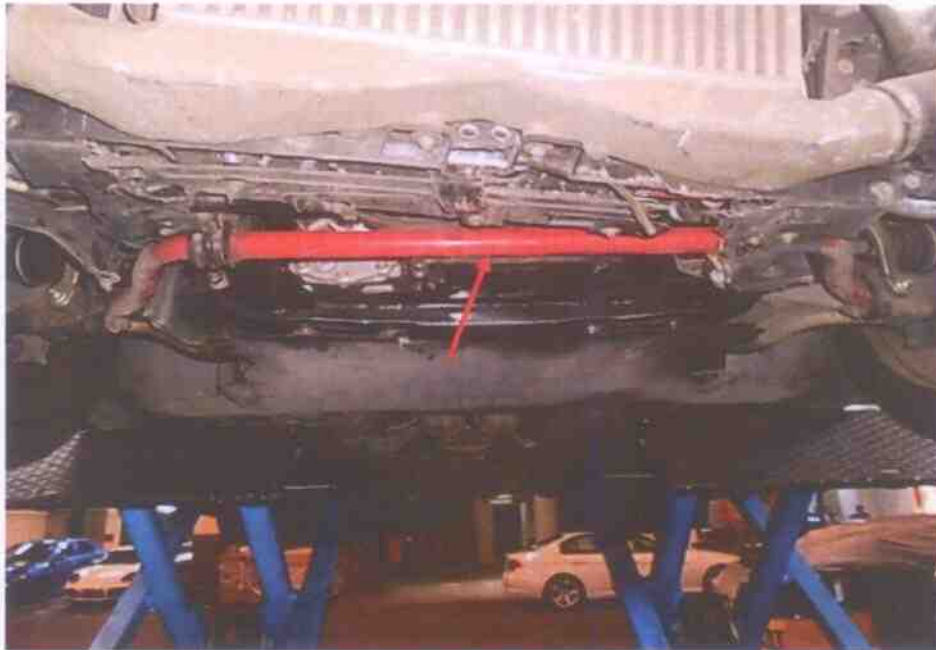
11. Checks on the underside of the insured vehicle after it was hoisted up revealed an aftermarket front and rear suspension system; and an aftermarket front and rear anti-roll bar fitted on the insured vehicle. See photo 17 – 19 below.
12. My close examination of the insured vehicle's exhaust system revealed that the rear section of the exhaust, from the middle pipe to the rear muffler was an aftermarket type. No weld mark(s) were found along the exhaust pipes. The catalytic converters and front sections of the exhaust were also closely examined and I did not find any sign(s) or indication(s) to suggest that the catalytic converters and/or front sections of the exhaust were tampered with. See photo 20 – 24 below.

**Photo 17** shows the aftermarket front anti-roll bar (arrowed) fitted on the insured vehicle.

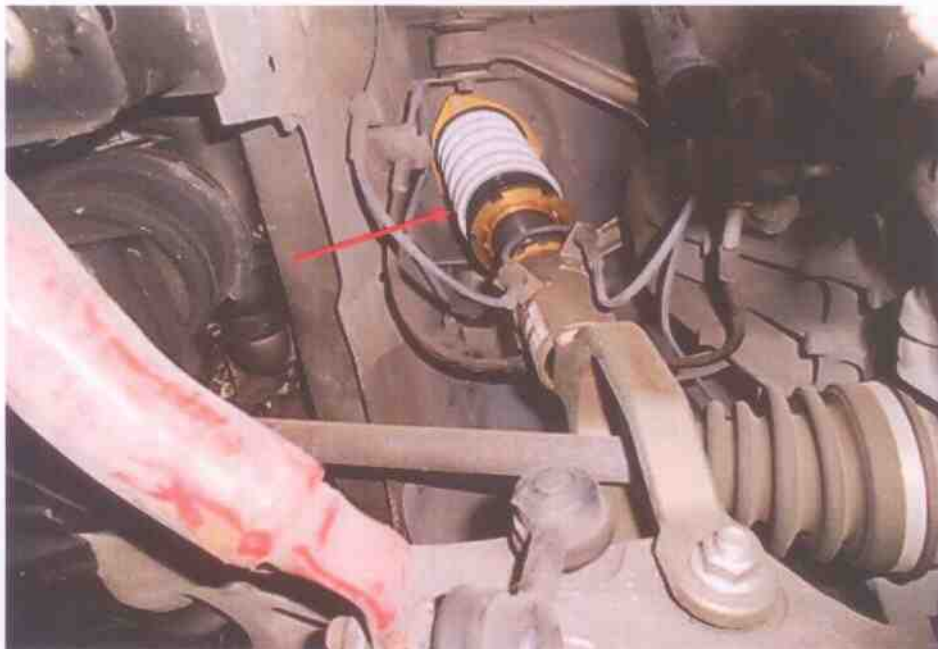
**Photo 18** shows the aftermarket front left suspension (arrowed) of the insured vehicle. The insured vehicle was fitted with aftermarket front and rear suspension system.

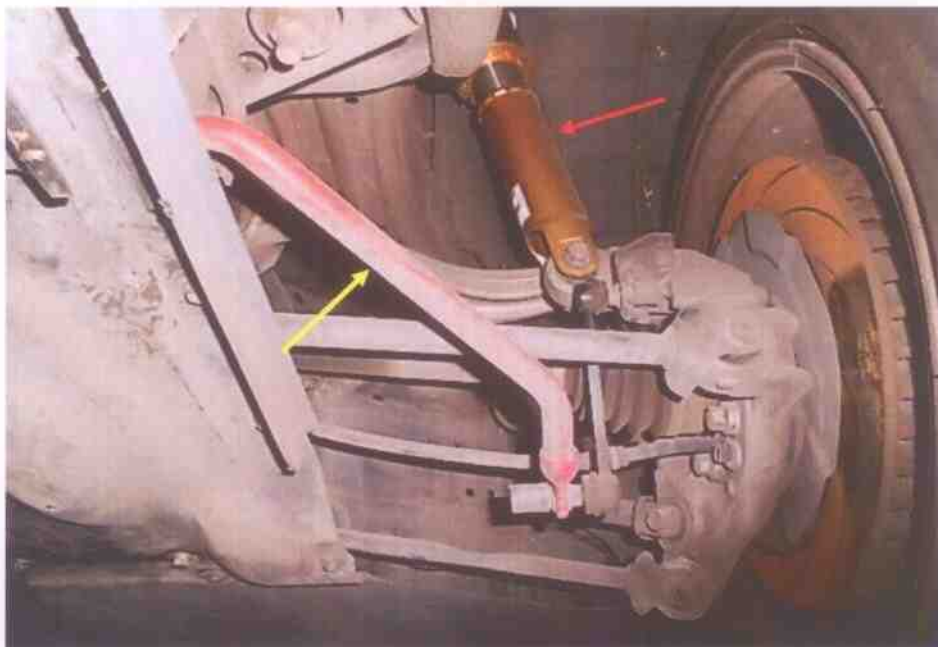
**Photo 19** shows the aftermarket rear right suspension (red arrow) and rear anti-roll bar (yellow arrow) that was fitted on the insured vehicle.

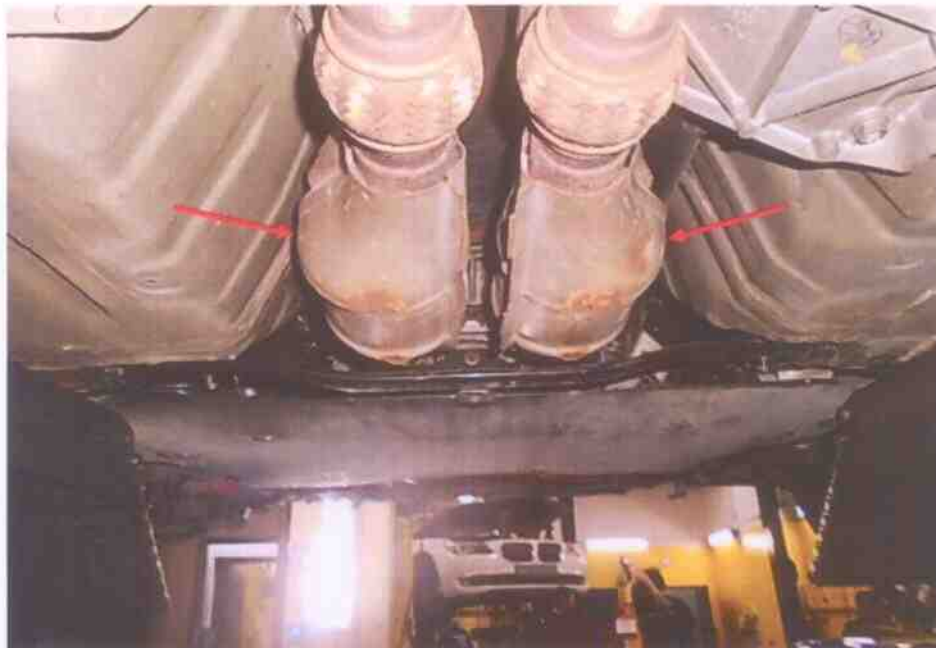
**Photo 20** shows the catalytic converters (arrowed) of the insured vehicle. The catalytic converters and front sections of the exhaust were closely examined and I did not find any sign(s) or indication(s) of any weld mark(s) to suggest that the catalytic converters and/or front sections of the exhaust were tampered with.

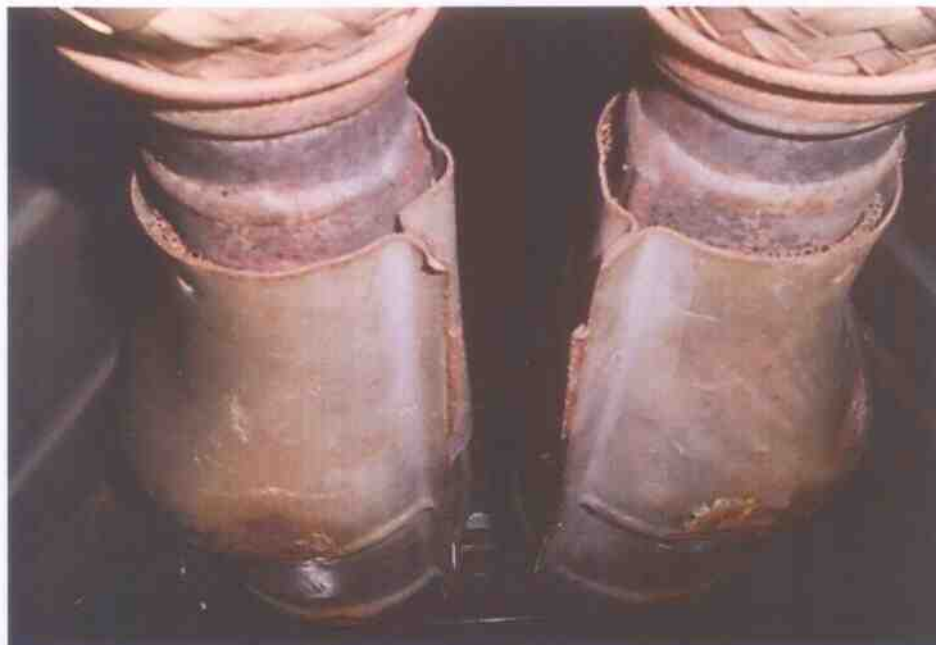
**Photo 21** shows a closer view of the catalytic converters of the insured vehicle. The catalytic converters and front sections of the exhaust were closely examined and I did not find any sign(s) or indication(s) of any weld mark(s) to suggest that the catalytic converters and/or front sections of the exhaust were tampered with.

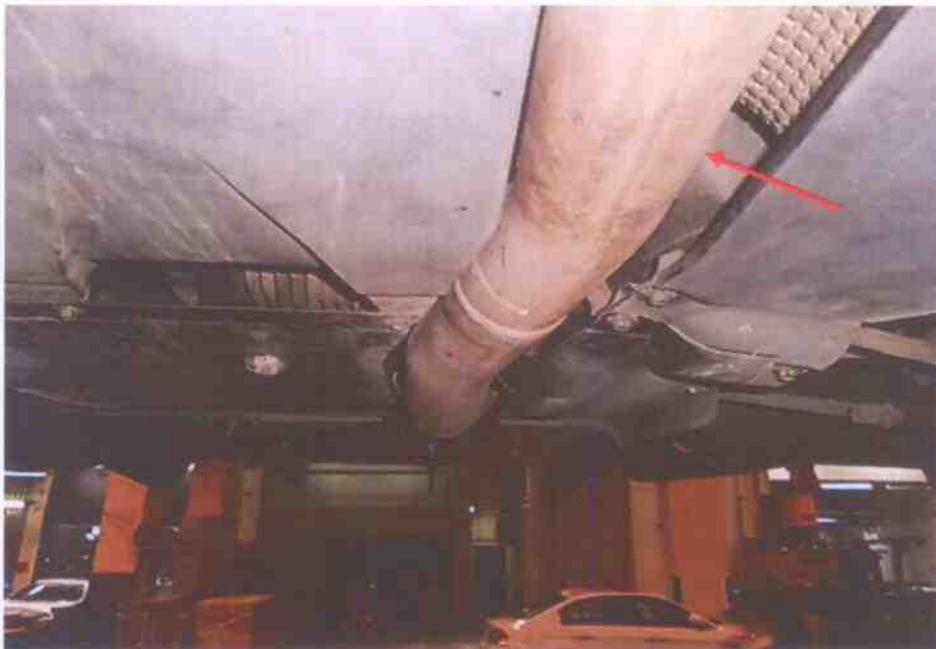
**Photo 22** shows the rear section of the exhaust, from the middle pipe (arrowed) to the rear muffler. The rear section of the insured vehicle's exhaust system was observed to be an aftermarket type.

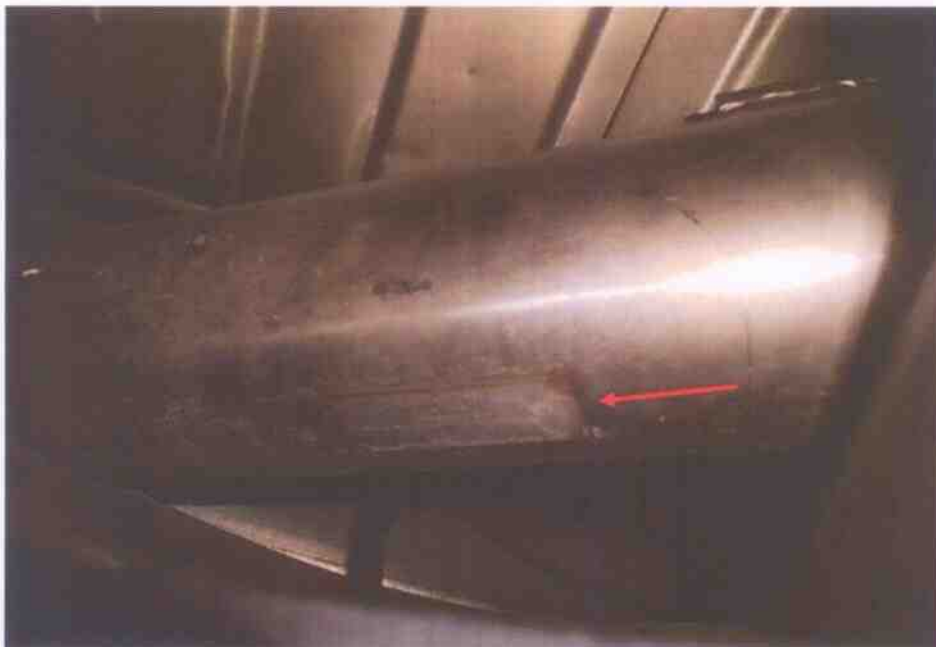
**Photo 23** shows the rear muffler of the insured vehicle. The rear section of the insured vehicle's exhaust system, from the middle pipe to the rear muffler, was observed to be an aftermarket type. The tag (arrowed) of this aftermarket exhaust was intact and not tampered with.

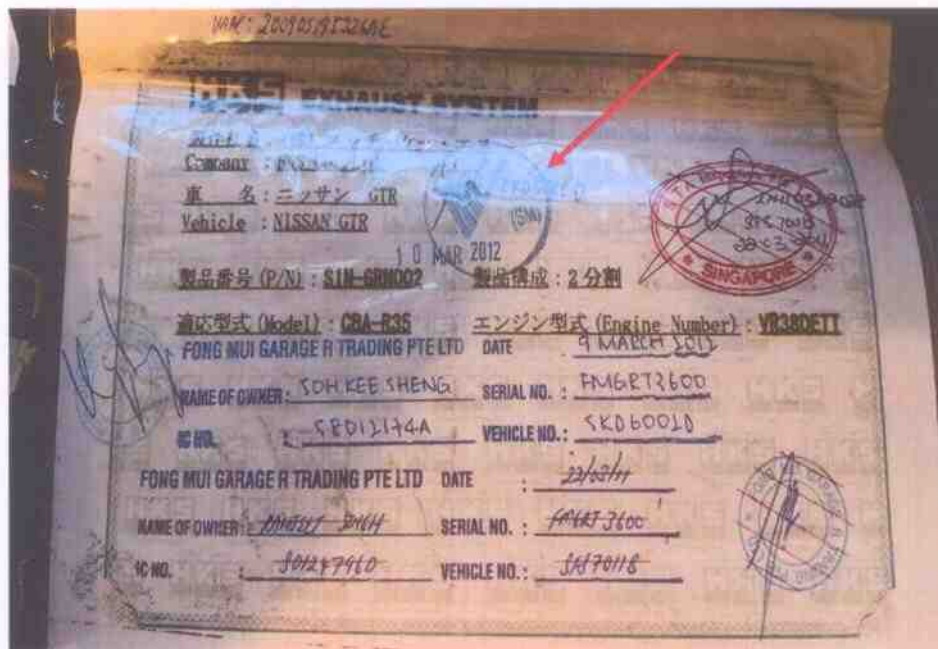
Photo 24 shows the document relating to the aftermarket rear exhaust of the insured vehicle. The serial number indicated in the document was checked and verified with the serial number indicated on the tag of the rear exhaust. Both serial numbers had corresponded. The Vicom Inspection Centre stamp (arrowed) indicated that the insured vehicle was presented for inspection of the aftermarket rear exhaust in 2012.
