Your Ref: C0397877
Our Ref : CI/AXA18004280/D

AUTOMOBILE INSPECTION REPORT OF INSURED VEHICLE SKD 6002D

1. I refer to your request dated 28 February 2018 to carry out an inspection of the insured vehicle SKD 6002D.
2. The objective of the inspection was to check whether the insured vehicle was fitted with any modification(s), in particular during the period 28 April 2016 to 27 August 2016.

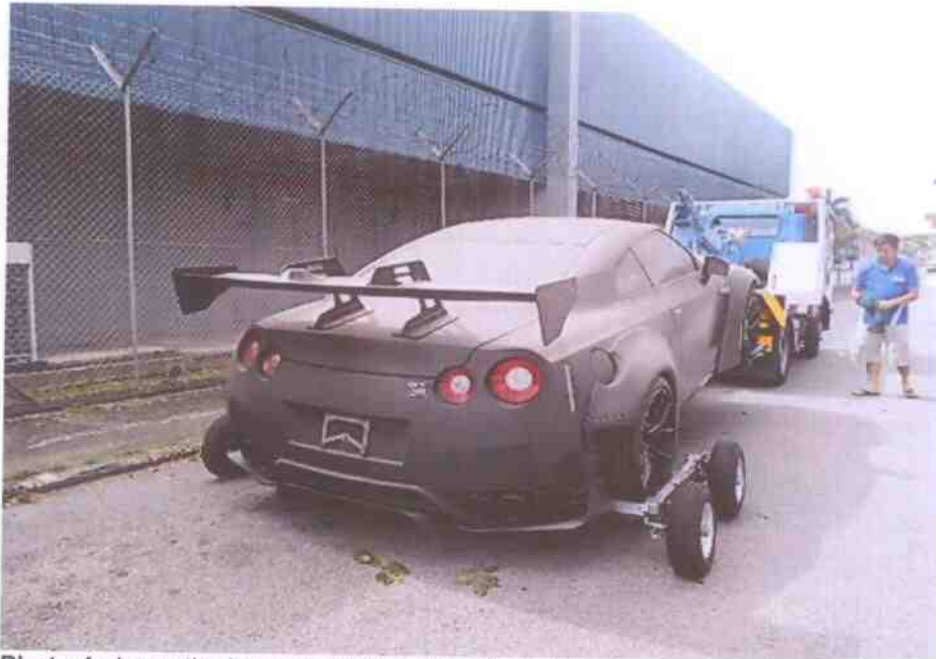
Photo 1 shows the insured vehicle at Traffic Police Pound prior to being towed to Teamwork Garage Pte Ltd. The method of towing was by, what is commonly referred to as king dolly method. Such method of towing is usually used when the towed vehicle is an all-wheel drive vehicle or rear wheel drive vehicle. The 4 wheels of the towed vehicle are lifted off ground during the towing.

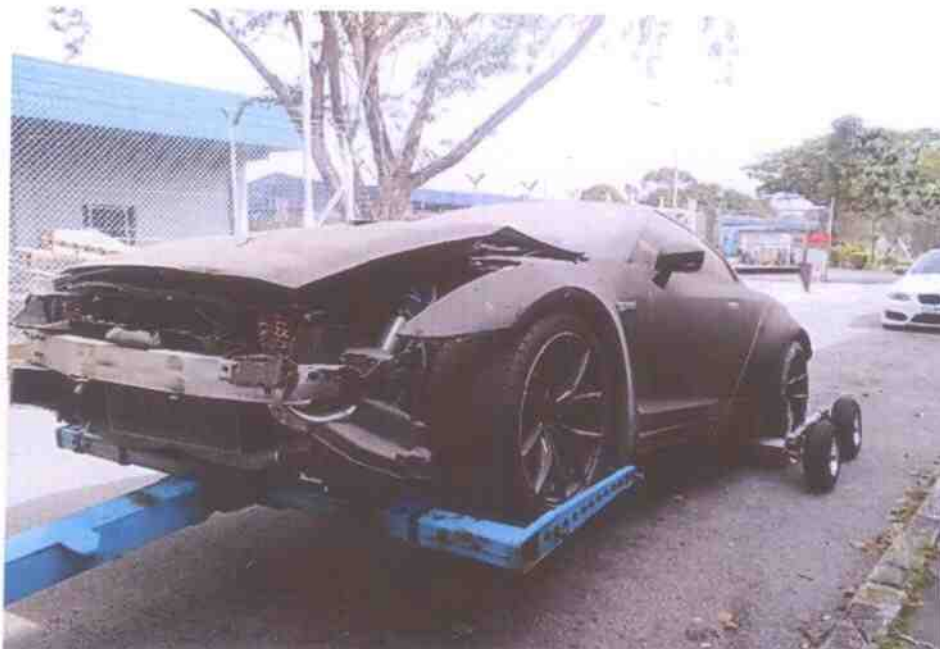
Photo 2 shows the insured vehicle at Traffic Police Pound prior to being towed to Teamwork Garage Pte Ltd. The method of towing was by, what is commonly referred to as king dolly method. Such method of towing is usually used when the towed vehicle is an all-wheel drive vehicle or rear wheel drive vehicle. The 4 wheels of the towed vehicle are lifted off ground during the towing.

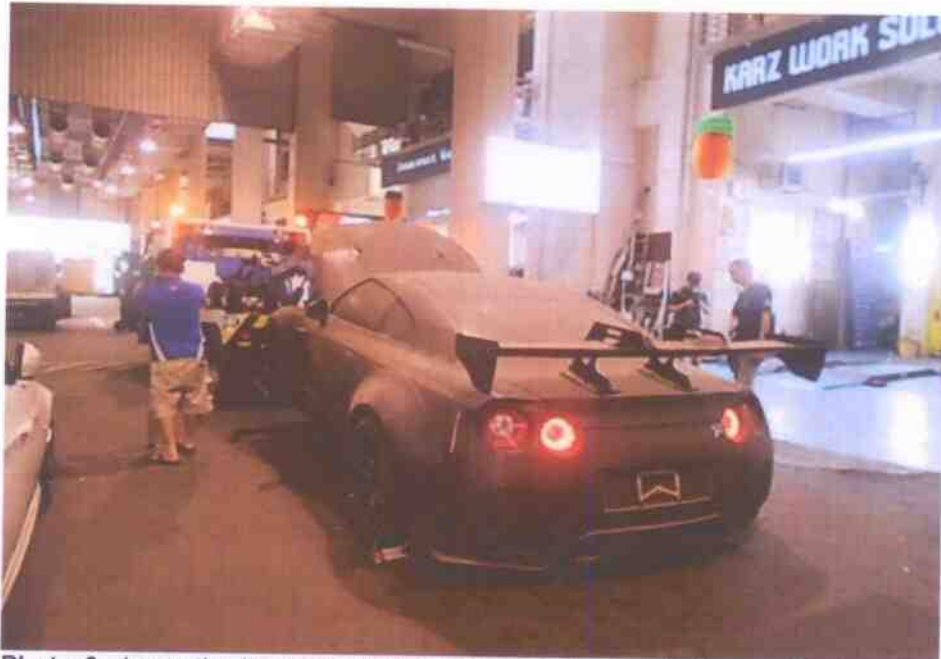
Photo 3 shows the insured vehicle arriving at Teamwork Garage Pte Ltd. The owner of the insured vehicle, who was present at Traffic Police Pound earlier, was also present when the insured vehicle had arrived at Teamwork Garage Pte Ltd.

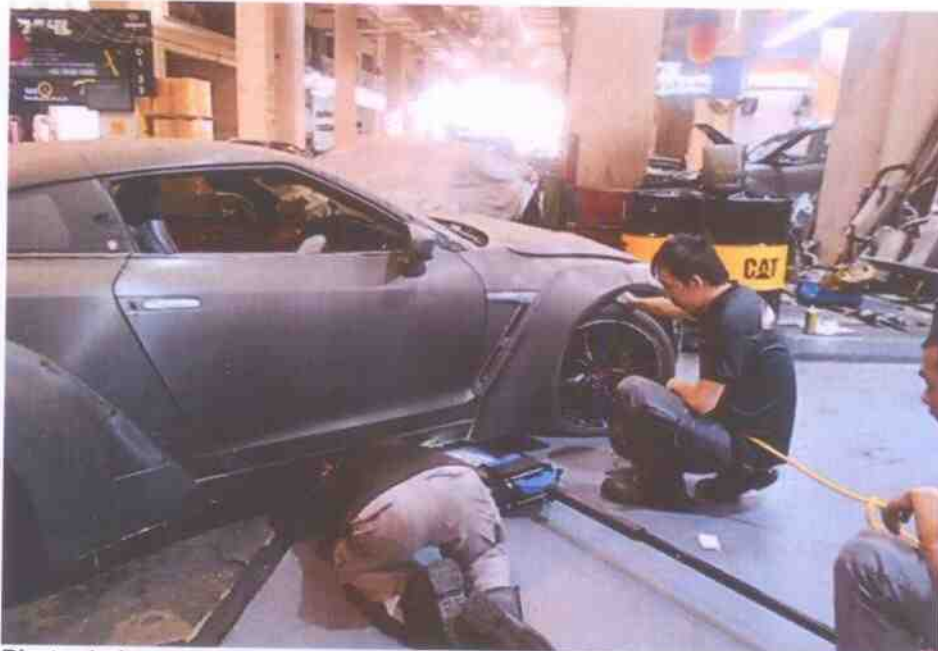
Photo 4 shows preparation works being done to move the insured vehicle onto a hoist for a detailed inspection.

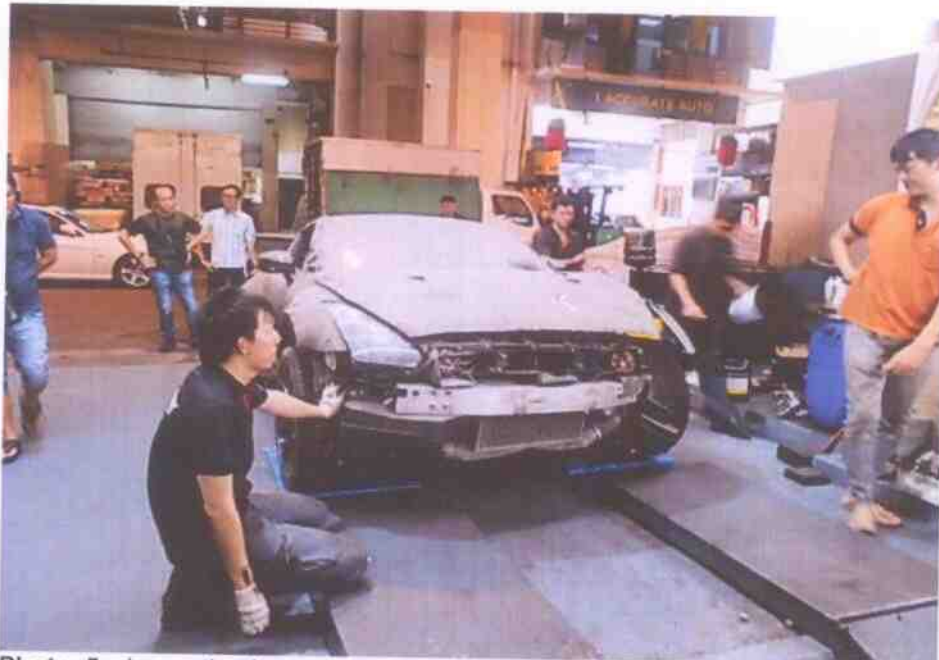
6. Generally, the insured vehicle was observed to be in good condition. It had sustained impact damages that were confined to its frontal portion. Its front bumper, front bonnet, front fenders and front headlamps were amongst the body parts that were observed to have been damaged. Its front right wheel rim was dented, leading to air loss from the front right tyre. Its driver's airbag and front left passenger airbag were both activated, along with the respective seat belts. See photo 1 – 6 below.

Photo 5 shows the insured vehicle being moved onto a hoist for a detailed inspection. Generally, the insured vehicle was observed to be of good condition. It had however sustained impact damages that were confined to its frontal portion. Its front bumper, front bonnet, front fenders and front headlamps were amongst the body parts that were observed to have been damaged.

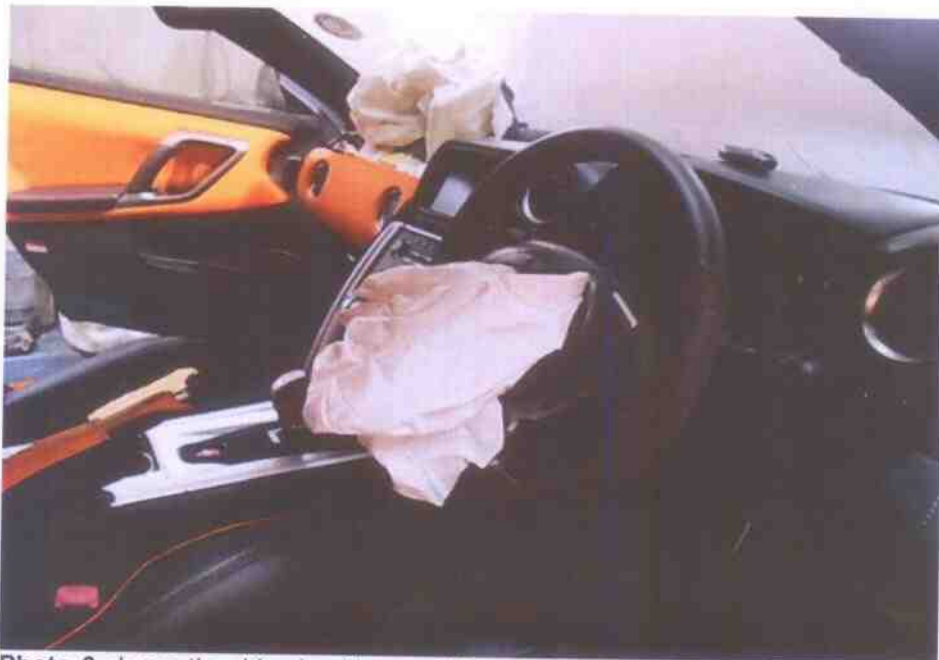
Photo 6 shows the driver's airbag and front left passenger airbag of the insured vehicle activated.

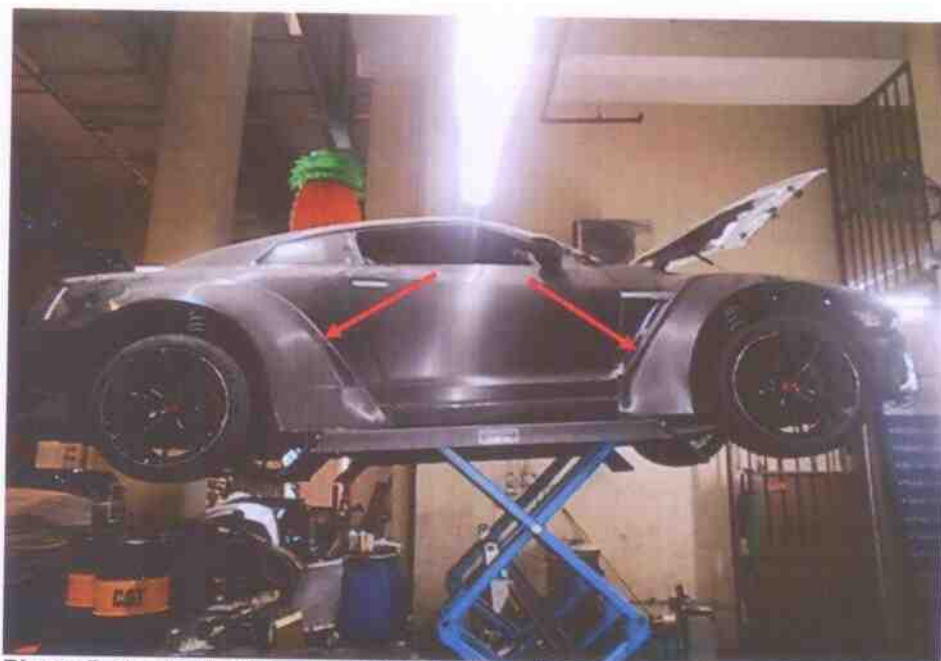
7. Exteriorly, the insured vehicle was fitted with a set of aftermarket bodykit. The type of bodykit fitted was observed to be, what is commonly referred to as "wide body" type, where an additional body panel is fabricated and attached by bolts onto the main body of the insured vehicle, at the wheel arc area above the 4 wheels. Fitting such type of bodykits causes the insured vehicle to be wider laterally. See photo 7 below.

Photo 7 shows the insured vehicle hoisted during my inspection. Exteriorly the insured vehicle was observed to be fitted with a set of wide body type of bodykit. For such bodykits, an additional body panel (arrowed) is fabricated and attached by bolts onto the main body of the insured vehicle, at the wheel arc area above the 4 wheels. Fitting such type of bodykits causes the insured vehicle to be wider laterally.

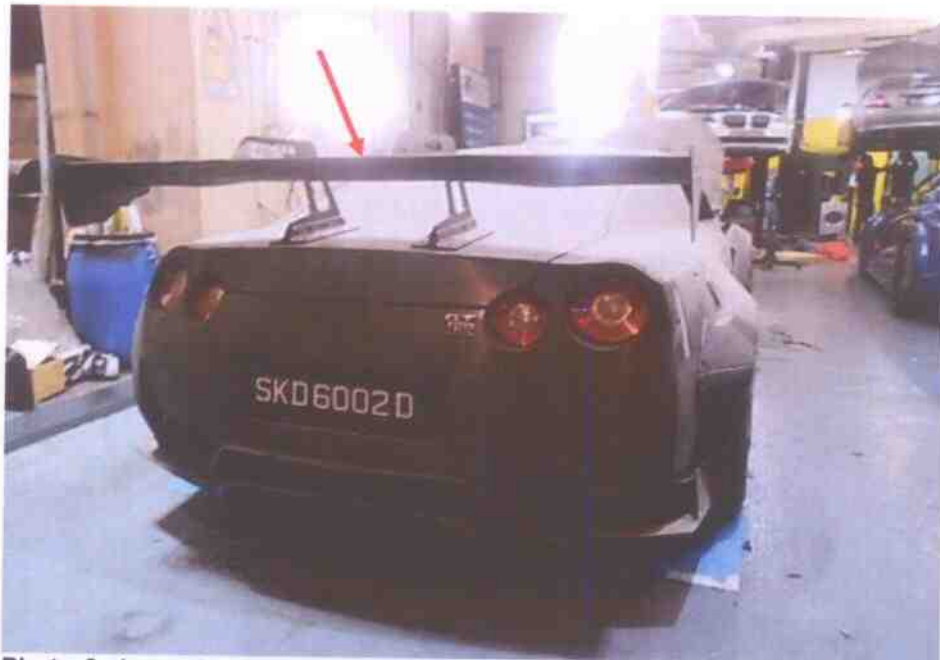
8. The rear spoiler that is fitted on the insured vehicle is an aftermarket type that is commonly referred to as "GT wing". The overall length of the rear spoiler was observed to have laterally protruded out of the insured vehicle's main body. See photo 8 - 10 below.

Photo 8 shows the rear spoiler (arrowed) fitted on the insured vehicle. The type of rear spoiler is commonly referred to as "GT wing". The overall length of the rear spoiler was observed to have laterally protruded out of the insured vehicle's main body.

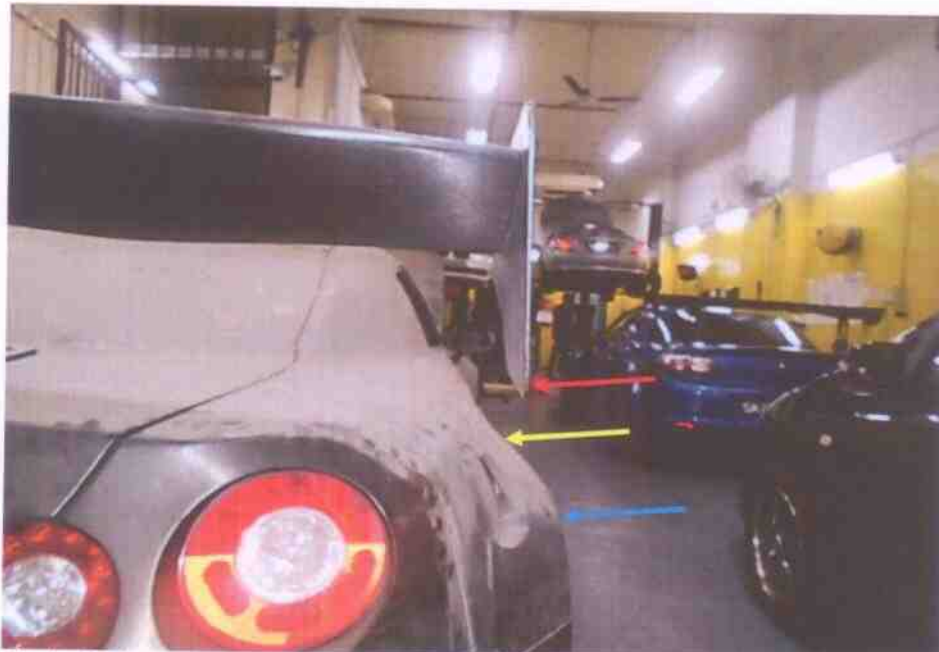
Photo 9 shows the rear spoiler (red arrow) protruding laterally out of the insured vehicle's main body (yellow arrow). This was at the rear right side of the insured vehicle. The additional body panel (blue arrow) for the wide body type of bodykit is fabricated and attached by bolts onto the main body of the insured vehicle, at the wheel arc area above the 4 wheels. Fitting such type of bodykits causes the insured vehicle to be wider laterally.

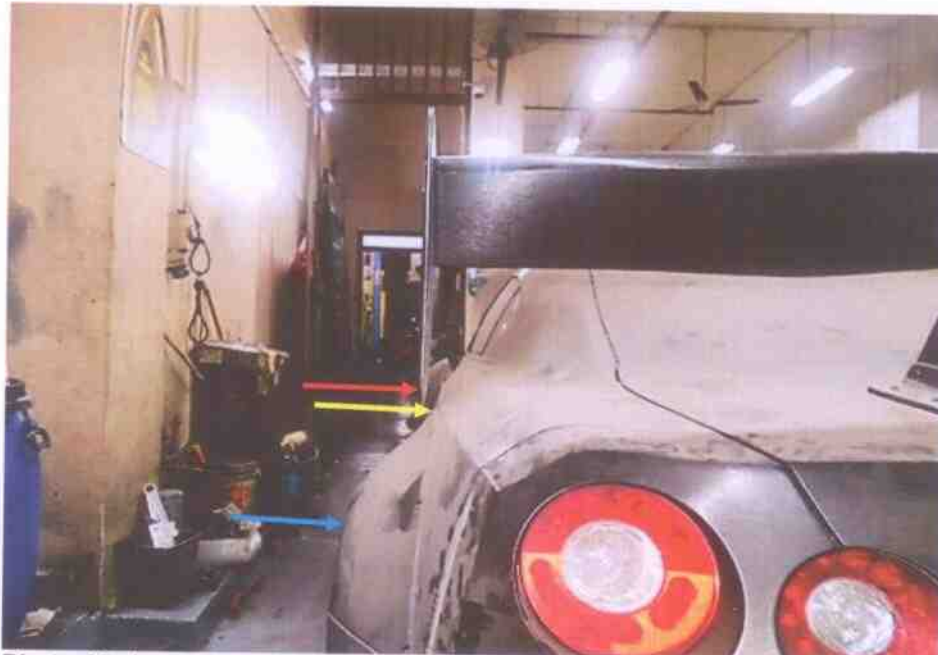
Photo 10 shows the rear spoiler (red arrow) protruding laterally out of the insured vehicle's main body (yellow arrow). This was at the rear left side of the insured vehicle. The additional body panel (blue arrow) for the wide body type of bodykit is fabricated and attached by bolts onto the main body of the insured vehicle, at the wheel arc area above the 4 wheels. Fitting such type of bodykits causes the insured vehicle to be wider laterally.

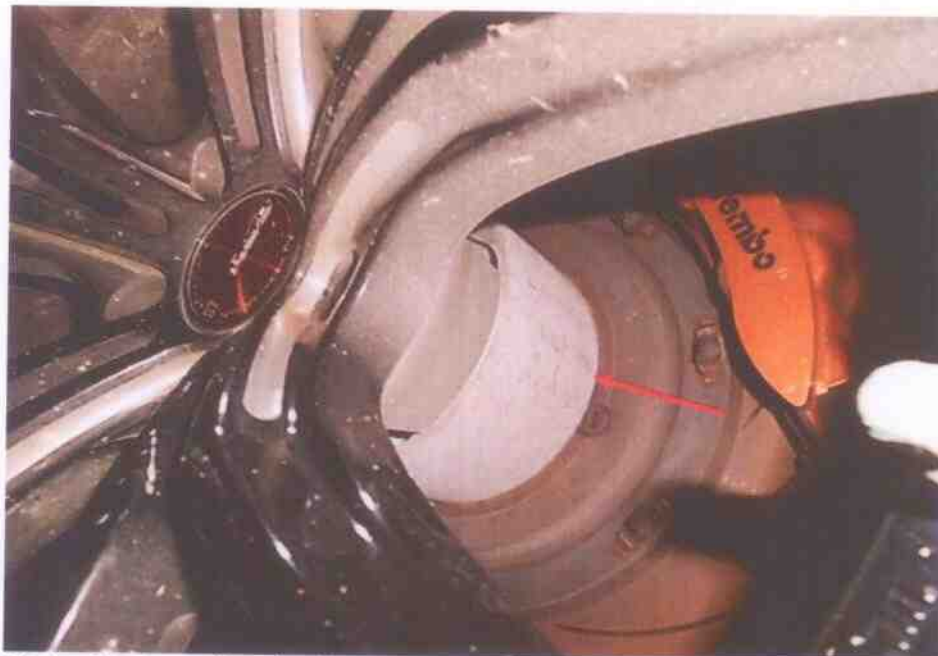
9. In order to accommodate the protruded side body of the insured vehicle that was caused by the fitting of the "wide body" type of bodykit, wheel spacers were added to all the 4 wheels so that the wheels of the insured vehicle were "pushed" outwards, becoming flush with the protruded body line of the insured vehicle. Such wheel spacers are not a standard feature of the insured vehicle and is an additionally fitted part. See photo 11 & 12 below.

Photo 11 shows the wheel spacer (arrowed) that was additionally fitted at the rear right wheel. Such wheel spacer was found to be fitted on all the 4 wheels of the insured vehicle, "pushing" the 4 wheels of the insured vehicle outwards, becoming flush with the protruded body line of the insured vehicle.

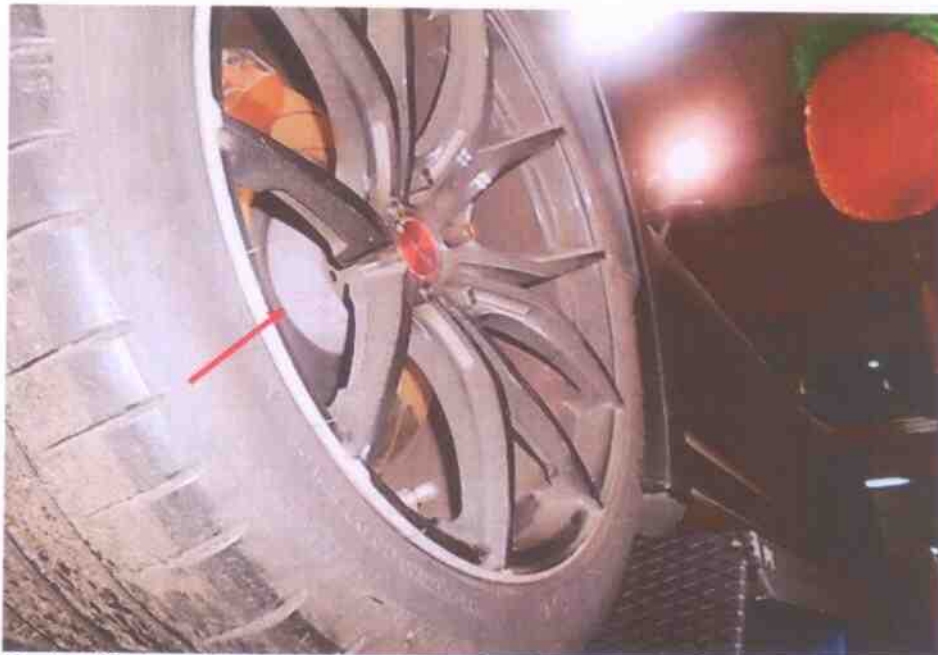
Photo 12 shows the wheel spacer (arrowed) that was additionally fitted at the front left wheel. Such wheel spacer was found to be fitted on all the 4 wheels of the insured vehicle, "pushing" the 4 wheels of the insured vehicle outwards, becoming flush with the protruded body line of the insured vehicle.

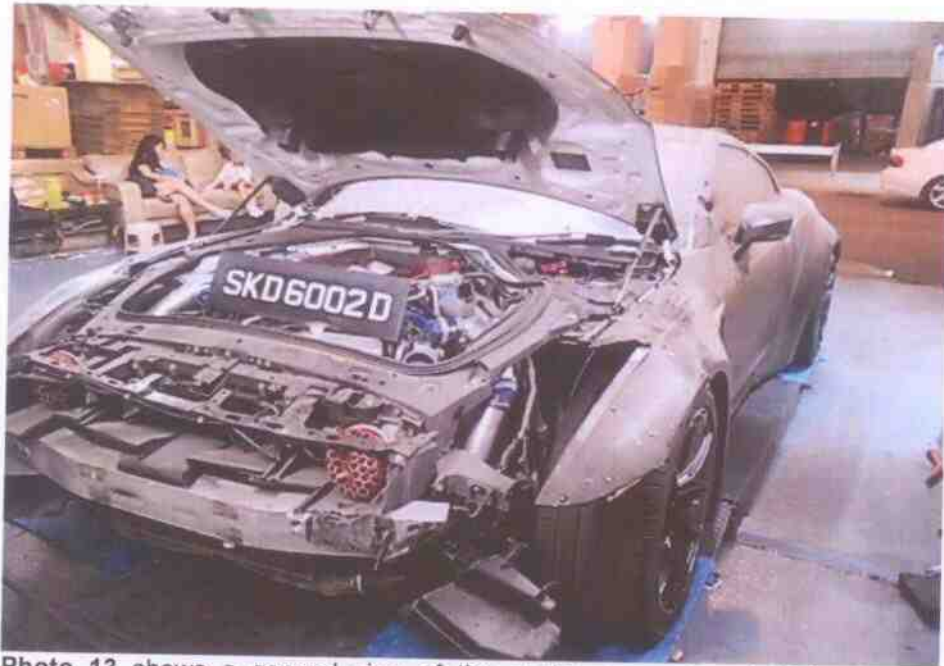
10. Upon checking the engine compartment of the insured vehicle, I had found several modifications fitted. This includes an aftermarket air intake system with all piping; an aftermarket intercooler; a non-original engine coolant reservoir tank; and some non-original fluid carry hoses. See photo 13 – 16 below.

Photo 13 shows a general view of the engine compartment of the insured vehicle. Several modifications were found fitted in the engine compartment. This had included an aftermarket air intake system with all piping; an aftermarket intercooler; a non-original engine coolant reservoir tank; and some non-original fluid carry hoses.

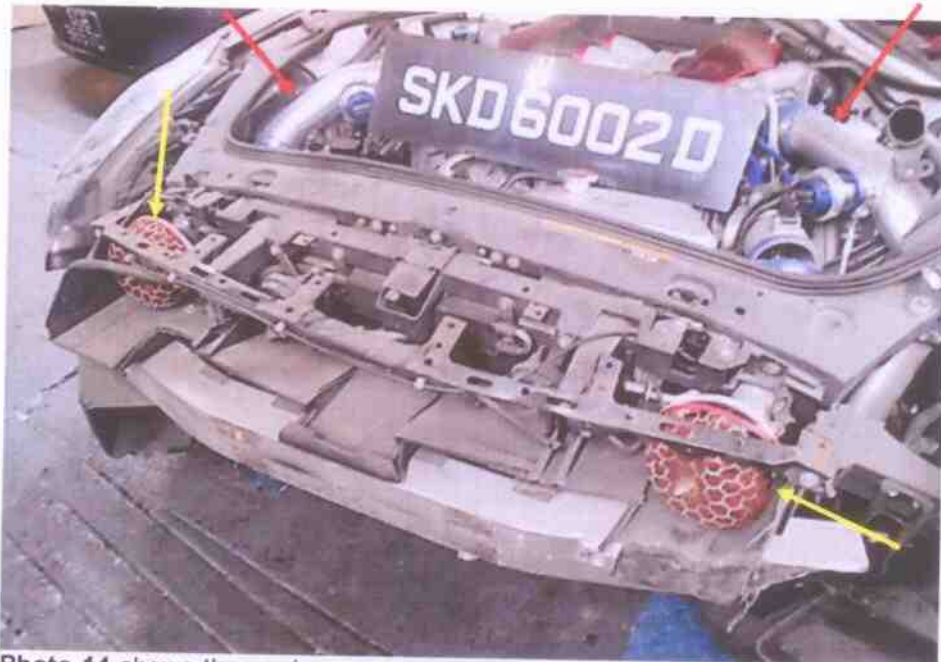
Photo 14 shows the engine compartment of the insured vehicle. An aftermarket air system was observed to be fitted on the insured vehicle. This had included non-original air filters (yellow arrow) and piping (red arrow).

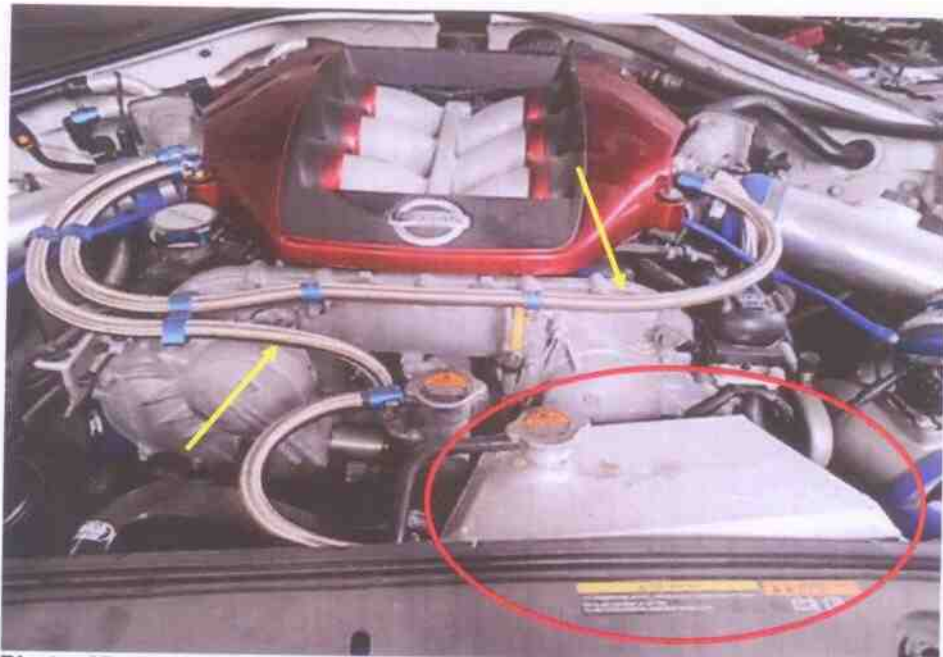
Photo 15 shows the engine compartment of the insured vehicle and the non-original engine coolant reservoir tank (circled) and some various non-original fluid carry hoses (yellow arrow).

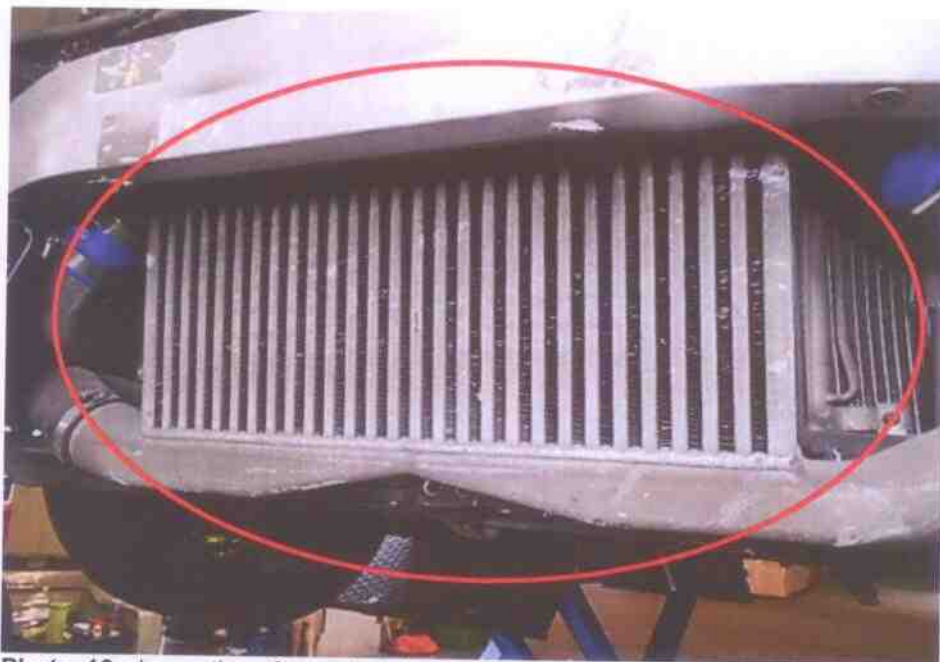
Photo 16 shows the aftermarket intercooler (circled) that was observed on the insured vehicle.

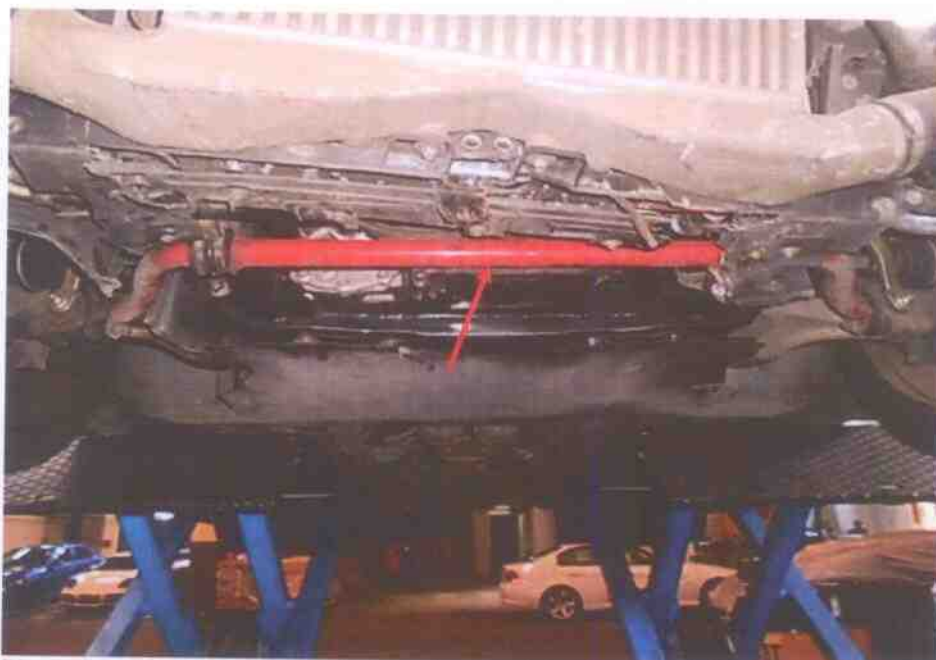
11. Checks on the underside of the insured vehicle after it was hoisted up revealed an aftermarket front and rear suspension system; and an aftermarket front and rear anti-roll bar fitted on the insured vehicle. See photo 17 – 19 below.
12. My close examination of the insured vehicle's exhaust system revealed that the rear section of the exhaust, from the middle pipe to the rear muffler was an aftermarket type. No weld mark(s) were found along the exhaust pipes. The catalytic converters and front sections of the exhaust were also closely examined and I did not find any sign(s) or indication(s) to suggest that the catalytic converters and/or front sections of the exhaust were tampered with. See photo 20 – 24 below.

Photo 17 shows the aftermarket front anti-roll bar (arrowed) fitted on the insured vehicle.

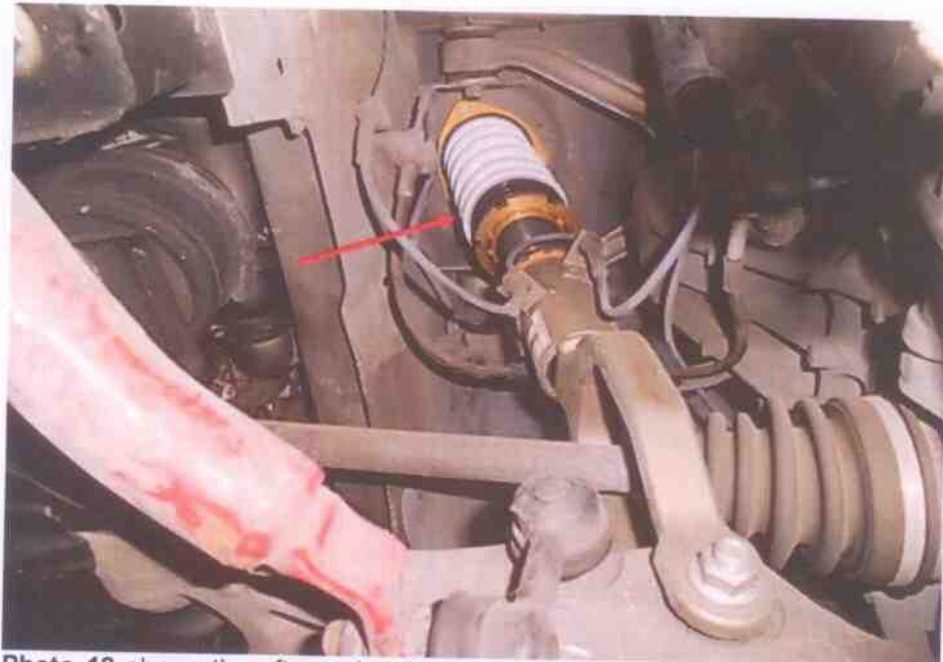
Photo 18 shows the aftermarket front left suspension (arrowed) of the insured vehicle. The insured vehicle was fitted with aftermarket front and rear suspension system.

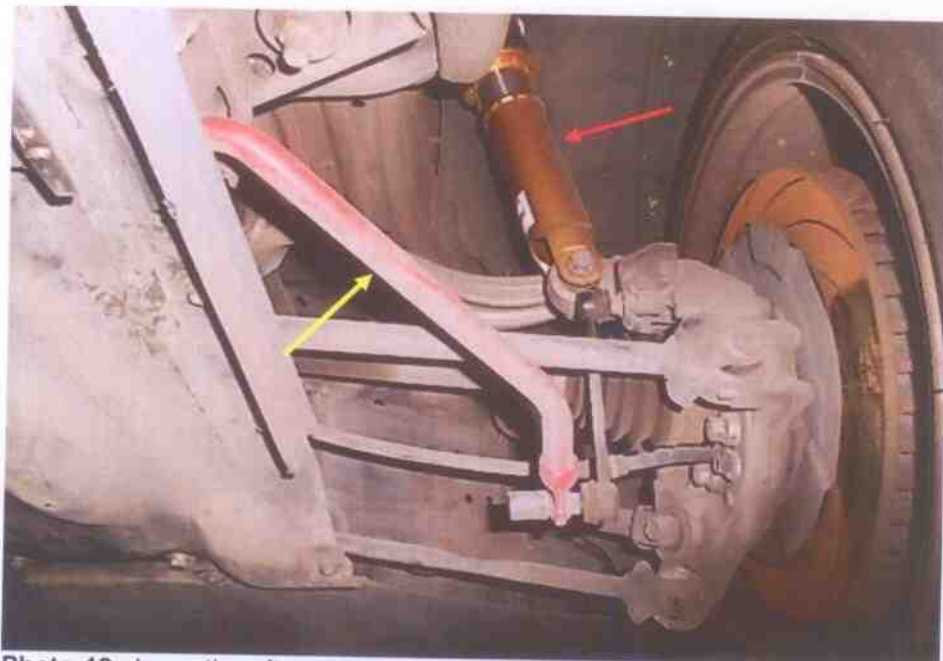
Photo 19 shows the aftermarket rear right suspension (red arrow) and rear anti-roll bar (yellow arrow) that was fitted on the insured vehicle.

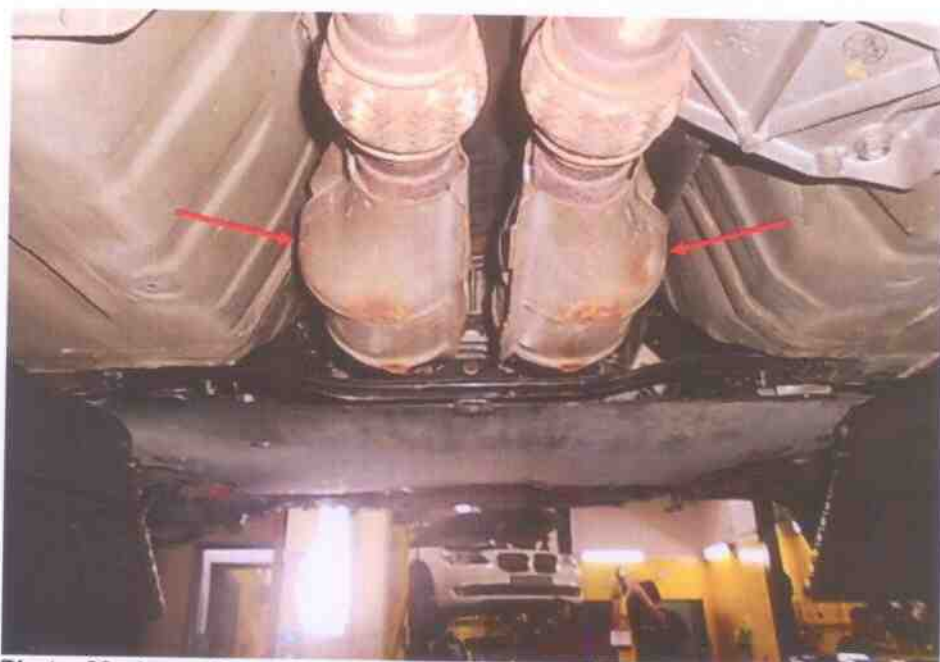
Photo 20 shows the catalytic converters (arrowed) of the insured vehicle. The catalytic converters and front sections of the exhaust were closely examined and I did not find any sign(s) or indication(s) of any weld mark(s) to suggest that the catalytic converters and/or front sections of the exhaust were tampered with.

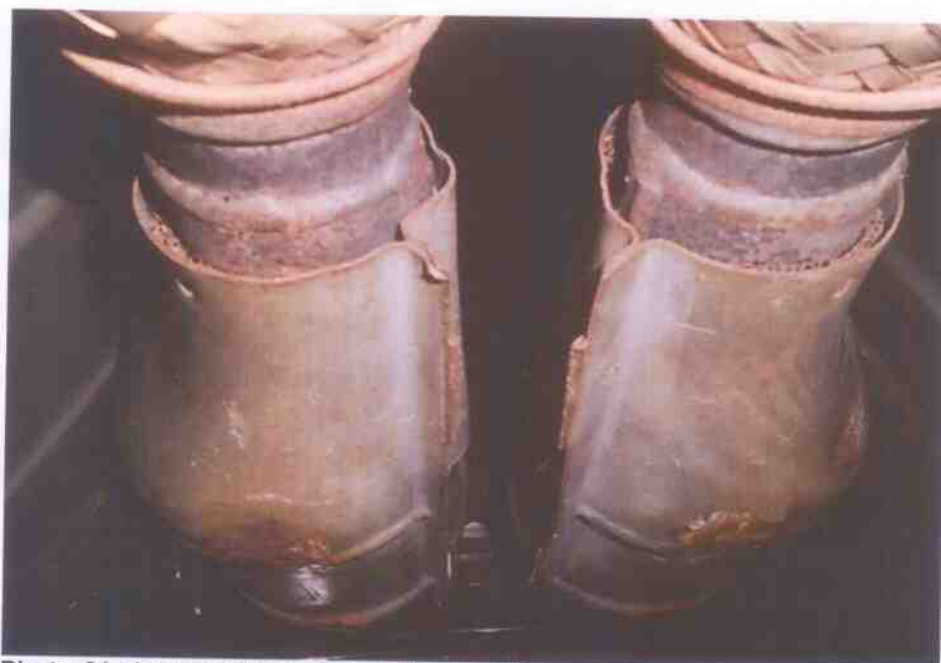
Photo 21 shows a closer view of the catalytic converters of the insured vehicle. The catalytic converters and front sections of the exhaust were closely examined and I did not find any sign(s) or indication(s) of any weld mark(s) to suggest that the catalytic converters and/or front sections of the exhaust were tampered with.

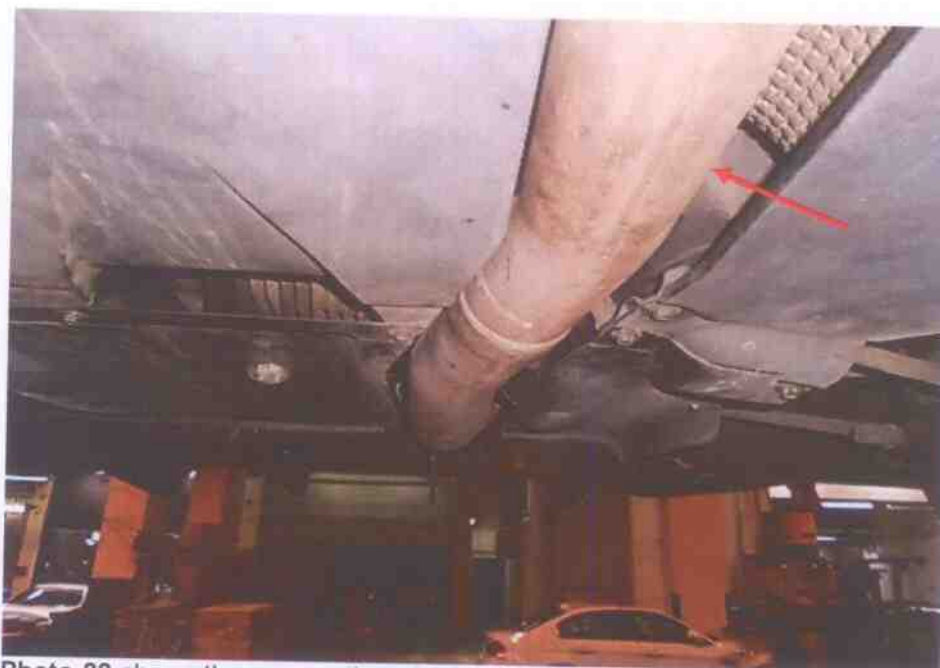
Photo 22 shows the rear section of the exhaust, from the middle pipe (arrowed) to the rear muffler. The rear section of the insured vehicle's exhaust system was observed to be an aftermarket type.

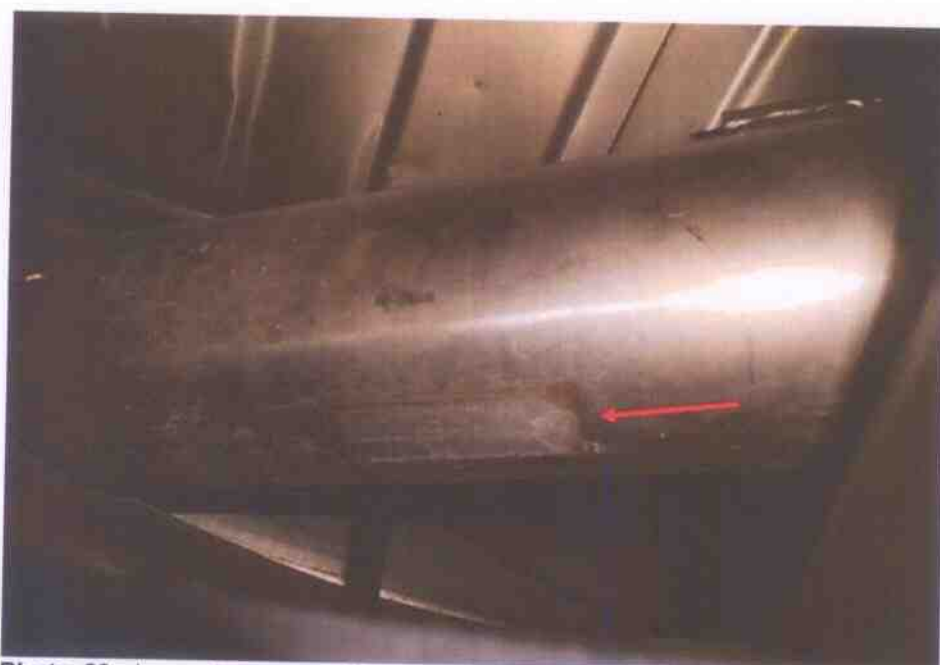
Photo 23 shows the rear muffler of the insured vehicle. The rear section of the insured vehicle's exhaust system, from the middle pipe to the rear muffler, was observed to be an aftermarket type. The tag (arrowed) of this aftermarket exhaust was intact and not tampered with.

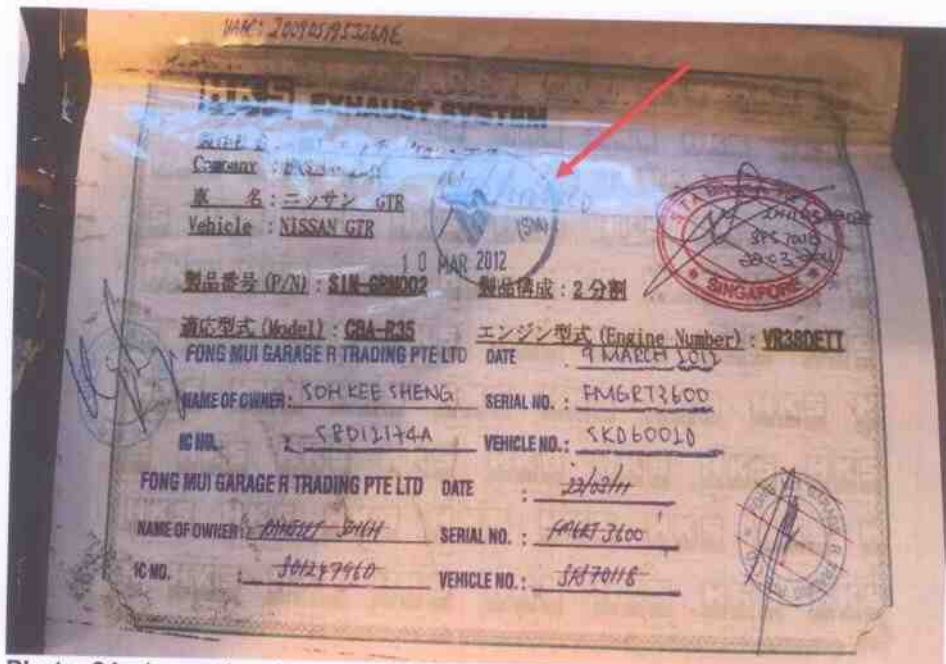
Photo 24 shows the document relating to the aftermarket rear exhaust of the insured vehicle. The serial number indicated in the document was checked and verified with the serial number indicated on the tag of the rear exhaust. Both serial numbers had corresponded. The Vicom Inspection Centre stamp (arrowed) indicated that the insured vehicle was presented for inspection of the aftermarket rear exhaust in 2012.
