Your Ref: S8M00A51
Our Ref : CS/ASM18004432/N

14 March 2018

**TECHNICAL INVESTIGATION REPORT OF FIRE INCIDENT INVOLVING THE
MOTOR VEHICLE YM 9113J ON 6 FEBRUARY 2018**

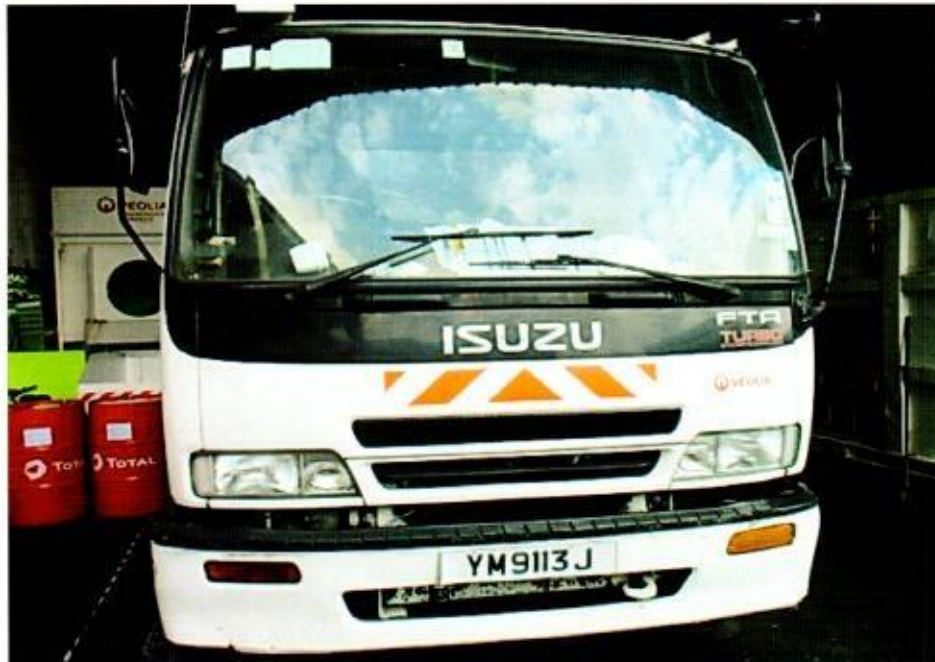
Photo 1 shows the front view of the Insured Vehicle at the time of our inspection. The fire damage to the Insured Vehicle was confined to its centre portion. The exterior body of the Insured Vehicle was relatively unaffected by the fire except for the centre portion.

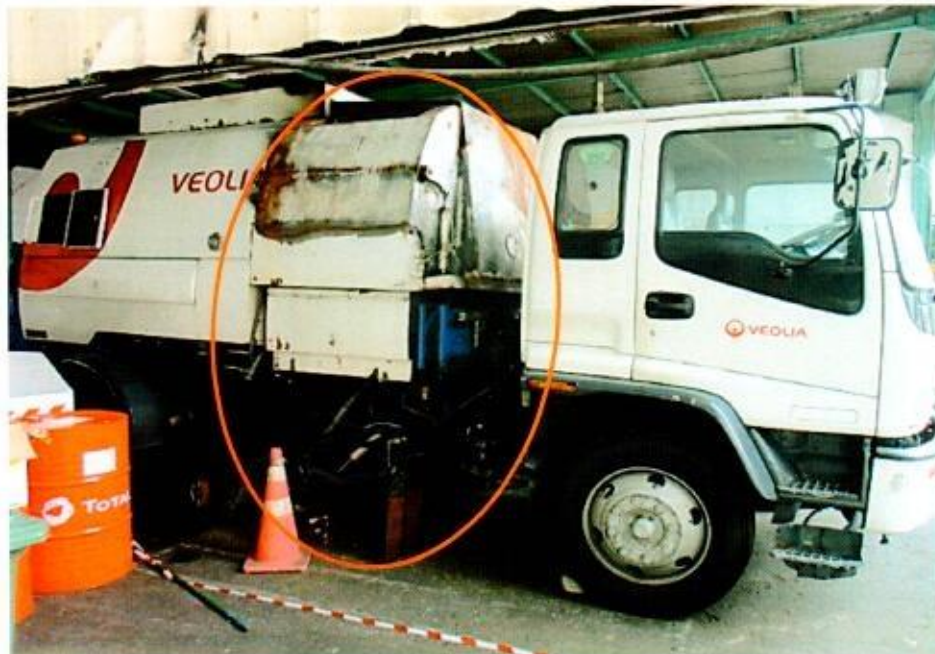
Photo 2 shows the right side of the Insured Vehicle at the time of our inspection. The exterior body of the Insured Vehicle was relatively unaffected by the fire except for the centre portion. The fire damage to the Insured Vehicle was confined to its centre portion (circled).

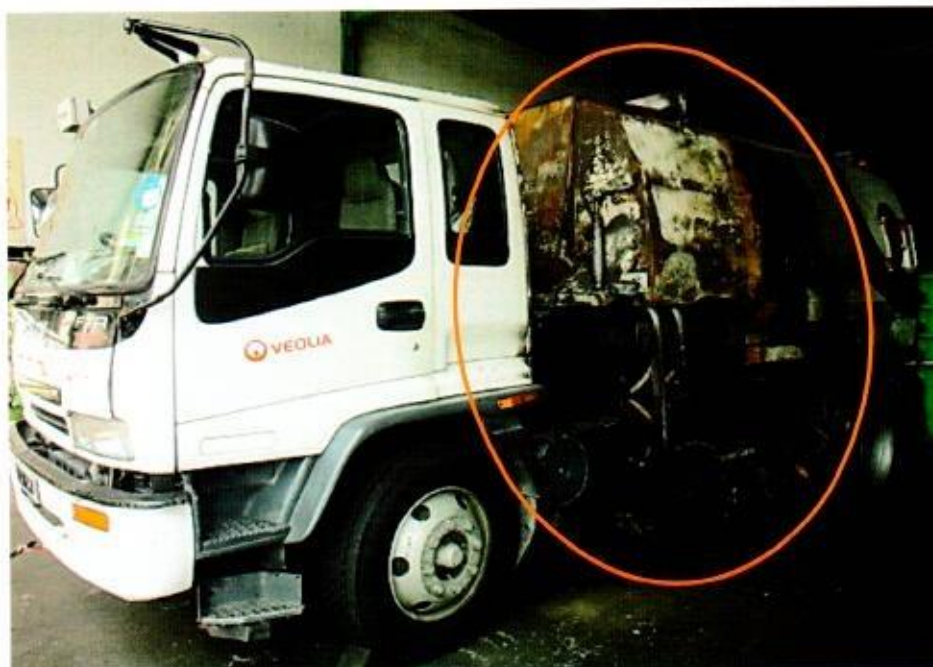
Photo 3 shows the left side of the Insured Vehicle at the time of our inspection. The exterior body of the Insured Vehicle was relatively unaffected by the fire except for the centre portion. The fire damage to the Insured Vehicle was confined to its centre portion. The fire damage was observed to be most severe at its left centre portion (circled).

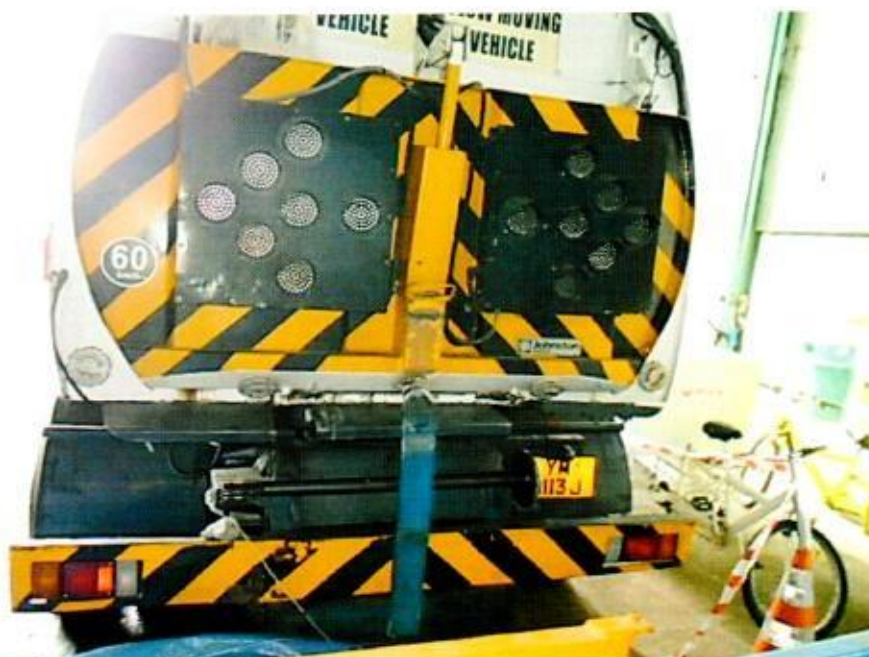
Photo 4 shows the rear portion of the Insured Vehicle at the time of our inspection. The fire damage to the Insured Vehicle was confined to its centre portion. The rear portion was observed to have been unaffected by the fire.

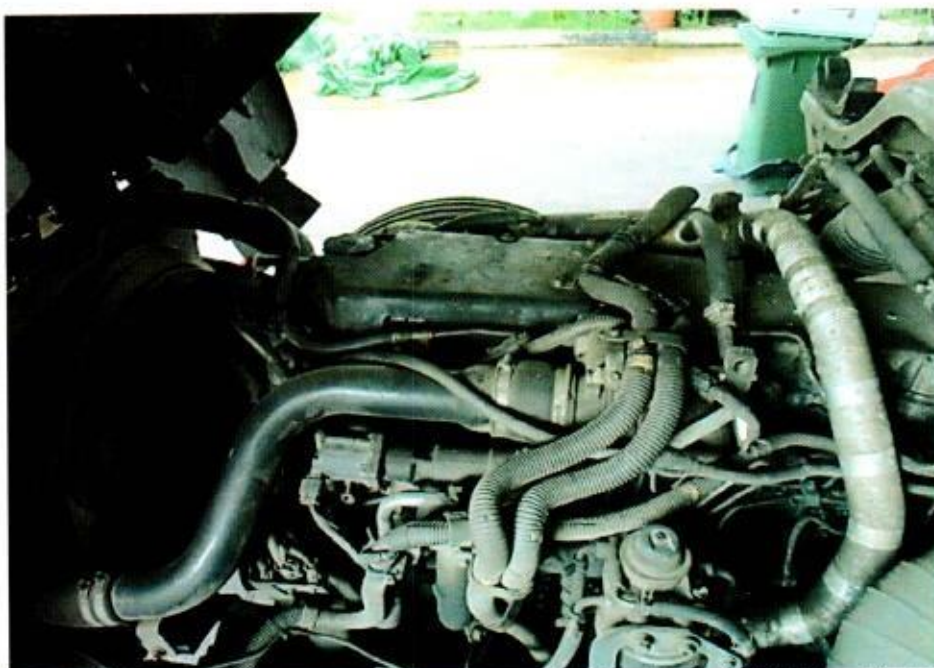
Photo 5 shows the main engine compartment of the Insured Vehicle which is situated beneath the front cabin at the time of our inspection. The main engine compartment of the Insured Vehicle was relatively unaffected by the fire.

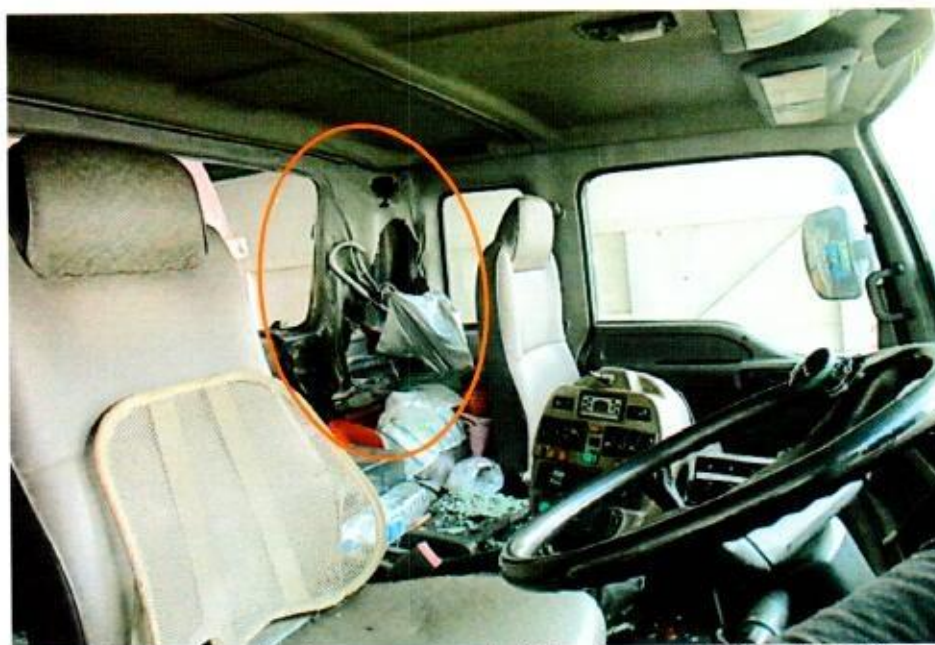
Photo 6 shows the interior compartment of the Insured Vehicle at the time of inspection. The rear portion of the interior compartment was significantly affected by the fire (circled).

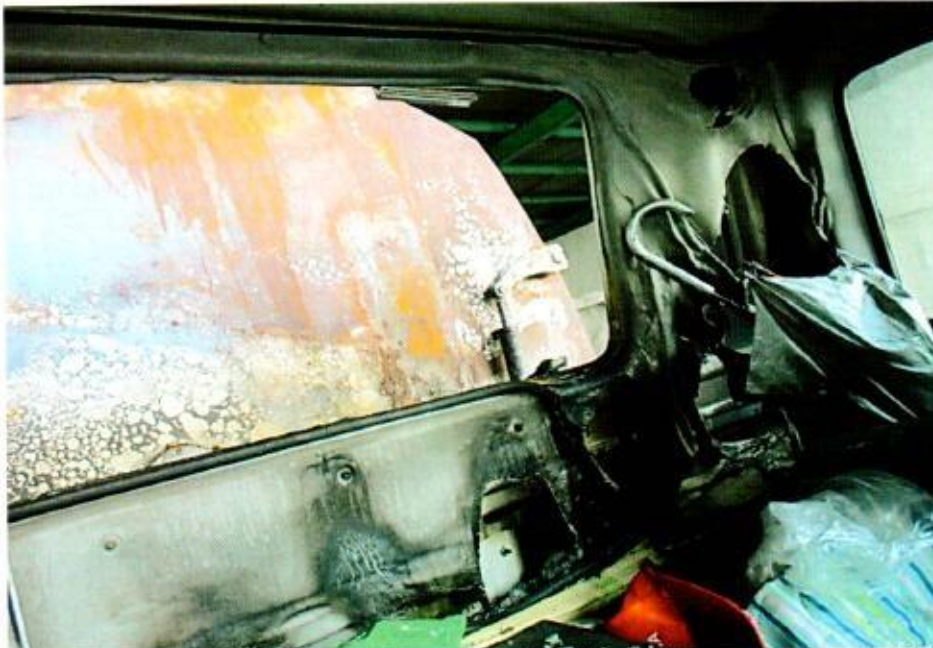
Photo 7 shows a closer view of the rear portion of the interior compartment which was significantly affected by the fire.

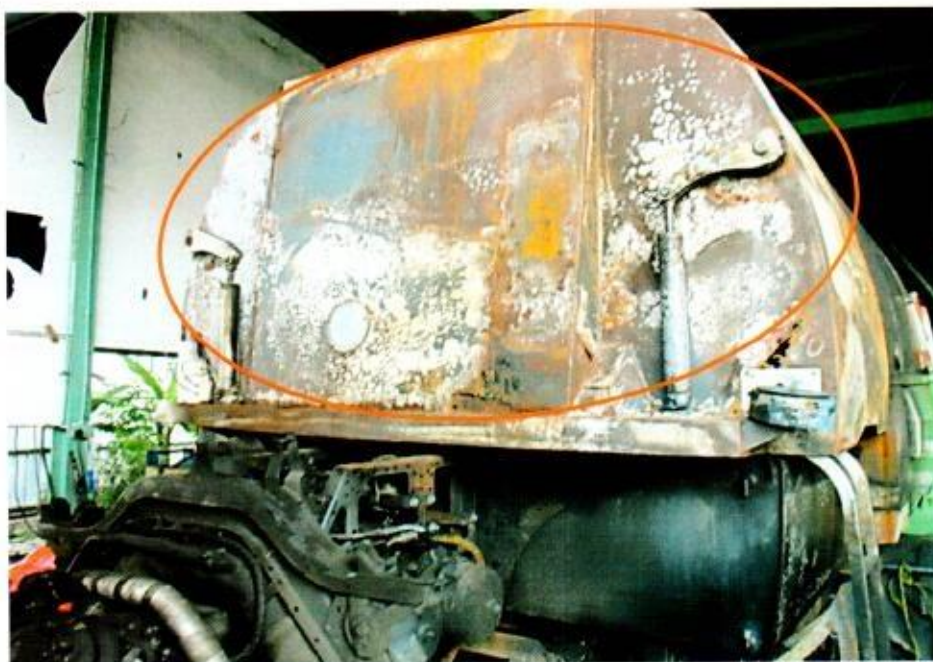
8. For this particular case, the fire appears to have originated from the left centre portion of the Insured Vehicle, which houses the sub engine (herein referred to as "**sub engine compartment**"). This can be determined from the burn pattern and the high heat intensity burn marks (whitish burn marks) found on the left portion of the Insured Vehicle's sub engine compartment and also the rust that had developed at the areas around the sub engine compartment.

9. The whitish burn marks are a result of exposure to prolonged heat intensity. Rust would normally start to develop around these areas soon after a fire as prolonged exposure to high heat intensity usually causes steel/metal material body parts to be exposed to natural environmental condition. Hence the rust that had developed around the sub engine compartment of the Insured Vehicle is an indication that the fire to the Insured Vehicle had originated from the sub engine.

Photo 8 shows the sub engine compartment of the Insured Vehicle where the burn pattern and whitish burn marks were found (circled). Such whitish burn marks are a result of exposure to prolonged heat intensity, which had caused the steel/metal material of the sub engine compartment to be exposed to natural environmental condition. Hence the rust that had developed around the sub engine compartment of the Insured Vehicle is an indication that the fire to the Insured Vehicle had originated from the sub engine.

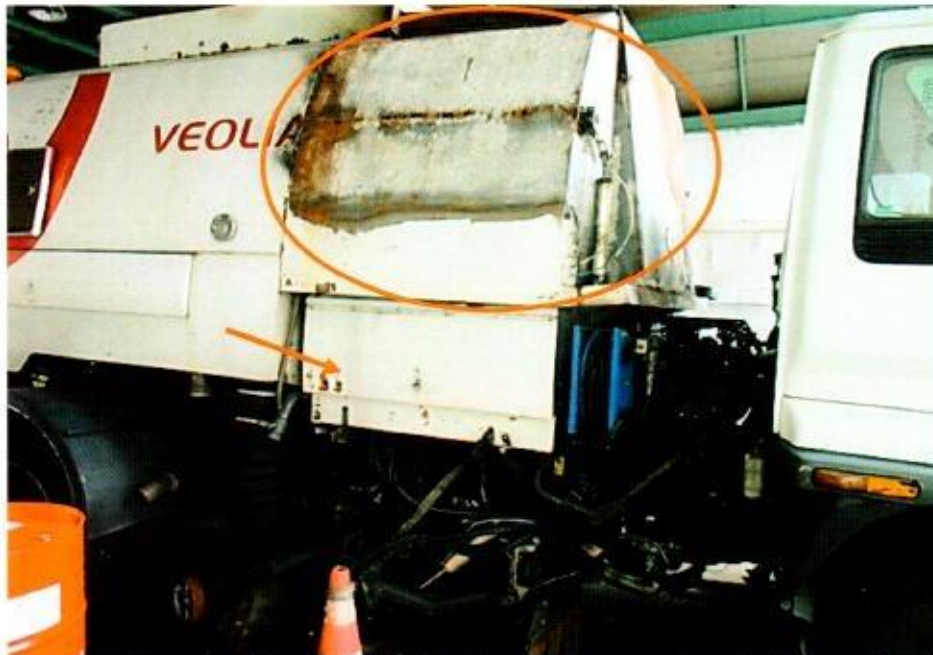
Photo 9 shows the right portion of the sub engine compartment which was badly burnt as a result of the fire (circled). Under normal operational conditions, the sub engine compartment of the Insured Vehicle can be raised to reveal the sub engine via an external control panel which is located at the right centre portion of the Insured Vehicle (arrowed).

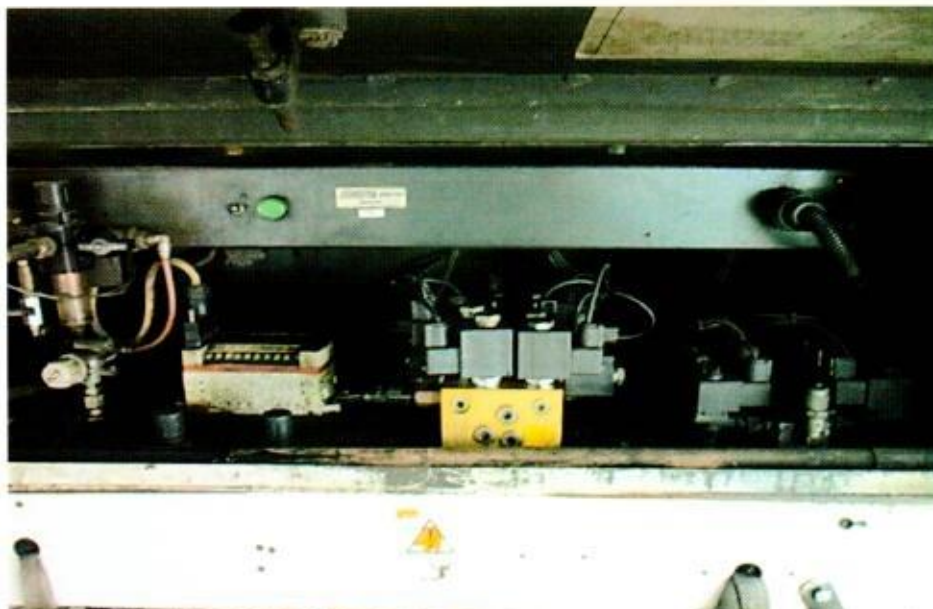
Photo 10 shows a closer view of the external control panel which is used to raise the sub engine compartment of the Insured Vehicle to reveal the sub engine under normal operational conditions. However due to the fire affecting the electrical system of the Insured Vehicle, we were unable to gain access to the sub engine to access the degree of fire damage.

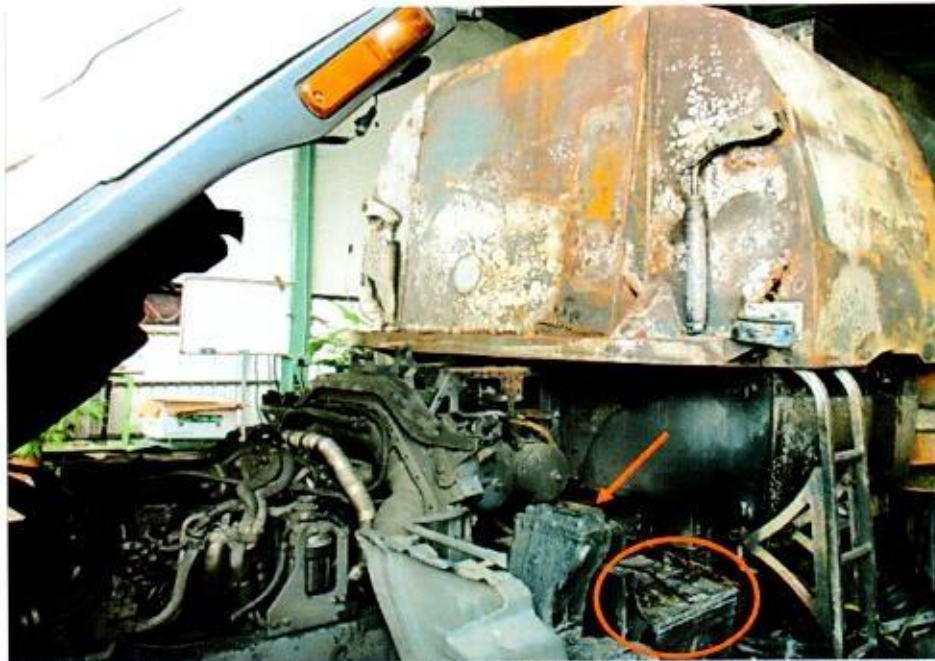
11. Upon closer examination around the areas in closest proximity to the sub engine which was where the fire to the Insured Vehicle had likely started, we had found several stretches of burnt wiring with greenish residue. These wirings were original factory fitted wirings below the sub engine compartment. We also found traces of greenish residue on several stretches of burnt wiring leading from the battery of the Insured Vehicle. The presence of greenish residue indicates internal heating of copper wires, a sign of an electrical short circuit occurring. The greenish residue is normally left behind from oxidation as a result of chemical reaction involving the copper wires. These physical evidences would appear to suggest that the cause of fire to the Insured Vehicle could have possibly been due to electrical in nature. See photos 11 - 17 below.

Photo 11 shows upon closer examination around the areas in closest proximity to the sub engine which was where the fire to the Insured Vehicle had likely started, we had found several stretches of burnt wiring with greenish residue. These wirings were original factory fitted wirings below the sub engine compartment (arrowed). We also found traces of greenish residue on several stretches of burnt wiring leading from the battery of the Insured Vehicle (circled). The presence of such greenish residue suggests occurrence of an electrical short circuit.

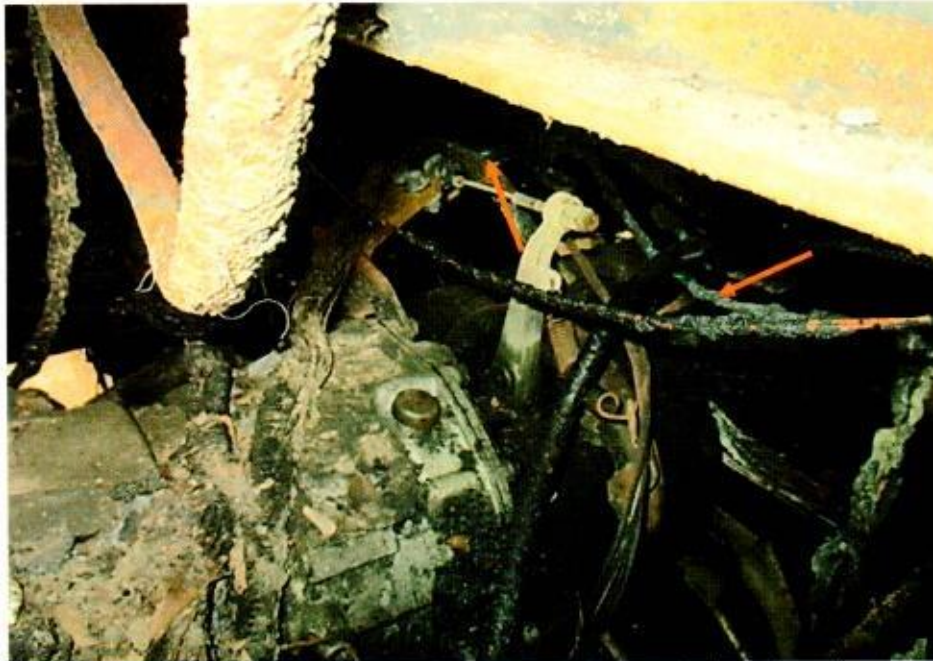
Photo 12 shows several original factory fitted wirings below the sub engine compartment with greenish residue (arrowed). The presence of such greenish residue suggests occurrence of an electrical short circuit.

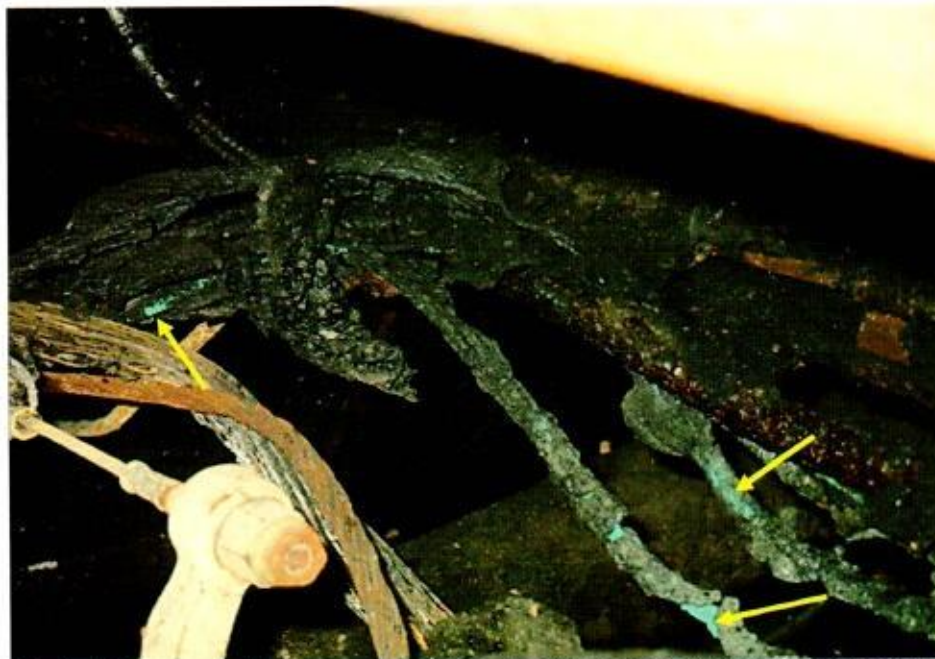
Photo 13 shows a close up view of the greenish residue found on some of the burnt wirings below the sub engine compartment of the Insured Vehicle (circled). The presence of such greenish residue suggests occurrence of an electrical short circuit.

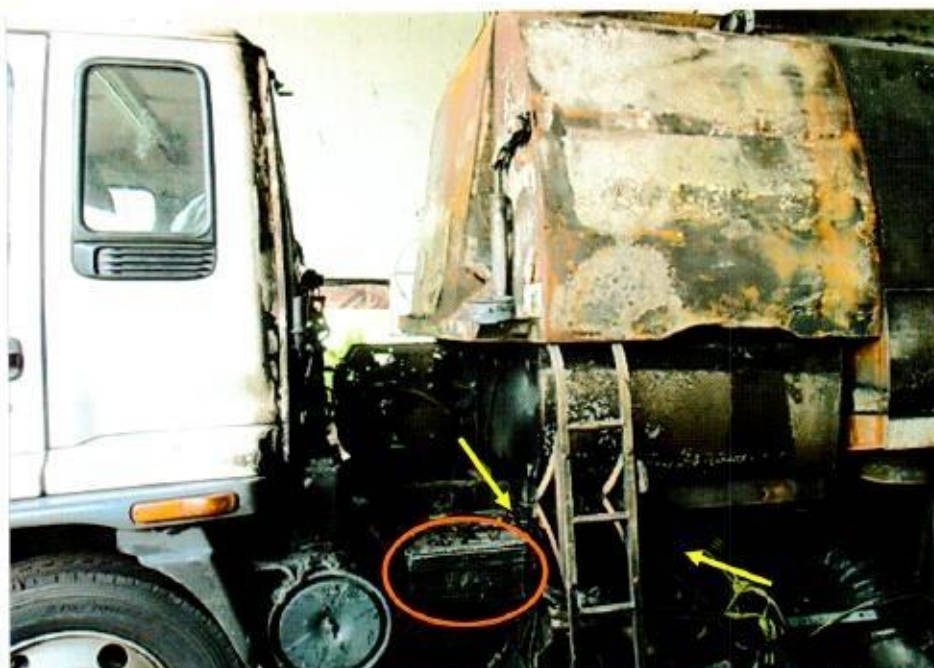
Photo 14 shows the several stretches of burnt wirings leading from the battery (circled) of the Insured Vehicle which had traces of greenish residue (arrowed). The presence of such greenish residue suggests occurrence of an electrical short circuit.

32. The possibility of the fire being due to electrical in nature would then seem more likely given that engine overheating and external factors would both seem unlikely. The fire being due to electrical nature is also supported by the condition of the wirings that were found beneath the sub engine compartment as well as the wirings leading from the battery of the Insured Vehicle, which was earlier discussed in paragraph 11 above.

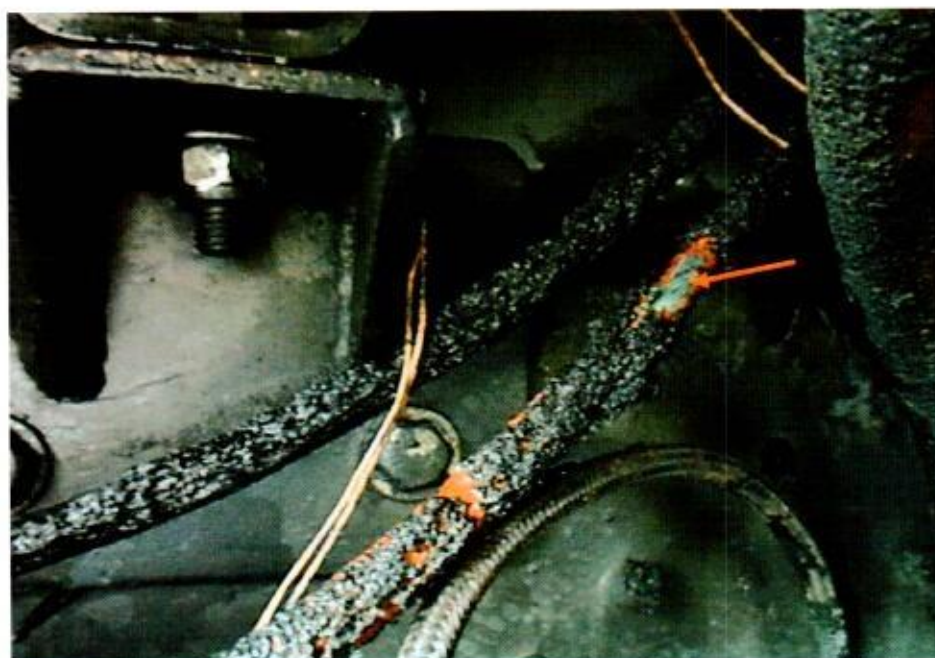
Photo 15 shows a closer view of the greenish residue found on some of the burnt wirings leading from the battery of the Insured Vehicle (arrowed). The presence of such greenish residue suggests occurrence of an electrical short circuit.

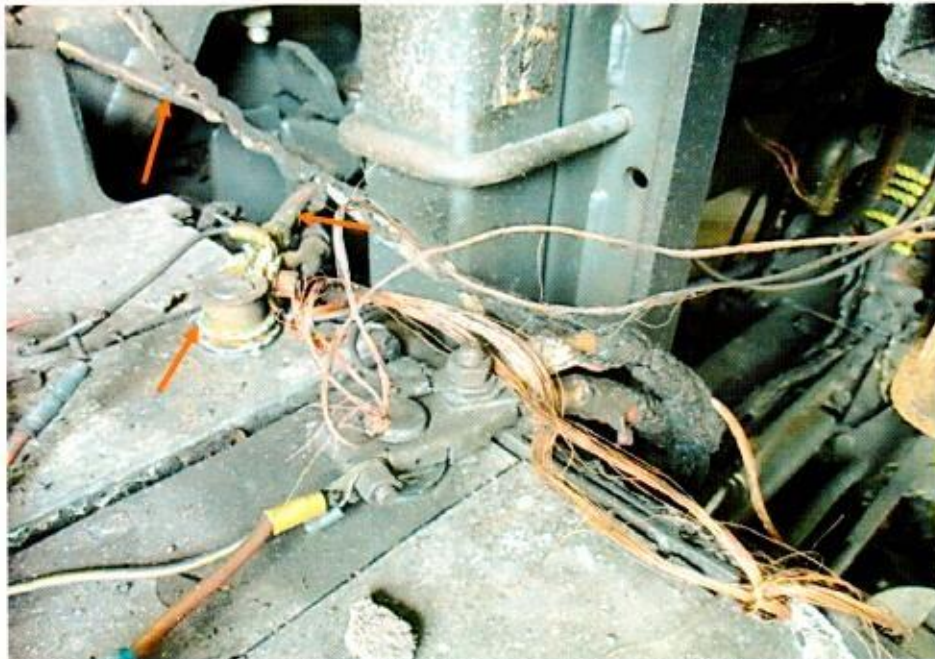
Photo 16 shows a closer view of the greenish residue found on some of the burnt wirings leading from the battery of the Insured Vehicle (arrowed). The presence of such greenish residue suggests occurrence of an electrical short circuit.

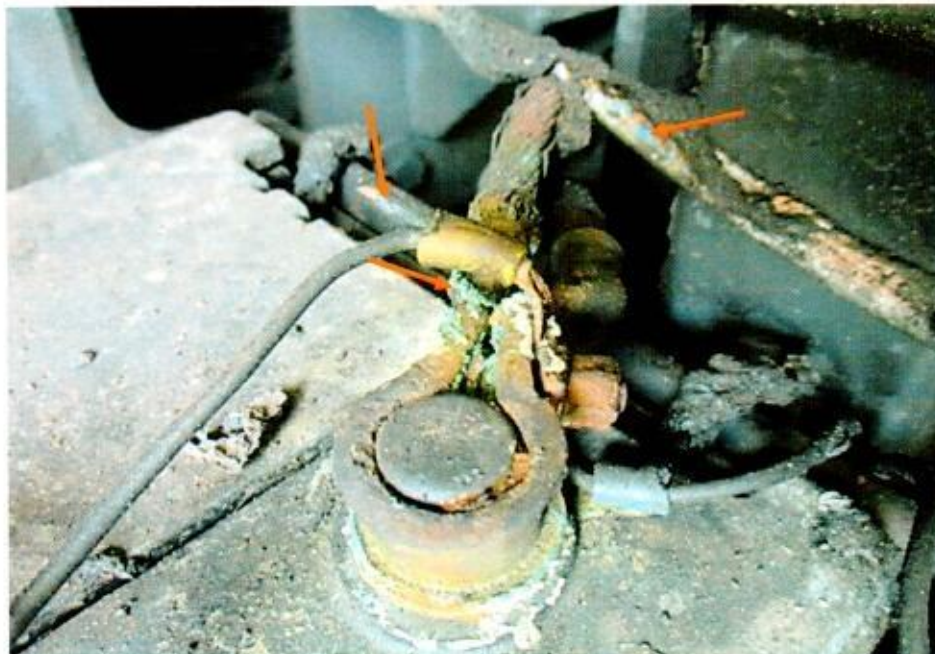
Photo 17 shows a close up view of the greenish residue found on some of the burnt wirings leading from the battery of the Insured Vehicle (arrowed). The presence of such greenish residue suggests occurrence of an electrical short circuit.

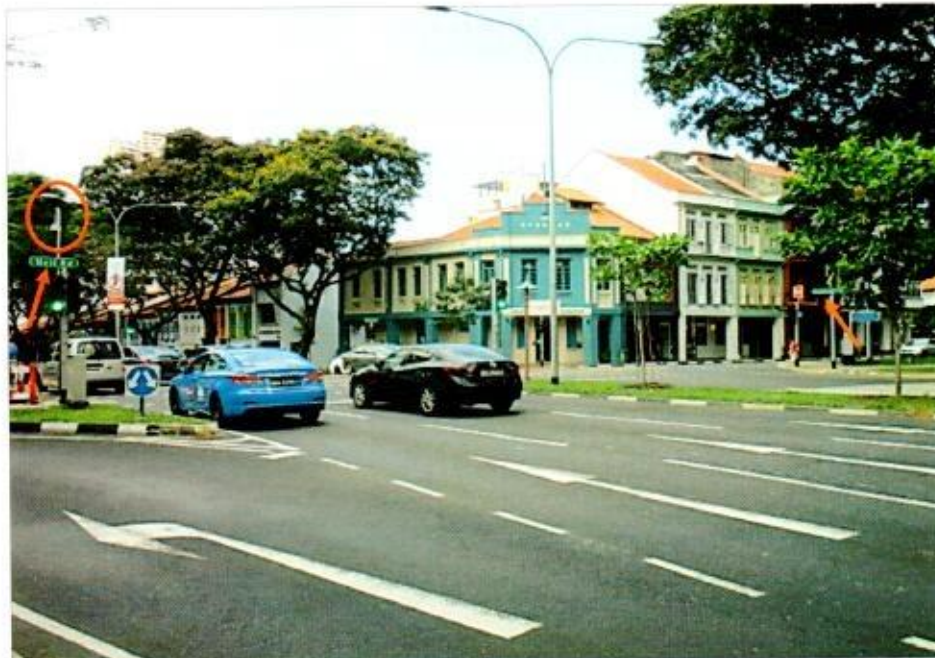
Photo 18 shows the traffic junction of Cantonment Road and Neil Road (arrowed) where the incident occurred along the 1st lane. There is a traffic camera affixed near the traffic lights at the left side of the traffic junction (circled).

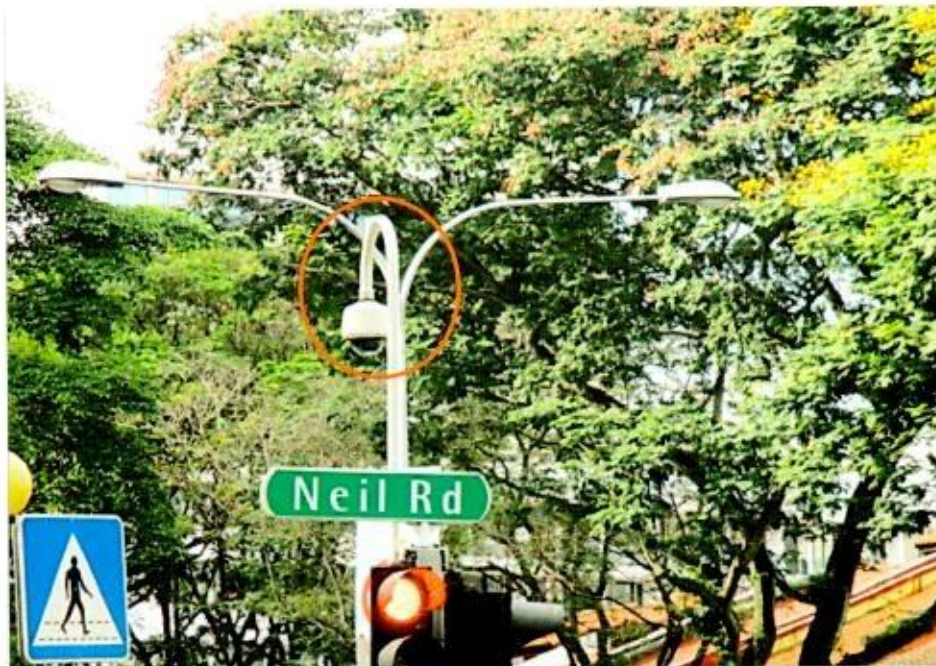
Photo 19 shows a closer view of the traffic camera affixed near the traffic lights at the left side of the traffic junction (circled). However we were unable to view or obtain the footage for security reasons.

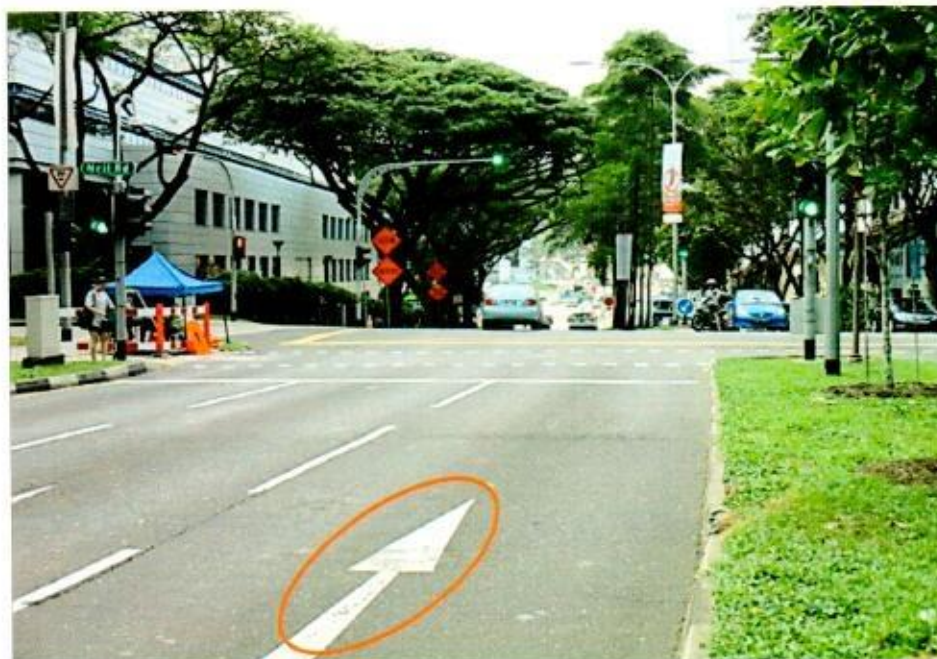
Photo 20 shows the burnt marks and/or burnt residual remains on the ground where the Insured Vehicle was positioned at the time of incident (circled). No further information could be gathered during our site inspection other than the observation that the area where the Insured Vehicle was positioned when the incident occurred was not a secluded location.

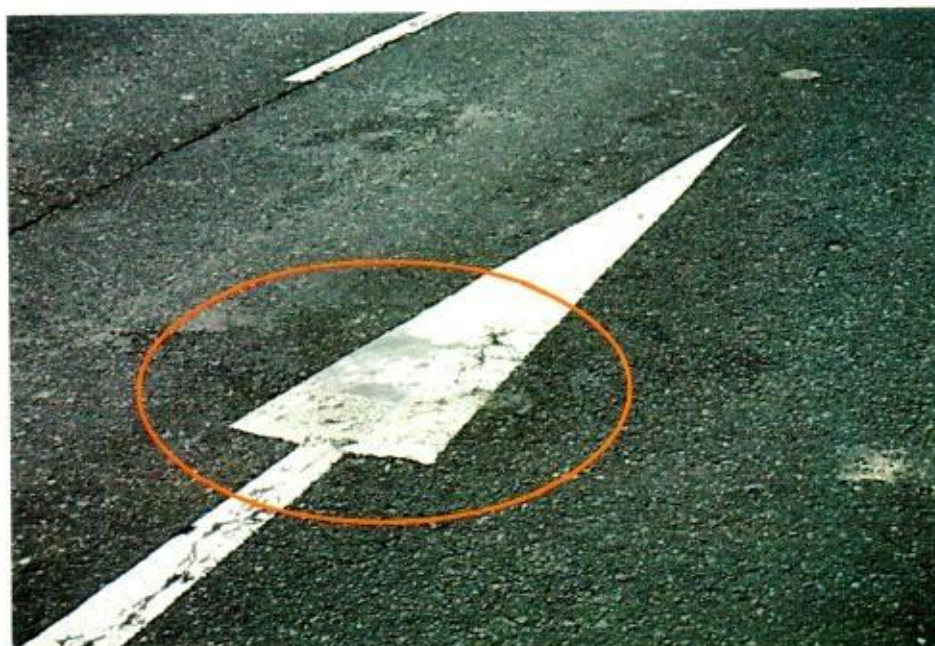
Photo 21 shows a closer view of the burnt marks and/or burnt residual remains on the ground where the Insured Vehicle was positioned at the time of incident (circled). Apart from the burn marks on the ground, we did not observe any other damaged or newly replaced government property at the time of our visit to the incident location.

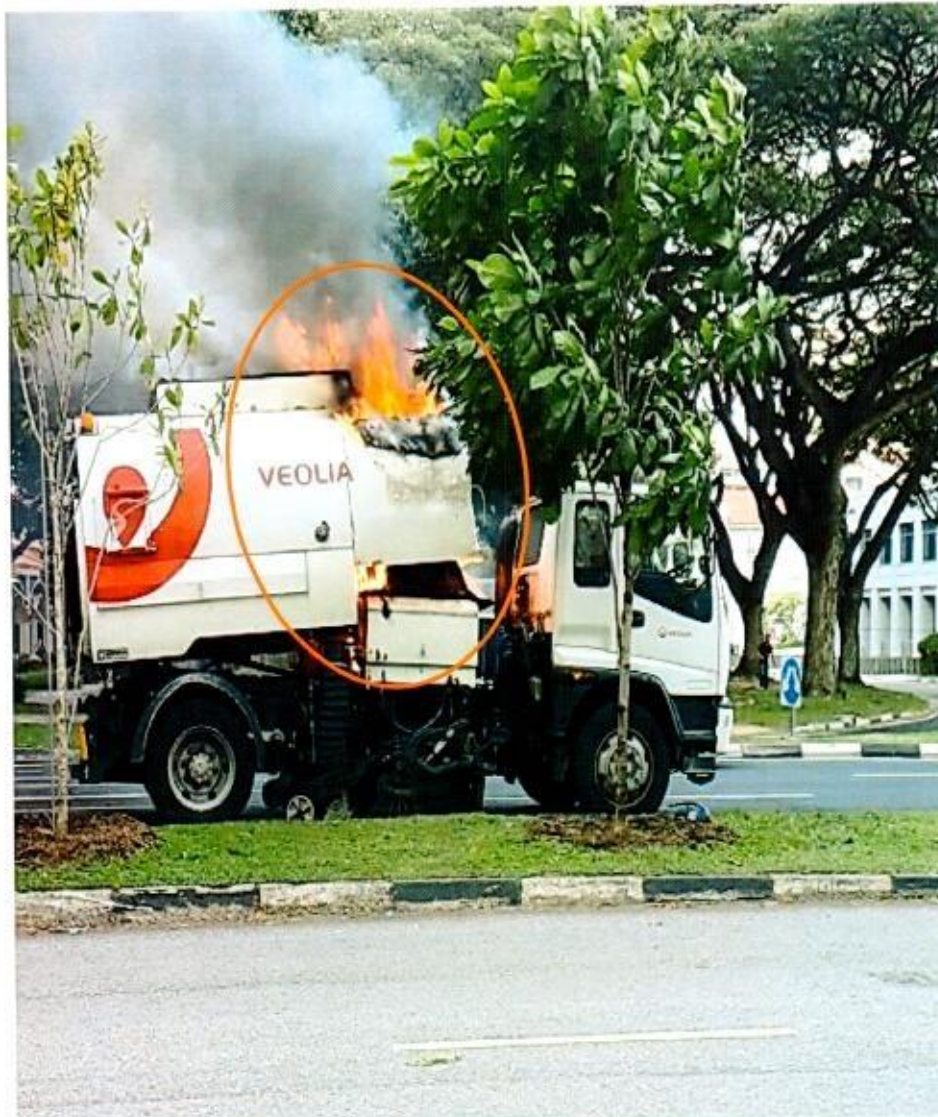
Photo 22 shows the left centre portion of the Insured Vehicle engulfed in flames before the arrival of the SCDF. In general, the information gathered from this photograph had corresponded to Ms Khairil's statement, which is the fire started from the left portion of the sub engine and that he tried to raise the sub engine compartment but it could not be raised fully (circled).

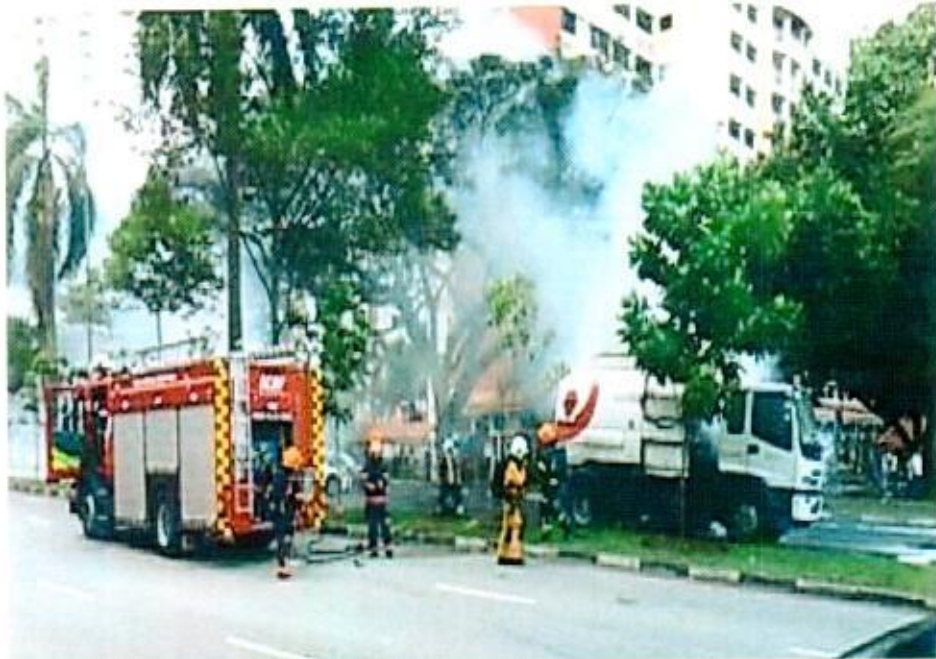
Photo 23 shows the SCDF attending to the fire.

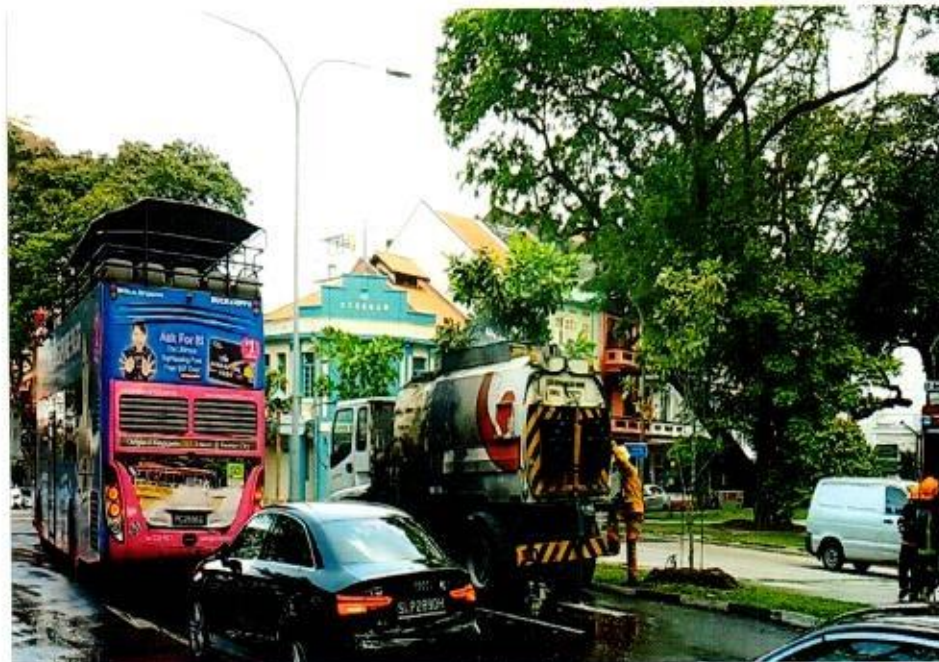
Photo 24 shows firefighters ensuring that the fire was completely extinguished.

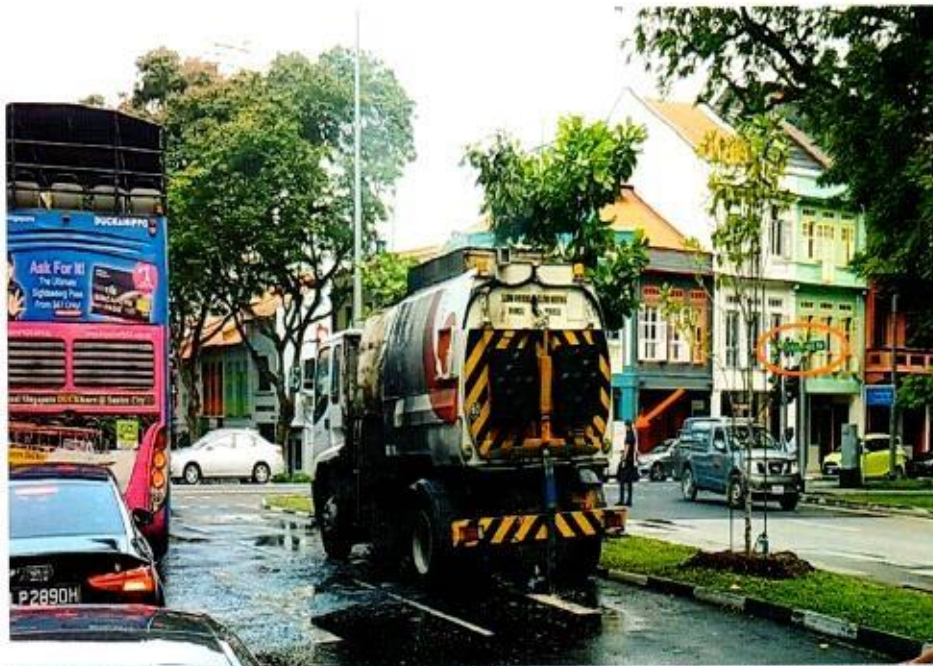
Photo 25 shows the Insured Vehicle after the fire was extinguished. In general, the information gathered from this photograph had corresponded to Ms Khairil's statement, which is the incident had occurred at the traffic junction of Cantonment Road (circled) and Neil Road along the 1st lane as well as police officers were present at the scene to re- direct traffic (arrowed).
