Your Ref: S8M00A51
Our Ref : CS/ASM18004432/N

14 March 2018

TECHNICAL INVESTIGATION REPORT OF FIRE INCIDENT INVOLVING THE MOTOR VEHICLE YM 9113J ON 6 FEBRUARY 2018

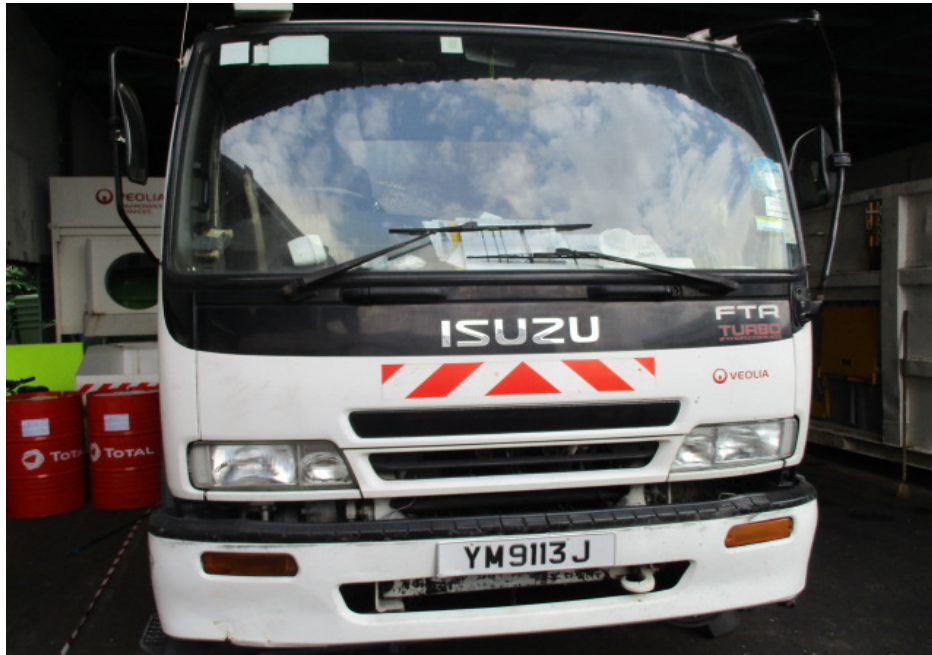
Photo 1 shows the front view of the Insured Vehicle at the time of our inspection. The fire damage to the Insured Vehicle was confined to its centre portion. The exterior body of the Insured Vehicle was relatively unaffected by the fire except for the centre portion.

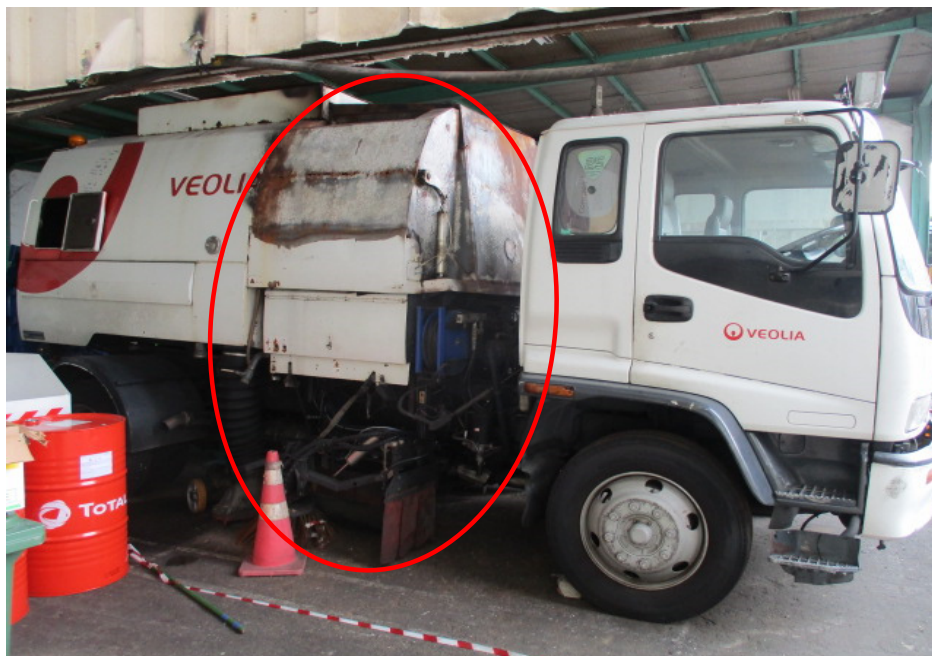
Photo 2 shows the right side of the Insured Vehicle at the time of our inspection. The exterior body of the Insured Vehicle was relatively unaffected by the fire except for the centre portion. The fire damage to the Insured Vehicle was confined to its centre portion (circled).

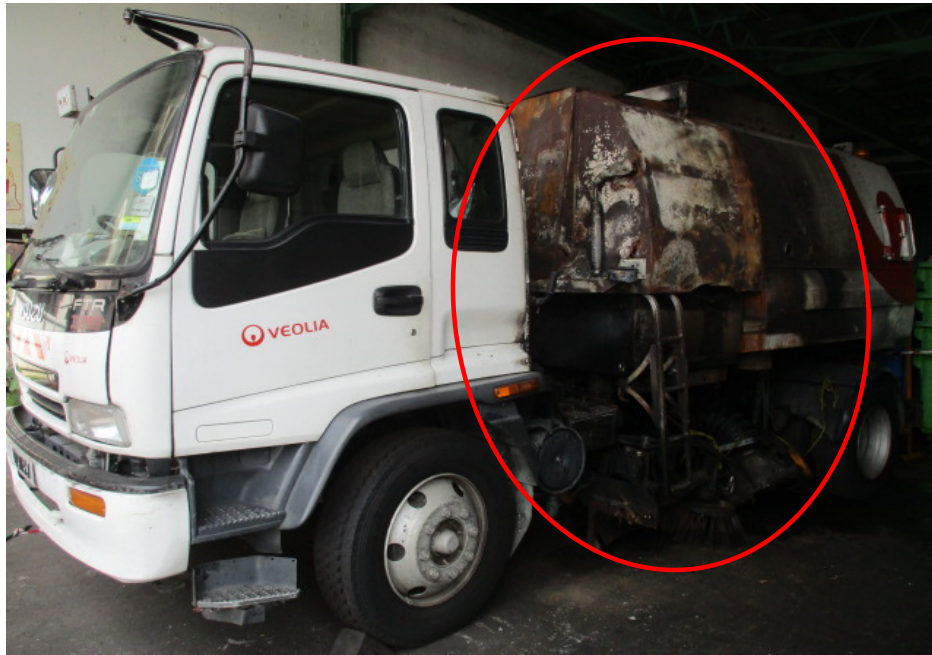
Photo 3 shows the left side of the Insured Vehicle at the time of our inspection. The exterior body of the Insured Vehicle was relatively unaffected by the fire except for the centre portion. The fire damage to the Insured Vehicle was confined to its centre portion. The fire damage was observed to be most severe at its left centre portion (circled).

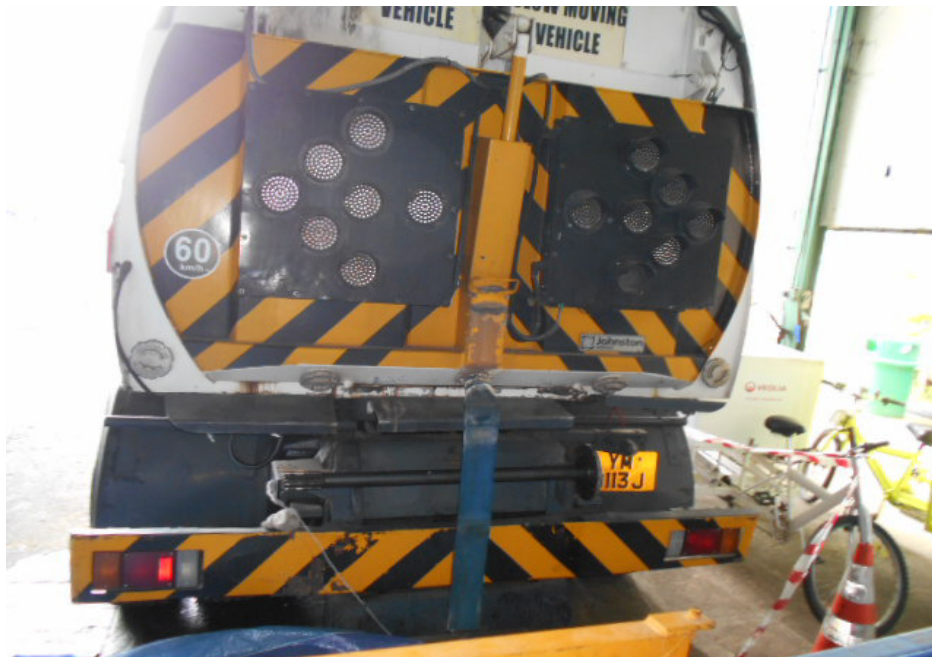
Photo 4 shows the rear portion of the Insured Vehicle at the time of our inspection. The fire damage to the Insured Vehicle was confined to its centre portion. The rear portion was observed to have been unaffected by the fire.

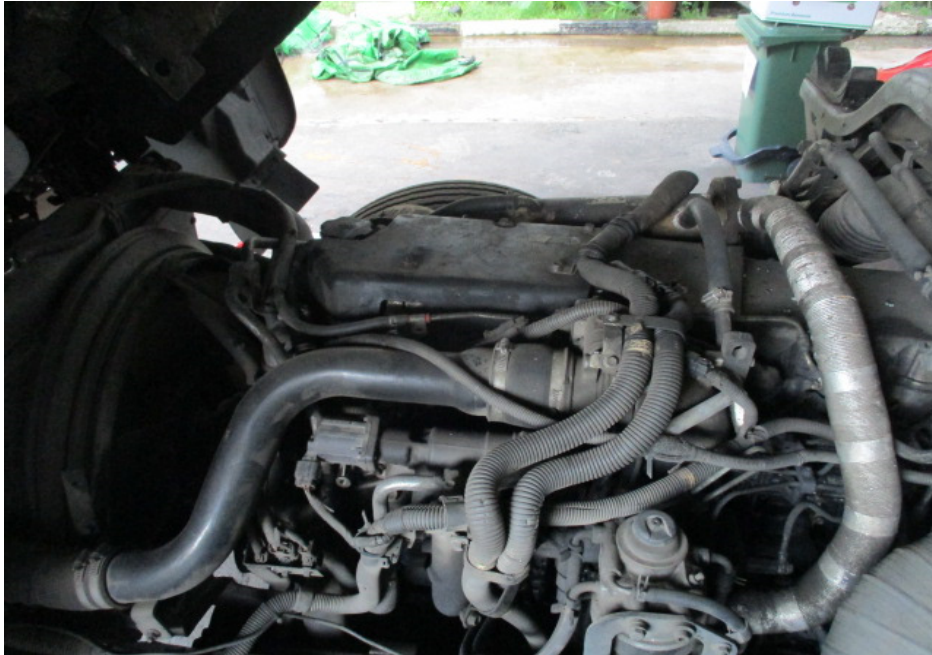
Photo 5 shows the main engine compartment of the Insured Vehicle which is situated beneath the front cabin at the time of our inspection. The main engine compartment of the Insured Vehicle was relatively unaffected by the fire.

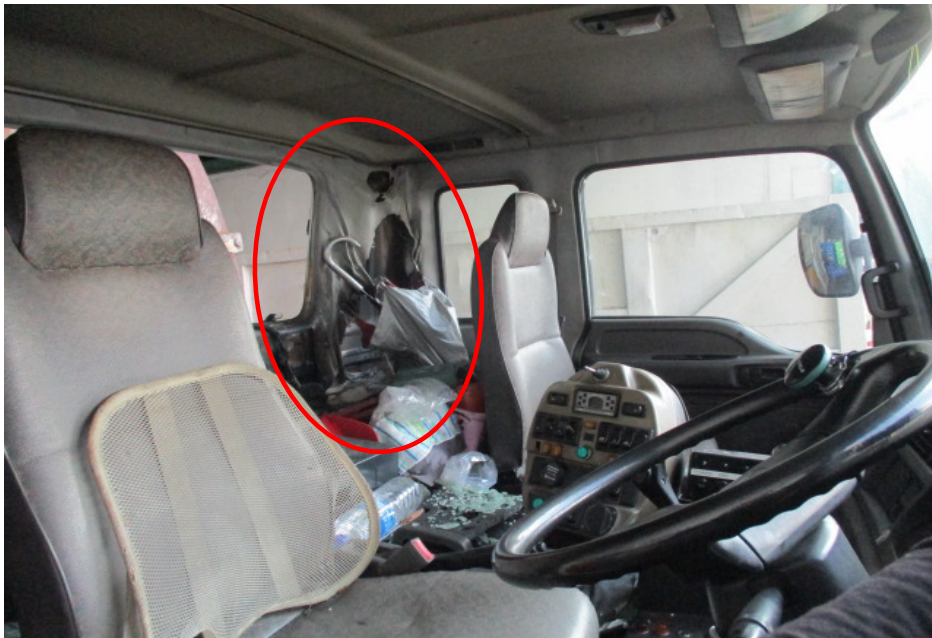
Photo 6 shows the interior compartment of the Insured Vehicle at the time of inspection. The rear portion of the interior compartment was significantly affected by the fire (circled).

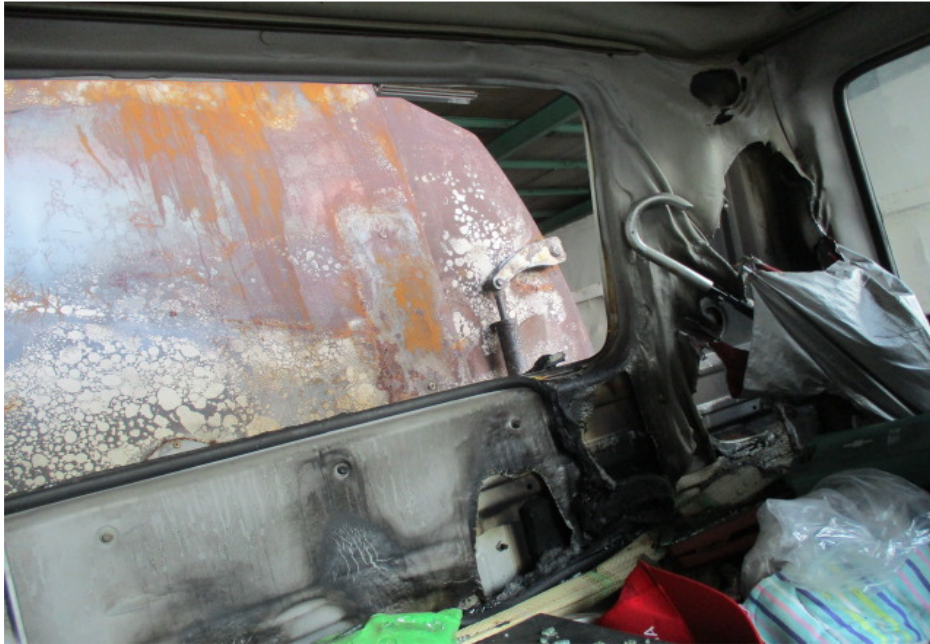
Photo 7 shows a closer view of the rear portion of the interior compartment which was significantly affected by the fire.

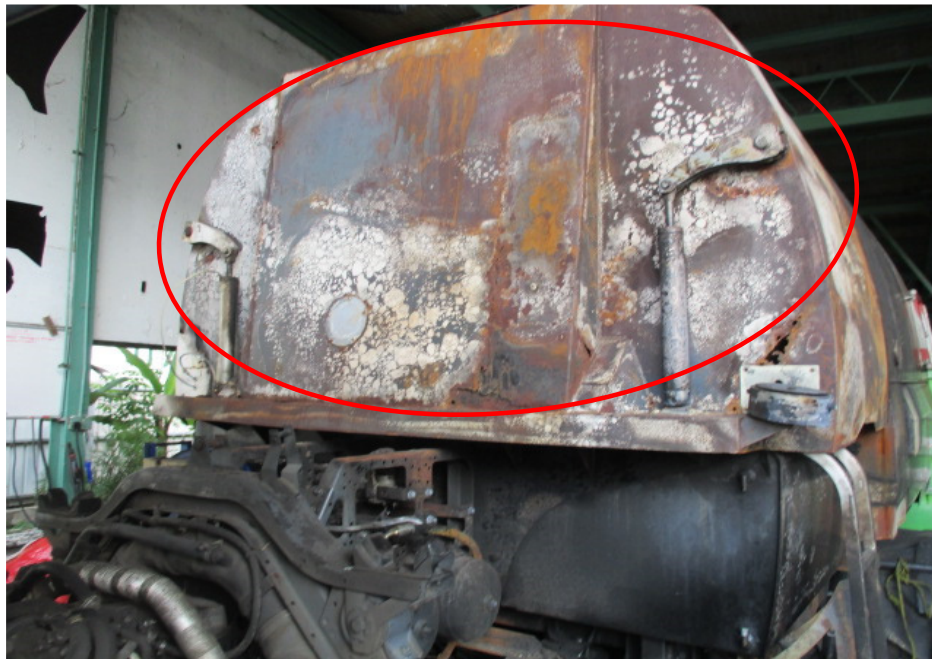
8. For this particular case, the fire appears to have originated from the left centre portion of the Insured Vehicle, which houses the sub engine (herein referred to as "**sub engine compartment**"). This can be determined from the burn pattern and the high heat intensity burn marks (whitish burn marks) found on the left portion of the Insured Vehicle's sub engine compartment and also the rust that had developed at the areas around the sub engine compartment.

9. The whitish burn marks are a result of exposure to prolonged heat intensity. Rust would normally start to develop around these areas soon after a fire as prolonged exposure to high heat intensity usually causes steel/metal material body parts to be exposed to natural environmental condition. Hence the rust that had developed around the sub engine compartment of the Insured Vehicle is an indication that the fire to the Insured Vehicle had originated from the sub engine.

Photo 8 shows the sub engine compartment of the Insured Vehicle where the burn pattern and whitish burn marks were found (circled). Such whitish burn marks are a result of exposure to prolonged heat intensity, which had caused the steel/metal material of the sub engine compartment to be exposed to natural environmental condition. Hence the rust that had developed around the sub engine compartment of the Insured Vehicle is an indication that the fire to the Insured Vehicle had originated from the sub engine.

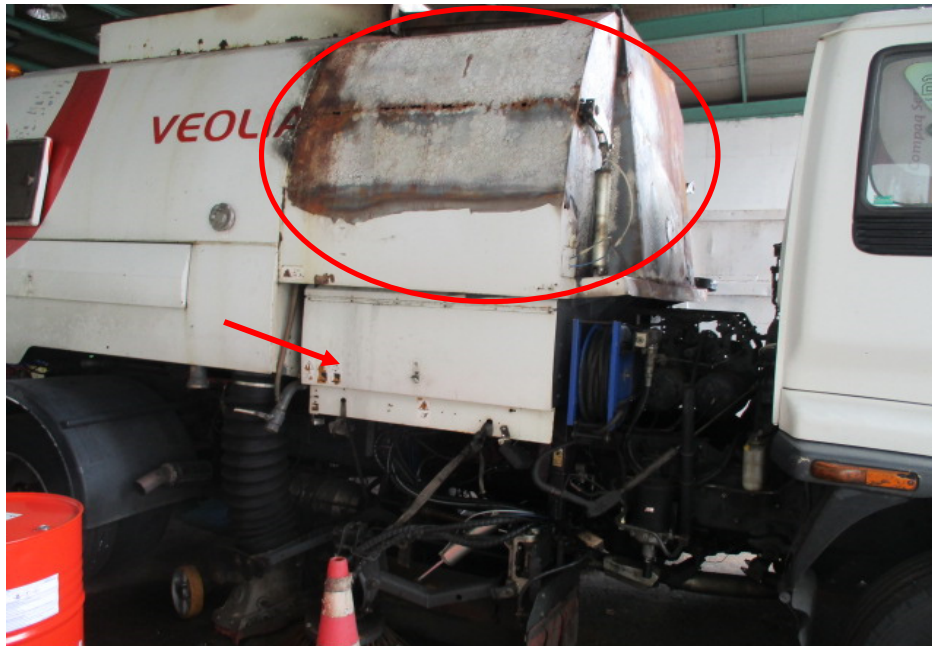
Photo 9 shows the right portion of the sub engine compartment which was badly burnt as a result of the fire (circled). Under normal operational conditions, the sub engine compartment of the Insured Vehicle can be raised to reveal the sub engine via an external control panel which is located at the right centre portion of the Insured Vehicle (arrowed).

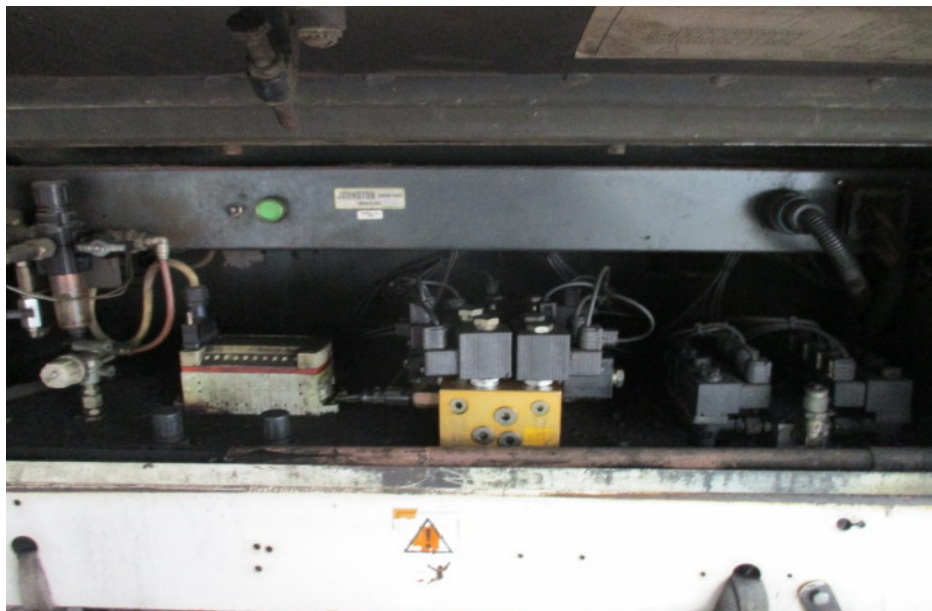
Photo 10 shows a closer view of the external control panel which is used to raise the sub engine compartment of the Insured Vehicle to reveal the sub engine under normal operational conditions. However due to the fire affecting the electrical system of the Insured Vehicle, we were unable to gain access to the sub engine to access the degree of fire damage.

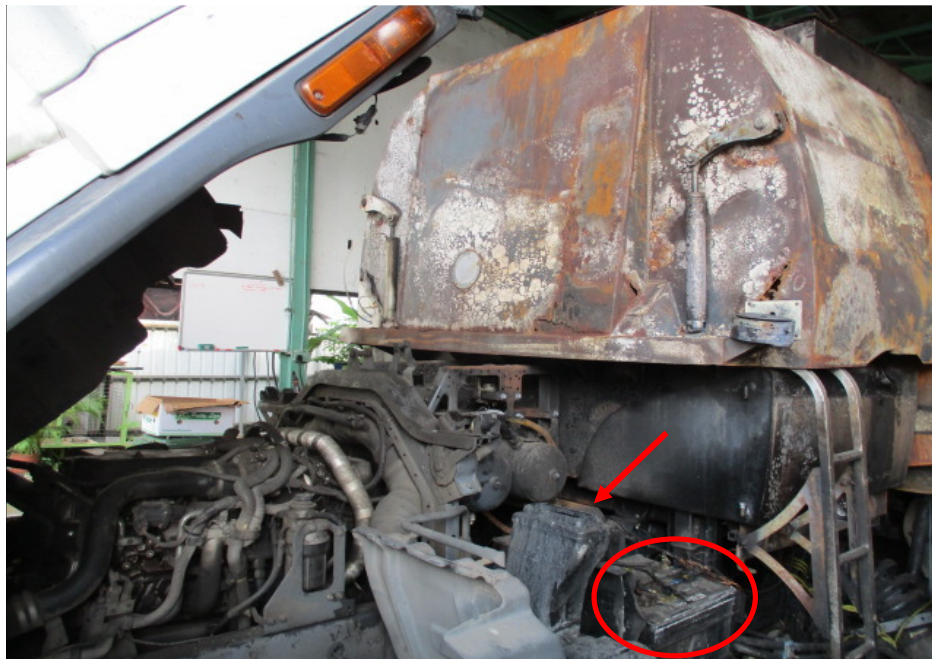
11. Upon closer examination around the areas in closest proximity to the sub engine which was where the fire to the Insured Vehicle had likely started, we had found several stretches of burnt wiring with greenish residue. These wirings were original factory fitted wirings below the sub engine compartment. We also found traces of greenish residue on several stretches of burnt wiring leading from the battery of the Insured Vehicle. The presence of greenish residue indicates internal heating of copper wires, a sign of an electrical short circuit occurring. The greenish residue is normally left behind from oxidation as a result of chemical reaction involving the copper wires. These physical evidences would appear to suggest that the cause of fire to the Insured Vehicle could have possibly been due to electrical in nature. See photos 11 - 17 below.

Photo 11 shows upon closer examination around the areas in closest proximity to the sub engine which was where the fire to the Insured Vehicle had likely started, we had found several stretches of burnt wiring with greenish residue. These wirings were original factory fitted wirings below the sub engine compartment (arrowed). We also found traces of greenish residue on several stretches of burnt wiring leading from the battery of the Insured Vehicle (circled). The presence of such greenish residue suggests occurrence of an electrical short circuit.

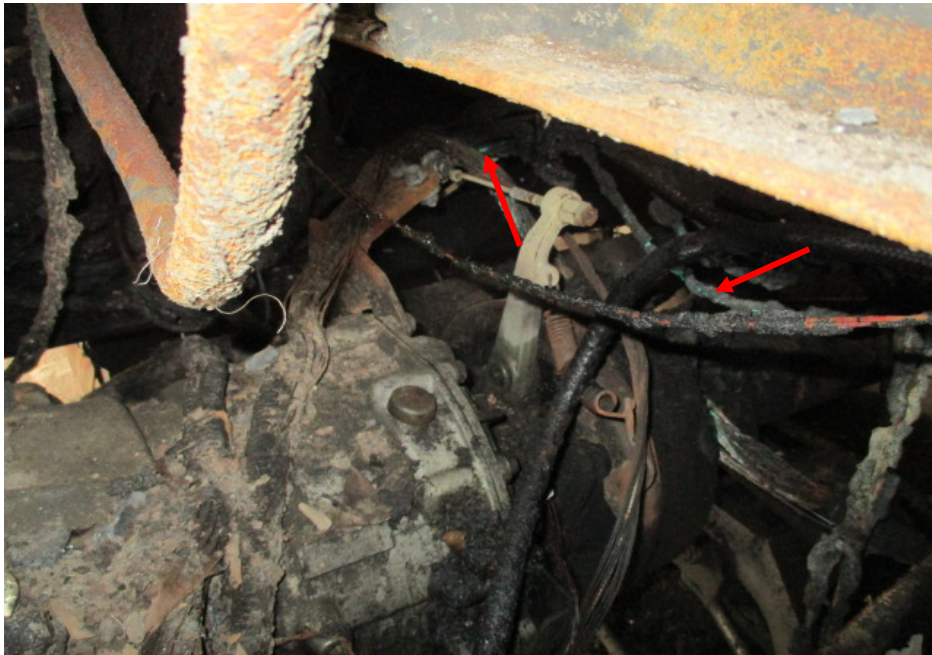
Photo 12 shows several original factory fitted wirings below the sub engine compartment with greenish residue (arrowed). The presence of such greenish residue suggests occurrence of an electrical short circuit.

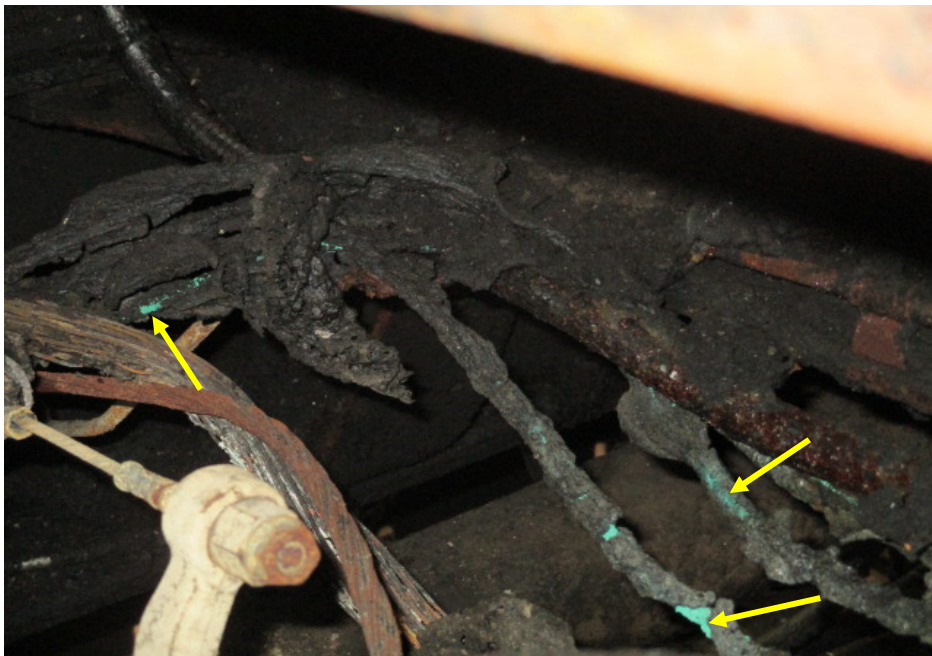
Photo 13 shows a close up view of the greenish residue found on some of the burnt wirings below the sub engine compartment of the Insured Vehicle (circled). The presence of such greenish residue suggests occurrence of an electrical short circuit.

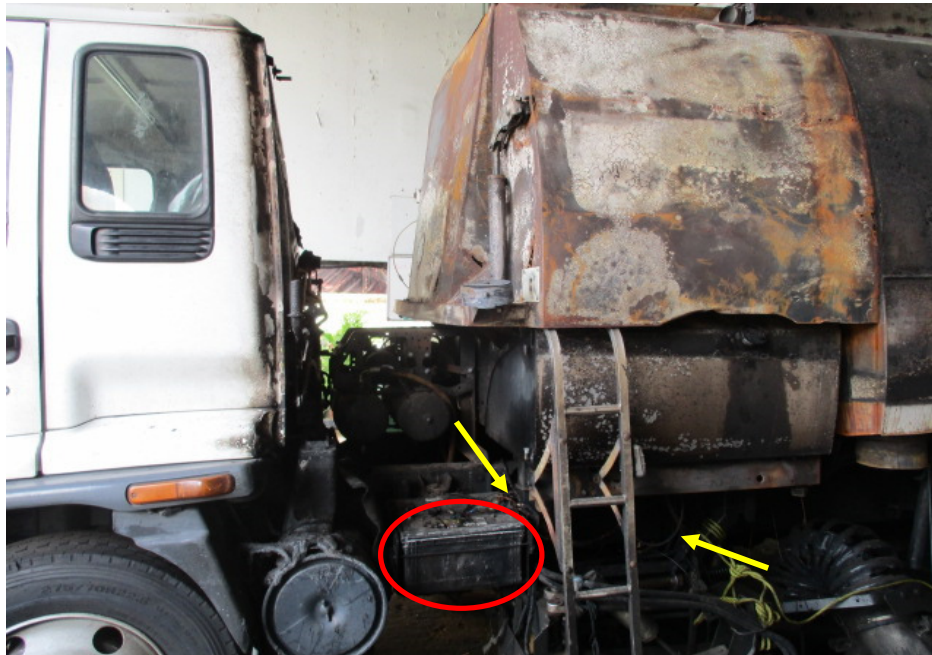
Photo 14 shows the several stretches of burnt wirings leading from the battery (circled) of the Insured Vehicle which had traces of greenish residue (arrowed). The presence of such greenish residue suggests occurrence of an electrical short circuit.

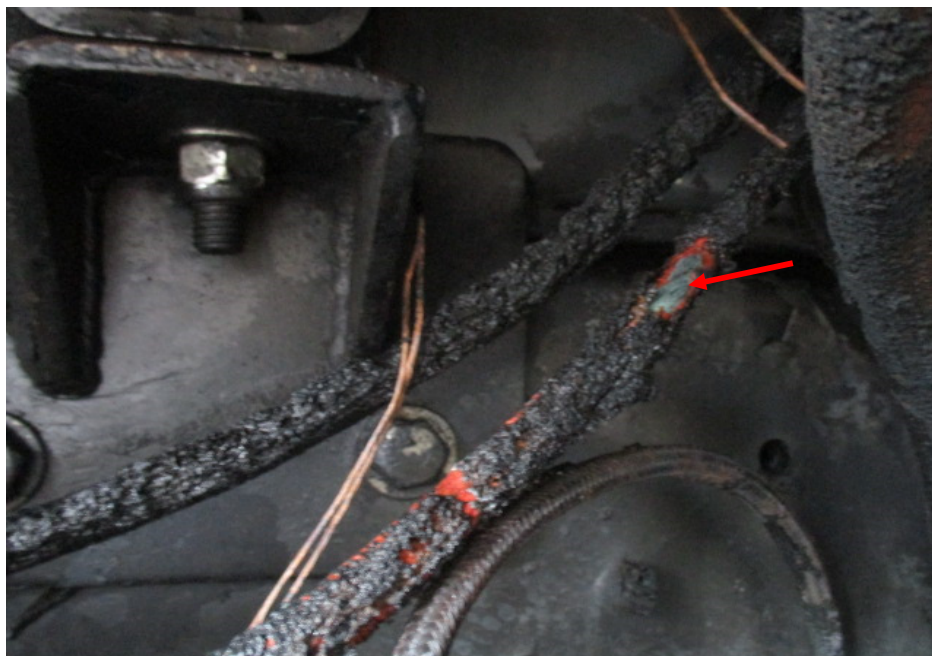
Photo 15 shows a closer view of the greenish residue found on some of the burnt wirings leading from the battery of the Insured Vehicle (arrowed). The presence of such greenish residue suggests occurrence of an electrical short circuit.

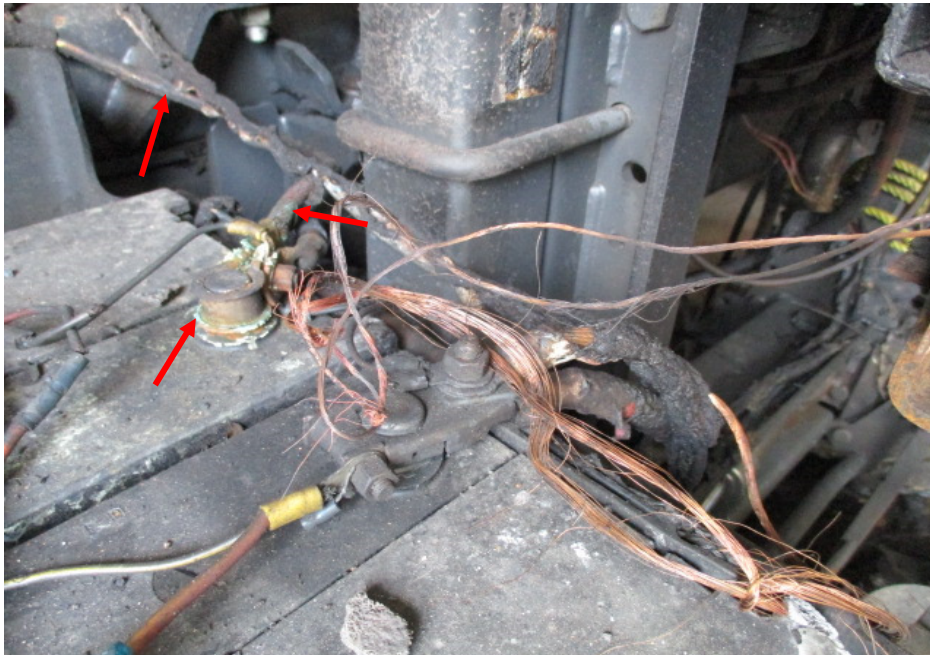
Photo 16 shows a closer view of the greenish residue found on some of the burnt wirings leading from the battery of the Insured Vehicle (arrowed). The presence of such greenish residue suggests occurrence of an electrical short circuit.

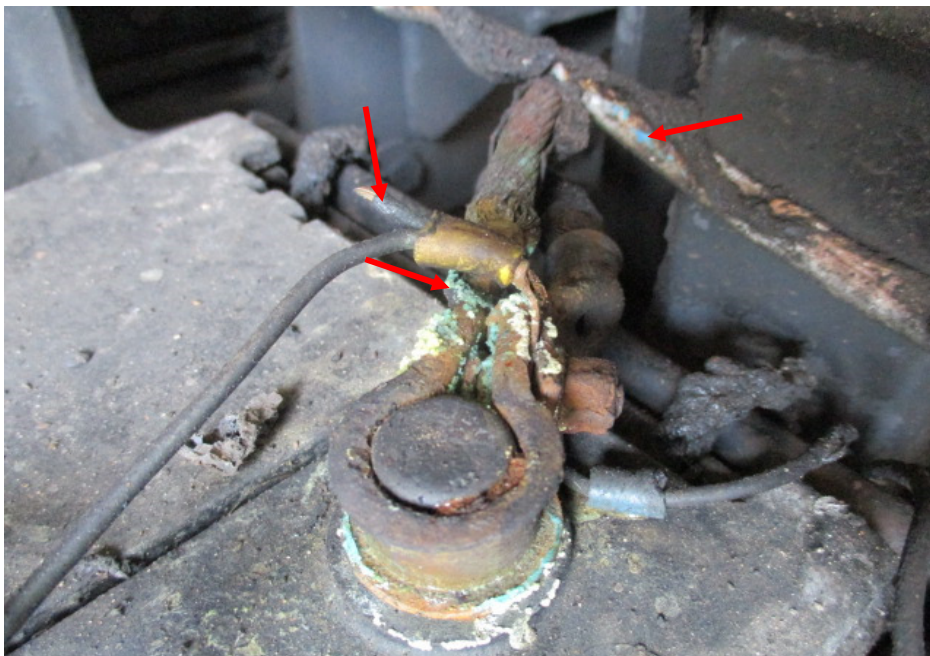
Photo 17 shows a close up view of the greenish residue found on some of the burnt wirings leading from the battery of the Insured Vehicle (arrowed). The presence of such greenish residue suggests occurrence of an electrical short circuit.

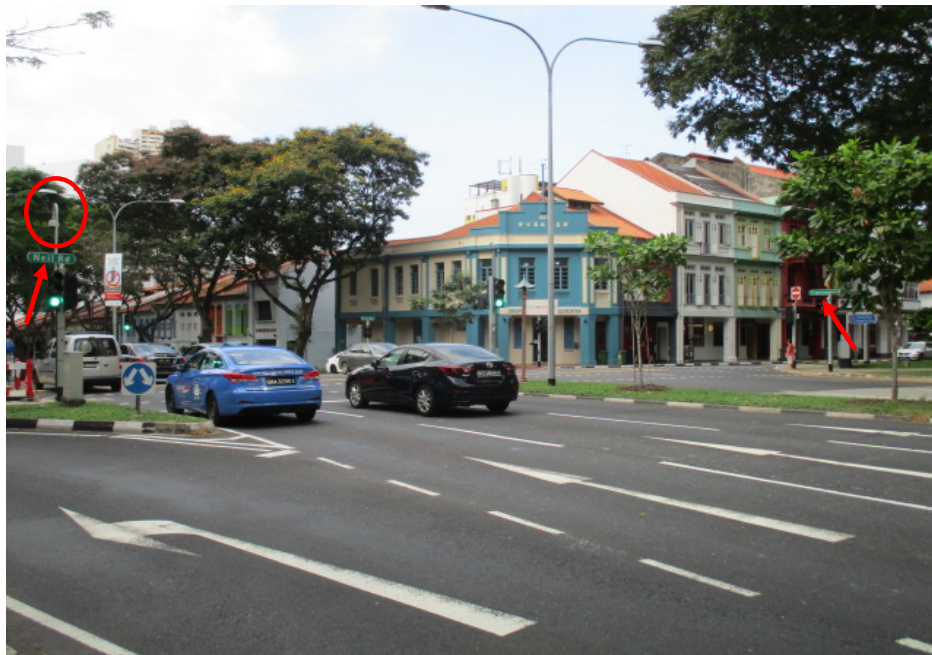
Photo 18 shows the traffic junction of Cantonment Road and Neil Road (arrowed) where the incident occurred along the 1st lane. There is a traffic camera affixed near the traffic lights at the left side of the traffic junction (circled).

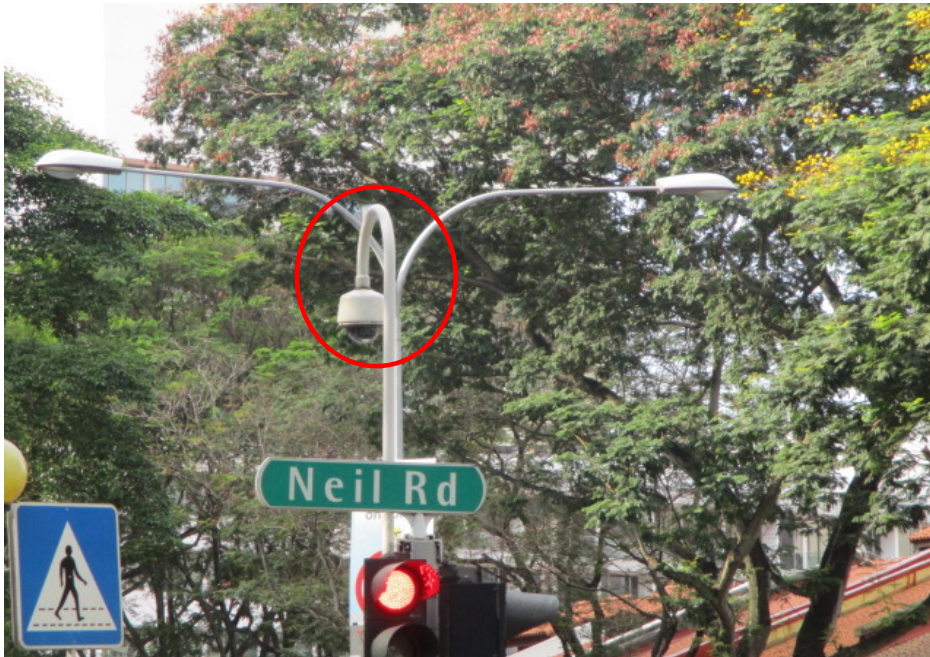
Photo 19 shows a closer view of the traffic camera affixed near the traffic lights at the left side of the traffic junction (circled). However we were unable to view or obtain the footage for security reasons.

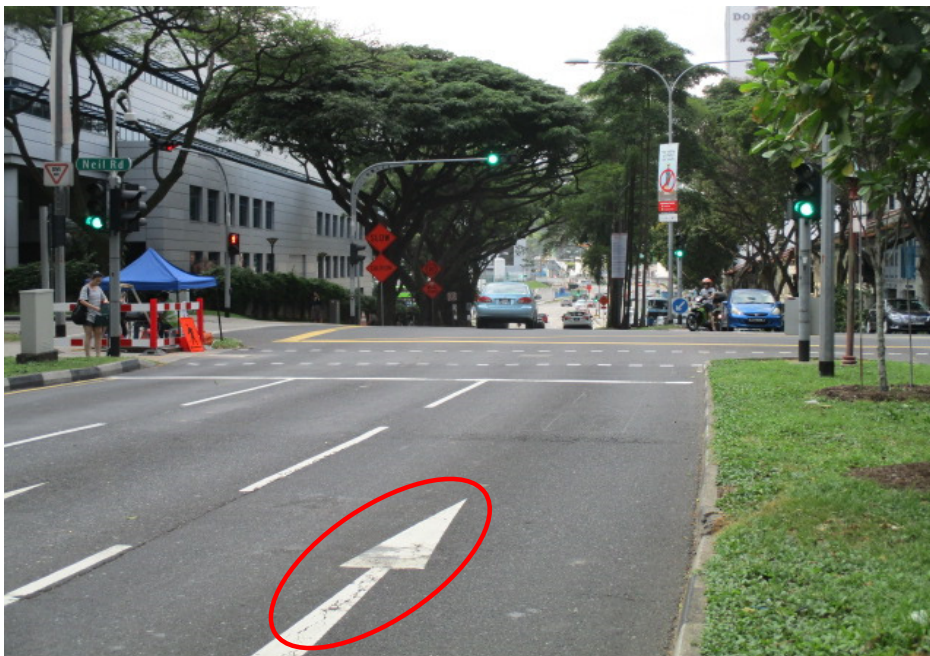
Photo 20 shows the burnt marks and/or burnt residual remains on the ground where the Insured Vehicle was positioned at the time of incident (circled). No further information could be gathered during our site inspection other than the observation that the area where the Insured Vehicle was positioned when the incident occurred was not a secluded location.

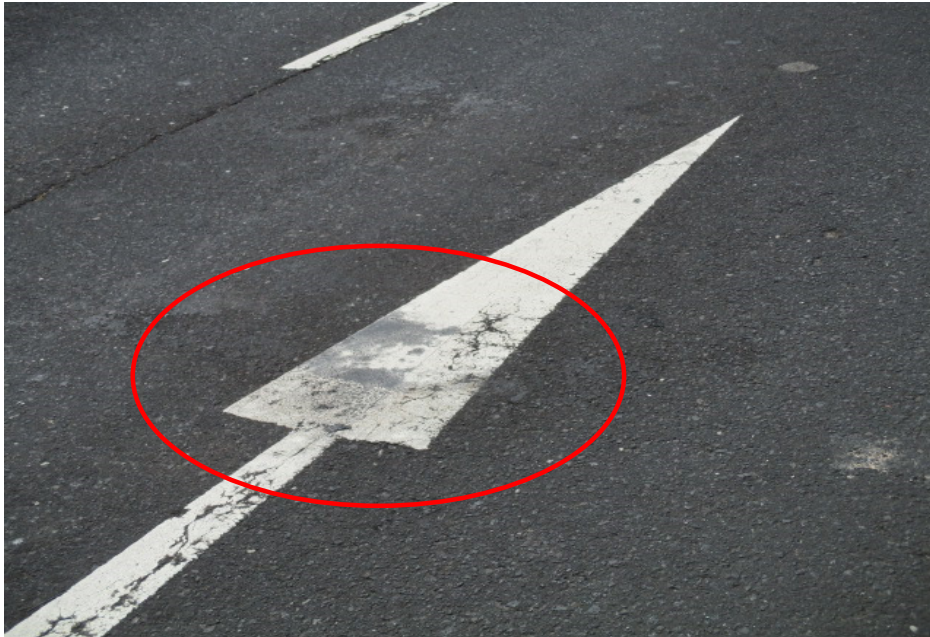
Photo 21 shows a closer view of the burnt marks and/or burnt residual remains on the ground where the Insured Vehicle was positioned at the time of incident (circled). Apart from the burn marks on the ground, we did not observe any other damaged or newly replaced government property at the time of our visit to the incident location.

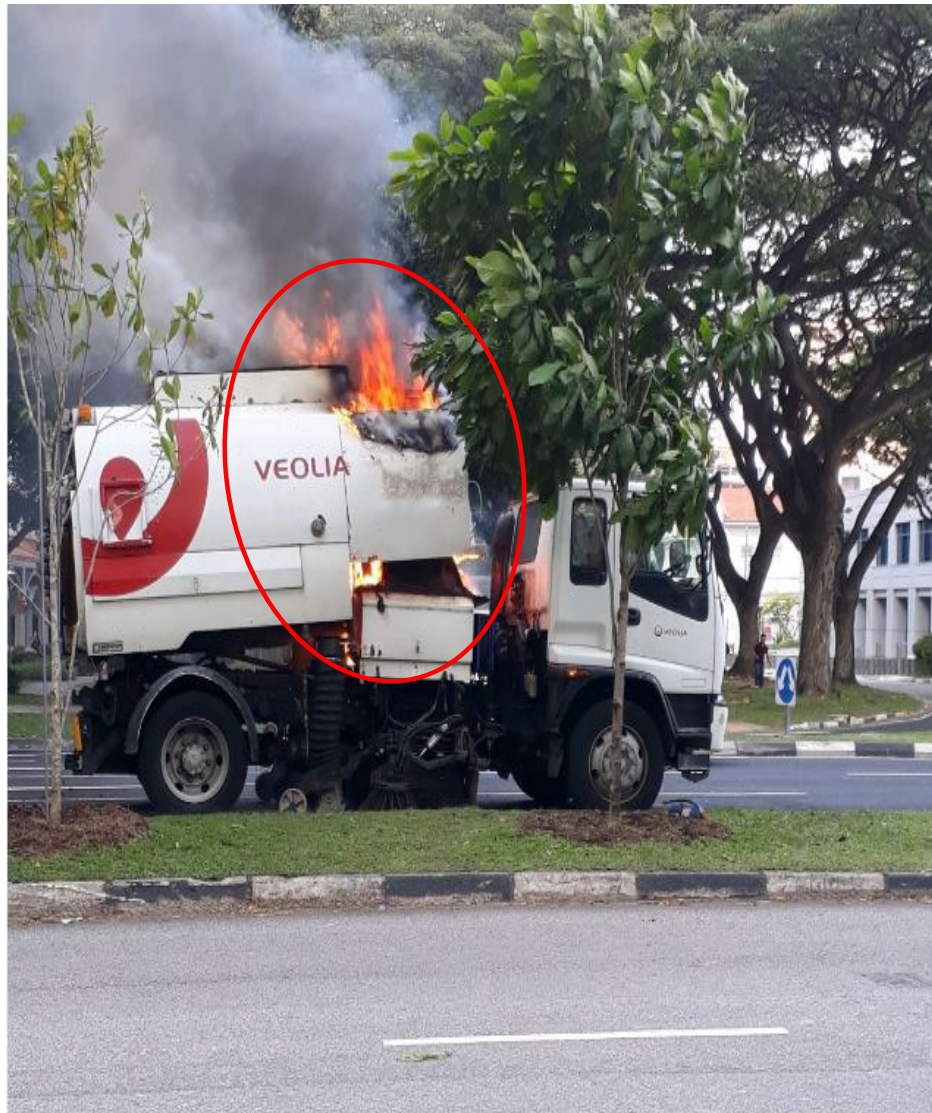
Photo 22 shows the left centre portion of the Insured Vehicle engulfed in flames before the arrival of the SCDF. In general, the information gathered from this photograph had corresponded to Ms Khairil's statement, which is the fire started from the left portion of the sub engine and that he tried to raise the sub engine compartment but it could not be raised fully (circled).

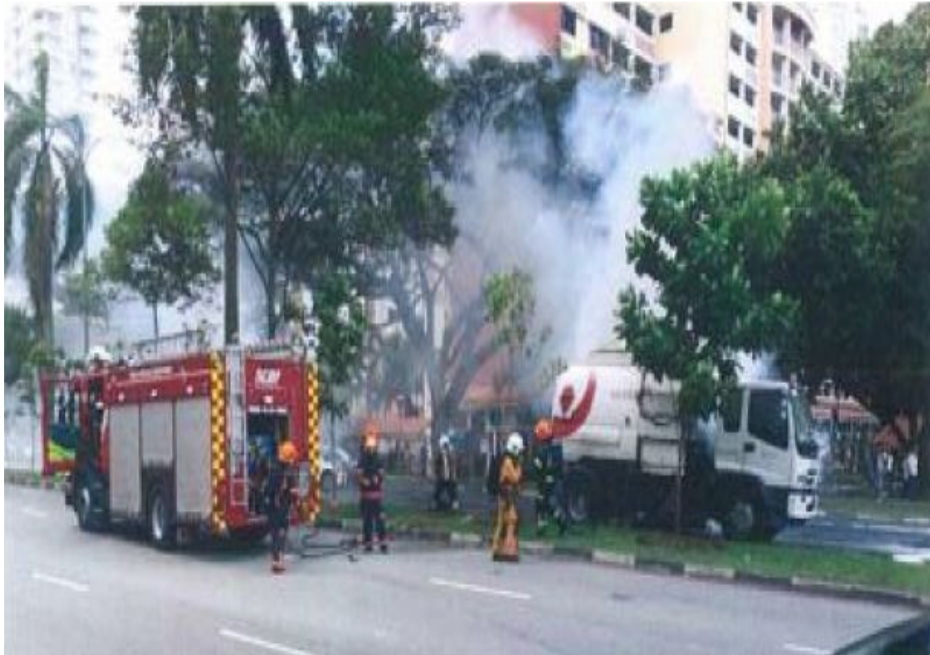
Photo 23 shows the SCDF attending to the fire.

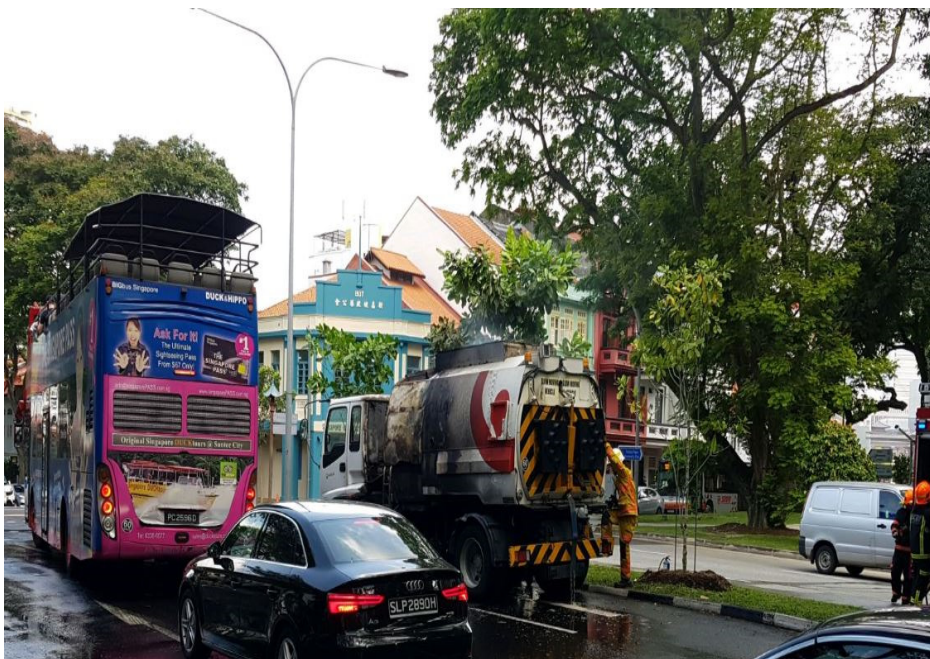
Photo 24 shows firefighters ensuring that the fire was completely extinguished.

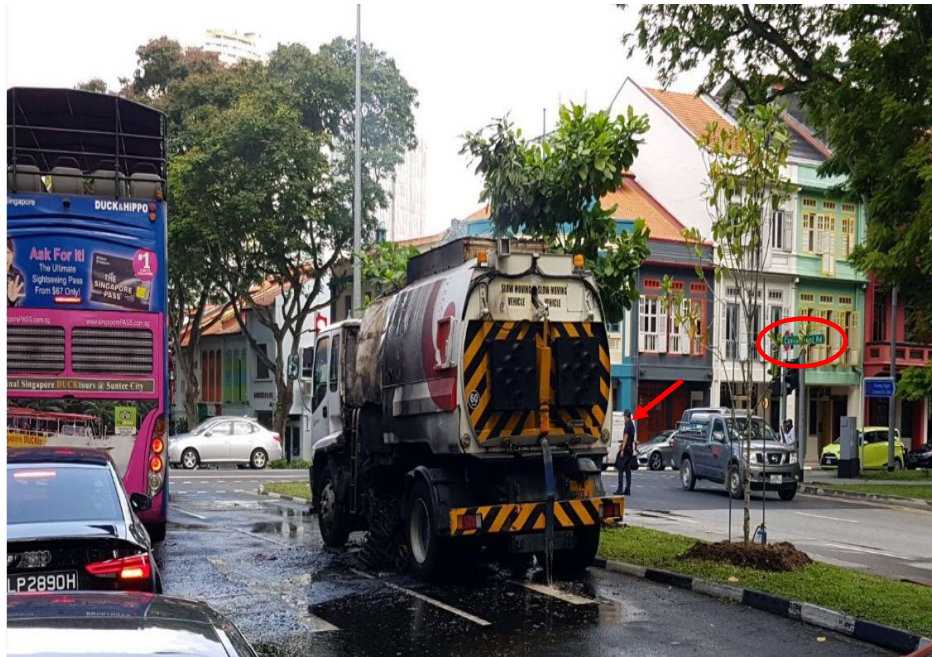
Photo 25 shows the Insured Vehicle after the fire was extinguished. In general, the information gathered from this photograph had corresponded to Ms Khairil's statement, which is the incident had occurred at the traffic junction of Cantonment Road (circled) and Neil Road along the 1st lane as well as police officers were present at the scene to re- direct traffic (arrowed).
