## SMRT Accident Vehicle Repair Estimates

Reg. No : SG5150E  
 Ref. No : BUS/02/18/7047  
 Reg. Date : 01/03/2018  
 Vehicle Type : DOUBLE DECK  
 Make : VOLVO  
 Model : Volvo B9TL DD  
 Name of Driver : Liu Rui Gang  
 Type of Accident : HEAD TO REAR  
 Date / Time of Accident : 14/02/2018 06:40:00 PM  
 Accident Reported Date / Time : 27/02/2018 12:00:00 AM  
 Surveyor is Required? : Yes  
 Survey by : AXA  
 Vehicle is Towed Back? : No  
 Towed Back Date/Time :  
 Replacement Vehicle issued? : No  
 Accident Repair Job Card No :  
 Special Instruction to ARC, if any :  
 SG5150E - REAR RIGHT CRACKED  
 YP6653X (TP) - INSURED WITH AXA  
 Prepared Date : 01/03/2018 09:38:07 AM

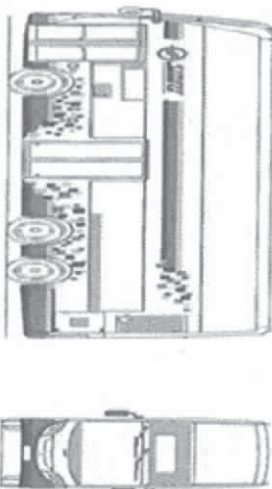
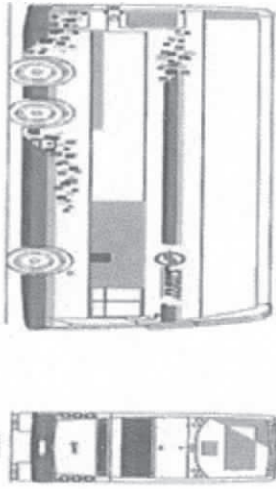
| Part Number | Portion | Stock No | Part Name | Qty | List Price (\$) | Discount (%) | Final Price (\$) | ARC Recommended | Surveyor Approved | Photos Attached |
|---|---|---|---|---|---|---|---|---|---|---|
| A12-03438 | | | COOLER DOOR ASSEMBLY | 1 | 2,872.05 | 10.00 | 2,584.84 | Replace | Replace | No<br>✓ Defective |
| A12-03302 | | | FLYSCREEN ASSEMBLY | 1 | 900.80 | 0.00 | 900.80 | Replace | Replace | No<br>✓ Defective |

- Part by part repair.

| Job Scope | Quotation from ARC | Adjusted by Surveyor, if applicable |
|---|---|---|
| TO REMOVE & INSTALL ALL ABOVE ITEMS AND REPAIR OTHERS DAMAGED AFFECTED AREAS. | 1,325.00 | <del>0.00</del> 1090 |

| Job Scope | Quotation from ARC | Adjusted by Surveyor, if applicable |
|---|---|---|
| PROVIDE LABOUR AND MATERIAL TO PUTTY AND RESPRAY ABOVE REPAIR ITEMS | 432.00 | <del>0.00</del> 300 |
