Your Ref: 2100500025
Our Ref : CI/AIG18004447/N

23 February 2018

**TECHNICAL INVESTIGATION REPORT OF FIRE INCIDENT INVOLVING THE
INSURED VEHICLE GBF 6895P ON 25 JANUARY 2018**

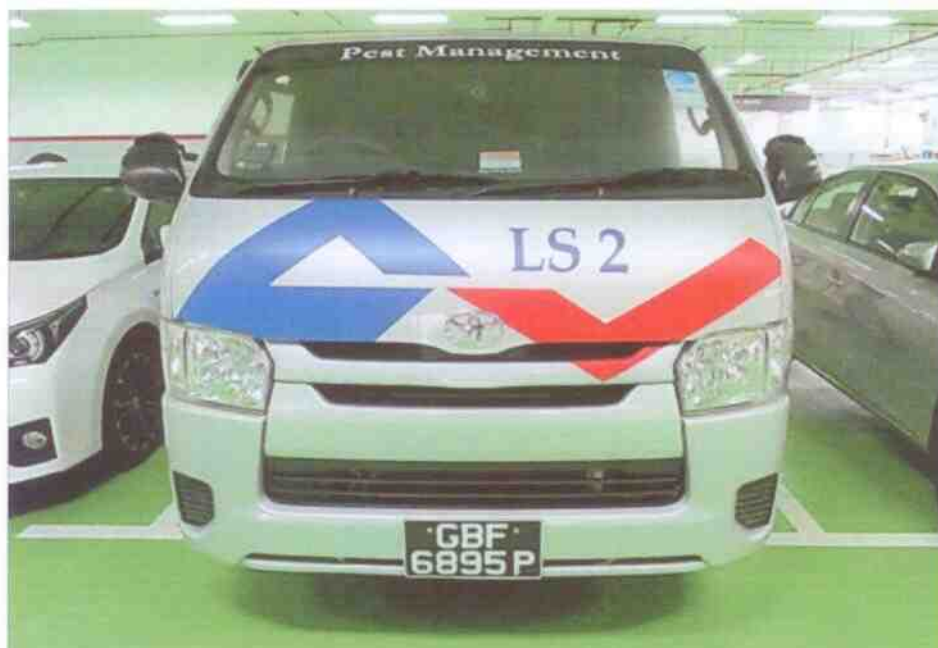
Photo 1 shows the general view of the front portion of the Insured Vehicle at the time of our inspection. The front portion of the Insured Vehicle was relatively unaffected by the fire.

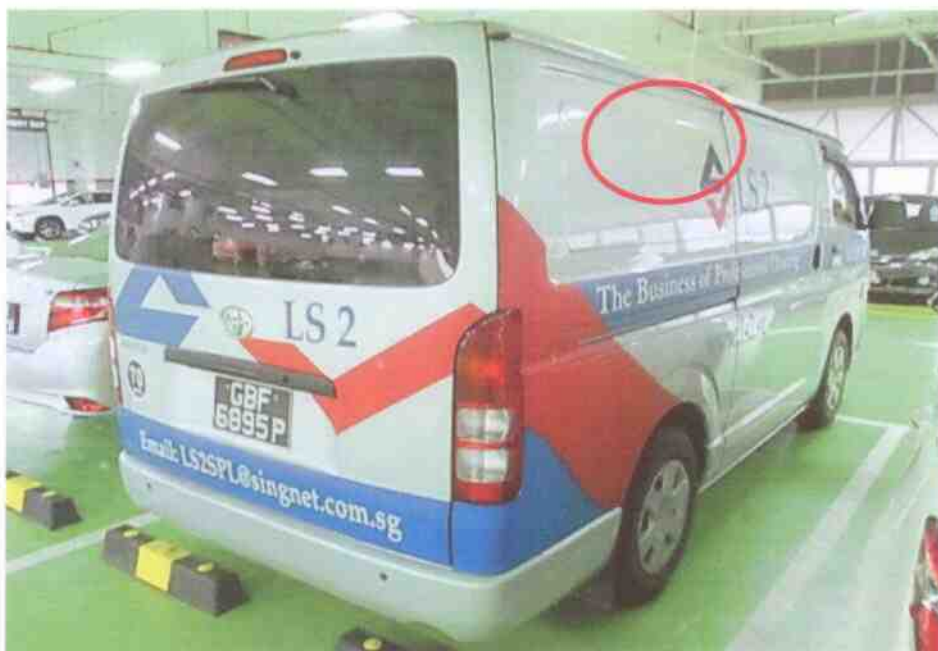
Photo 2 shows the general view of the right rear portion of the Insured Vehicle at the time of our inspection. The exterior body of the Insured Vehicle had sustained minor fire damage at the right rear portion (circled).

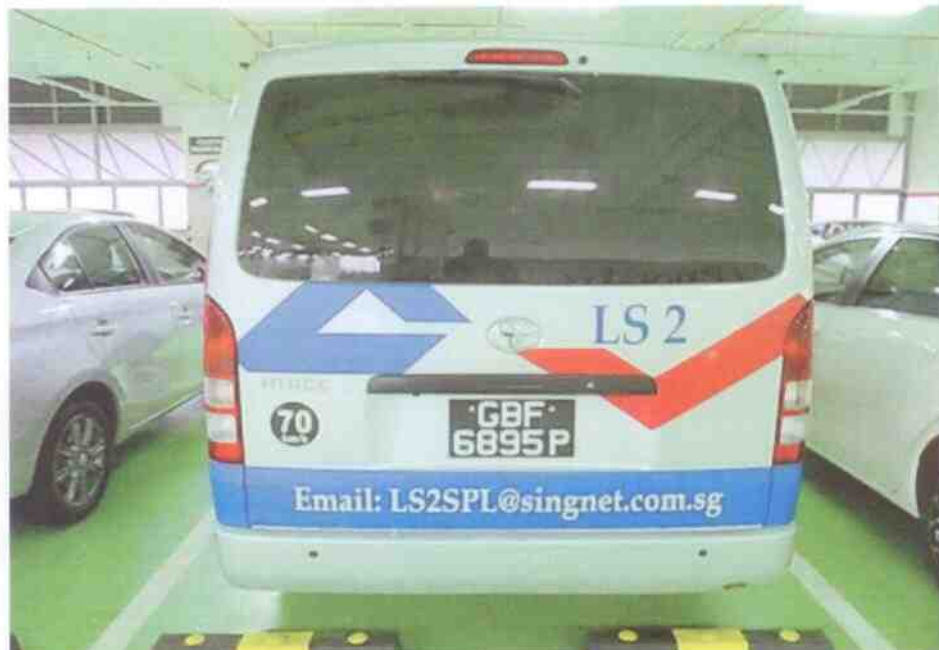
Photo 3 shows the general view of the rear portion of the Insured Vehicle at the time of our inspection. The rear portion of the Insured Vehicle was relatively unaffected by the fire.

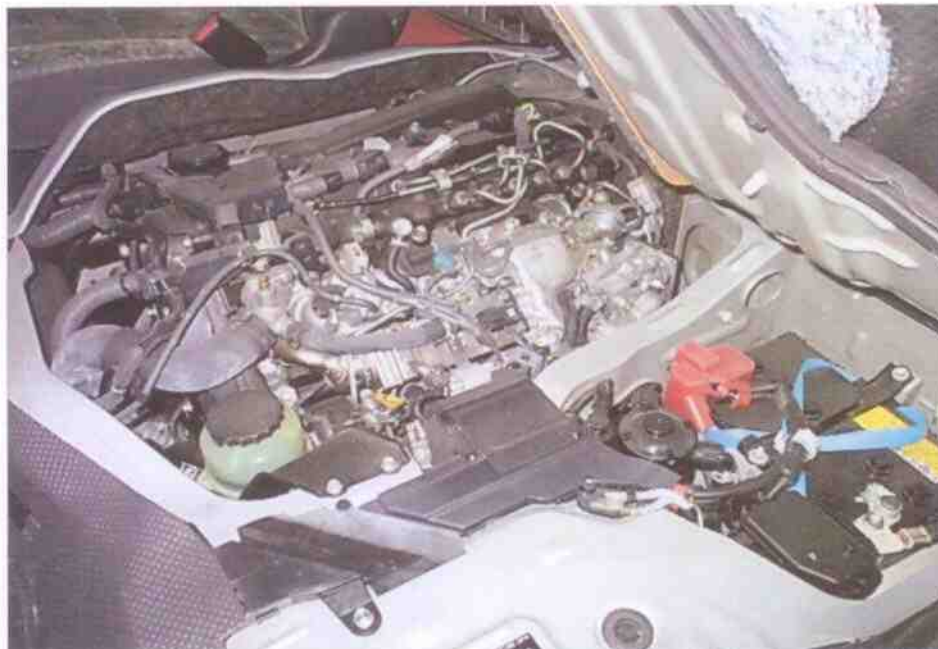
Photo 4 shows a general view of the engine compartment of the Insured Vehicle at the time of our inspection. The engine compartment of the Insured Vehicle was relatively unaffected by the fire.

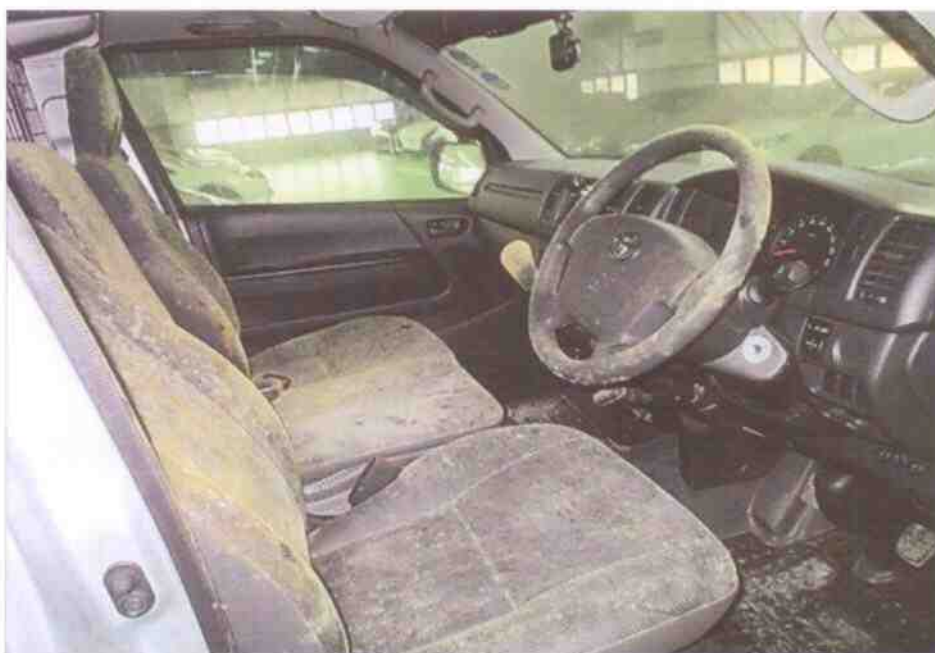
Photo 5 shows the interior compartment of the Insured Vehicle, which was covered in fire extinguisher residue at the time of our inspection. Some of the interior components were partially melted and/or burned as a result of the fire. These had included the seats, sun visors, roof upholstery, cabin lights and side panels, amongst others.

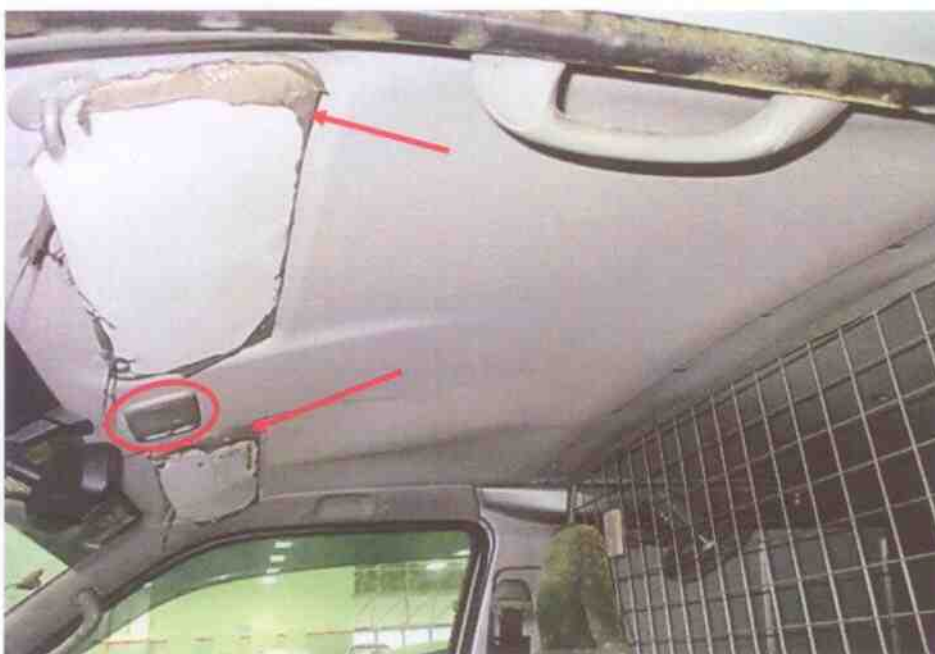
Photo 6 shows a closer view of the sun visors (arrowed) and the cabin lighting (circled) that were partially melted and/or burnt as a result of the fire.

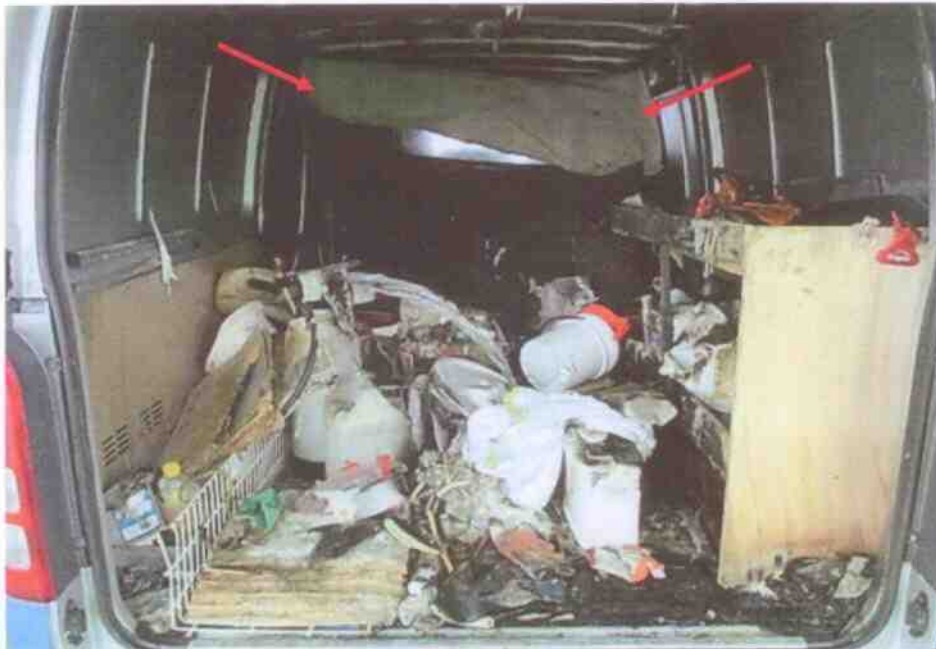
Photo 7 shows a closer view of the roof upholstery (arrowed) of the rear cabin that was partially melted and/or burnt as a result of the fire.

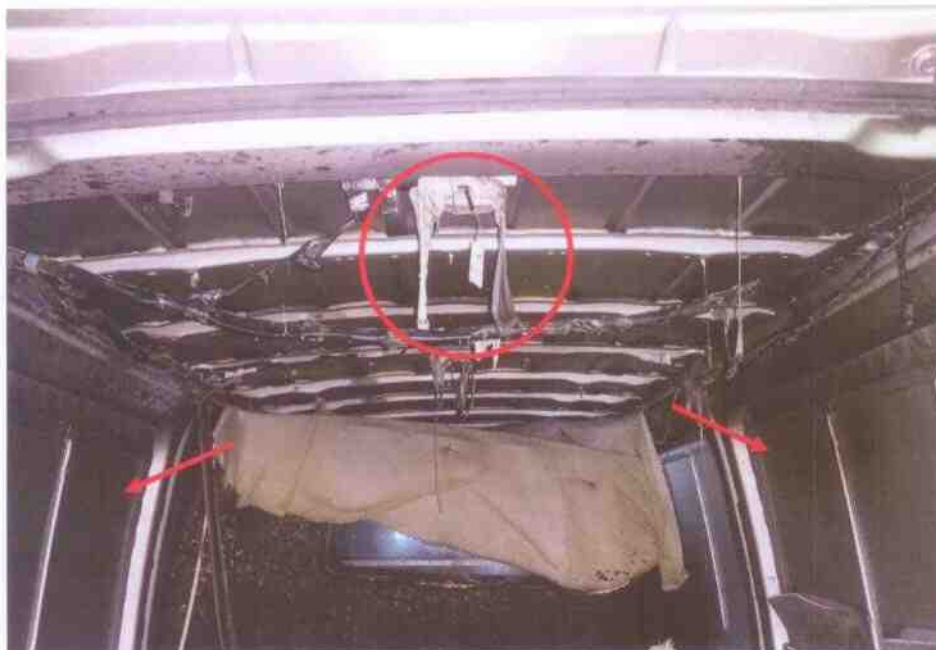
Photo 8 shows a closer view of the cabin lighting (circled) and side panels (arrowed) of the rear cabin of the Insured Vehicle that were partially melted and/or burnt as a result of the fire.

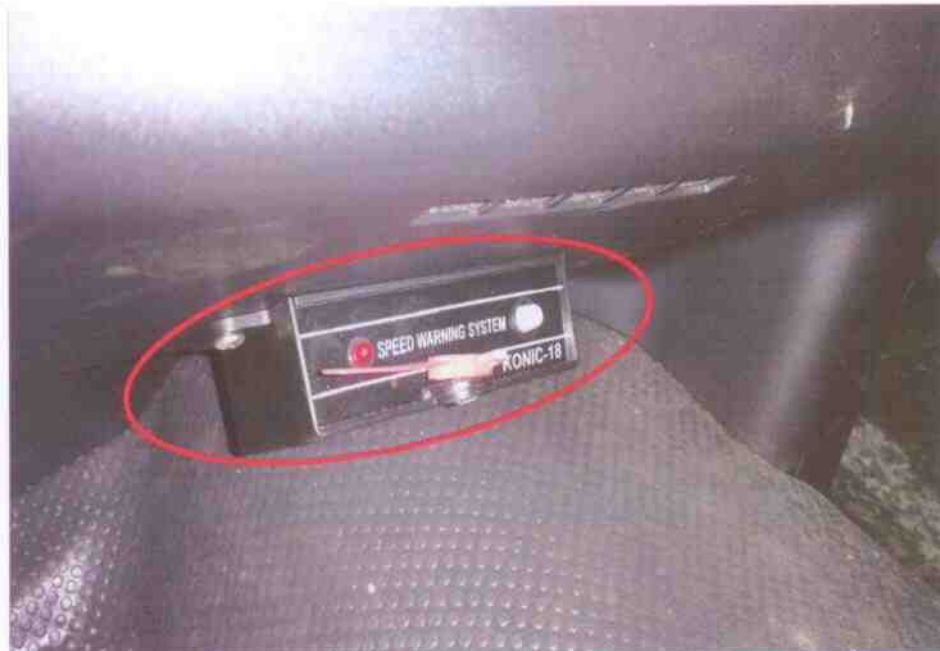
Photo 9 shows the vehicle speed limiter device fitted underneath the glove compartment of the Insured Vehicle upon our inspection (circled).

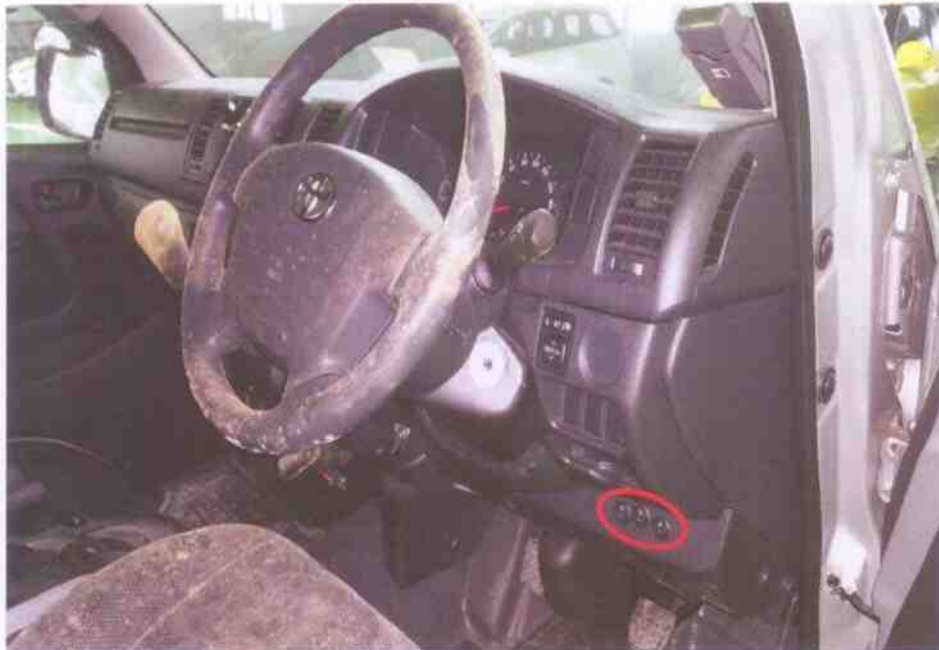
Photo 10 shows the 3 aftermarket on/off switches fitted above the foot pedals of the Insured Vehicle upon our inspection (circled).

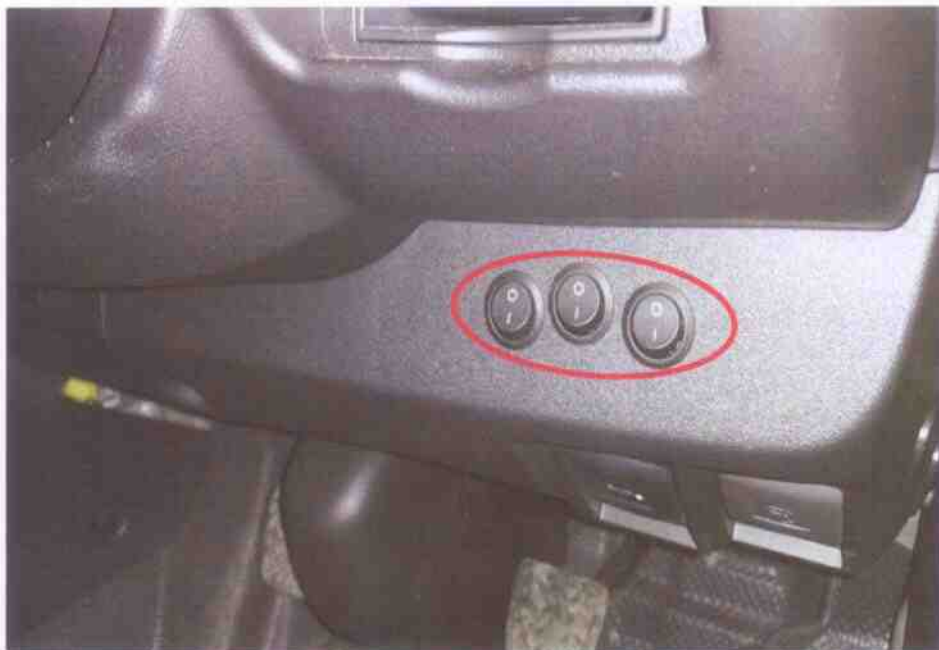
Photo 11 shows a closer view of the 3 aftermarket on/off switches fitted above the foot pedals of the Insured Vehicle (circled) upon our inspection.

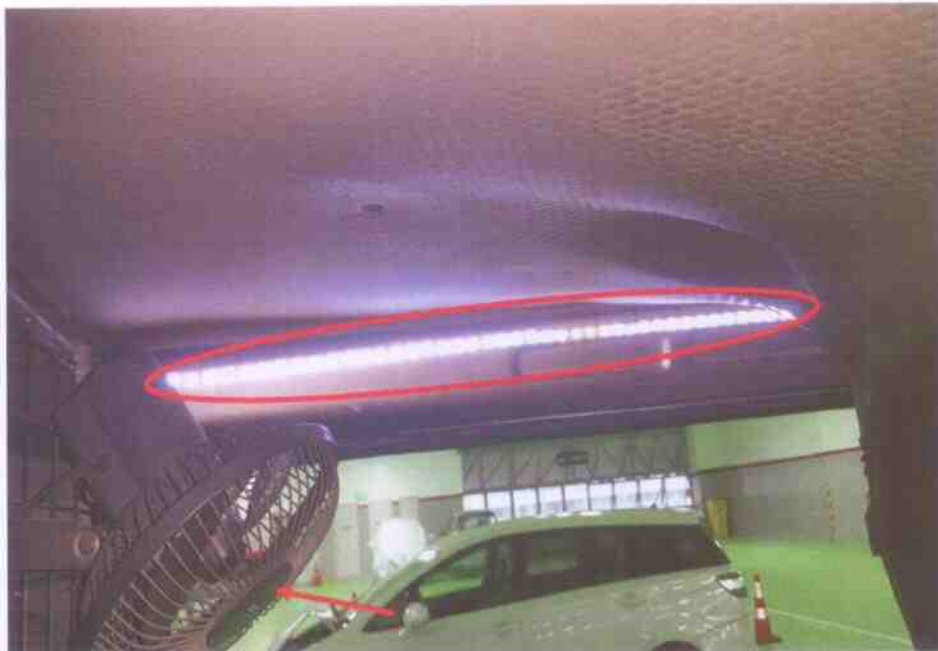
Photo 12 shows the 1st LED light strip fitted on the right side panel of the rear cabin (circled) after the 1st switch was turned on. The mini fan was fitted directly behind the centre console of the Insured Vehicle (arrowed).

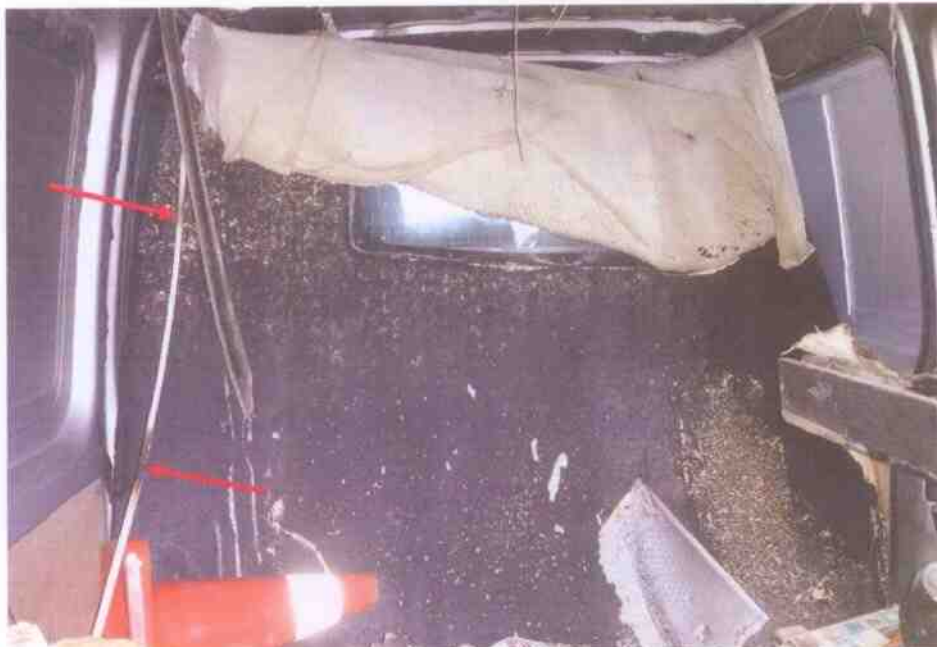
Photo 13 shows the 2nd LED light strip fitted on the left side panel of the rear cabin of the Insured Vehicle which had sustained fire damage (arrowed).

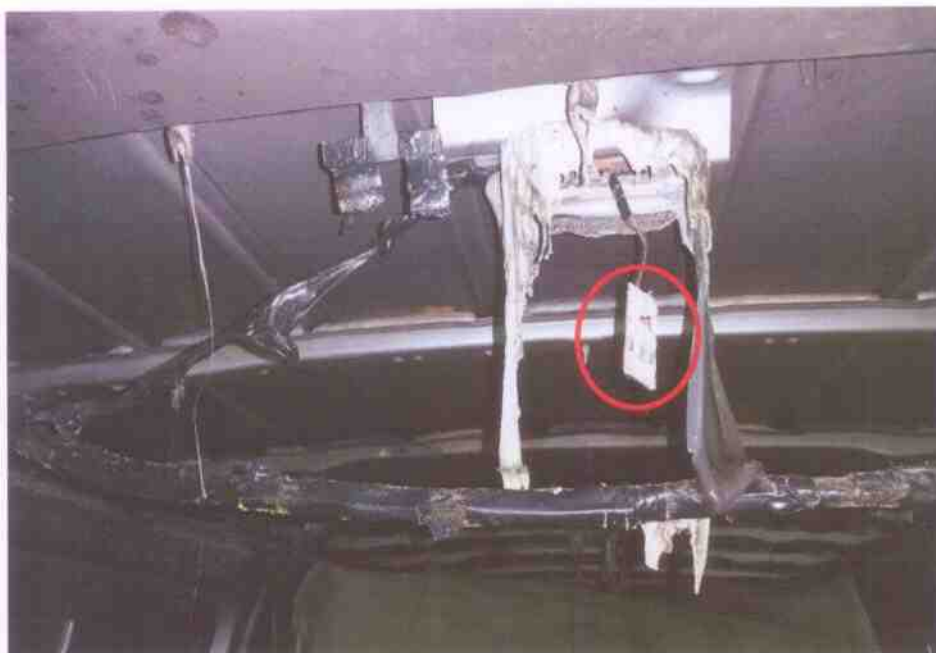
Photo 14 shows a close up view of the rear cabin LED light strip of the Insured Vehicle which had sustained fire damage (circled).

25. Having investigated and technically analysed the damages of burnt nature to the Insured Vehicle, we are of the view that the cause of fire to the Insured Vehicle was of electrical in nature. For this particular case, the fire had originated along the wirings of the LED light strips in the rear cabin. The LED light strips were not original factory components of the Insured Vehicle.

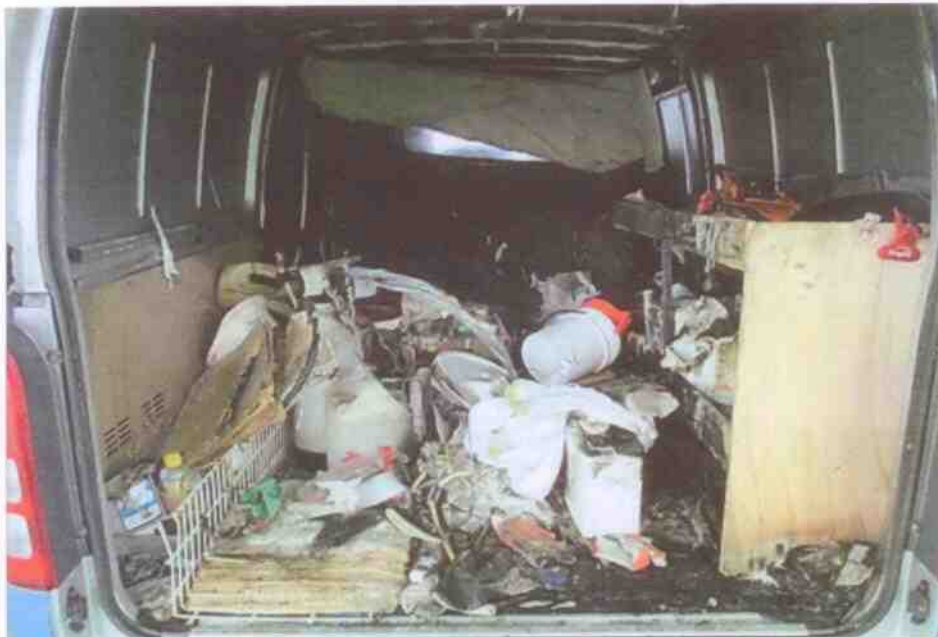
Photo 15 shows the many containers containing flammable fluids and hazardous chemicals stored at the rear cabin of the Insured Vehicle which were used for pest control purposes. Such items included pesticides, insecticides and rodent poison pellets, amongst others.

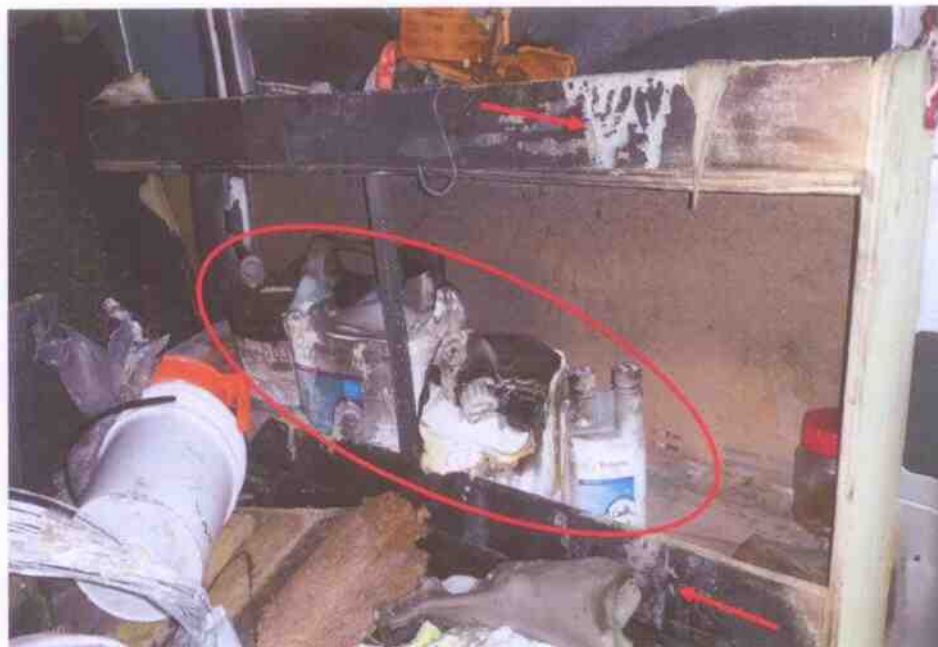
Photo 16 shows a closer view of the pesticides, insecticides and rodent poison pellets which were stored on the wooden shelf at the right side of the rear cabin of the Insured Vehicle in the immediate vicinity where the fire had likely started (circled). We also found high heat intensity burn marks (whitish burn marks) found on these wooden shelves (arrowed). The top portion of some of these partially melted and/or burnt containers were wet with fluid (circled).

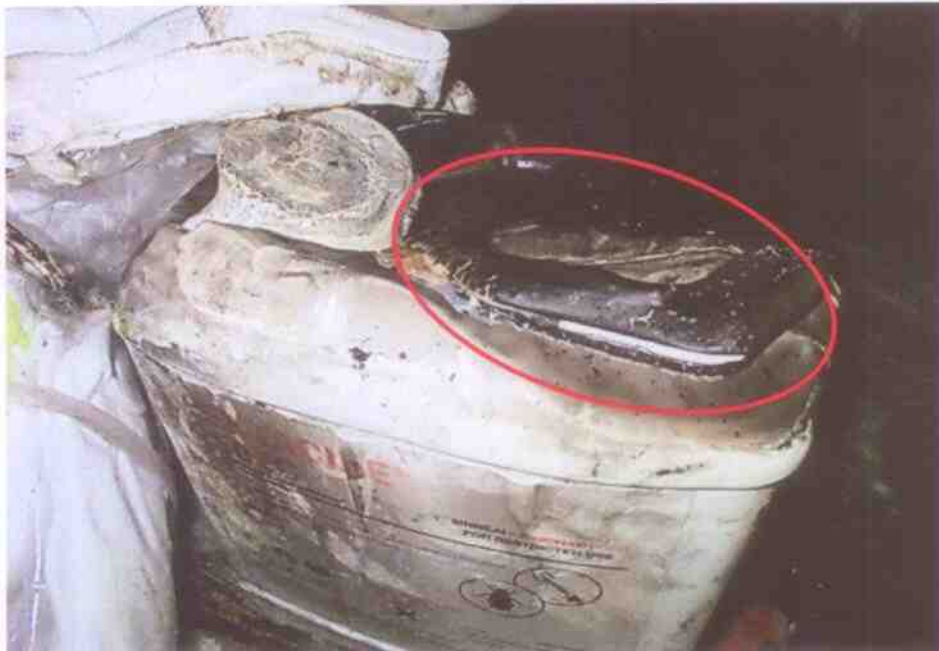
Photo 17 shows a close up view of the top portion of 1 of the partially melted and/or burnt containers wet with fluid (circled).

22. The possibility of the fire being due to a fluid leak would also seem unlikely given that flammable fluids would require a spark and/or an igniting source for it to catch fire. The fluids observed on the top portion of the partially melted and/or burnt containers could have been a result of fluid spillage from some plastic containers which had melted and/or toppled over due to the prolonged exposure to high heat intensity.

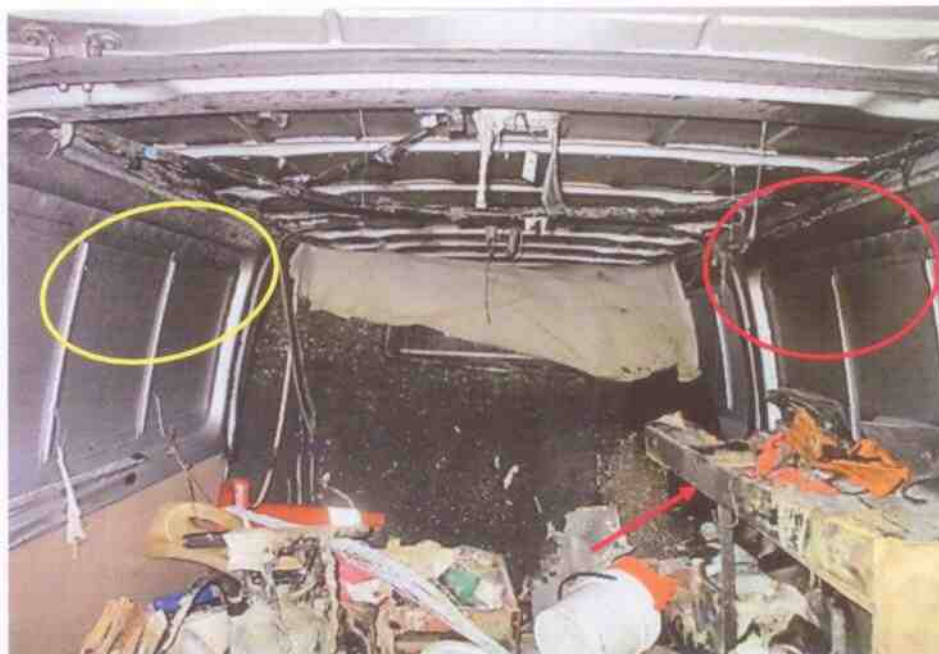
9. Furthermore, there was a higher concentration of burn marks on the right side panel as compared to the left side panel of the rear cabin of the Insured Vehicle. There were also high heat intensity burn marks (whitish burn marks) found on the wooden shelves and metallic items that were stored around the immediate vicinity to where the fire had likely started. These whitish burn marks are a result of exposure to prolonged heat intensity. Rust would normally start to develop around the metallic items soon after a fire as the prolonged exposure to high heat intensity usually causes the bare steel/metal material of these items to be exposed to natural environmental condition. The rust that had developed on the surfaces of the metallic items stored at the immediate vicinity where these whitish burn marks were found would also support our findings of where the fire to the Insured Vehicle had originated.

Photo 18 shows the higher concentration of burn marks on the right side panel (red circle) as compared to the left side panel (yellow circle) of the rear cabin of the Insured Vehicle. There were also high heat intensity burn marks (whitish burn marks) found on the wooden shelves (arrowed) and metallic items that were stored around the immediate vicinity to where the fire had likely started.

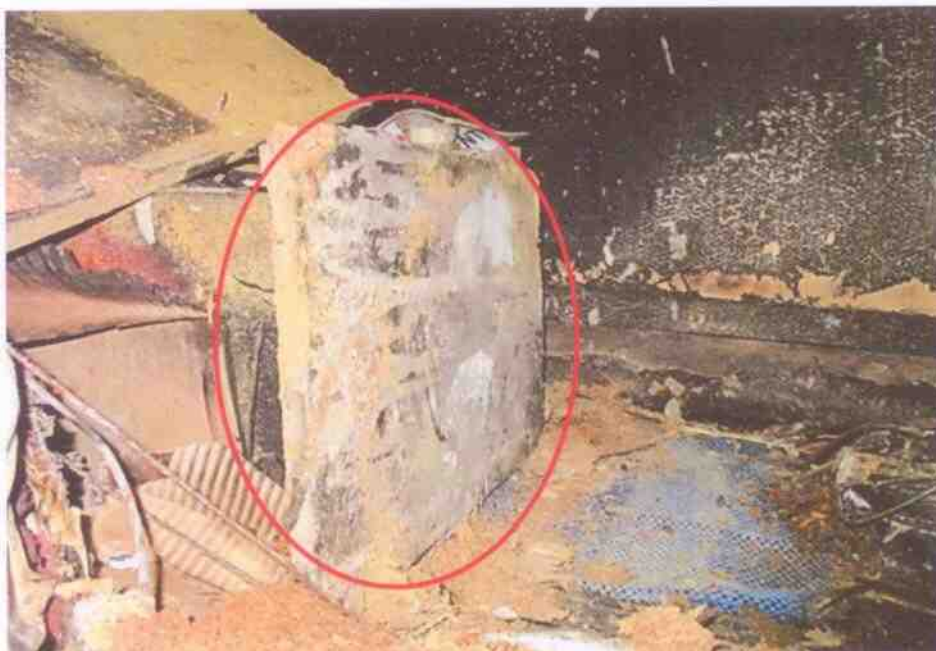
Photo 19 shows a closer view of the high heat intensity burn marks (whitish burn marks) found on the wooden shelves (circled) that were stored around the immediate vicinity to where the fire had likely started. These whitish burn marks are a result of exposure to prolonged heat intensity.

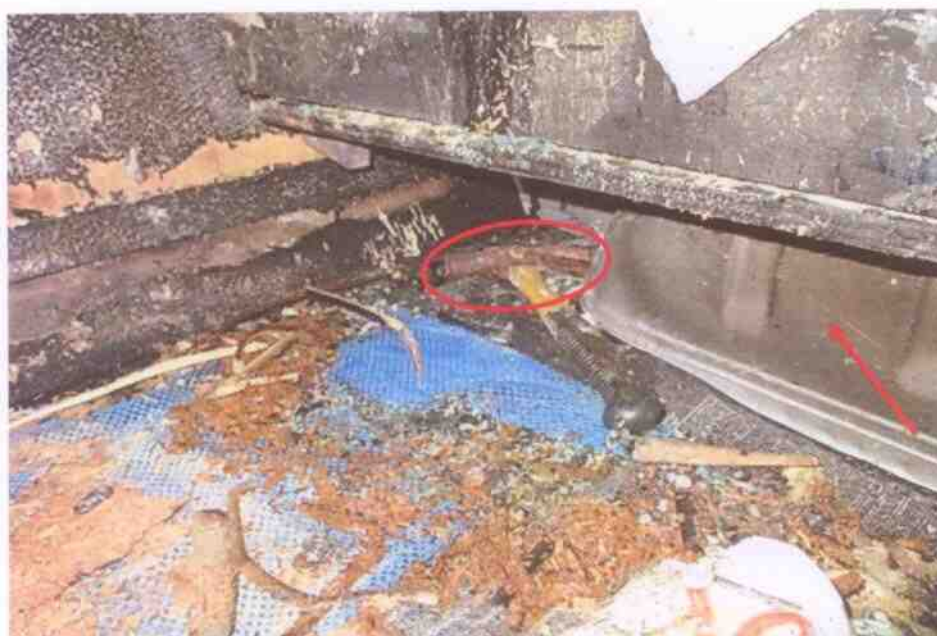
Photo 20 shows the rust that had developed on the surfaces of the metallic items (circled) and vehicle body (arrowed) at the immediate vicinity where the fire had likely started. Prolonged exposure to high heat intensity usually causes the bare steel/metal material of these items and vehicle body to be exposed to natural environmental condition. The rust that had developed on these surfaces would also support our findings of where the fire to the Insured Vehicle had originated.

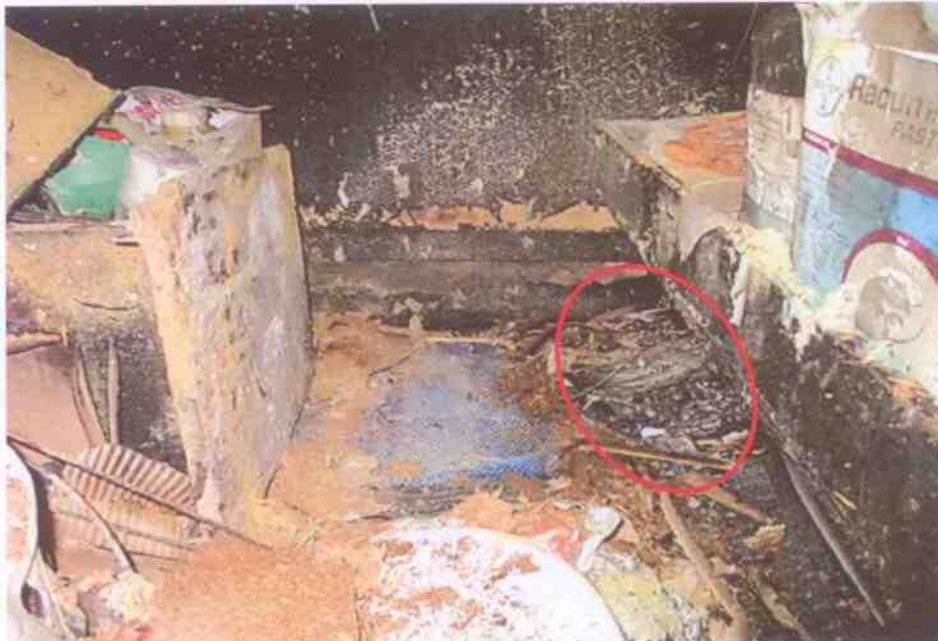
Photo 21 shows upon closer examination of the right side of the rear cabin of the Insured Vehicle as well as around the immediate vicinity to where the fire had likely started, we found a partially melted and/or burnt plastic bag containing metal hooks placed in the centre of coils made out of metal wires (circled).

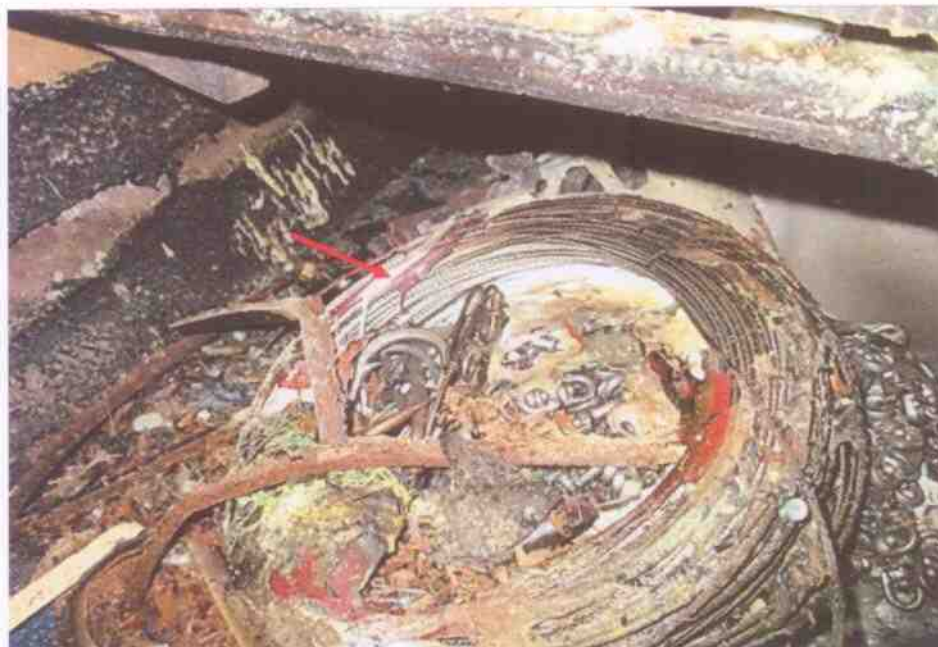
Photo 22 shows a close up view of the partially melted and/or burnt plastic bag (arrowed) containing metal hooks placed in the centre of coils made out of metal wires.

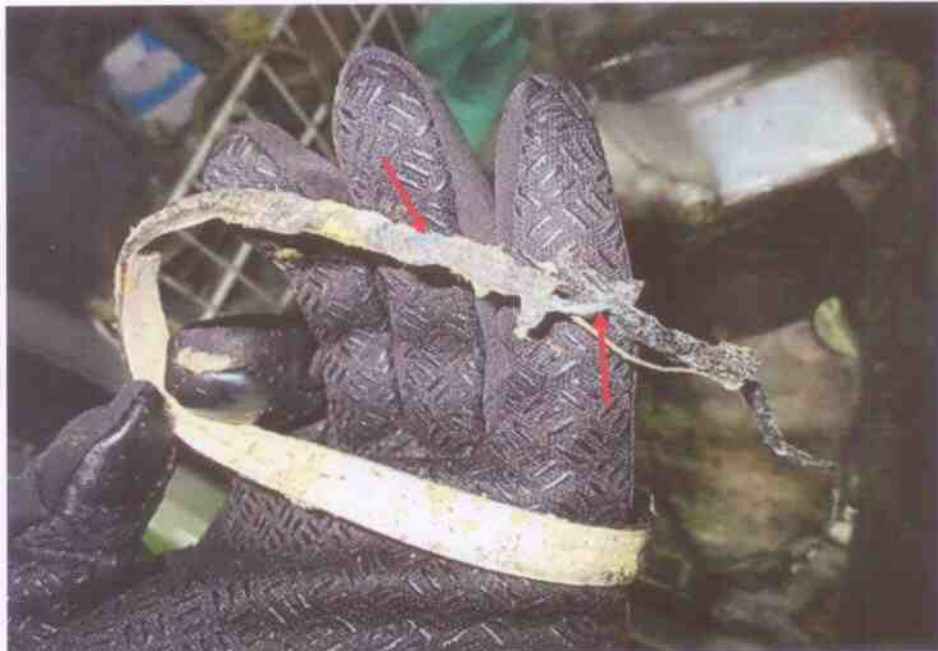
Photo 23 shows a close up view of the faint traces of greenish residue there were found on the LED light strip that was fitted along the left side panel of the rear cabin of the Insured Vehicle (arrowed). The presence of such greenish residue suggests occurrence of an electrical short circuit.

23. The possibility of the fire being due to electrical in nature would then seem more likely given that engine overheating, external factors and fluid leakage would seem unlikely. The fire being due to electrical nature is also supported by the faint traces of greenish residue that were found on several burnt stretches of the LED light strips that were fitted at the rear cabin of the Insured Vehicle, which was earlier discussed in paragraph 10 above.

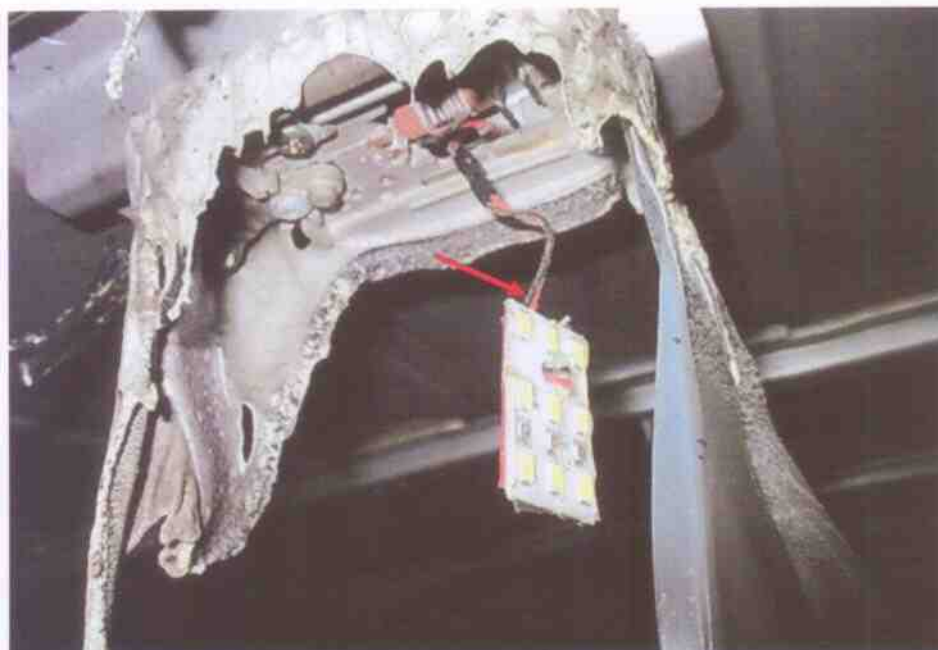
Photo 24 shows a close up view of the faint traces of greenish residue there were found on the wirings of the rear cabin LED light strip of the Insured Vehicle (arrowed). The presence of such greenish residue suggests occurrence of an electrical short circuit.

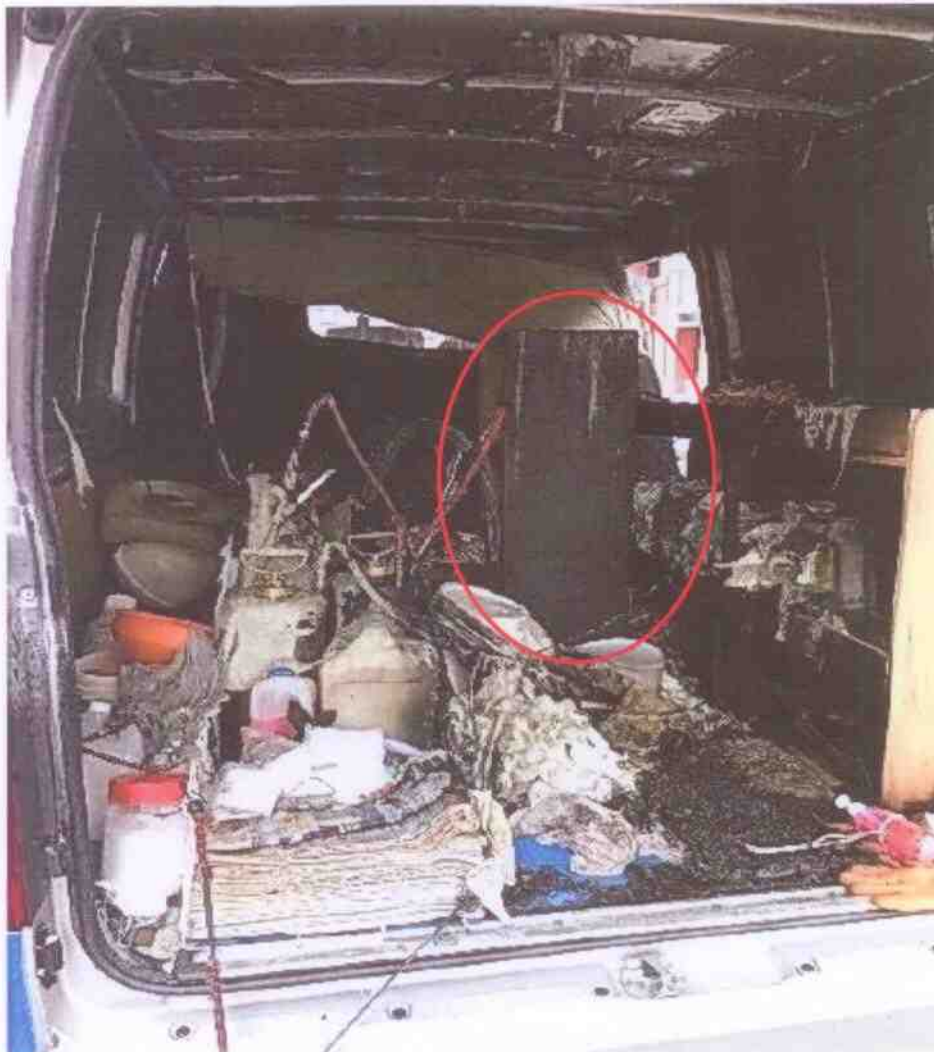
Photo 25 shows the rear cabin of the Insured Vehicle after the fire was extinguished. In general, the information that could be gathered from this photograph pertaining to the nature of fire damage had corresponded to the events that were related to us by Mr Seah, which is the fire had started from the right side of the rear cabin of the Insured Vehicle (circled).

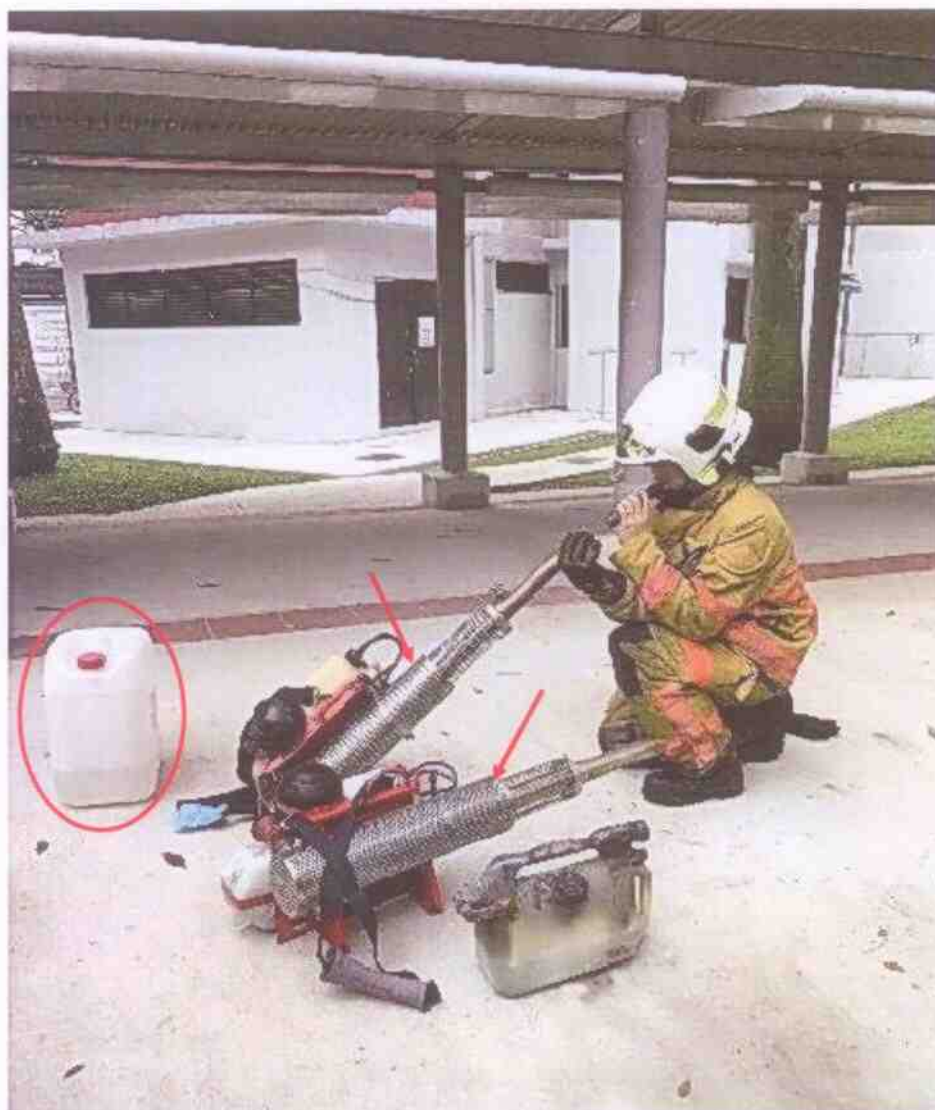
Photo 26 shows a firefighter checking 1 of the fogging machines after the fire had been extinguished. In general, the information that could be gathered from this photograph had corresponded to the events that were related to us by Mr Seah, which is he removed the 2 fogging machines (arrowed) and the jerrycan containing petrol (circled) as soon as he saw the fire at the right side of the rear cabin of the Insured Vehicle.

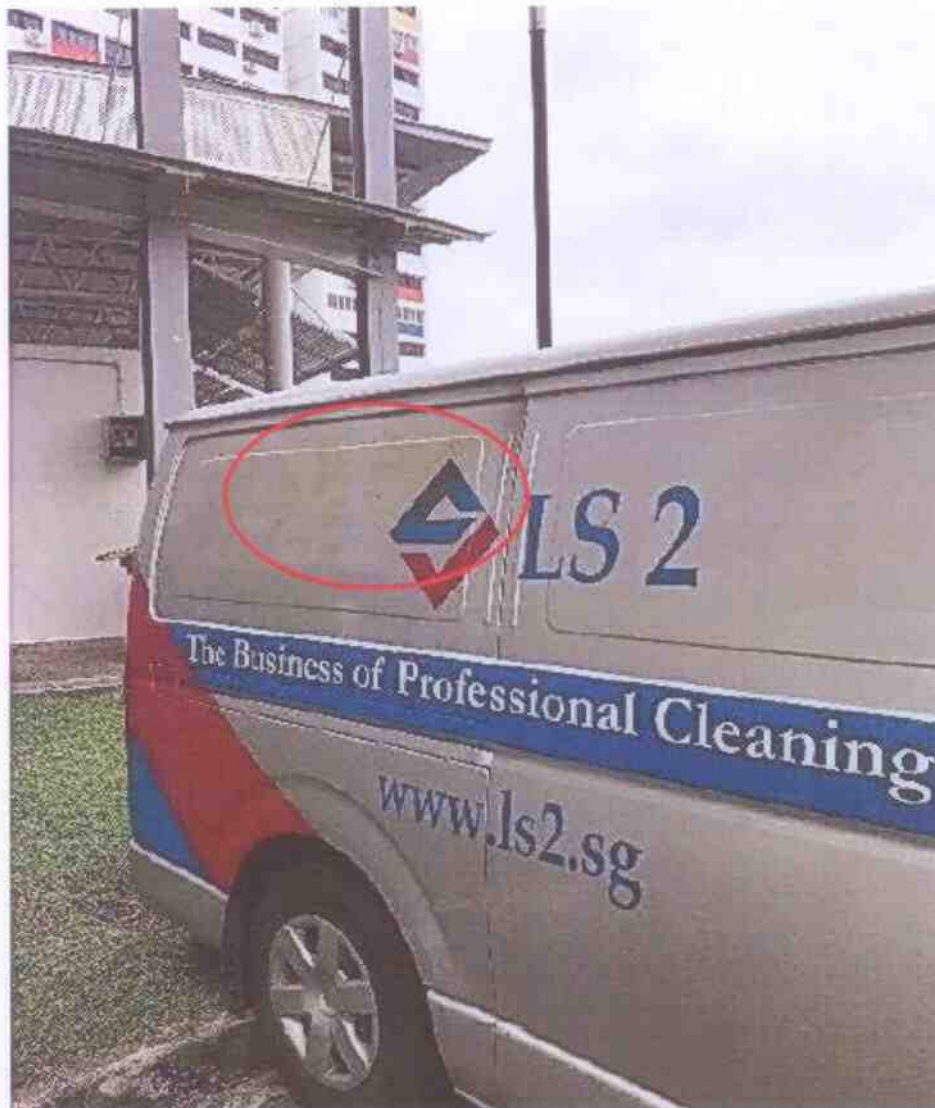
Photo 27 shows the right rear portion of the Insured Vehicle after the Insured Vehicle was parked post- incident. In general, the faint burnt marks observed on the right rear portion (circled) had corresponded to the events that were related to us by Mr Seah, which is the fire had started from the right side of the rear cabin of the Insured Vehicle.
