Full Report - V1  
Registration: SGJ9566P  
Printed: 02/05/2018 17:34

| Registration: | SGJ9566P |

**VEHICLE DAMAGE INSPECTION REPORT**China Taiping Insurance (Singapore) Pte. Ltd.  
3 Anson Road, #16-00 Springleaf Tower  
Singapore 079909**Our File No:** CS/CTI18004471/GQD3E2**Date:** 23/05/2018REFERENCEInsured/Claimant: ANG BIN KEONG, LAWRENCE Policy No: DMPCSN7042621710  
Date of Loss: 05/03/2018 Nature of Claim: OD Claim No: SNM18D01178C01DESCRIPTION & IDENTIFICATION OF VEHICLE

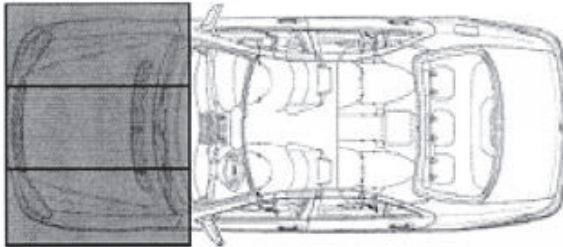
Primary Impact  
Secondary Impact
