# LKK Auto Consultants Pte Ltd

**Preliminary Advice**

| TP Vehicle No | : SDD2112D | Assignment Date | : 08/03/2018 |

## VEHICLE DAMAGE INSPECTION REPORT

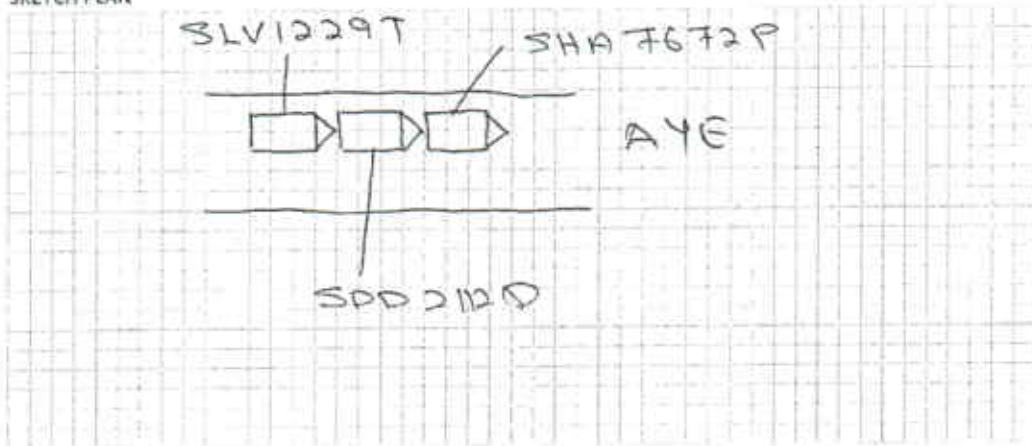
SKETCH PLAN

on 5 MAR 18 around 5pm, I was travelling along AYE (Exit @ ALEXANDER), a Taxi (SHA 7672 P) made a sudden brake, I manage to stop in time. Suddenly a car SLV 1229 T has knocked into at rear portion of my car and my car surged forward collided into the taxi.
