REF: CSI/LAW/8004521/T11b52

**SURVEY OF VEHICLE NO. GBF 6161Z**

## AUTOMOBILE ASSESSMENT REPORT

## ADJUSTMENT ON REPAIR COST FOR VEHICLE NO. GBF 6161Z

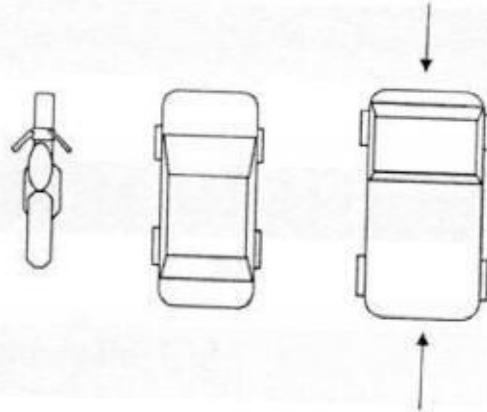
## 4. DESCRIPTION OF DAMAGE

At the time of inspection, this vehicle sustained damages to the **Front & Rear** portion. Please see attached scheduled for details.
