Your Ref : 546561/IT
Our Ref : CI/MSG18004905/D

14 March 2018

AUTOMOBILE TECHNICAL INVESTIGATION REPORT OF INCIDENT INVOLVING SKM 3602U AND SLS 2598L ON 23 DECEMBER 2017

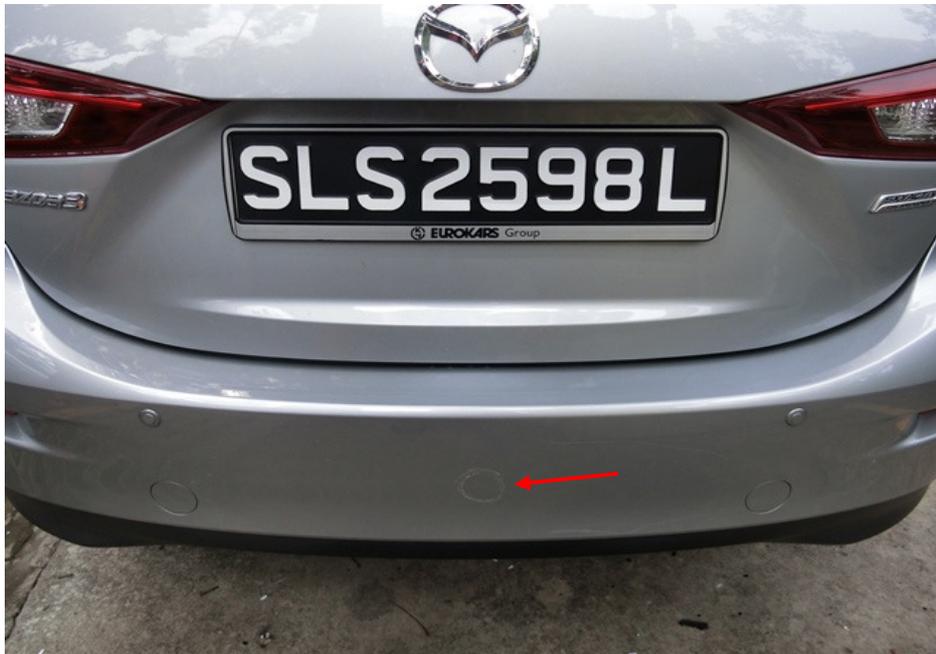
7. The Third Party Vehicle was not able to be inspected as repairs have been completed prior to your request to comment on this incident. I will hence be relying on the provided photographs showing the Third Party Vehicle for my analysis.
8. The photographs taken at the time of reporting on 26 December 2017 (3 days after the incident) had showed what appears to be a barely visible distortion to the rear bumper of the Third Party Vehicle, evident from the need to use non-permanent markings to highlight the area of distortion during the photograph taking. This distortion was noted to be directly at the centre of the rear bumper. See photo 1 & 2 below.

Photo 1 shows a general view of the rear portion of the Third Party Vehicle at the time of incident reporting on 26 December 2017 (3 days after the incident). Upon closer examination of the photographs, what appears to be a barely visible distortion to the rear bumper of the Third Party Vehicle was observed, evident from the need to use non-permanent markings to highlight the area of distortion. This distortion was noted to be directly at the centre of the rear bumper (arrowed).

17. My examination of the photographs showing the Third Party Vehicle, which was discussed earlier in paragraph 8 and paragraph 10, revealed slight distortion on the centre area of its rear bumper, light scratches on the right side of its rear bumper and slight dent on the right side of its rear bootlid. These damages were all direct contact/impact type of damage, where the object which had caused the damage had come into direct contact with the Third Party Vehicle.

22. For this case, my technical analysis that were set out in paragraph 15 to paragraph 21 above had indicated that the slight distortion on the centre area of the Third Party Vehicle's rear bumper was caused by contact from the Insured Vehicle. Given that the distortion was barely visible, it would be reasonable to say that the force/load arising from the contact was minimal. This force/load would have also unlikely penetrated to other body parts, beyond the rear bumper of the Third Party Vehicle.
23. In this regard, the cost of repair to restore the rear bumper of the Third Party Vehicle would involve minor heat treatment to the rear bumper to straighten the slightly distorted area, and thereafter spray painting of the rear bumper. A reasonable cost for such nature of restoration work would be approximately \$400/- with 2 working days for the completion of the work.

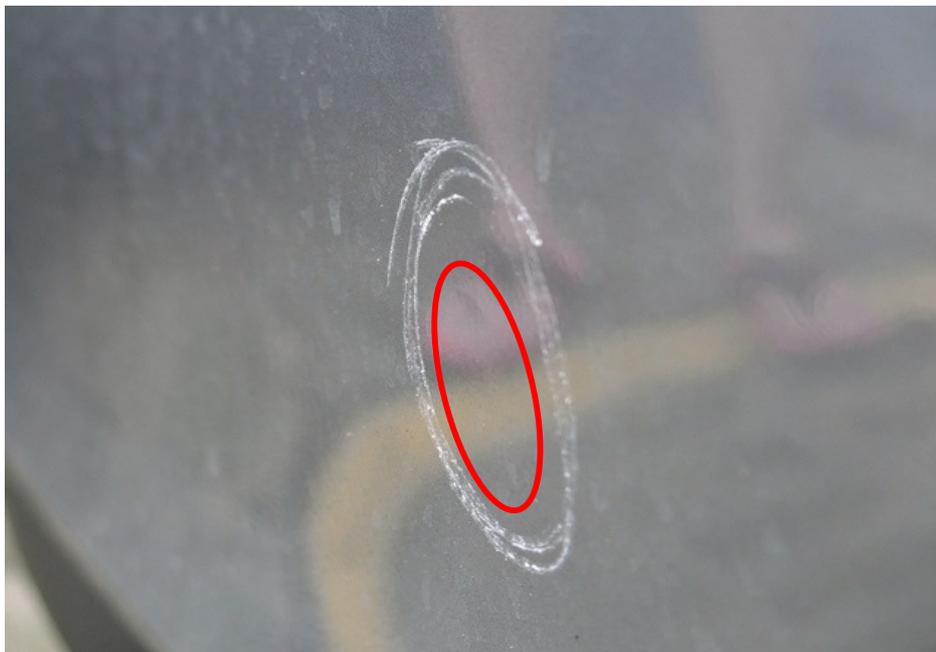
Photo 2 shows a close up view of the distorted area of the rear bumper. This was at the time of incident reporting on 26 December 2017. The distortion (red circle) was directly at the centre of the rear bumper and barely visible.

20. The height measurements carried out appear to indicate that the slight distortion on the centre area of the Third Party Vehicle's rear bumper was likely caused by contact from the front number plate of the Insured Vehicle. The light scratches on the right side of the rear bumper and slight dent on the right side of the rear bootlid were unlikely to be caused by contact from the Insured Vehicle.
21. Given the findings of the height measurements, it can be established that there was a single point of contact between the Insured Vehicle and the Third Party Vehicle. This single point of contact was at the most protruded body part ie front number plate of the Insured Vehicle and the rear bumper of the Third Party Vehicle.

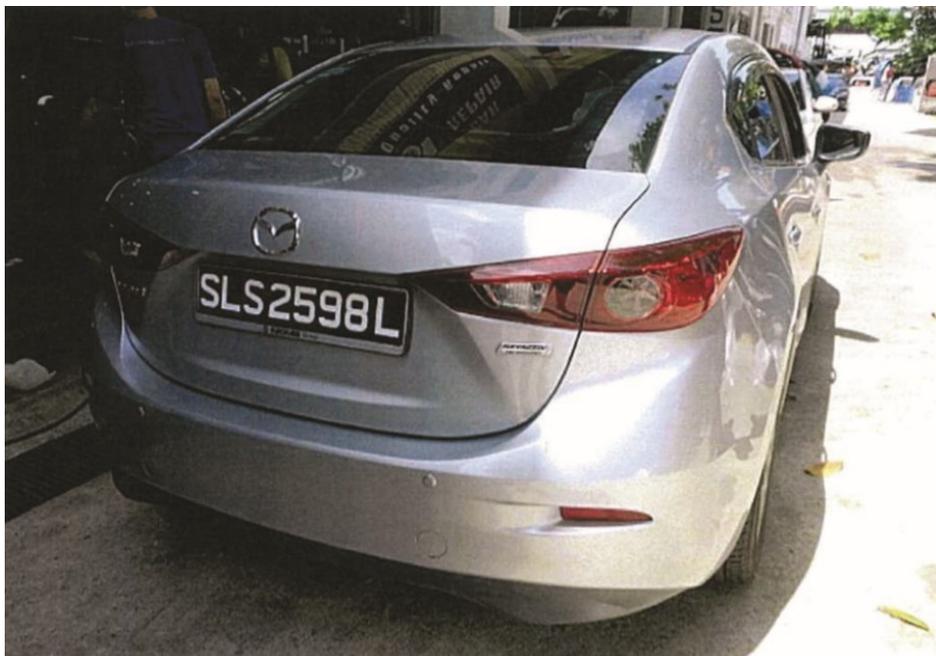
9. The 12 coloured photographs showing the Third Party Vehicle before repair, after dismantling of body parts, and after repair, which were all taken at an unknown date after the time of incident reporting (non-permanent markings not seen during this time), appear to have been focused on the rear right side of the Third Party Vehicle.
10. What appears to be light scratches were observed on the right side of the rear bumper, towards the top area. A relatively minor dent was also observed on the right side of the Third Party Vehicle's rear bootlid. See photo 3 – 5 below.

Photo 3 shows a general view of the rear portion of the Third Party Vehicle before the start of repairs. This was at a later date after the incident report as the non-permanent markings were no longer visible. The photographs taken had appeared to primarily be focussed on the rear right side of the Third Party Vehicle.

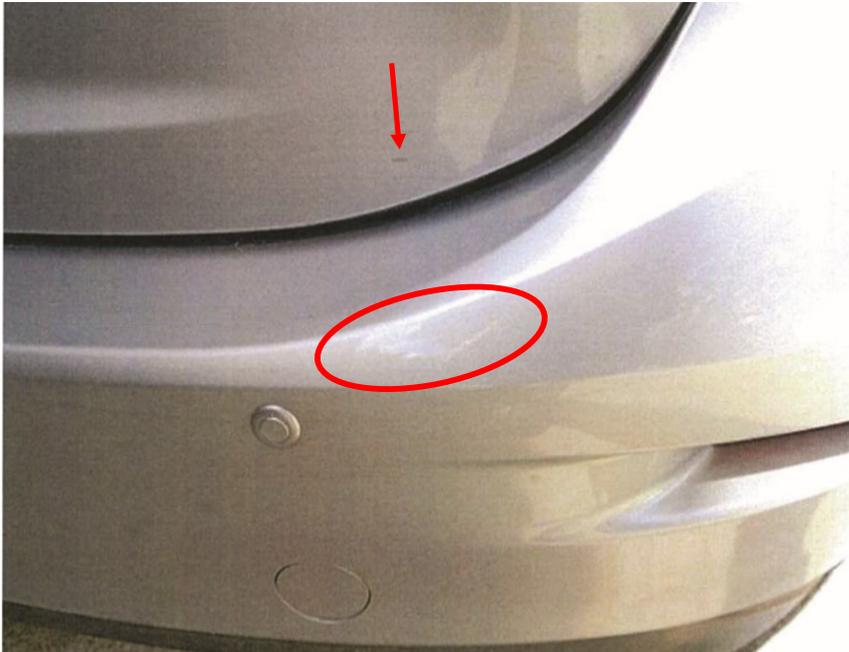
Photo 4 shows a closer view of the rear right side of the Third Party Vehicle. From the photographs taken, I had observed what appears to be light scratches on the right side of the rear bumper, towards the top area (circled). A relatively minor dent was also observed on the right side of the Third Party Vehicle's rear bootlid (arrowed).

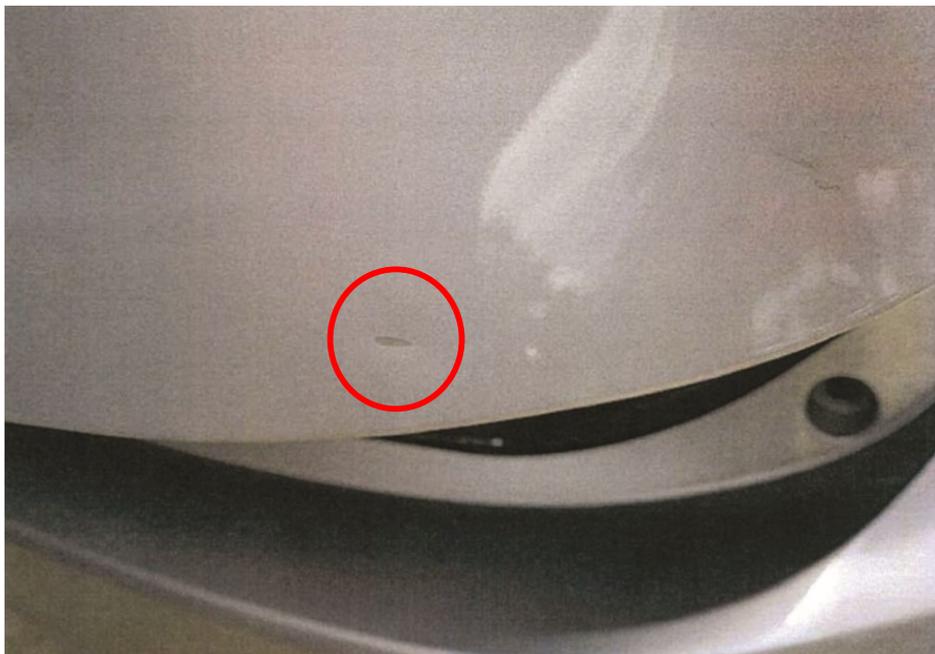
Photo 5 shows a close up view of the relatively minor dent (circled) that was observed on the right side of the Third Party Vehicle's rear bootlid.

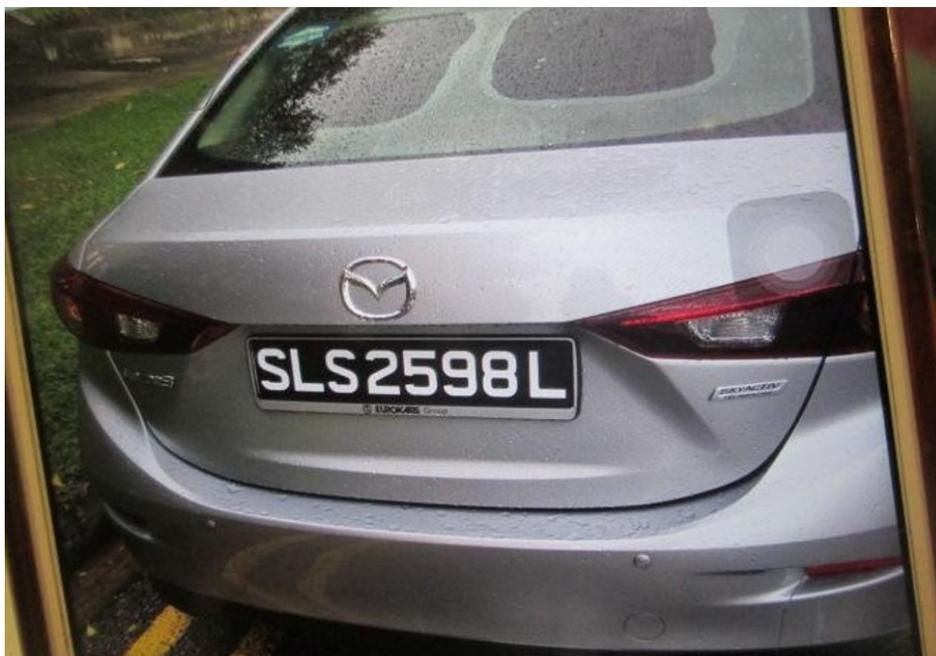
11. The photograph showing the Third Party Vehicle taken at the incident location, and attached in the Singapore Accident Statement of the driver of the Insured Vehicle had showed the general view of the rear portion of the Third Party Vehicle with no close up view. Closer examination of the photograph did not produce any significant observation(s) as the resolution of the photograph deteriorates upon enlarging the size of the photograph. From the general view as seen in the photograph, there appears to be no visible damage on the rear portion of the Third Party Vehicle. See photo 6 below.

Photo 6 shows the rear portion of the Third Party Vehicle at the incident location. No notable observation(s) was made as there was no closer view of the Third Party Vehicle. However, from the general view seen in the photograph, there appears to be no visible damage seen on the rear portion of the Third Party Vehicle.

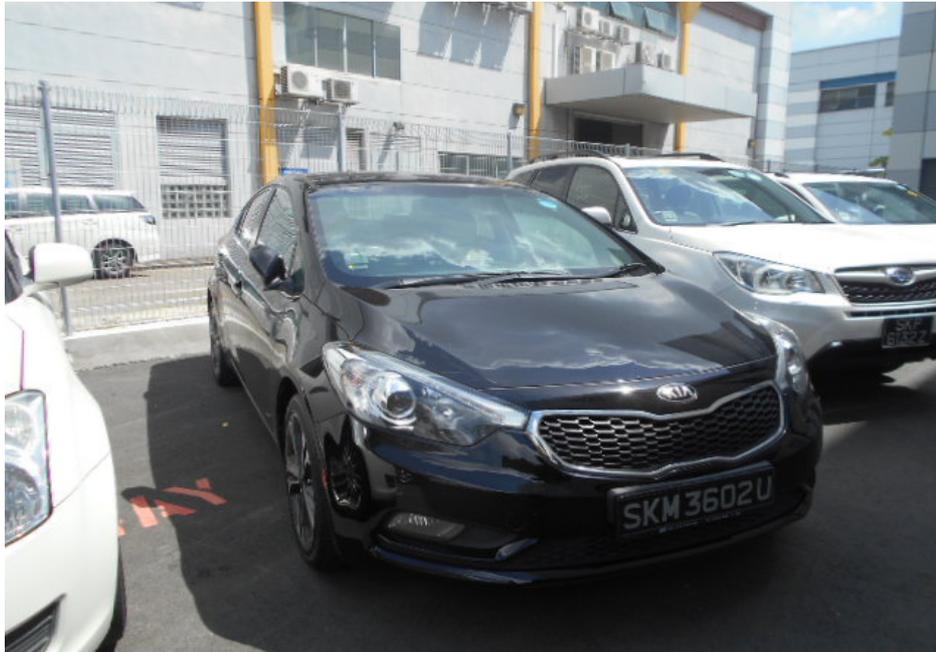
Photo 7 shows a general view of the front right portion of the Insured Vehicle at the time of my inspection. The mileage of the Insured Vehicle at the time of my inspection was recorded to be 127,974km.

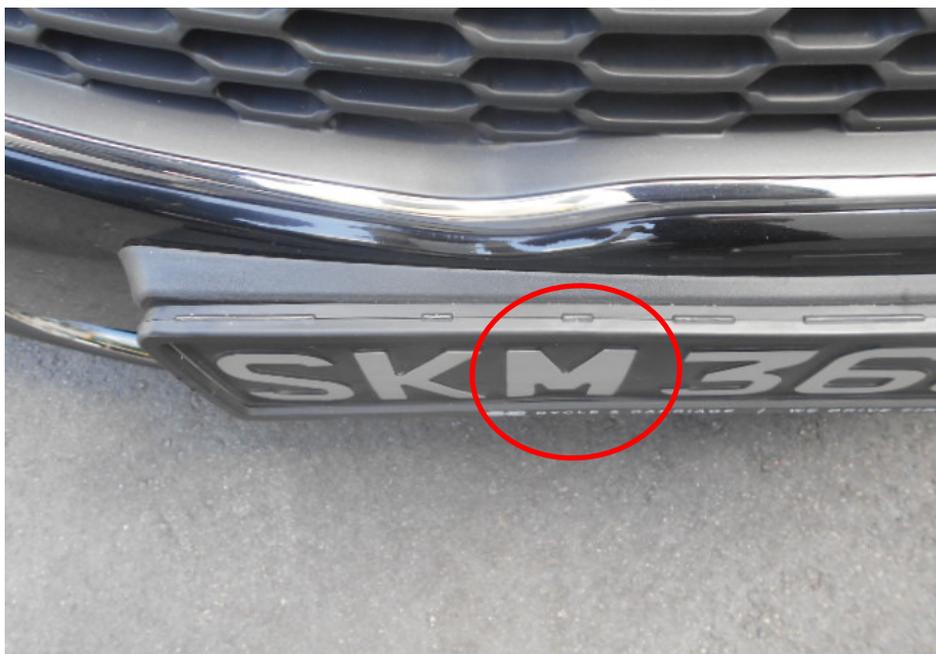
13. My visual examination of the frontal portion of the Insured Vehicle revealed a slight bending of its front number plate and front number plate casing. No other visible damage was observed. See photo 7 – 12 below

Photo 8 shows the front number plate and front number plate casing of the Insured Vehicle slightly bent at a single area (circled).

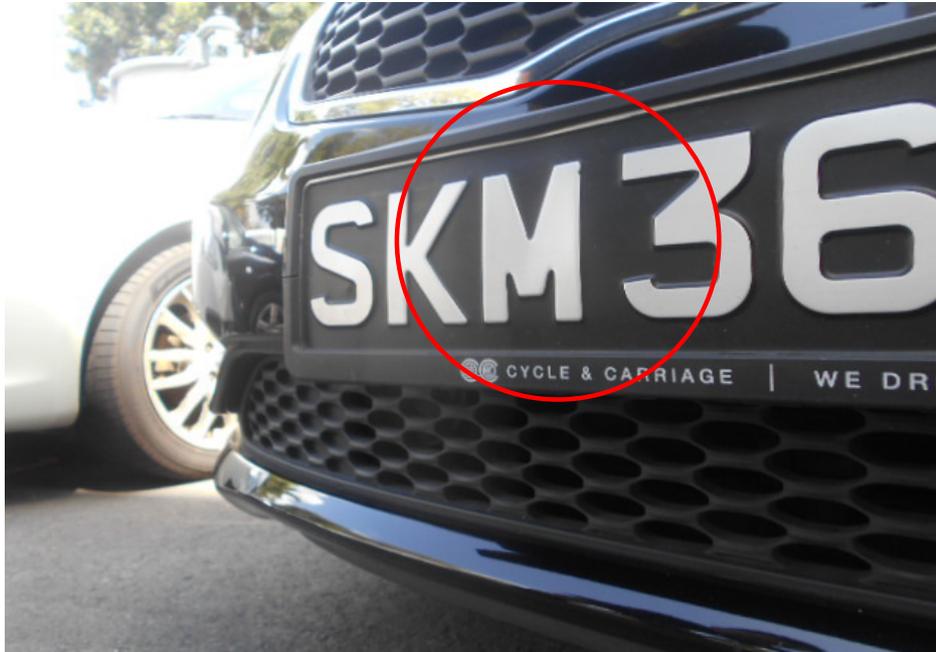
Photo 9 shows the front number plate and front number plate casing of the Insured Vehicle slightly bent at a single area (circled). Apart from this, I did not observe any other visible damage to the frontal portion of the Insured Vehicle at the time of my inspection.

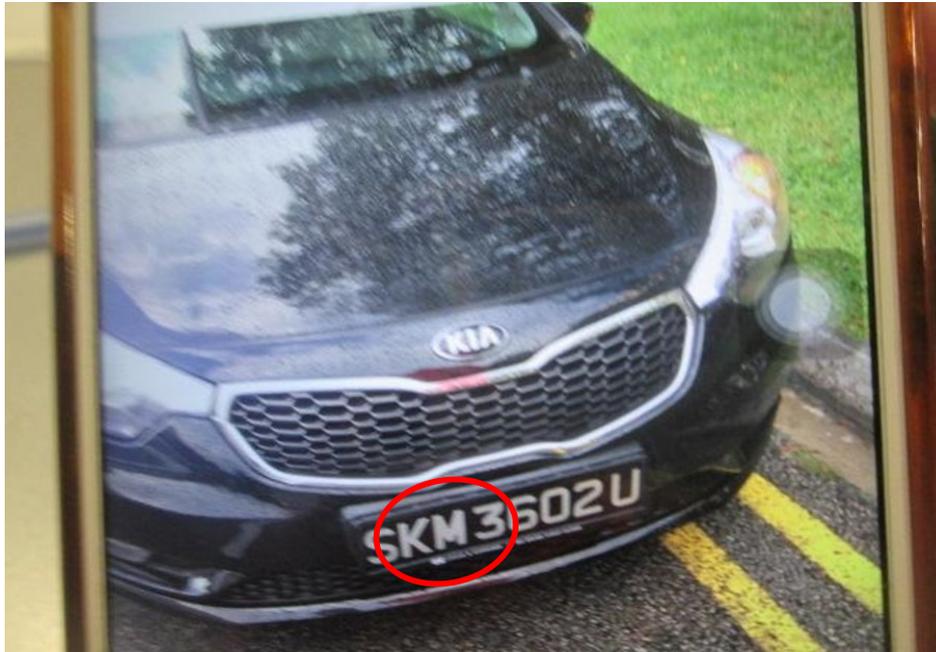
14. The bending of the front number plate and front number plate casing of the Insured Vehicle that I had observed at the time of my inspection was similarly observed from the photograph showing the Insured Vehicle that was taken at the incident location. See photo 10 below.

Photo 10 shows the frontal portion of the Insured Vehicle at the incident location. Its front number plate and front number plate casing was observed to be bent (circled). This was similar to my observations at the time of my inspection of the Insured Vehicle on 13 February 2018.

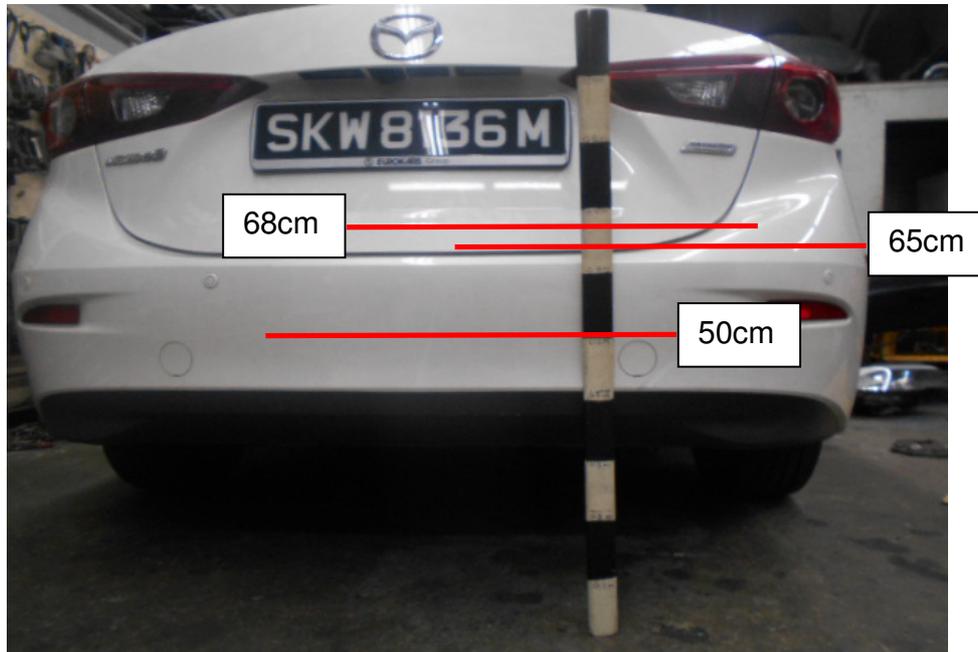
19. I now set out below the findings gathered following the height measurements that was conducted: -
- a) the height above ground level of the Third Party Vehicle's rear bumper, where the slight distortion and light scratches were found was measured to be approximately 50cm and 65cm above ground level respectively;

- b) the height above ground level of the slight dent on the right side of the Third Party Vehicle's rear bootlid was measured to be approximately 68cm above ground level;

- d) comparing these measured heights, I note that the height above ground level of the top end of the Insured Vehicle's front number plate casing (48cm) was slightly below the height of the slight distortion that was found on the centre area of Third Party Vehicle's rear bumper (50cm);

- e) there was no visible damage found on the front portion of the Insured Vehicle at the height of 65cm and 68cm above ground level. These heights were the height recorded for the light scratches and slight dent that were observed on the rear right side of the Third Party Vehicle. See photo 11 & 12 below.

Photo 11 shows the height measurement that was conducted on the rear portion of the Third Party Vehicle. The height above ground level of the distortion on the centre area of the rear bumper was approximately 50cm; the scratches on the right side of the rear bumper was approximately 65cm; the dent on the right side of the rear bootlid was 68cm.

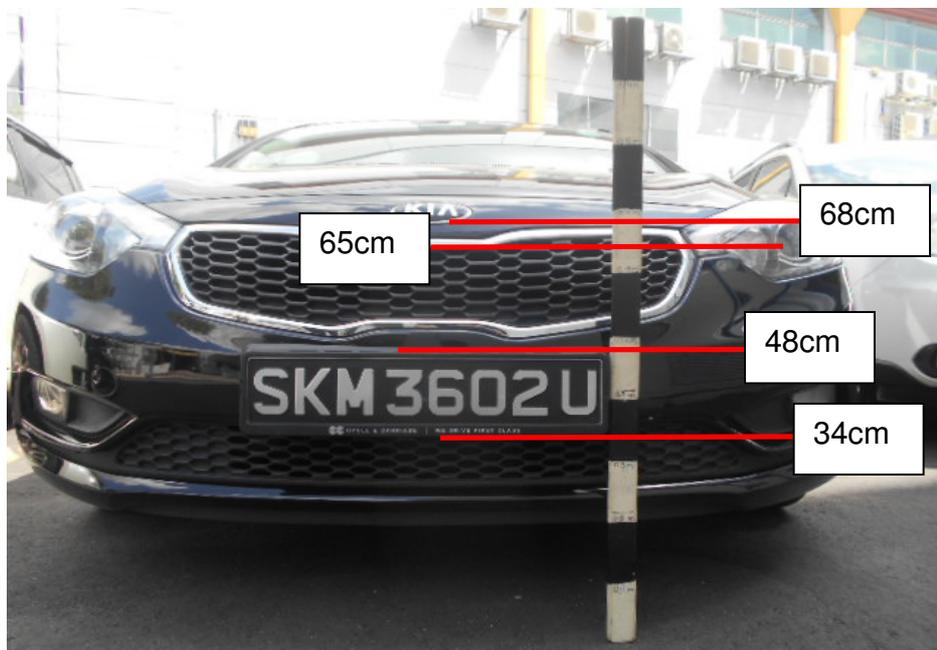
- c) the height above ground level of the lower end of the Insured Vehicle's front number plate casing was measured to be approximately 34cm above ground level while the top end was measured to be approximately 48cm above ground level;

Photo 12 shows the height measurement that was conducted on the front portion of the Insured Vehicle. The lower end of the Insured Vehicle's front number plate casing was approximately 34cm while the top end was measured to be approximately 48cm above ground level.
