Your Ref : 532371 16 February 2018

Our Ref : CI/MSG18004996/N

AUTOMOBILE TECHNICAL INVESTIGATION REPORT OF ACCIDENT INVOLVING SLL 4333H AND SKL 6125R ON 6 OCTOBER 2017

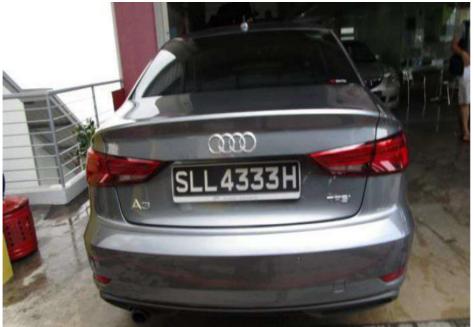
Photo 1 shows a general view of the rear portion of the Audi at the time of reporting, which was taken the next day after the accident. Based on the circumstances of the case contained in the Singapore Accident Statement, we note that the Audi had sustained damages to its rear portion.

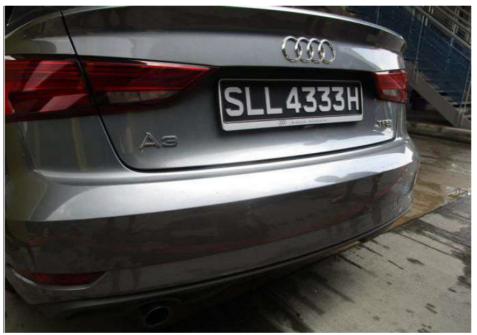
Photo 2 shows a closer view of the rear portion of the Audi at the time of reporting, which was taken the next day after the accident. Based on the circumstances of the case contained in the Singapore Accident Statement, the damage to the Audi was observed to be confined to its rear portion. However our review of the photographs showing the Audi at the time of reporting did not produce any significant information as the photographs were all taken from afar, without any close up photographs of the damaged body parts at the rear portion of the Audi.

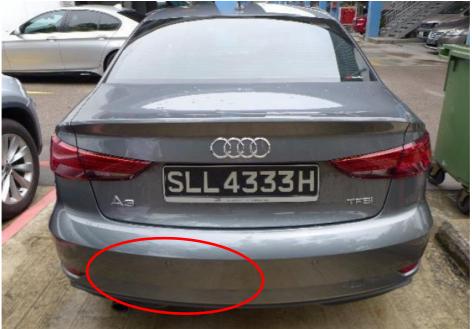
Photo 3 shows a general view of the rear bumper of the Audi at the time of the Pre-Repair Survey conducted by FormTeam Consultancy Pte. Ltd. which was taken 20 days after the accident. The damages were concentrated at the left portion of the rear bumper (circled).

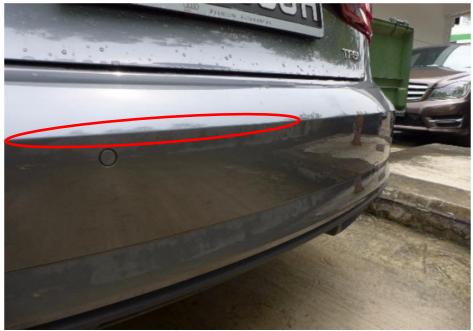
Photo 4 shows the paint scratch marks on the left portion of the rear bumper of the Audi, above the reverse sensor (circled).

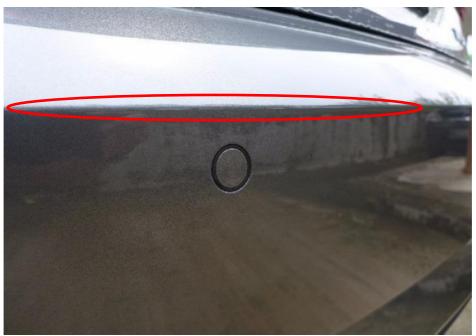
Photo 5 shows a close up view of the paint scratch marks on the left portion of the rear bumper of the Audi, above the reverse sensor (circled).

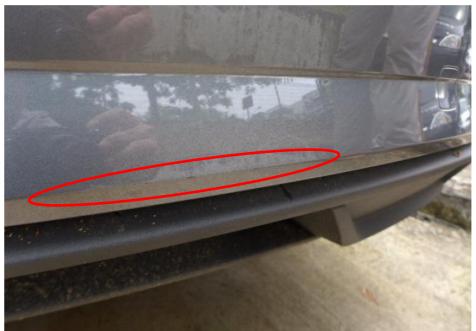
Photo 6 shows the black paint graze marks found on the lower left portion of the Audi's rear bumper (circled).

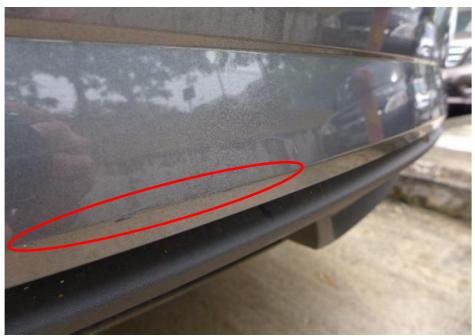
Photo 7 shows a closer view of the black paint graze marks found on the lower left portion of the Audi's rear bumper (circled).

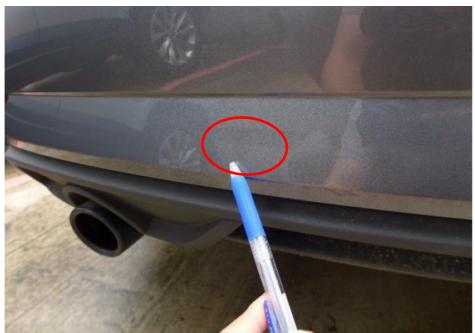
Photo 8 shows the small circular dent on the lower left portion of Audi's rear bumper followed by 2 parallel horizontal indentations which had stretched horizontally towards the lower centre portion of its rear bumper (circled).

- 16. Firstly, the small circular dent on the lower left portion of the Audi's rear bumper followed by 2 parallel indentations which had stretched horizontally towards the lower centre portion of its rear bumper was caused by an object that is of a similar shape, pressing onto the rear portion of the Audi. If one was to consider the slight dent that was observed on some of the lower alpha-numeric letterings of the Toyota's front number plate, it would then appear that this small circular dent was caused by the lower alpha-numeric letterings of the Toyota's front number plate.

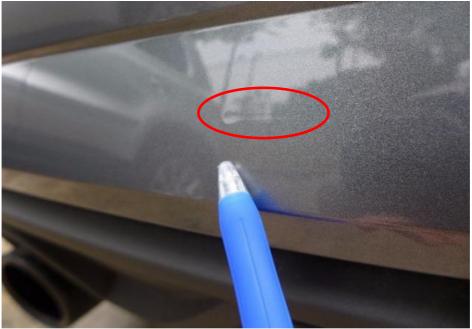
Photo 9 shows a close up view of the small circular dent on the lower left portion of Audi's rear bumper followed by 2 parallel indentations which had stretched horizontally towards the lower centre portion of its rear bumper (circled).

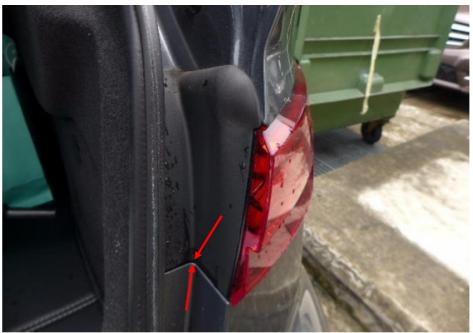
Photo 10 shows no obvious misalignment at the right corner edges of the rear bumper of the Audi, below its tail lights (arrowed), indicating that the impact onto its rear portion was relatively light.

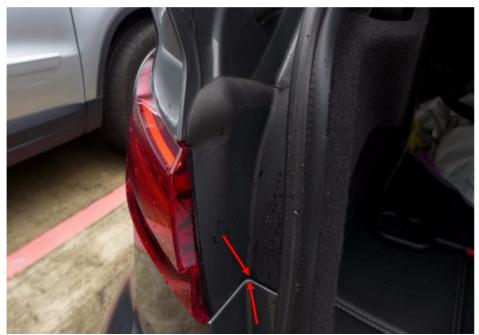
Photo 11 shows no obvious misalignment at the left corner edges of the rear bumper of the Audi, below its tail lights (arrowed), indicating that the impact onto its rear portion was relatively light.

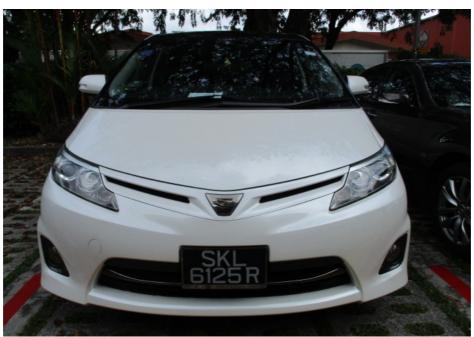
Photo 12 shows the general view of the front portion of the Toyota at the time of our inspection.

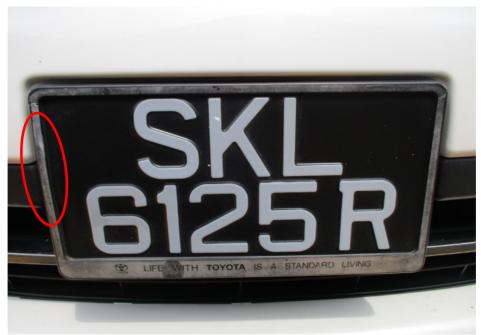
Photo 13 shows a slight distortion on the right side of the Toyota's front number plate frame (circled), indicating that it had sustained an impact directly onto its front number plate.

- 17. Although there was no obvious crack or break on the front number plate frame of the Toyota at the time of our inspection, it could be due to the impact force arising from the contact being not significant enough to have stretched pass the material strength of the front number plate frame. In this aspect, one would have to consider the material stiffness of the Toyota's front number plate frame, which is constructed of hard plastic, against the thermoplastic (soft plastic) material of the Audi's rear bumper.

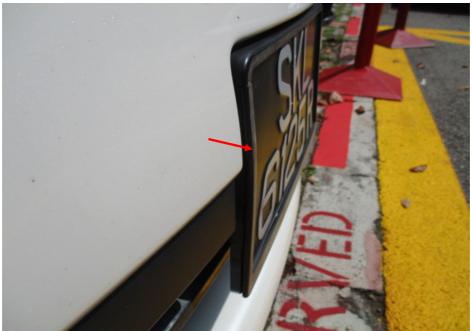
Photo 14 shows upon closer examination, we observed that the top portion of the front number plate of the Toyota had been pushed inwards (arrowed).

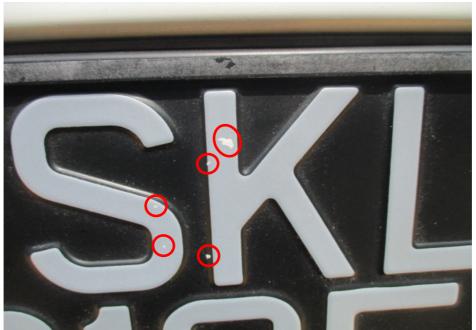
Photo 15 shows a close up view of the whitish marks found on the top alphanumeric letterings of the Toyota's front number plate (circled).

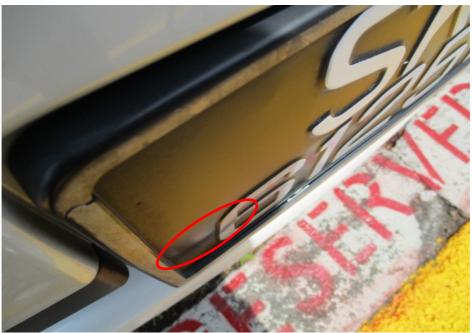
Photo 16 shows a slight dent observed on the bottom alpha- numeric letterings of the Toyota's front number plate (circled).

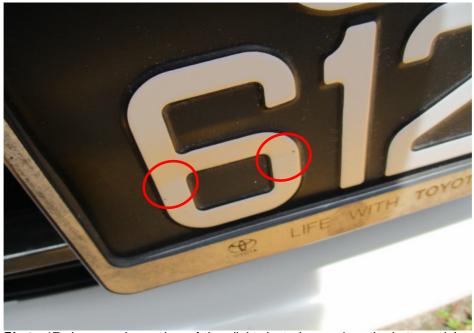
Photo 17 shows a closer view of the slight dent observed on the bottom alphanumeric letterings of the Toyota's front number plate (circled).

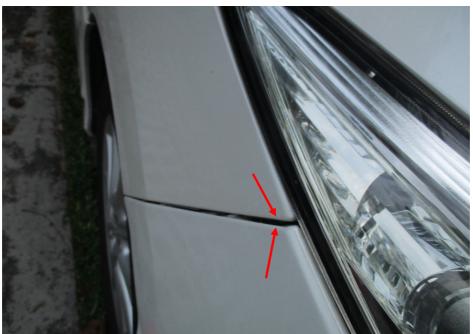
Photo 18 shows a close up view of the right corner edge of the front bumper of the Toyota. We observed that there was a slight misalignment at the corner edges (arrowed).

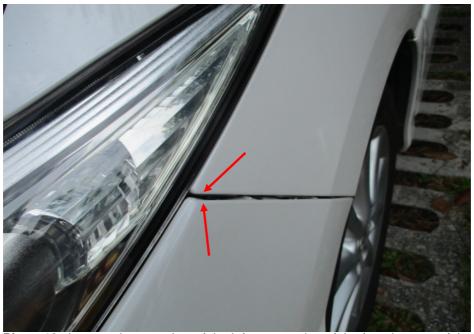
Photo 19 shows a close up view of the left corner edge of the front bumper of the Toyota. We observed that there was a slight misalignment at the corner edges (arrowed).

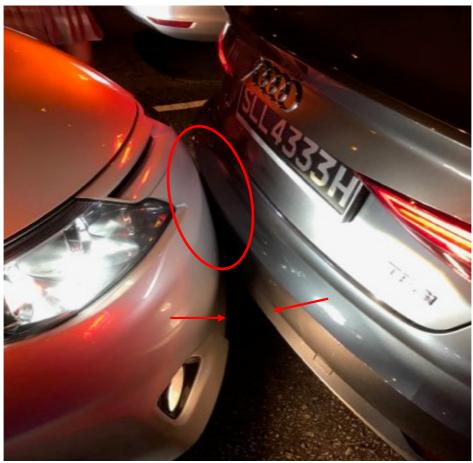
Photo 20 shows a right side view of the final position of the Involved Motor Cars at the accident location. The front centre portion of the Toyota was observed to be directly in contact with the rear left portion of the Audi (circled). It can be observed that there was no contact between the rear right portion of the Audi and the front right portion of the Toyota (arrowed).

- 18. As seen from the accident scene photographs, there was no contact between the rear right portion of the Audi and the front right portion of the Toyota. The Toyota was positioned slightly towards the left from the rear of the Audi. Hence the front number plate of the Toyota had contacted onto the left portion of the Audi's rear bumper.

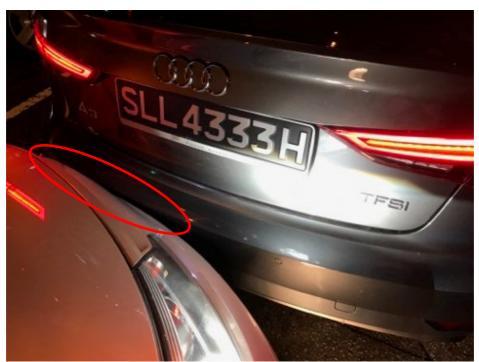
Photo 21 shows a frontal view of the final position of the Involved Motor Cars at the accident location. The front centre portion of the Toyota was observed to be directly in contact with the rear left portion of the Audi (circled). It would appear that the most significant damage to the Toyota that could possibly have been a result of contact with the rear portion of the Audi was the front number plate of the Toyota.

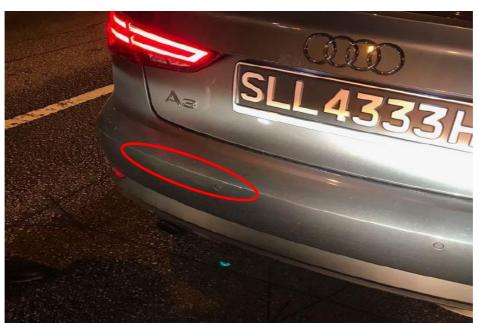
Photo 22 shows a closer examination of this photograph taken at the accident scene showing the rear bumper of the Audi revealed what appears to be paint scratch marks on the left portion of the rear bumper of the Audi (circled).

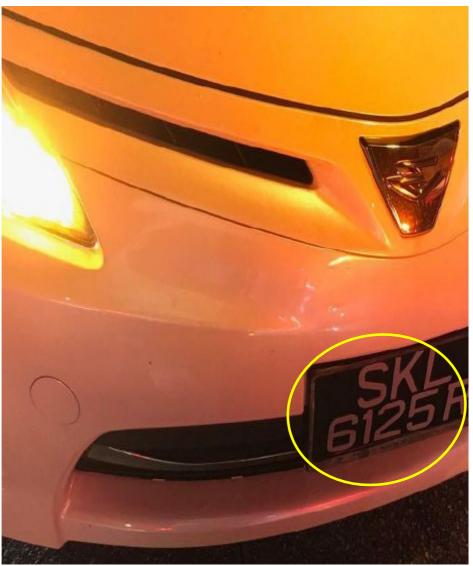
Photo 23 shows the damage to the front portion of the Toyota at the accident scene, particularly to its front number plate. The damages observed on the front number plate of the Toyota at the time of our inspection had corresponded to its damages (circled) as seen in the accident scene photographs.

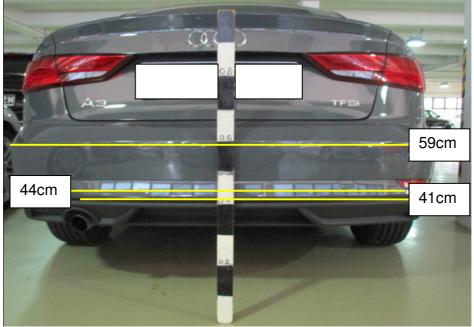
Photo 24 shows the height measurement being conducted on the rear portion of the Audi (using a similar make and model). The height above ground level of the lower left portion of the rear bumper of the Audi, where the black paint graze marks were found was measured to be approximately 41cm. The height above ground level of the lower left portion of the Audi's rear bumper where the small circular dent was found was measured to be approximately 44cm. The height above ground level of the upper left portion of the rear bumper of the Audi above the reverse sensor, where the paint scratch marks were found was measured to be approximately 59cm.

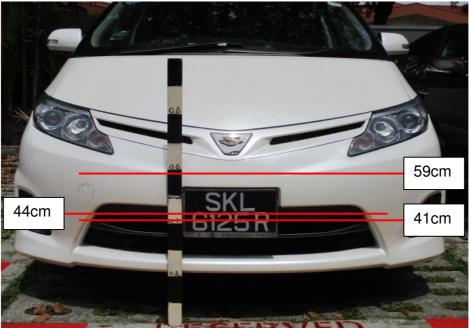
Photo 25 shows the height measurement being conducted on the front portion of the Toyota. The body part at 41cm above ground was the lower alpha- numeric letterings of the front number plate where the slight dent was found. The body part at 44cm above ground was the centre portion of the front number plate which was pushed inwards. The body part at 59cm above ground was the top portion of the front bumper of the Toyota which corresponded to the height of the paint scratch marks found on the upper left portion of the Audi's rear bumper.
