Your Ref : M533628  
Our Ref : CI/MSG18005184/N

9 February 2018

**AUTOMOBILE TECHNICAL INVESTIGATION REPORT OF ACCIDENT  
INVOLVING SHA 4304Y AND SKP 7941Z ON 20 OCTOBER 2017**

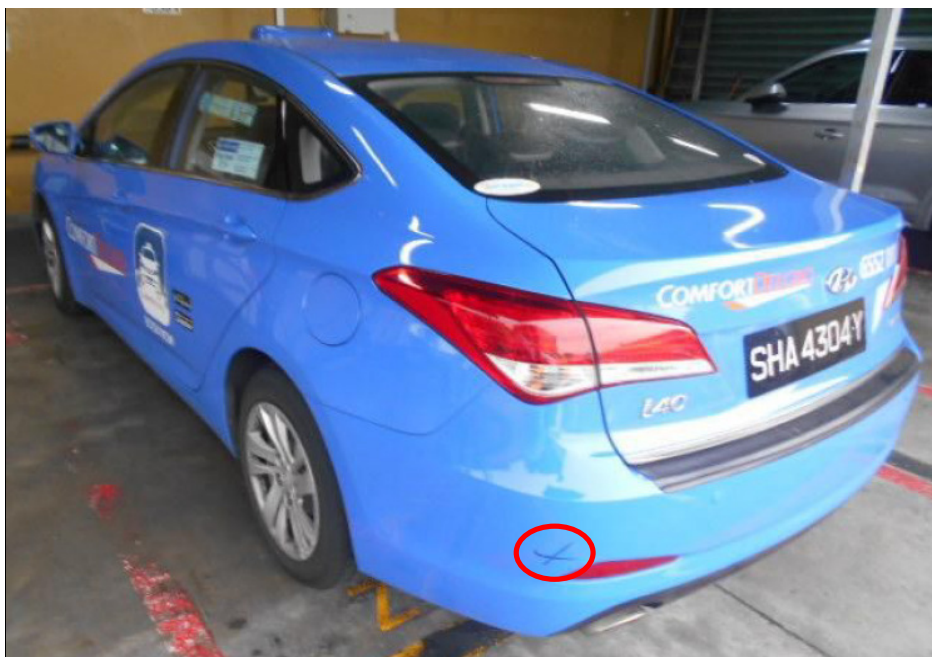
9. From the photographs contained in the Singapore Accident Statement of the Taxi, which were taken about 3 days after the reported accident, we note that the Taxi had sustained an impact onto its rear lower left portion. Examination of the photographs taken at the time of accident reporting showed the Taxi had sustained paint graze marks to the lower left portion of the rear bumper. See photos 1 & 2 below.

**Photo 1** shows a general view of the rear portion of the Taxi at the time of reporting, which was about 3 days after the accident. We noted that the Taxi had sustained an impact onto its rear lower left portion as marked by the 'X' (circled).

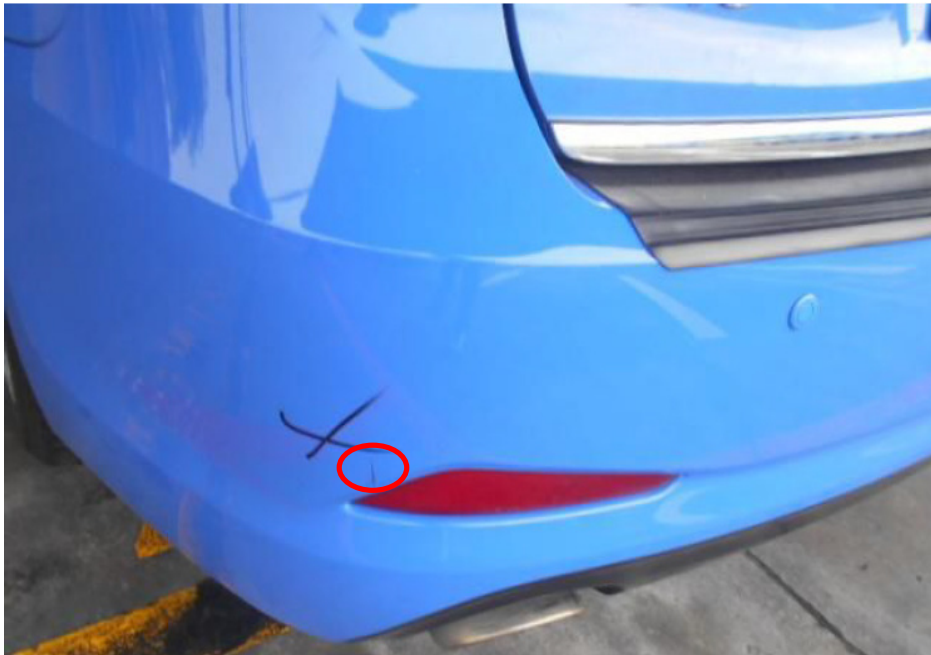
**Photo 2** shows upon closer examination of the photographs taken at the time of accident reporting, we observed that the Taxi had sustained paint graze marks to the lower left portion of the rear bumper as marked by the 'X' (circled).

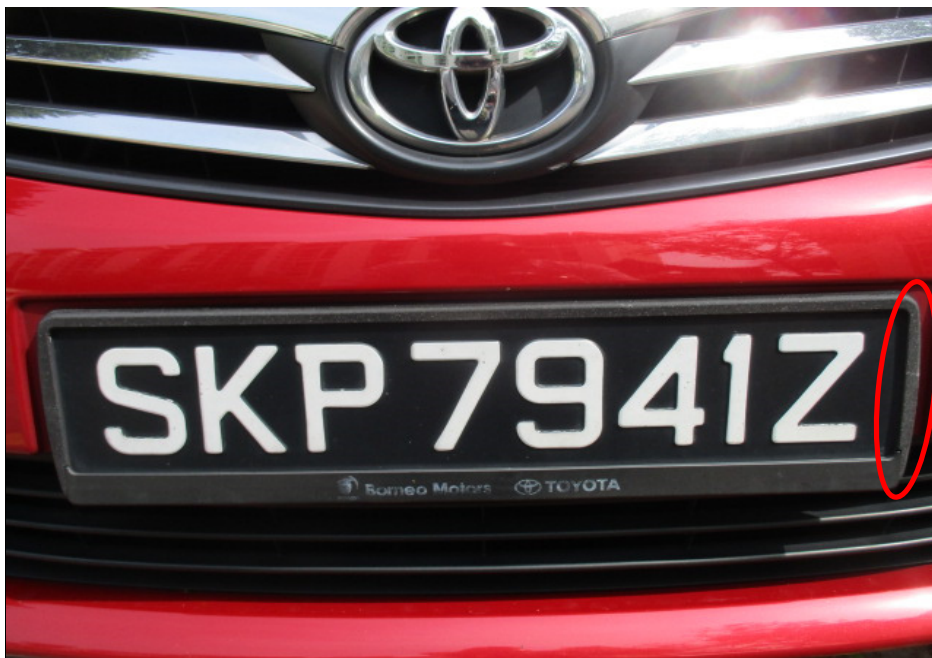
13. At the time of our inspection, we note that there was a slight distortion on the left side of the Toyota's front number plate frame, indicating that it had sustained an impact directly onto its front number plate frame. Closer examination had showed paint scratch marks and paint chips at the left portion of the front bumper, above the air vent. We also observed faint paint graze marks on the front left portion of the Toyota. However it was noted that the front bumper was not misaligned at its corner edges. See photos 3 - 10 below.

**Photo 4** shows at the time of our inspection, we noted that there was a slight distortion on the left side of the Toyota's front number plate frame, indicating that it had sustained an impact directly onto its front number plate frame (circled).

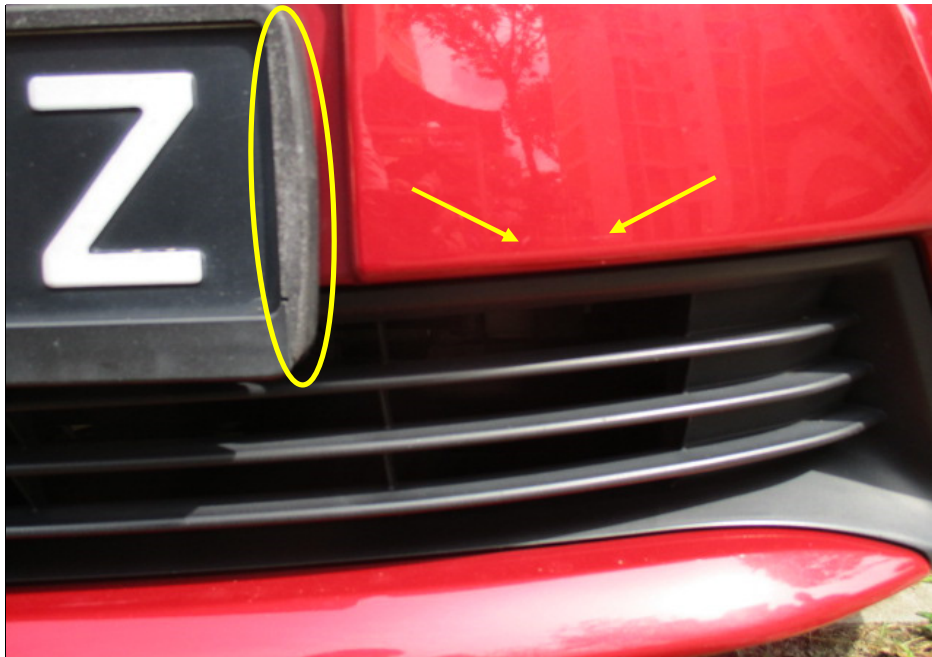
**Photo 5** shows a closer view of the slight distortion on the left side of the Toyota's front number plate frame (circled). Paint scratch marks and paint chips were found at the left portion of the front bumper, above the air vent (arrowed).

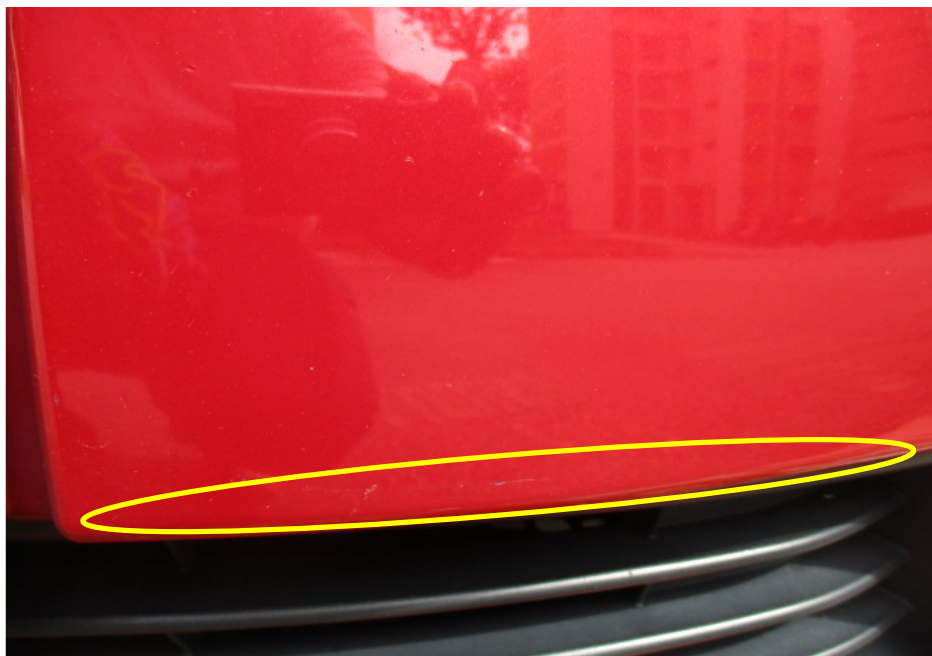
**Photo 6** shows a close up view of the paint scratch marks and paint chips found at the left portion of the front bumper, above the air vent (circled).

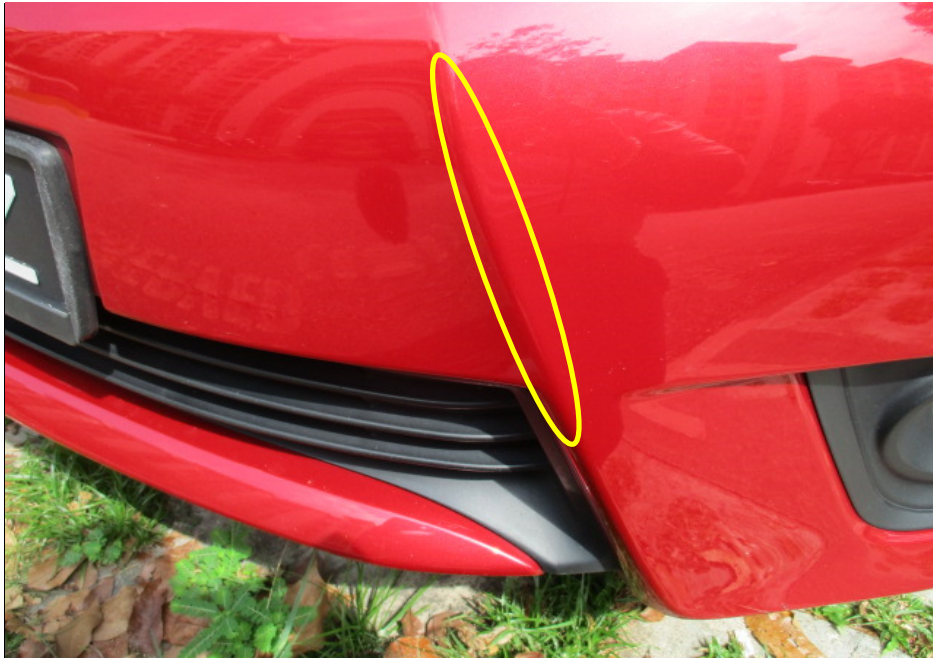
**Photo 7** shows the faint paint graze marks observed on the front left portion of the Toyota (circled).

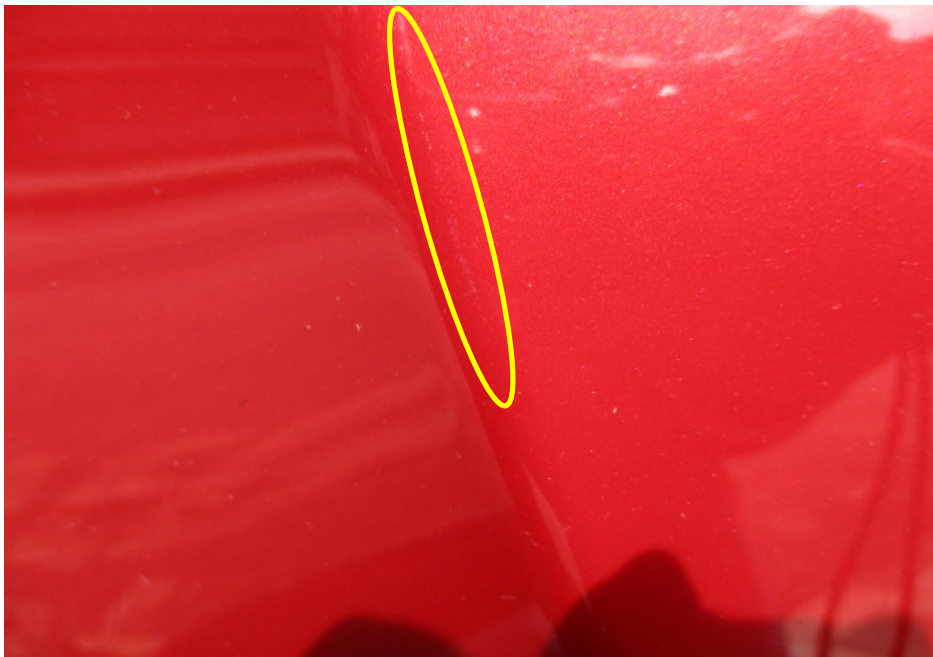
**Photo 8** shows a close up view of the faint paint graze marks observed on the front left portion of the Toyota (circled).

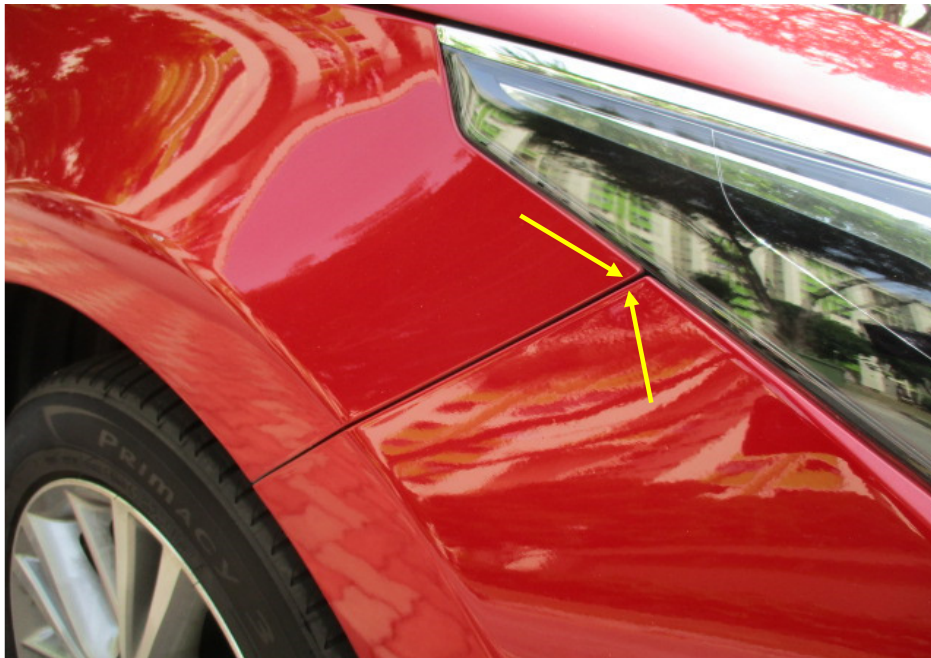
**Photo 9** shows a close up view of the right corner edge of the front bumper of the Toyota. We observed that there was no misalignment at the corner edges (arrowed).

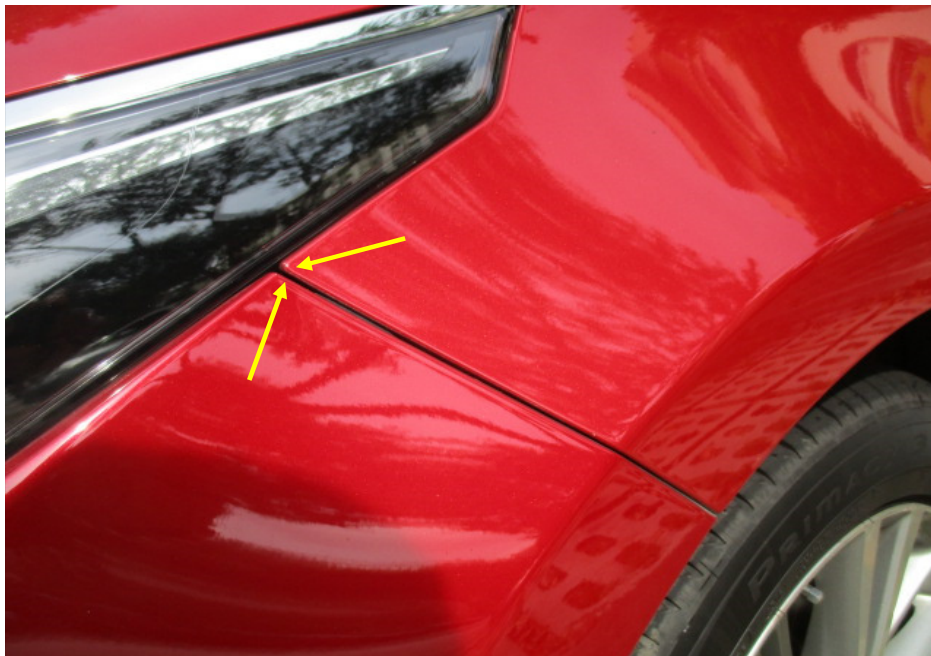
**Photo 10** shows a close up view of the left corner edge of the front bumper of the Toyota. We observed that there was no misalignment at the corner edges (arrowed).

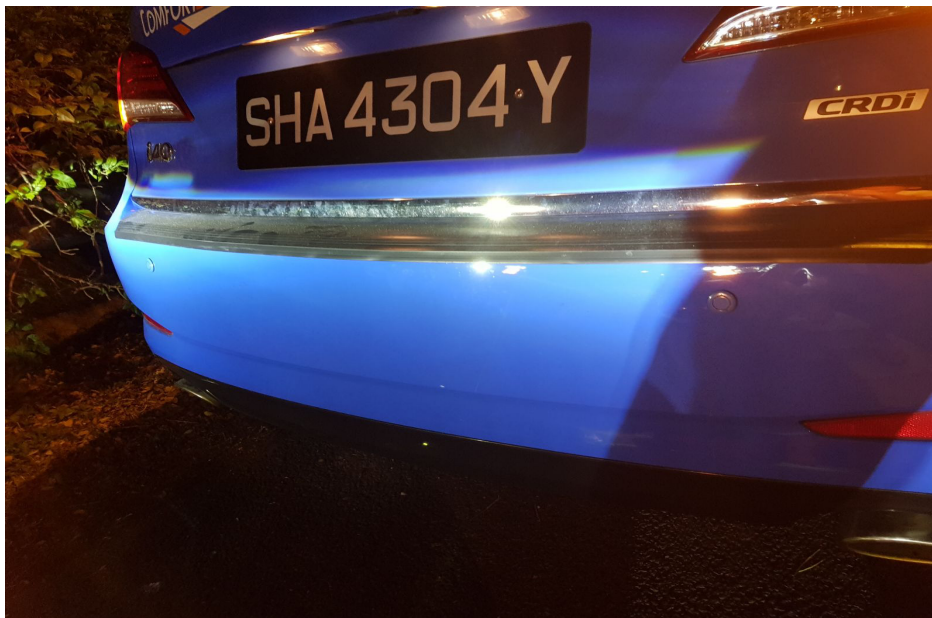
14. For this case, we were able to obtain several photographs taken by Mr Ong at the accident scene. It shows the rear bumper of the Taxi after the accident. Mr Ong did not take any photograph of the left portion of the Taxi's rear bumper as Mr Ching had told him that the damages were sustained to the right portion of the rear bumper as stated in Mr Ong's accident report. Upon closer examination of the photograph, we could not find any damages to the right portion of the Taxi's rear bumper.

**Photo 11** shows the rear bumper of the Taxi after the accident. Mr Ong did not take any photograph of the left portion of the Taxi's rear bumper as Mr Ching had told him that the damages were sustained to the right portion of the rear bumper as stated in Mr Ong's accident report. Upon closer examination of the photograph, we could not find any damages to the right portion of the Taxi's rear bumper.

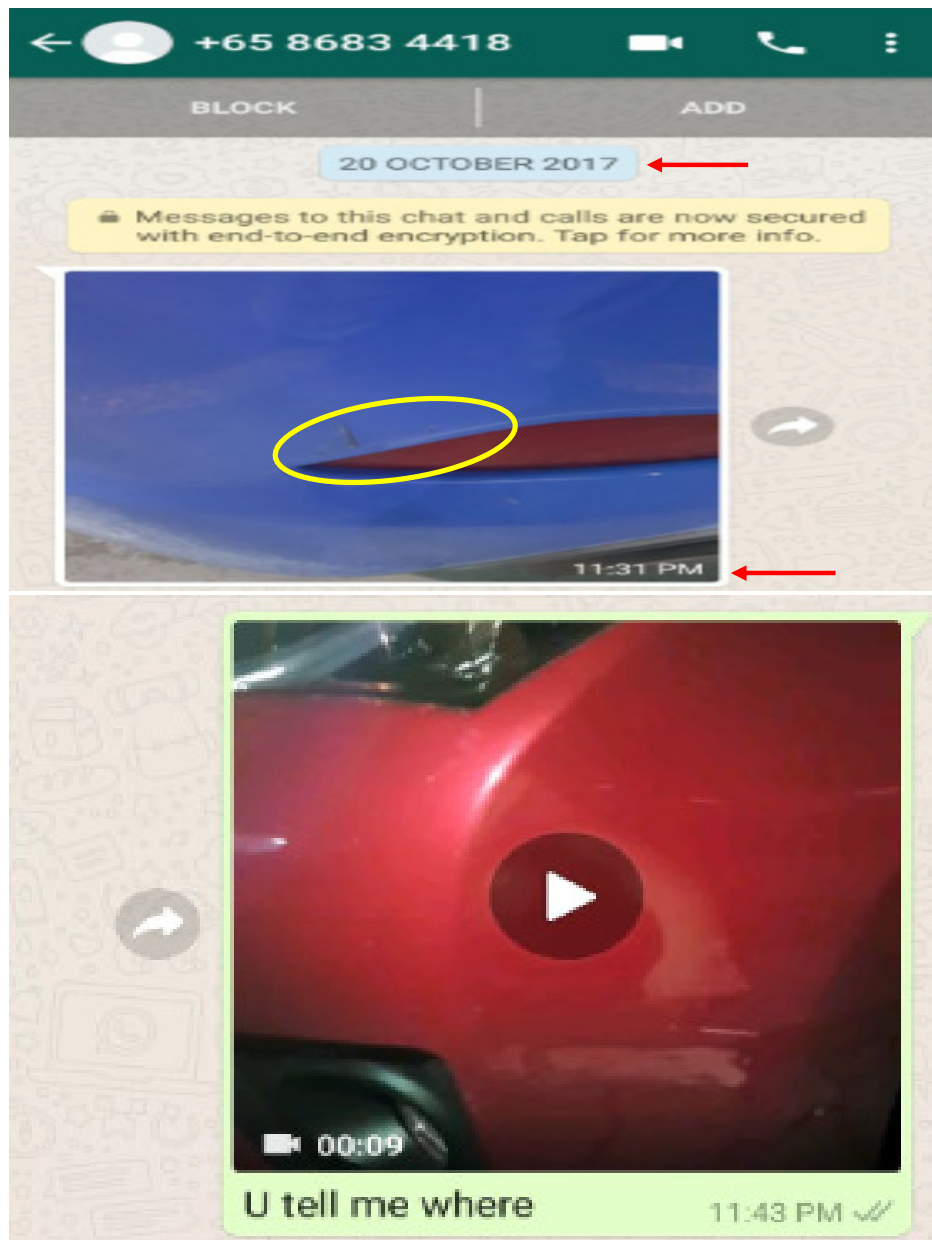
15. However, Mr Ong did forward us a photograph which was sent to him by Mr Ching during their text message correspondence an hour post- accident. The photograph showed the damages sustained to the lower left portion of the Taxi's rear bumper which Mr Ching claimed was caused by the accident. Upon closer examination of the photograph, we observed paint graze marks at the lower left portion of the Taxi's rear bumper, above the rear left reflector. Mr Ong responded by taking a video of the front left portion of the Toyota to show Mr Ching that there was no damage sustained to the front portion of the Toyota. See photos 11 - 13 below.

**Photo 12** shows the photograph which was sent to Mr Ong by Mr Ching during their text message correspondence an hour post- accident (arrowed). The photograph showed the damages sustained to the lower left portion of the Taxi's rear bumper which Mr Ching claimed was caused by the accident (circled). Mr Ong responded by taking a video of the front left portion of Toyota to show Mr Ching that there was no damage sustained to the front portion of the Toyota.

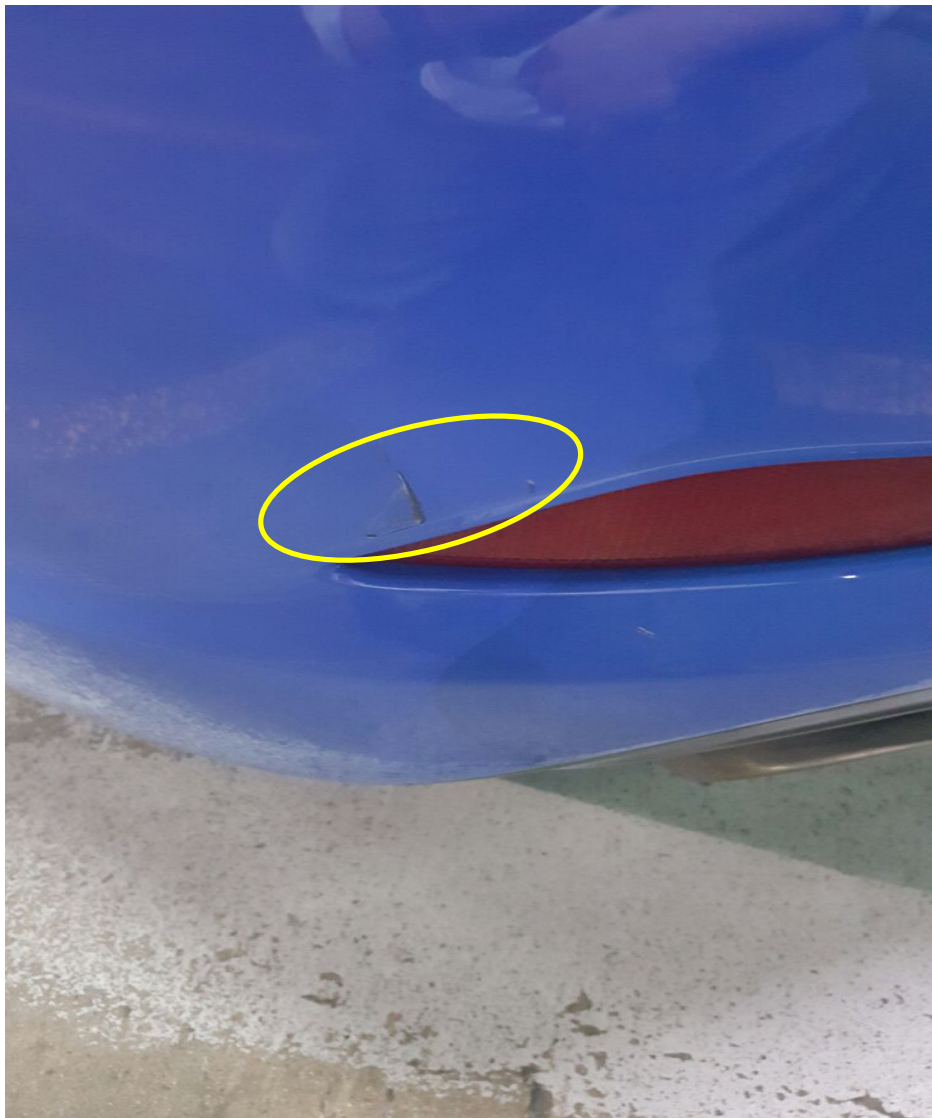
**Photo 13** shows upon closer examination of the photograph sent to Mr Ong by Mr Ching, we observed paint graze marks at the lower left portion of the Taxi's rear bumper, above the rear left reflector (circled).

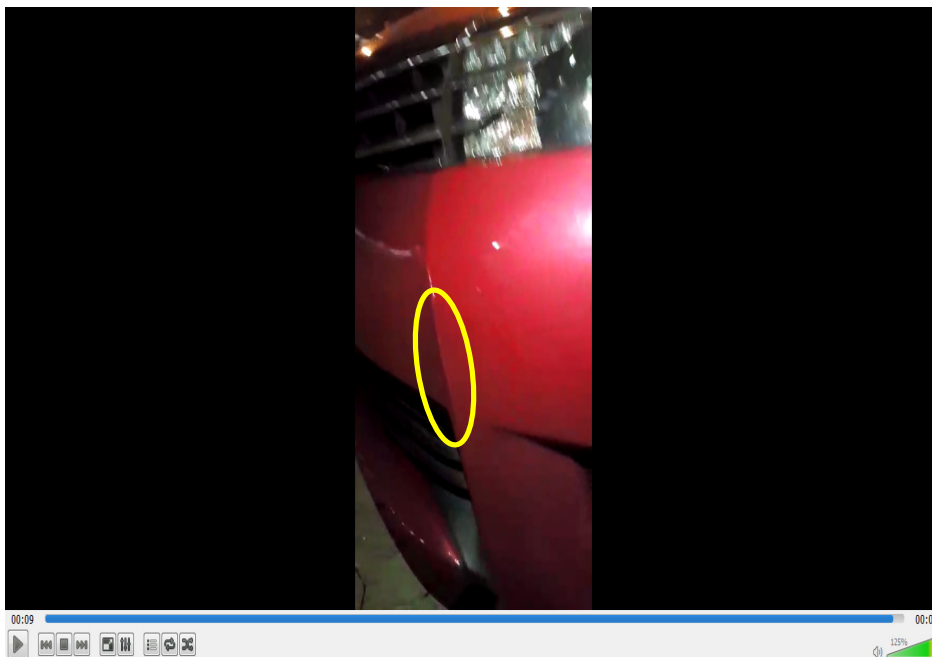
17. From the video recording, we observed what appeared to be faint paint graze marks at the left portion of the Toyota's front bumper at the 9 second mark. These damages seem to indicate that there might be possible contact between the rear left portion of the Taxi and the front left portion of the Toyota. However one would have to view the recording to see these damages. See screenshot 1 below.

**Screenshot 1** of the video recording of the front left portion of the Toyota taken from Mr Ong's mobile phone in response to the photograph he received from Mr Ching depicting damages to the lower left portion of the Taxi's rear bumper. At the 9 second mark, we observed what appeared to be faint paint graze marks at the left portion of the Toyota's front bumper (circled).

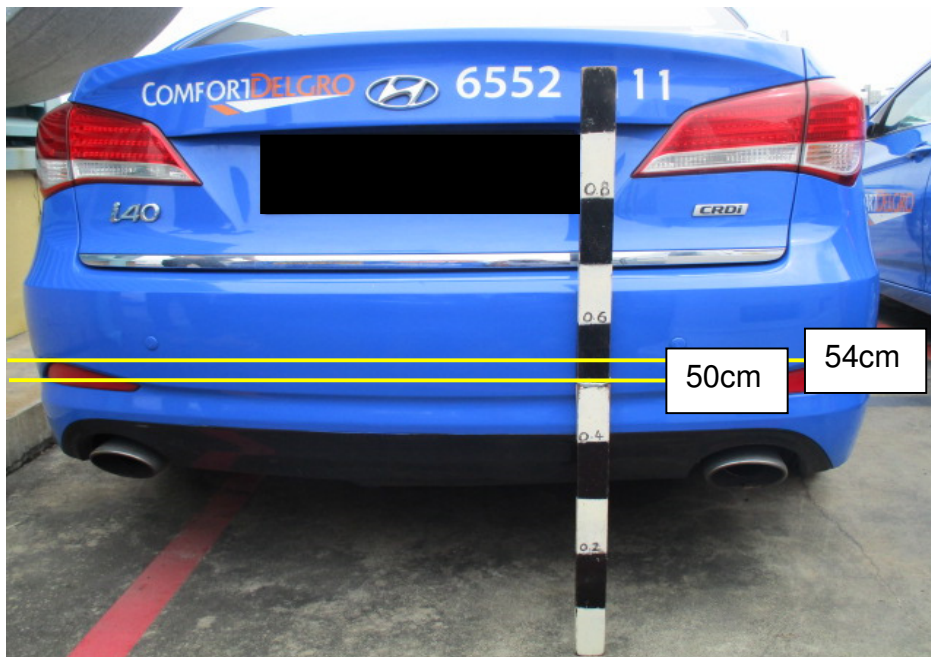
**Photo 14** shows the height measurement being conducted on the rear portion of the Taxi (using a similar make and model). The height of the paint graze marks on the lower left portion of the Taxi's rear bumper was between the ranges of 50cm to 54cm above ground level.

- a) the height of the paint graze marks on the lower left portion of the Taxi's rear bumper was between the ranges of 50cm to 54cm above ground level;
- b) the faint paint graze marks found on the front left portion of the Toyota are within the 50cm to 54cm height range;
- c) the height measurements appear to support the findings of possible contact between the rear left portion of the Taxi and the front left portion of the Toyota. The damage observed on the rear left portion of the Taxi was a result of this contact and corresponds to the damage observed on the front left portion of the Toyota.

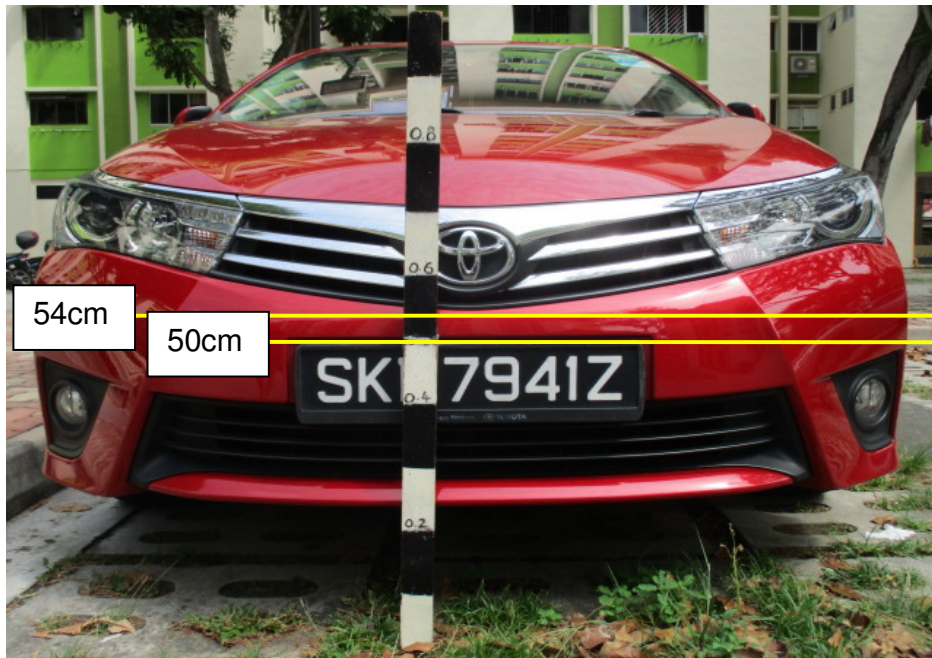
**Photo 15** shows the height measurement being conducted on the front portion of the Toyota. The faint paint graze marks found on the front left portion of the Toyota are within the 50cm to 54cm height range.
