Your Ref : M533628  
Our Ref : CI/MSG18005184/N

9 February 2018

**AUTOMOBILE TECHNICAL INVESTIGATION REPORT OF ACCIDENT  
INVOLVING SHA 4304Y AND SKP 7941Z ON 20 OCTOBER 2017**

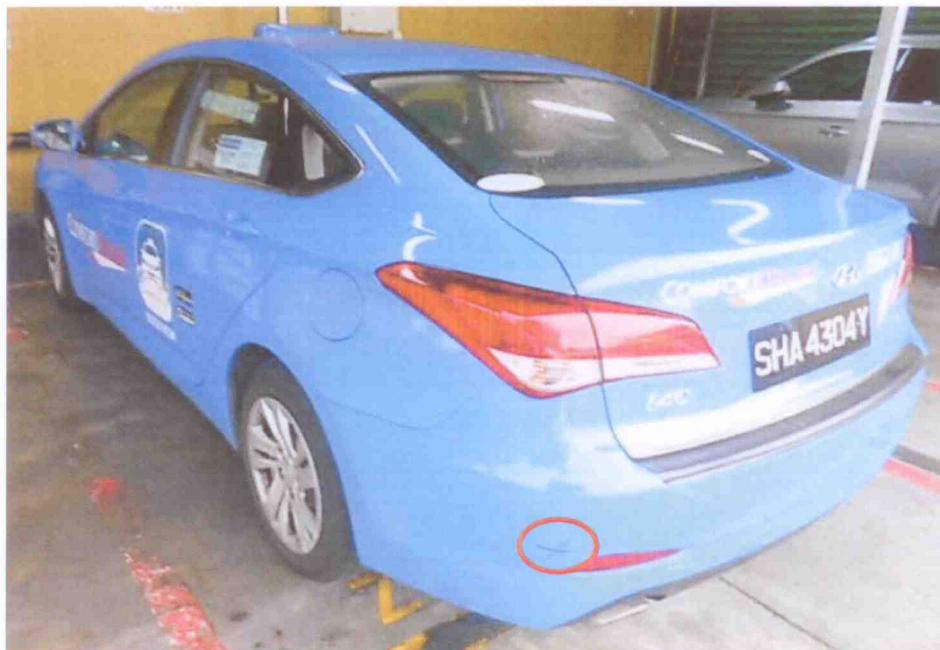
9. From the photographs contained in the Singapore Accident Statement of the Taxi, which were taken about 3 days after the reported accident, we note that the Taxi had sustained an impact onto its rear lower left portion. Examination of the photographs taken at the time of accident report showed the Taxi had sustained paint graze marks to the lower left portion of the rear bumper. See photos 1 & 2 below.

**Photo 1** shows a general view of the rear portion of the Taxi at the time of reporting, which was about 3 days after the accident. We noted that the Taxi had sustained an impact onto its rear lower left portion as marked by the 'X' (circled).

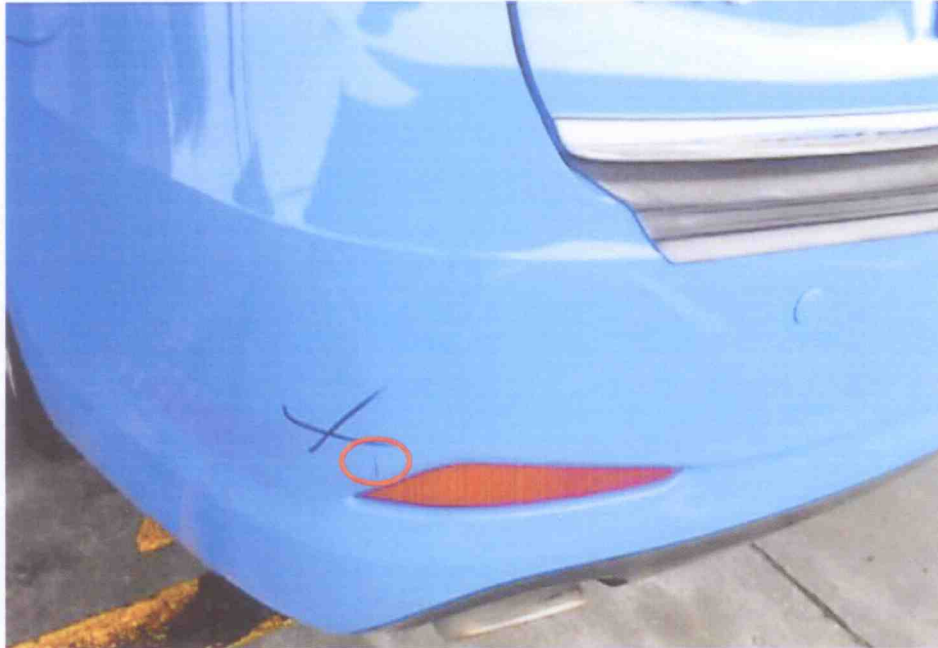
**Photo 2** shows upon closer examination of the photographs taken at the time of accident reporting, we observed that the Taxi had sustained paint graze marks to the lower left portion of the rear bumper as marked by the 'X' (circled).

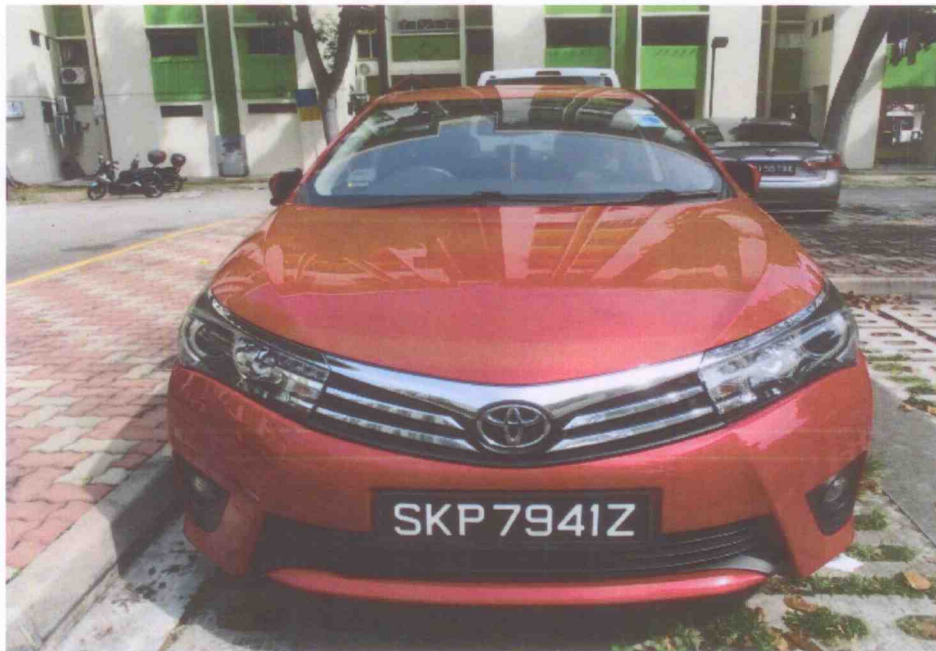
**Photo 3** shows the general view of the front portion of the Toyota at the time of our inspection.

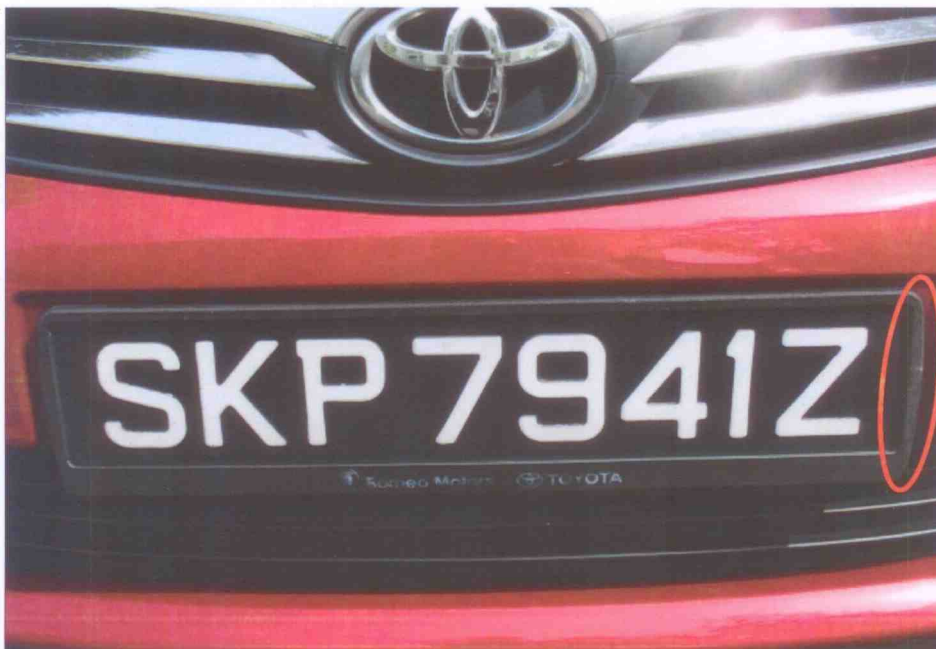
13. At the time of our inspection, we note that there was a slight distortion on the left side of the Toyota's front number plate frame, indicating that it had sustained an impact directly onto its front number plate frame. Closer examination had showed paint scratch marks and paint chips at the left portion of the front bumper, above the air vent. We also observed faint paint graze marks on the front left portion of the Toyota. However it was noted that the front bumper was not misaligned at its corner edges. See photos 3 - 10 below.

**Photo 4** shows at the time of our inspection, we noted that there was a slight distortion on the left side of the Toyota's front number plate frame, indicating that it had sustained an impact directly onto its front number plate frame (circled).

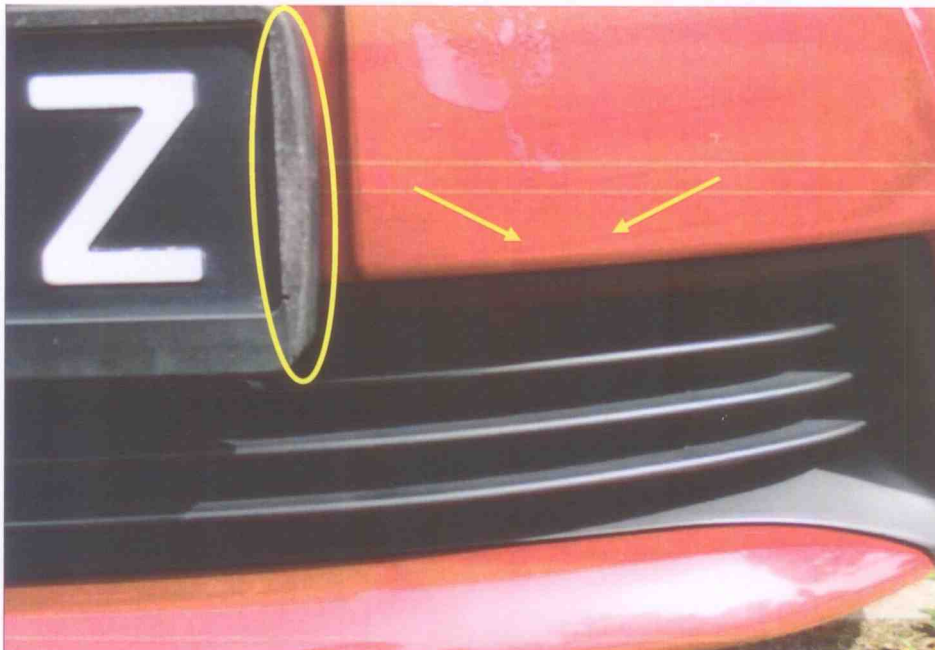
**Photo 5** shows a closer view of the slight distortion on the left side of the Toyota's front number plate frame (circled). Paint scratch marks and paint chips were found at the left portion of the front bumper, above the air vent (arrowed).

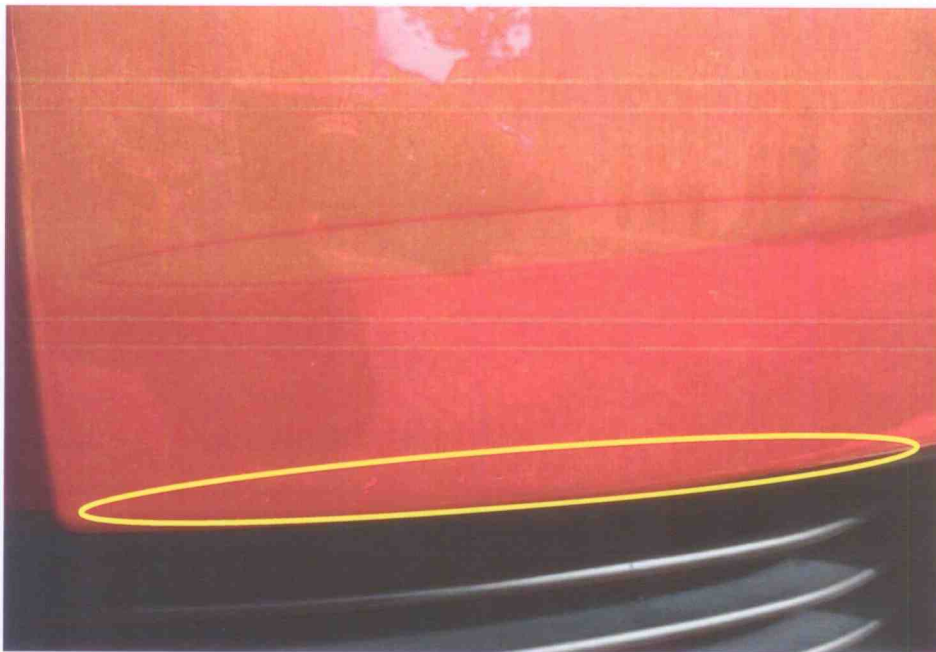
**Photo 6** shows a close up view of the paint scratch marks and paint chips found at the left portion of the front bumper, above the air vent (circled).

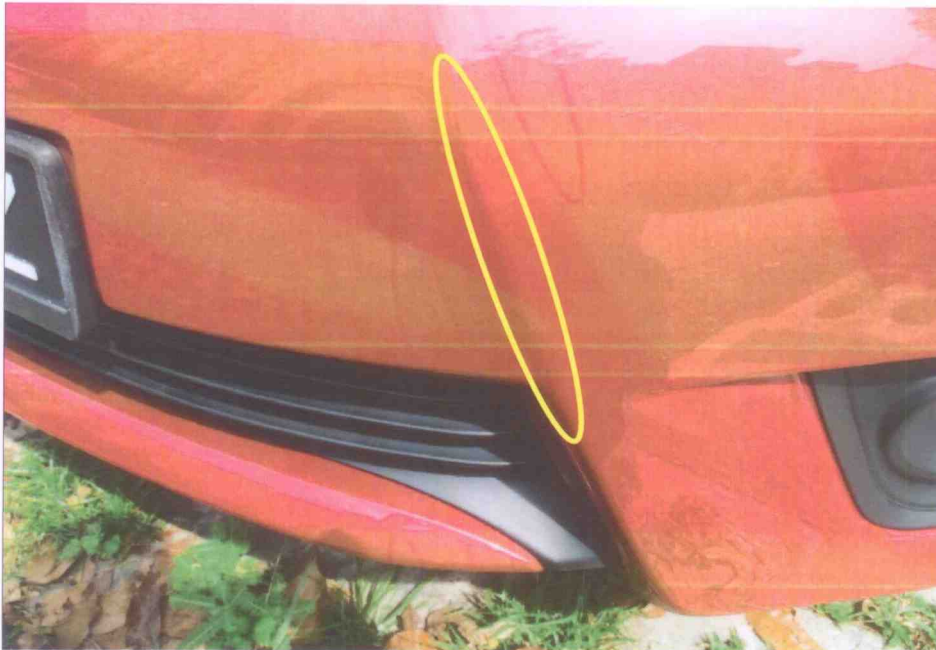
**Photo 7** shows the faint paint graze marks observed on the front left portion of the Toyota (circled).

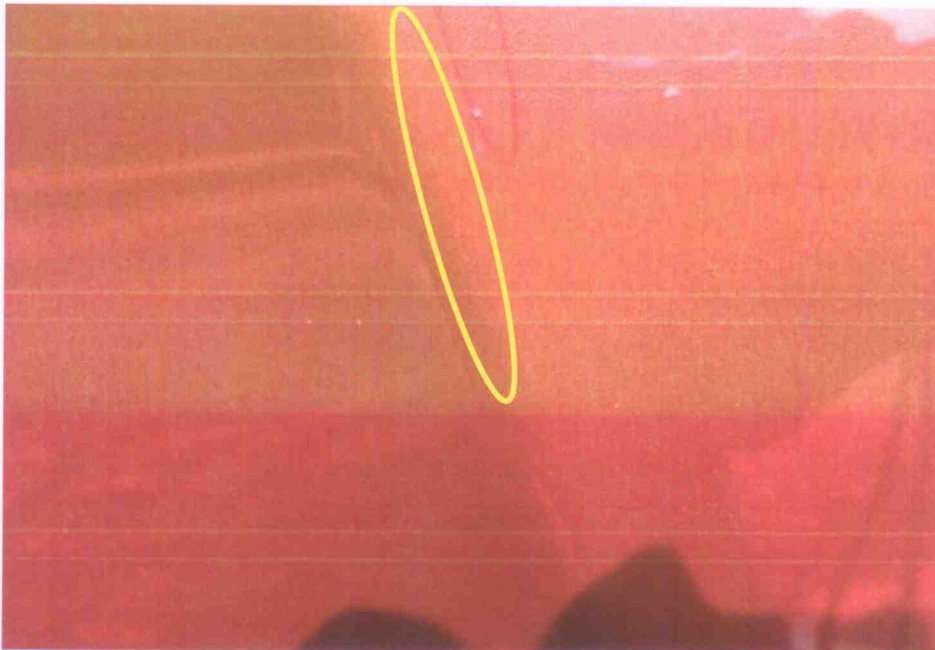
**Photo 8** shows a close up view of the faint paint graze marks observed on the front left portion of the Toyota (circled).

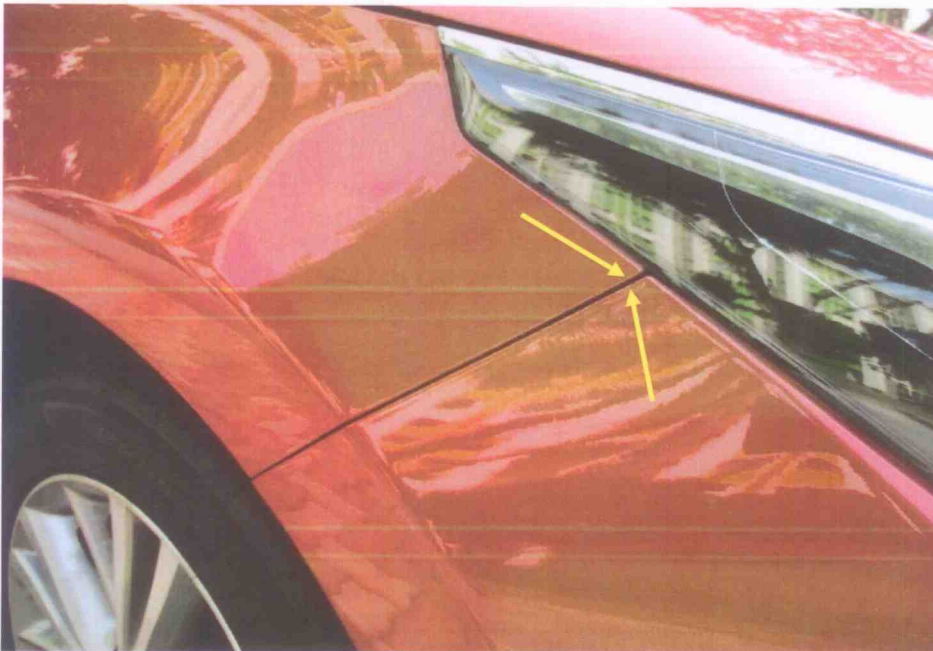
**Photo 9** shows a close up view of the right corner edge of the front bumper of the Toyota. We observed that there was no misalignment at the corner edges (arrowed).

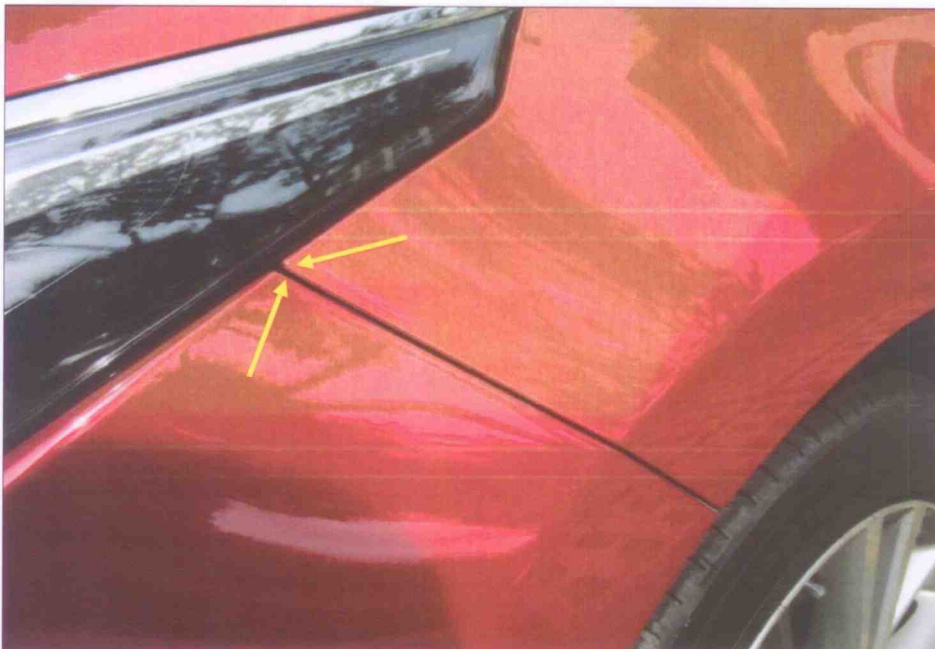
**Photo 10** shows a close up view of the left corner edge of the front bumper of the Toyota. We observed that there was no misalignment at the corner edges (arrowed).

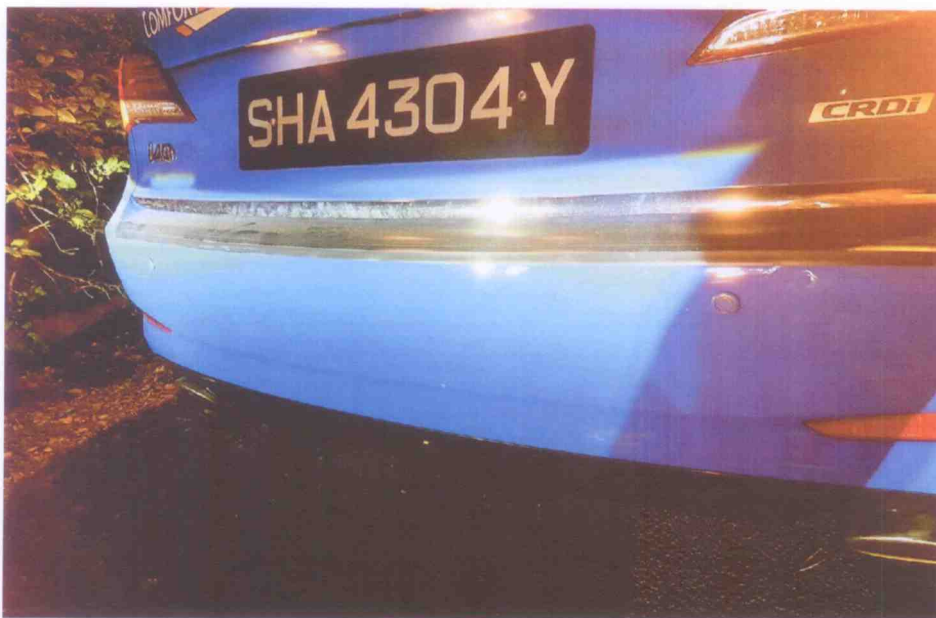
14. For this case, we were able to obtain several photographs taken by Mr Ong at the accident scene. It shows the rear bumper of the Taxi after the accident. Mr Ong did not take any photograph of the left portion of the Taxi's rear bumper as Mr Ching had told him that the damages were sustained to the right portion of the rear bumper as stated in Mr Ong's accident report. Upon closer examination of the photograph, we could not find any damages to the right portion of the Taxi's rear bumper.

**Photo 11** shows the rear bumper of the Taxi after the accident. Mr Ong did not take any photograph of the left portion of the Taxi's rear bumper as Mr Ching had told him that the damages were sustained to the right portion of the rear bumper as stated in Mr Ong's accident report. Upon closer examination of the photograph, we could not find any damages to the right portion of the Taxi's rear bumper.

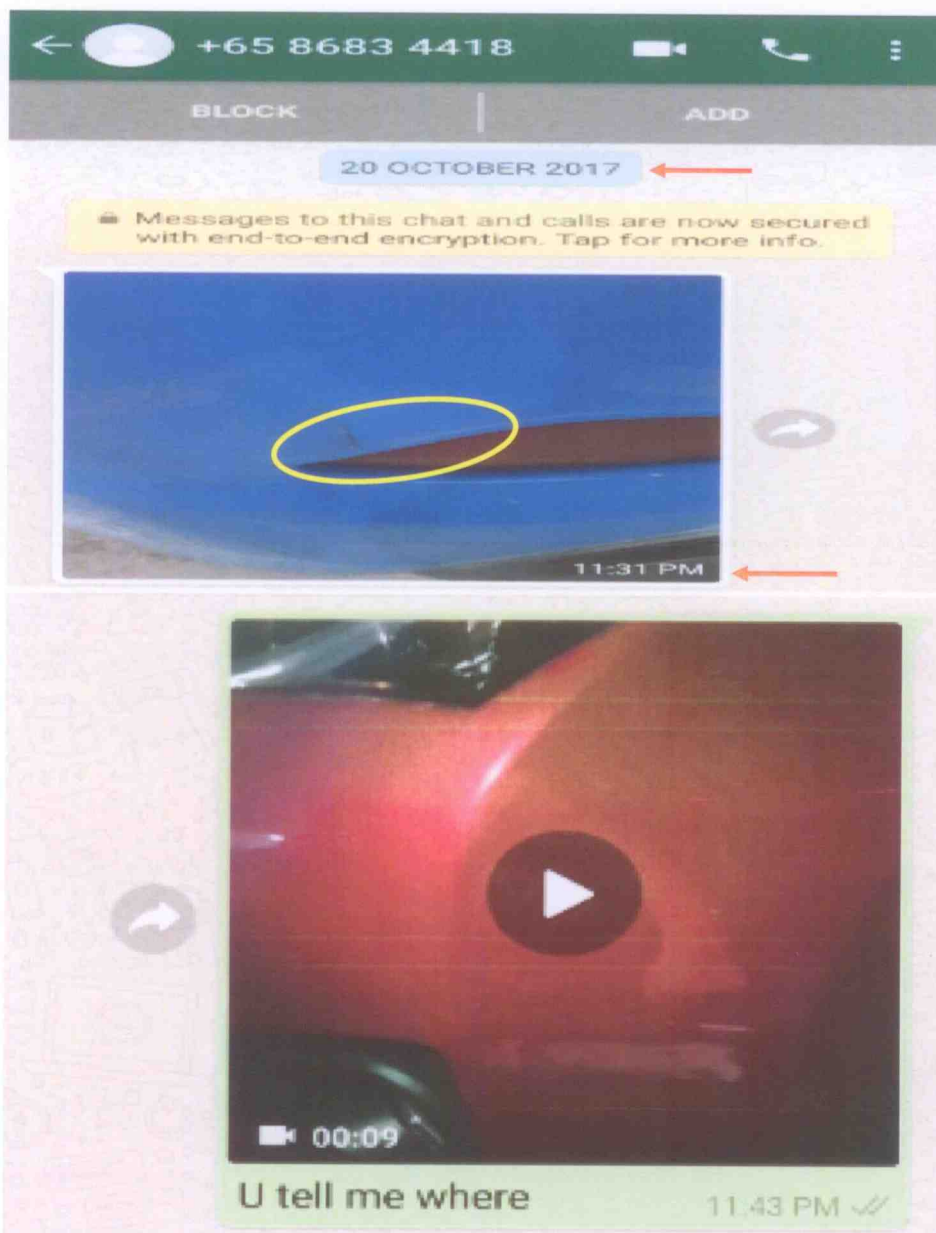
**Photo 12** shows the photograph which was sent to Mr Ong by Mr Ching during their text message correspondence an hour post- accident (arrowed). The photograph showed the damages sustained to the lower left portion of the Taxi's rear bumper which Mr Ching claimed was caused by the accident (circled). Mr Ong responded by taking a video of the front left portion of Toyota to show Mr Ching that there was no damage sustained to the front portion of the Toyota.

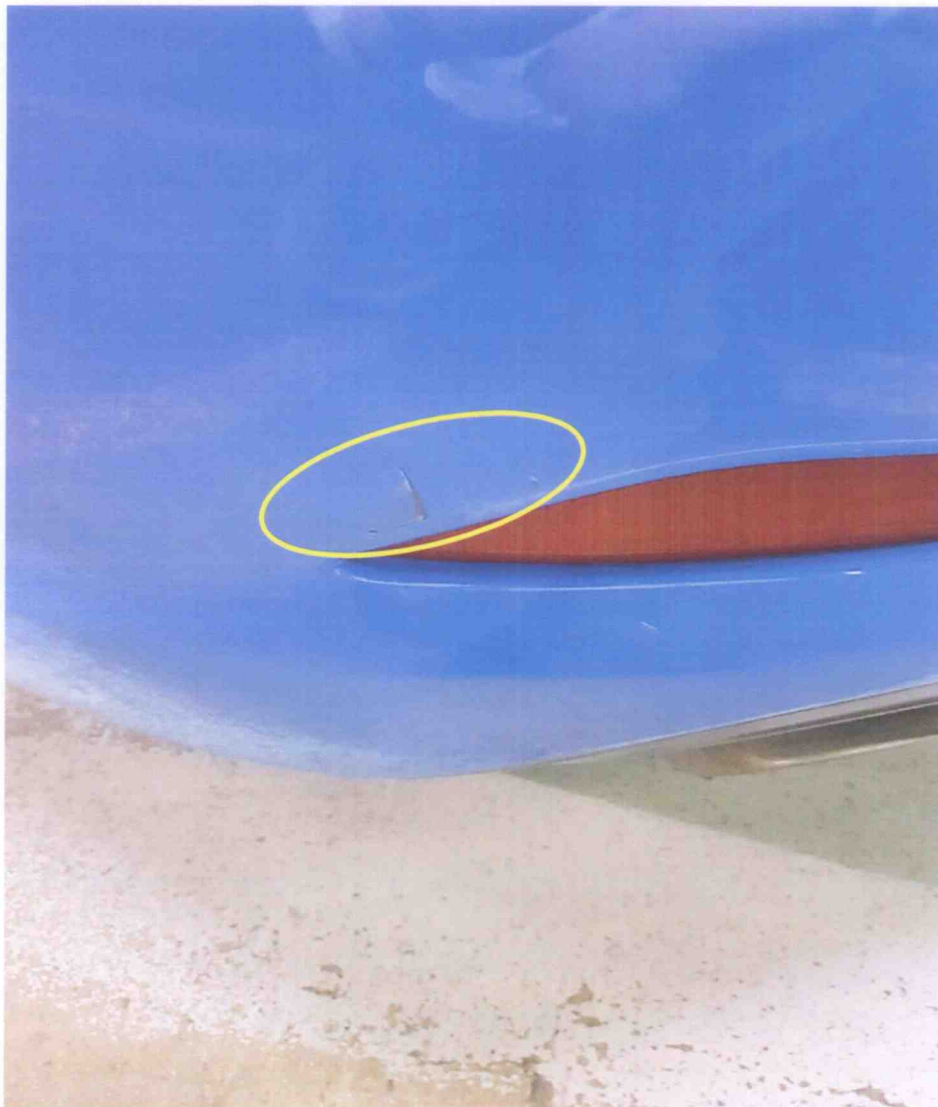
15. However, Mr Ong did forward us a photograph which was sent to him by Mr Ching during their text message correspondence an hour post- accident. The photograph showed the damages sustained to the lower left portion of the Taxi's rear bumper which Mr Ching claimed was caused by the accident. Upon closer examination of the photograph, we observed paint graze marks at the lower left portion of the Taxi's rear bumper, above the rear left reflector. Mr Ong responded by taking a video of the front left portion of the Toyota to show Mr Ching that there was no damage sustained to the front portion of the Toyota. See photos 11 - 13 below.

**Photo 13** shows upon closer examination of the photograph sent to Mr Ong by Mr Ching, we observed paint graze marks at the lower left portion of the Taxi's rear bumper, above the rear left reflector (circled).

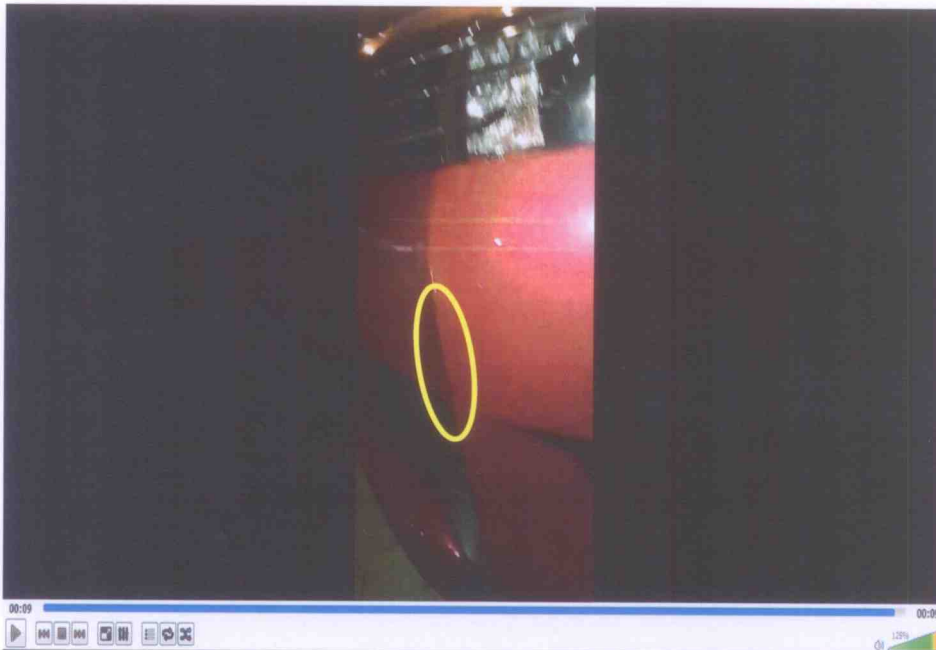
17. From the video recording, we observed what appeared to be faint paint graze marks at the left portion of the Toyota's front bumper at the 9 second mark. These damages seem to indicate that there might be possible contact between the rear left portion of the Taxi and the front left portion of the Toyota. However one would have to view the recording to see these damages. See screenshot 1 below.

**Screenshot 1** of the video recording of the front left portion of the Toyota taken from Mr Ong's mobile phone in response to the photograph he received from Mr Ching depicting damages to the lower left portion of the Taxi's rear bumper. At the 9 second mark, we observed what appeared to be faint paint graze marks at the left portion of the Toyota's front bumper (circled).

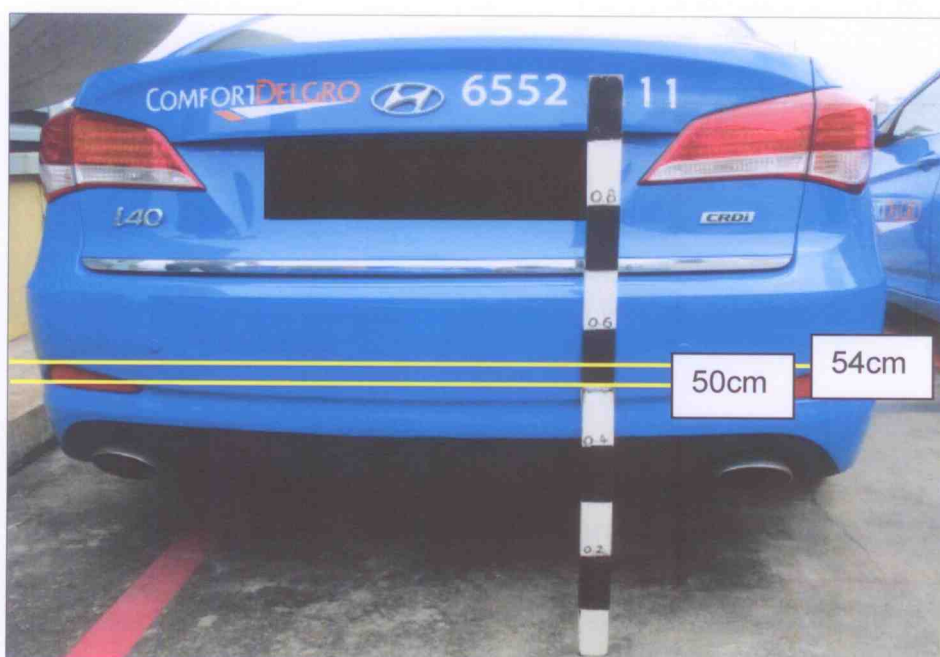
**Photo 14** shows the height measurement being conducted on the rear portion of the Taxi (using a similar make and model). The height of the paint graze marks on the lower left portion of the Taxi's rear bumper was between the ranges of 50cm to 54cm above ground level.

- a) the height of the paint graze marks on the lower left portion of the Taxi's rear bumper was between the ranges of 50cm to 54cm above ground level;
- b) the faint paint graze marks found on the front left portion of the Toyota are within the 50cm to 54cm height range;
- c) the height measurements appear to support the findings of possible contact between the rear left portion of the Taxi and the front left portion of the Toyota. The damage observed on the rear left portion of the Taxi was a result of this contact and corresponds to the damage observed on the front left portion of the Toyota.

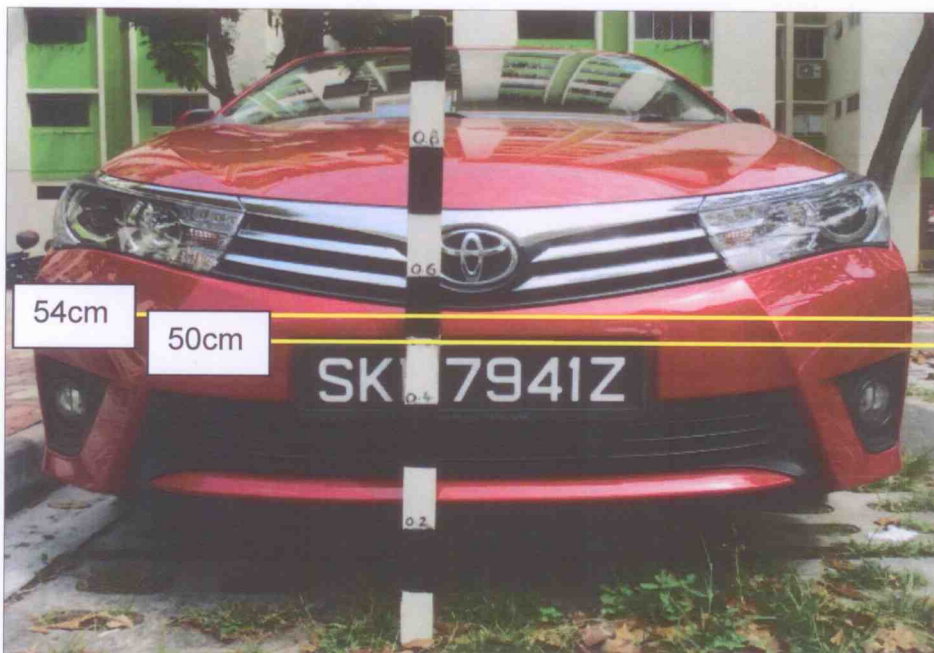
**Photo 15** shows the height measurement being conducted on the front portion of the Toyota. The faint paint graze marks found on the front left portion of the Toyota are within the 50cm to 54cm height range.
