INVESTIGATION REPORT:

CS/CTI18005574/N

SJM 2236L

18 March 2018

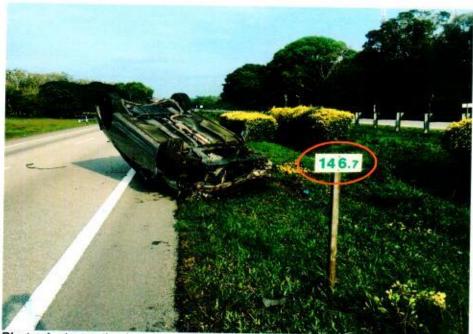
Photo 1 shows the Insured Vehicle at its respective final rest position at the incident scene before it was towed away. It seems to correlate with Mr Thina's account of the incident which had occurred along the North South Highway before the Pagoh R&R after the 146.7km mark (circled).

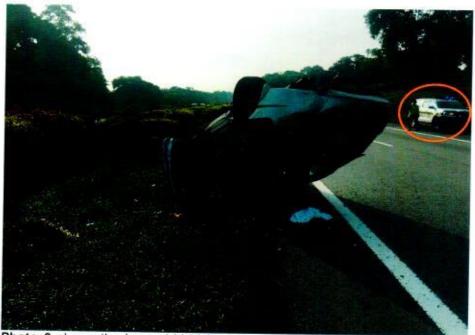
Photo 2 shows the Insured Vehicle at its respective final rest position at the incident scene before it was towed away. It seems to correlate with Mr Thina's statement in which the Insured Vehicle was facing the oncoming traffic as seen from the position of the PLUS personnel's vehicle (circled).

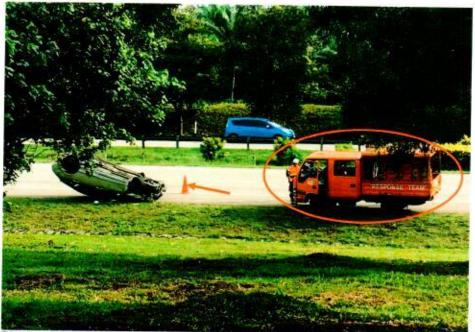
Photo 3 shows Response Team personnel (circled) setting up cones (arrowed) to warn other motorists while the Insured Vehicle was being cleared from the main road.

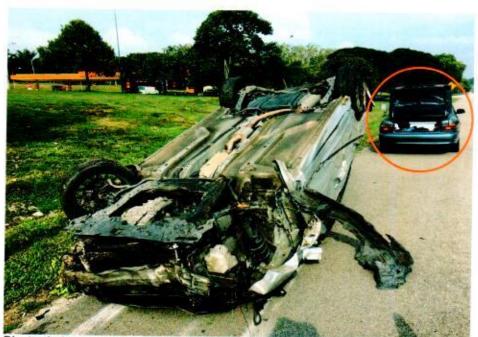
Photo 4 shows the Insured Vehicle after it had been cleared from the main road. It seems to correlate with Mr Thina's statement in which a passer—by in a blue Proton Wira (circled) told Mr Thina that he could assist Mr Thina in towing the Insured Vehicle back to Singapore to an authorized workshop of his choice.

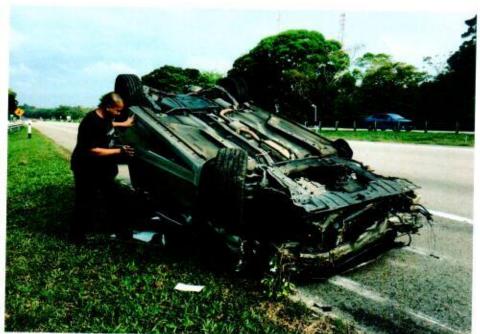
Photo 5 shows the towing personnel prepping the Insured Vehicle to be flipped over before being loaded onto a tow truck.

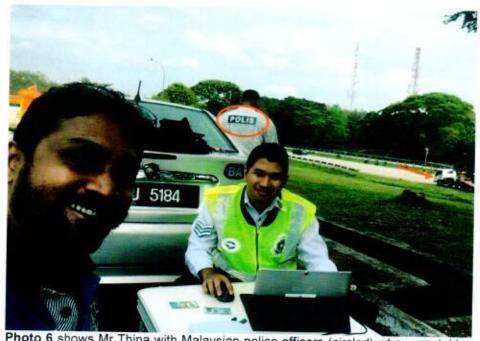
Photo 6 shows Mr Thina with Malaysian police officers (circled) who were taking down his statement while the Insured Vehicle was being loaded onto a tow truck in the background (arrowed). It seems to correlate with Mr Thina's statement, in particular the presence of police officers together with the ability of Mr Thina to take clear photographs post- incident would suggest that there was no drink driving involved in this particular incident.

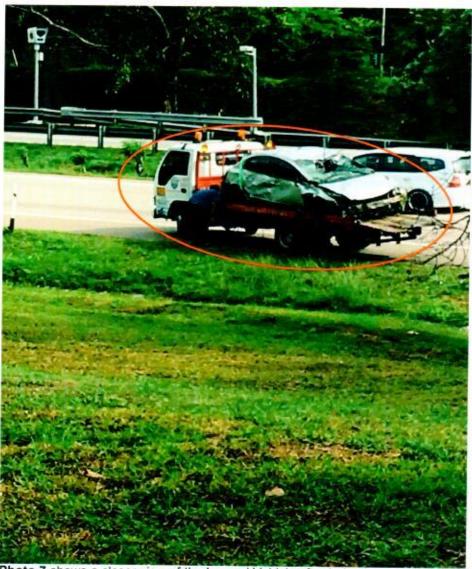
Photo 7 shows a closer view of the Insured Vehicle after being loaded onto a tow truck and getting prepped to be towed back to Singapore (circled).

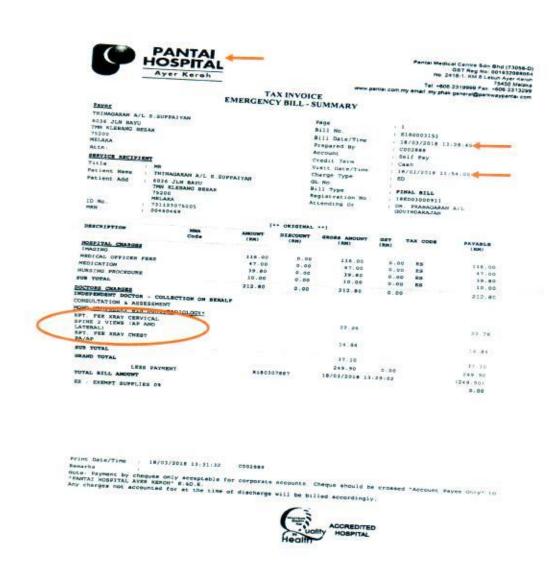
Emergency Bill 1 shows the details of Mr Thina' visit to Pantai Hospital on 18 March 2018 (arrowed). It also shows the type of X-rays that were conducted (circled). The info gathered from the emergency bill summary would correlate with Mr Thina's statement that he visited the Pantai Hospital post-incident.

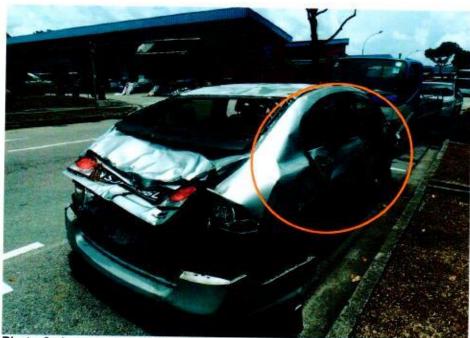
Photo 9 shows a view of the right rear portion of the Insured Vehicle during our physical inspection. The Insured Vehicle sustained extensive damages as a result of the incident. The buckled right portion (circled) seems to be consistent with Mr Thina's statement in which the Insured Vehicle had flipped over on its right side after the steering wheel locked.

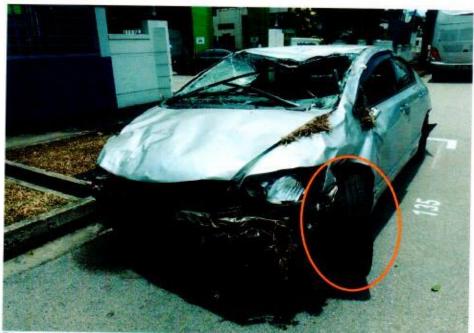
Photo 10 shows a view of the front portion of the Insured Vehicle during our physical inspection. The angle of the front left tyre seems to correlate with Mr Thina's statement in which the steering wheel had locked after he made a hard left turn to avoid the dog.

- 23. Static tests could not be conducted on its steering system due to the extent of damage sustained by the Insured Vehicle as a result of the incident, which had affected several of its steering components.
- 24. Static tests conducted on its braking system during the physical inspection revealed no abnormality. This indicated that the braking system was likely to be in serviceable condition at the time of incident.
- 25. There was no modifications found fitted on the Insured Vehicle SJM 2236L at the time of physical inspection.
- 26. Our investigations also revealed there was no evidence gathered to suggest that Mr Thina was driving under the influence of medication(s) and/or alcohol at the material time of incident.

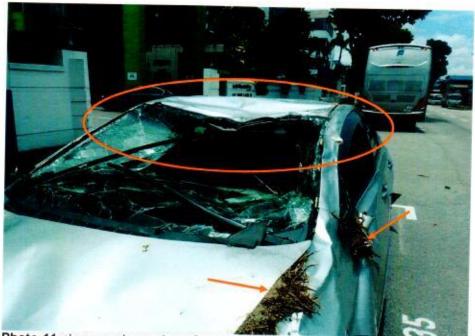
Photo 11 shows a closer view of the front portion of the Insured Vehicle during our physical inspection. The buckled hood (circled), dried leaves and/or soil particles (arrowed) that were found stuck at the left side of the front bonnet and left side mirror seem to correlate with Mr Thina's statement in which the Insured Vehicle had flipped over on its right side before coming to a stop in an overturned near the central divider.

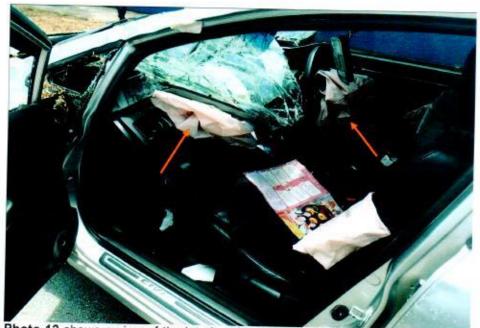
Photo 12 shows a view of the interior of the Insured Vehicle during our physical inspection. We observed airbag remains (arrowed) which corroborates with Mr Thina's statement that the front airbags were deployed after the Insured Vehicle flipped over on its right side.
