Your Ref: Honda Engine Our Ref: CI/TP18005927/D 04 April 2018

Esprit Motor Trading 210 Turf Club Road Lot C10 Singapore 287995

INSPECTION REPORT OF A HONDA ENGINE

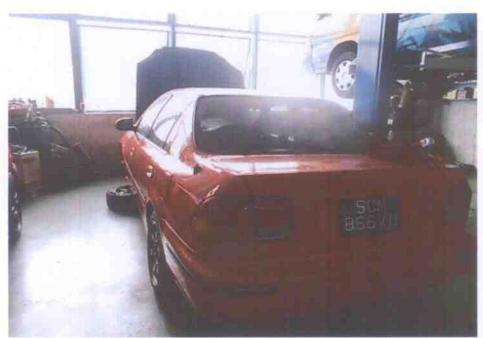
Photo 1 shows a general view of the motor car with registration number SCM 8667U. The Honda engine that I had inspected was a used engine that was fitted on this motor car. It was also observed to be a complete assembly with all mechanical parts still intact, within the engine housing.

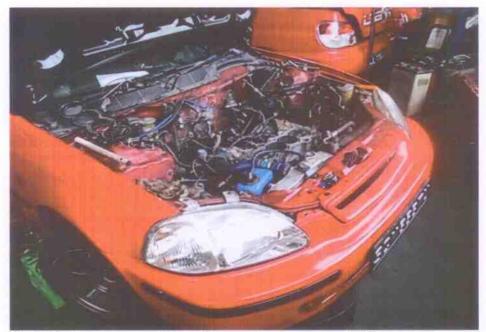
Photo 2 shows a general view of the engine compartment of the motor car with registration number SCM 8667U. The Honda engine that I had inspected was a used engine that was fitted on this motor car. It was also observed to be a complete assembly with all mechanical parts still intact, within the engine housing.

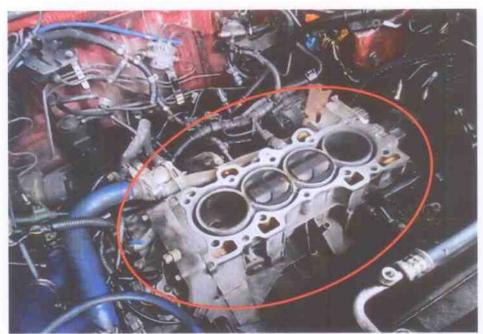
Photo 3 shows a general view of the Honda engine (circled) that I had inspected. My visual examination of the engine housing revealed the housing to be of serviceable/satisfactory condition. There was no crack and/or hole observed on the engine housing. During my inspection, its top block was separated from its bottom block to enable me to carry out measurements of its cylinders, in particular the bore and stroke measurements of each cylinder, which typically can be used to determine the engine displacement or more commonly referred to as engine cc.

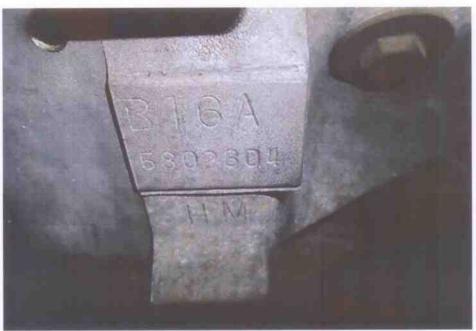
Photo 4 shows the engine number engraved on the housing of the Honda engine that I had inspected. The engine number was B16A5802604.

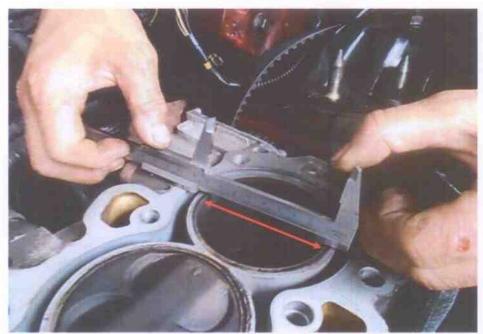
Photo 5 shows measurement being carried out to the bore of cylinder 1 of the Honda engine. The bore and stroke measurements of the Honda engine were carried out using a Vernier Caliper. The bore measurement of cylinder 1 was recorded to be 80.70mm.

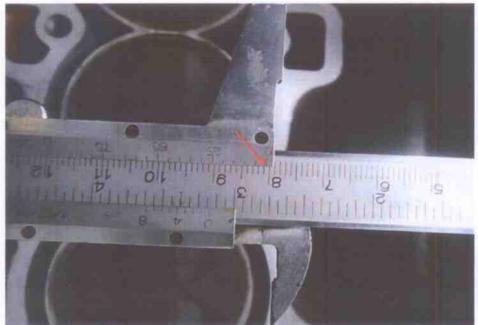
Photo 6 shows the bore measurement of cylinder 1, which was recorded to be 80.70mm.

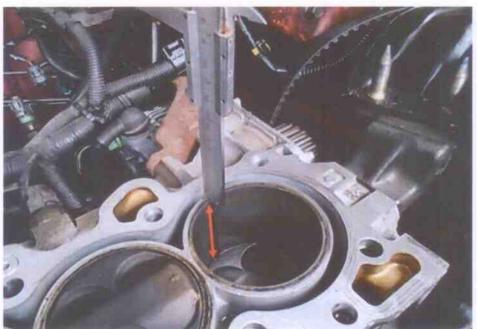
Photo 7 shows measurement being carried out to the stroke of cylinder 1 of the Honda engine. The bore and stroke measurements of the Honda engine were carried out using a Vernier Caliper.

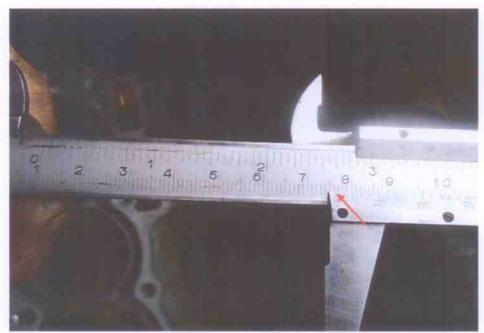
Photo 8 shows the stroke measurement of cylinder 1, which was recorded to be 76.10mm.

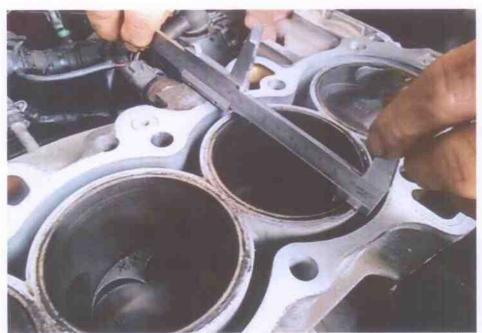
Photo 9 shows measurement being carried out to the bore of cylinder 2 of the Honda engine. The bore and stroke measurements of the Honda engine were carried out using a Vernier Caliper. The bore measurement of cylinder 2 was recorded to be 80.50mm.

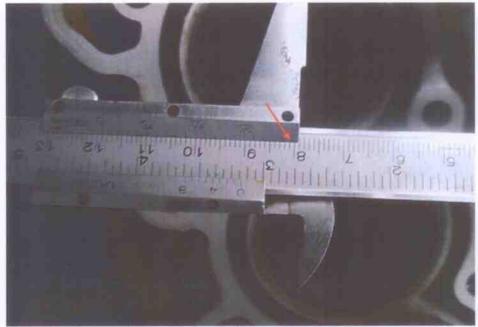
Photo 10 shows the bore measurement of cylinder 2, which was recorded to be 80.50mm.

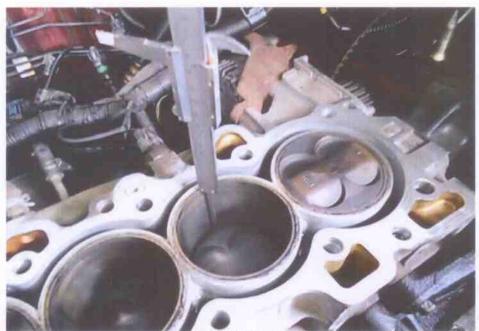
Photo 11 shows measurement of the stroke for cylinder 2 of the Honda engine that I had inspected.

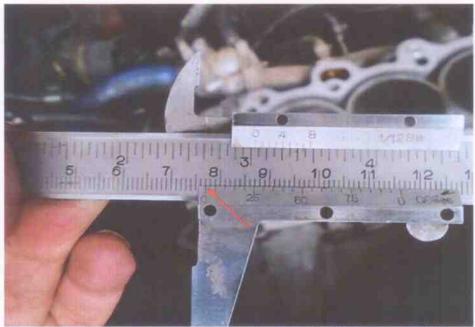
Photo 12 shows the stroke measurement of cylinder 2, which was recorded to be 77.00mm.

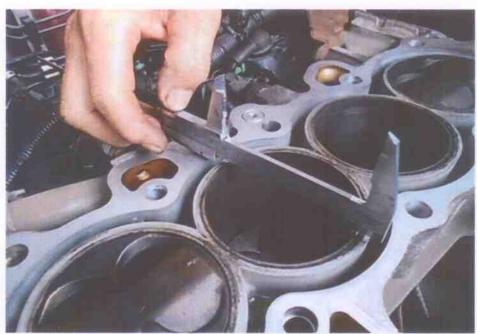
Photo 13 shows measurement being carried out to the bore of cylinder 3 of the Honda engine. The bore and stroke measurements of the Honda engine were carried out using a Vernier Caliper.

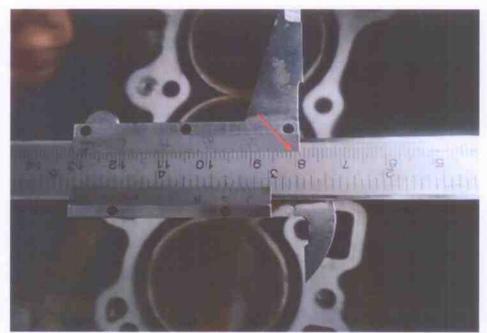
Photo 14 shows the bore measurement of cylinder 3, which was recorded to be 80.30mm.

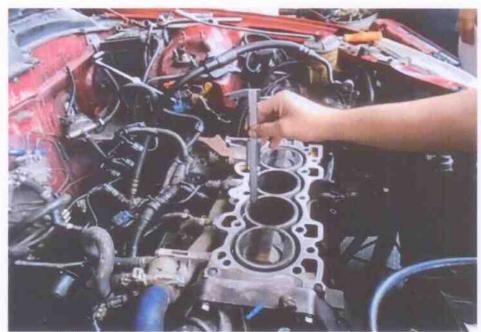
Photo 15 shows measurement of the stroke for cylinder 3 of the Honda engine that I had inspected. The stroke measurement of cylinder 3 was recorded to be 77.20mm.

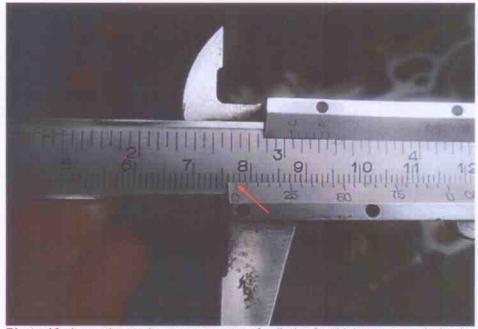
Photo 16 shows the stroke measurement of cylinder 3, which was recorded to be 77.20mm.

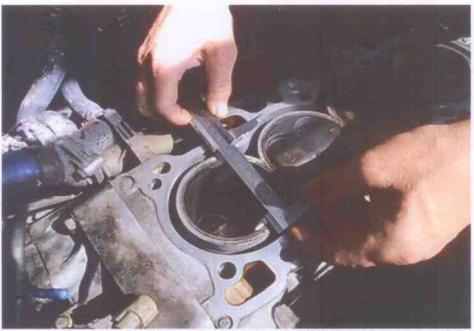
Photo 17 shows measurement being carried out to the bore of cylinder 4 of the Honda engine. The bore and stroke measurements of the Honda engine were carried out using a Vernier Caliper.

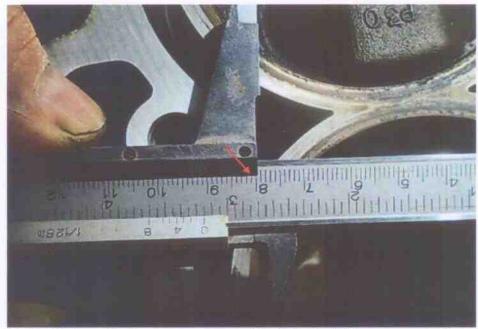
Photo 18 shows the bore measurement of cylinder 4, which was recorded to be 81.00mm.

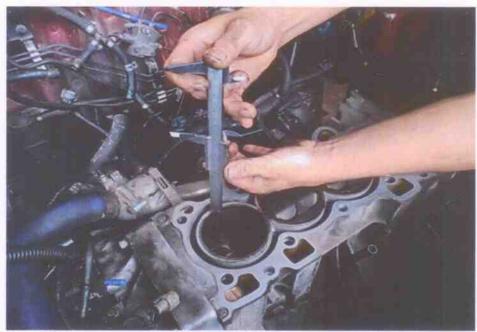
Photo 19 shows measurement being carried out to the stroke of cylinder 4 of the Honda engine. The bore and stroke measurements of the Honda engine were carried out using a Vernier Caliper.

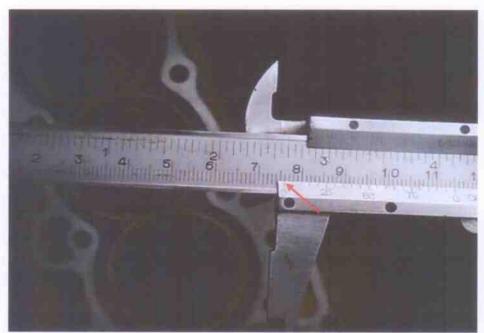
Photo 20 shows the stroke measurement of cylinder 4, which was recorded to be 75.90mm.
