Vehicle No. SHF 614C  
Insured Veh. SHD 8595G  
Claim No. D18002484MFSH  
Policy No. D-18088937MFSH  
Accident Date 25/03/2018  
Inspection Date 03/04/2018

### ADJUSTMENT ON REPAIR COST FOR VEHICLE NO. SHF 614C

PHOTOGRAPHS FOR VEHICLE NO. SHF 614C

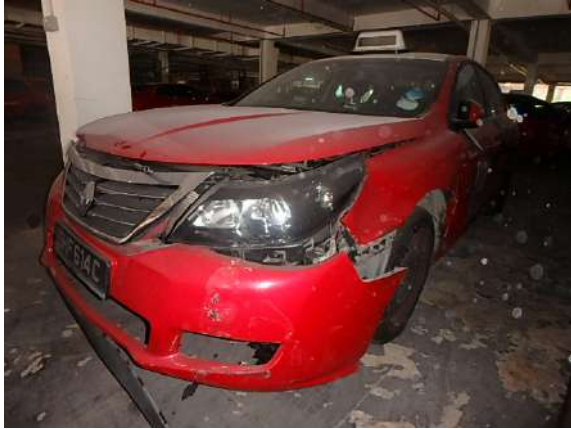
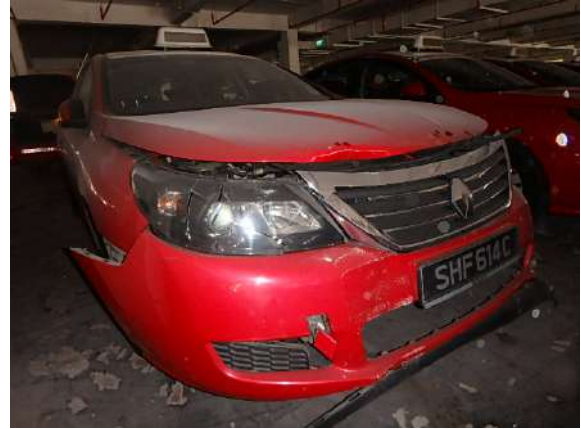
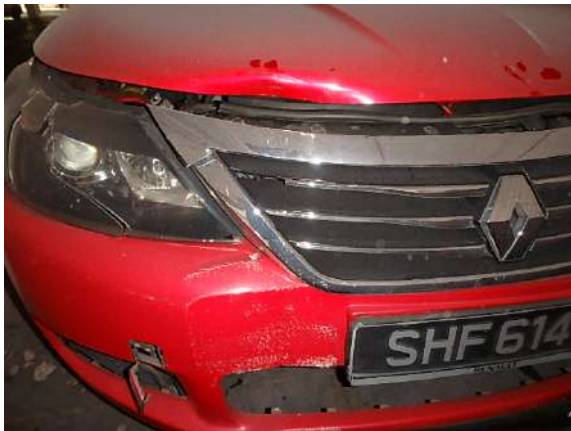
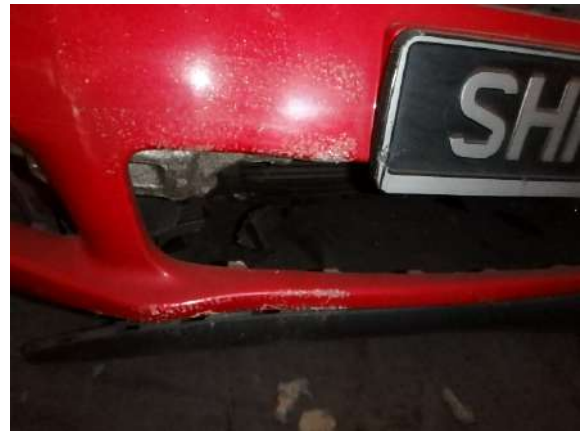
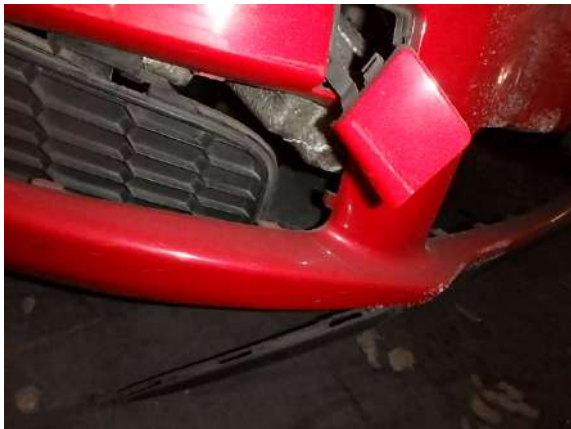
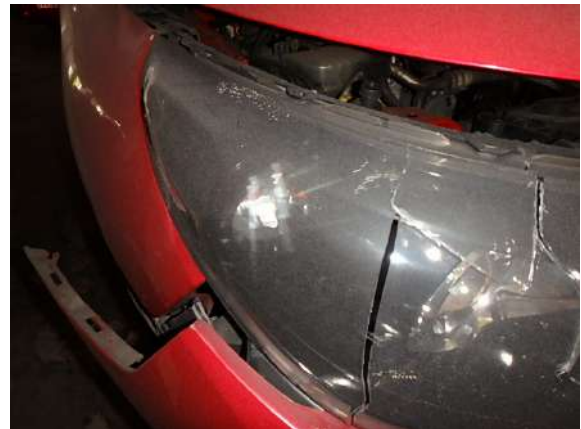
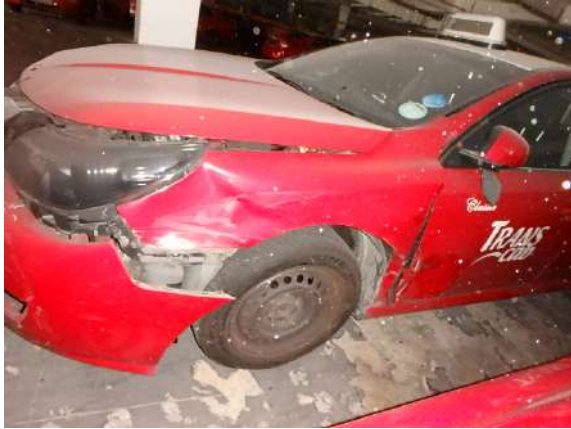
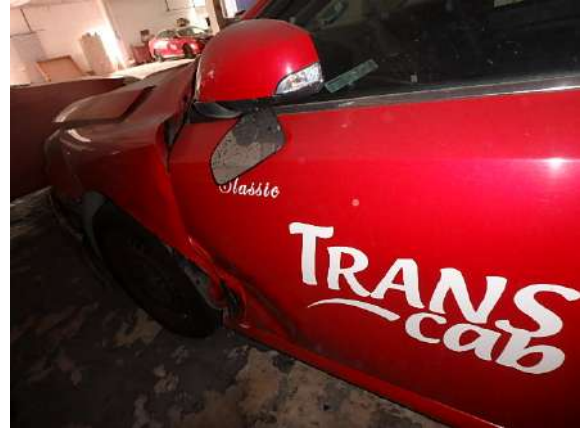
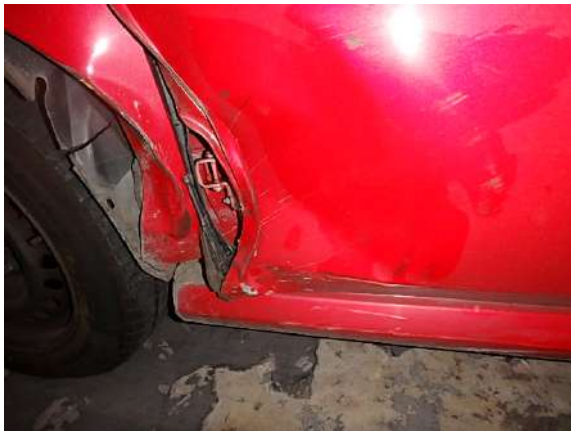
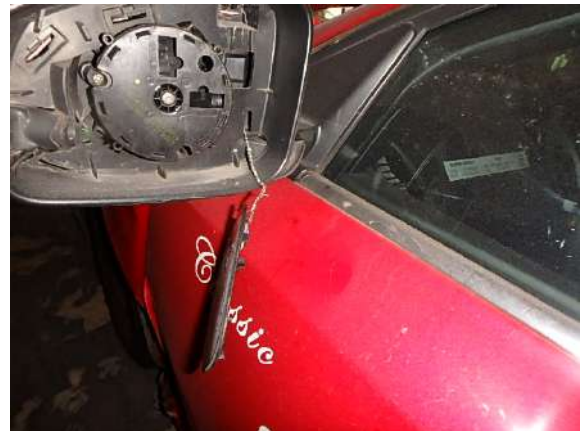
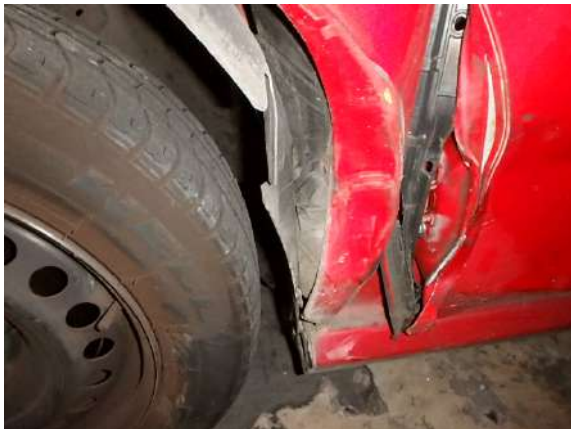
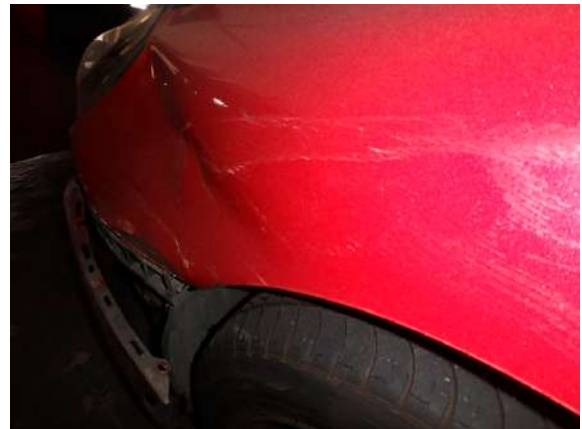
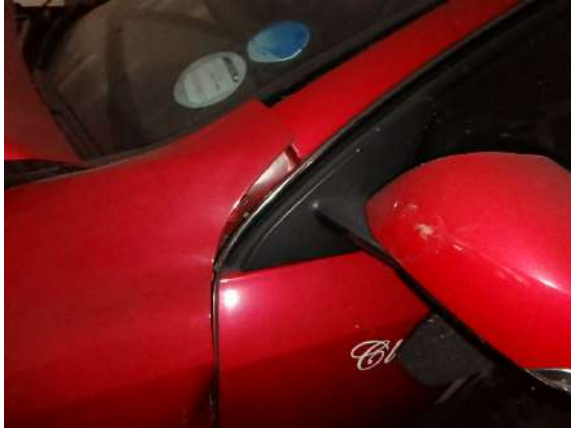
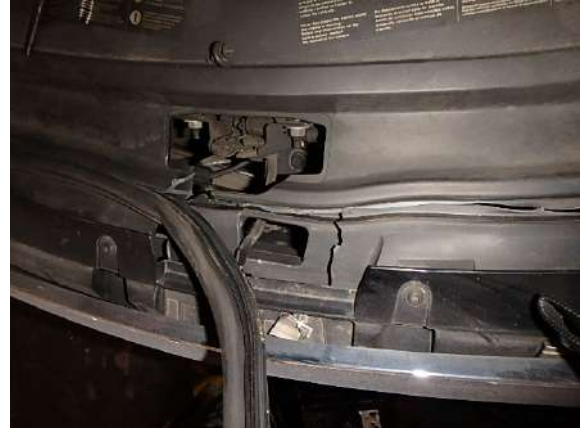
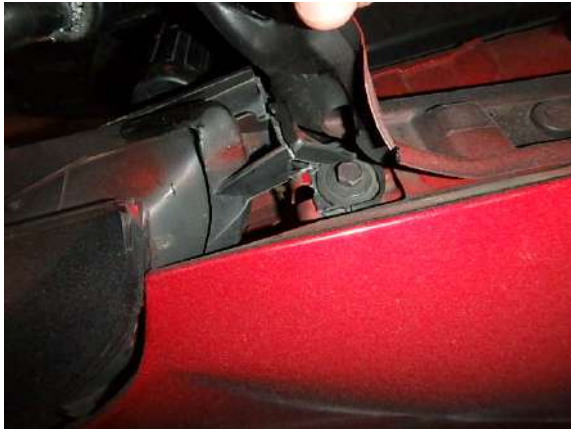
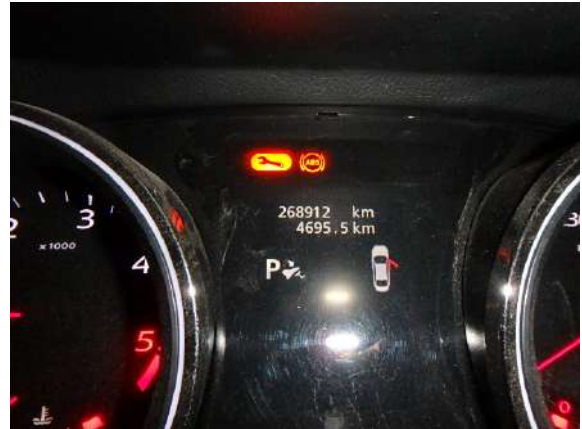
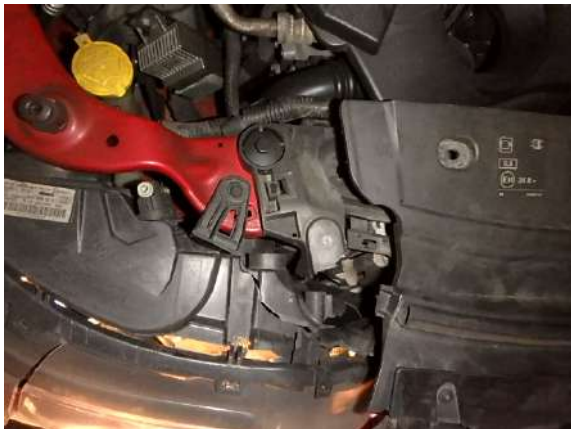
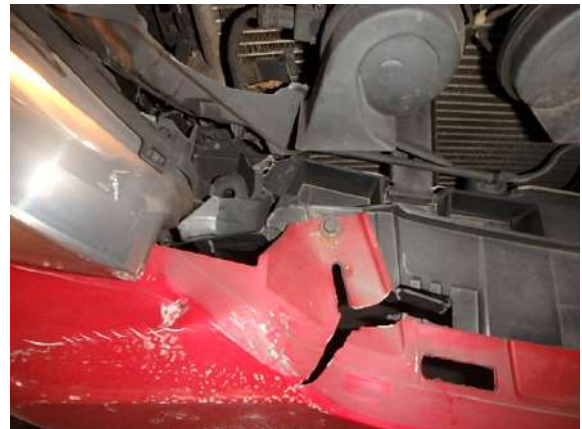
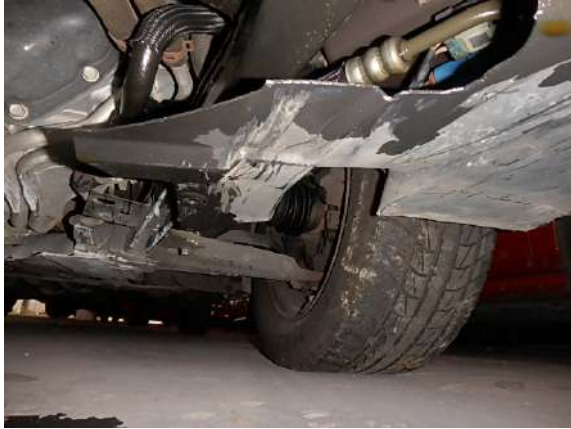
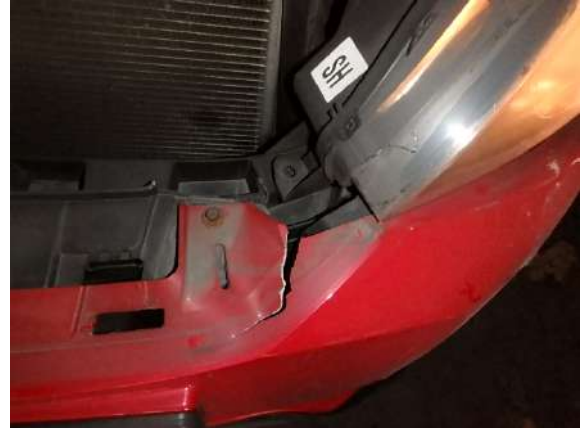
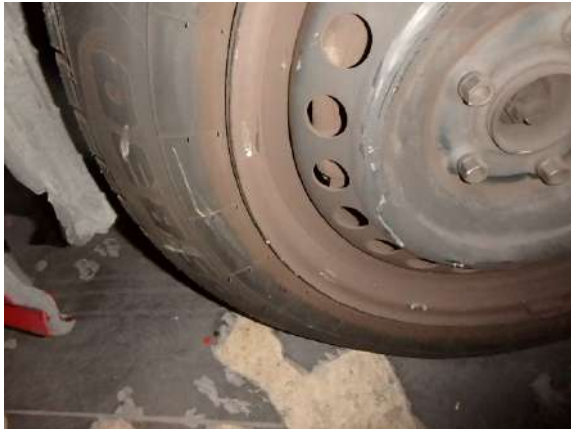
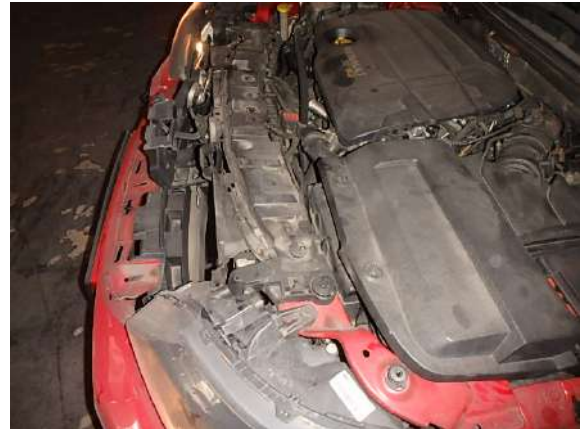
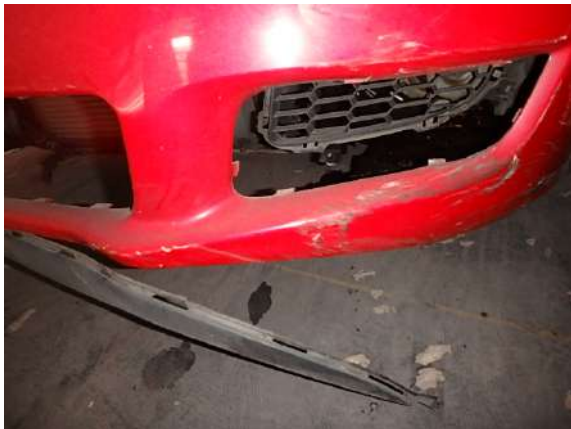
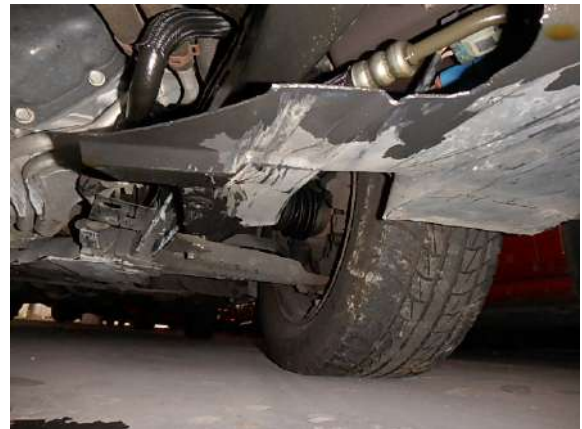
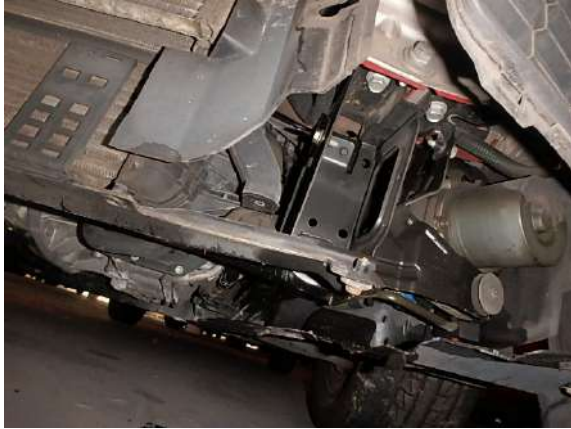
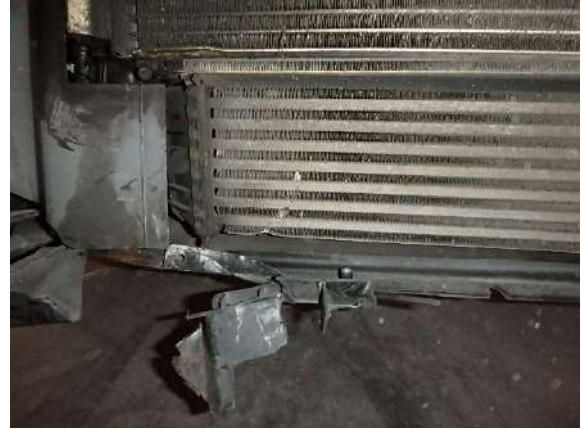
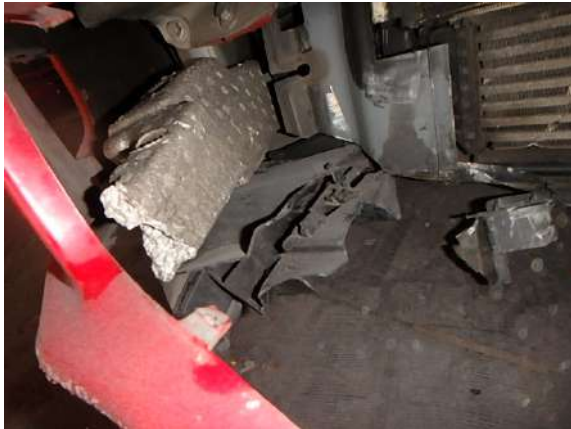
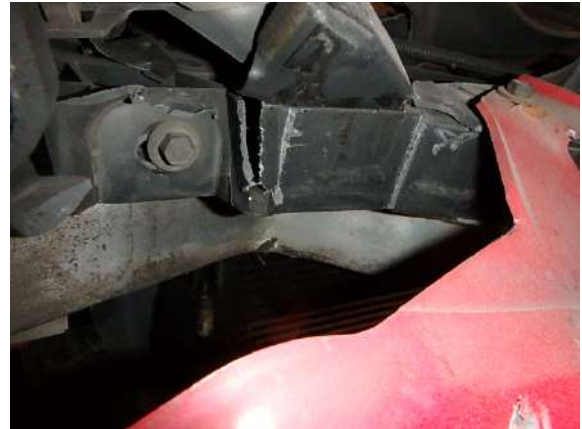
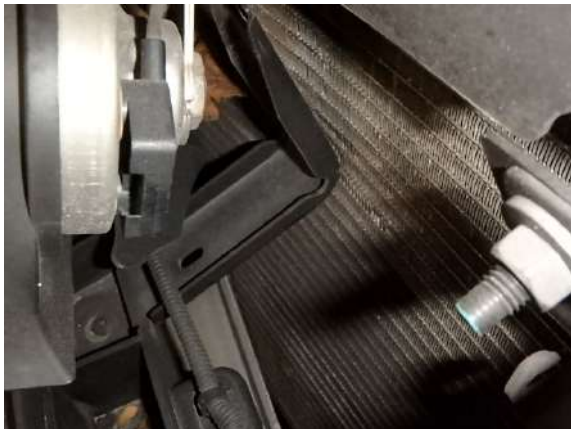
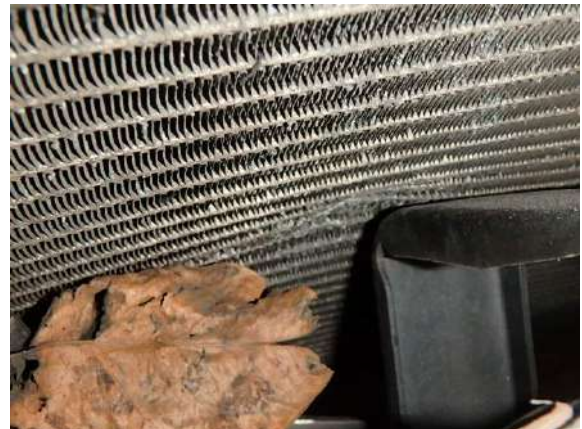
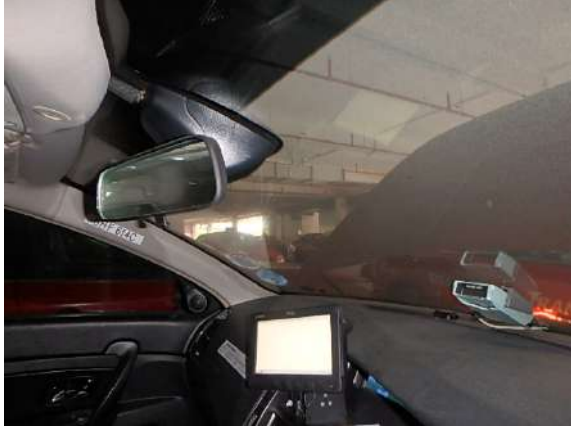
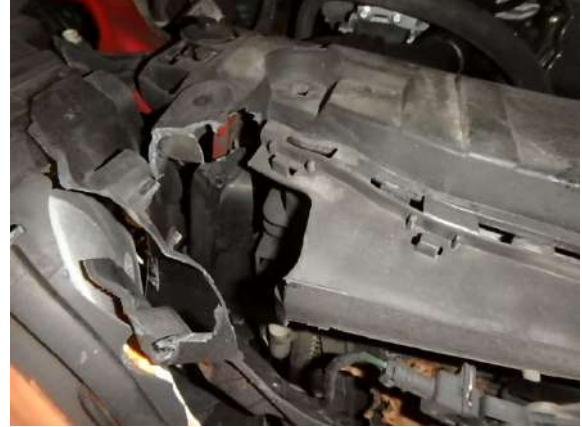
INSPECTION

| Affiliated to Federation Internationale Des Experts En Automobile | | | | |
|---|---|---|---|--|
| THE VEHICLE SUSTAINED DAMAGES AT THE N/S FRONT PORTION AND FRONT PORTION.<br>DAMAGES SEE DETAILS. | | | | |
