Your Ref: D18/2008/LJ
Our Ref :CS/FCI18006220/D

04 April 2018

**TECHNICAL INVESTIGATION REPORT OF FIRE INCIDENT INVOLVING THE
INSURED VEHICLE SHA 9380T ON 04 MARCH 2018**

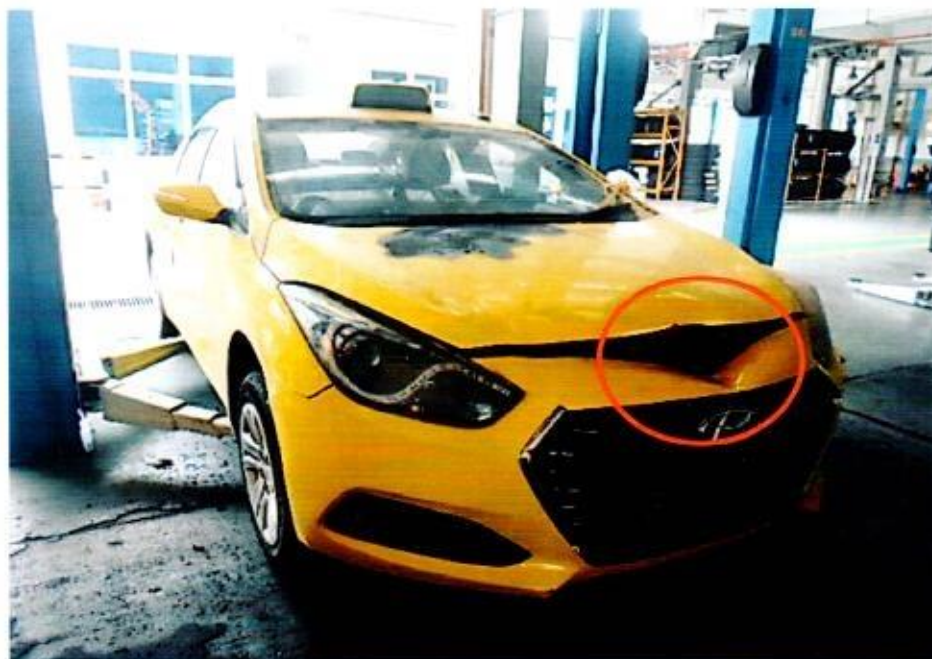
Photo 1 shows a general view of the front right body of the Insured Vehicle at the time of my inspection. The fire had affected most of the parts within the engine compartment. The damage to the front bumper (circled) was a result of firefighting operation.

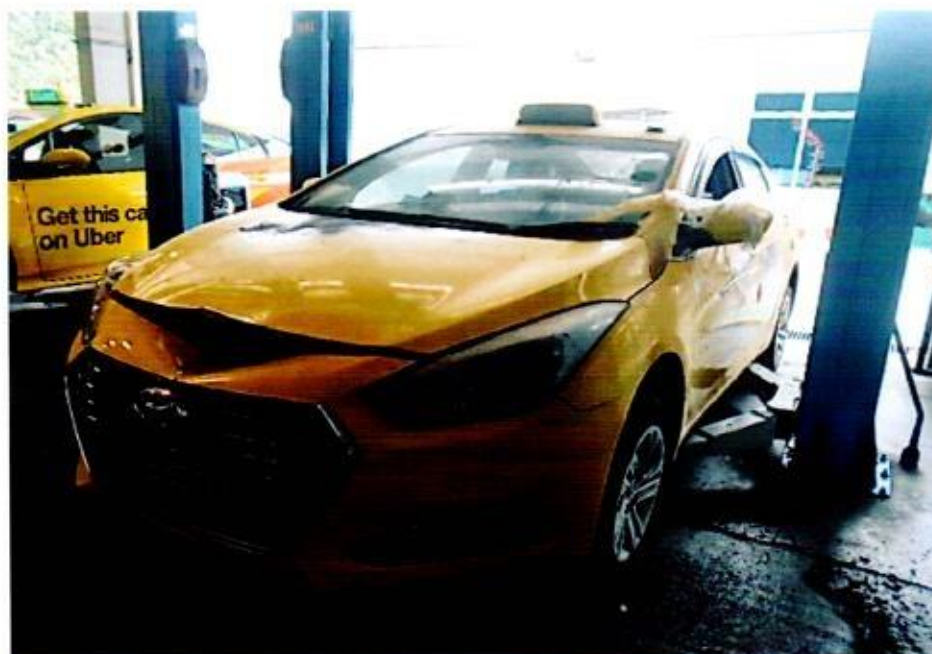
Photo 2 shows a general view of the front left body of the Insured Vehicle at the time of my inspection. The fire had affected most of the parts within the engine compartment. The mileage of the Insured Vehicle could not be recorded due to its wirings being affected by the fire.

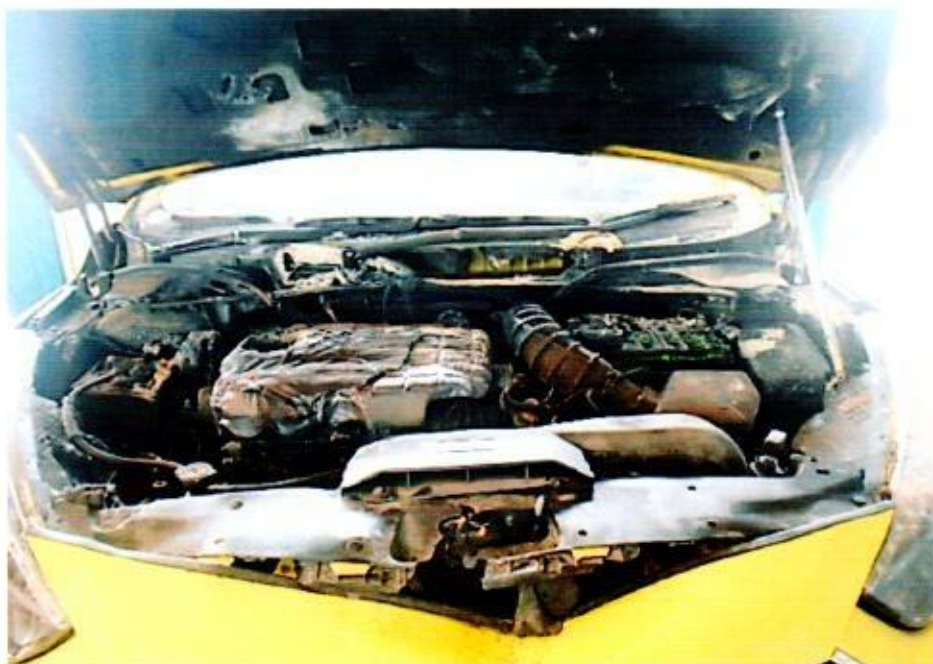
5. The Insured Vehicle was noted to have sustained fire damage that was confined to its engine compartment. Most of the parts and components within the engine compartment were found to have been affected. Parts that were made of plastic or rubber type material were observed to be partially melted. This had included the various rubber hoses, wiper panel, battery, air intake duct, bonnet insulator and brake fluid reservoir amongst others.
6. Apart from the normal standard additional equipment(s) which can be found on a motor taxi, there appears to be no modification(s) and/or additional electronic and/or electrical component(s) fitted on the Insured Vehicle. See photo 1 – 4 below.

Photo 3 shows a general view of the Insured Vehicle's engine compartment at the time of my inspection. The engine compartment was observed to have sustained moderate fire damage. Parts that were made of plastic or rubber type material were observed to be partially melted. This had included the various rubber hoses, wiper panel, battery, air intake duct, bonnet insulator and brake fluid reservoir amongst others.

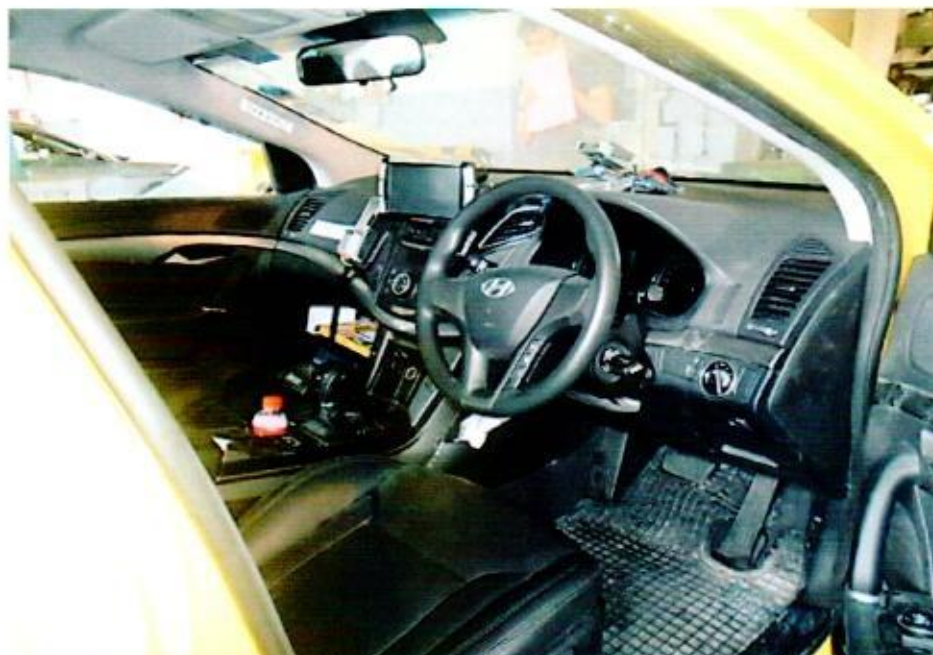
Photo 4 shows the interior compartment of the Insured Vehicle, which was unaffected by the incident. Apart from the normal standard additional equipment(s), there appears to be no modification(s) and/or additional electronic and/or electrical component(s) fitted on the Insured Vehicle.

27. There were no modification(s) or additional electronic and/or electrical component(s) fitted on the Insured Vehicle at the time of my inspection of the Insured Vehicle other than the standard additional equipment(s) which can be found on a motor taxi.

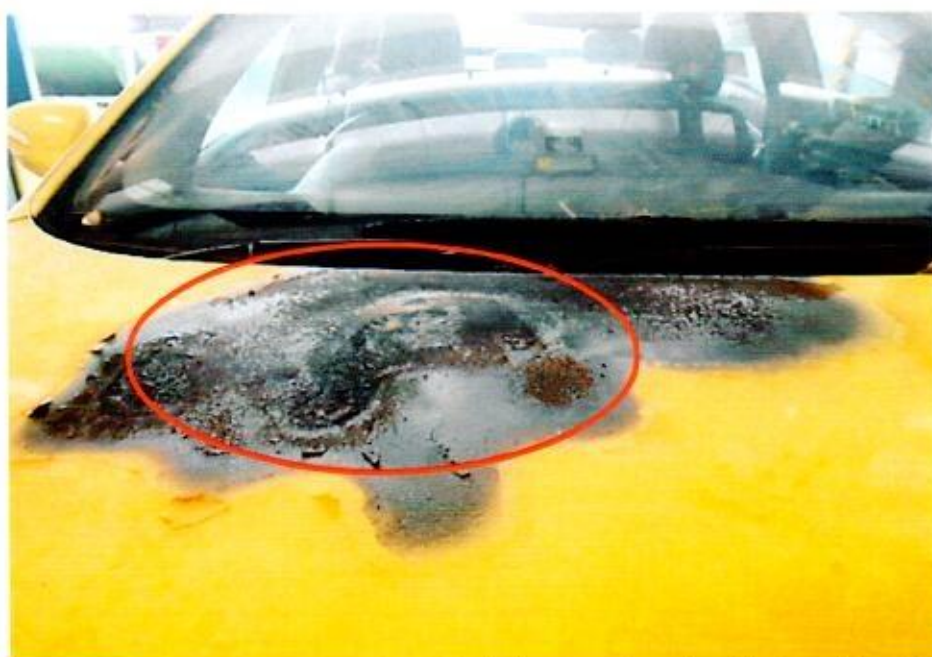
7. For this particular case, a single burn mark was found on the exterior body of the Insured Vehicle. This was at the top side of its front bonnet. Given this single burn mark on the exterior body, the fire can then be established to have originated within the engine compartment of the Insured Vehicle, somewhere around the rear centre of the engine compartment.

Photo 5 shows the burned marks (circled) that were found on the top side of the Insured Vehicle's front bonnet. Apart from these burned marks, there were no other marks of burnt nature found on the exterior body of the Insured Vehicle. Given this single burn mark on the exterior body, the fire can then be established to have originated within the engine compartment of the Insured Vehicle, somewhere around the rear centre of the engine compartment.

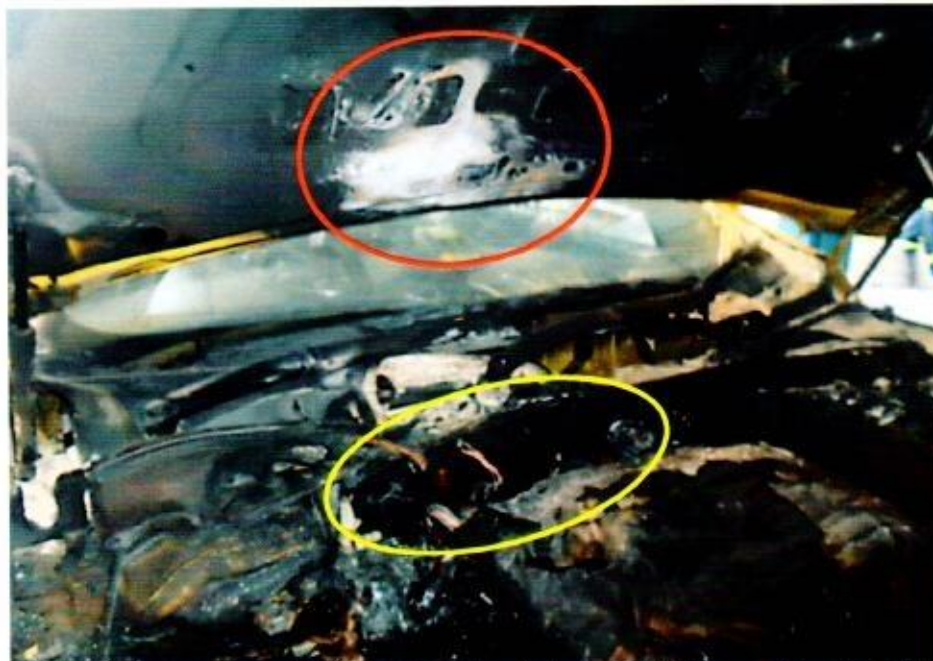
8. Correspondingly, high heat intensity burn marks (whitish burn marks) were found on the underside of the Insured Vehicle's front bonnet, directly below the area where the burn marks were formed on the top side of the front bonnet. These whitish burn marks are a result of exposure to prolong heat intensity. Rust would normally start to develop around these areas soon after a fire as prolonged exposure to high heat intensity usually causes steel/metal material body parts to be exposed to natural environmental condition. See photo 5 & 6 below.

Photo 6 shows the whitish burn marks (red circle) that were found on the underside of the Insured Vehicle's front bonnet, directly under the area where the burn marks were formed on the top side of the front bonnet. Such whitish burn marks are a result of exposure to prolong heat intensity. The fire to the Insured Vehicle can then be established to have originated around the rear centre of the engine compartment (yellow circle).

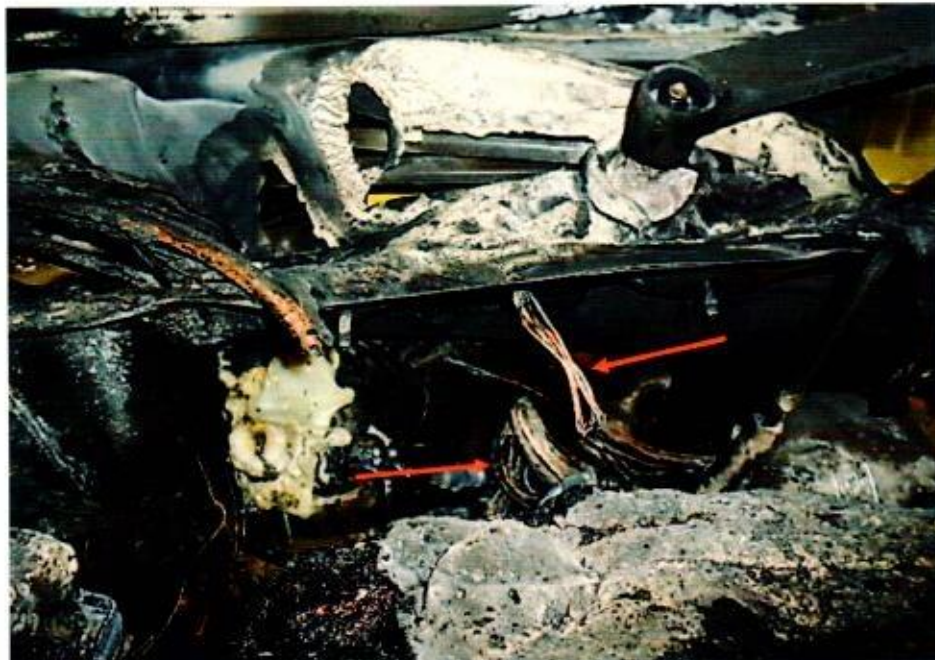
9. My examination of the rear centre area of the engine compartment, during my inspection of the Insured Vehicle, revealed wirings that were completely burned to its copper state. The bright reddish colour of the copper wires suggest that the wirings were exposed to high heat. Such condition normally indicates internal heating of copper wires which is a sign of an electrical short circuit occurring. This would then appear to suggest that the cause of fire to the Insured Vehicle could have possibly been due to electrical in nature. See photo 7 – 10 below.

10. Heat from engine operation could cause the rubber insulation of the wires and/or wiring harness within the engine compartment to lose its flexibility and become hardened after a prolong period of time. The hardened rubber insulation may then become brittle and break off bits by bits, exposing live wires that may come into contact with each other and/or the metal body of the vehicle, creating sparks that could ignite a fire.

11. Unlike countries with different seasons, the hot local climate increases the heat within the engine compartment of locally used vehicles. This enhances the deterioration of any rubber material parts or components contained within the engine compartment.

Photo 7 shows the wirings at the rear centre area of the Insured Vehicle's engine compartment, which was where the fire had originated. The wirings (arrowed) were found to be completely burned to its bare copper state. The bright reddish colour of the copper wires suggest that the wirings were exposed to high heat. Such condition normally indicates internal heating of copper wires which is a sign of an electrical short circuit occurring. The wires were likely to be original factory fitted wire harnesses of the Insured Vehicle.

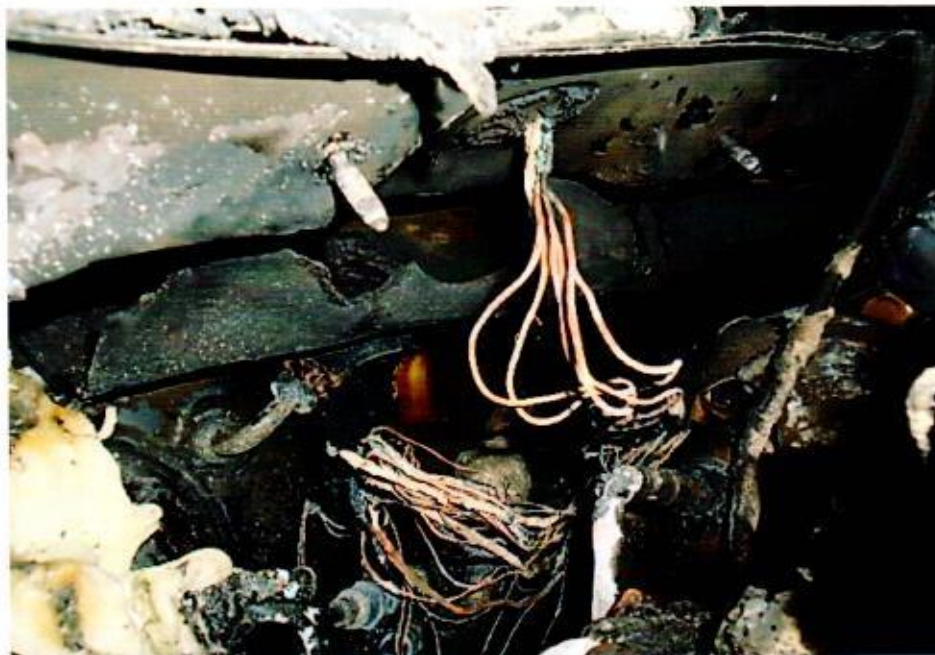
Photo 8 shows a closer view of the wirings at the rear centre area of the Insured Vehicle's engine compartment. The wirings were found to be completely burned to its bare copper state. Such condition normally indicates internal heating of copper wires which is a sign of an electrical short circuit occurring.

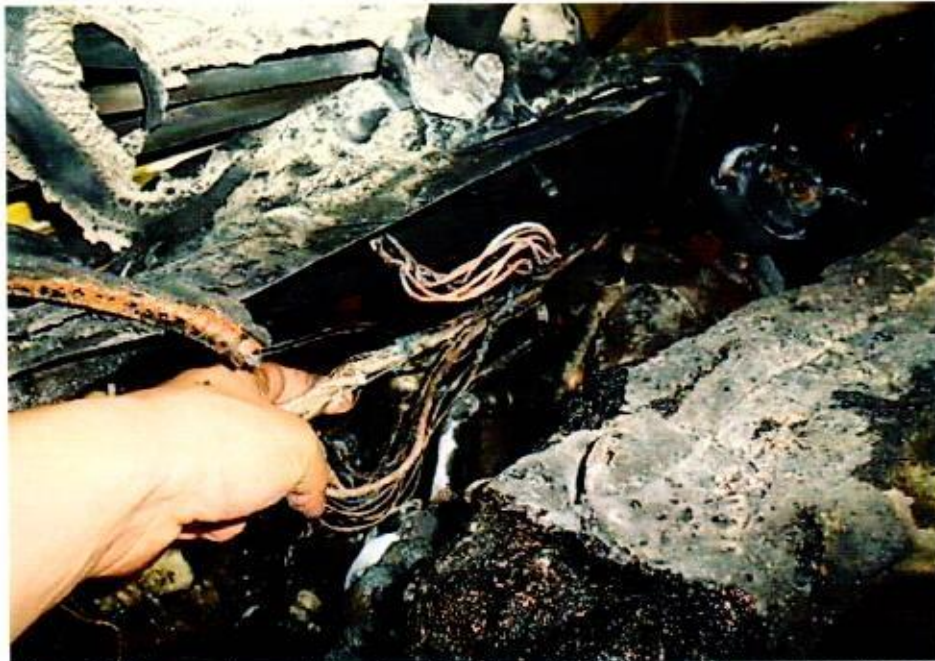
Photo 9 shows a closer view of another stretch of wirings at the rear centre area of the Insured Vehicle's engine compartment. The bright reddish colour of the copper wires suggest that the wirings were exposed to high heat. Such condition normally indicates internal heating of copper wires which is a sign of an electrical short circuit occurring. This would then appear to suggest that the cause of fire to the Insured Vehicle could have possibly been due to electrical in nature.

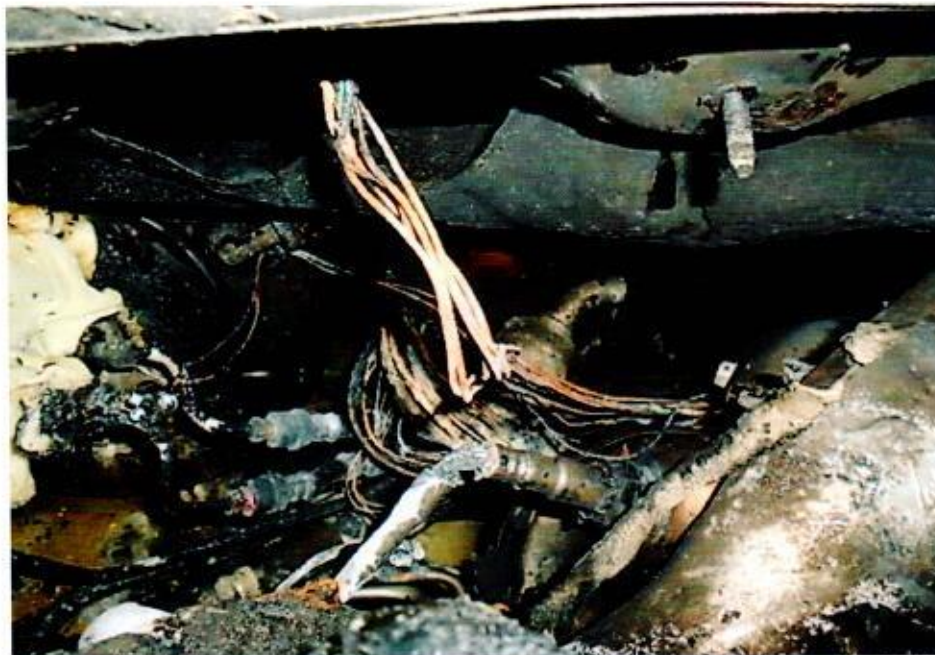
Photo 10 shows the burnt wirings at the rear centre area of the Insured Vehicle's engine compartment. The bright reddish colour of the copper wires suggest that the wirings were exposed to high heat, indicating internal heating of copper wires, which is a sign of an electrical short circuit occurring.

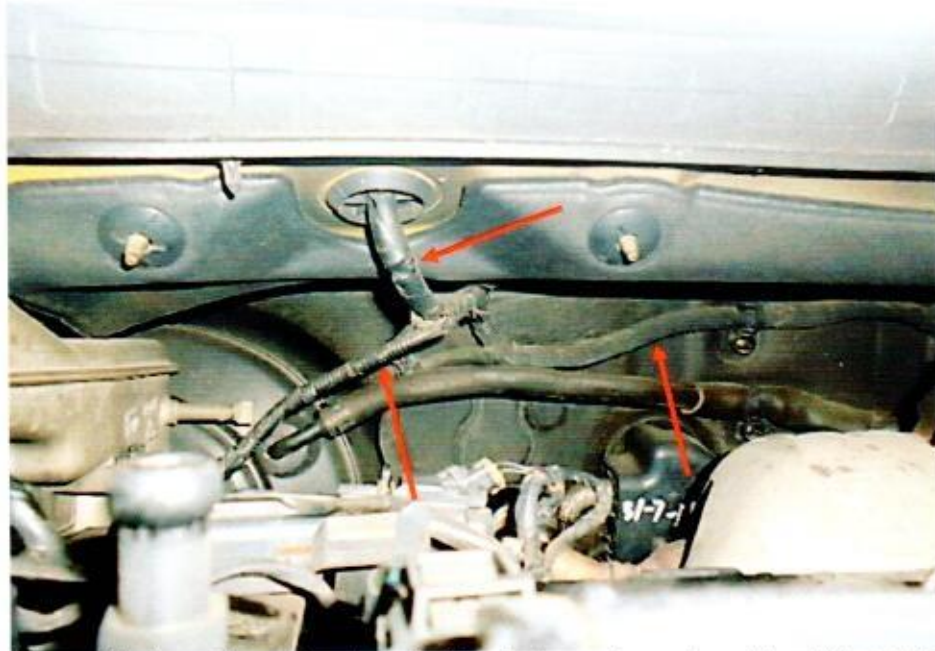
12. At the time of my inspection, I was able to inspect the engine layout of a similar make and model vehicle as the Insured Vehicle. Upon comparison, it was observed that the burnt stretch of wirings observed on the Insured Vehicle were original factory fitted wiring harness. See photo 11 below.

Photo 11 shows the engine layout of a similar make and model vehicle as the Insured Vehicle. This was at the rear centre area of the engine compartment. Upon comparison, it was observed that the burnt stretch of wirings observed on the Insured Vehicle were original factory fitted wiring harness (arrowed).
