LKK Auto Consultants Pte Ltd

ADJUSTMENT ON REPAIR COST FOR VEHICLE NO. GBG 1202S

PHOTOGRAPHS FOR VEHICLE NO. GBG 1202S

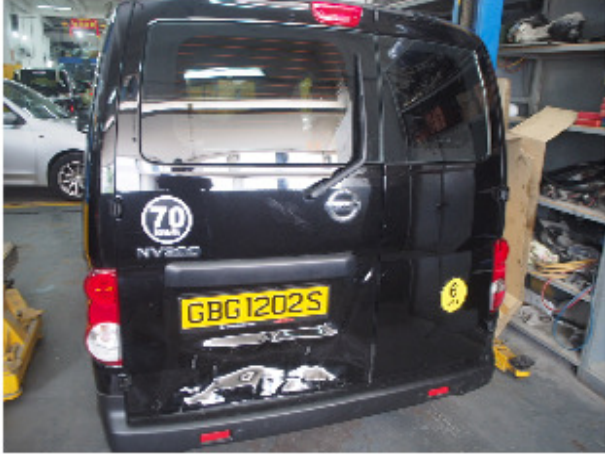
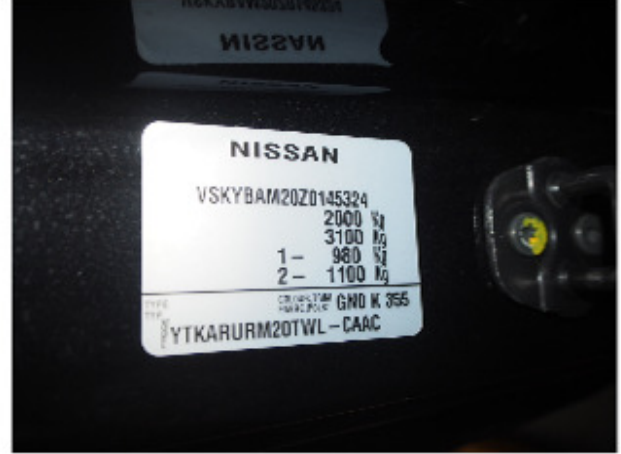
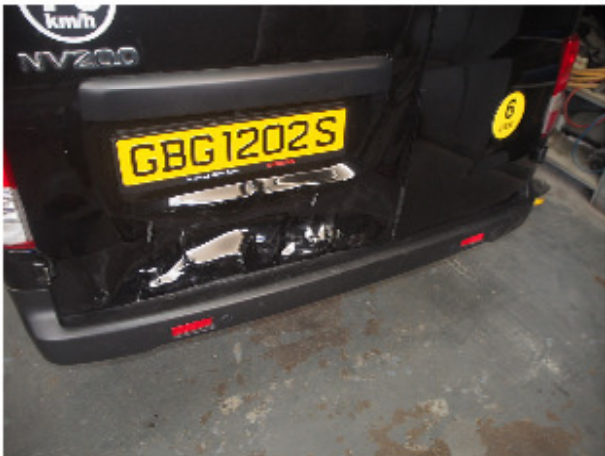
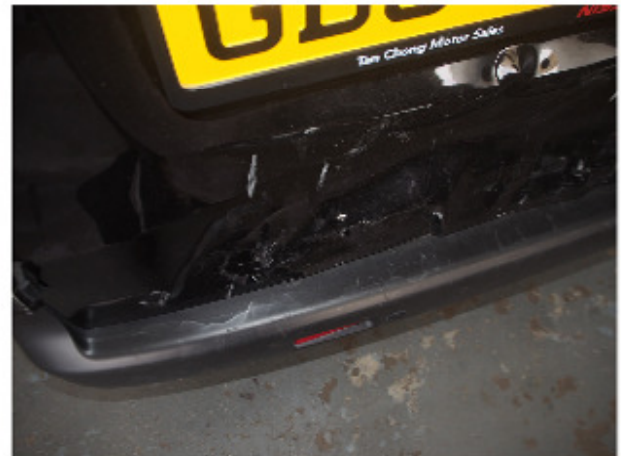
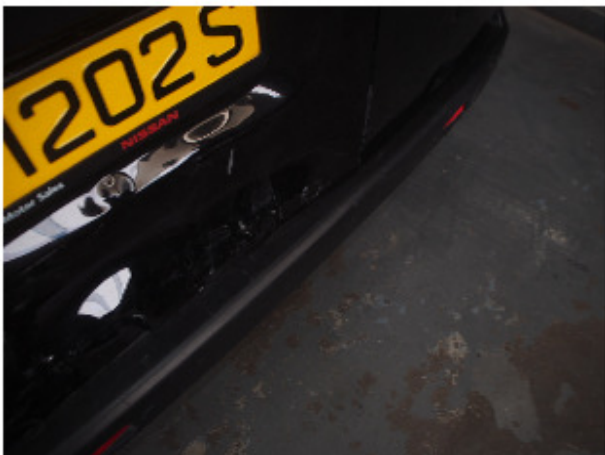
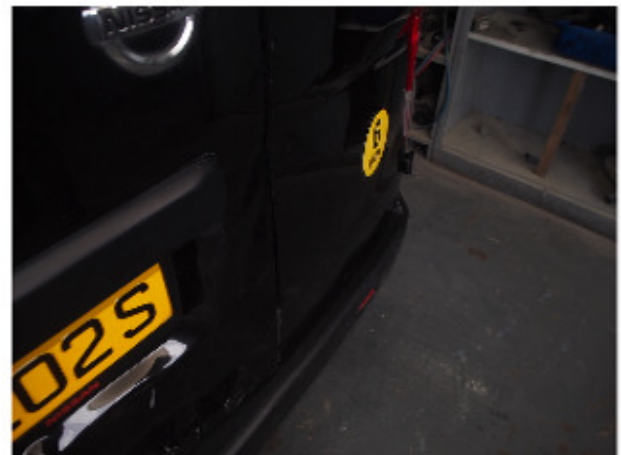
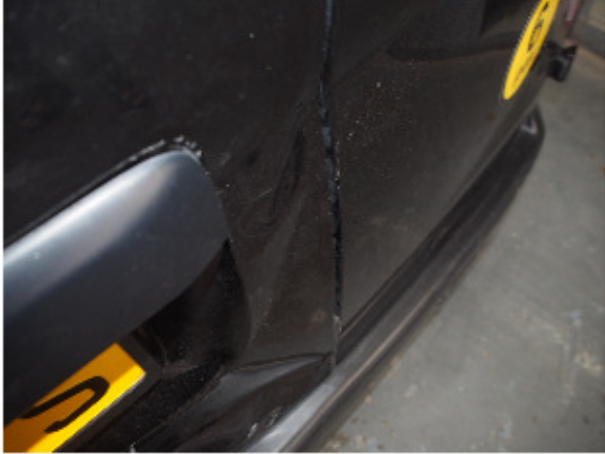
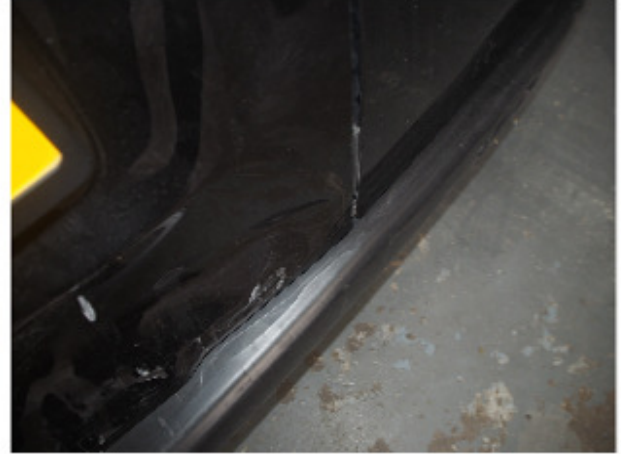
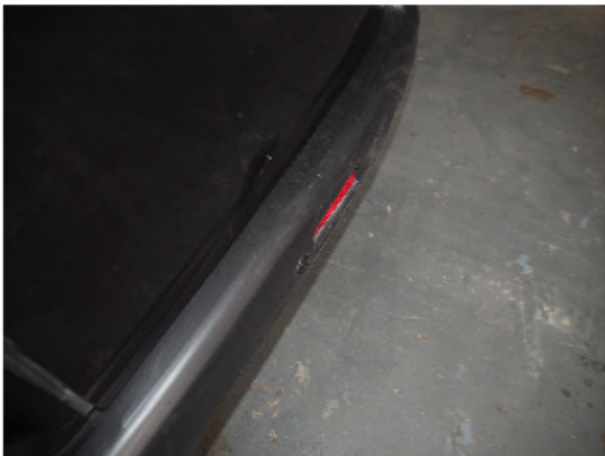
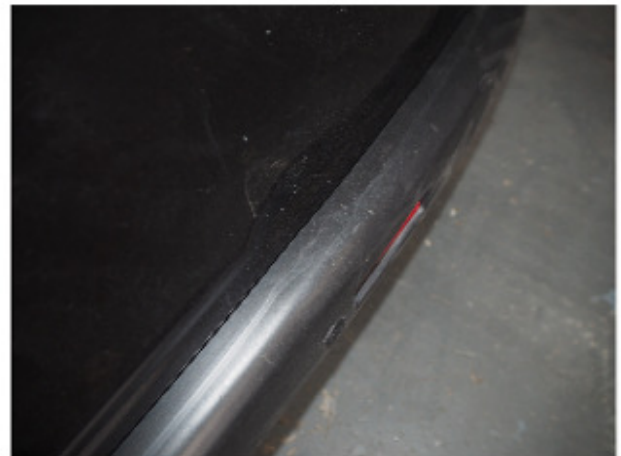
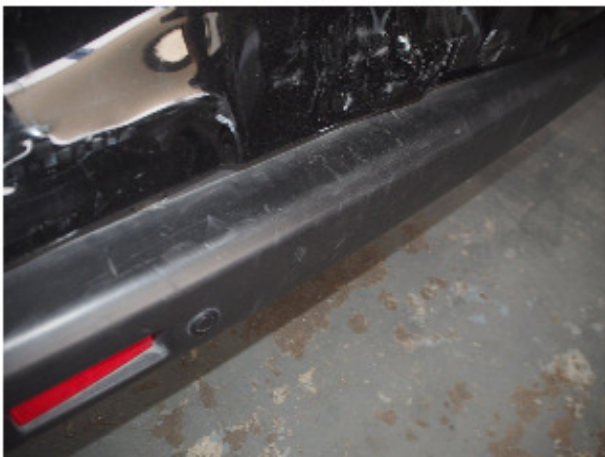
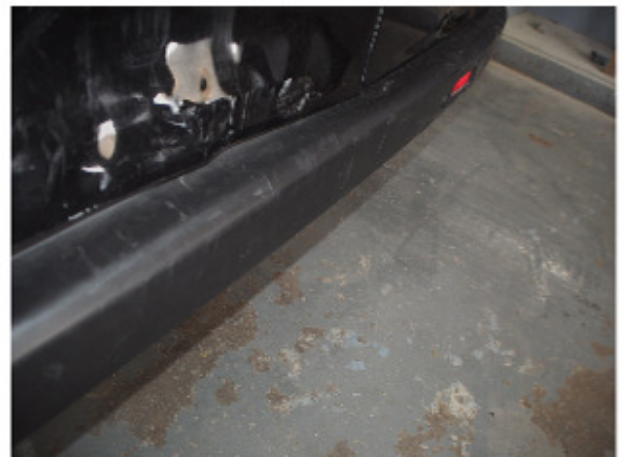
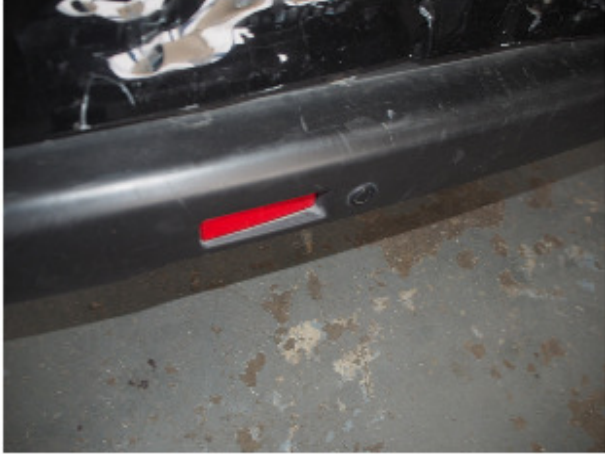
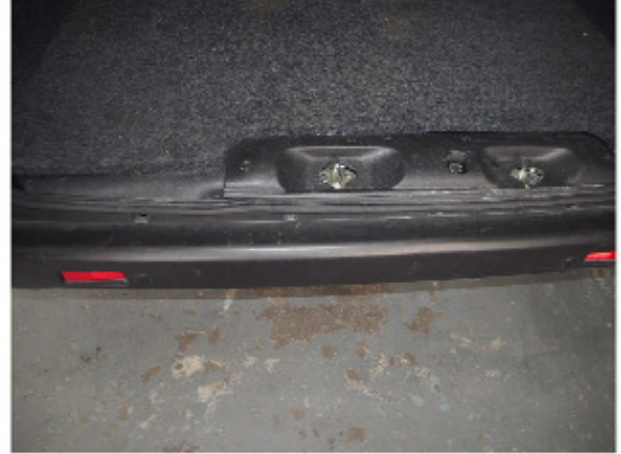
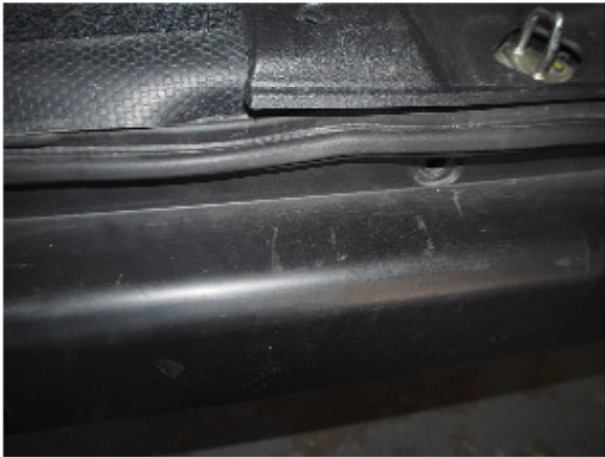
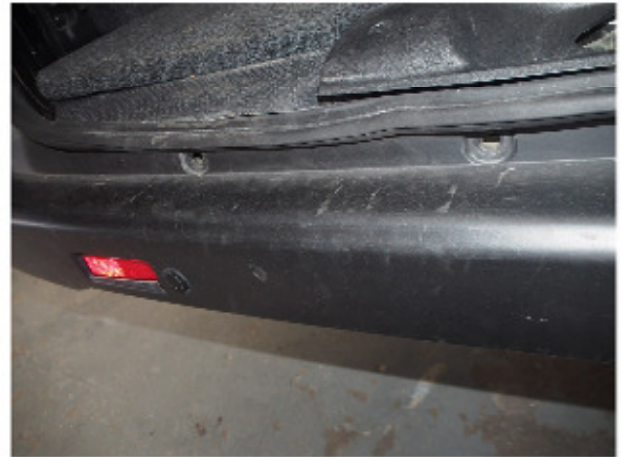
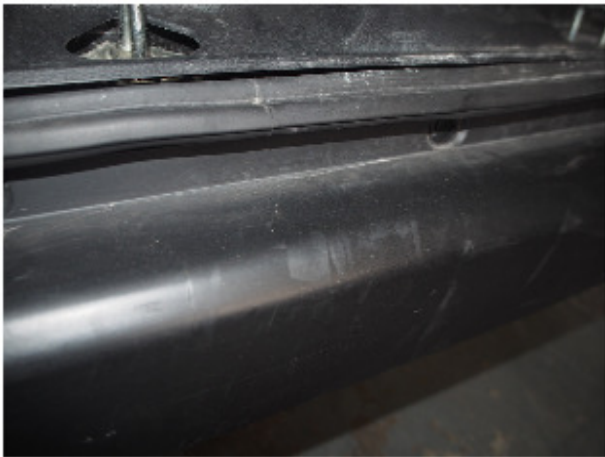
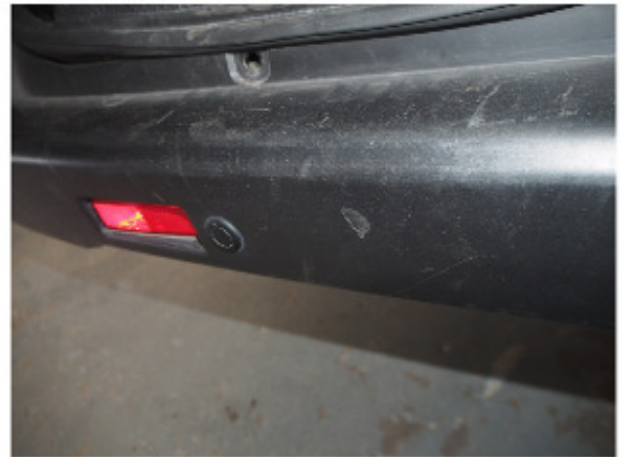
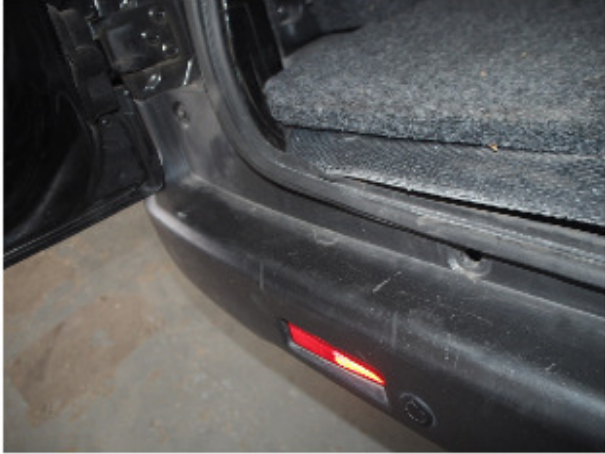
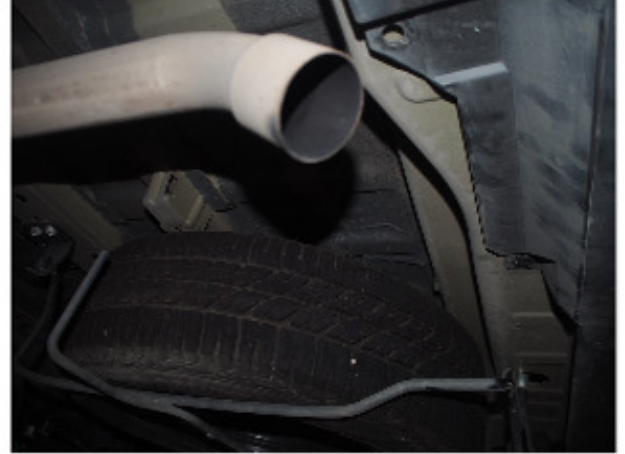
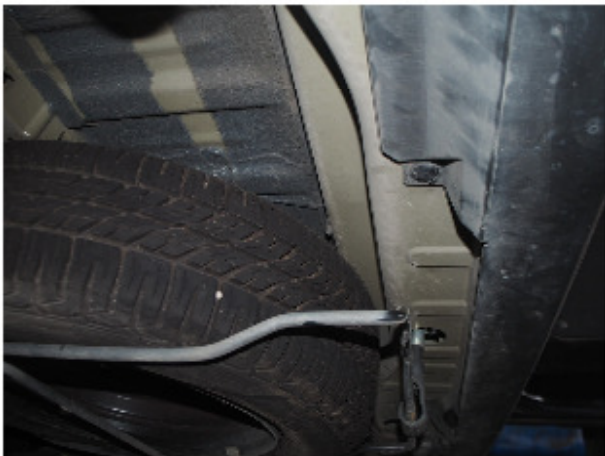
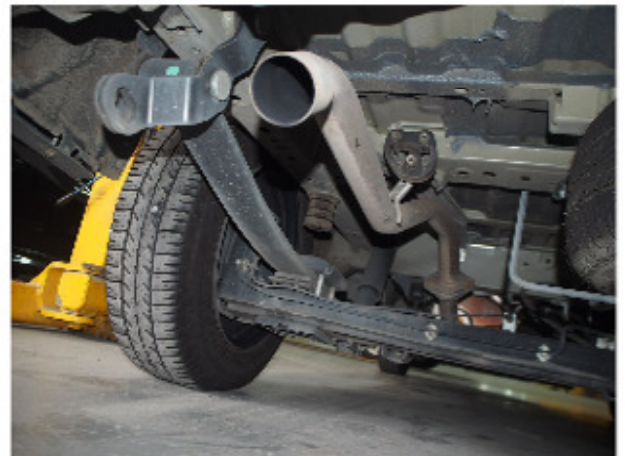
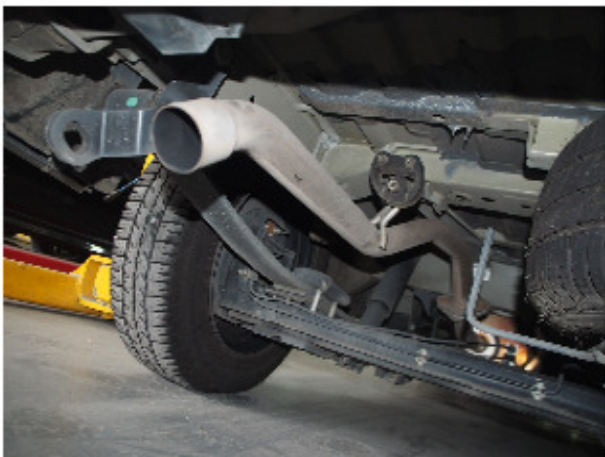
INSPECTION

THE VEHICLE SUSTAINED DAMAGES AT THE REAR PORTION.

Qty	Description of Parts	Condition	Estimate By Workshop (\$)	Our Adjusted (\$)
<u>REPLACEMENT OF PARTS</u>				
1	REAR BUMPER	DEFORMED	566.80	566.80
2	REAR BUMPER SIDE RETAINER @\$52.90	NECESSARY	105.80	105.80
1	REAR BUMPER SPONGE	CRACKED	128.90	128.90
2	TAIL LAMP PANEL @\$271.50	TO REPAIR SEE LABOUR	543.00	-
1	REAR DOOR LH	DISTORTED	2,250.00	1,481.60
1	REAR DOOR RH	DENTED	2,200.00	1,153.70
1	REAR DOOR NUMBER PLATE LAMP GARNISH	CRACKED	379.50	379.50
	LESS 30% DISCOUNT		-1,852.20	-1,144.89
			4,321.80	2,671.41
<u>NETT ITEMS</u>				
2	REAR BUMPER REFLECTOR @\$41.60 (N)	NOT NECESSARY	83.20	-
1	REAR DOOR EMBLEM "NV200" (N)	NECESSARY	87.90	87.90
1	REAR DOOR LOGO (N)	NECESSARY	63.90	63.90
2	REAR DOOR UPPER LOCK @\$128.50 (N)	NOT NECESSARY	257.00	-
2	REAR DOOR LOWER LOCK @\$128.50 (N)	DAMAGED	257.00	257.00
2	REAR DOOR MECHANISM @\$128.50 (N)	NOT NECESSARY	257.00	-
4	REAR DOOR HINGE @\$99.60 (N)	NOT NECESSARY	398.40	-

2	REAR DOOR CHECKER @\$87.00 (N)	NOT NECESSARY	174.00	-
2	REAR DOOR GLASS MOULDING @\$150.00 (N)	NECESSARY	300.00	170.00
2	TAILLAMP @\$280.90 (N)	N/S CRACKED	561.80	280.90
1	REAR END PANEL (N)	DENTED	630.00	630.00
1	REAR END PANEL TOP GARNISH (N)	DEFORMED	120.00	120.00
1	REAR END PANEL WEATHERSTRIP (N)	CUT	124.20	124.20
	LESS 10% DISCOUNT		-331.44	-173.39
			2,982.96	1,560.51
<u>SPECIAL NETT ITEMS</u>				
1	REAR BUMPER PLATE (SN)	BENT	30.00	30.00
10	SET REAR BUMPER CLIP @\$6.50 (SN)	NECESSARY	65.00	30.00
2	TAIL LAMP PANEL SEALANT @\$80.00 (SN)	NOT NECESSARY	160.00	-
