## RE-APPRAISAL REPORT

GENERAL INFORMATION			
VAC Ref. No.	: 517828	Claim No.	: MCT17100199
Accident Date	: 06/10/2017	Policy No.	:
Assignment Date	: 06/11/2017		
Report Date	: 10/11/2017		
VEHICLE PARTICULARS			
Vehicle No.	: SJJ3789S	Chassis No.	: MR053HY9305073869
Registration Date	: 11/09/2008	Engine No.	: 1NZX777215
Make	: TOYOTA	Engine Cap.	: 1497CC
Model	: VIOS	Transmission	: AUTOMATIC
		Colour	: WHITE
INSTRUCTIONS			
To provide re-appraisal of repair cost based on documents availed to us. The documents are :			
1) III COVER NOTE			
2) LAWYER COVER NOTE			
3) GIA REPORT			
4) PHOTOGRAPHS			
5) THIRD PARTY SURVEY REPORT			
6) WORKSHOP REPAIRER ESTIMATE			
REMARKS			
[1]Original repair cost	:	S\$ 6,700.00	
[2]Revised repair cost	:	S\$ 2,700.00	
[3]Original recommended repair period	:	9 days	
[4]Revised recommended repair period	:	6 days

SJJ3789S @ 06/10/2017

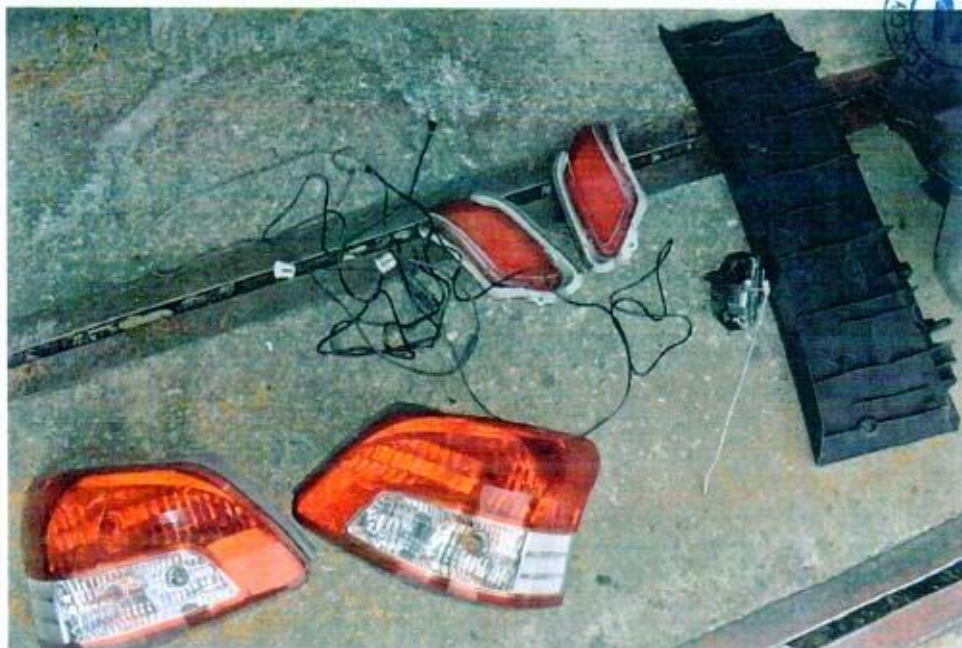
spare light sign tray
