Your Ref : 554594
Our Ref : CS3/MSG18006359/N

20 April 2018

**AUTOMOBILE TECHNICAL INVESTIGATION REPORT OF ACCIDENT
INVOLVING SLN 4634D AND SJT 9999K ON 4 APRIL 2018**

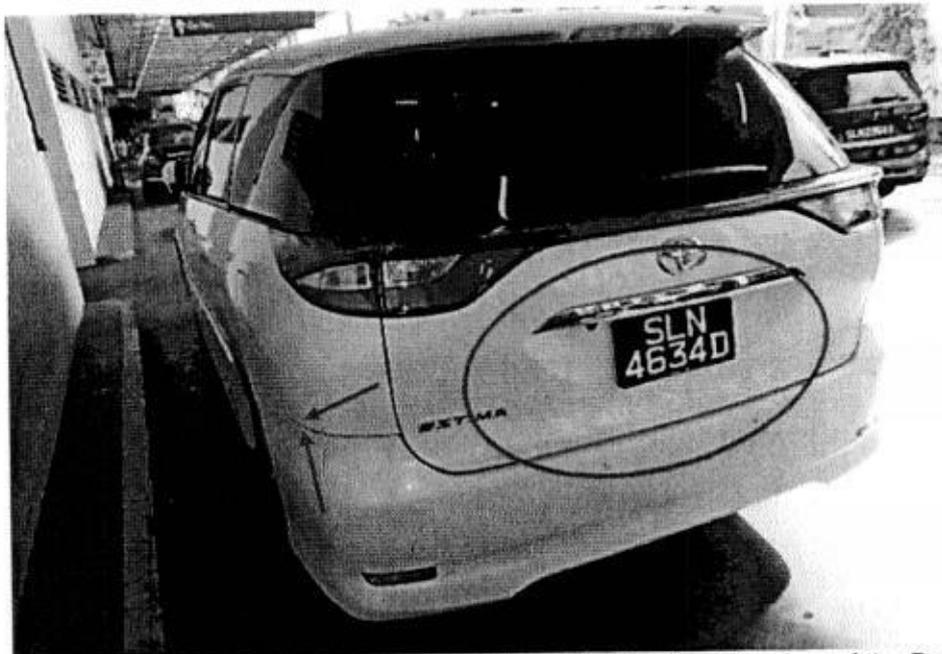
Photo 1 shows a left view of the rear portion of the Toyota at the time of the Pre- Repair Survey conducted by LKK Auto Consultants Pte. Ltd. taken 13 days after the accident. The damages were concentrated at the lower portion of the boot lid and the top portion of the rear bumper (circled). We did not observe any obvious misalignment at the left corner edges of the rear bumper (arrowed).

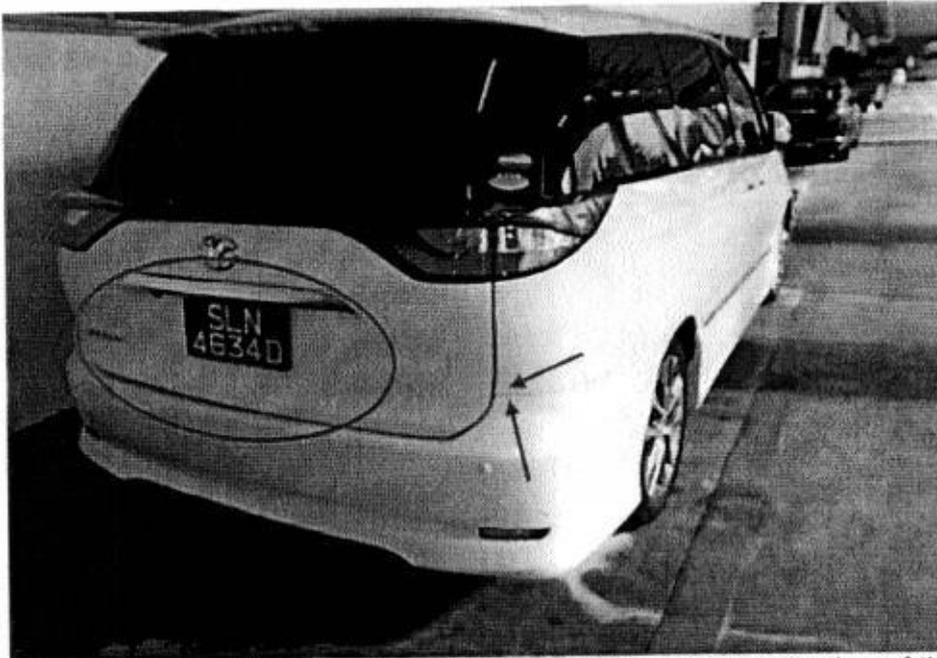
Photo 2 shows a right view of the rear portion of the Toyota at the time of the Pre-Repair Survey conducted by LKK Auto Consultants Pte. Ltd. taken 13 days after the accident. The damages were concentrated at the lower portion of the boot lid and the top portion of the rear bumper (circled). We did not observe any obvious misalignment at the right corner edges of the rear bumper (arrowed).

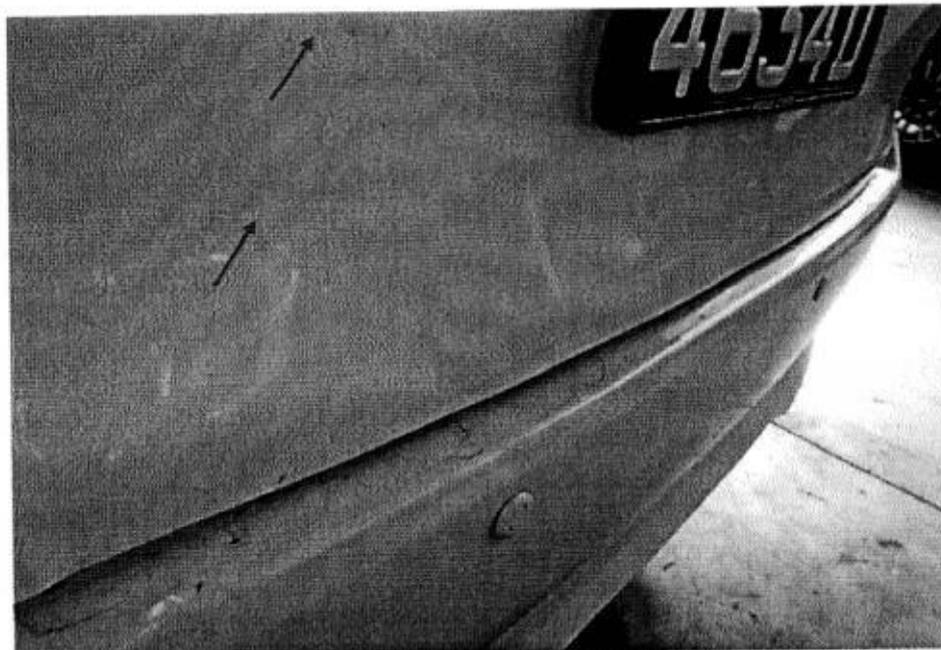
Photo 3 shows a close up view of the 2 parallel horizontal indentations on the lower left portion of the Toyota's boot lid (arrowed).

15. Firstly, the 2 parallel horizontal indentations as well as the rectangular indentation on the lower left portion of the Toyota's boot lid were caused by an object that is of a similar shape, pressing onto the rear portion of the Toyota. If one was to consider the rectangular shape and size of the left blinker light and front grille, it would then appear that these indentations were caused by the left blinker light and the front grille of the Nissan.

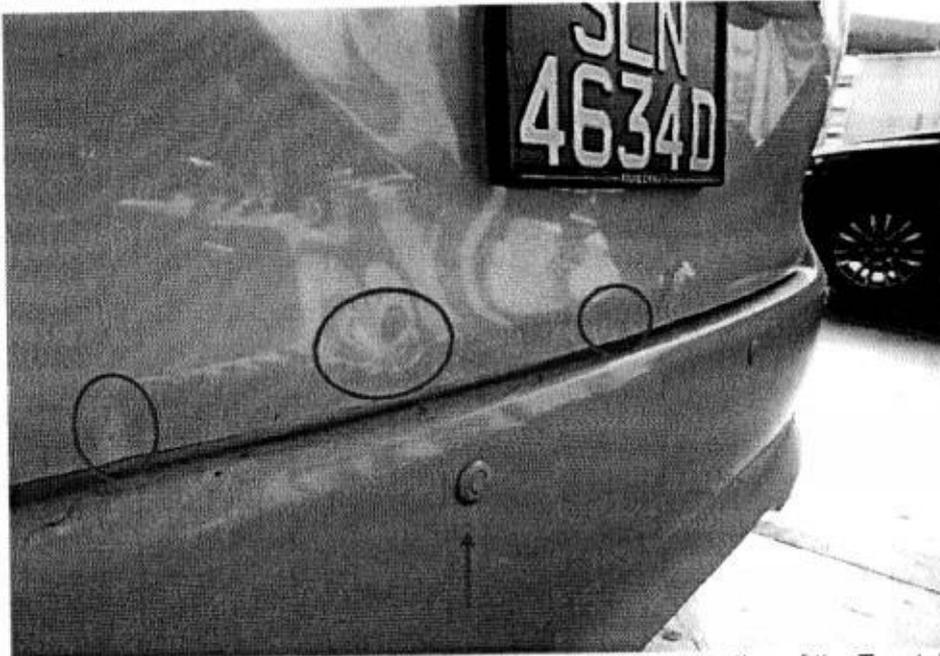
Photo 4 shows a close up view of the dents on the bottom portion of the Toyota's boot lid (circled). We also noticed faint horizontal black marks below the Toyota's left reverse sensor (arrowed).

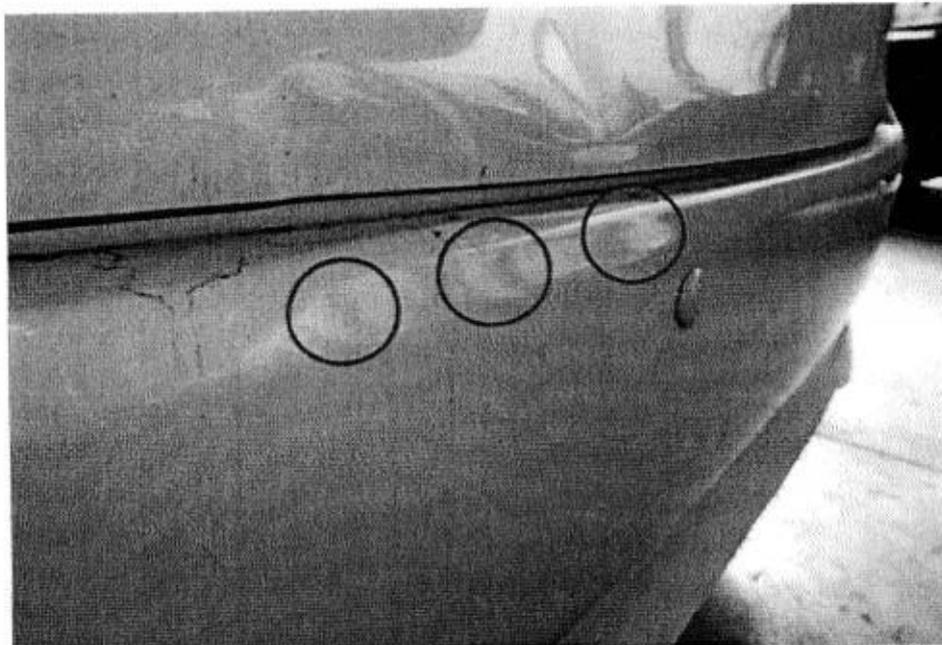
Photo 5 shows a close up view of the dents on the top portion of the Toyota's rear bumper (circled).

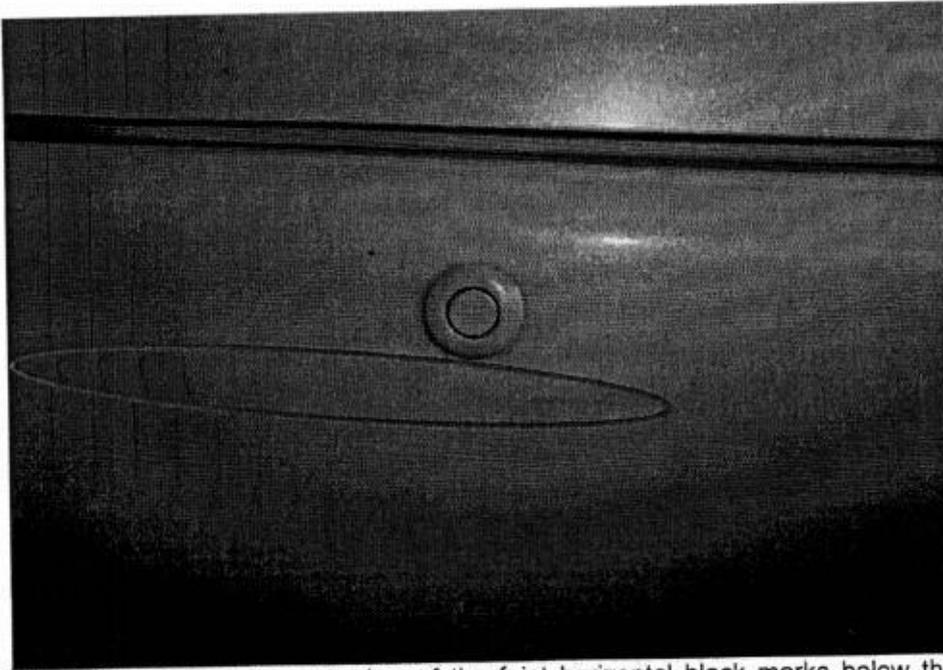
Photo 6 shows a close up view of the faint horizontal black marks below the Toyota's left reverse sensor (circled).

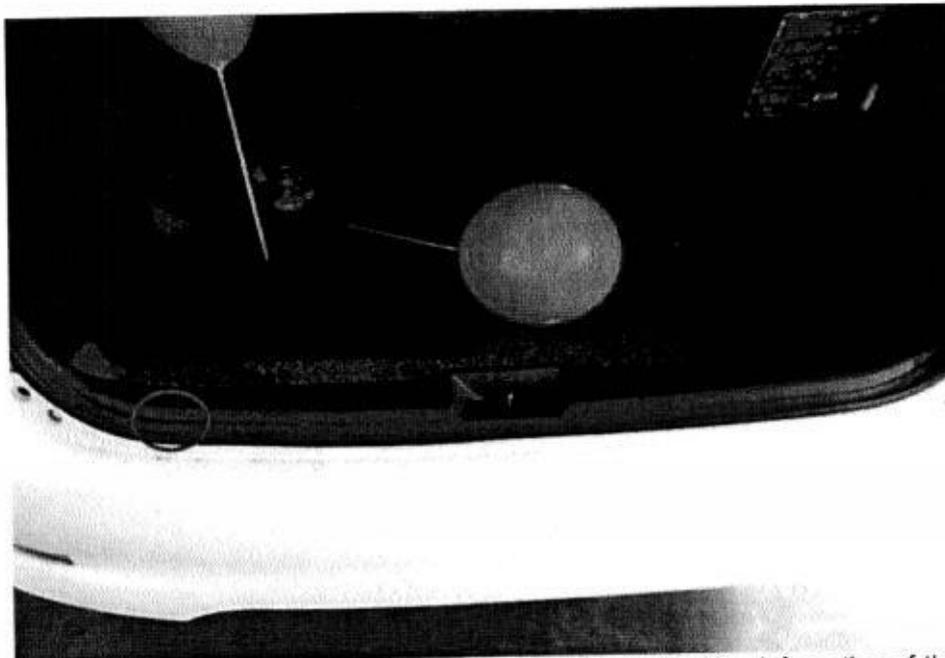
Photo 7 shows a view of the Toyota's rear panel garnish. The left portion of the rear panel garnish rubber lining had been pressed inwards (circled).

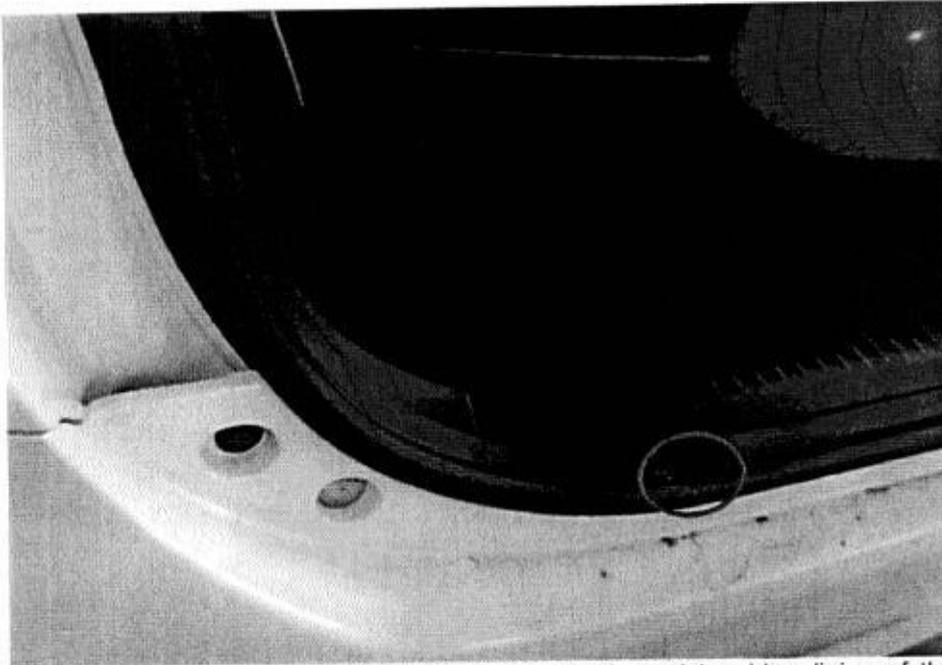
Photo 8 shows a close up view of the rear panel garnish rubber lining of the Toyota had been pressed inwards (circled).

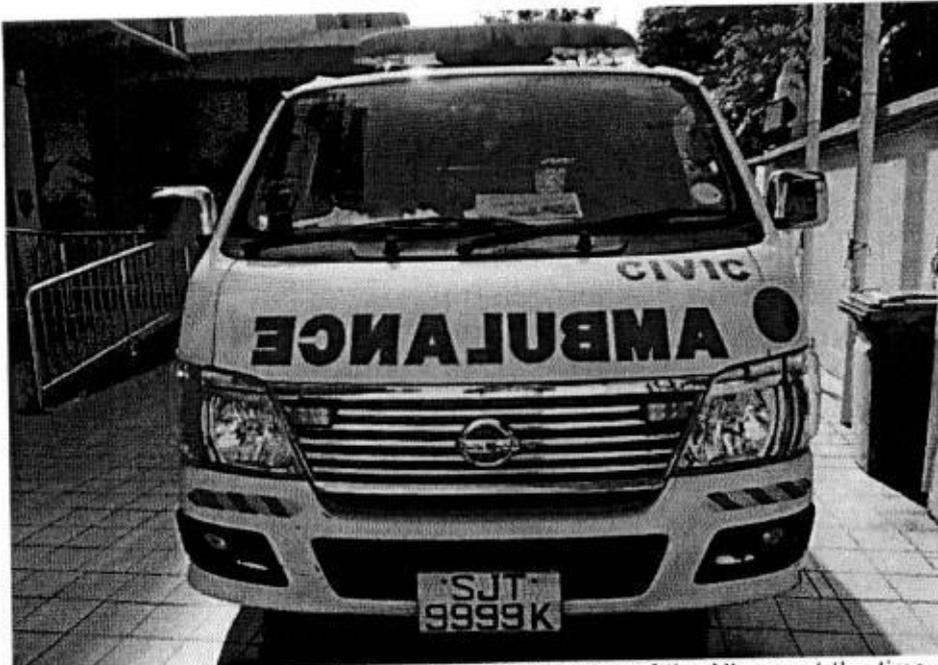
Photo 9 shows the general view of the front portion of the Nissan at the time of our physical inspection. We observed that the Nissan had sustained numerous damages on its front portion as a result of past accidents as mentioned by Mr Singh who was present during our physical inspection.

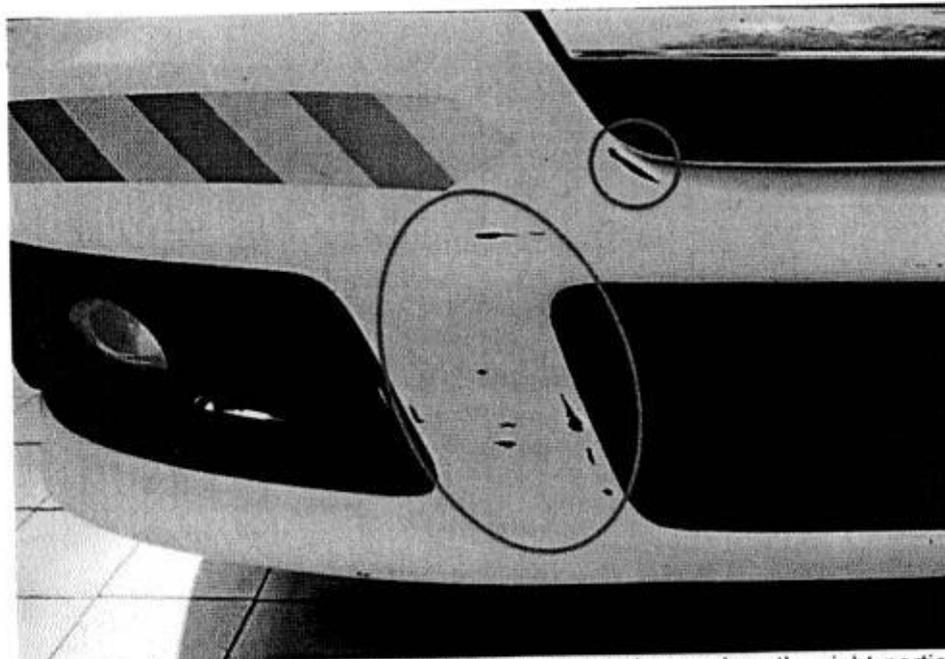
Photo 10 shows the numerous black graze marks observed on the right portion of the Nissan's front bumper (circled).

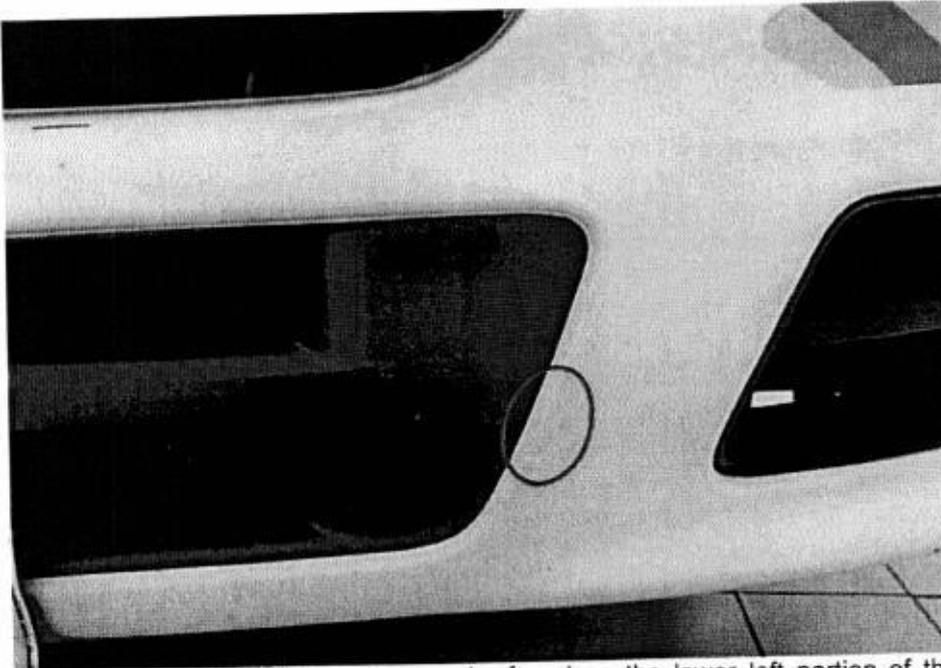
Photo 11 shows the paint graze marks found on the lower left portion of the Nissan's front bumper (circled).

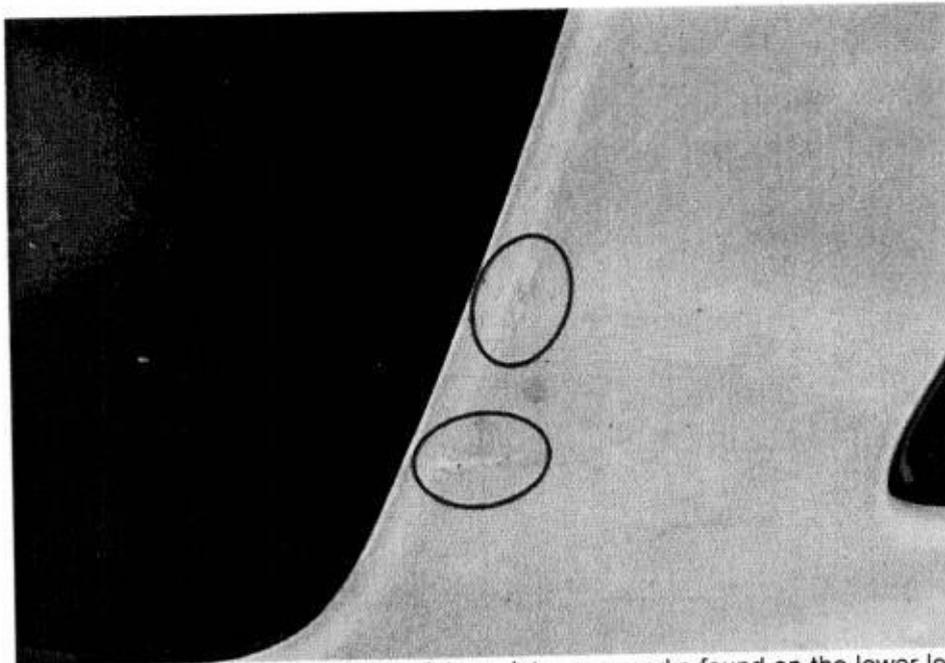
Photo 12 shows a close up view of the paint graze marks found on the lower left portion of the Nissan's front bumper (circled).

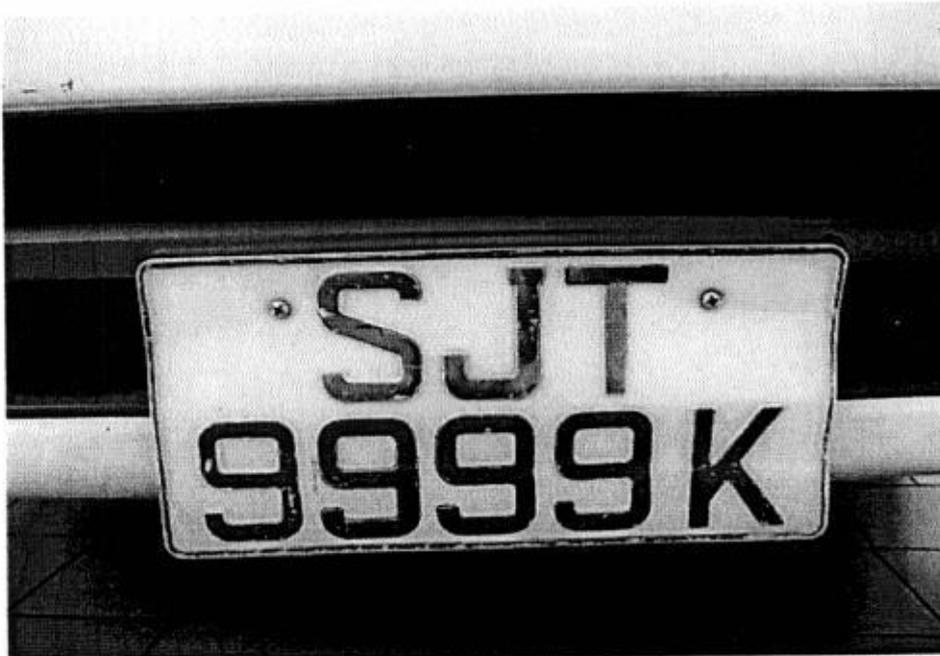
Photo 13 shows the Nissan's front number plate which was observed to be distorted. There were whitish marks found on the alpha-numeric letterings.

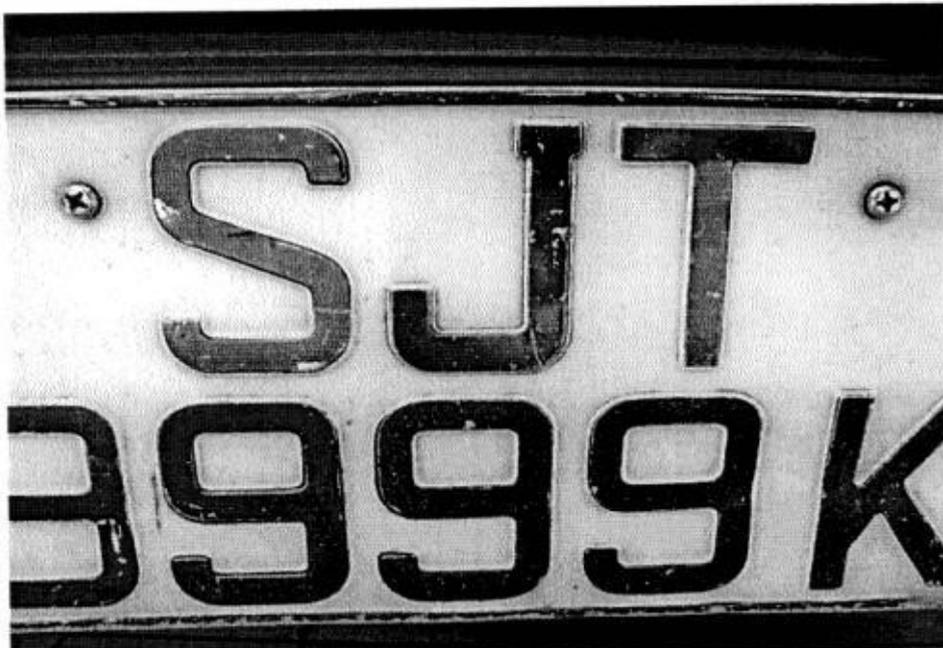
Photo 14 shows a closer view of the whitish marks found on the Nissan's front number plate alpha-numeric letterings.

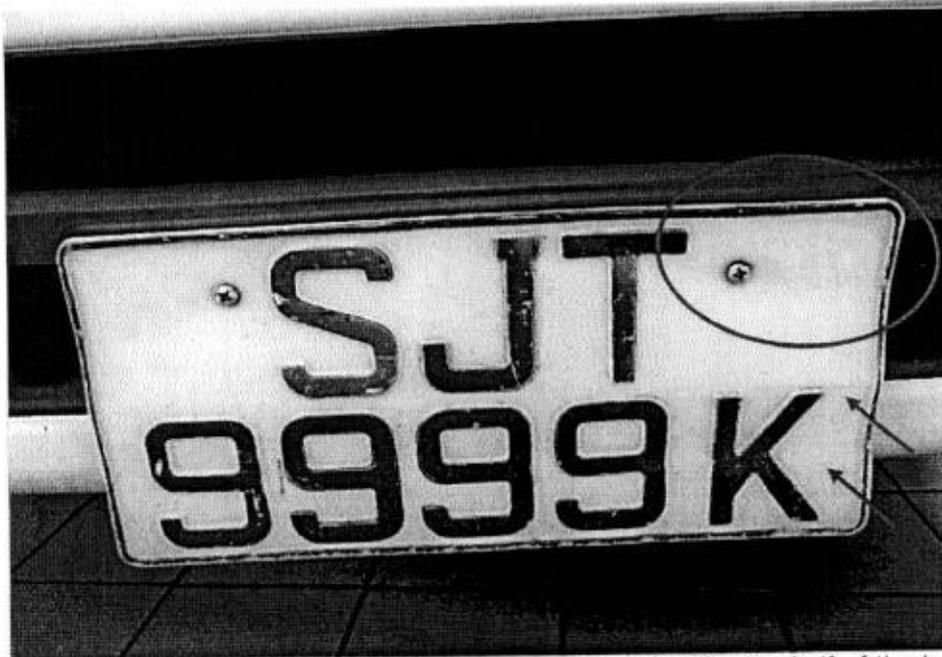
Photo 15 shows upon closer examination, we found that the top half of the left portion of the front number plate had been pushed inwards (circled). There were also 2 slight horizontal dents across the front number plate (arrowed).

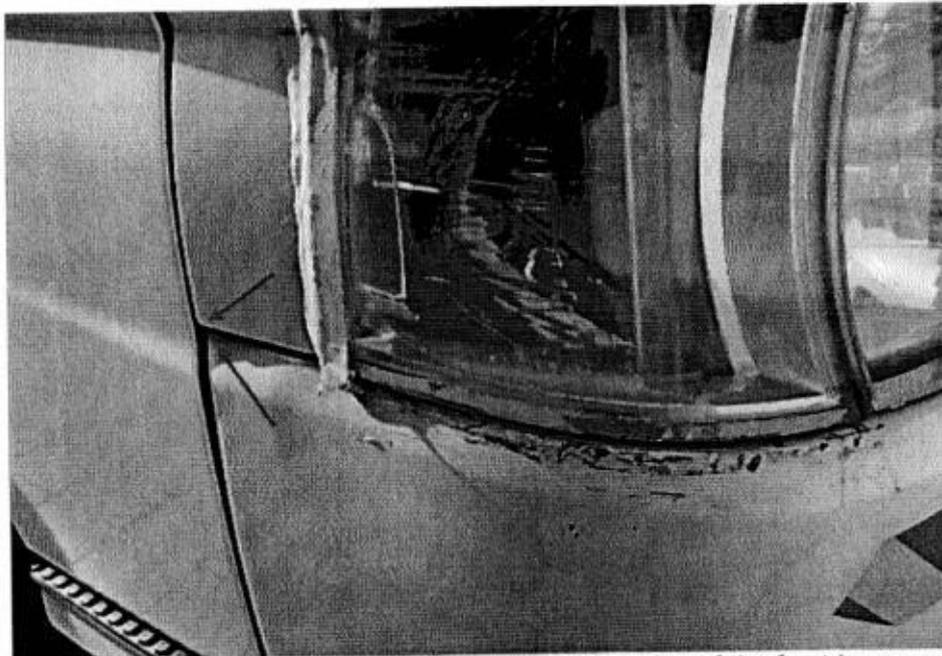
Photo 16 shows a close up view of the right corner edge of the front bumper of the Nissan. We observed that there was a slight misalignment at the corner edges (arrowed).

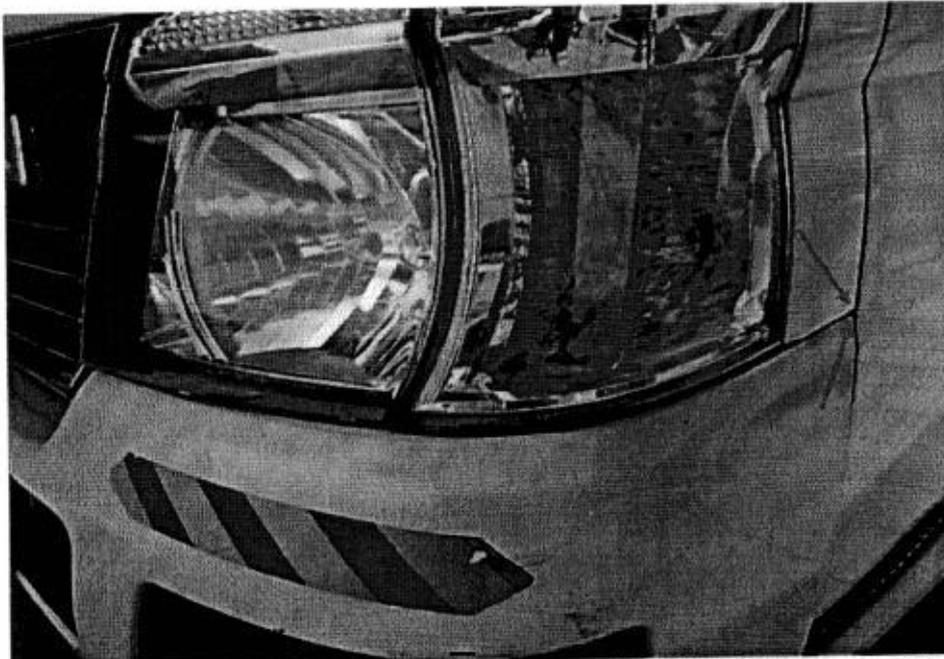
Photo 17 shows a close up view of the left corner edge of the front bumper of the Nissan. We observed that there was a slight misalignment at the corner edges (arrowed).

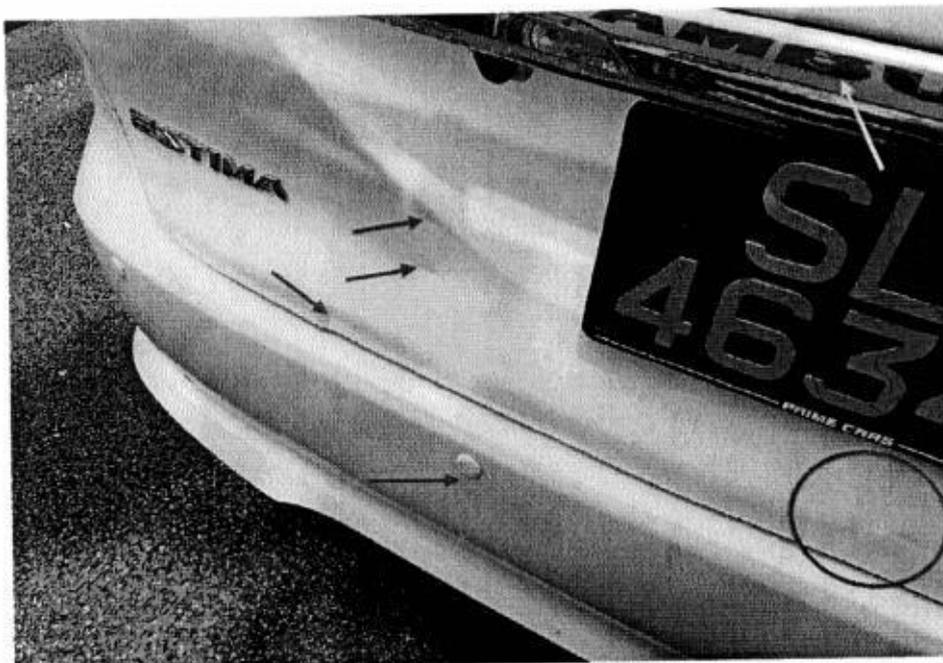
16. Secondly, the circular black marks on the lower centre portion of the Toyota's boot lid, below the rear number plate were most likely caused by an object that is of a similar shape, pressing onto the rear portion of the Toyota. If one was to consider the circular shape and size of the Nissan's front emblem, it would then appear that these circular black marks were caused by the front emblem of the Nissan.

Photo 18 shows the final position of the Toyota at the accident scene. The Nissan was observed to be directly behind the rear of the Toyota based on the silhouette of the Nissan's front portion which can be seen from the rear portion of the Toyota, in particular off the reflection from the tail door trunk lid chrome cover of the Toyota (yellow arrow). We observed the same 2 parallel horizontal indentations and dents on the boot lid as well as the dents and faint horizontal black marks on the rear bumper of the Toyota as per the pre-repair survey photographs of the Toyota (red arrows). We also noticed circular-shaped black marks on the lower centre portion of the Toyota's boot lid, below the rear number plate (circled).

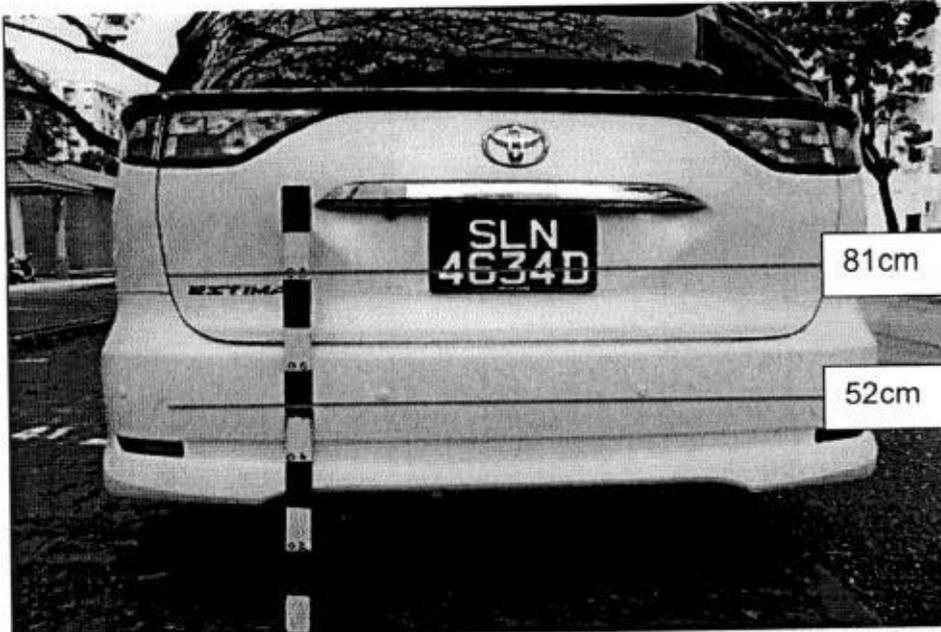
Photo 19 shows the height measurement being conducted on the rear portion of the Toyota. The height above ground level of the lower portion of the Toyota's boot lid, at the area where the highest horizontal indentation was found was measured to be approximately 81cm. The height above ground level of the centre portion of the Toyota's rear bumper below the left reverse sensor, at the area where the faint horizontal black marks were found was measured to be approximately 52cm. The damages on the rear portion of the Toyota were between the ranges of 52cm to 81cm above ground level.

- a) the height above ground level of the lower portion of the Toyota's boot lid, at the area where the highest horizontal indentation was found was measured to be approximately 81cm;

- b) the height above ground level of the centre portion of the Toyota's rear bumper below the left reverse sensor, at the area where the faint horizontal black marks were found was measured to be approximately 52cm;

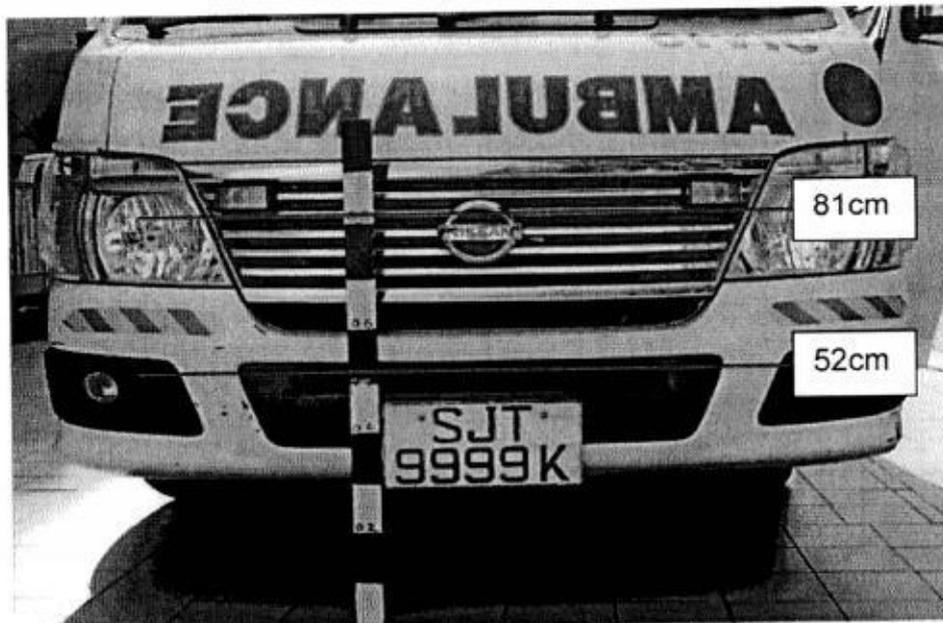
Photo 20 shows the height measurement being conducted on the front portion of the Nissan. The blinker lights, front emblem and front grille of the Nissan are within the 52cm to 81cm height range.

- c) the damages on the rear portion of the Toyota were between the ranges of 52cm to 81cm above ground level;
- d) The blinker lights, front emblem and front grille of the Nissan are within the 52cm to 81cm height range;

- e) the height measurements appear to support the findings of possible contact between the rear portion of the Toyota and the front portion of the Nissan because the point of contact to the rear portion of the Toyota would have been from the left blinker light, front emblem and front grille of the Toyota given that these was the most protruded body parts at the front portion of the Nissan as per our discussions set out in paragraph 17, and also the height range of these body parts above ground level had corresponded to the height above ground level of the damages found on the rear portion of the Toyota.
