Your Ref : 554594  
Our Ref : CS3/MSG18006359/N

20 April 2018

**AUTOMOBILE TECHNICAL INVESTIGATION REPORT OF ACCIDENT  
INVOLVING SLN 4634D AND SJT 9999K ON 4 APRIL 2018**

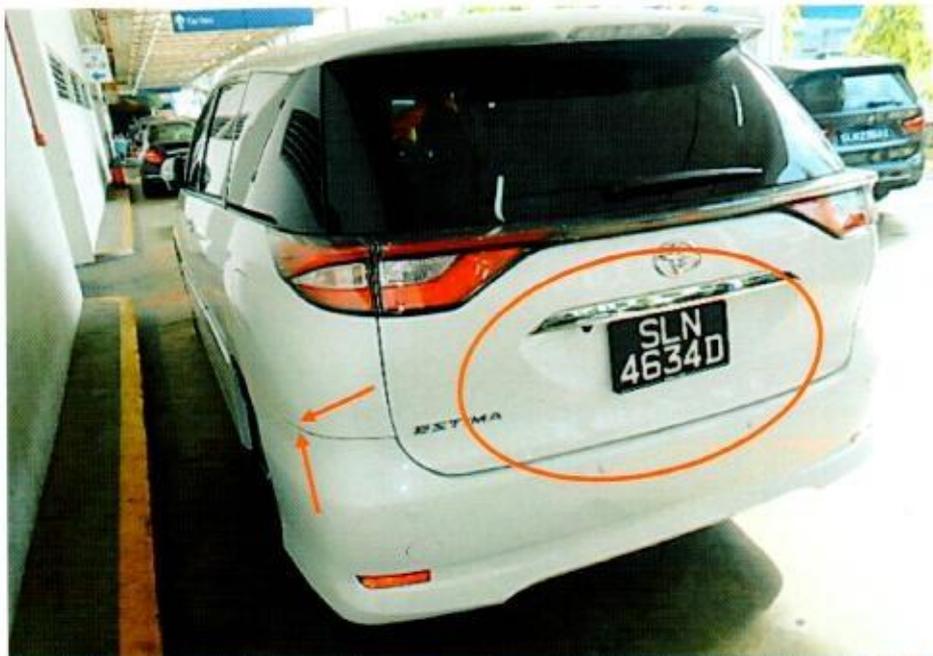
8. Our examination of the photographs taken during the Pre- Repair Survey conducted by LKK Auto Consultants Pte. Ltd. 13 days after the accident revealed 2 parallel horizontal indentations on the lower left portion of the boot lid. We observed dents on the bottom portion of the boot lid as well as on the top portion of the rear bumper of the Toyota. The left portion of the rear panel garnish rubber lining had been pressed inwards. We also noticed faint horizontal black marks below the Toyota's left reverse sensor.
9. In general, these physical damages observed on the rear portion of the Toyota indicate that it had sustained an impact directly onto its rear portion. This impact was relatively light as we did not observe any obvious misalignment at the corner edges of the rear bumper. See photos 1 - 8 below.

**Photo 1** shows a left view of the rear portion of the Toyota at the time of the Pre- Repair Survey conducted by LKK Auto Consultants Pte. Ltd. taken 13 days after the accident. The damages were concentrated at the lower portion of the boot lid and the top portion of the rear bumper (circled). We did not observe any obvious misalignment at the left corner edges of the rear bumper (arrowed).

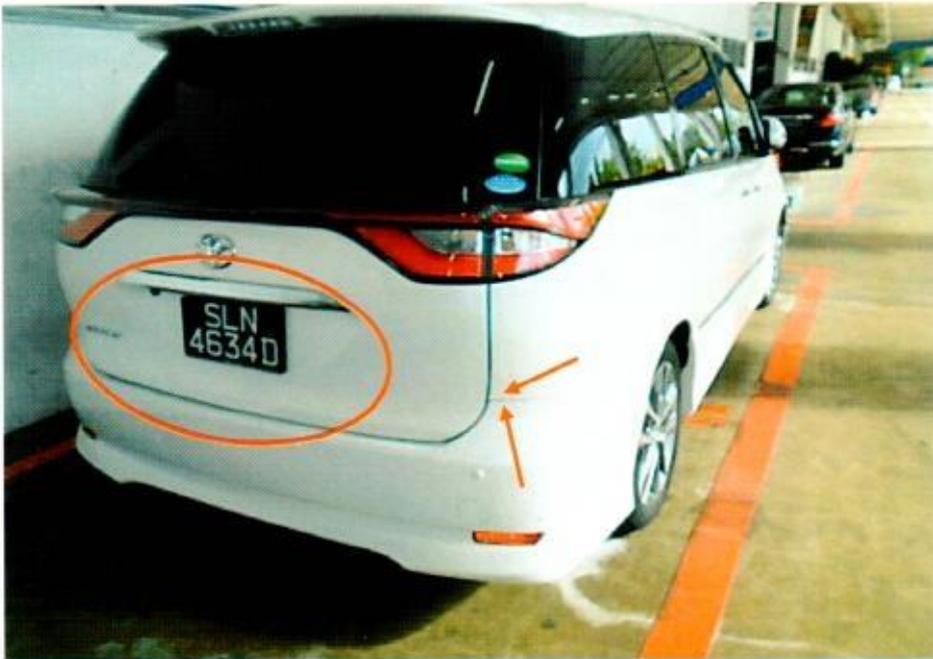
**Photo 2** shows a right view of the rear portion of the Toyota at the time of the Pre-Repair Survey conducted by LKK Auto Consultants Pte. Ltd. taken 13 days after the accident. The damages were concentrated at the lower portion of the boot lid and the top portion of the rear bumper (circled). We did not observe any obvious misalignment at the right corner edges of the rear bumper (arrowed).

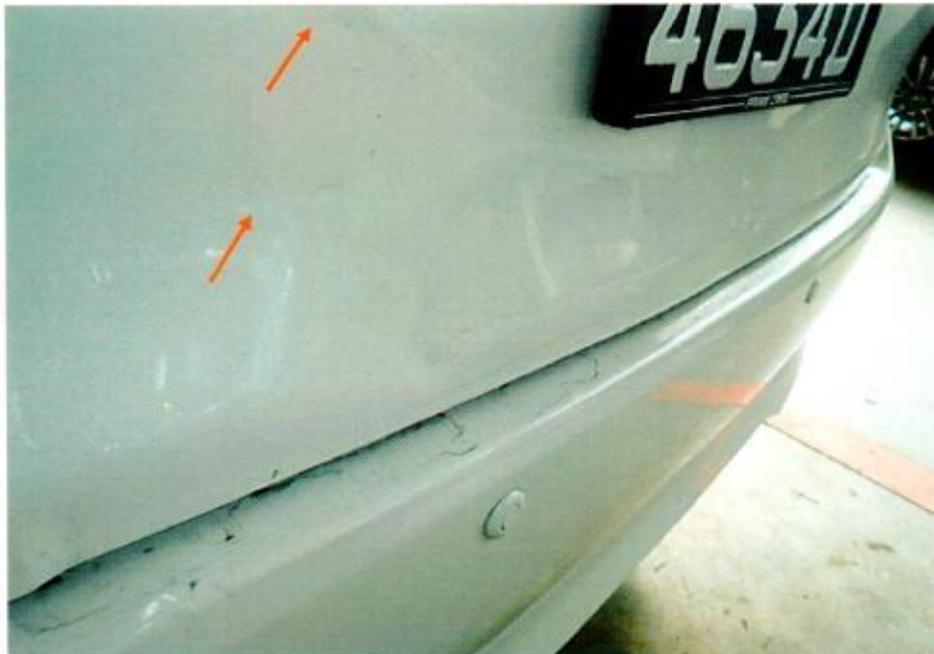
**Photo 3** shows a close up view of the 2 parallel horizontal indentations on the lower left portion of the Toyota's boot lid (arrowed).

15. Firstly, the 2 parallel horizontal indentations as well as the rectangular indentation on the lower left portion of the Toyota's boot lid were caused by an object that is of a similar shape, pressing onto the rear portion of the Toyota. If one was to consider the rectangular shape and size of the left blinker light and front grille, it would then appear that these indentations were caused by the left blinker light and the front grille of the Nissan.

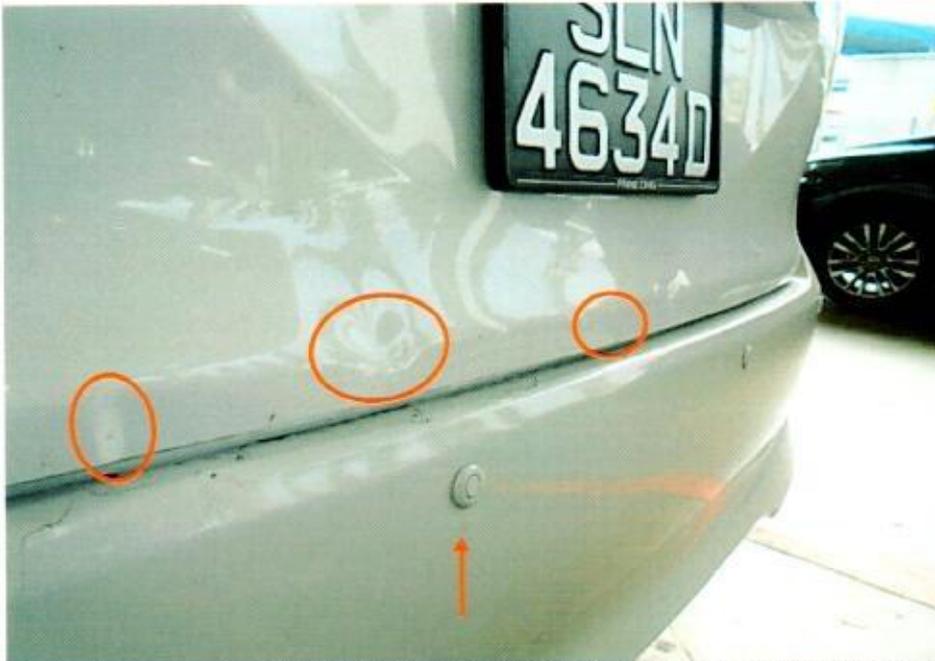
**Photo 4** shows a close up view of the dents on the bottom portion of the Toyota's boot lid (circled). We also noticed faint horizontal black marks below the Toyota's left reverse sensor (arrowed).

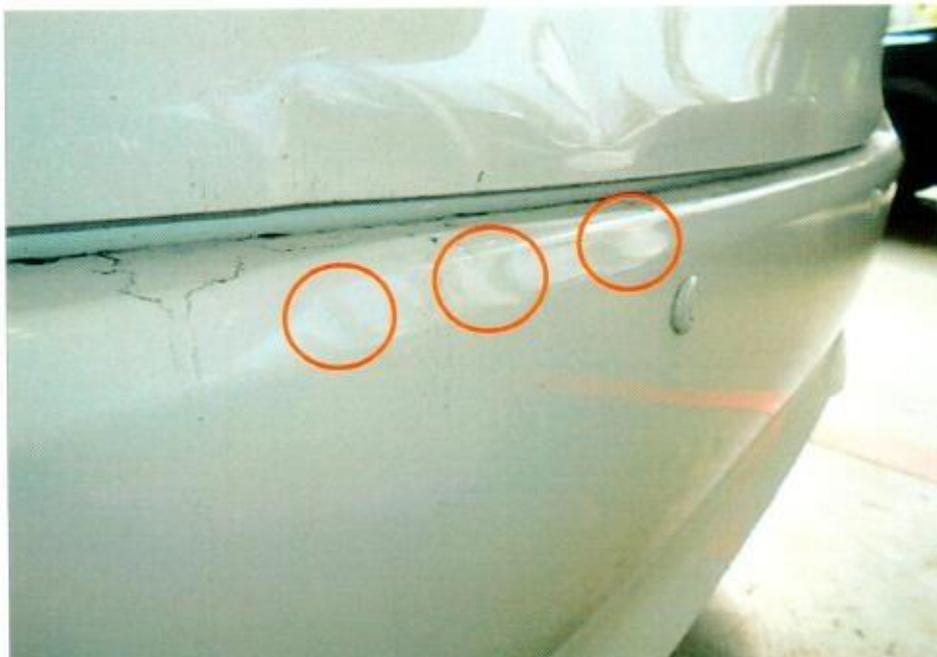
**Photo 5** shows a close up view of the dents on the top portion of the Toyota's rear bumper (circled).

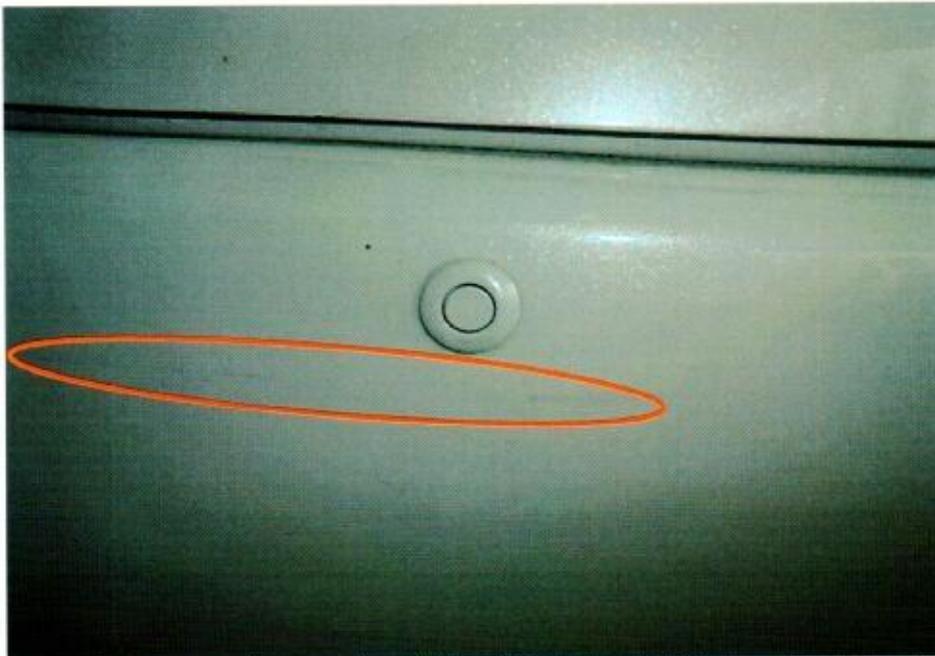
**Photo 6** shows a close up view of the faint horizontal black marks below the Toyota's left reverse sensor (circled).

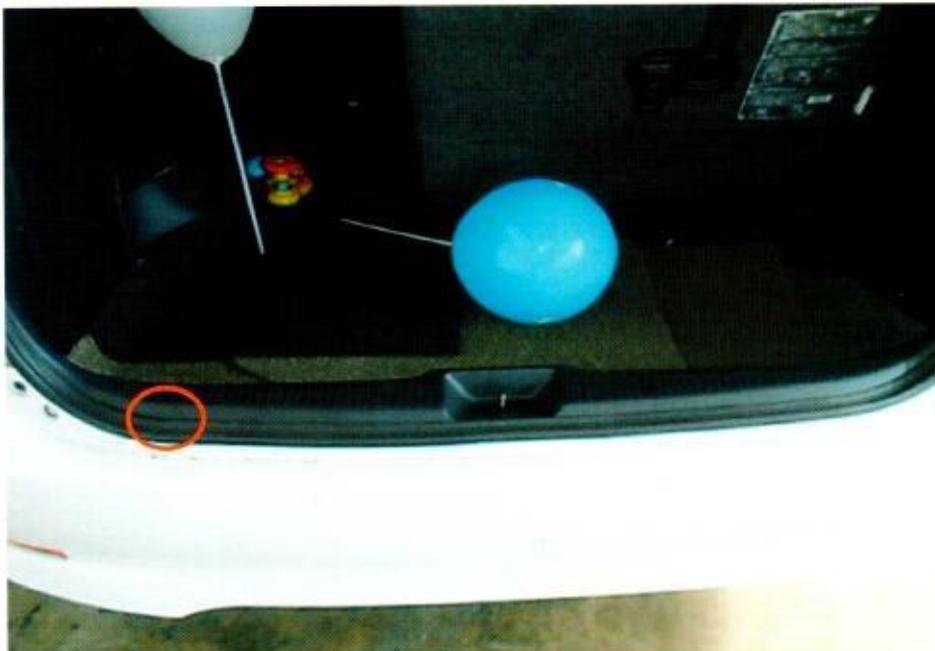
**Photo 7** shows a view of the Toyota's rear panel garnish. The left portion of the rear panel garnish rubber lining had been pressed inwards (circled).

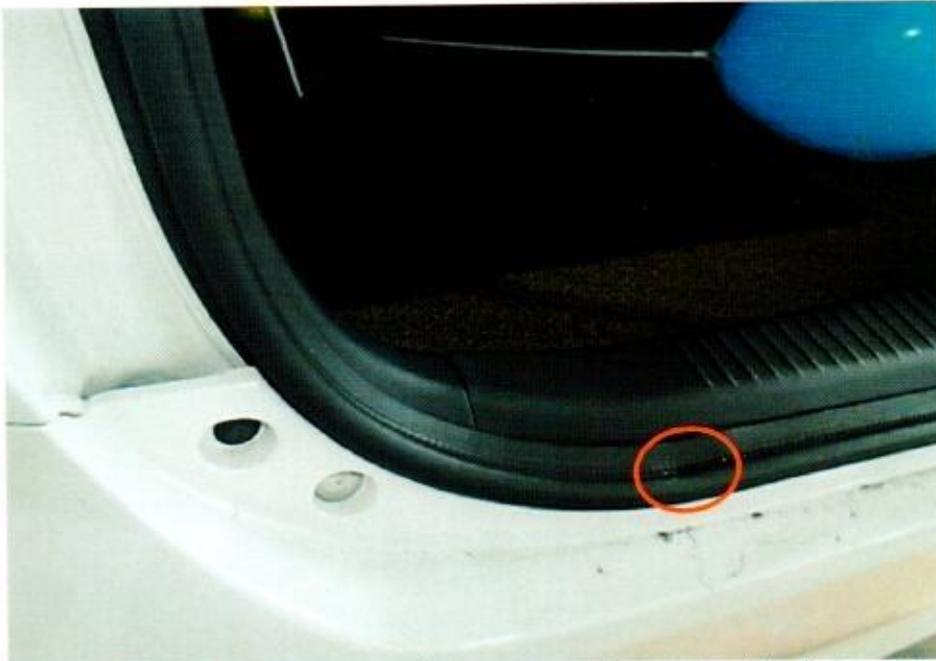
**Photo 8** shows a close up view of the rear panel garnish rubber lining of the Toyota had been pressed inwards (circled).

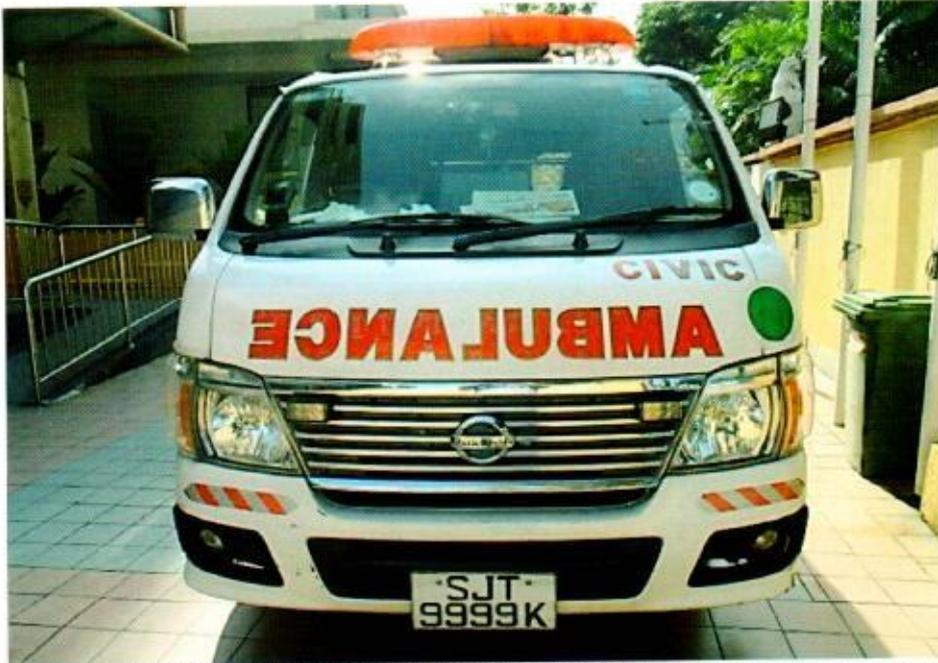
11. The mileage recorded was 258, 890km.
12. At the time of our inspection, we observed that the Nissan had sustained numerous damages on its front portion as a result of past accidents as mentioned by Mr Singh who was present during the physical inspection. We observed numerous black graze marks on the right portion of the front bumper. Paint graze marks were found on the lower left portion of the front bumper. We noticed that the Nissan's front number plate was distorted. Upon closer examination, we found that the top half of the left portion of the front number plate had been pushed inwards. There were 2 slight horizontal dents across the front number plate. There were whitish marks on the alpha- numeric letterings. The front bumper was misaligned at its corner edges. See photos 9 – 17 below.

Photo 9 shows the general view of the front portion of the Nissan at the time of our physical inspection. We observed that the Nissan had sustained numerous damages on its front portion as a result of past accidents as mentioned by Mr Singh who was present during our physical inspection.

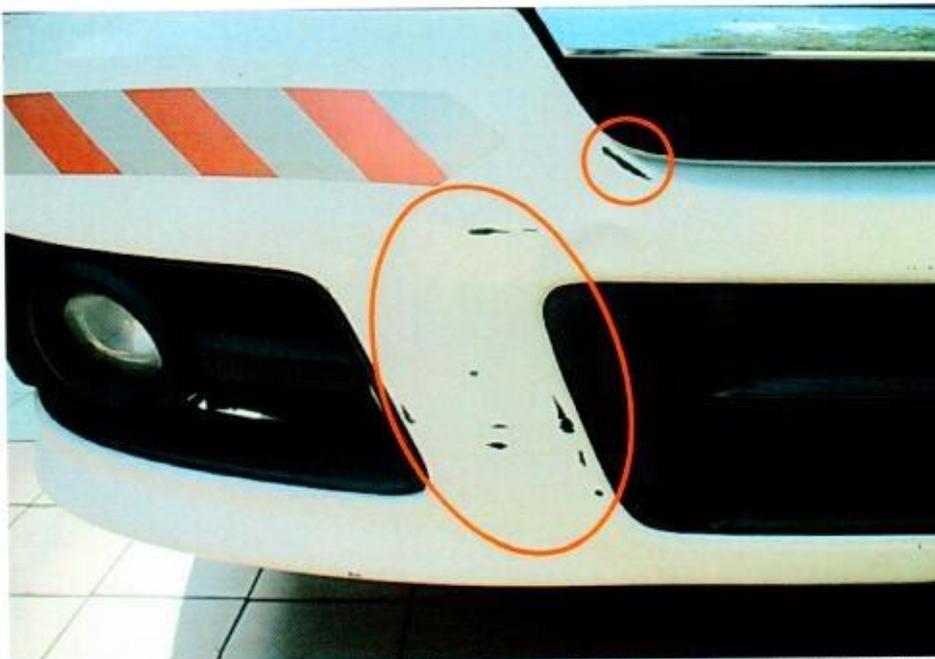
Photo 10 shows the numerous black graze marks observed on the right portion of the Nissan's front bumper (circled).

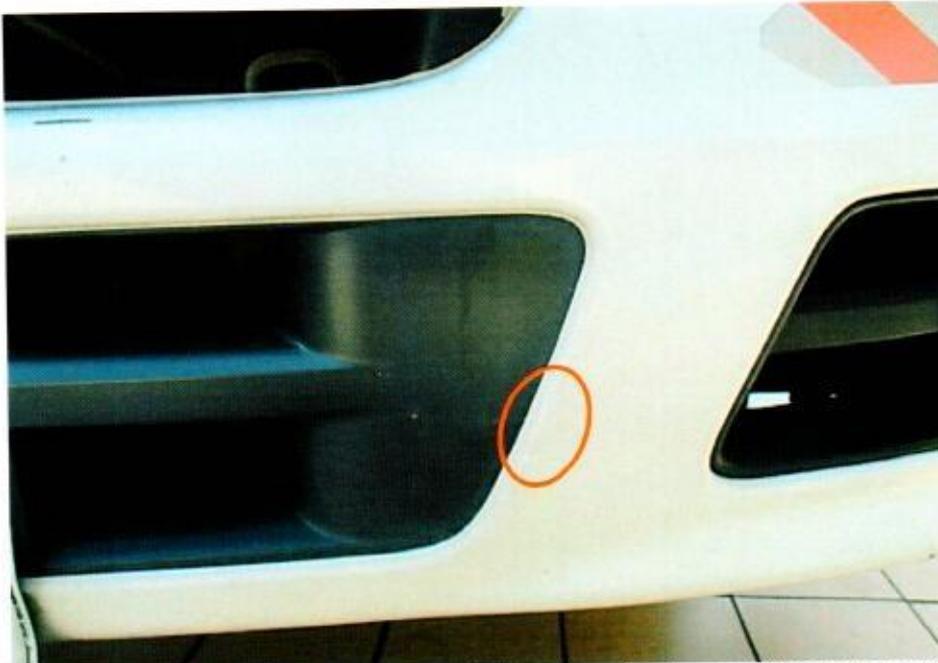
**Photo 11** shows the paint graze marks found on the lower left portion of the Nissan's front bumper (circled).

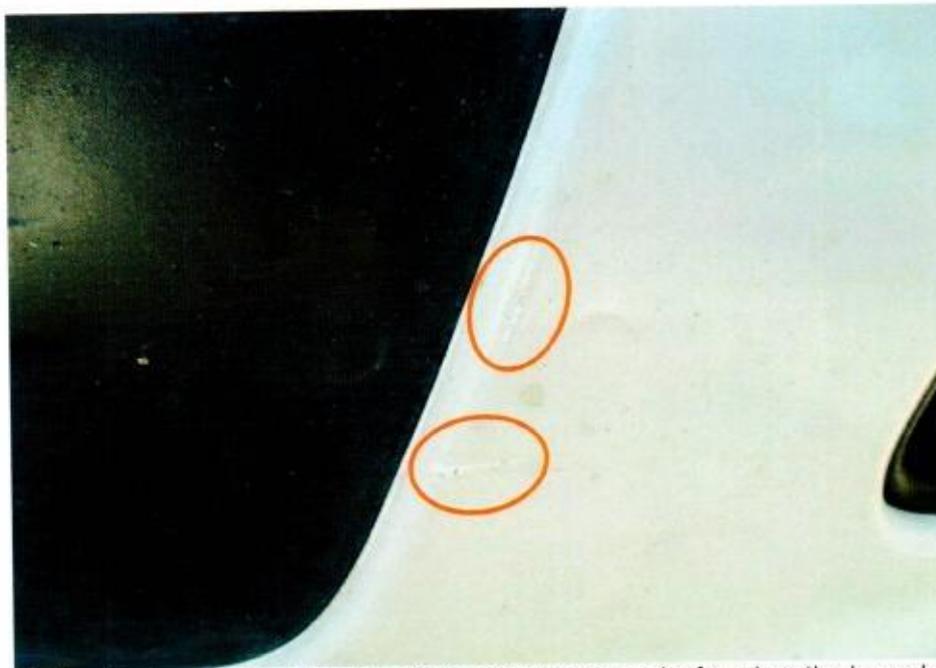
**Photo 12** shows a close up view of the paint graze marks found on the lower left portion of the Nissan's front bumper (circled).

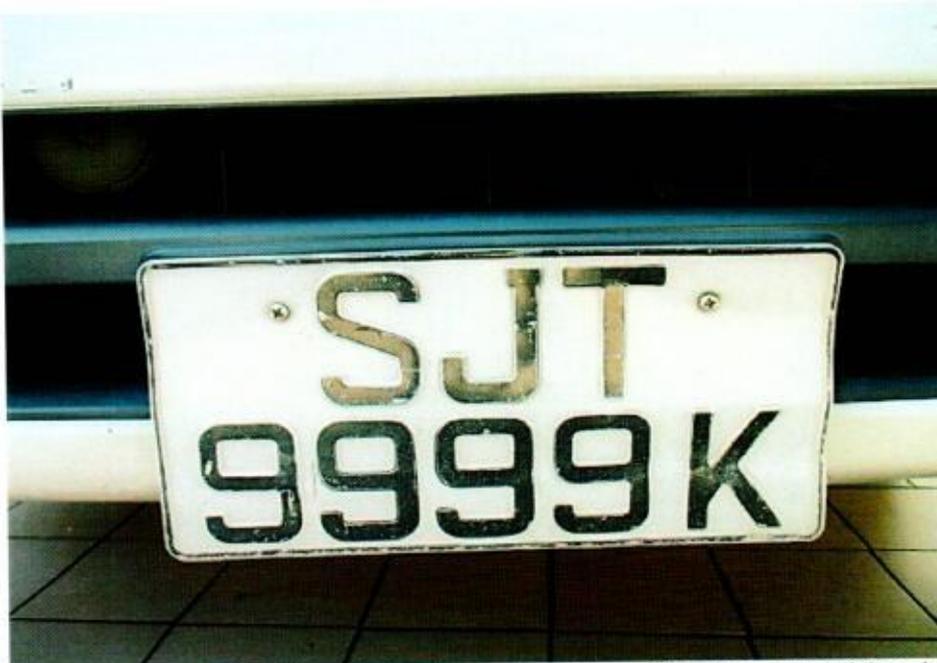
**Photo 13** shows the Nissan's front number plate which was observed to be distorted. There were whitish marks found on the alpha- numeric letterings.

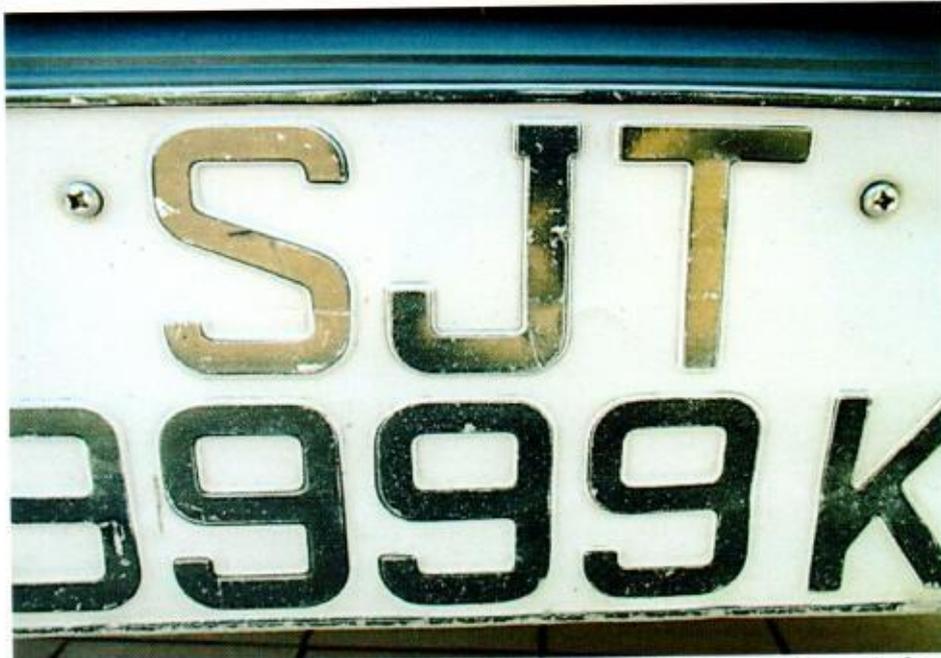
**Photo 14** shows a closer view of the whitish marks found on the Nissan's front number plate alpha- numeric letterings.

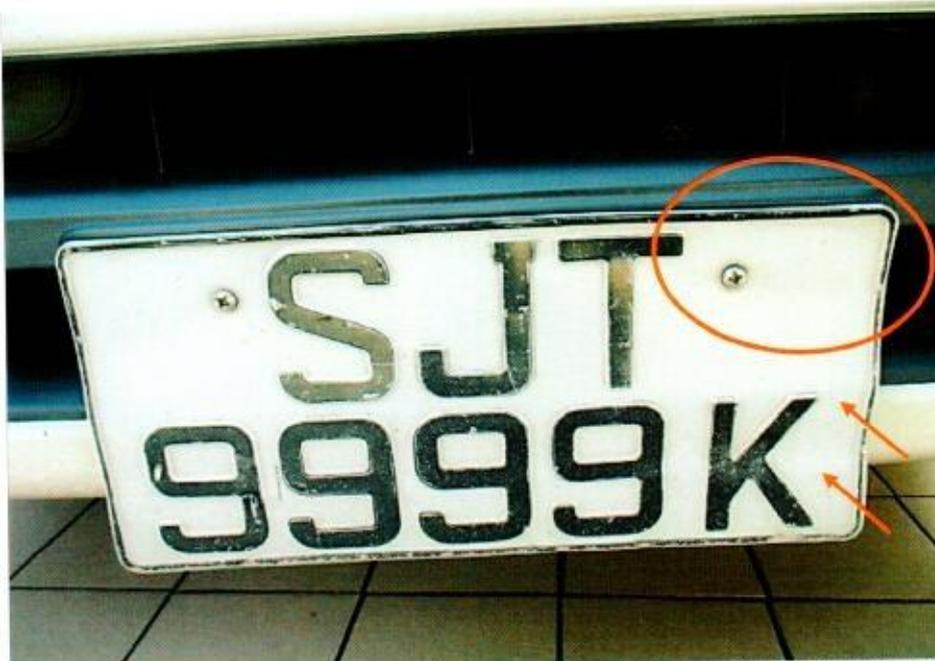
**Photo 15** shows upon closer examination, we found that the top half of the left portion of the front number plate had been pushed inwards (circled). There were also 2 slight horizontal dents across the front number plate (arrowed).

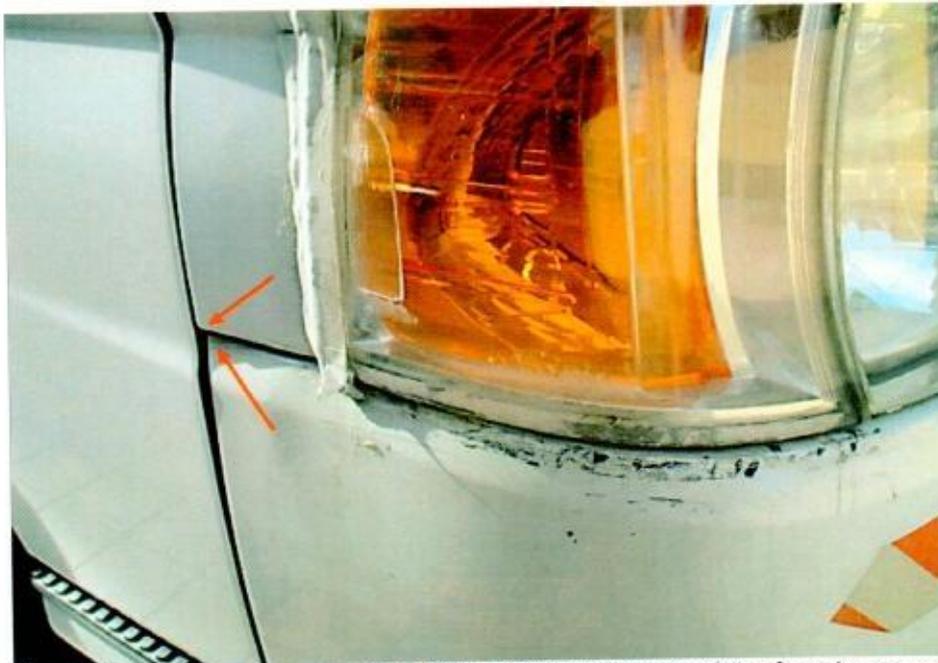
**Photo 16** shows a close up view of the right corner edge of the front bumper of the Nissan. We observed that there was a slight misalignment at the corner edges (arrowed).

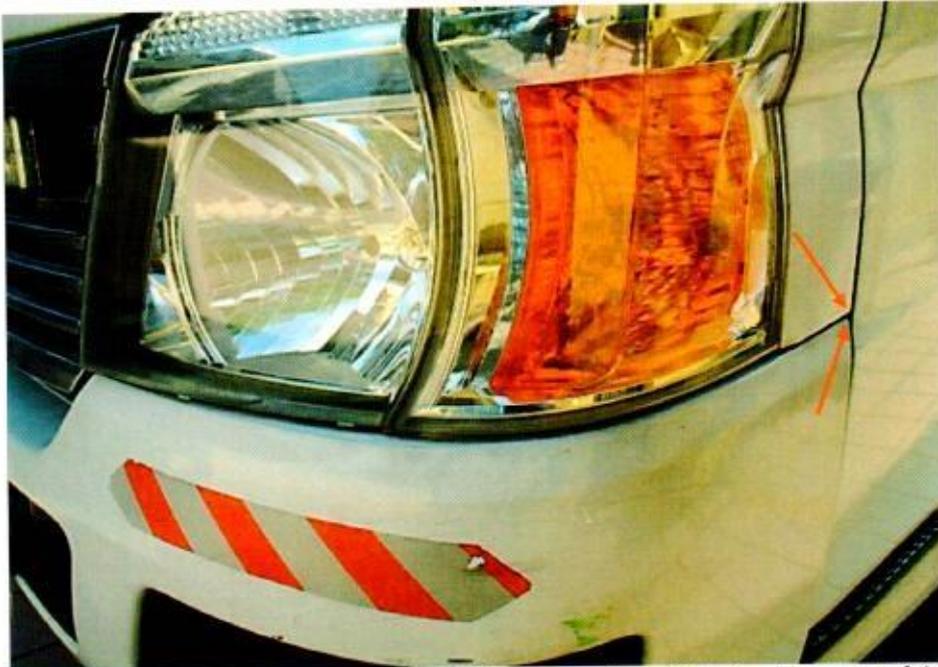
**Photo 17** shows a close up view of the left corner edge of the front bumper of the Nissan. We observed that there was a slight misalignment at the corner edges (arrowed).

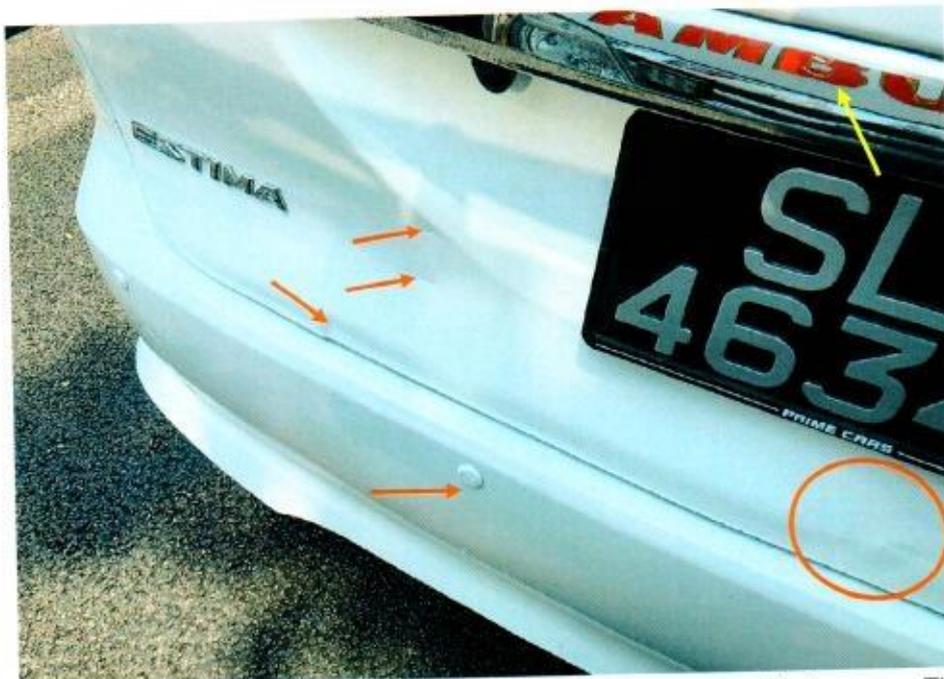
13. For this case, we were able to obtain from Mr Yick a photograph which was taken at the accident scene. It shows the final position of the Toyota at the accident scene. The Nissan was observed to be directly behind the rear of the Toyota based on the silhouette of the Nissan's front portion which can be seen from the rear portion of the Toyota, in particular off the reflection from the tail door trunk lid chrome cover of the Toyota. We observed the same 2 parallel horizontal indentations and dents on the boot lid as well as the dents and faint horizontal black marks on the rear bumper of the Toyota as per the pre-repair survey photographs of the Toyota. We also noticed circular-shaped black marks on the lower centre portion of the Toyota's boot lid, below the rear number plate.

16. Secondly, the circular black marks on the lower centre portion of the Toyota's boot lid, below the rear number plate were most likely caused by an object that is of a similar shape, pressing onto the rear portion of the Toyota. If one was to consider the circular shape and size of the Nissan's front emblem, it would then appear that these circular black marks were caused by the front emblem of the Nissan.

17. In the event of any contact, the blinker lights, front emblem and grille of the Nissan would have come into contact with the rear portion of the Toyota as these were the most protruded body parts at the frontal portion of the Nissan. See photo 18 below.

**Photo 18** shows the final position of the Toyota at the accident scene. The Nissan was observed to be directly behind the rear of the Toyota based on the silhouette of the Nissan's front portion which can be seen from the rear portion of the Toyota, in particular off the reflection from the tail door trunk lid chrome cover of the Toyota (yellow arrow). We observed the same 2 parallel horizontal indentations and dents on the boot lid as well as the dents and faint horizontal black marks on the rear bumper of the Toyota as per the pre- repair survey photographs of the Toyota (red arrows). We also noticed circular- shaped black marks on the lower centre portion of the Toyota's boot lid, below the rear number plate (circled).

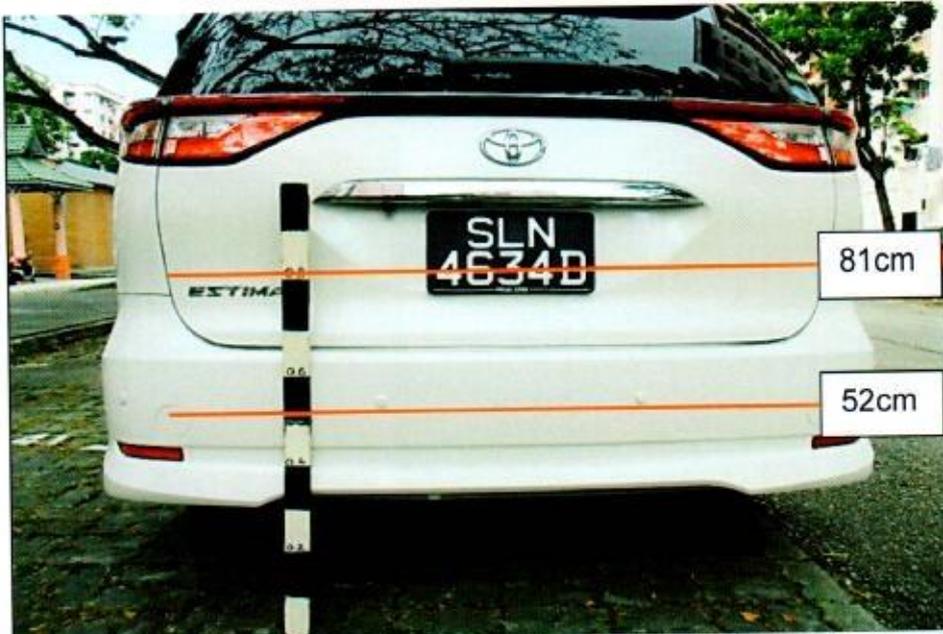
Photo 19 shows the height measurement being conducted on the rear portion of the Toyota. The height above ground level of the lower portion of the Toyota's boot lid, at the area where the highest horizontal indentation was found was measured to be approximately 81cm. The height above ground level of the centre portion of the Toyota's rear bumper below the left reverse sensor, at the area where the faint horizontal black marks were found was measured to be approximately 52cm. The damages on the rear portion of the Toyota were between the ranges of 52cm to 81cm above ground level.

- a) the height above ground level of the lower portion of the Toyota's boot lid, at the area where the highest horizontal indentation was found was measured to be approximately 81cm;

- b) the height above ground level of the centre portion of the Toyota's rear bumper below the left reverse sensor, at the area where the faint horizontal black marks were found was measured to be approximately 52cm;

- c) the damages on the rear portion of the Toyota were between the ranges of 52cm to 81cm above ground level;
- d) The blinker lights, front emblem and front grille of the Nissan are within the 52cm to 81cm height range;

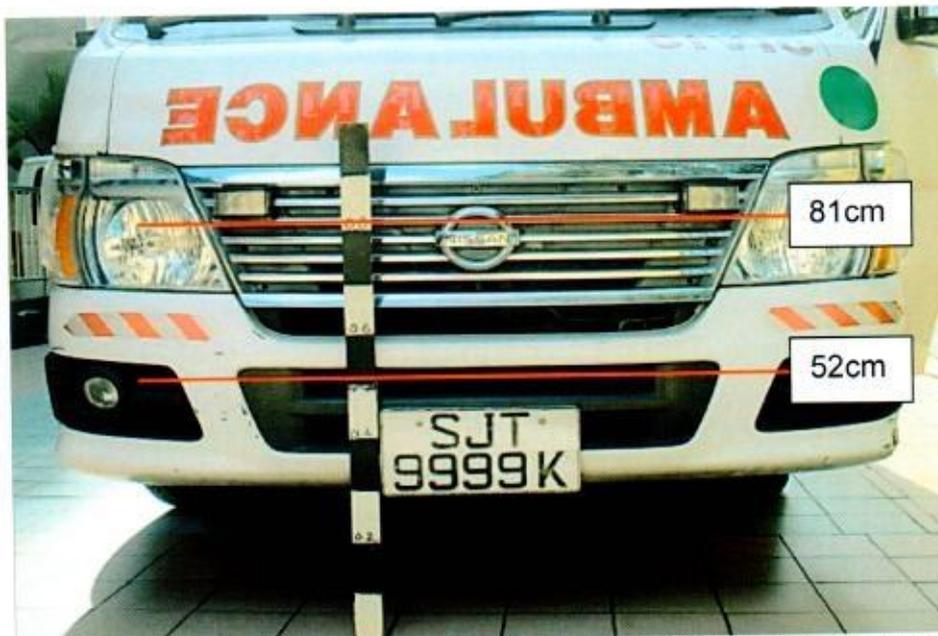
Photo 20 shows the height measurement being conducted on the front portion of the Nissan. The blinker lights, front emblem and front grille of the Nissan are within the 52cm to 81cm height range.

- e) the height measurements appear to support the findings of possible contact between the rear portion of the Toyota and the front portion of the Nissan because the point of contact to the rear portion of the Toyota would have been from the left blinker light, front emblem and front grille of the Toyota given that these was the most protruded body parts at the front portion of the Nissan as per our discussions set out in paragraph 17, and also the height range of these body parts above ground level had corresponded to the height above ground level of the damages found on the rear portion of the Toyota.
