Your Ref : 554594
Our Ref : CS3/MSG18006359/N

20 April 2018

**AUTOMOBILE TECHNICAL INVESTIGATION REPORT OF ACCIDENT
INVOLVING SLN 4634D AND SJT 9999K ON 4 APRIL 2018**

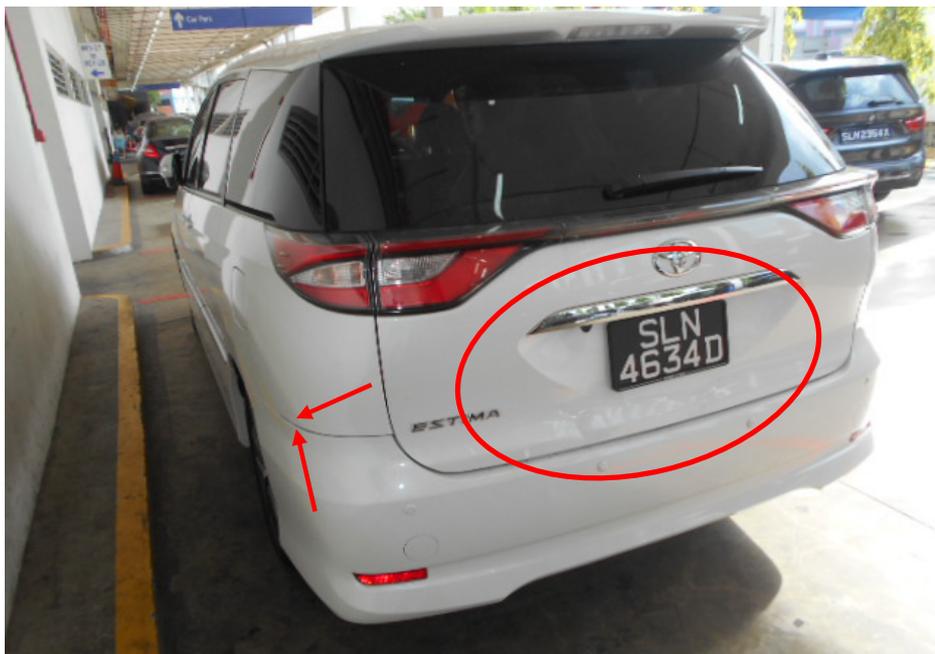
Photo 1 shows a left view of the rear portion of the Toyota at the time of the Pre- Repair Survey conducted by LKK Auto Consultants Pte. Ltd. taken 13 days after the accident. The damages were concentrated at the lower portion of the boot lid and the top portion of the rear bumper (circled). We did not observe any obvious misalignment at the left corner edges of the rear bumper (arrowed).

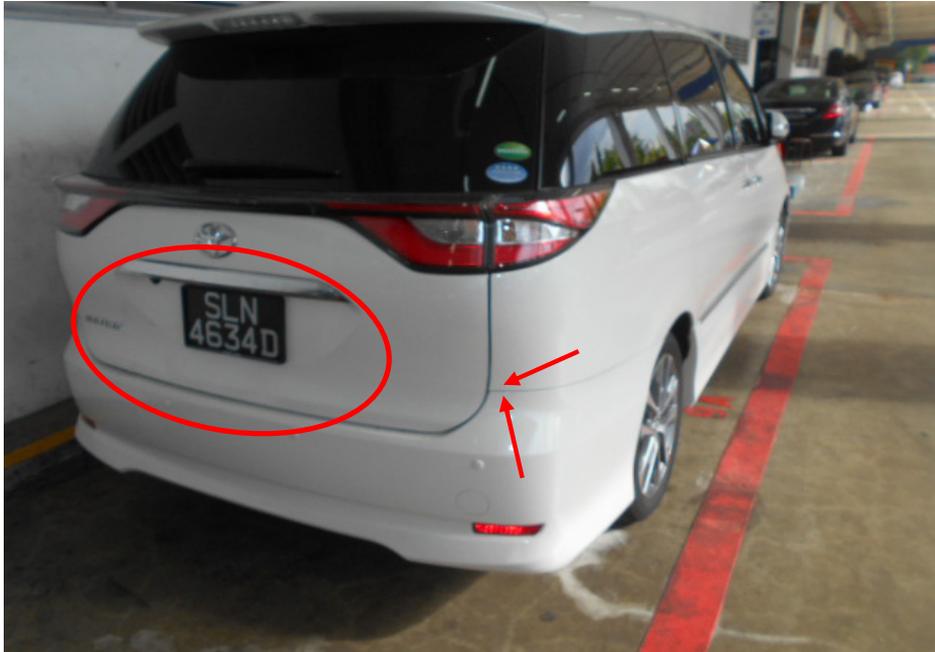
Photo 2 shows a right view of the rear portion of the Toyota at the time of the Pre-Repair Survey conducted by LKK Auto Consultants Pte. Ltd. taken 13 days after the accident. The damages were concentrated at the lower portion of the boot lid and the top portion of the rear bumper (circled). We did not observe any obvious misalignment at the right corner edges of the rear bumper (arrowed).

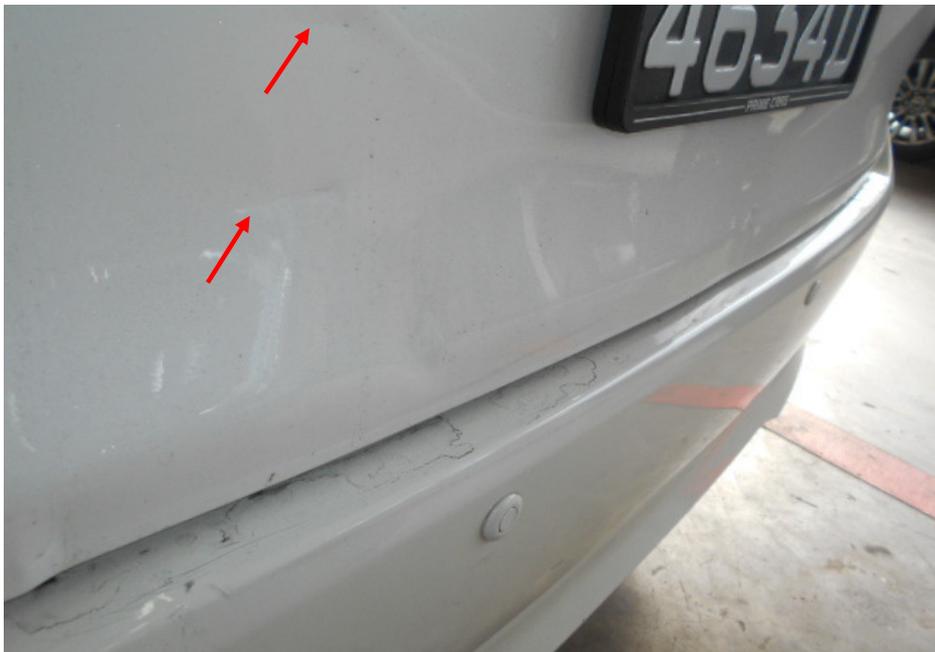
Photo 3 shows a close up view of the 2 parallel horizontal indentations on the lower left portion of the Toyota's boot lid (arrowed).

15. Firstly, the 2 parallel horizontal indentations as well as the rectangular indentation on the lower left portion of the Toyota's boot lid were caused by an object that is of a similar shape, pressing onto the rear portion of the Toyota. If one was to consider the rectangular shape and size of the left blinker light and front grille, it would then appear that these indentations were caused by the left blinker light and the front grille of the Nissan.

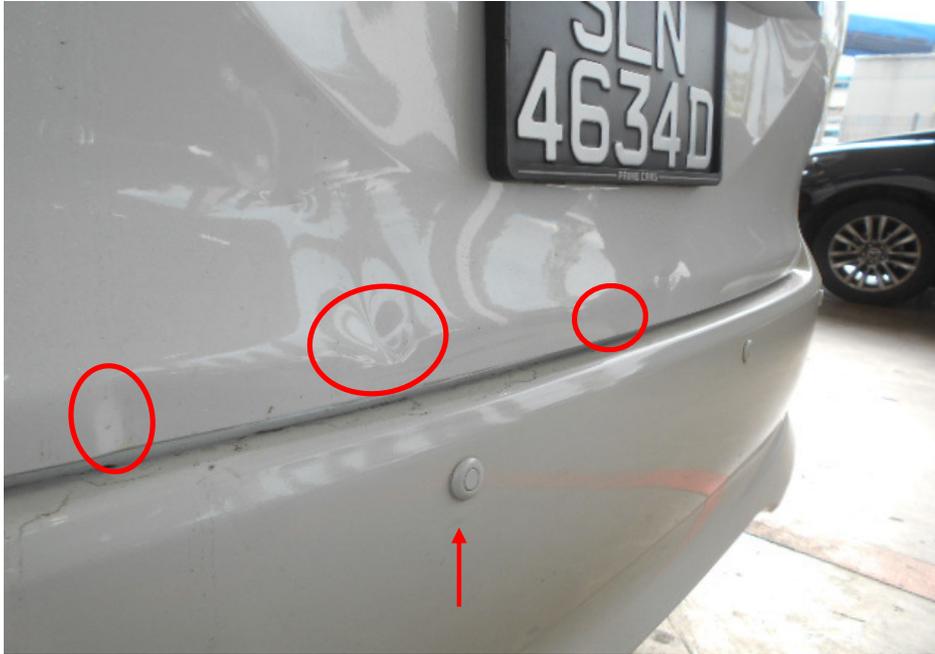
Photo 4 shows a close up view of the dents on the bottom portion of the Toyota's boot lid (circled). We also noticed faint horizontal black marks below the Toyota's left reverse sensor (arrowed).

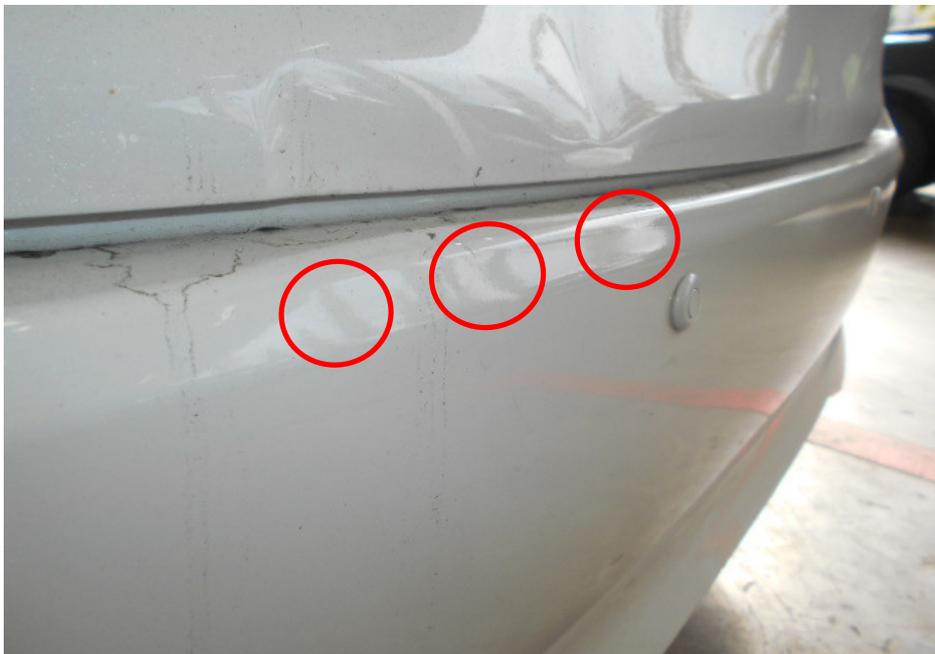
Photo 5 shows a close up view of the dents on the top portion of the Toyota's rear bumper (circled).

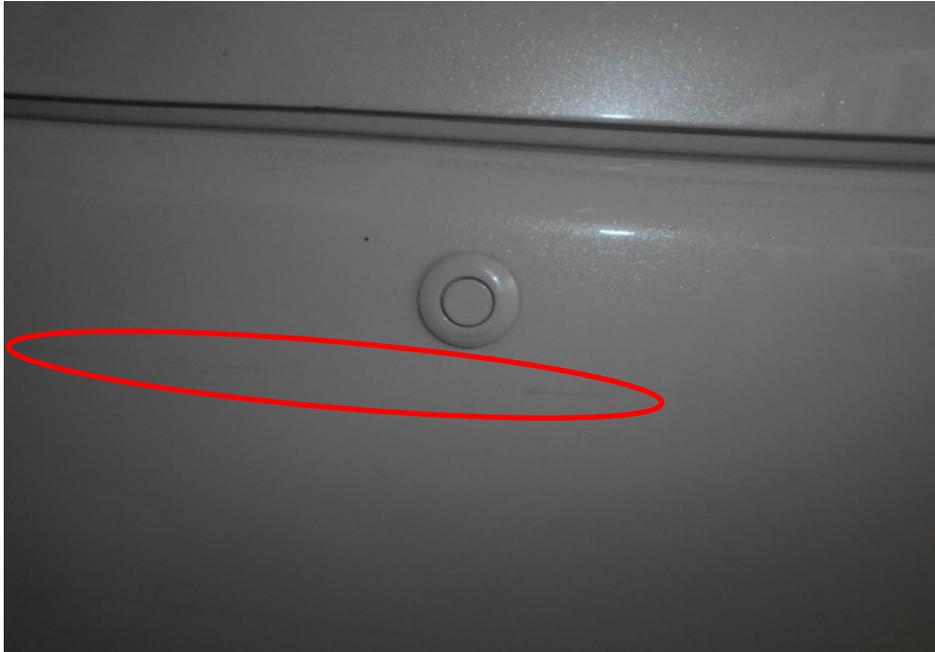
Photo 6 shows a close up view of the faint horizontal black marks below the Toyota's left reverse sensor (circled).

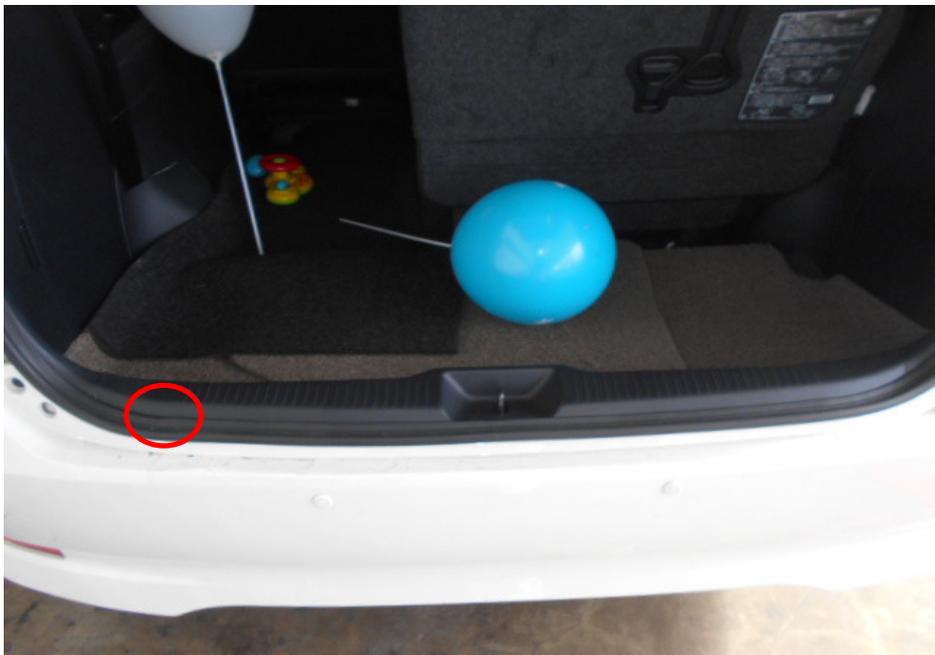
Photo 7 shows a view of the Toyota's rear panel garnish. The left portion of the rear panel garnish rubber lining had been pressed inwards (circled).

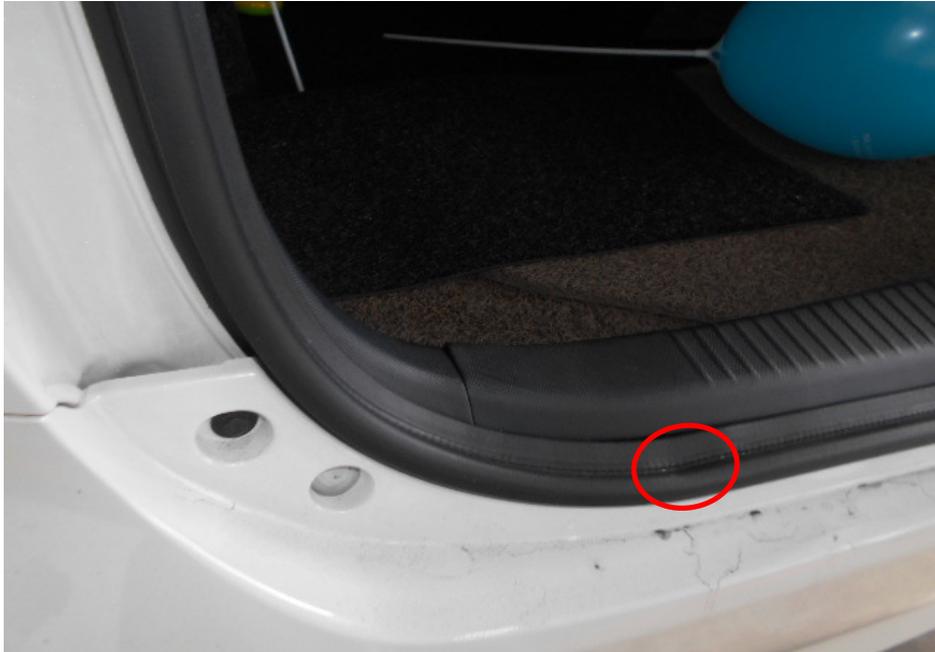
Photo 8 shows a close up view of the rear panel garnish rubber lining of the Toyota had been pressed inwards (circled).

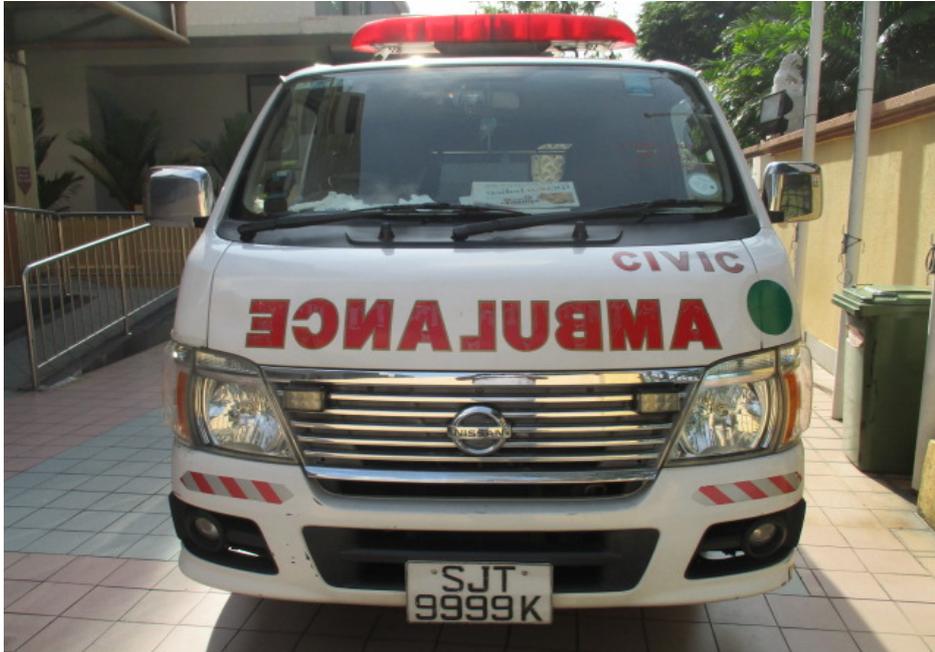
Photo 9 shows the general view of the front portion of the Nissan at the time of our physical inspection. We observed that the Nissan had sustained numerous damages on its front portion as a result of past accidents as mentioned by Mr Singh who was present during our physical inspection.

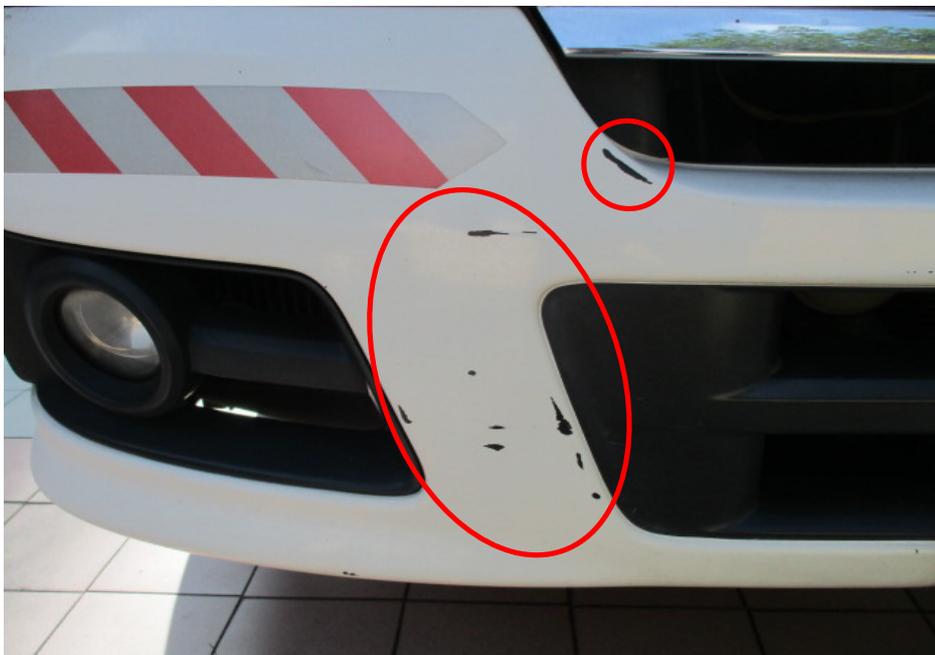
Photo 10 shows the numerous black graze marks observed on the right portion of the Nissan's front bumper (circled).

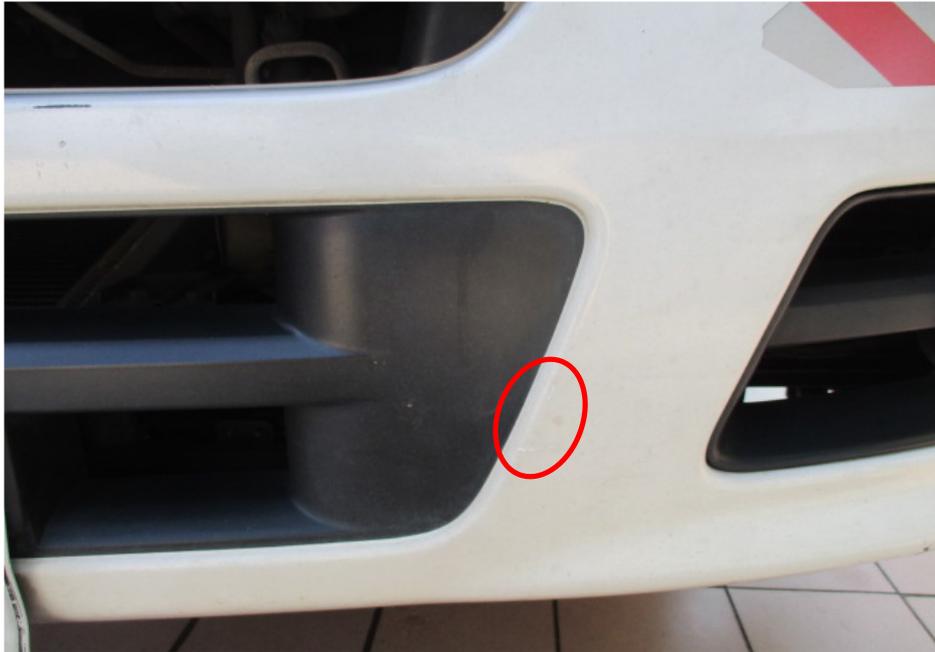
Photo 11 shows the paint graze marks found on the lower left portion of the Nissan's front bumper (circled).

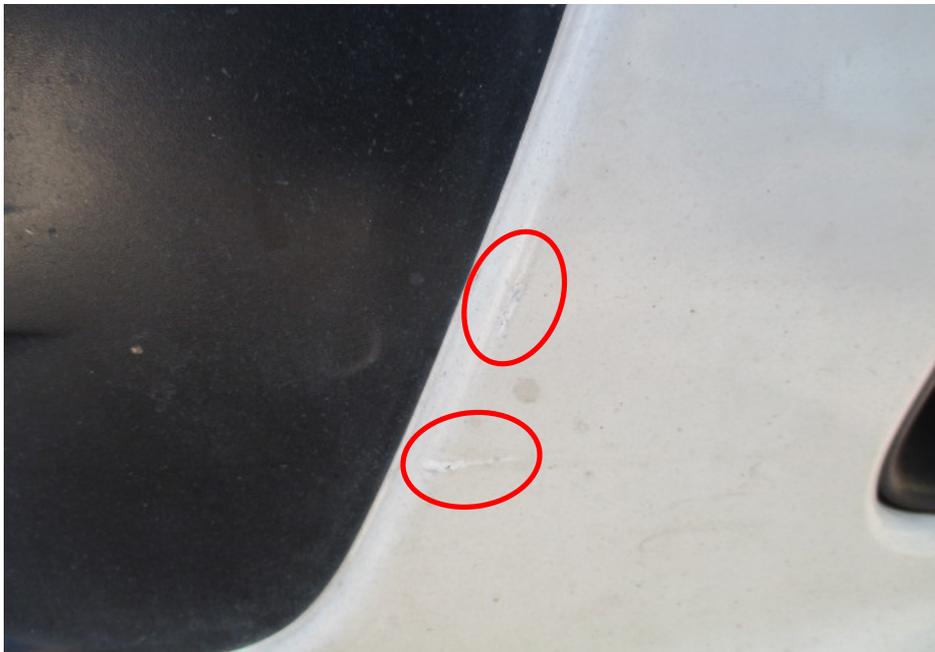
Photo 12 shows a close up view of the paint graze marks found on the lower left portion of the Nissan's front bumper (circled).

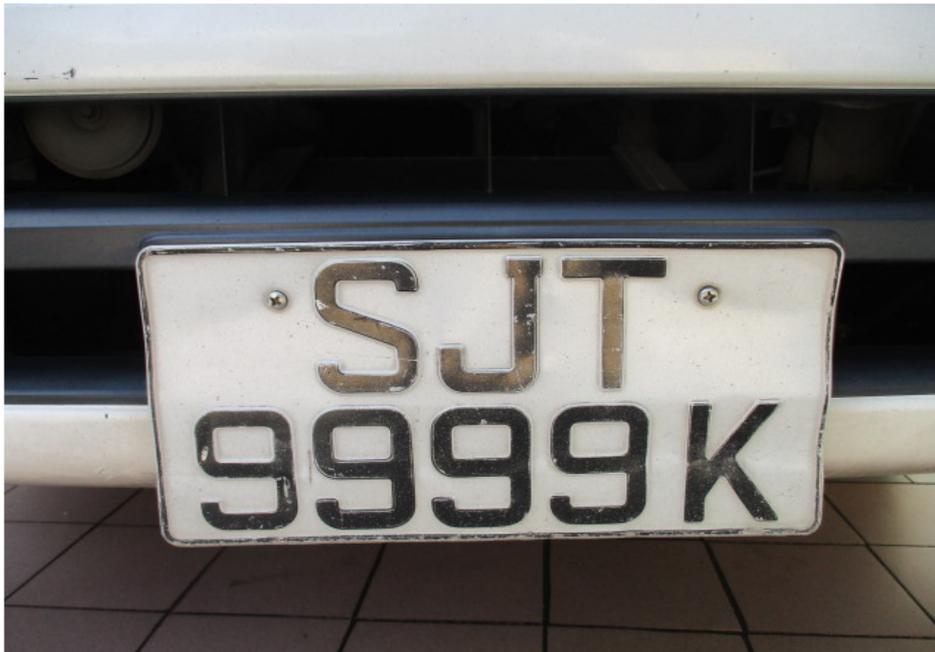
Photo 13 shows the Nissan's front number plate which was observed to be distorted. There were whitish marks found on the alpha- numeric letterings.

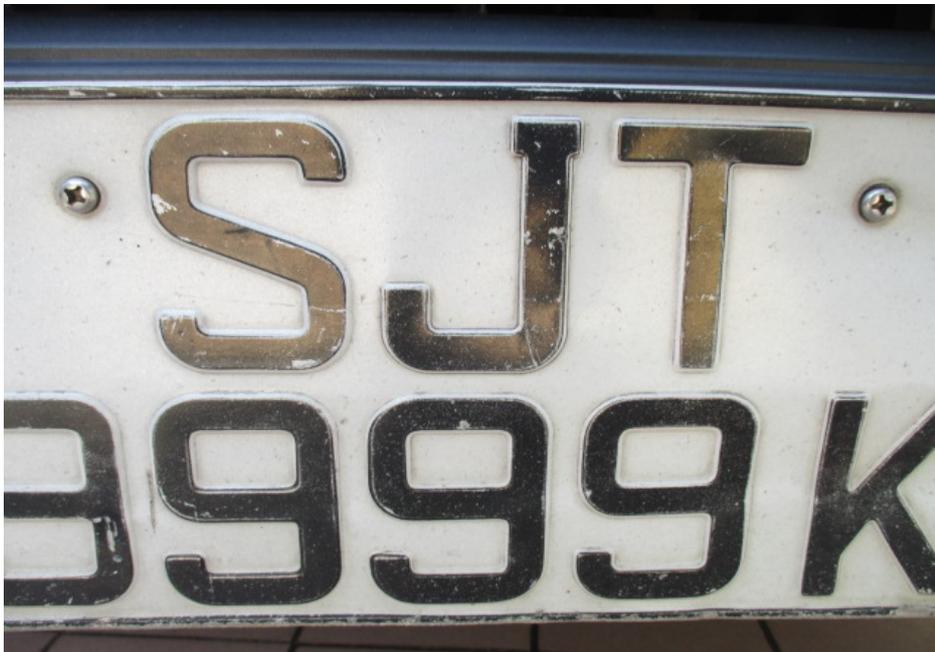
Photo 14 shows a closer view of the whitish marks found on the Nissan's front number plate alpha- numeric letterings.

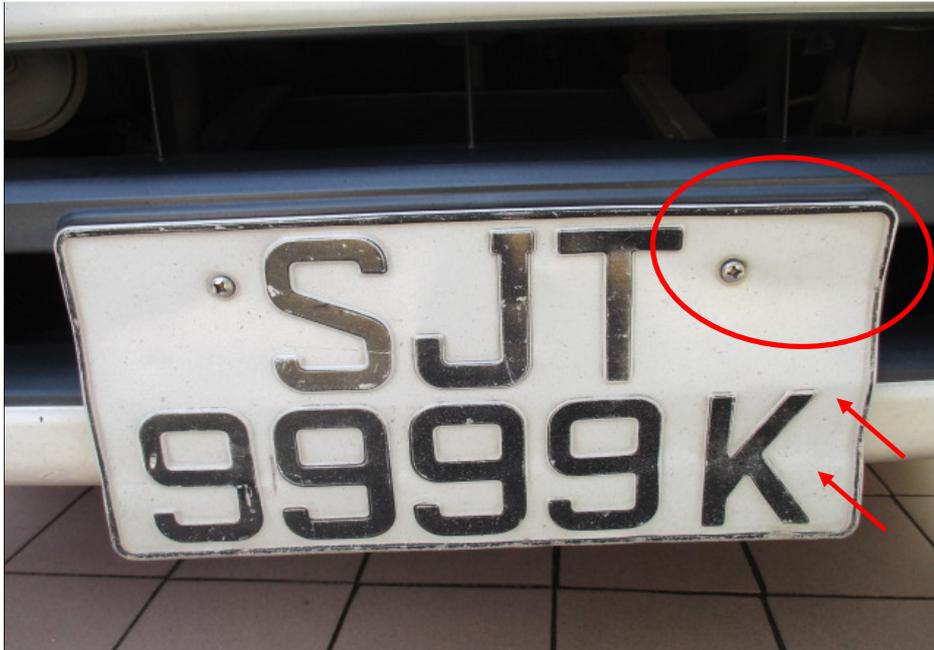
Photo 15 shows upon closer examination, we found that the top half of the left portion of the front number plate had been pushed inwards (circled). There were also 2 slight horizontal dents across the front number plate (arrowed).

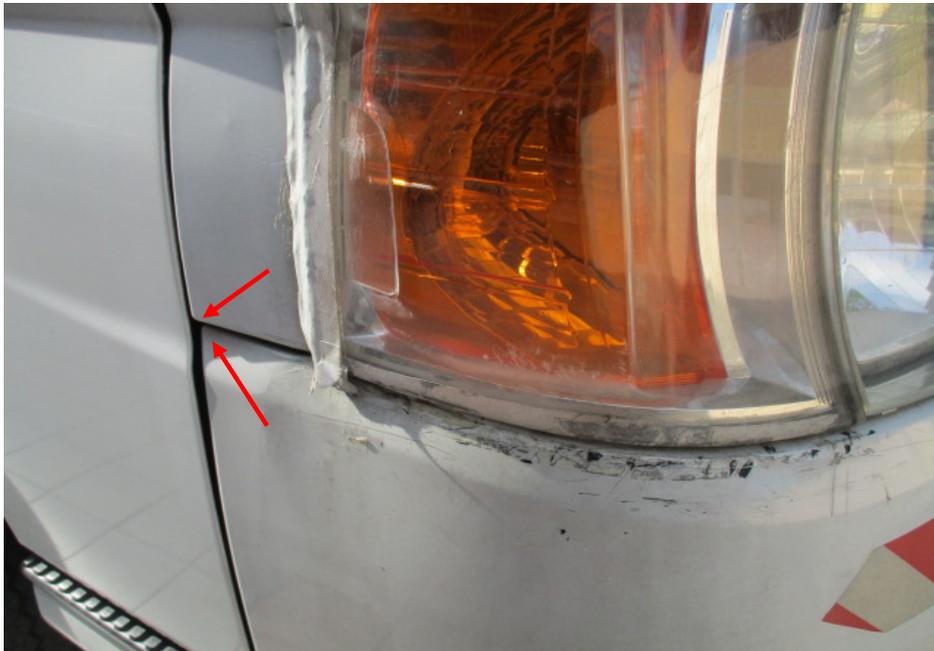
Photo 16 shows a close up view of the right corner edge of the front bumper of the Nissan. We observed that there was a slight misalignment at the corner edges (arrowed).

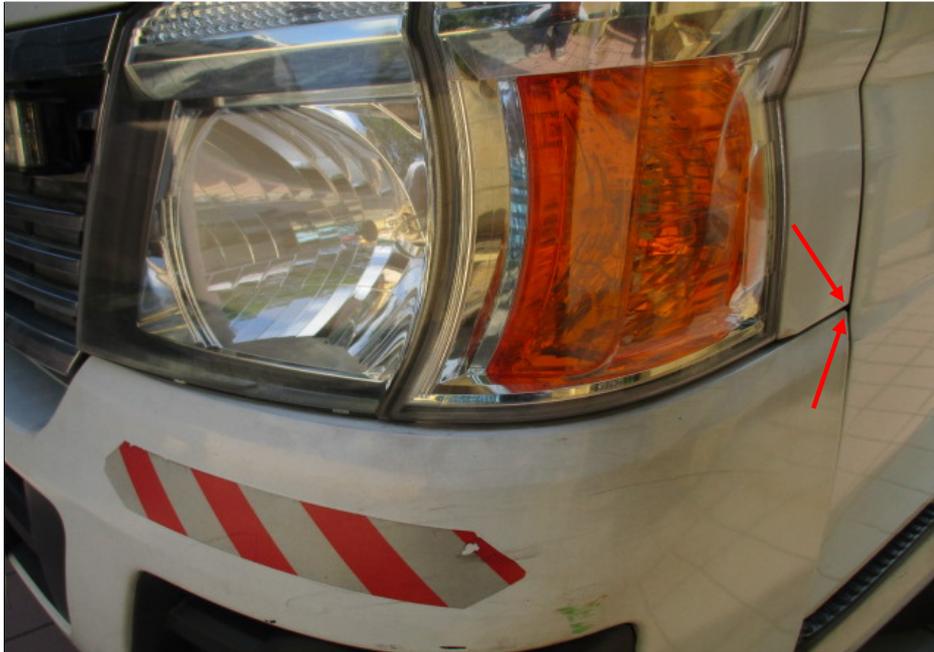
Photo 17 shows a close up view of the left corner edge of the front bumper of the Nissan. We observed that there was a slight misalignment at the corner edges (arrowed).

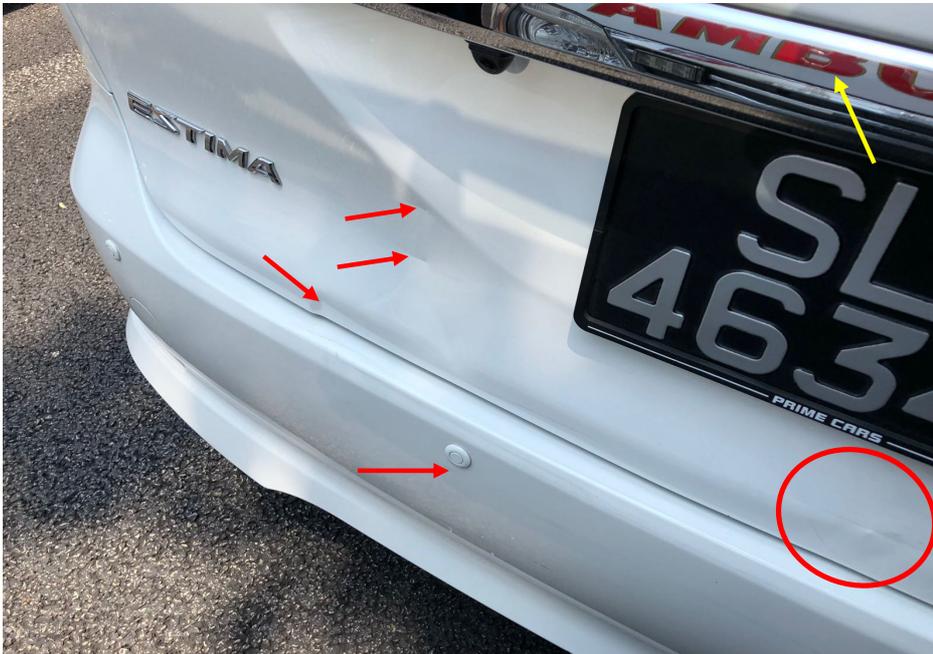
16. Secondly, the circular black marks on the lower centre portion of the Toyota's boot lid, below the rear number plate were most likely caused by an object that is of a similar shape, pressing onto the rear portion of the Toyota. If one was to consider the circular shape and size of the Nissan's front emblem, it would then appear that these circular black marks were caused by the front emblem of the Nissan.

17. In the event of any contact, the blinker lights, front emblem and grille of the Nissan would have come into contact with the rear portion of the Toyota as these were the most protruded body parts at the frontal portion of the Nissan. See photo 18 below.

Photo 18 shows the final position of the Toyota at the accident scene. The Nissan was observed to be directly behind the rear of the Toyota based on the silhouette of the Nissan's front portion which can be seen from the rear portion of the Toyota, in particular off the reflection from the tail door trunk lid chrome cover of the Toyota (yellow arrow). We observed the same 2 parallel horizontal indentations and dents on the boot lid as well as the dents and faint horizontal black marks on the rear bumper of the Toyota as per the pre- repair survey photographs of the Toyota (red arrows). We also noticed circular- shaped black marks on the lower centre portion of the Toyota's boot lid, below the rear number plate (circled).

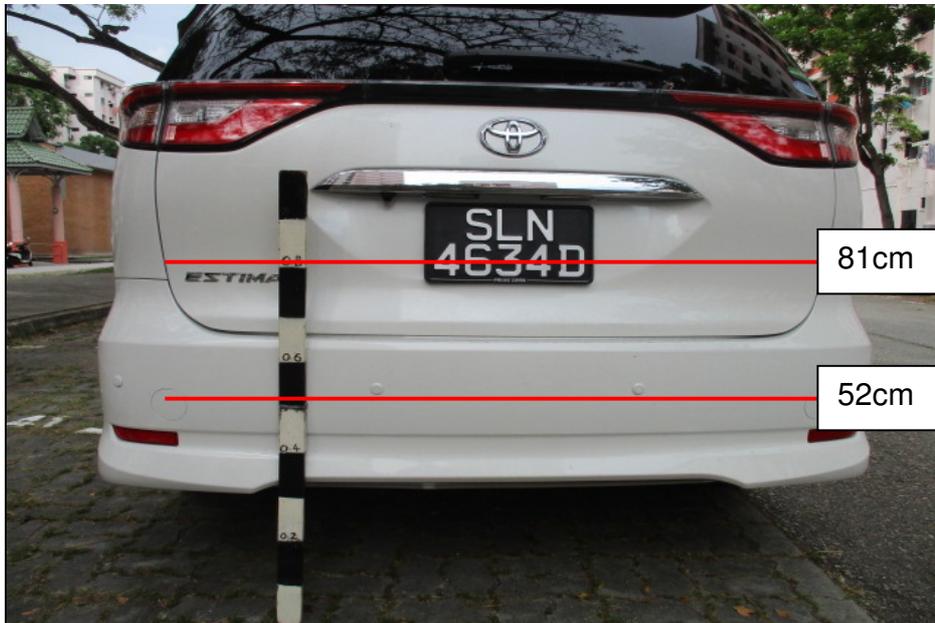
Photo 19 shows the height measurement being conducted on the rear portion of the Toyota. The height above ground level of the lower portion of the Toyota's boot lid, at the area where the highest horizontal indentation was found was measured to be approximately 81cm. The height above ground level of the centre portion of the Toyota's rear bumper below the left reverse sensor, at the area where the faint horizontal black marks were found was measured to be approximately 52cm. The damages on the rear portion of the Toyota were between the ranges of 52cm to 81cm above ground level.

- a) the height above ground level of the lower portion of the Toyota's boot lid, at the area where the highest horizontal indentation was found was measured to be approximately 81cm;

- b) the height above ground level of the centre portion of the Toyota's rear bumper below the left reverse sensor, at the area where the faint horizontal black marks were found was measured to be approximately 52cm;

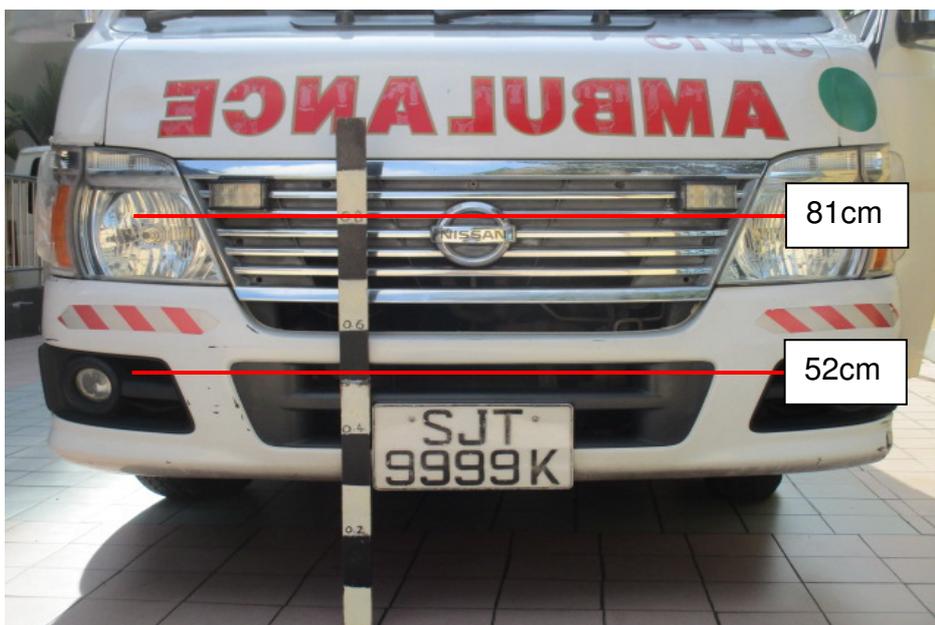
Photo 20 shows the height measurement being conducted on the front portion of the Nissan. The blinker lights, front emblem and front grille of the Nissan are within the 52cm to 81cm height range.

- c) the damages on the rear portion of the Toyota were between the ranges of 52cm to 81cm above ground level;
- d) The blinker lights, front emblem and front grille of the Nissan are within the 52cm to 81cm height range;

- e) the height measurements appear to support the findings of possible contact between the rear portion of the Toyota and the front portion of the Nissan because the point of contact to the rear portion of the Toyota would have been from the left blinker light, front emblem and front grille of the Toyota given that these was the most protruded body parts at the front portion of the Nissan as per our discussions set out in paragraph 17, and also the height range of these body parts above ground level had corresponded to the height above ground level of the damages found on the rear portion of the Toyota.
