Your Ref : 554594
Our Ref : CS3/MSG18006359/N

20 April 2018

**AUTOMOBILE TECHNICAL INVESTIGATION REPORT OF ACCIDENT
INVOLVING SLN 4634D AND SJT 9999K ON 4 APRIL 2018**

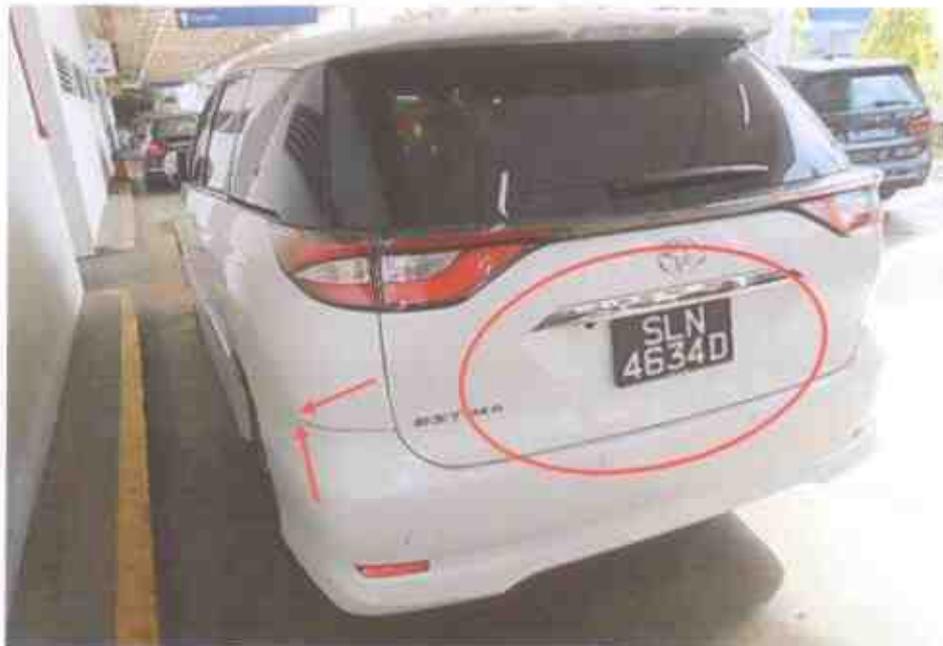
Photo 1 shows a left view of the rear portion of the Toyota at the time of the Pre- Repair Survey conducted by LKK Auto Consultants Pte. Ltd. taken 13 days after the accident. The damages were concentrated at the lower portion of the boot lid and the top portion of the rear bumper (circled). We did not observe any obvious misalignment at the left corner edges of the rear bumper (arrowed).

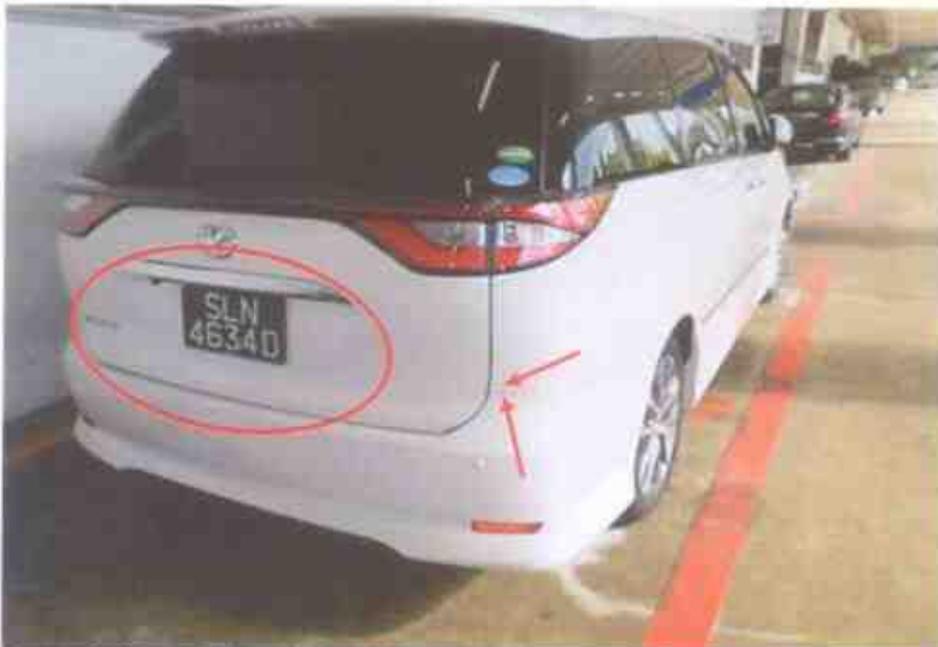
Photo 2 shows a right view of the rear portion of the Toyota at the time of the Pre-Repair Survey conducted by LKK Auto Consultants Pte. Ltd. taken 13 days after the accident. The damages were concentrated at the lower portion of the boot lid and the top portion of the rear bumper (circled). We did not observe any obvious misalignment at the right corner edges of the rear bumper (arrowed).

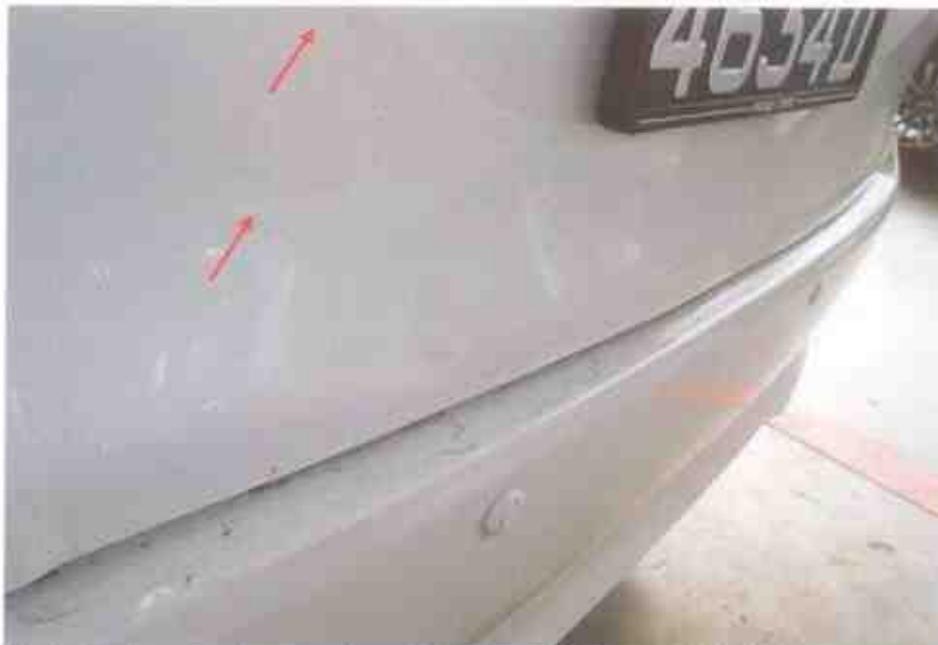
Photo 3 shows a close up view of the 2 parallel horizontal indentations on the lower left portion of the Toyota's boot lid (arrowed).

15. Firstly, the 2 parallel horizontal indentations as well as the rectangular indentation on the lower left portion of the Toyota's boot lid were caused by an object that is of a similar shape, pressing onto the rear portion of the Toyota. If one was to consider the rectangular shape and size of the left blinker light and front grille, it would then appear that these indentations were caused by the left blinker light and the front grille of the Nissan.

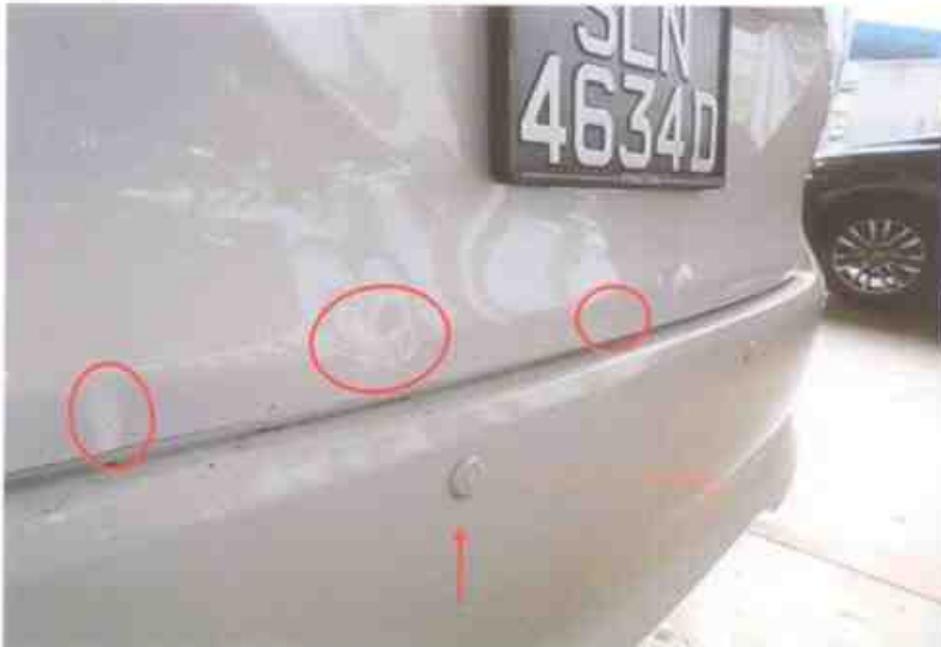
Photo 4 shows a close up view of the dents on the bottom portion of the Toyota's boot lid (circled). We also noticed faint horizontal black marks below the Toyota's left reverse sensor (arrowed).

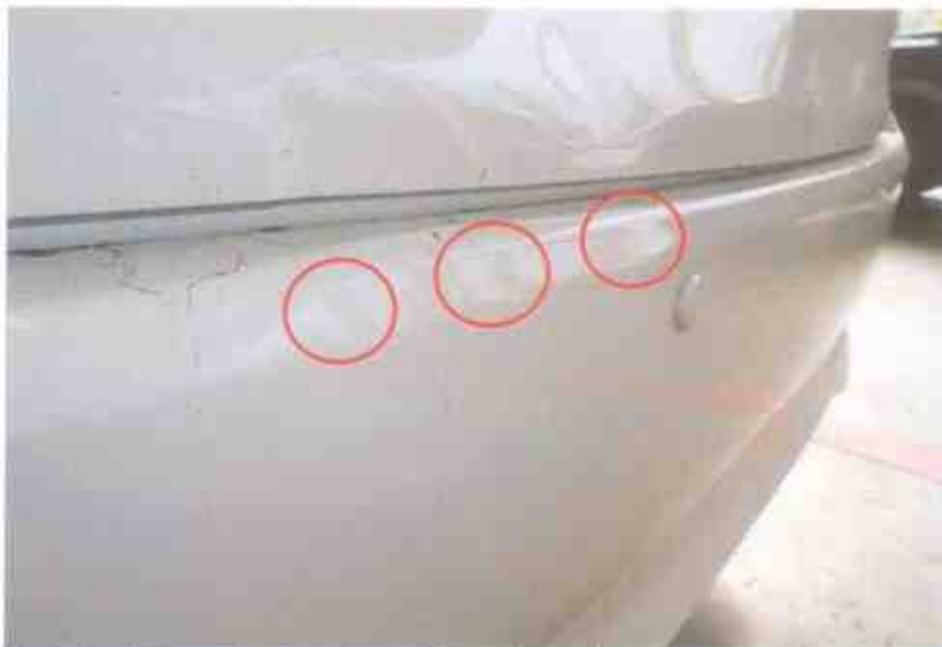
Photo 5 shows a close up view of the dents on the top portion of the Toyota's rear bumper (circled).

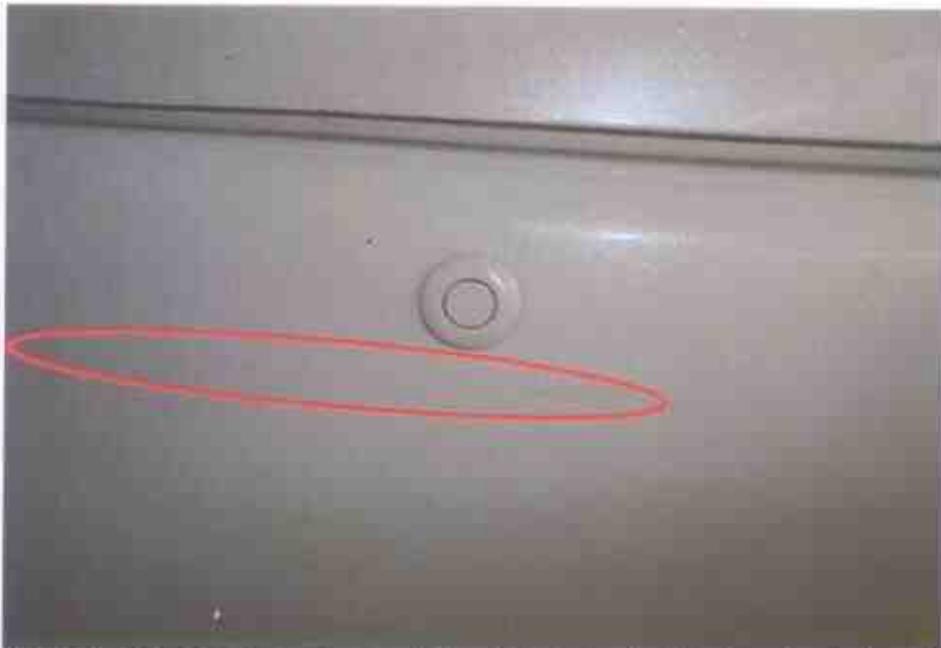
Photo 6 shows a close up view of the faint horizontal black marks below the Toyota's left reverse sensor (circled).

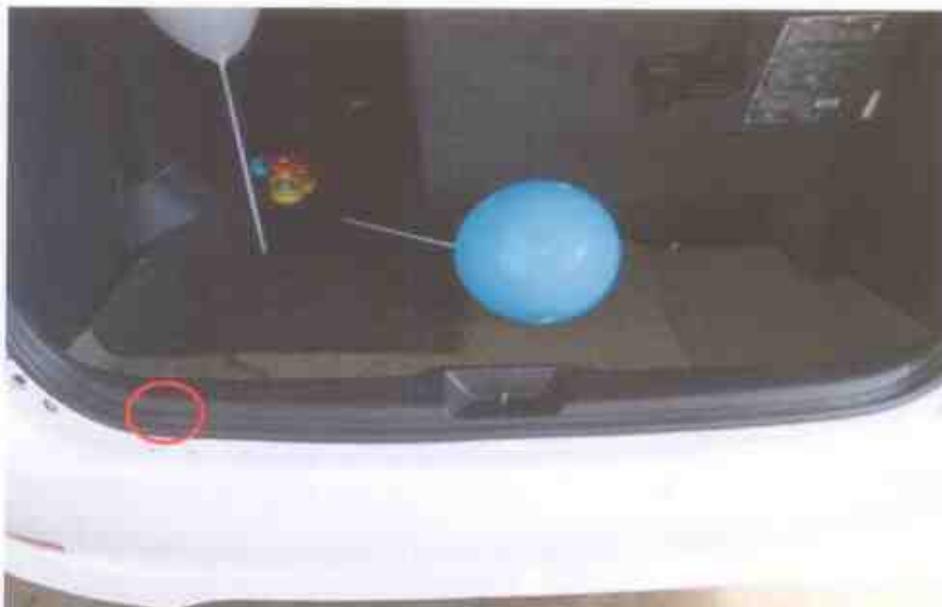
Photo 7 shows a view of the Toyota's rear panel garnish. The left portion of the rear panel garnish rubber lining had been pressed inwards (circled).

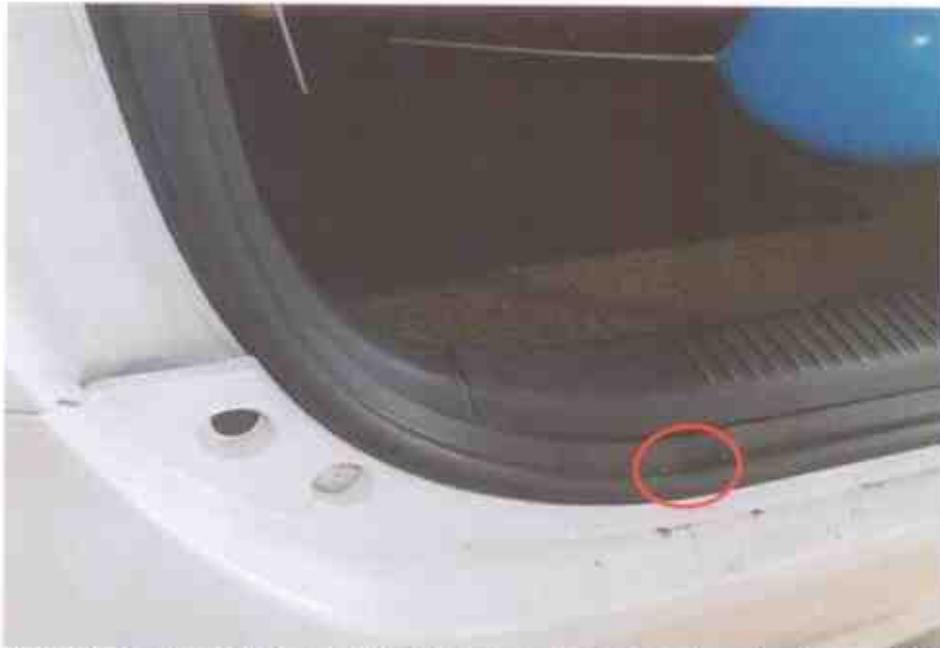
Photo 8 shows a close up view of the rear panel garnish rubber lining of the Toyota had been pressed inwards (circled).

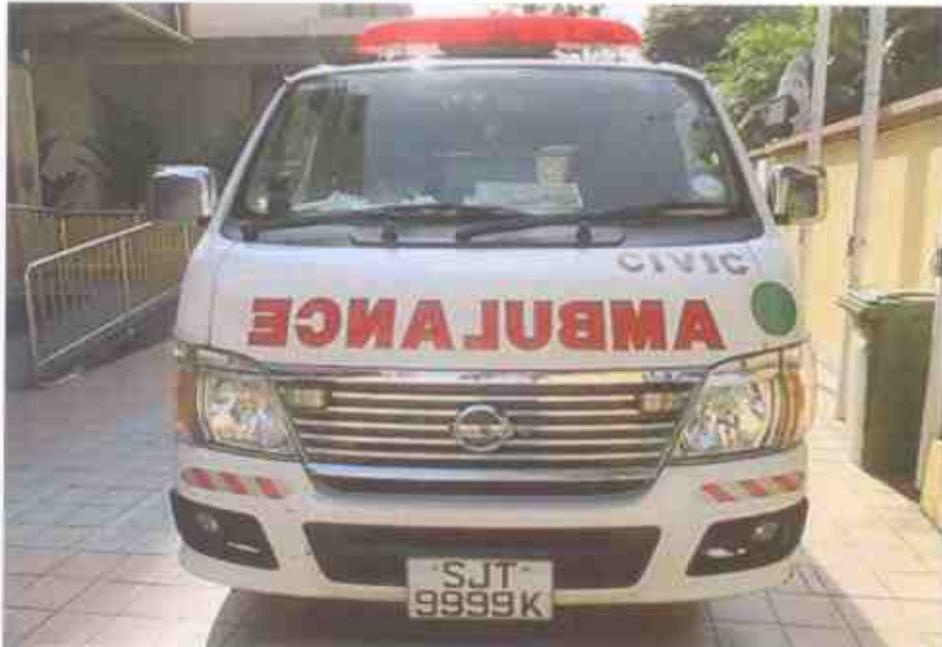
Photo 9 shows the general view of the front portion of the Nissan at the time of our physical inspection. We observed that the Nissan had sustained numerous damages on its front portion as a result of past accidents as mentioned by Mr Singh who was present during our physical inspection.

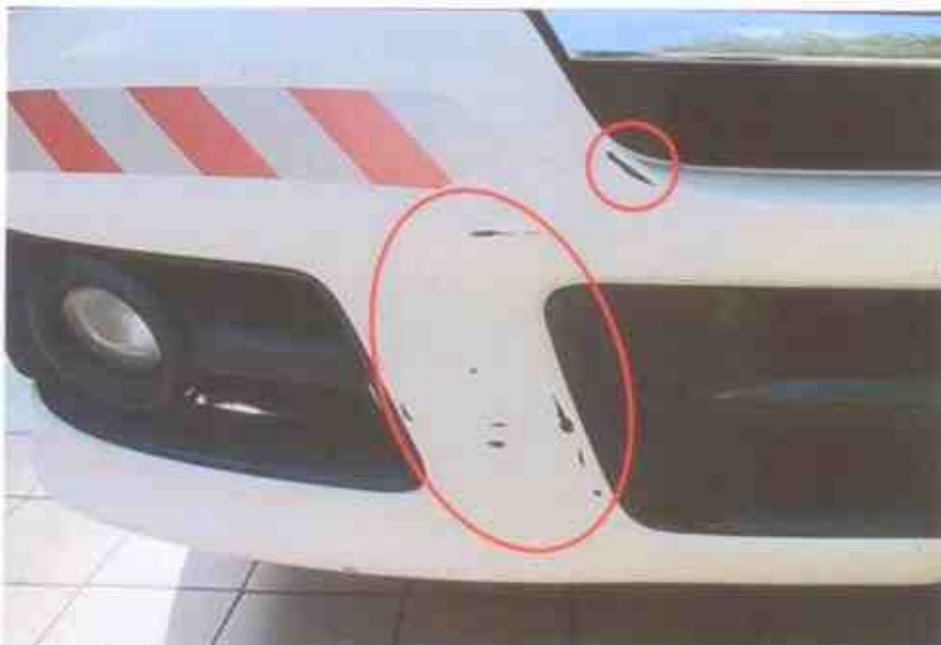
Photo 10 shows the numerous black graze marks observed on the right portion of the Nissan's front bumper (circled).

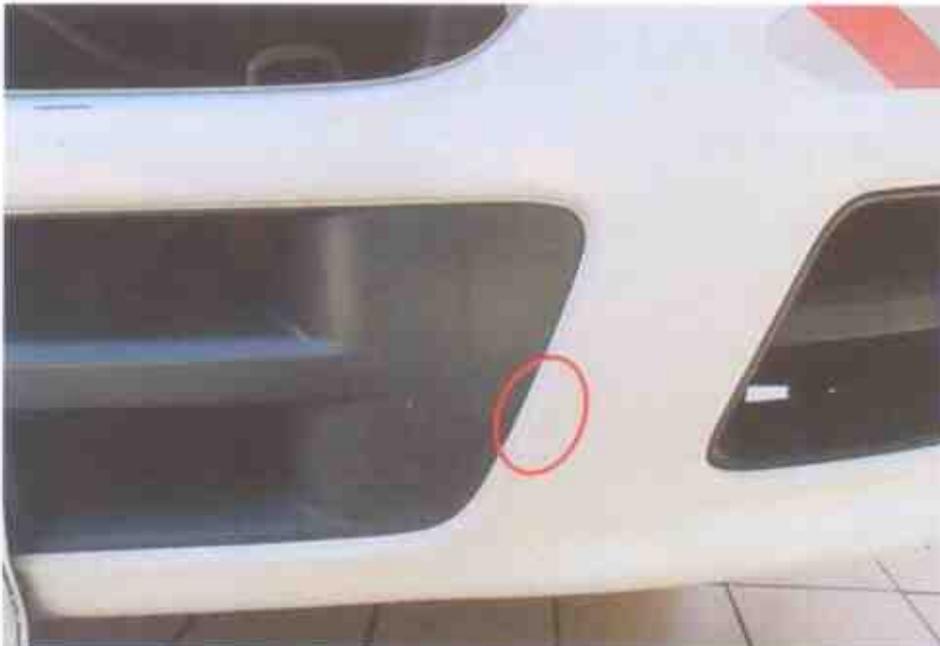
Photo 11 shows the paint graze marks found on the lower left portion of the Nissan's front bumper (circled).

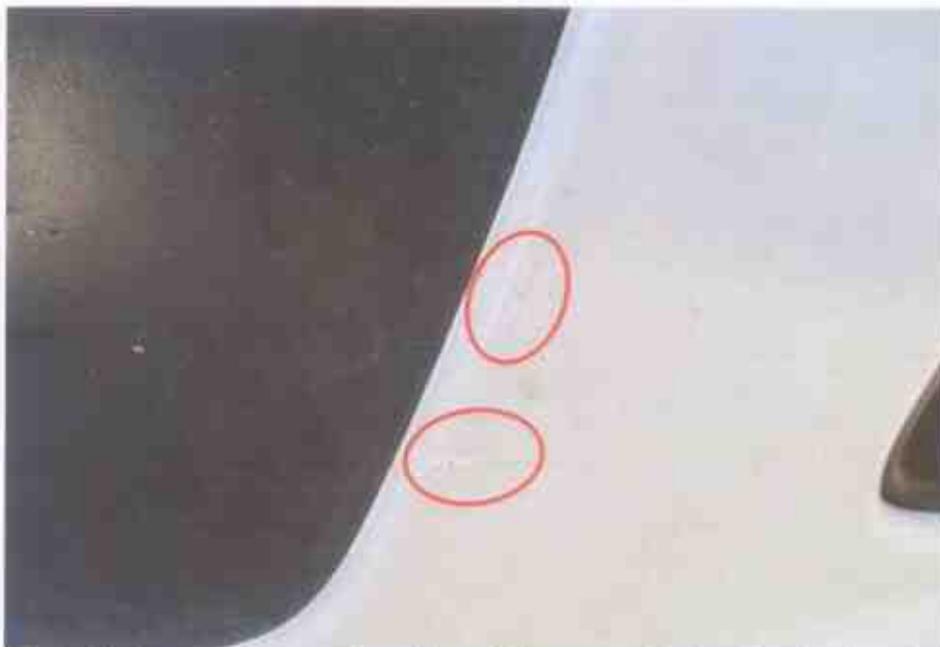
Photo 12 shows a close up view of the paint graze marks found on the lower left portion of the Nissan's front bumper (circled).

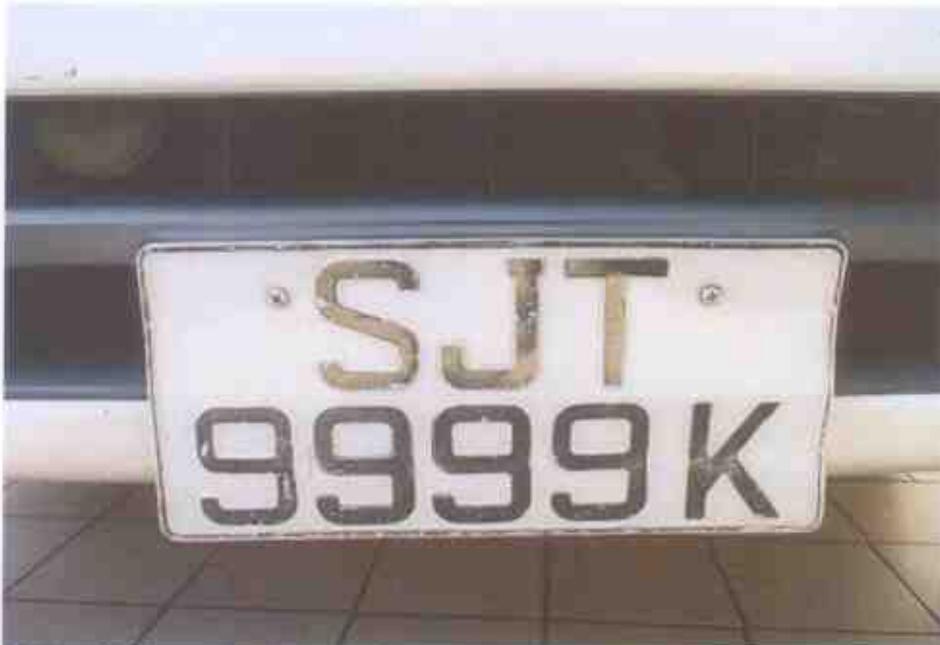
Photo 13 shows the Nissan's front number plate which was observed to be distorted. There were whitish marks found on the alpha-numeric letterings.

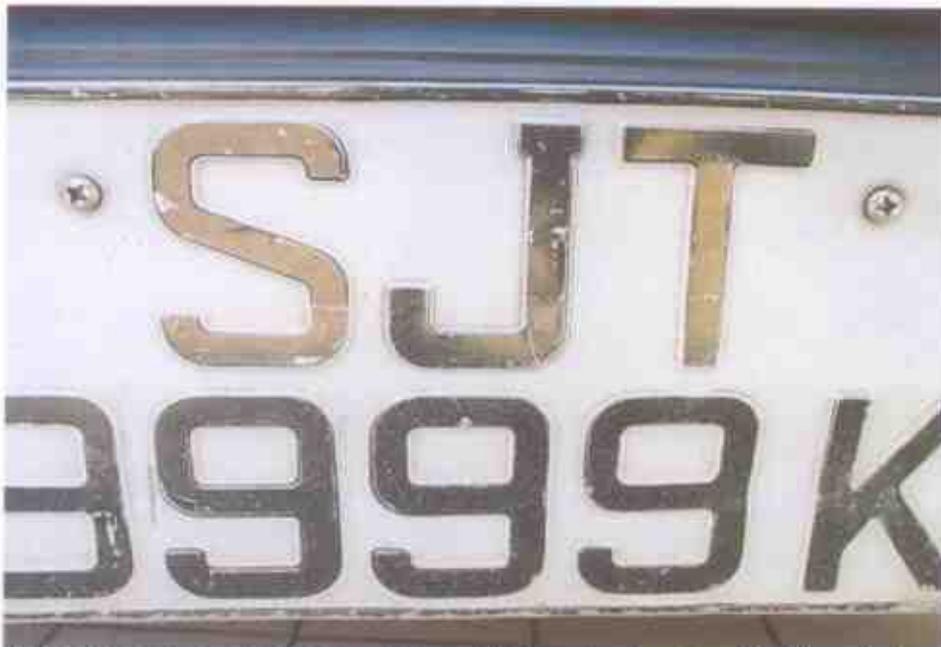
Photo 14 shows a closer view of the whitish marks found on the Nissan's front number plate alpha-numeric letterings.

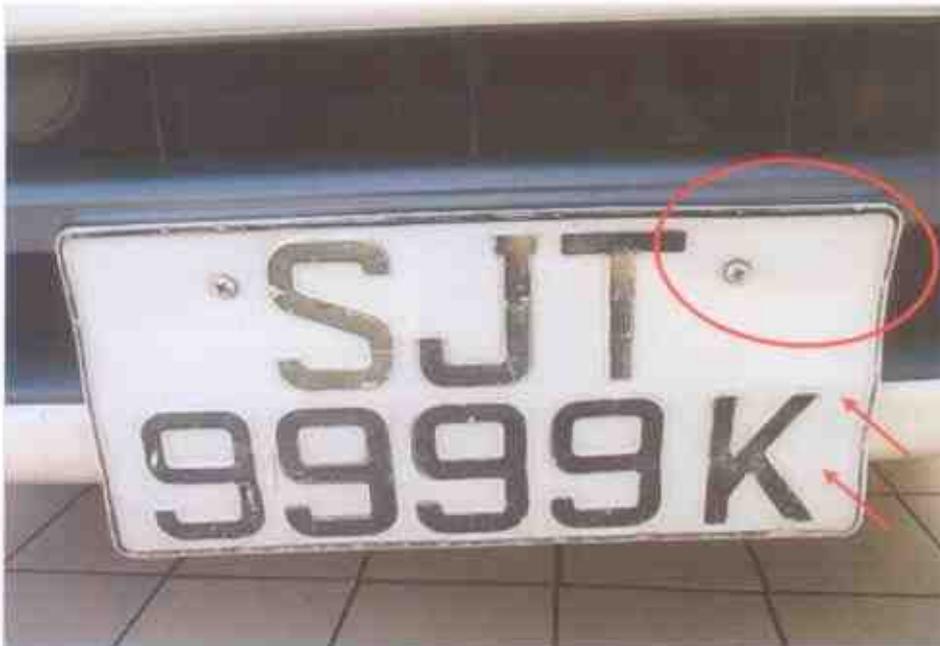
Photo 15 shows upon closer examination, we found that the top half of the left portion of the front number plate had been pushed inwards (circled). There were also 2 slight horizontal dents across the front number plate (arrowed).

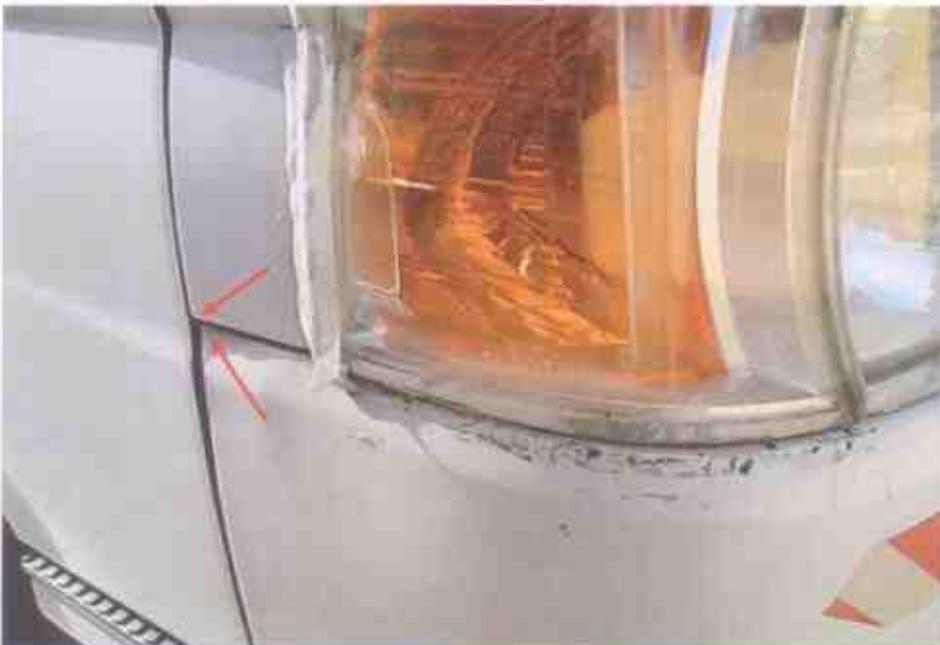
Photo 16 shows a close up view of the right corner edge of the front bumper of the Nissan. We observed that there was a slight misalignment at the corner edges (arrowed).

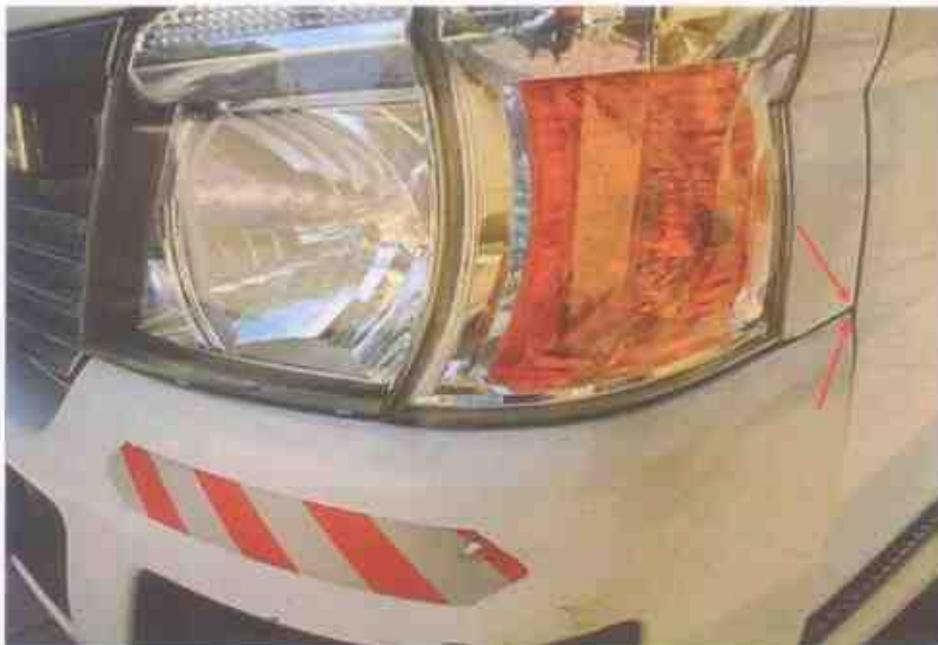
Photo 17 shows a close up view of the left corner edge of the front bumper of the Nissan. We observed that there was a slight misalignment at the corner edges (arrowed).

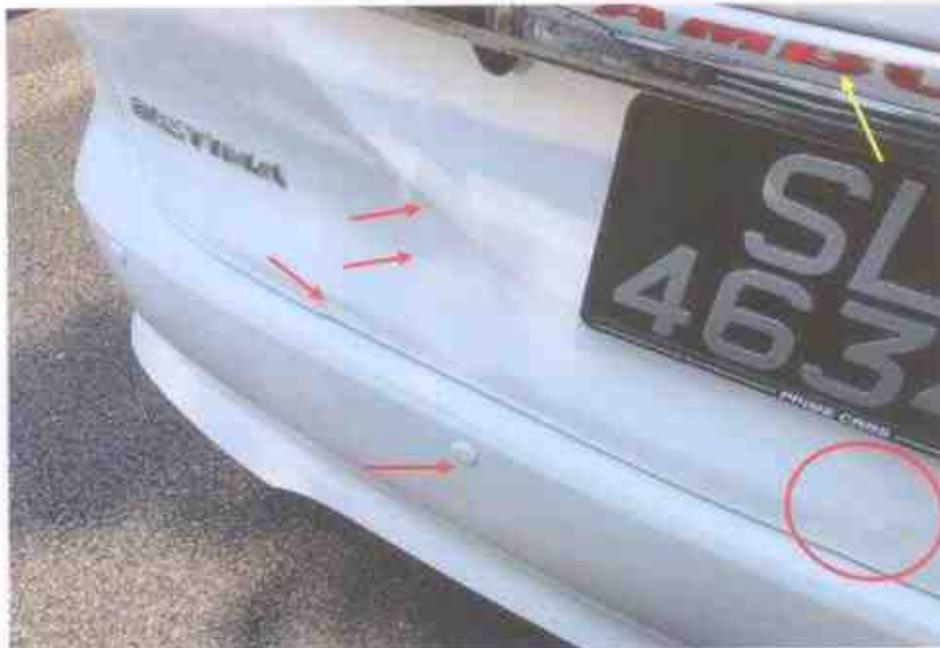
16. Secondly, the circular black marks on the lower centre portion of the Toyota's boot lid, below the rear number plate were most likely caused by an object that is of a similar shape, pressing onto the rear portion of the Toyota. If one was to consider the circular shape and size of the Nissan's front emblem, it would then appear that these circular black marks were caused by the front emblem of the Nissan.

Photo 18 shows the final position of the Toyota at the accident scene. The Nissan was observed to be directly behind the rear of the Toyota based on the silhouette of the Nissan's front portion which can be seen from the rear portion of the Toyota, in particular off the reflection from the tail door trunk lid chrome cover of the Toyota (yellow arrow). We observed the same 2 parallel horizontal indentations and dents on the boot lid as well as the dents and faint horizontal black marks on the rear bumper of the Toyota as per the pre-repair survey photographs of the Toyota (red arrows). We also noticed circular-shaped black marks on the lower centre portion of the Toyota's boot lid, below the rear number plate (circled).

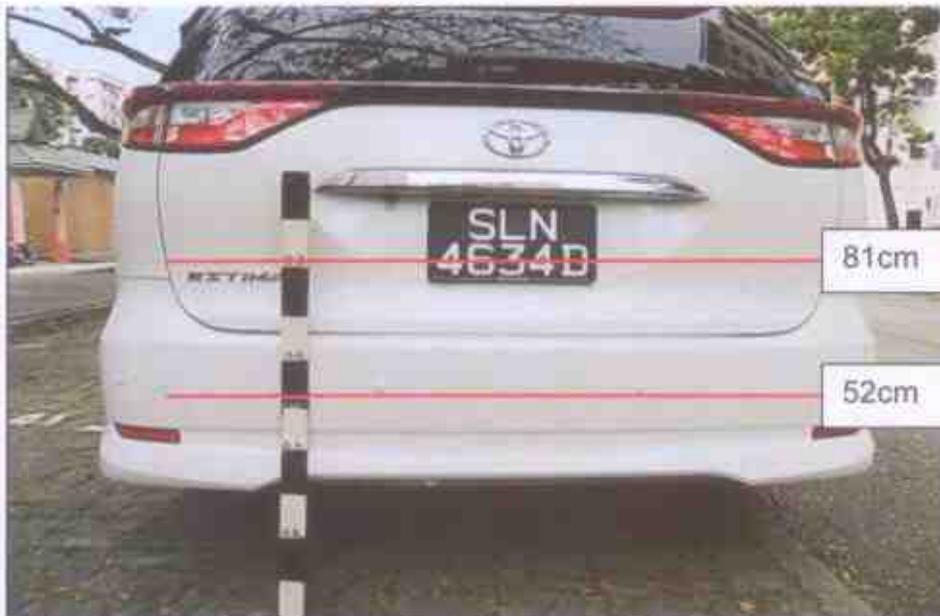
Photo 19 shows the height measurement being conducted on the rear portion of the Toyota. The height above ground level of the lower portion of the Toyota's boot lid, at the area where the highest horizontal indentation was found was measured to be approximately 81cm. The height above ground level of the centre portion of the Toyota's rear bumper below the left reverse sensor, at the area where the faint horizontal black marks were found was measured to be approximately 52cm. The damages on the rear portion of the Toyota were between the ranges of 52cm to 81cm above ground level.

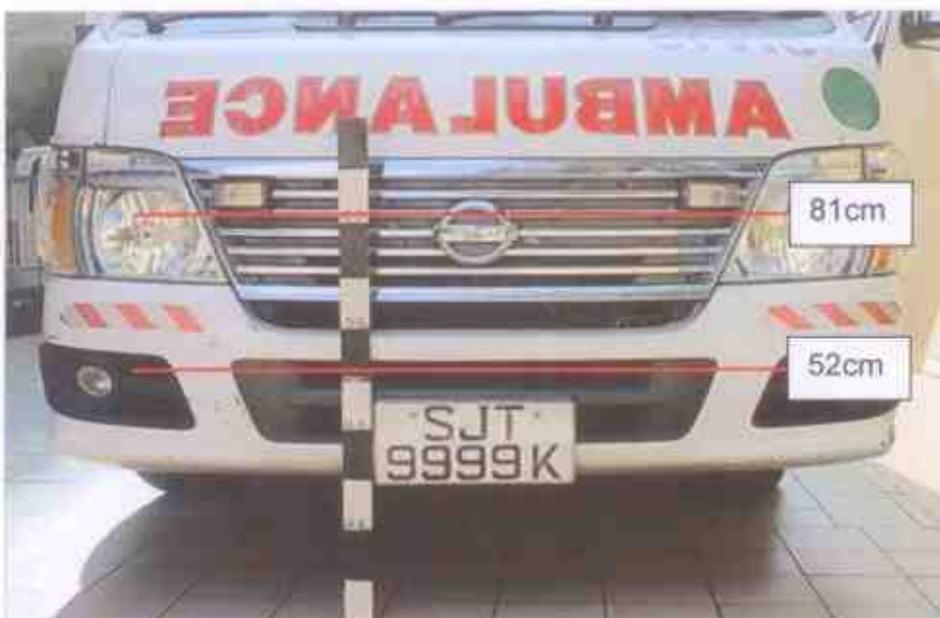
Photo 20 shows the height measurement being conducted on the front portion of the Nissan. The blinker lights, front emblem and front grille of the Nissan are within the 52cm to 81cm height range.
