SINGAPORE ACCIDENT STATEMENT

Vehicle Inspection Report

RE-INSPECTION REPORT

ADJUSTMENT ON REPAIR COST FOR VEHICLE NO. SLB 4458J

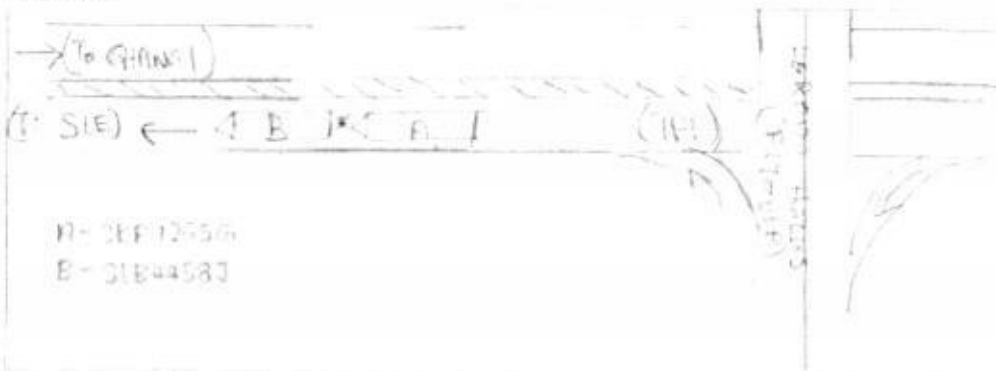
Sketch Plan

AT 12.55 HRS, A2 WAS DRIVING IN THE LEFT LANE. HE WAS
VEHICLE B (31B44583) STOPPED. REPORTER AND I WAS
UNABLE TO STOP IN TIME RESULTING IN MY VEHICLE (A)
CRASHING INTO VEHICLE B. IMMEDIATELY AFTER THE ACCIDENT, THERE
WAS NO PERCEIVED INJURIES TO ALL PERSONS INVOLVED IN
THE ACCIDENT. TRAFFIC FLOW WAS HEAVY AND SLOW AT
THAT PERIOD OF TIME.
