#### **INVESTIGATION REPORT:**

Our Ref : CI/AIG18006414/N  
Claim No : 7600975041SG  
Insured : SLJ 7417R  
Date of Accident : 29 March 2018  
Location : T- junction of Woodlands Avenue 12 and Woodlands Avenue 5

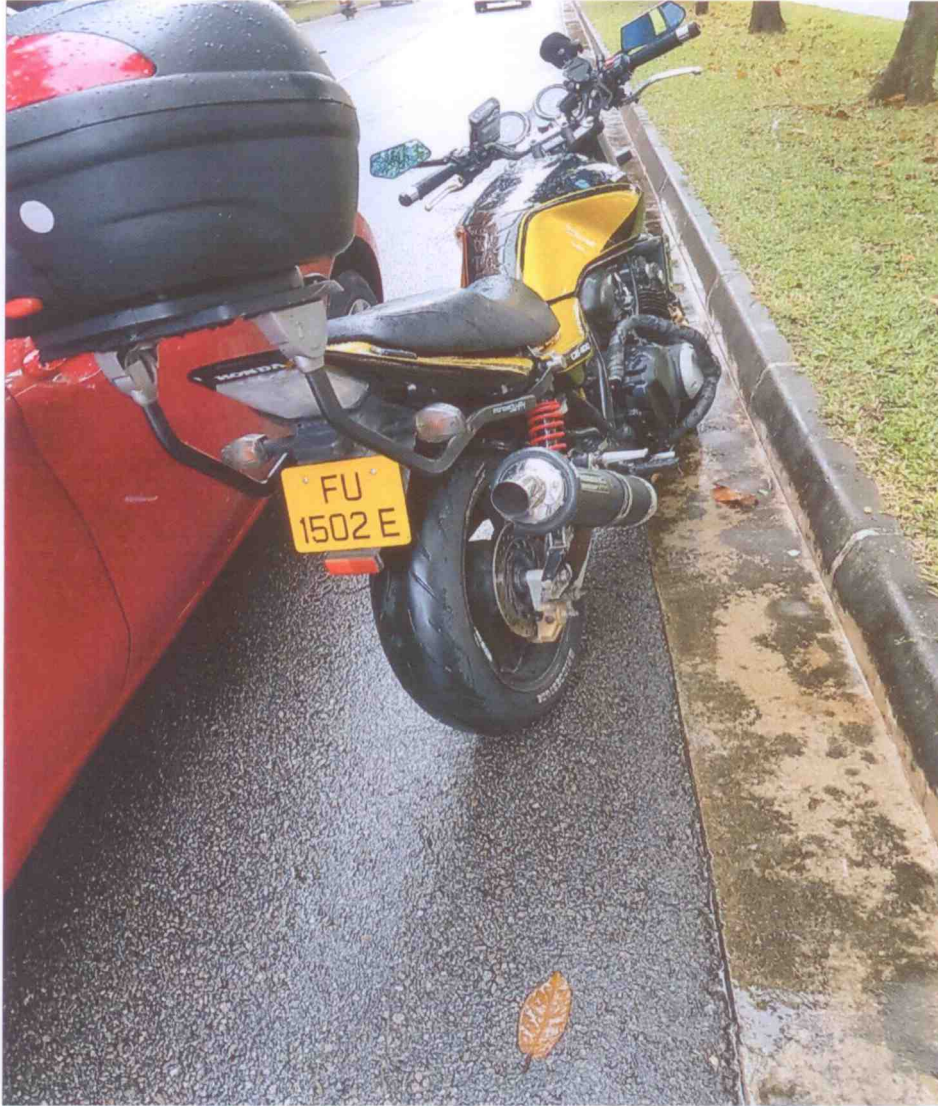
**Photo 1** taken by Mr Shariff shows both vehicles post- accident after Mr Jabbar lifted the motorcycle and put it on its side stand. The position of both vehicles seems to correlate with Mr Shariff's statement in which Mr Jabbar had fell onto the grass patch of the central divider.

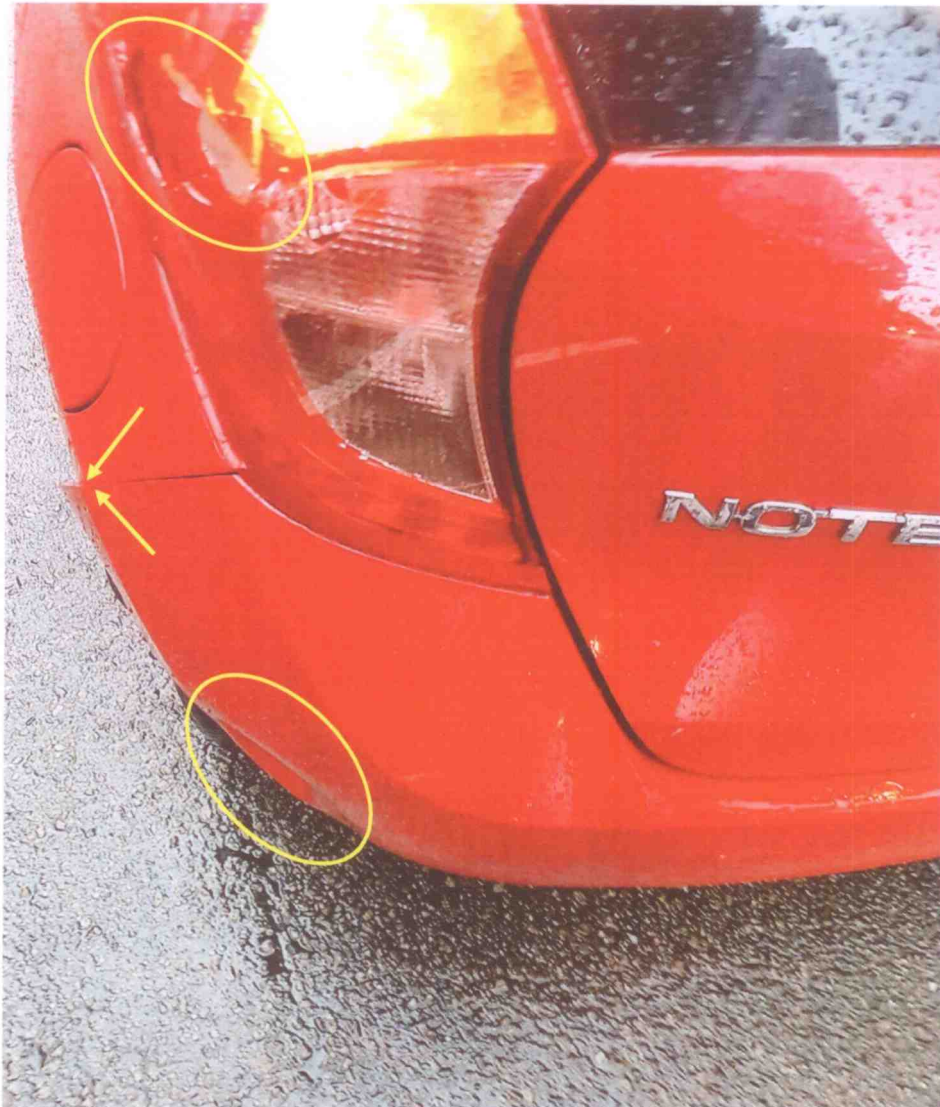
**Photo 2** taken by Mr Shariff shows the misalignment of the rear bumper at the left corner edge (arrowed), the cracked left tail light and the dent on the lower left portion of the rear bumper of the Insured Vehicle (circled). The damages sustained to the Insured Vehicle seems to correlate with Mr Jabbar's statement where he could not slow down the motorcycle in time and hit the left rear portion of the Insured Vehicle. Our observation of Mr Shariff's ability to take clear post-accident photographs would suggest that there was no drink driving involved in this particular accident.

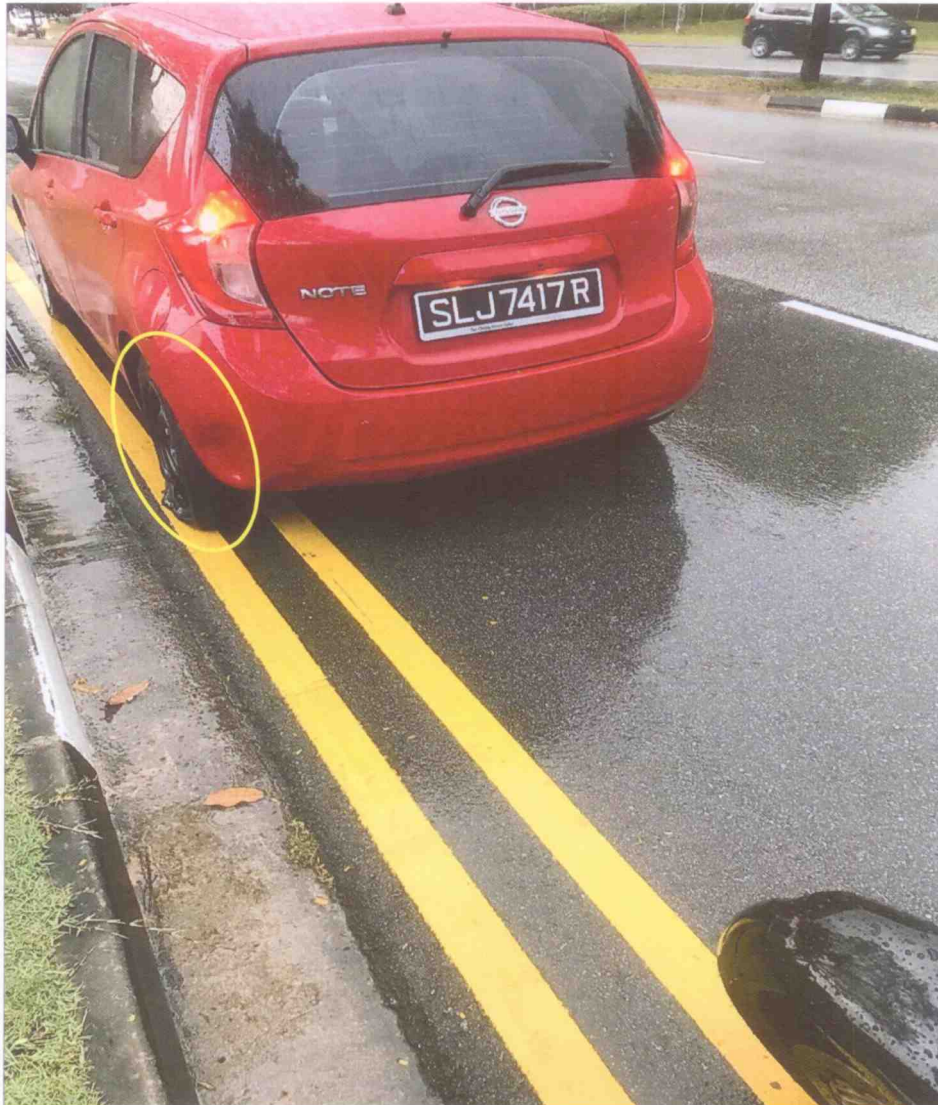
**Photo 3** taken by Mr Jabbar shows the damaged left rear wheel rim and punctured tyre of the Insured Vehicle (circled) noticed by Mr Shariff after Mr Jabbar told him of the damages. Our observation of Mr Shariff's ability to be able to still drive the Insured Vehicle to another location after the accident would suggest that there was no drink driving involved in this particular accident.

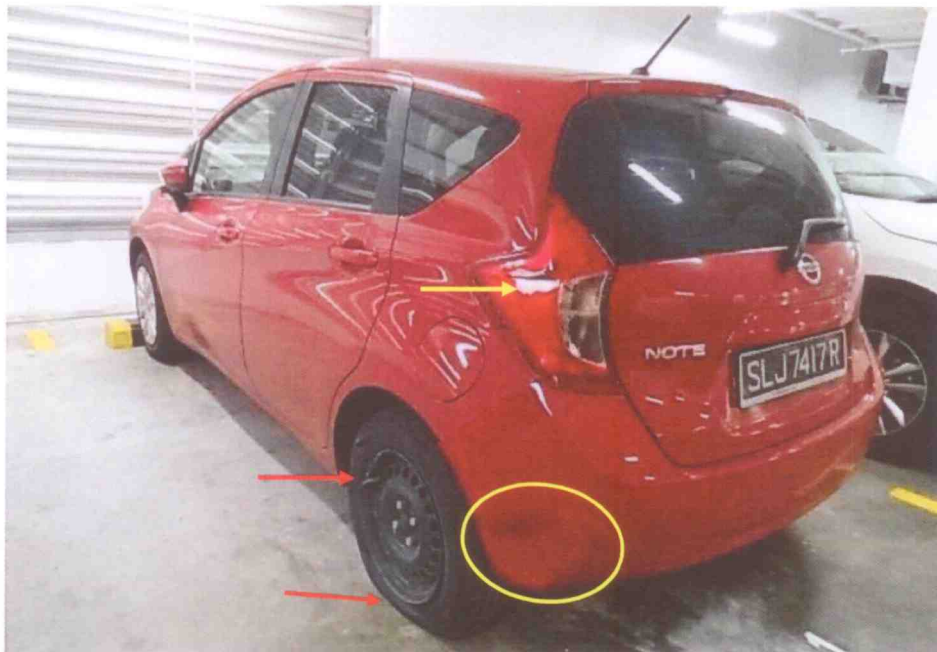
14. The photographs of the Insured Vehicle taken during the accident reporting at TCM 4 days after the accident revealed that the Insured Vehicle had sustained damages to its rear bumper, left tail light, left rear wheel rim and tyre. Our review of the photographs revealed there was a crack on the left tail light, a dent on the lower left portion of the rear bumper, a buckled rear left wheel rim and punctured rear left tyre. The damages sustained to the Insured Vehicle seem consistent with the circumstances of the accident, where the left rear portion was hit by a motorcycle. See photos 4 - 6 below.

**Photo 4** shows the left rear view of the Insured Vehicle during the accident reporting at TCM which was taken 4 days after the accident occurred. We observed a crack on the left tail light (yellow arrow), a dent on the lower left portion of the rear bumper (circled), a buckled rear left wheel rim and punctured rear left tyre (red arrows). The damages sustained to the Insured Vehicle seem consistent with the circumstances of the accident, where the left rear portion was hit by a motorcycle.

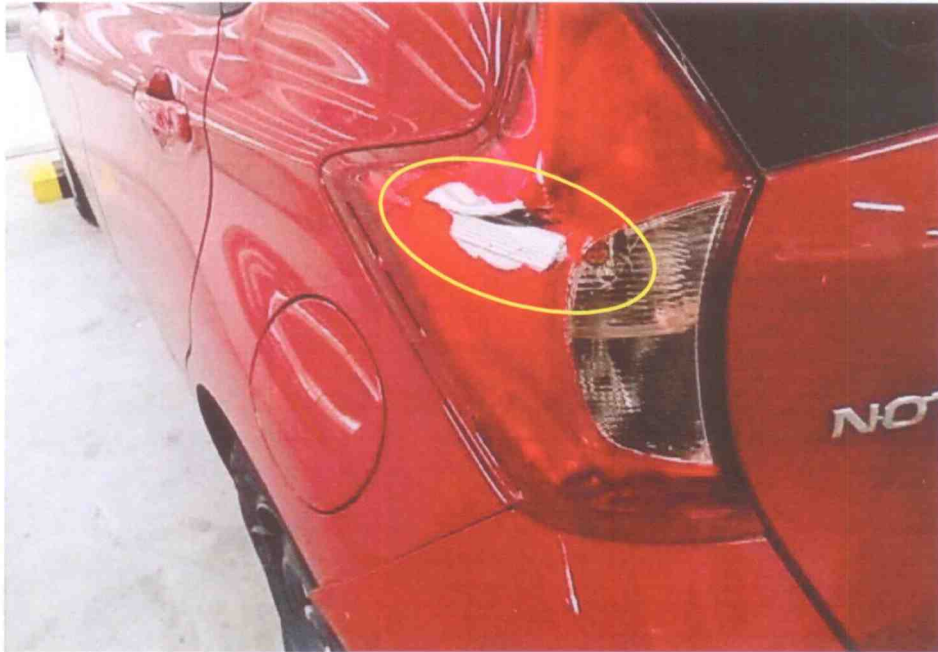
**Photo 5** shows a close up view of the crack on the left tail light (circled), which was caused by the right handlebar of the motorcycle.

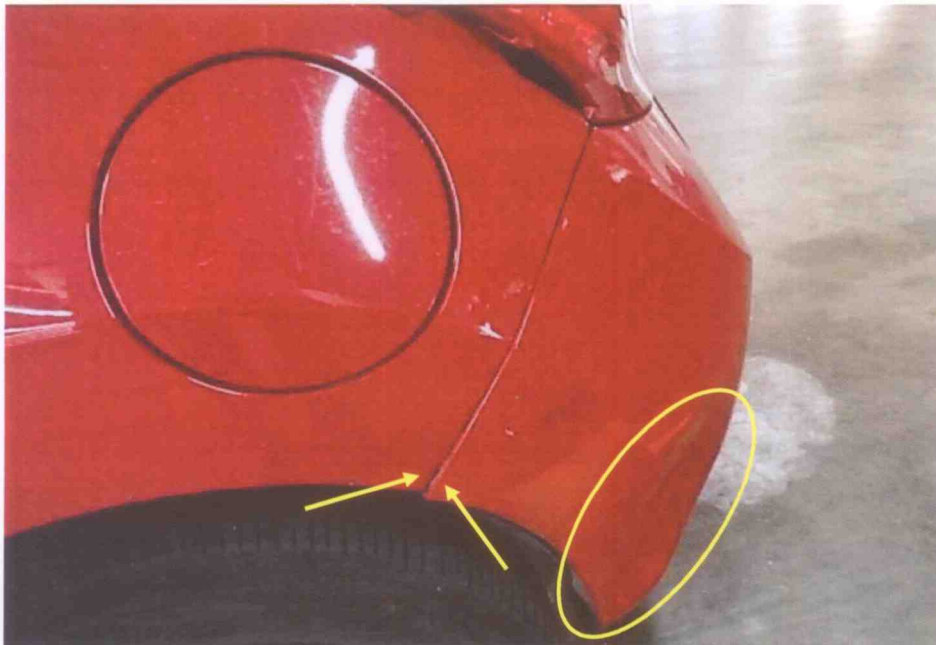
**Photo 6** shows a close up view of the dent on the lower left portion of the rear bumper (circled) and misalignment of the rear bumper at the left corner edge (arrowed) which was caused by the motorcycle hitting the Insured Vehicle.

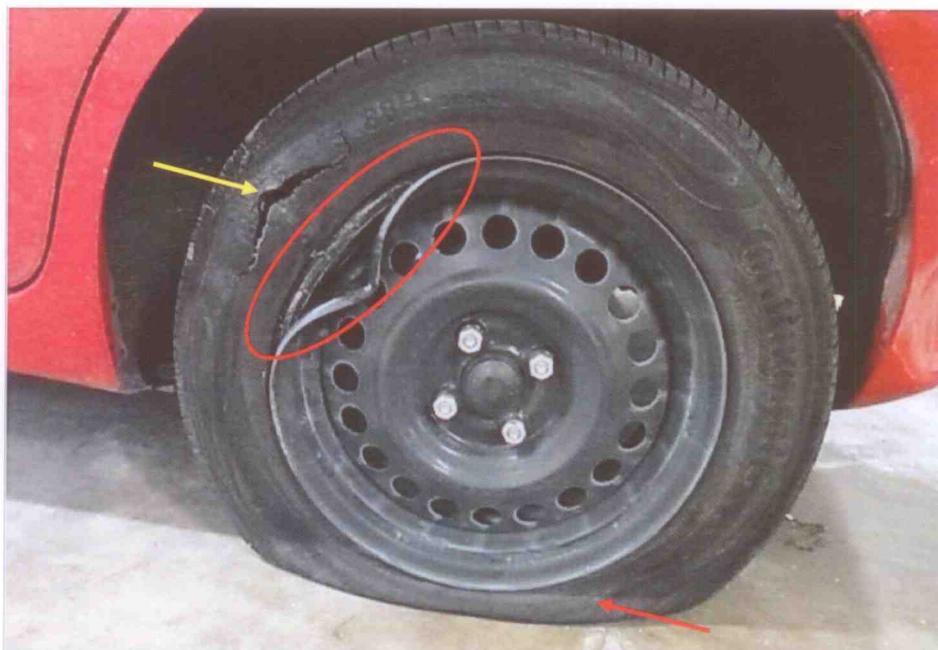
15. Upon closer examination of the damages sustained to the left rear wheel rim and tyre, we observed that a part of the outer wheel rim had buckled. There was also a tear on the sidewall of the left rear tyre adjacent to the buckled outer wheel rim which was the likely cause of the puncture. The tear in the sidewall of the left rear tyre was most probably caused by a sharp protruding object from the motorcycle which in this case may be the right pillion foot peg as it is the most protruding part of the right rear portion of the motorcycle when it came into contact with the left rear portion of the Insured Vehicle.

16. The damage profile of the tear in the sidewall of the left rear tyre could have been a result of the impact while the Insured Vehicle was in motion. As the right pillion foot peg hit the sidewall of the left rear tyre of the Insured Vehicle while the left rear tyre was in rotation, the impact caused a tear in the sidewall, puncturing the left rear tyre followed by the buckling of the left rear wheel rim and the wheel rim cover to be dislodged from the left rear wheel rim. See photo 7 below.

**Photo 7** shows a close up view of the buckled left rear wheel rim (circled) and punctured left rear tyre (red arrow) which was most probably caused by a sharp protruding object from the motorcycle which in this case may be the right pillion foot peg. As the right pillion foot peg hit the sidewall of the left rear tyre of the Insured Vehicle while the left rear tyre was in rotation, the impact caused a tear in the sidewall, puncturing the left rear tyre (yellow arrow) followed by the buckling of the wheel rim, resulting in the wheel rim cover to be dislodged from the left rear wheel rim.
