Auto
Consultants
Pte Ltd

Your Reference: SLU 3473X
Our Reference: CI/TP18006746/D

INSPECTION REPORT OF MOTOR CAR SLU 3473X

**Requested By:
Tan Ai Wei
331 River Valley Road #02-01
Singapore 238363**

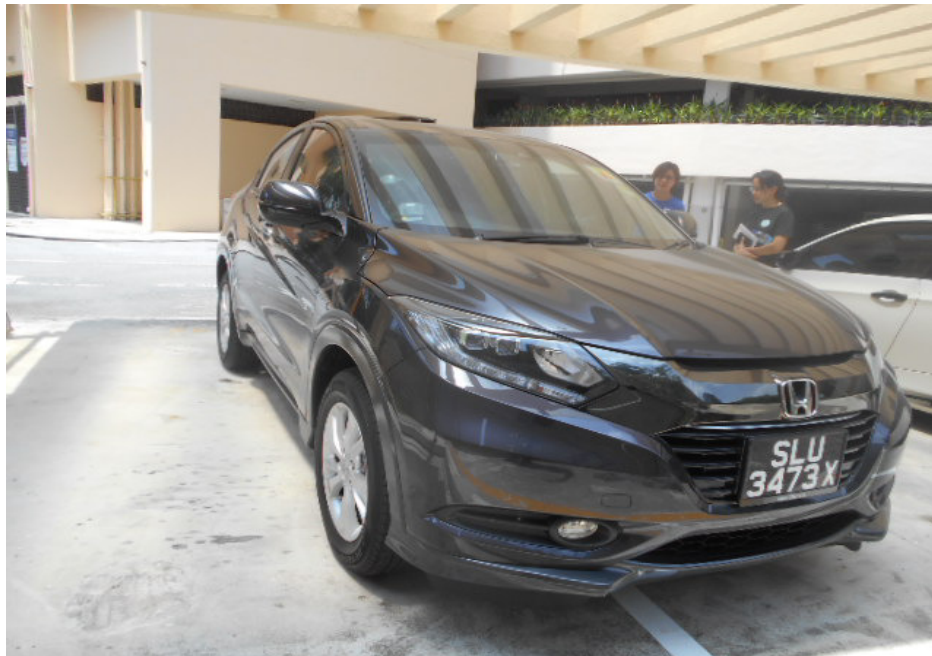
Photo 1 shows the front right body of the Motor Car at the time of my inspection. The Motor Car was observed to be in good general condition exteriorly. There was also no visible damage and/or loose exterior fittings observed on the exterior body of the Motor Car.

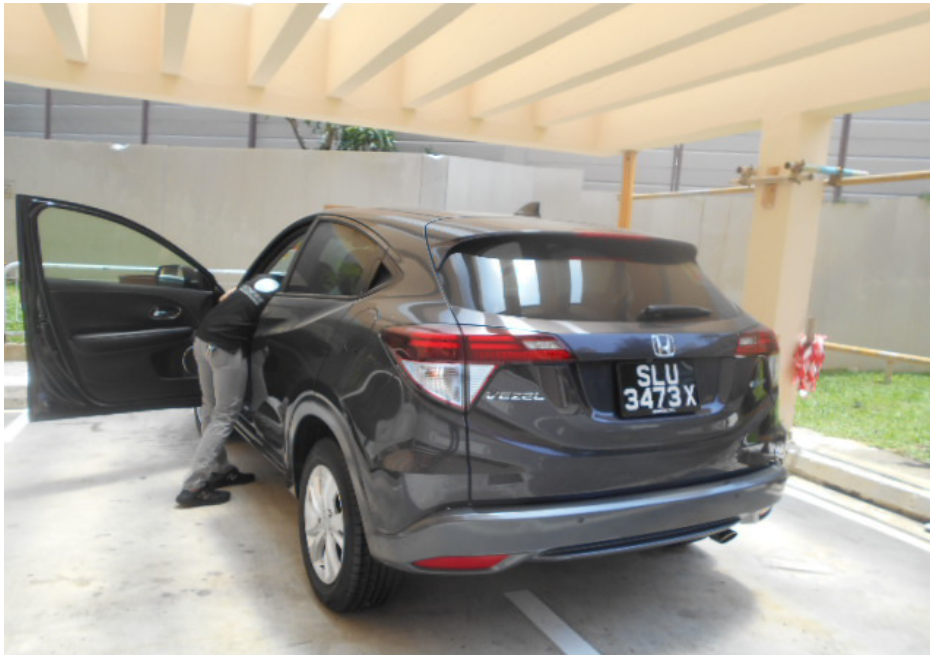
Photo 2 shows the rear left body of the Motor Car at the time of my inspection. The Motor Car was observed to be in good general condition exteriorly. There was also no visible damage and/or loose exterior fittings observed on the exterior body of the Motor Car.

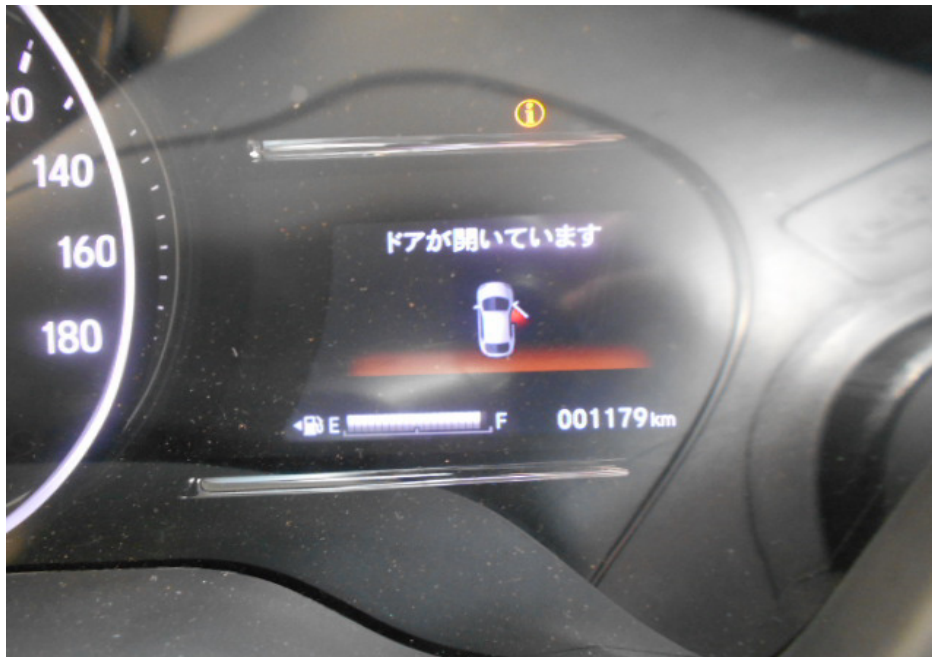
Photo 3 shows the mileage of the Motor Car at the time of my inspection. The mileage recorded was 1,179km.

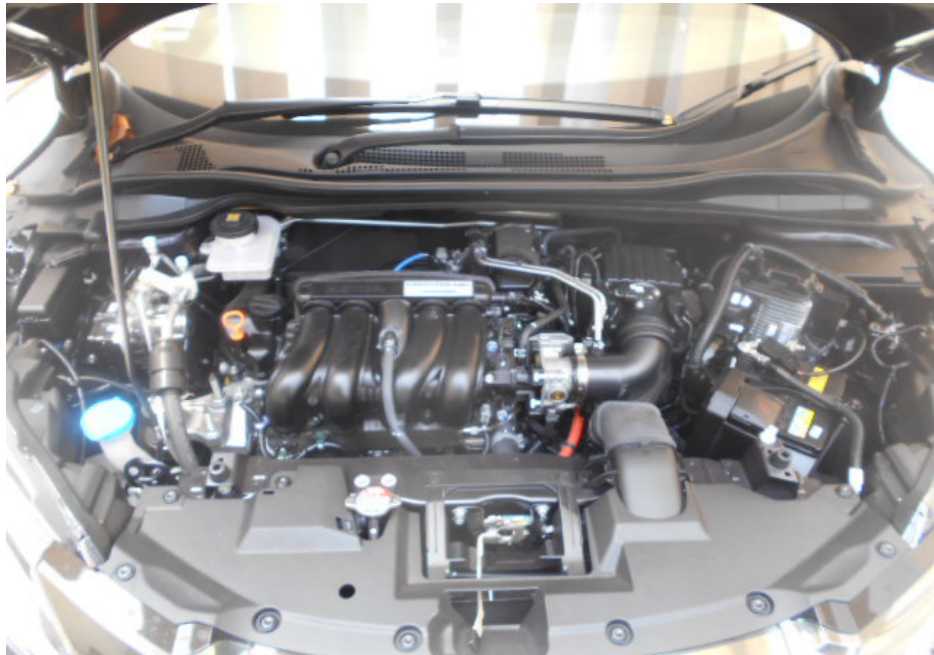
20. Upon checking the engine compartment of the Motor Car, I had observed that the various mechanical components, hoses and sensors were all intact and securely fitted/attached. Checks on the various operating fluids like the engine oil, engine coolant and brake fluid revealed all to be of sufficient level for operating purposes and without any contamination. There was also fluid stain(s) and/or fluid leak(s) found within the engine compartment. See photo 1 – 7 below.

Photo 4 shows a general view of the Motor Car's engine compartment. I had observed that the various mechanical components, hoses and sensors were all intact and securely fitted/attached. The engine compartment was also observed to be relatively clean with no fluid stain(s) and/or fluid leak(s) found.

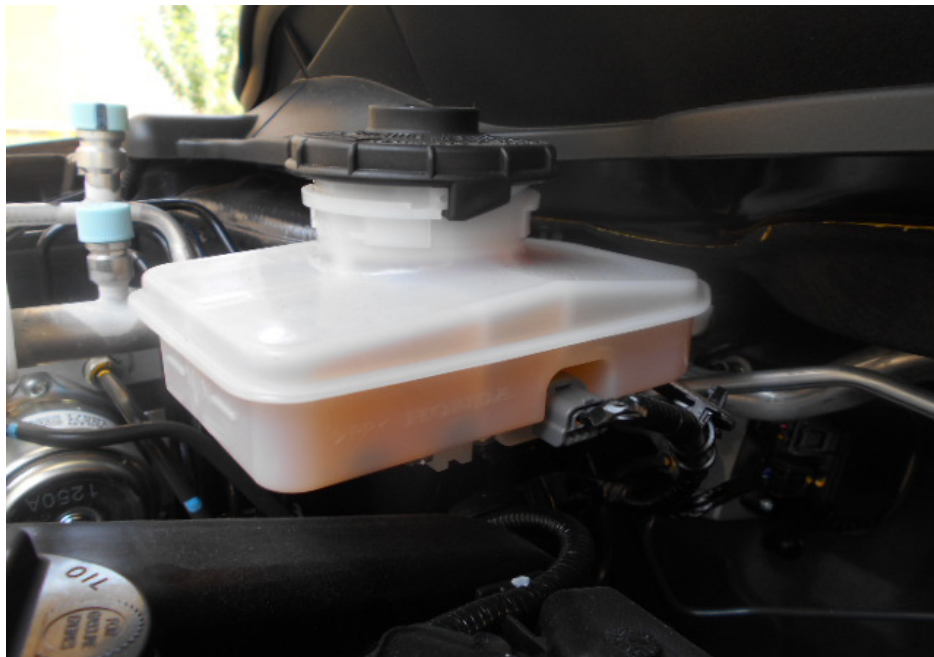
Photo 5 shows the brake fluid reservoir of the Motor Car at the time of my inspection. The brake fluid was observed to be of sufficient level for operating purposes and without any visible contamination.

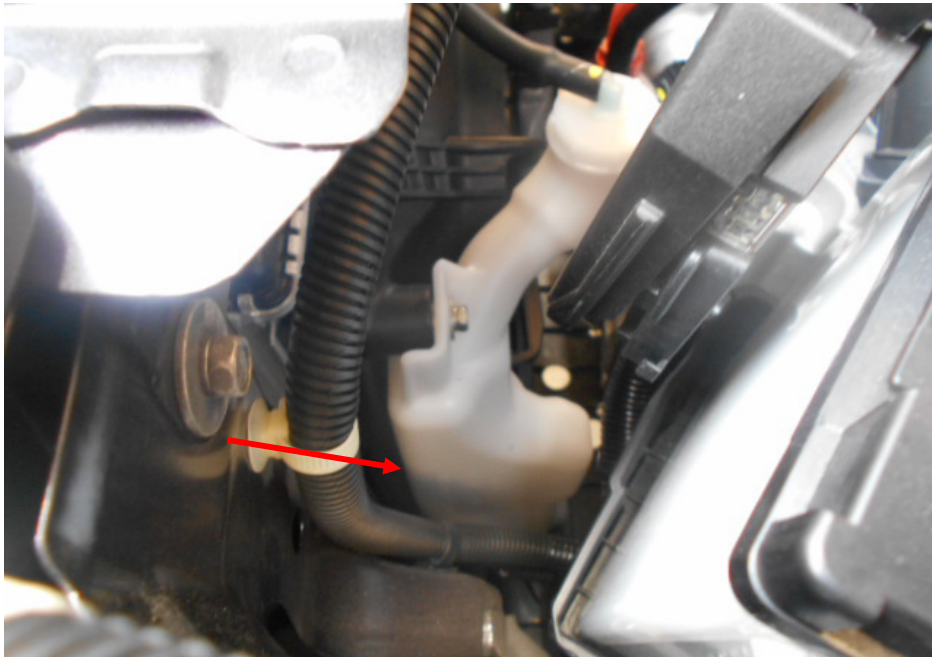
Photo 6 shows the engine coolant reservoir of the Motor Car at the time of my inspection. The engine coolant was observed to be of sufficient level (arrowed) and without any visible contamination.

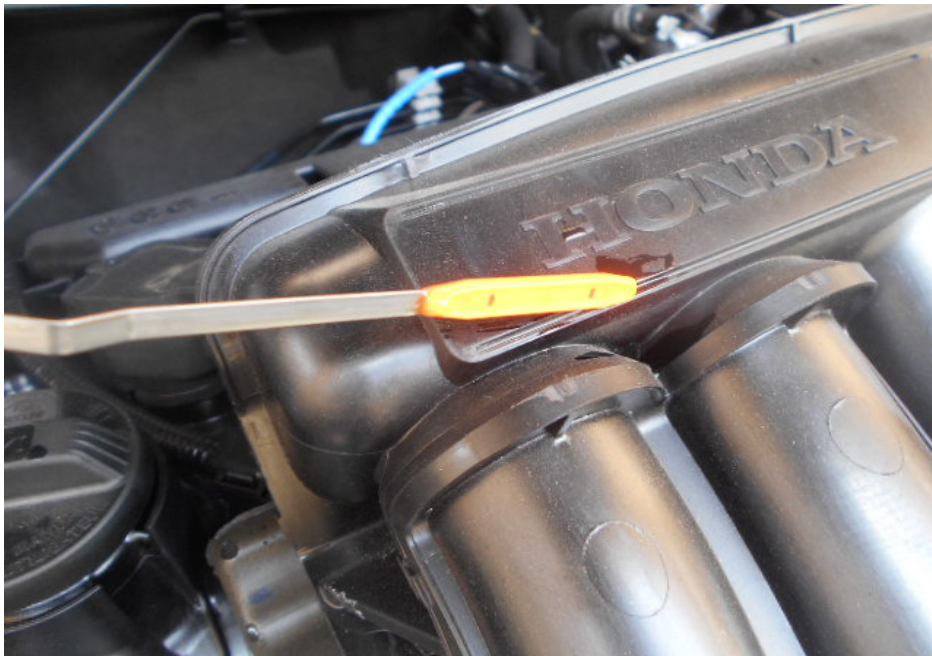
Photo 7 shows the engine oil dip stick of the Motor Car at the time of my inspection. The engine oil was observed to be of sufficient level and without any visible contamination.

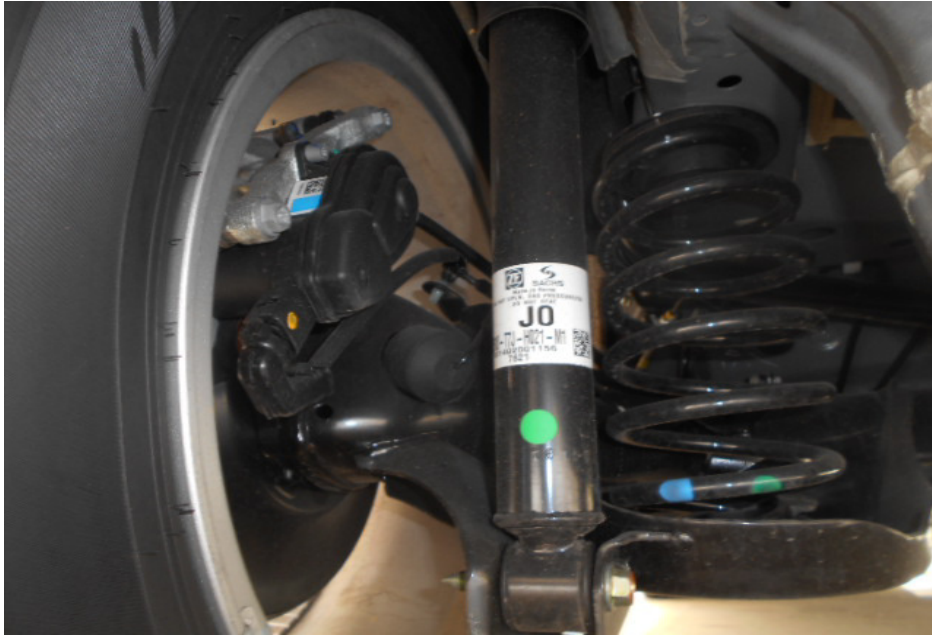
21. Checks to the underside of the Motor Car revealed its various undercarriage components intact and without any visible damage. The Motor Car's 4 tyres were also observed to be in serviceable condition and sufficiently inflated for vehicular operation. See photo 8 & 9 below.

Photo 8 shows the various undercarriage components at the rear left wheel of the Motor Car. The undercarriage components of the Motor Car were all observed to be intact and without any visible damage.

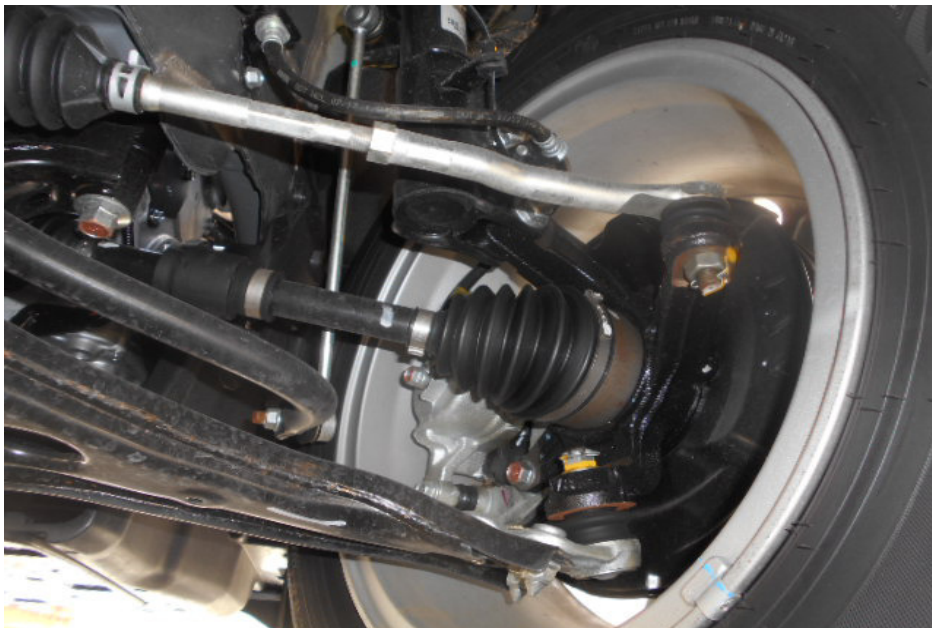
Photo 9 shows the various undercarriage components at the front right wheel of the Motor Car. The undercarriage components of the Motor Car were all observed to be intact and without any visible damage.

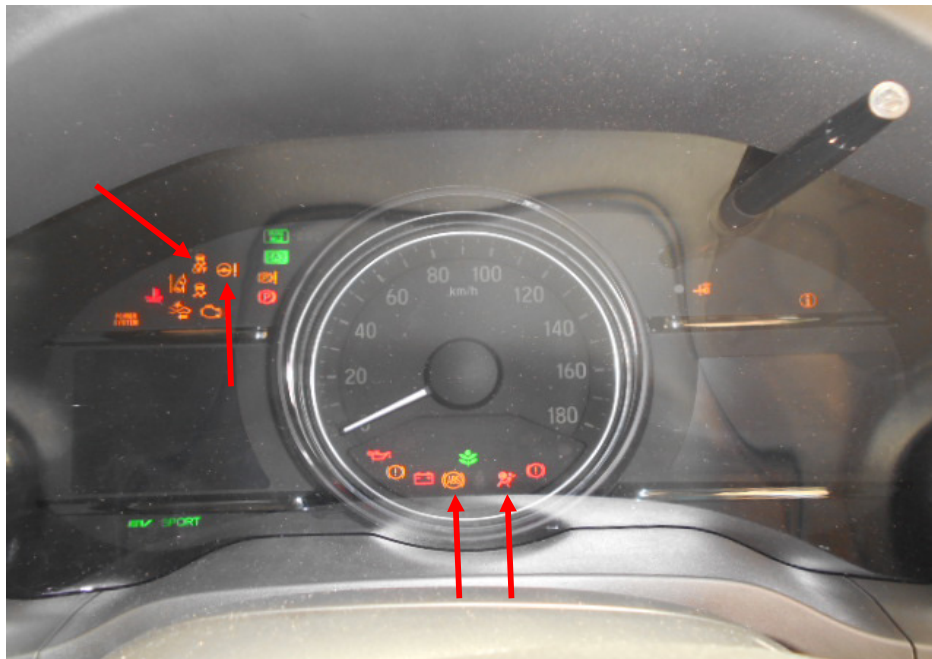
22. The Motor Car's automatic self-test of the functionality of its various electronic operating systems like the Anti-Lock Brake System (ABS), Electronic Power Steering (EPS), Traction Control (TC) and Supplemental Restraint System (SRS) during cranking of the engine had indicated that these systems were in working condition and without abnormality. This can be established from the warning lights disappearing from the instrument panel after the self-test. See photo 10 & 11 below.

Photo 10 shows the warning light for the Anti-Lock Brake System (ABS), Electric Power Steering System (EPS), Traction Control (TC) and Supplemental Restraint System (SRS) appearing on the instrument panel of the Motor Car during the self-test of its various electronic operating systems when its engine was cranked.

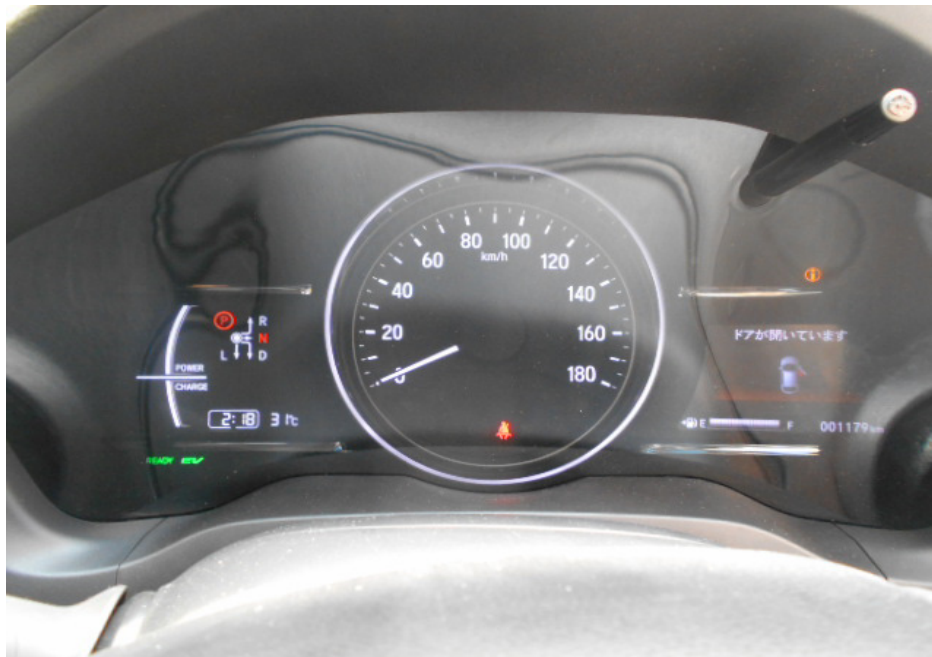
Photo 11 shows no warning lights illuminated on the instrument panel of the Motor Car after the engine was cranked. This would suggest that there was no abnormality to the various electronic operating systems of the motor car, like the ABS, EPS, TC and SRS etc.

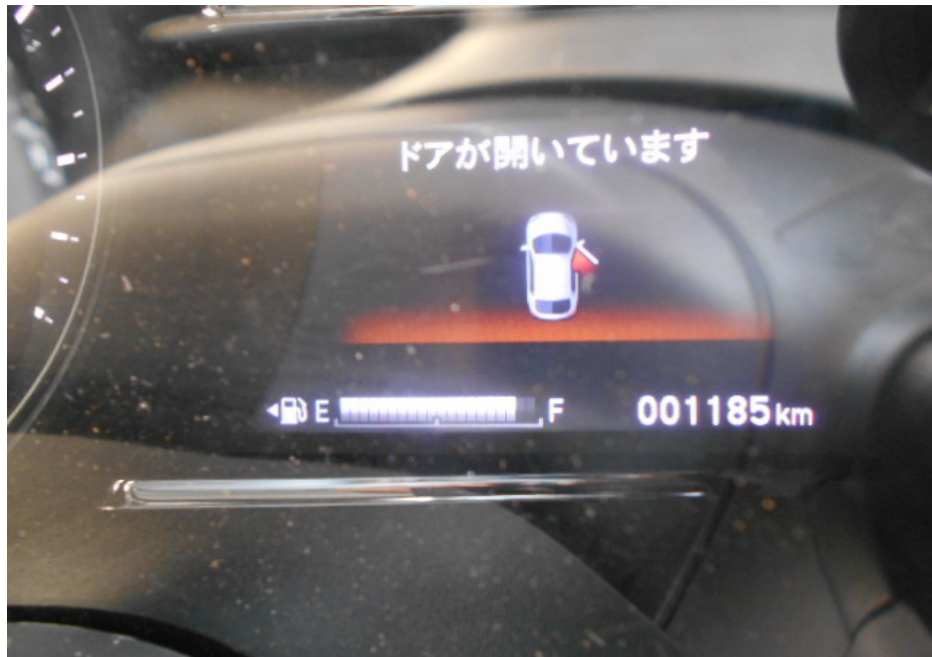
Photo 12 shows the mileage of the Motor Car at the end of my test drive. The mileage recorded was 1,185km.

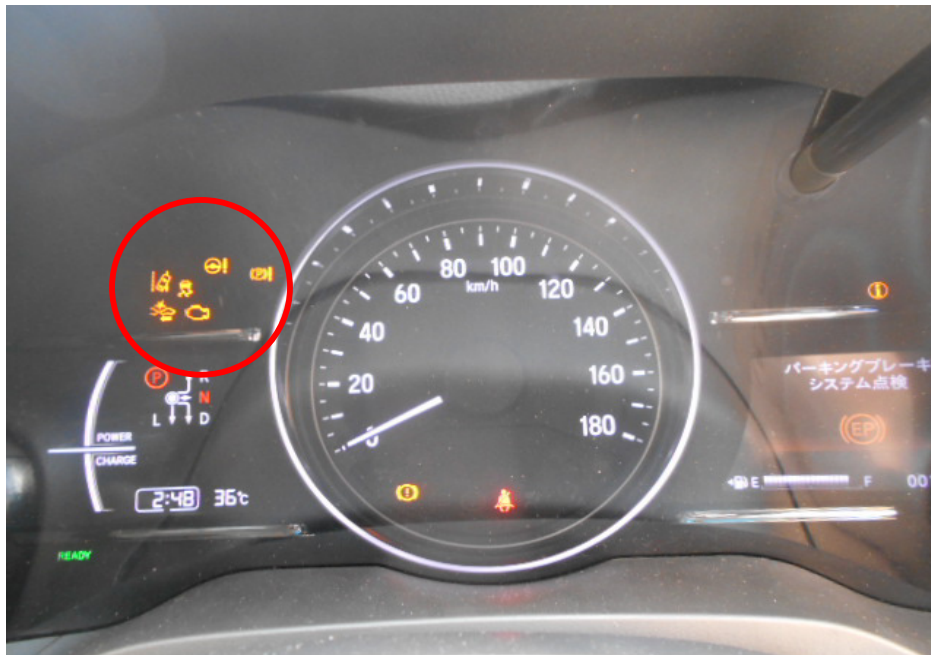
25. Upon returning to 331 River Valley Road after my test drive, several warning/indicator lights abruptly came on whilst the Motor Car was idling. These lights were the warning/indicator light for the engine system, collision mitigation braking system, vehicle stability assist, electric power steering and road departure mitigation system. The parking brake indicator light also came on intermittently. I then turned off the engine and restarted the engine. The same warning/indicator lights remained lighted up after the Motor Car's automatic self-test of the functionality of its various electronic operating systems. See photo 13 below.

Photo 13 shows several warning/indicator lights lighted up. These lights (circled) had abruptly came on whilst the Motor Car was idling after my test drive. These lights were the warning/indicator light for the engine system, collision mitigation braking system, vehicle stability assist, electric power steering and road departure mitigation system. The lights had remained lighted up after I had turned off and restarted the engine of the Motor Car.

31. During my inspection, several warning/indicator lights of the Motor Car abruptly came on. These lights were the warning/indicator light for the engine system, collision mitigation braking system, vehicle stability assist, electric power steering and road departure mitigation system. Despite turning off and re-starting the Motor Car's engine, these lights remain lighted and did not go off.

34. Given that the warning/indicator lights did not come on during the initial period of my physical inspection but had subsequently came on abruptly, I am of the view that the Motor Car is in an unsafe condition to be driven. The Motor Car's abnormal behaviour when the warning/indicator lights came on may pose a danger to the driver and other road users. The multiple occasions, experienced by Ms Tan, pertaining to these warning/indicator lights abruptly coming on, would seem to suggest that this issue is not an intermittent issue. The issue had continued to recur despite attempts by Venture Cars to rectify.

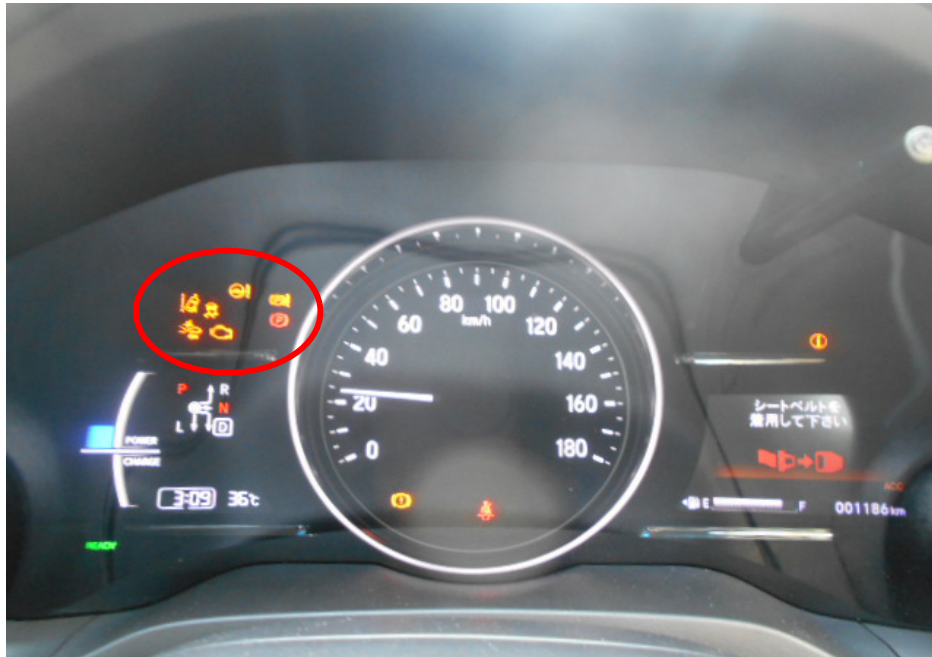
27. Firstly, it was noted that the transmission of the Motor Car could be shifted without any difficulty. I was able to shift the transmission from drive mode to reverse mode, and from reverse mode back to drive mode. The braking system of the Motor Car was also observed to be functioning without any abnormality. Upon stepping on the accelerator pedal, the Motor Car had moved however the speed of the Motor Car did not correspond to the accelerator/throttle input. In other words, despite depressing more on the accelerator pedal, the Motor Car's speed did not increase accordingly. The Motor Car felt sluggish, moving more slowly than normal and with less power. This sluggishness was experienced throughout the second test drive. The Motor Car even "struggled" to move up a slope within the premise of 331 River Valley Road. It had displayed a lack of power and was extremely slow when moving up the slope even though the accelerator pedal was fully depressed. The air-conditioning system was also observed to be functioning intermittently ie blowing hot air with intermittent cool air.

Photo 14 shows the warning/indicator lights (circled) lighted up during my second test drive of the Motor Car. During this second test drive, the Motor Car felt sluggish. The Motor Car had displayed a lack of power and was extremely slow even when the accelerator pedal was fully depressed. The air-conditioning system was also observed to be functioning intermittently ie blowing hot air with intermittent cool air.

32. My test drive of the Motor Car when these warning/indicator lights came on revealed abnormal behaviour of its engine system. The Motor Car displayed symptoms of sluggishness and lack of power. The speed of the Motor Car did not correspond to the accelerator/throttle input. It was moving slowly despite depressing more on the accelerator pedal. The air-conditioning system was also observed to be functioning intermittently.
