Your Reference: SLU 3473X  
Our Reference: CI/TP18006746/D  
13 April 2018

## INSPECTION REPORT OF MOTOR CAR SLU 3473X

Requested By:  
Tan Ai Wei  
331 River Valley Road #02-01  
Singapore 238363

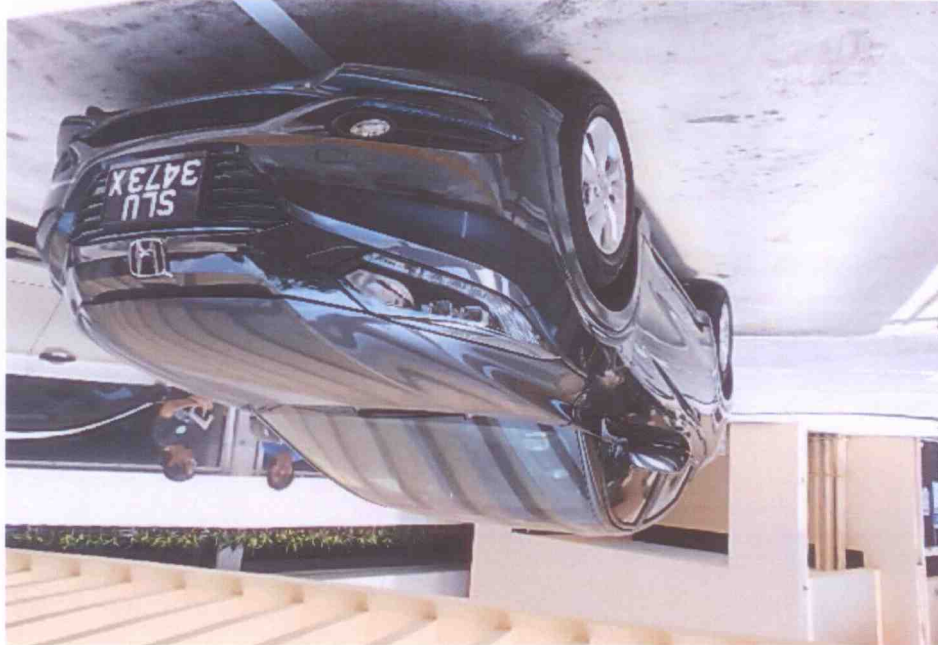
**Photo 1** shows the front right body of the Motor Car at the time of my inspection. The Motor Car was observed to be in good general condition exteriorly. There was also no visible damage and/or loose exterior fittings observed on the exterior body of the Motor Car.

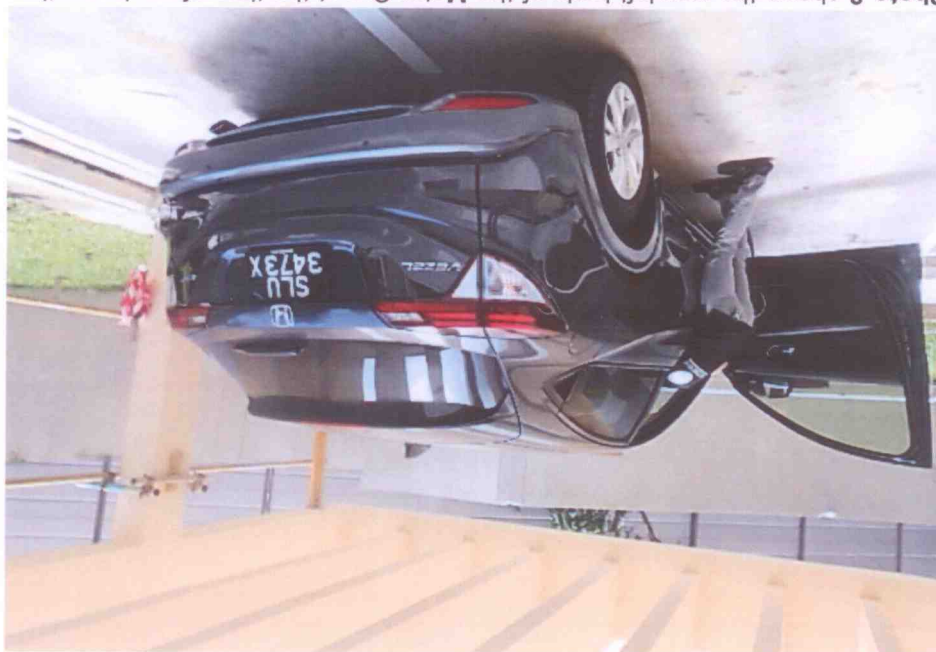
**Photo 2** shows the rear left body of the Motor Car at the time of my inspection. The Motor Car was observed to be in good general condition exteriorly. There was also no visible damage and/or loose exterior fittings observed on the exterior body of the Motor Car.

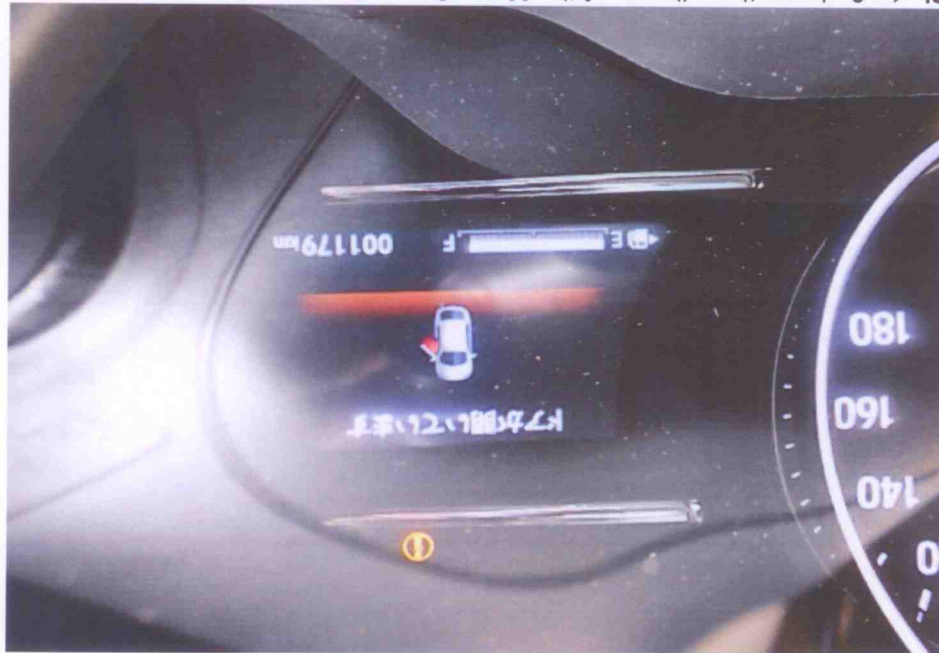
**Photo 3** shows the mileage of the Motor Car at the time of my inspection. The mileage recorded was 1,179km.

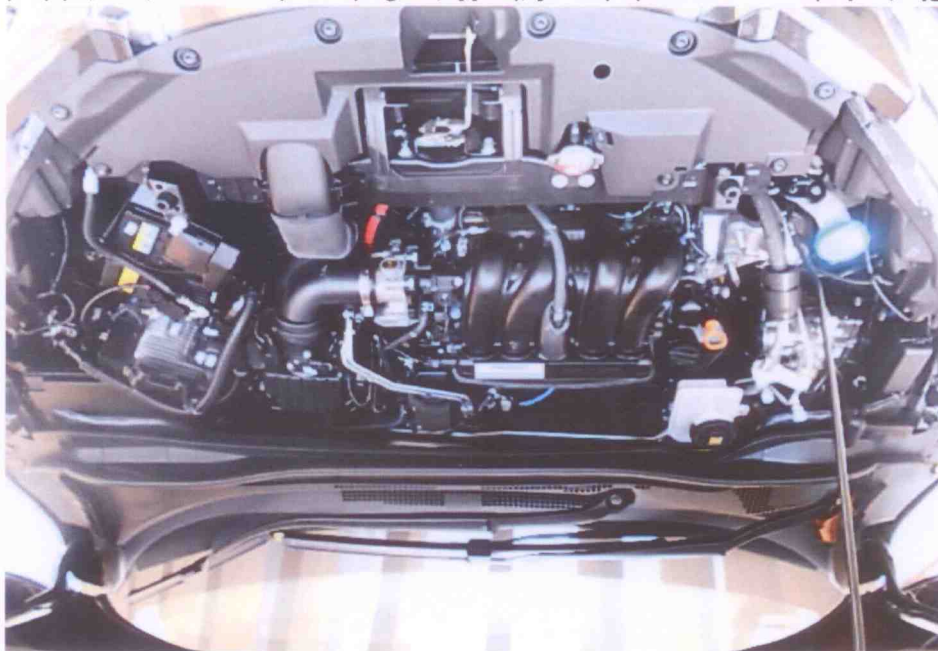
**Photo 4** shows a general view of the Motor Car's engine compartment. I had observed that the various mechanical components, hoses and sensors were all intact and securely fitted/attached. The engine compartment was also observed to be relatively clean with no fluid stain(s) and/or fluid leak(s) found.

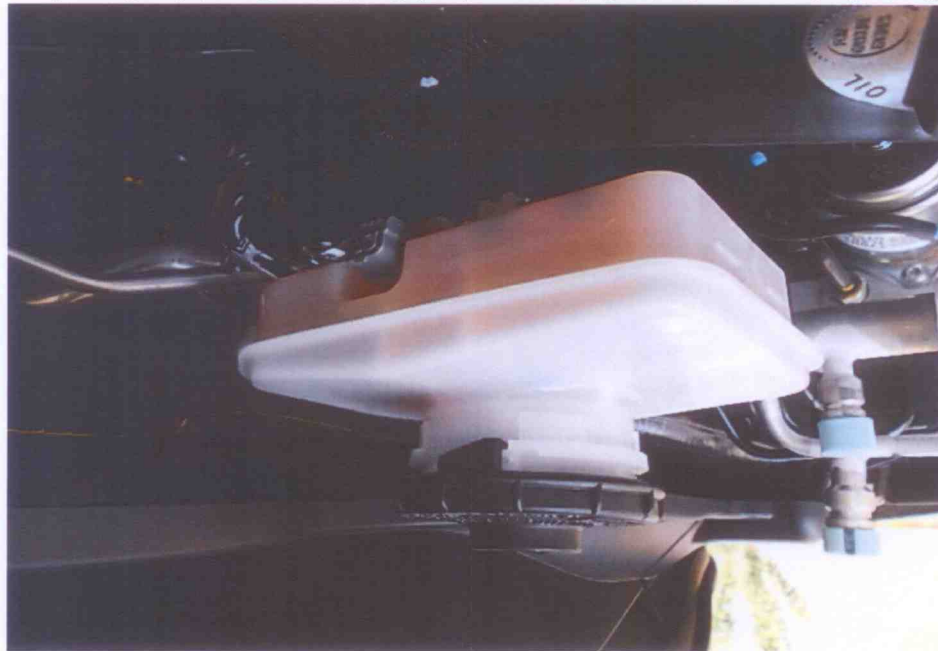
**Photo 5** shows the brake fluid reservoir of the Motor Car at the time of my inspection. The brake fluid was observed to be of sufficient level for operating purposes and without any visible contamination.

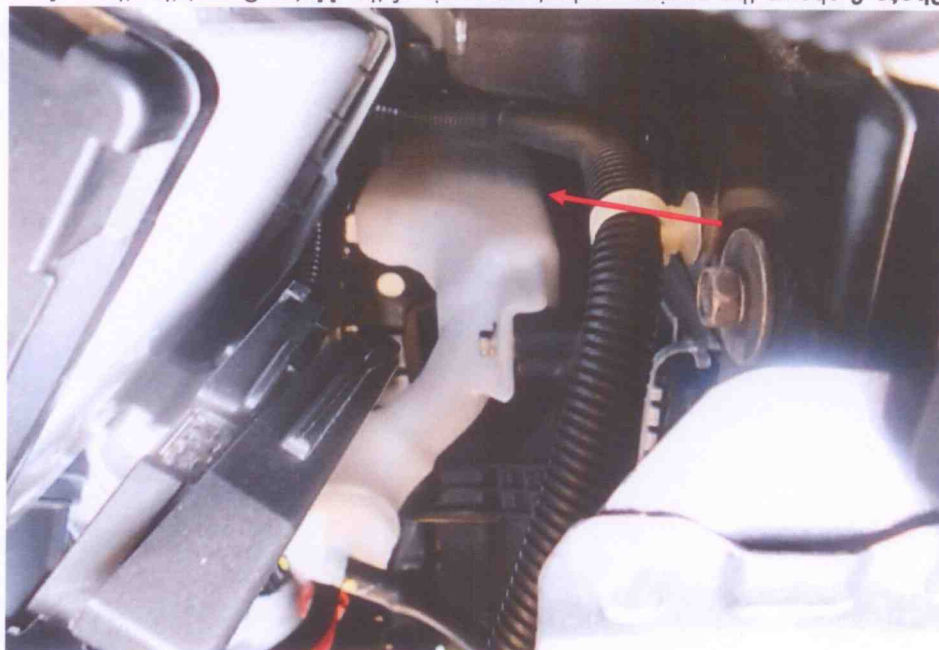
Photo 6 shows the engine coolant reservoir of the Motor Car at the time of my inspection. The engine coolant was observed to be of sufficient level (arrowed) and without any visible contamination.

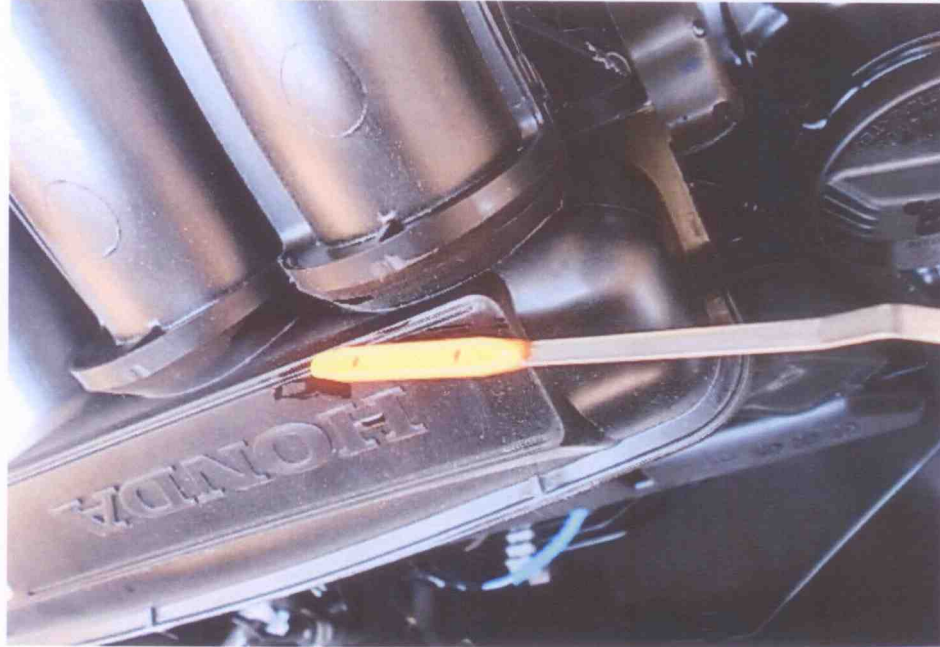
Photo 7 shows the engine oil dip stick of the Motor Car at the time of my inspection. The engine oil was observed to be of sufficient level and without any visible contamination.

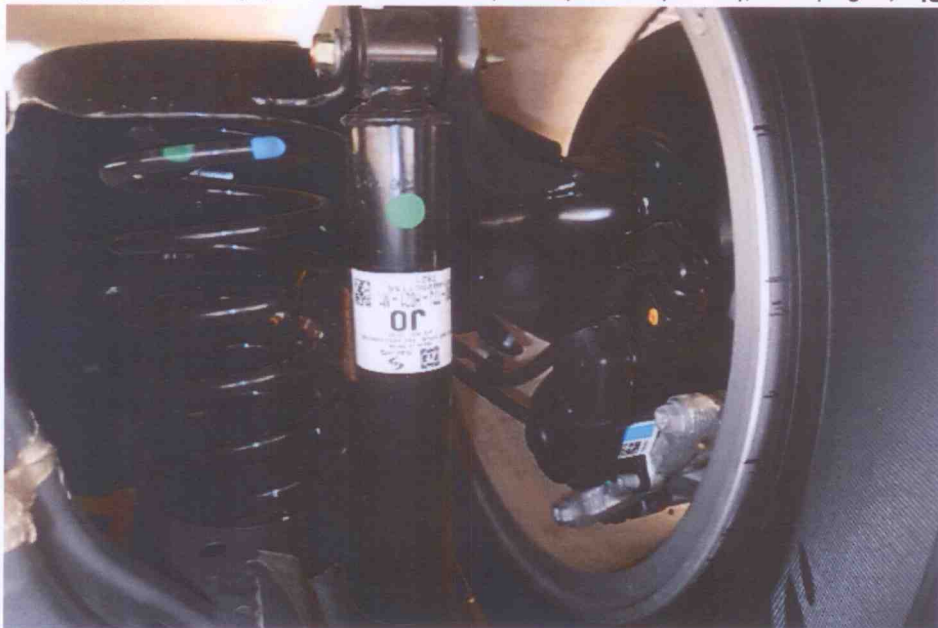
**Photo 8** shows the various undercarriage components at the rear left wheel of the Motor Car. The undercarriage components of the Motor Car were all observed to be intact and without any visible damage.

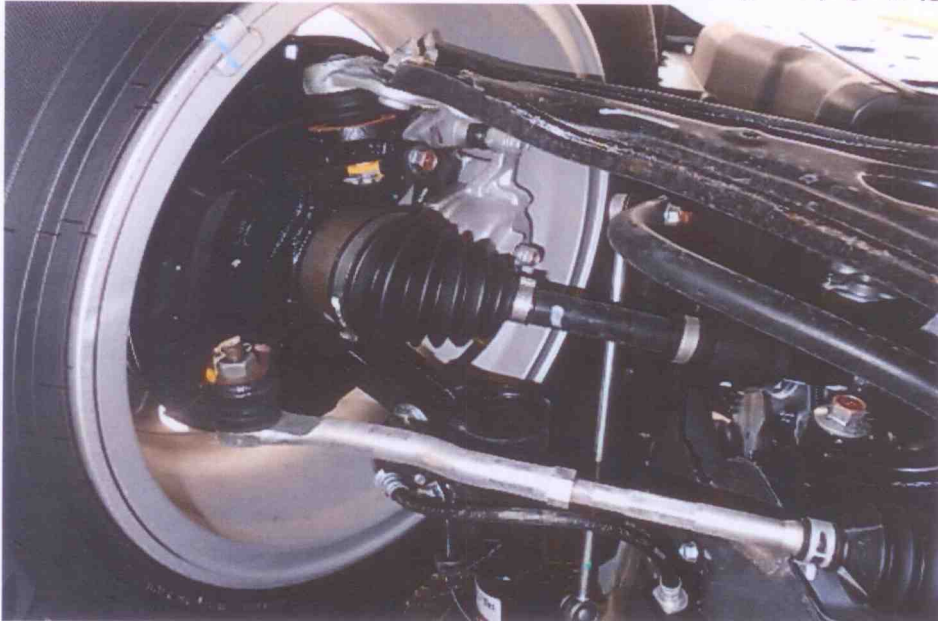
**Photo 9** shows the various undercarriage components at the front right wheel of the Motor Car. The undercarriage components of the Motor Car were all observed to be intact and without any visible damage.

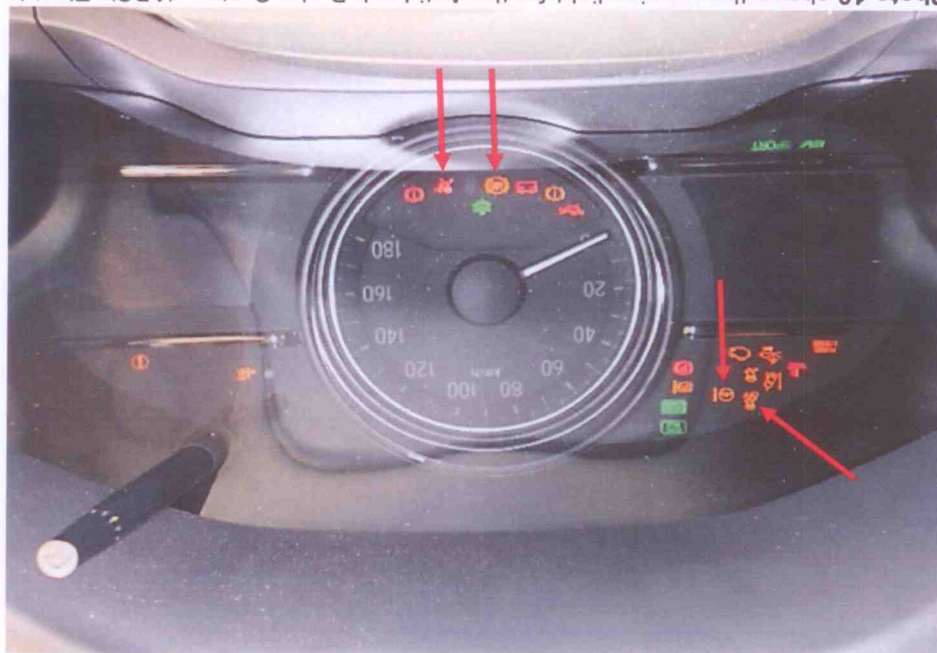
**Photo 10** shows the warning light for the Anti-Lock Brake System (ABS), Electric Power Steering System (EPS), Traction Control (TC) and Supplemental Restraint System (SRS) appearing on the instrument panel of the Motor Car during the self-test of its various electronic operating systems when its engine was cranked.

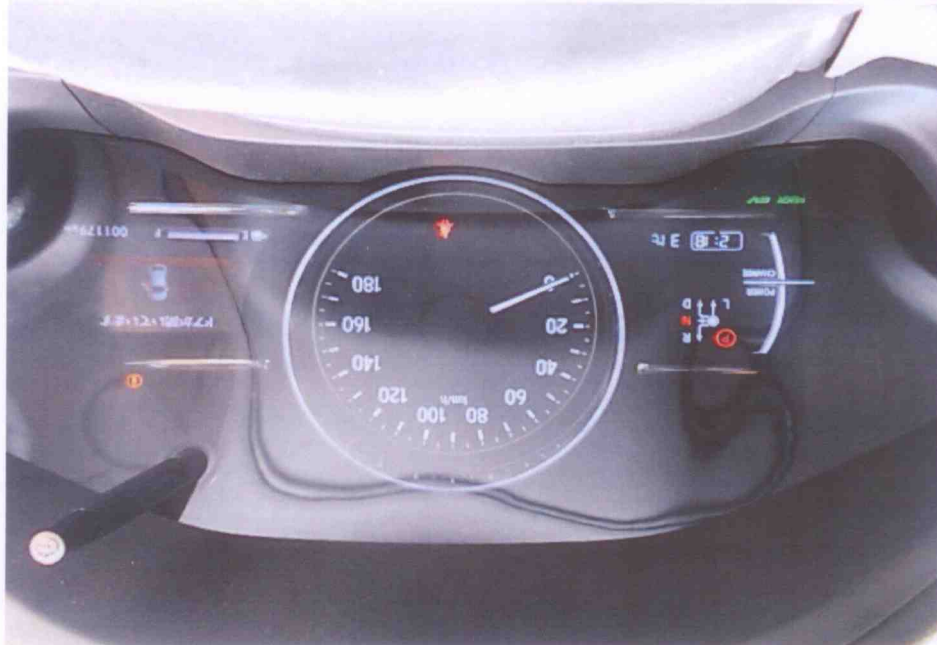
**Photo 11** shows no warning lights illuminated on the instrument panel of the Motor Car after the engine was cranked. This would suggest that there was no abnormality to the various electronic operating systems of the motor car, like the ABS, EPS, TC and SRS etc.

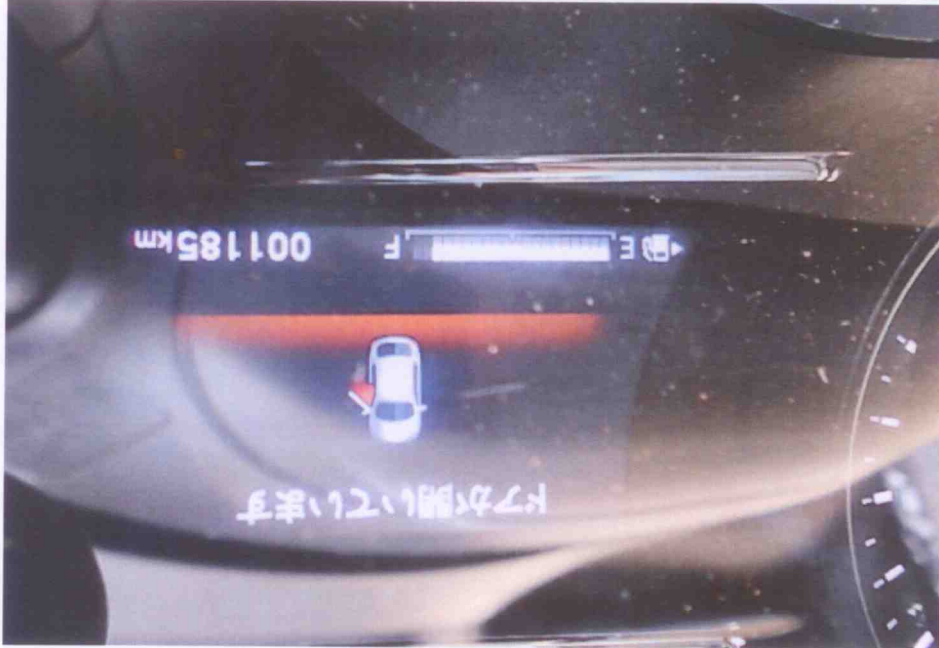
Photo 12 shows the mileage of the Motor Car at the end of my test drive. The mileage recorded was 1,185km.

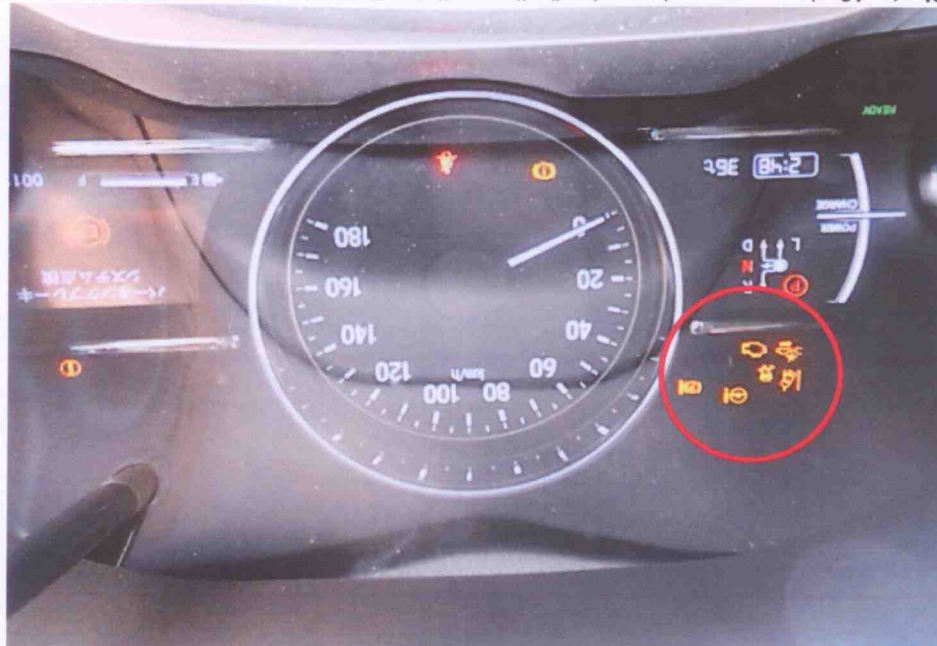
25. Upon returning to 331 River Valley Road after my test drive, several warning/indicator lights abruptly came on whilst the Motor Car was idling. These lights were the warning/indicator light for the engine system, collision mitigation braking system, vehicle stability assist, electric power steering and road departure mitigation system. The parking brake indicator light also came on intermittently. I then turned off the engine and restarted the engine. The same warning/indicator lights remained lighted up after the Motor Car's automatic self-test of the functionality of its various electronic operating systems. See photo 13 below.

**Photo 13** shows several warning/indicator lights lighted up. These lights (circled) had abruptly came on whilst the Motor Car was idling after my test drive. These lights were the warning/indicator light for the engine system, collision mitigation braking system, vehicle stability assist, electric power steering and road departure mitigation system. The lights had remained lighted up after I had turned off and restarted the engine of the Motor Car.

31. During my inspection, several warning/indicator lights of the Motor Car abruptly came on. These lights were the warning/indicator light for the engine system, collision mitigation braking system, vehicle stability assist, electric power steering and road departure mitigation system. Despite turning off and re-starting the Motor Car's engine, these lights remain lighted and did not go off.

34. Given that the warning/indicator lights did not come on during the initial period of my physical inspection but had subsequently came on abruptly, I am of the view that the Motor Car is in an unsafe condition to be driven. The Motor Car's abnormal behaviour when the warning/indicator lights came on may pose a danger to the driver and other road users. The multiple occasions experienced by Ms Tan, pertaining to these warning/indicator lights abruptly coming on, would seem to suggest that this issue is not an intermittent issue. The issue had continued to recur despite attempts by Venture Cars to rectify.

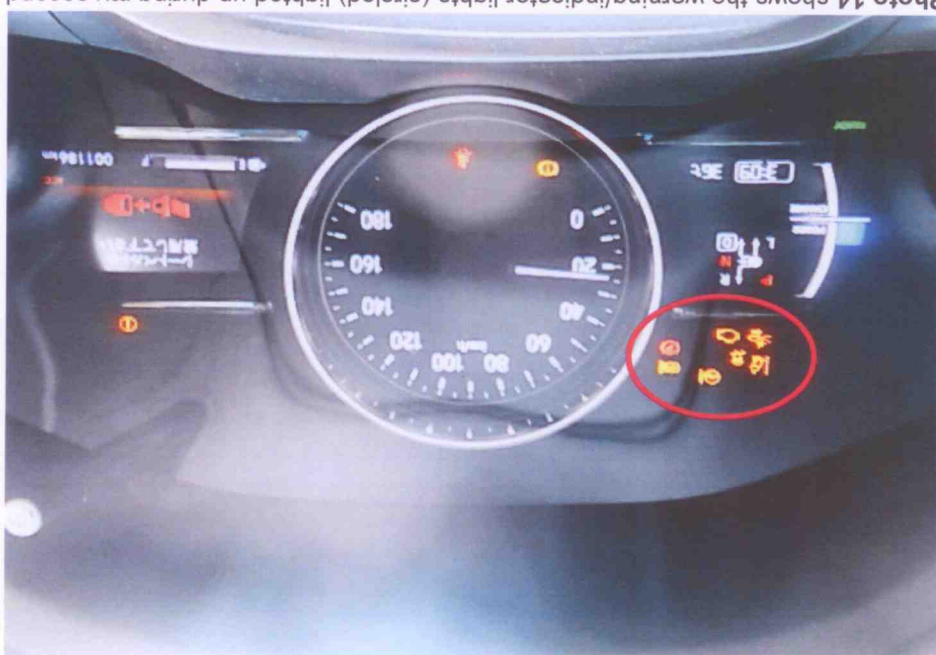
Photo 14 shows the warning/indicator lights (circled) lighted up during my second test drive of the Motor Car. During this second test drive, the Motor Car felt sluggish. The Motor Car had displayed a lack of power and was extremely slow even when the accelerator pedal was fully depressed. The air-conditioning system was also observed to be functioning intermittently ie blowing hot air with intermittent cool air.

32. My test drive of the Motor Car when these warning/indicator lights came on revealed abnormal behaviour of its engine system. The Motor Car displayed symptoms of sluggishness and lack of power. The speed of the Motor Car did not correspond to the accelerator/throttle input. It was moving slowly despite depressing more on the accelerator pedal. The air-conditioning system was also observed to be functioning intermittently.
