Your Ref : S8M00DMN
Our Ref : CS/ASM18006764/Z

18th April 2018

**TECHNICAL INVESTIGATION REPORT OF FIRE INCIDENT INVOLVING THE
INSURED VEHICLE SFL 9297S ON 09th April 2018**

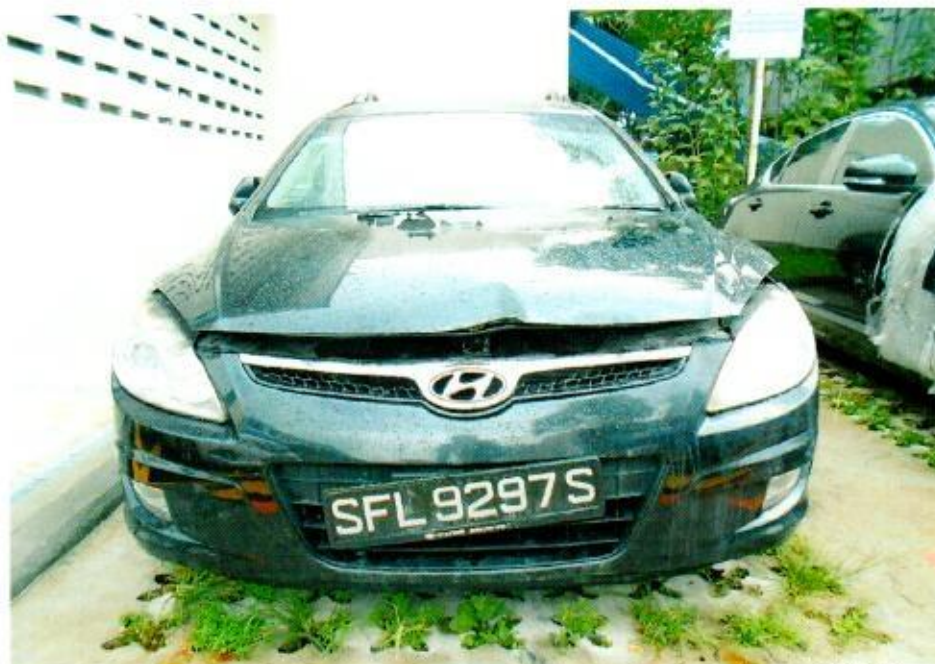
Photo 1 shows the general view of the front right portion of the Insured Vehicle at the time of our inspection. The fire damage to the Insured Vehicle was confined to its front portion. Its front bumper, front bonnet, front grille and front right headlamp were amongst the body parts that were found to have been affected as a result of the fire.

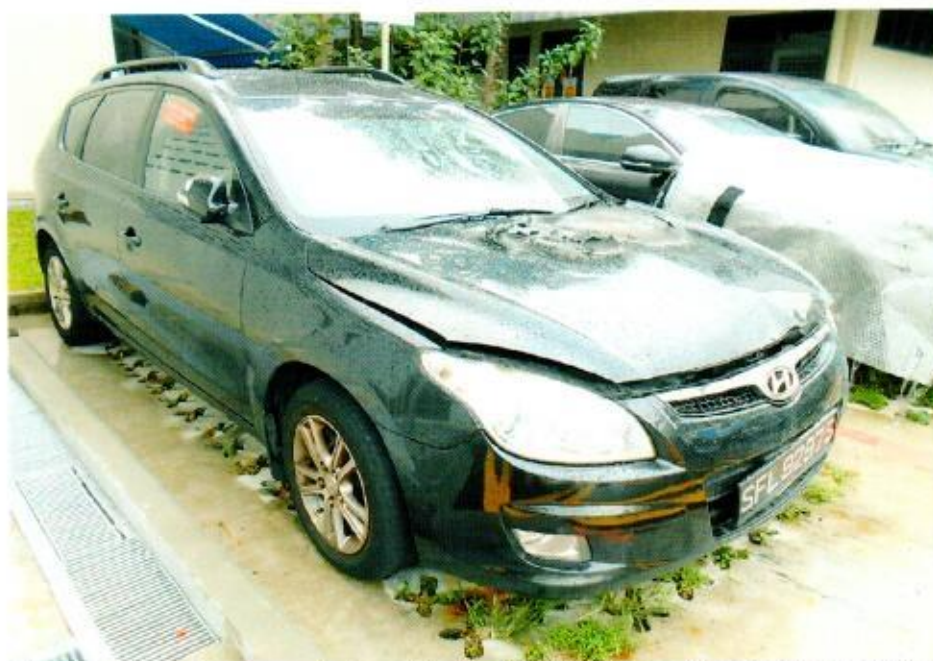
Photo 2 shows the general view of the front right portion of the Insured Vehicle at the time of our inspection. The fire damage to the Insured Vehicle was confined to its front portion. Its front bumper, front bonnet and front left headlamp were amongst the body parts that were found to have been affected as a result of the fire.

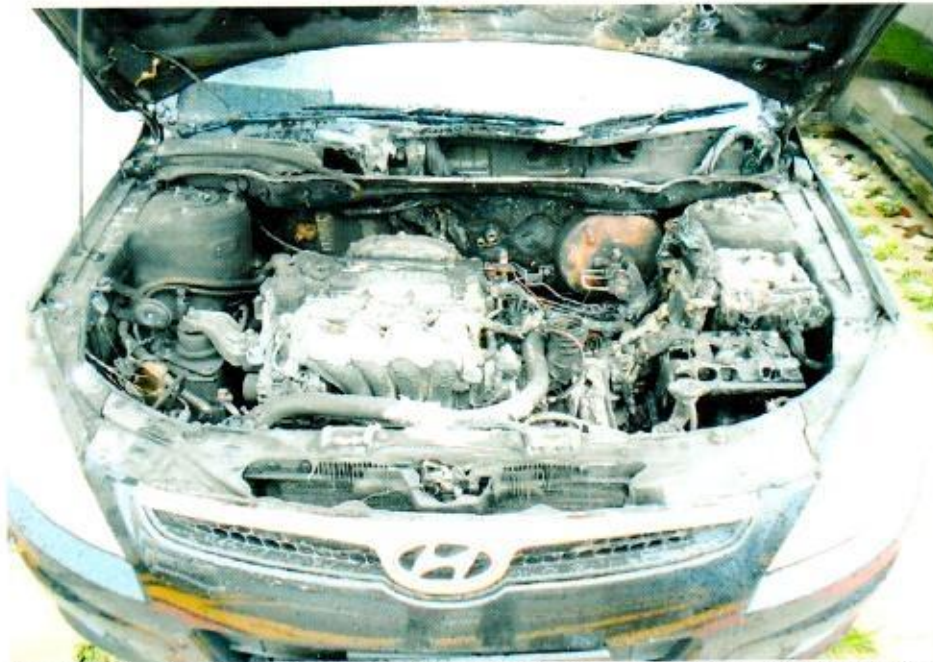
Photo 3 shows the engine compartment of the Insured Vehicle at the time of our inspection. The entire engine compartment of the Insured Vehicle was observed to be severely burnt. Most of the parts inside the engine compartment were found to be burnt and/or melted as a result of the fire.

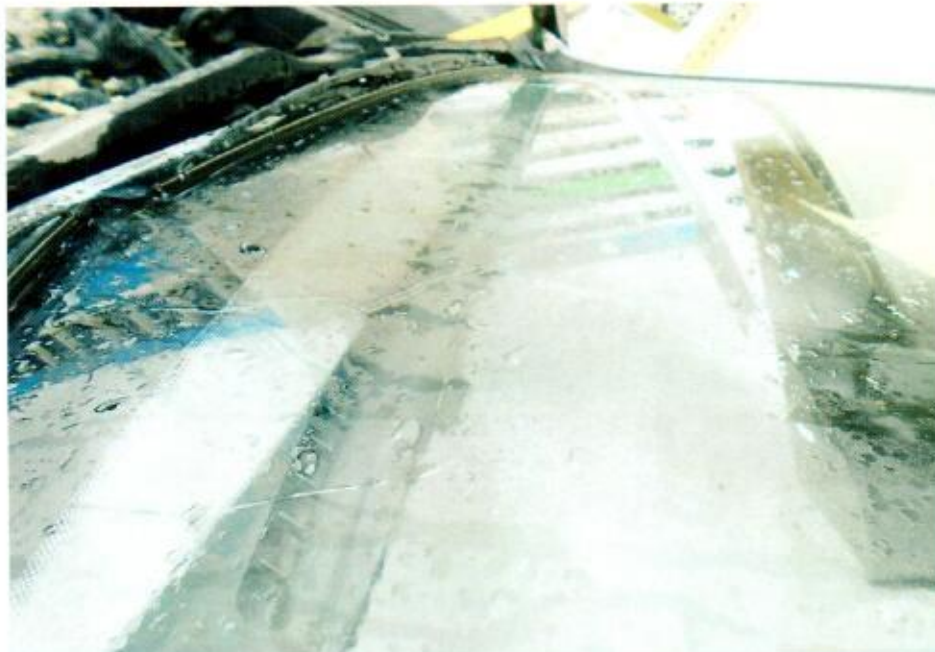
Photo 4 shows the windshield of the Insured Vehicle, which was observed to be cracked were amongst the parts that were found to have been damaged as a result of the fire.

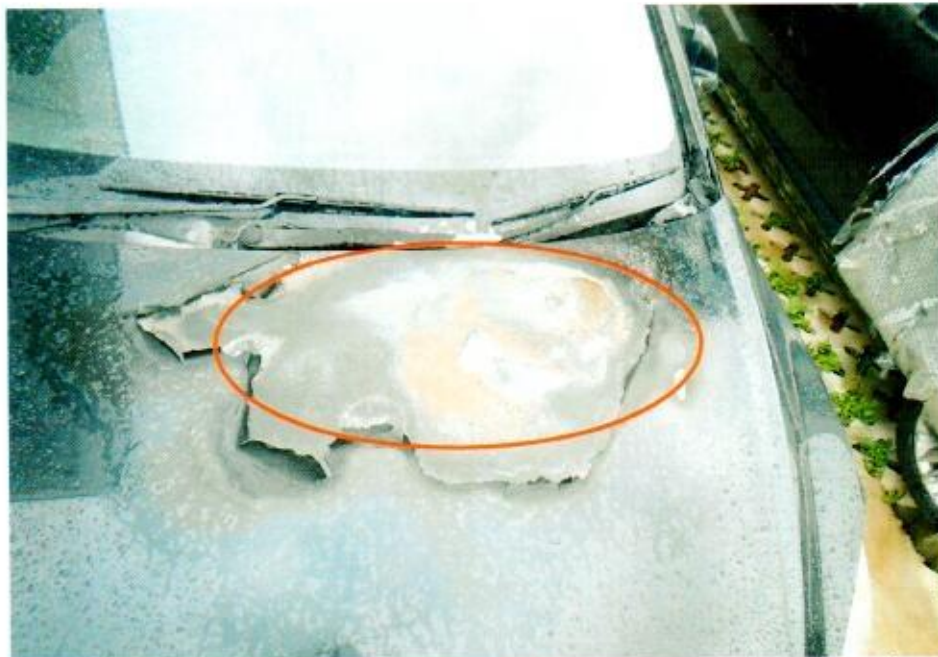
8. For this particular case, the fire appears to have originated within the engine compartment of the Insured Vehicle, somewhere around the centre and towards the rear of the engine compartment. This can be determined from the burn pattern and the high heat intensity burn marks (whitish burn marks) found on the front bonnet of the Insured Vehicle, at both its top and under side.
9. These whitish burn marks are a result of exposure to prolong heat intensity. Rust would normally start to develop around these areas soon after a fire as prolonged exposure to high heat intensity usually causes steel/metal material body parts to be exposed to natural environmental condition. See photo 5 & 6 below.

Photo 5 shows the burn pattern and whitish burn marks (circled) that were found on the top side of the front bonnet of the Insured Vehicle. Such whitish burn marks are a result of exposure to prolong heat intensity, which may indicate where the fire had started. Rust would also begin to develop on these areas soon after the fire.

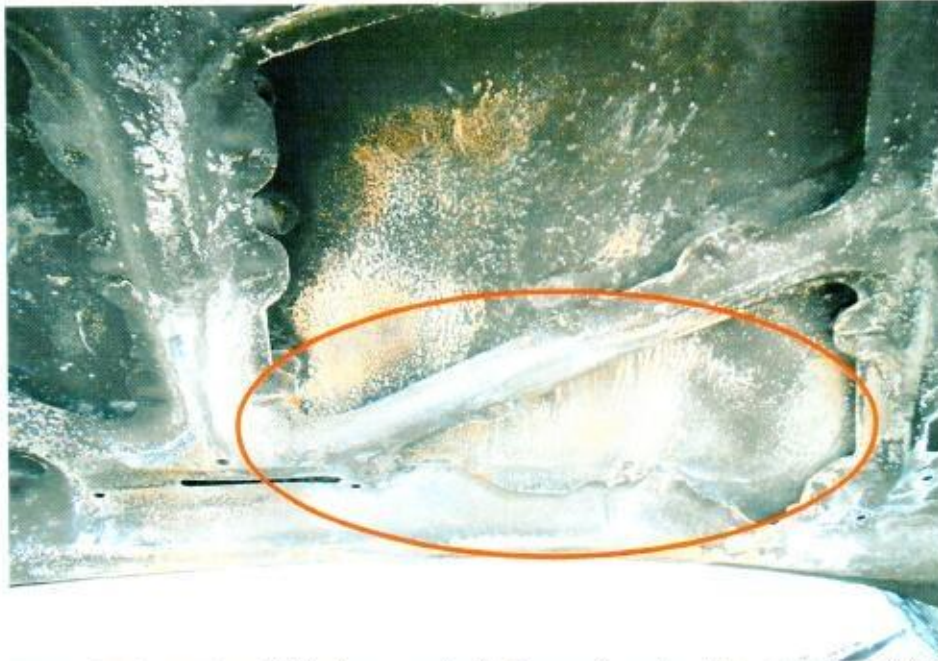
Photo 6 shows the whitish burn marks that were found on the underside of the front bonnet, directly under the area where the same whitish burn marks were found on the top side of the front bonnet. The rust (circled) that had developed around this area was a result of prolong exposure to high heat intensity, which had caused the steel/metal material of the front bonnet to be exposed to natural environmental condition.

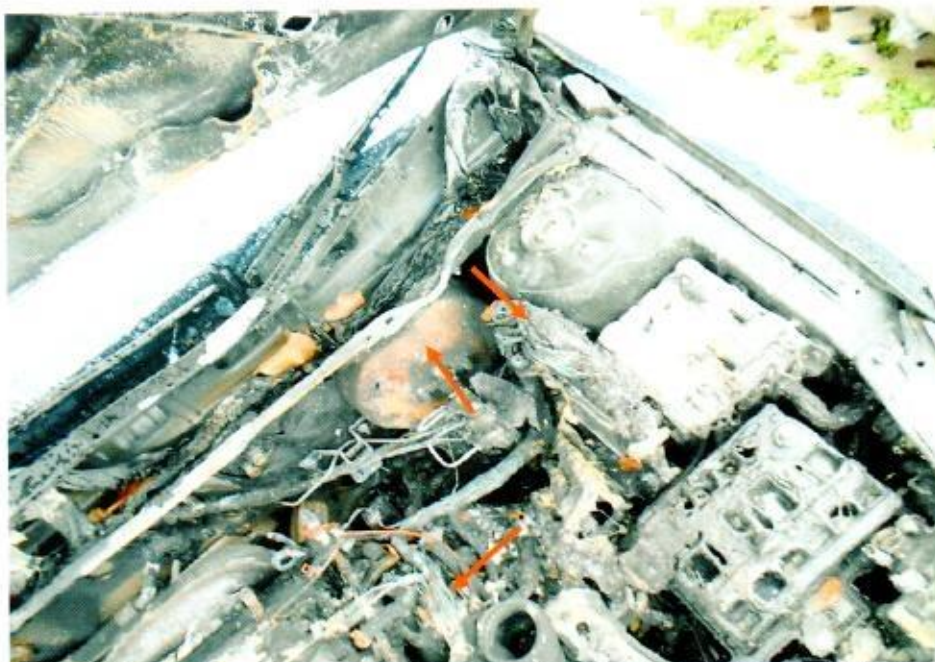
10. Upon closer examination of the area around the left rear of the engine compartment, which was in the immediate vicinity of where the fire to the Insured Vehicle had likely started, we had found several stretches of wiring burnt internally to its bare copper state. The wirings of the Insured Vehicle and are likely to be the original engine wire harness. Such condition normally indicate internal heating of copper wires which is a sign of an electrical short circuit occurring. This would then appear to suggest that the cause of fire to the Insured Vehicle could have possibly been due to electrical in nature. See photo 7 - 8 below.

Photo 7 shows the wirings around the left rear of the engine compartment, which was in the immediate vicinity where the fire to the Insured Vehicle had likely started. The wirings (red arrow) were found to have been burnt internally, suggesting occurrence of an electrical short circuit. The wirings also appear to be an original engine wire harness of the insured vehicle.

29. Having investigated and technically analysed the damages of burnt nature to the Insured Vehicle, we are of the view that the cause of fire to the Insured Vehicle was of electrical in nature. For this particular case, the fire had originated along the wiring inside the engine compartment, somewhere around the left rear of the engine compartment. The wiring was an original factory fitted on the Insured Vehicle.
30. We did not find any evidence which had suggested that the cause of fire to the Insured Vehicle was due to poor maintenance and/or recurring electrical problem.
31. There were no modification(s) or additional electronic and/or electrical component(s) fitted on the Insured Vehicle at the time of our inspection of the Insured Vehicle.

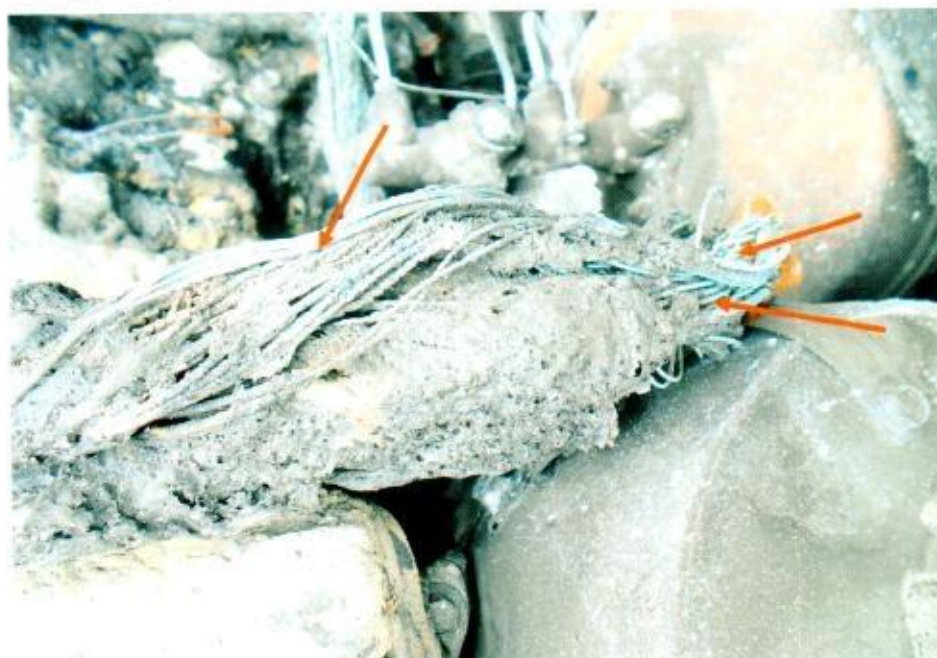
Photo 8 shows a closer view of the wirings (red arrow) which were found to have been burnt internally, suggesting occurrence of an electrical short circuit.

26. The possibility of the fire being due to electrical in nature would then seem more likely given that engine overheating and external factor would both seem unlikely. The fire being due to electrical nature is also supported by the condition of the wirings of the Insured Vehicle, which was earlier discussed in paragraph 10 above.

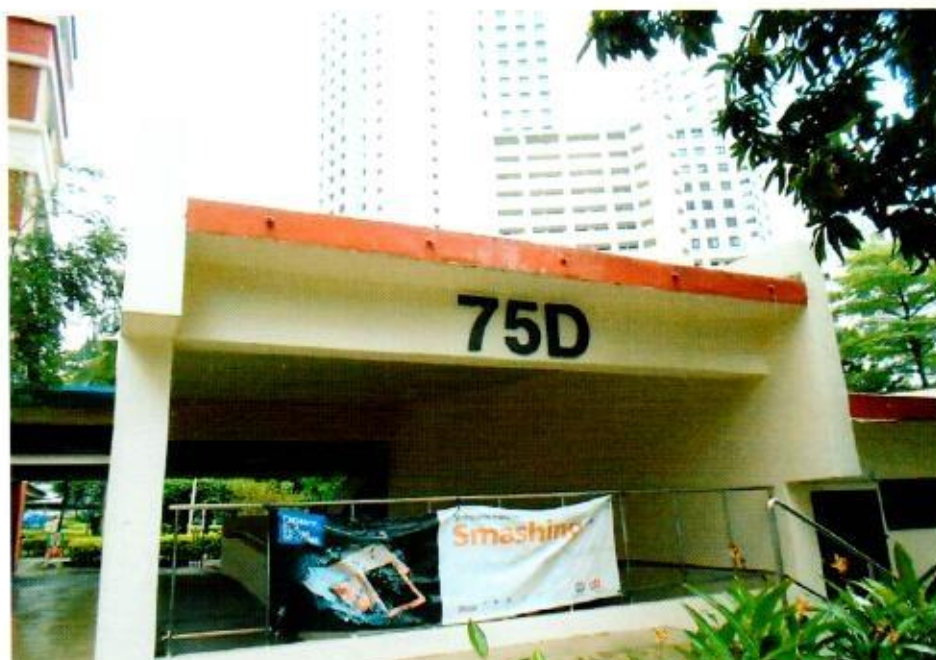
Photo 11 shows the general view of block 75D beside the open carpark where the Insured Vehicle was parked at the time of incident.

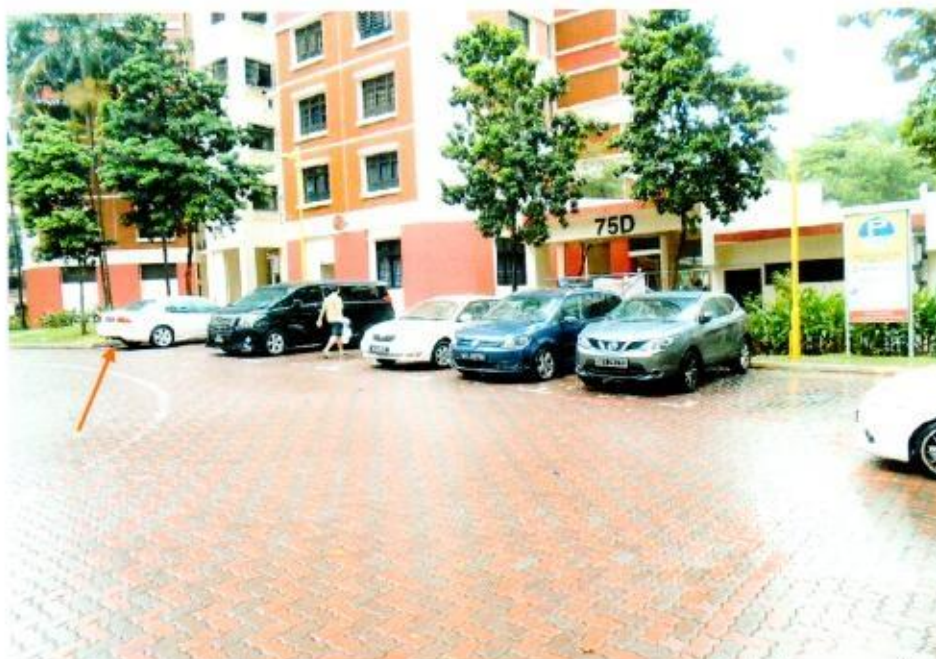
Photo 12 shows the general view of where the Insured Vehicle was parked (arrowed) at the time of incident. This was inside parking lot 07, which is on the right side upon entering the open car park.

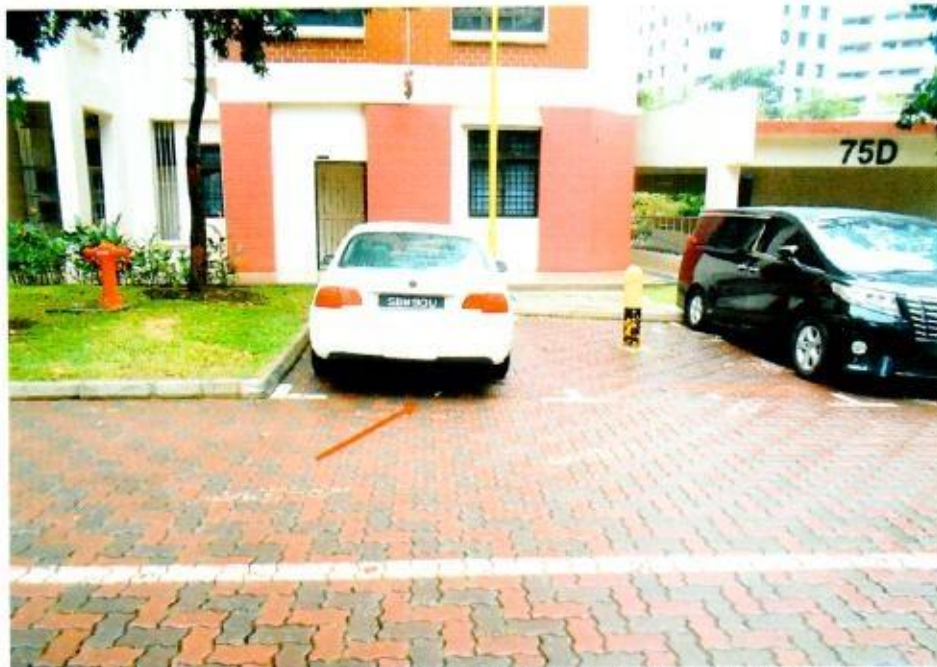
Photo 13 shows the general view of where the Insured Vehicle was parked (arrowed) at the time of incident. This was inside parking lot 07, which is on the right side upon entering the open car park.

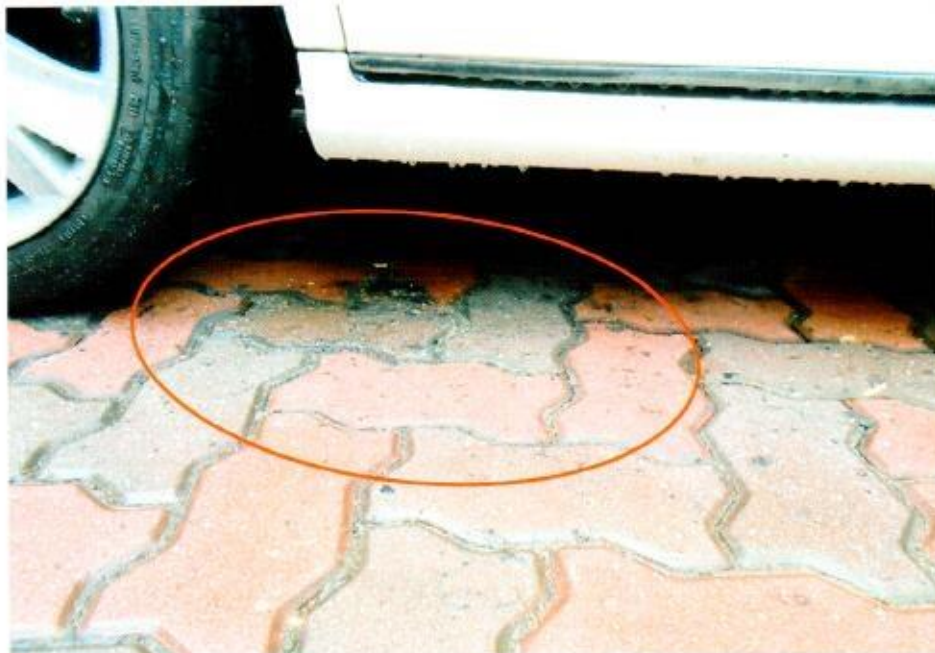
Photo 14 shows the close-up view of where the Insured Vehicle was parked at the time of incident. Further observations on the ground, we found burnt marks/ burnt residual on the red bricks at the parking lot. This reveals that there's evidence that fire incident happen at the said spot.

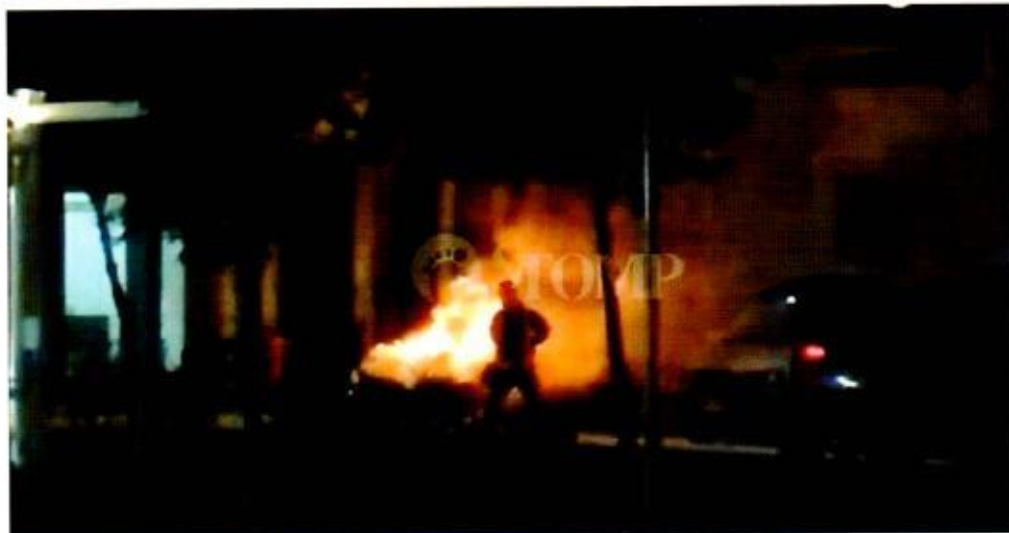
Photo 15 shows the Insured Vehicle at the incident scene. SCDF fire fighters were seen trying to extinguish the fire from the Insured Vehicle.

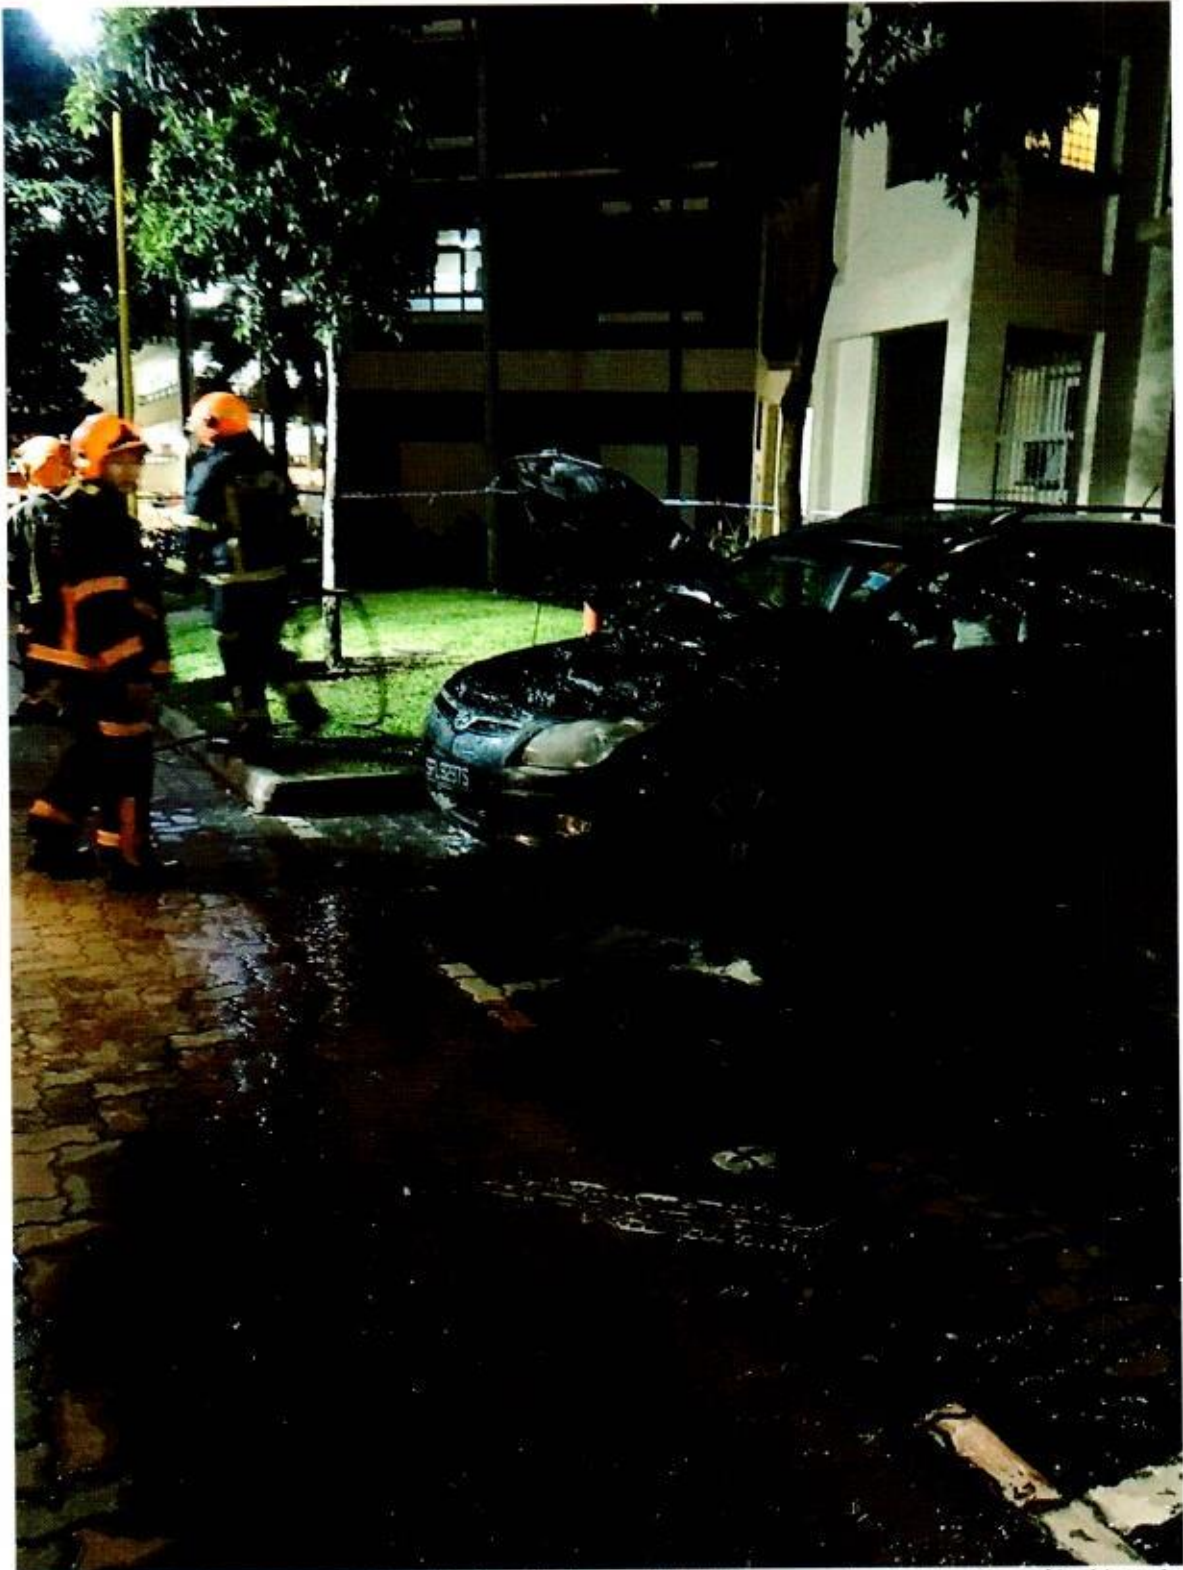
Photo 17 shows the close-up view of where the Insured Vehicle was parked at the time of incident. It was after the fire-fighter's had extinguished the fire.

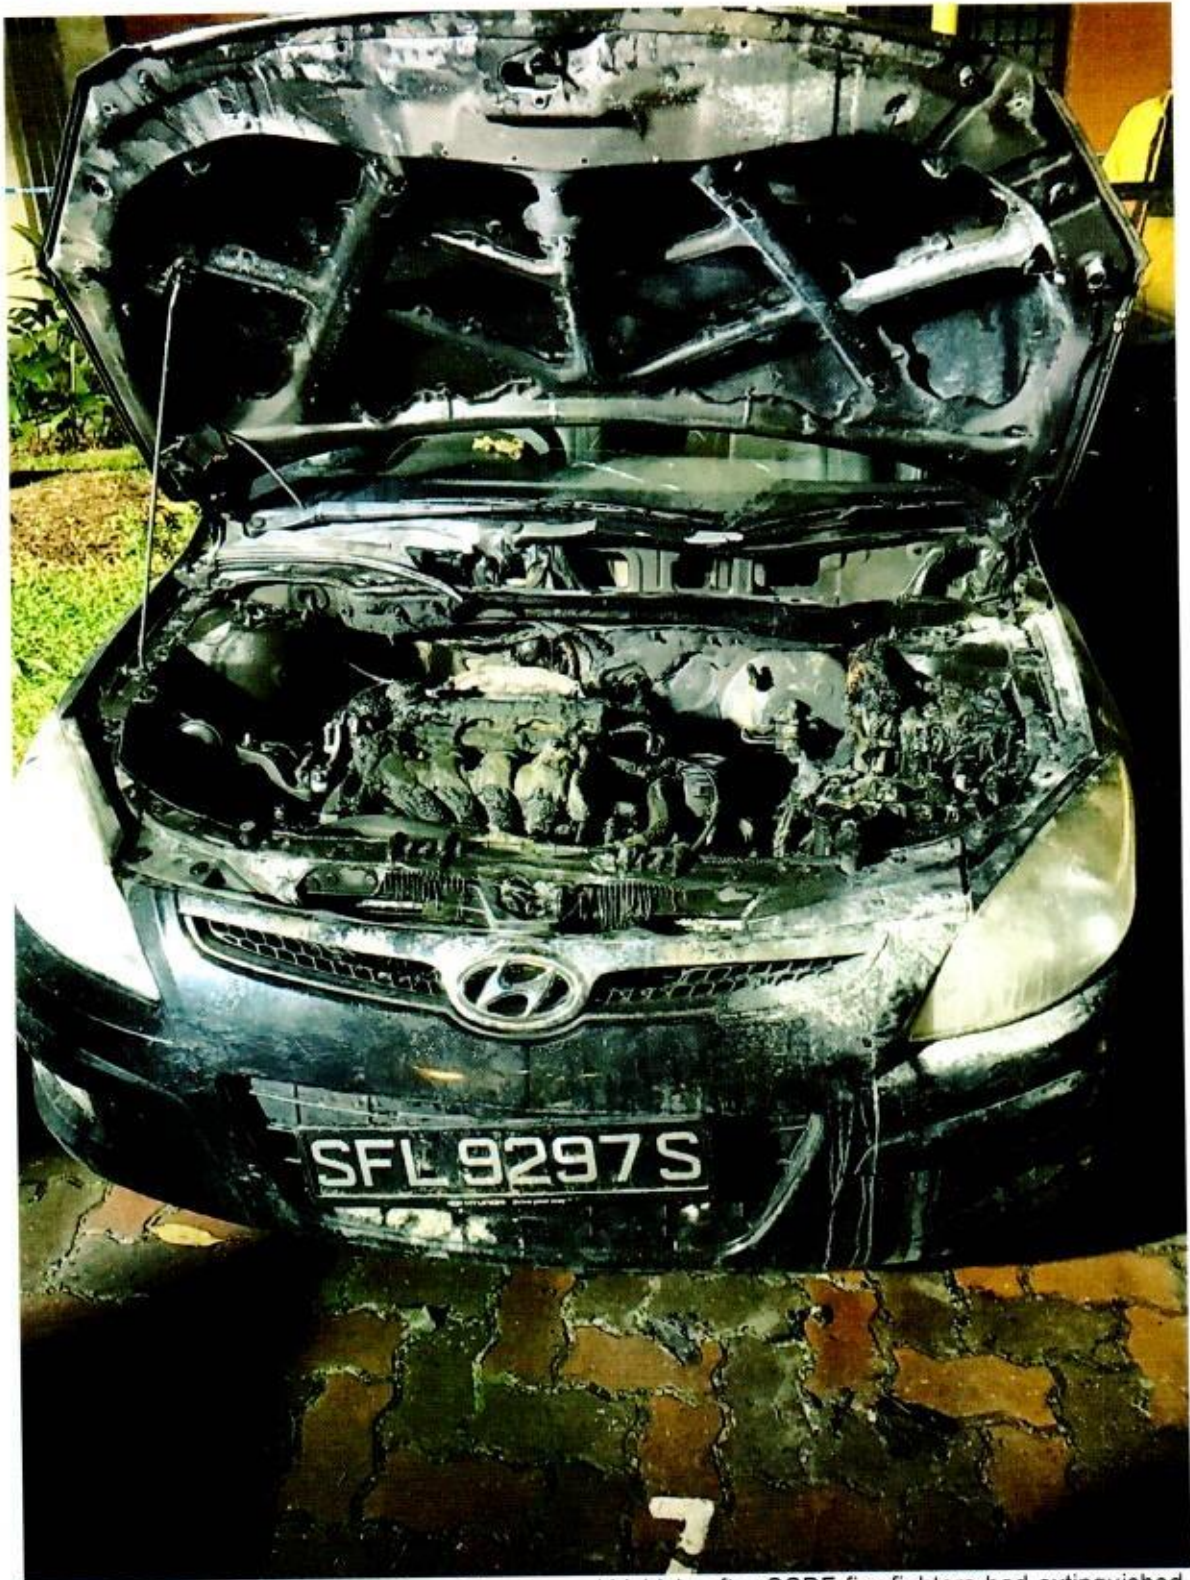
Photo 18 shows the close-up view of the Insured Vehicle after SCDF fire fighters had extinguished the fire.
