Auto
Consultants
Pte Ltd

Your Ref : 76171
Our Ref : CI/DAI18006786/Z

17th April 2018

**TECHNICAL INVESTIGATION REPORT OF FIRE INCIDENT INVOLVING THE
INSURED VEHICLE SFV 6655J ON 06th April 2018**

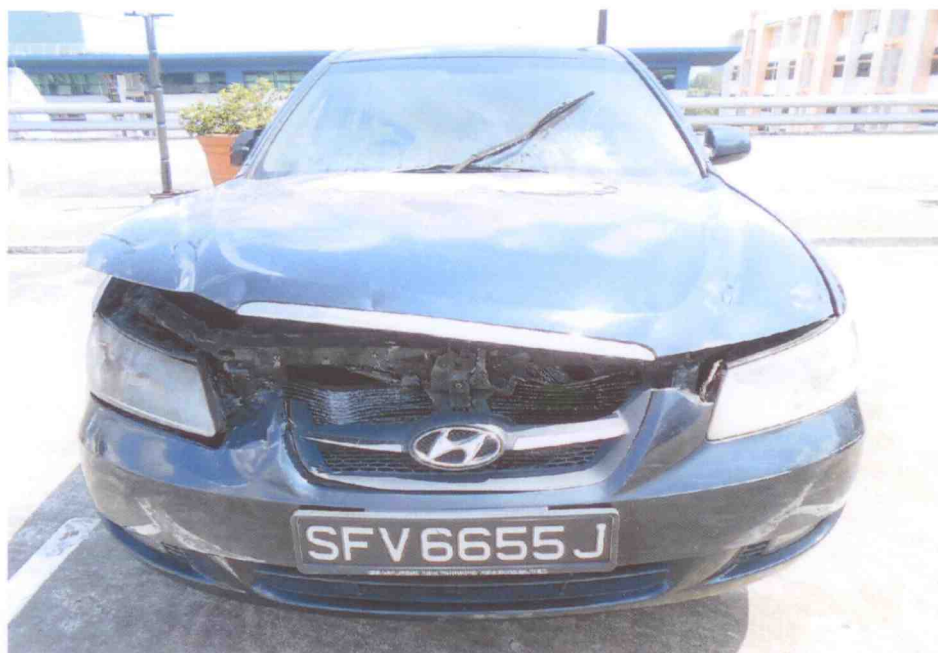
Photo 1 shows the general view of the front right portion of the Insured Vehicle at the time of our inspection. The fire damage to the Insured Vehicle was confined to its front portion. Its front bumper, front bonnet, front grille and front right headlamp were amongst the body parts that were found to have been affected as a result of the fire.

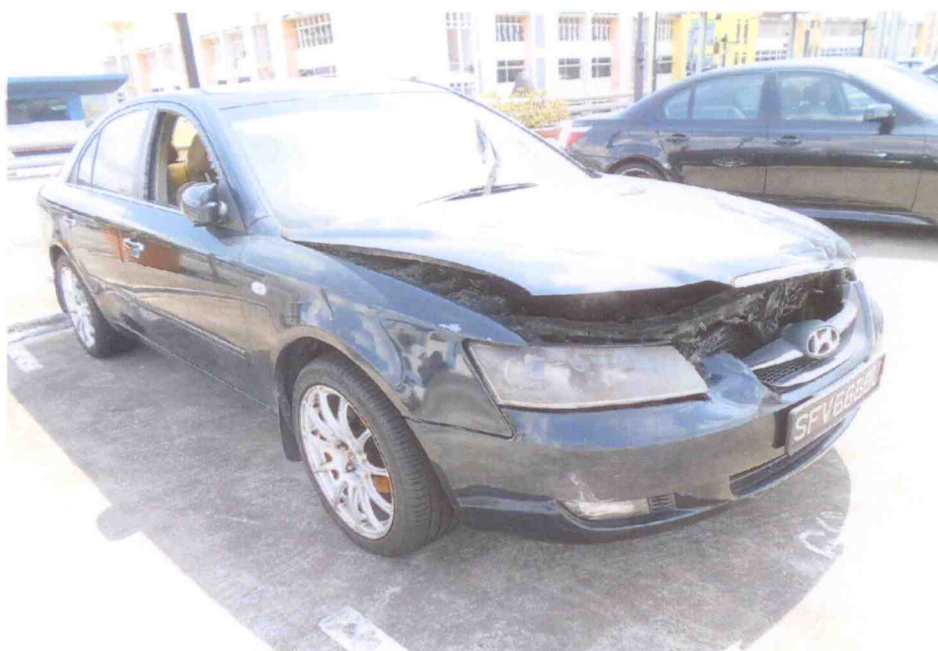
Photo 2 shows the general view of the front right portion of the Insured Vehicle at the time of our inspection. The fire damage to the Insured Vehicle was confined to its front portion. Its front bumper, front bonnet and front left headlamp were amongst the body parts that were found to have been affected as a result of the fire.

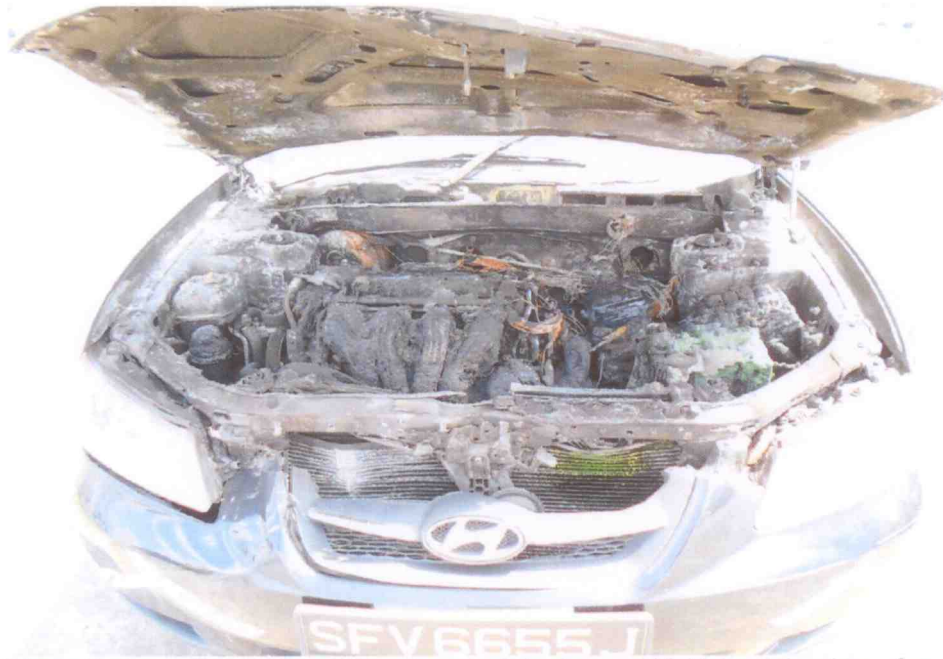
Photo 3 shows the engine compartment of the Insured Vehicle at the time of our inspection. The entire engine compartment of the Insured Vehicle was observed to be severely burnt. Most of the parts inside the engine compartment were found to be burnt and/or melted as a result of the fire.

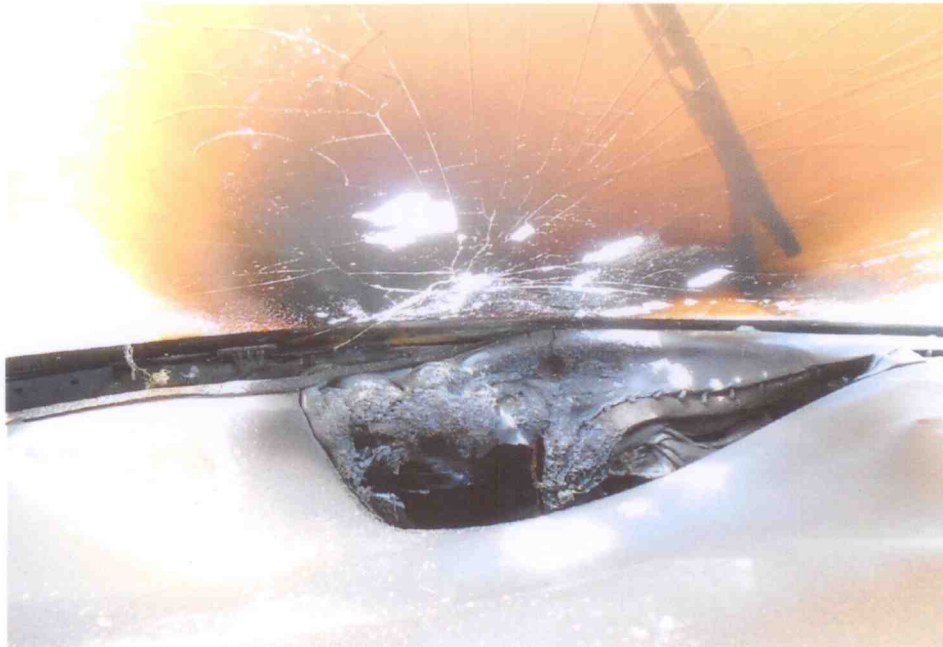
Photo 4 shows the interior compartment of the Insured Vehicle, which was observed to be partially burnt and/or melted. The front dashboard, front windscreen and roof upholstery were amongst the parts that were found to have been burnt and/or melted as a result of the fire.

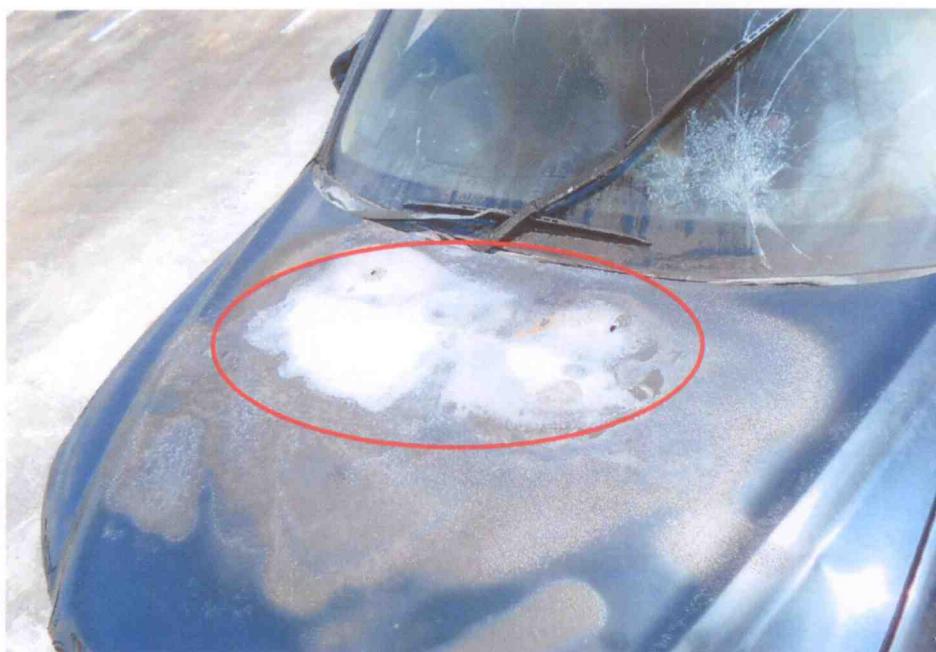
8. For this particular case, the fire appears to have originated within the engine compartment of the Insured Vehicle, somewhere around the centre and towards the rear of the engine compartment. This can be determined from the burn pattern and the high heat intensity burn marks (whitish burn marks) found on the front bonnet of the Insured Vehicle, at both its top and under side.
9. These whitish burn marks are a result of exposure to prolong heat intensity. Rust would normally start to develop around these areas soon after a fire as prolonged exposure to high heat intensity usually causes steel/metal material body parts to be exposed to natural environmental condition. See photo 5 & 6 below.

Photo 5 shows the burn pattern and whitish burn marks (circled) that were found on the top side of the front bonnet of the Insured Vehicle. Such whitish burn marks are a result of exposure to prolong heat intensity, which may indicate where the fire had started. Rust would also begin to develop on these areas soon after the fire.

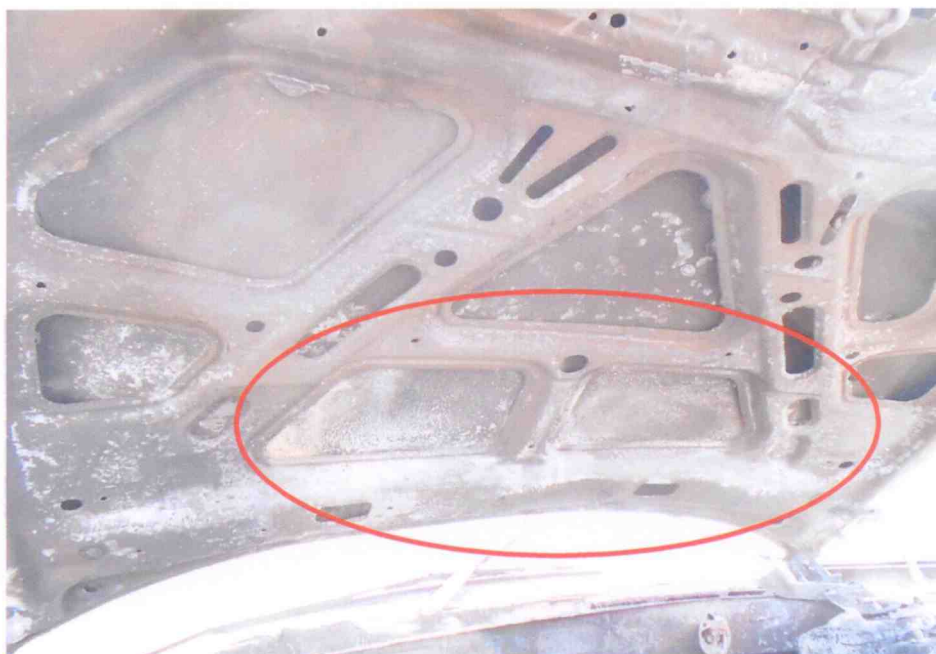
Photo 6 shows the whitish burn marks that were found on the underside of the front bonnet, directly under the area where the same whitish burn marks were found on the top side of the front bonnet. The rust (circled) that had developed around this area was a result of prolong exposure to high heat intensity, which had caused the steel/metal material of the front bonnet to be exposed to natural environmental condition.

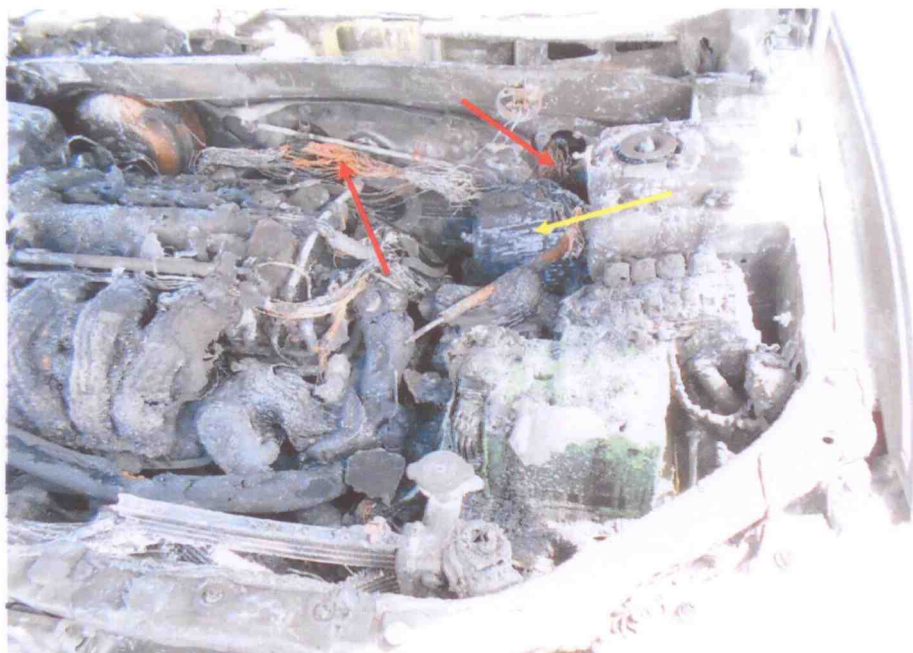
10. Upon closer examination of the area around the left rear of the engine compartment, which was in the immediate vicinity of where the fire to the Insured Vehicle had likely started, we had found several stretches of wiring burnt internally to its bare copper state. The wirings were leading towards the Engine Control Module (ECM) of the Insured Vehicle and are likely to be the original engine wire harness. Such condition normally indicate internal heating of copper wires which is a sign of an electrical short circuit occurring. This would then appear to suggest that the cause of fire to the Insured Vehicle could have possibly been due to electrical in nature. See photo 7 - 8 below.

Photo 7 shows the wirings around the left rear of the engine compartment, which was in the immediate vicinity where the fire to the Insured Vehicle had likely started. The wirings (red arrow) were found to have been burnt internally to its bare copper state, suggesting occurrence of an electrical short circuit. The wirings also appear to be an original engine wire harness of the insured vehicle leading to the Engine Control Module (yellow arrow), which was also observed to be burnt.

28. Having investigated and technically analysed the damages of burnt nature to the Insured Vehicle, we are of the view that the cause of fire to the Insured Vehicle was of electrical in nature. For this particular case, the fire had originated along the wiring inside the engine compartment, somewhere around the left rear of the engine compartment. The wiring was an original factory wiring leading to the Engine Control Module (ECM) of the Insured Vehicle.

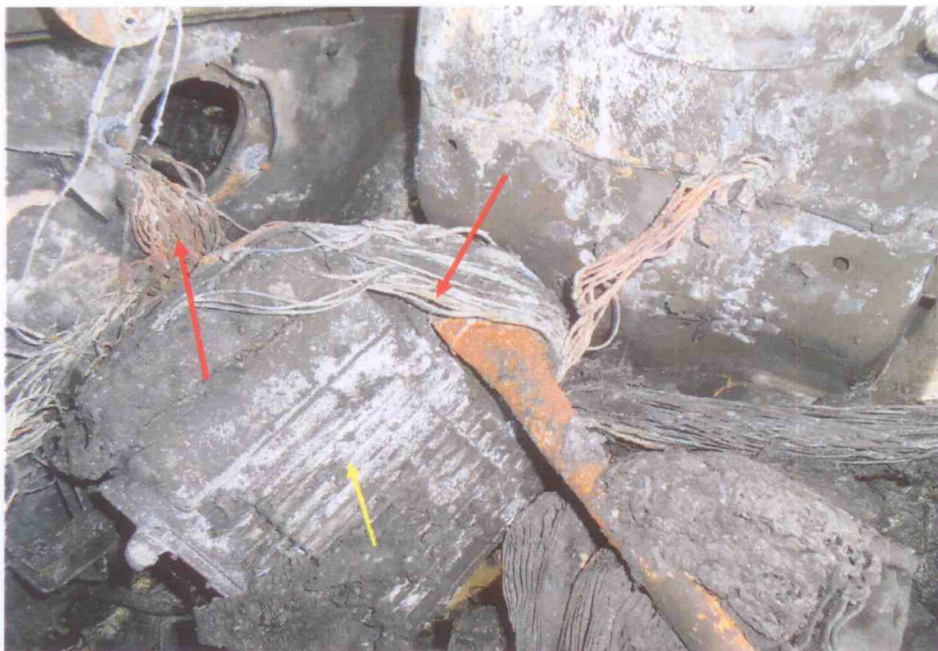
Photo 8 shows a closer view of the wirings (red arrow) which were found to have been burnt internally to its bare copper state, suggesting occurrence of an electrical short circuit. These wirings were observed to be leading to the Engine Control Module (yellow arrow) of the Insured Vehicle.

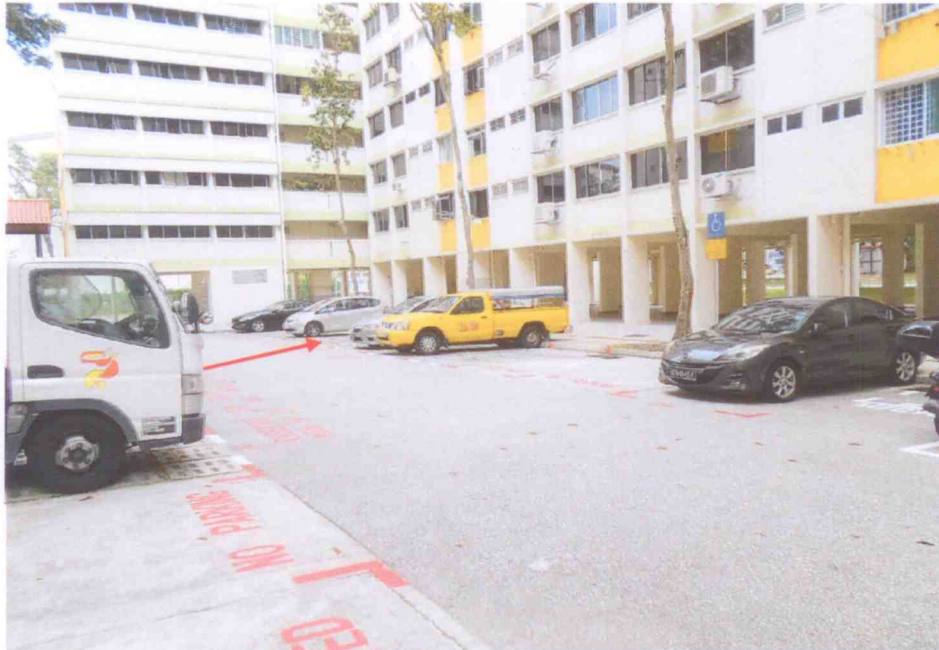
Photo 12 shows the general view of where the Insured Vehicle was parked (arrowed) at the time of incident. This was inside parking lot 109, which is on the right side upon entering the open car park.

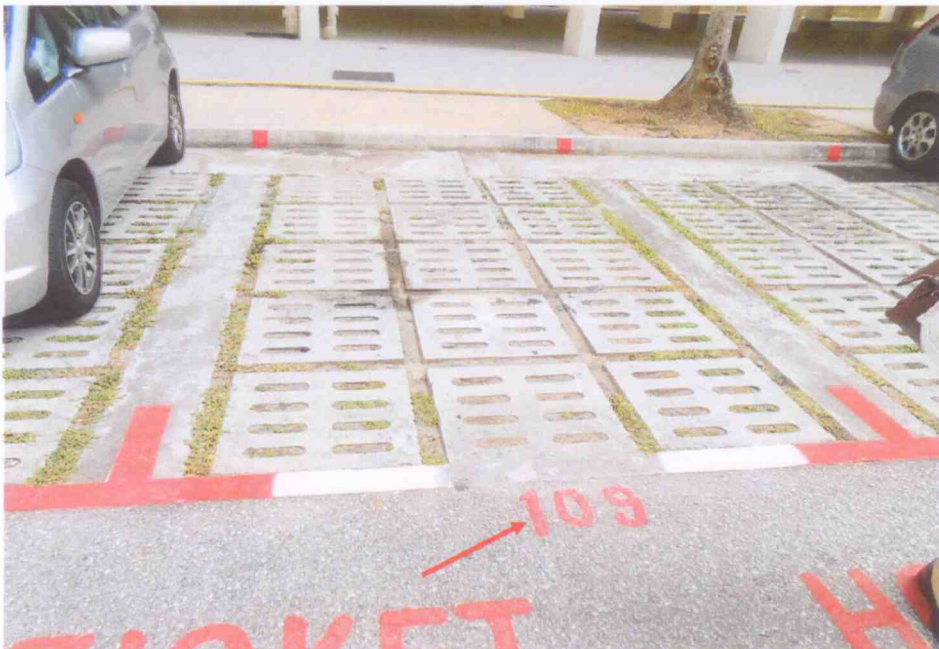
Photo 13 shows the general view of where the Insured Vehicle was parked (arrowed) at the time of incident. This was inside parking lot 109, which is on the right side upon entering the open car park.

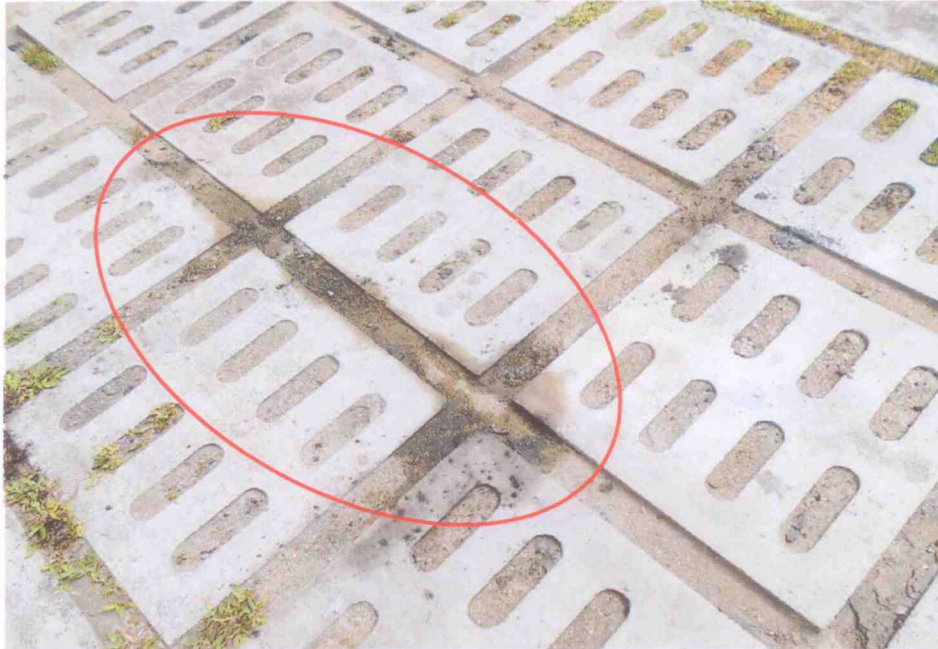
Photo 14 shows the close-up view of where the Insured Vehicle was parked at the time of incident. Further observations on the ground, we found burnt marks/ burnt residual on the laid bricks at the parking lot. This reveals that there's evidence that fire incident happen at the said spot.

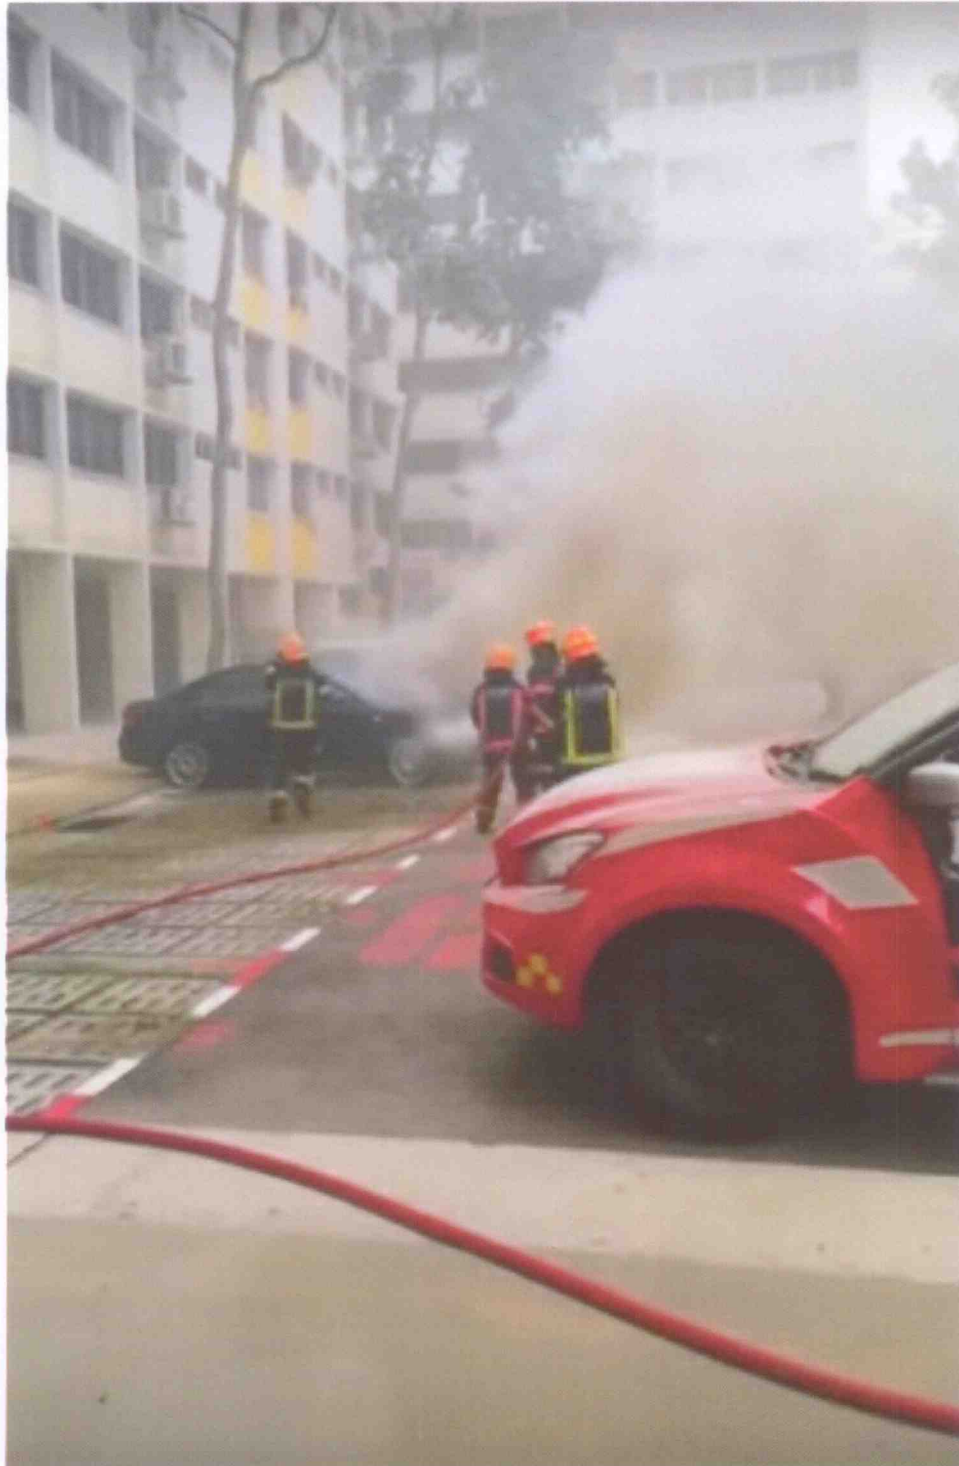
Photo 15 shows the Insured Vehicle at the incident scene. SCDF fire fighters were seen trying to extinguish the fire from the Insured Vehicle.

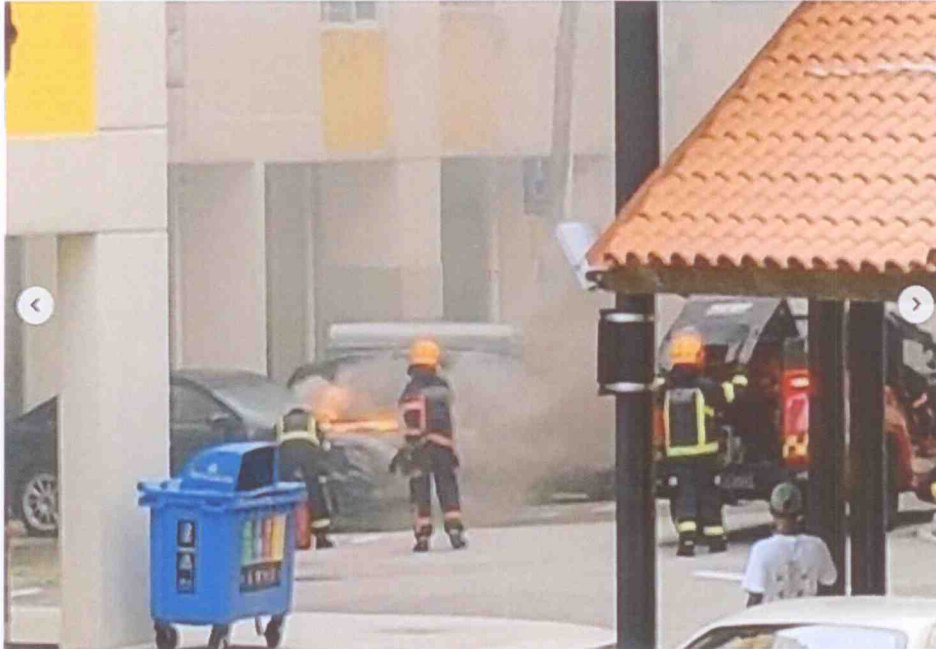
Photo 16 shows the Insured Vehicle at the incident scene. SCDF fire fighters were seen trying to extinguish the fire from the Insured Vehicle.
