Auto  
Consultants  
Pte Ltd

Your Ref : 76171  
Our Ref : CI/DAI18006786/Z

17<sup>th</sup> April 2018

**TECHNICAL INVESTIGATION REPORT OF FIRE INCIDENT INVOLVING THE  
INSURED VEHICLE SFV 6655J ON 06<sup>th</sup> April 2018**

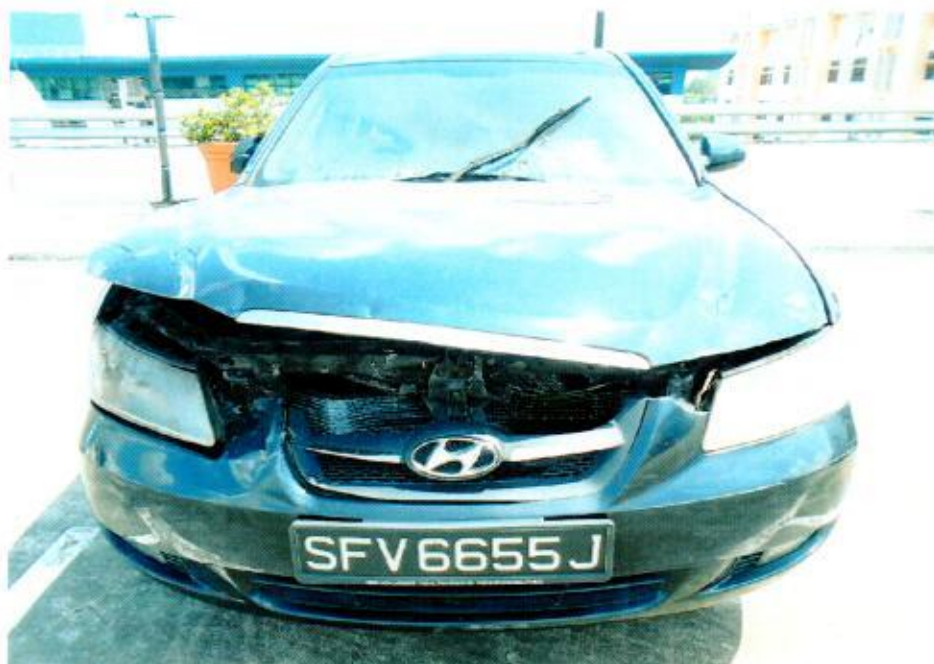
**Photo 1** shows the general view of the front right portion of the Insured Vehicle at the time of our inspection. The fire damage to the Insured Vehicle was confined to its front portion. Its front bumper, front bonnet, front grille and front right headlamp were amongst the body parts that were found to have been affected as a result of the fire.

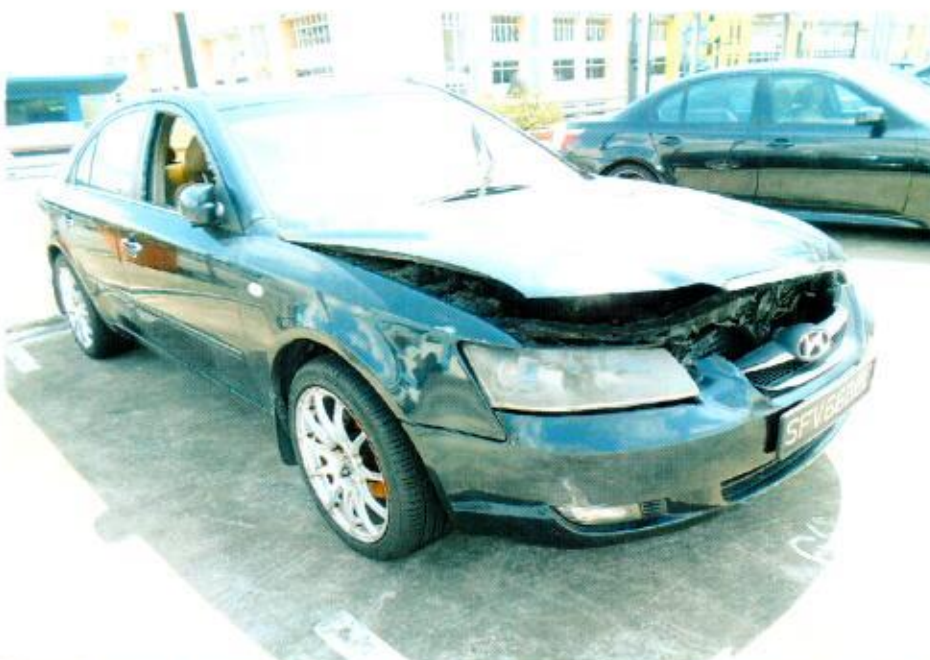
**Photo 2** shows the general view of the front right portion of the Insured Vehicle at the time of our inspection. The fire damage to the Insured Vehicle was confined to its front portion. Its front bumper, front bonnet and front left headlamp were amongst the body parts that were found to have been affected as a result of the fire.

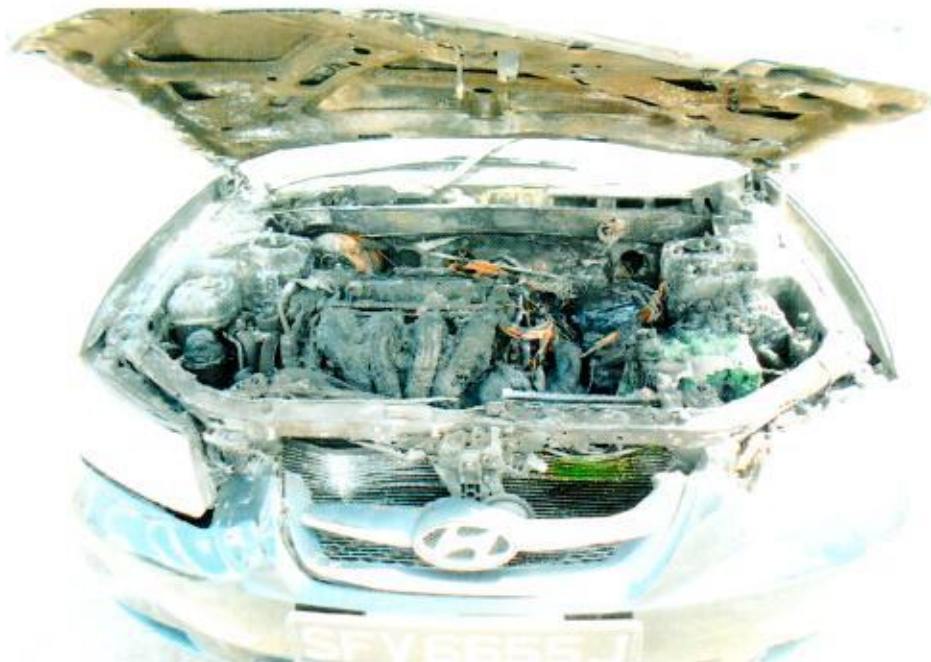
**Photo 3** shows the engine compartment of the Insured Vehicle at the time of our inspection. The entire engine compartment of the Insured Vehicle was observed to be severely burnt. Most of the parts inside the engine compartment were found to be burnt and/or melted as a result of the fire.

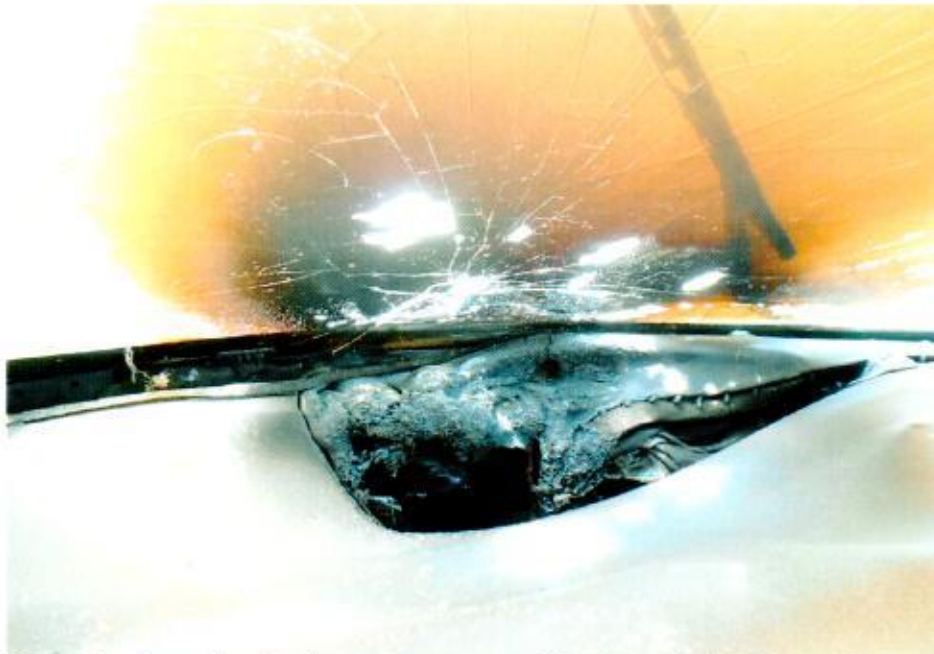
**Photo 4** shows the interior compartment of the Insured Vehicle, which was observed to be partially burnt and/or melted. The front dashboard, front windscreen and roof upholstery were amongst the parts that were found to have been burnt and/or melted as a result of the fire.

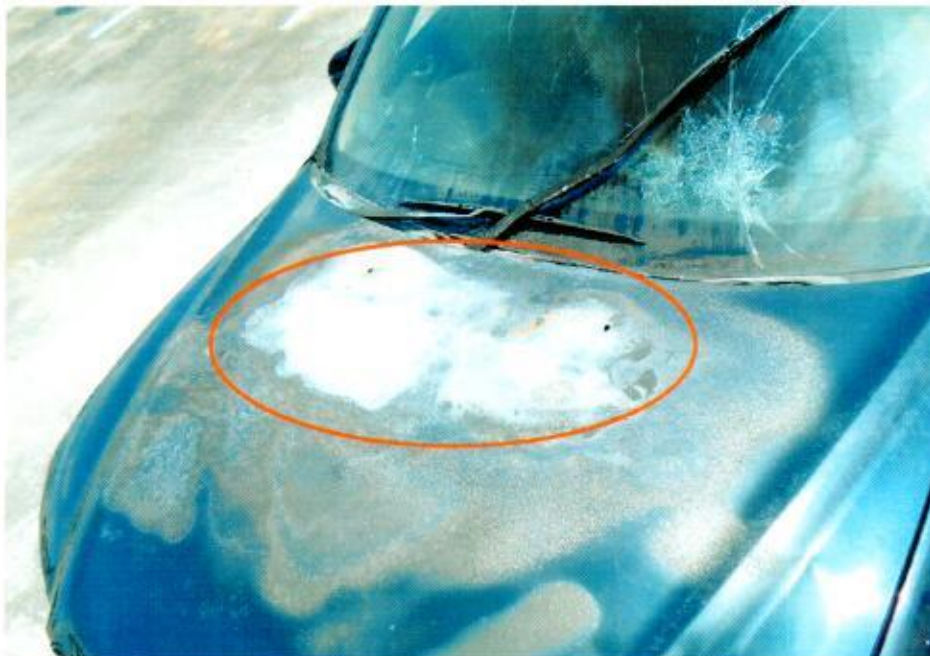
8. For this particular case, the fire appears to have originated within the engine compartment of the Insured Vehicle, somewhere around the centre and towards the rear of the engine compartment. This can be determined from the burn pattern and the high heat intensity burn marks (whitish burn marks) found on the front bonnet of the Insured Vehicle, at both its top and under side.
9. These whitish burn marks are a result of exposure to prolong heat intensity. Rust would normally start to develop around these areas soon after a fire as prolonged exposure to high heat intensity usually causes steel/metal material body parts to be exposed to natural environmental condition. See photo 5 & 6 below.

**Photo 5** shows the burn pattern and whitish burn marks (circled) that were found on the top side of the front bonnet of the Insured Vehicle. Such whitish burn marks are a result of exposure to prolong heat intensity, which may indicate where the fire had started. Rust would also begin to develop on these areas soon after the fire.

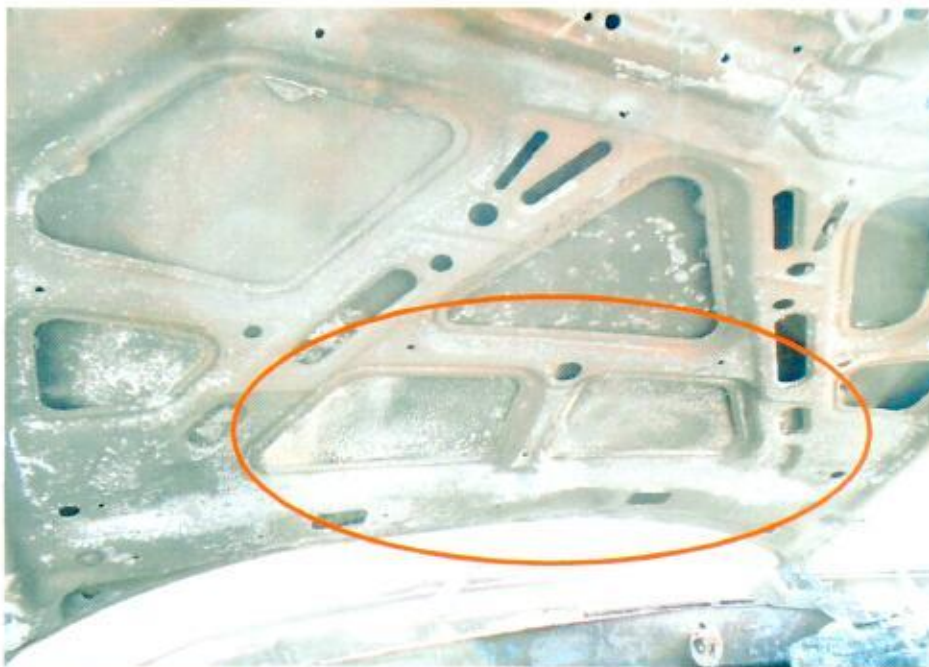
**Photo 6** shows the whitish burn marks that were found on the underside of the front bonnet, directly under the area where the same whitish burn marks were found on the top side of the front bonnet. The rust (circled) that had developed around this area was a result of prolong exposure to high heat intensity, which had caused the steel/metal material of the front bonnet to be exposed to natural environmental condition.

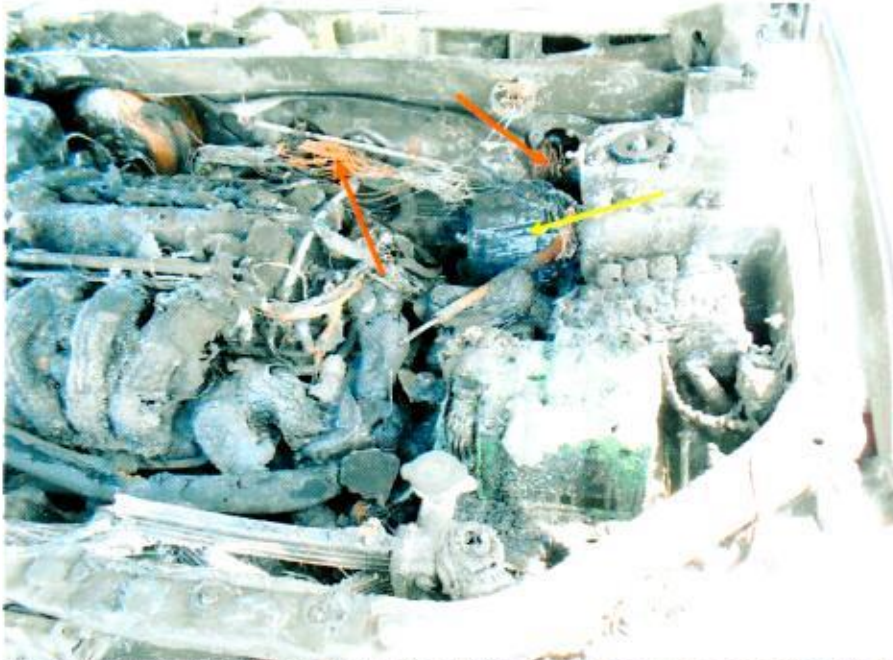
10. Upon closer examination of the area around the left rear of the engine compartment, which was in the immediate vicinity of where the fire to the Insured Vehicle had likely started, we had found several stretches of wiring burnt internally to its bare copper state. The wirings were leading towards the Engine Control Module (ECM) of the Insured Vehicle and are likely to be the original engine wire harness. Such condition normally indicate internal heating of copper wires which is a sign of an electrical short circuit occurring. This would then appear to suggest that the cause of fire to the Insured Vehicle could have possibly been due to electrical in nature. See photo 7 - 8 below.

**Photo 7** shows the wirings around the left rear of the engine compartment, which was in the immediate vicinity where the fire to the Insured Vehicle had likely started. The wirings (red arrow) were found to have been burnt internally to its bare copper state, suggesting occurrence of an electrical short circuit. The wirings also appear to be an original engine wire harness of the insured vehicle leading to the Engine Control Module (yellow arrow), which was also observed to be burnt.

28. Having investigated and technically analysed the damages of burnt nature to the Insured Vehicle, we are of the view that the cause of fire to the Insured Vehicle was of electrical in nature. For this particular case, the fire had originated along the wiring inside the engine compartment, somewhere around the left rear of the engine compartment. The wiring was an original factory wiring leading to the Engine Control Module (ECM) of the Insured Vehicle.

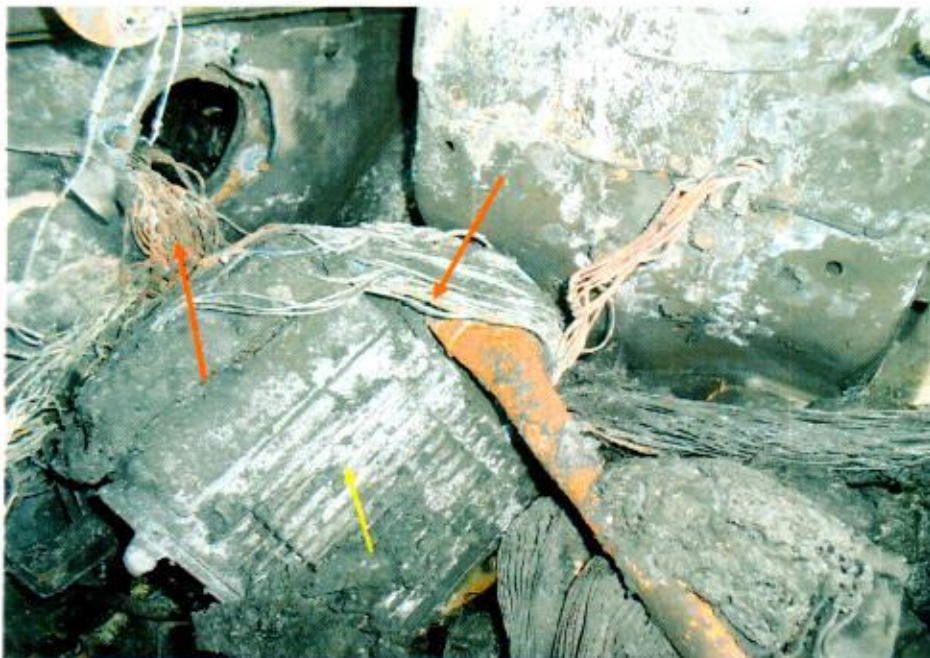
**Photo 8** shows a closer view of the wirings (red arrow) which were found to have been burnt internally to its bare copper state, suggesting occurrence of an electrical short circuit. These wirings were observed to be leading to the Engine Control Module (yellow arrow) of the Insured Vehicle.

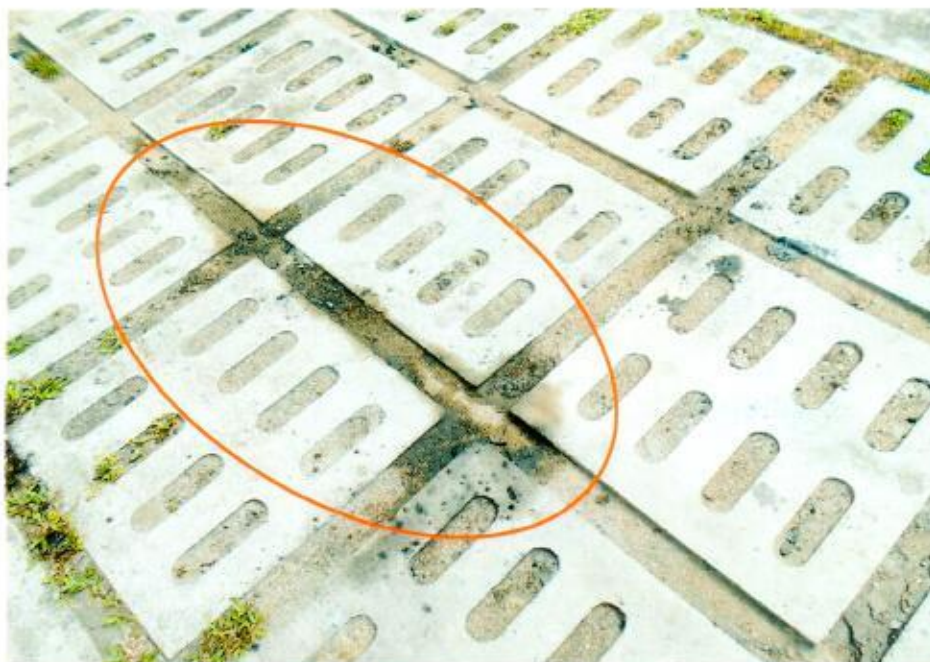
**Photo 14** shows the close-up view of where the Insured Vehicle was parked at the time of incident. Further observations on the ground, we found burnt marks/ burnt residual on the laid bricks at the parking lot. This reveals that there's evidence that fire incident happen at the said spot.
