Our Ref : CS/FCI18006948/N

15 April 2018

TECHNICAL INVESTIGATION REPORT OF FIRE INCIDENT INVOLVING THE INSURED VEHICLE SHD 6966H ON 30 MARCH 2018

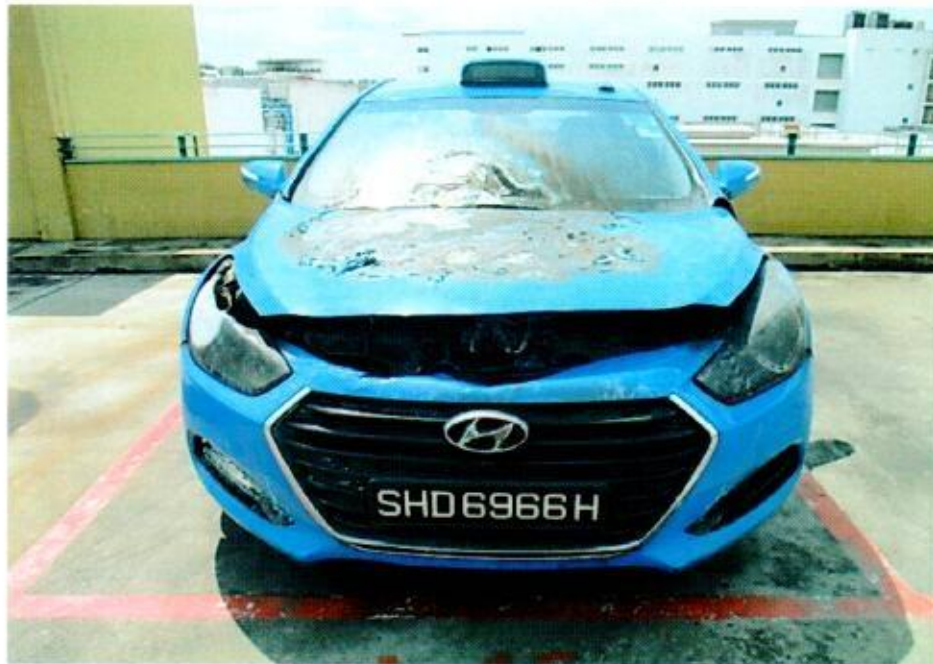
Photo 1 shows the general view of the front portion of the Insured Vehicle at the time of our inspection. The fire damage to the Insured Vehicle was confined to its front portion. Its front bumper, front bonnet, front grille, front windscreen and front headlamps were amongst the body parts that were found to have been affected as a result of the fire.

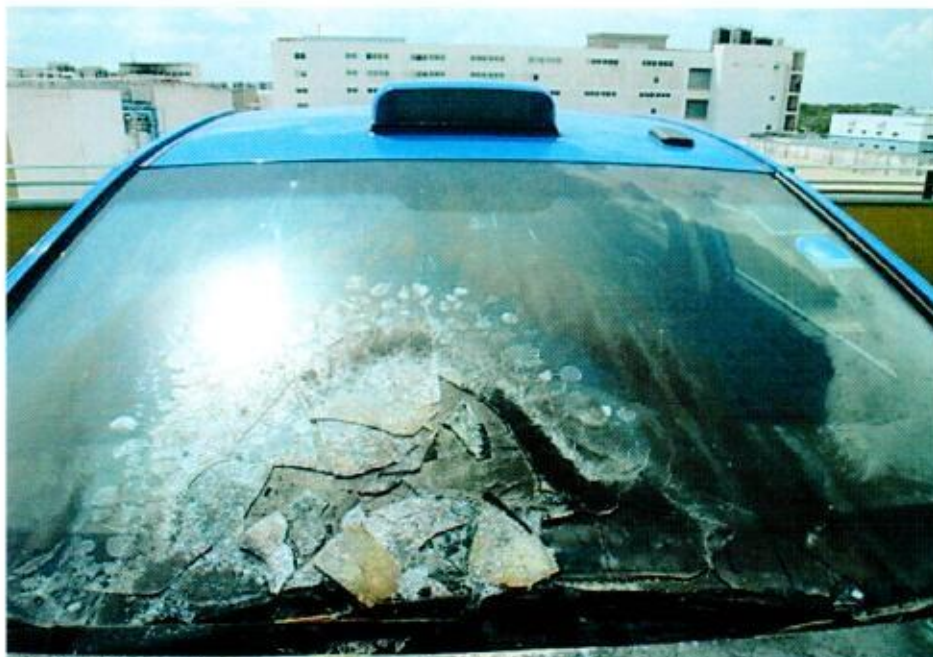
Photo 2 shows the general view of the front windscreen of the Insured Vehicle at the time of our inspection. The fire damage to the Insured Vehicle was confined to its centre portion.

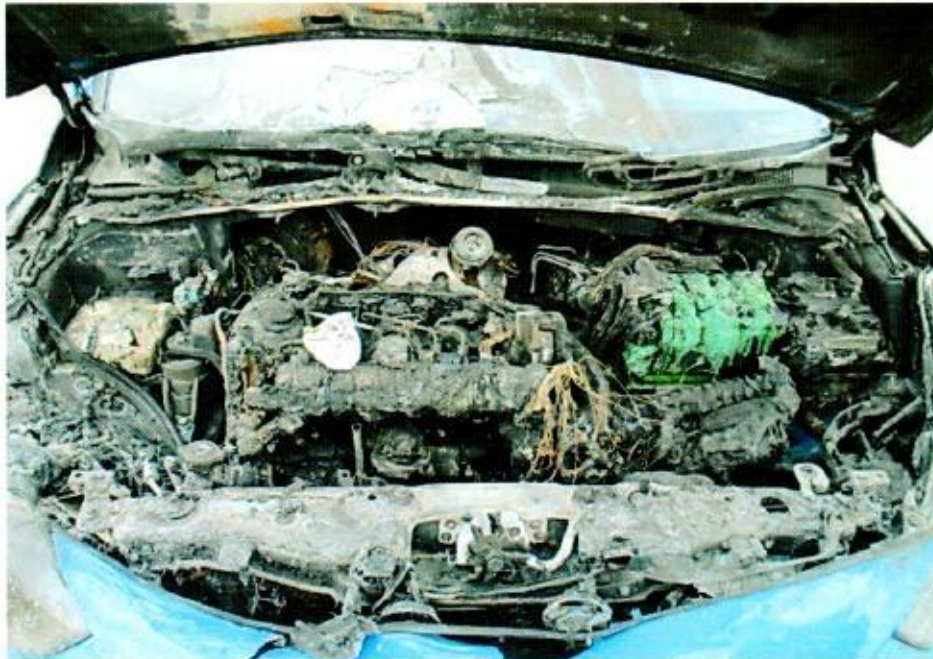
Photo 3 shows the engine compartment of the Insured Vehicle at the time of our inspection. The entire engine compartment of the Insured Vehicle was observed to be severely burnt. Most of the parts inside the engine compartment were found to be burnt and/or melted as a result of the fire.

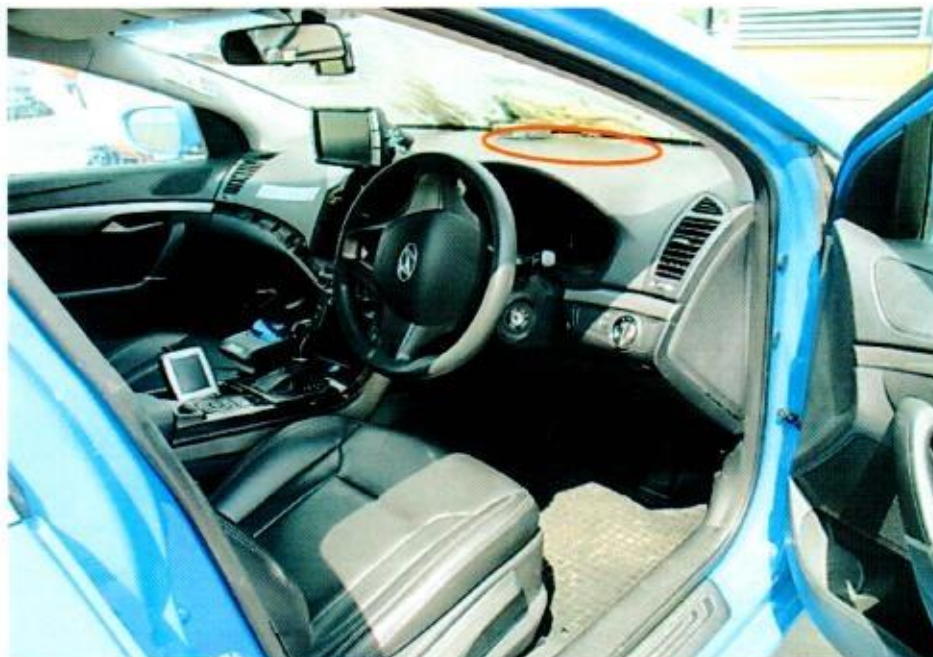
Photo 4 shows the interior compartment of the Insured Vehicle which was relatively unaffected by the fire except for the centre portion of the dashboard panel which was observed to be partially burnt and/or melted (circled).

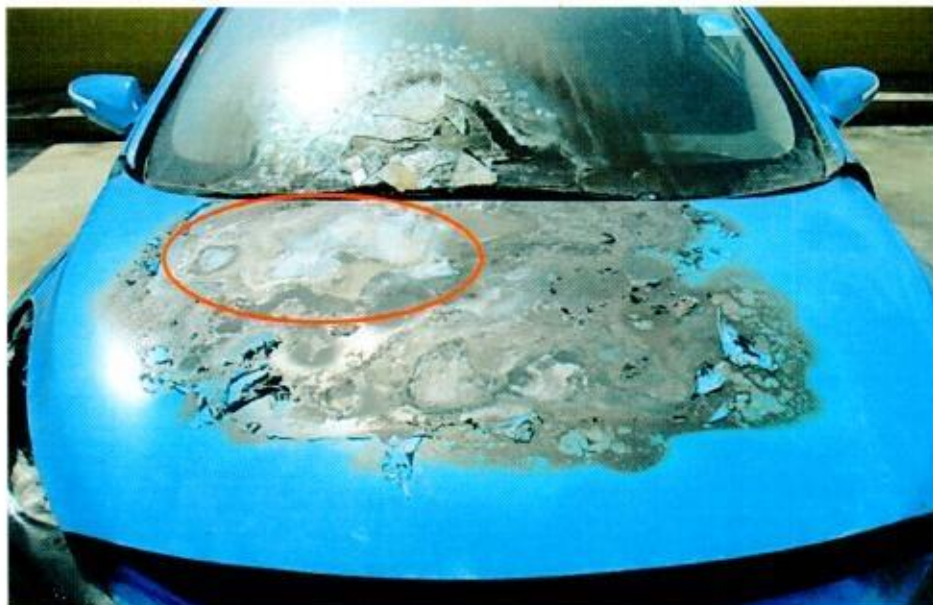
7. For this particular case, the fire appears to have originated within the engine compartment of the Insured Vehicle, somewhere around the rear left portion of the engine compartment. This can be determined from the burn pattern and the high heat intensity burn marks (whitish burn marks) found on the rear right portion of the bonnet of the Insured Vehicle and also the rust that had developed on the underside of the front bonnet, at the bottom right portion.

8. The whitish burn marks are a result of exposure to prolonged heat intensity. Rust would normally start to develop around these areas soon after a fire as prolonged exposure to high heat intensity usually causes steel/metal material body parts to be exposed to natural environmental condition. The rust that had developed on the underside of the front bonnet, around the bottom right portion, is an indication that the rear right portion of the engine compartment had sustained exposure to prolonged high heat intensity. See photos 5 & 6 below.

Photo 5 shows the burn pattern and whitish burn marks that were found on the rear right portion of the front bonnet of the Insured Vehicle (circled). Such whitish burn marks are a result of exposure to prolonged heat intensity, which may indicate where the fire had started. Rust would also begin to develop on these areas soon after the fire.

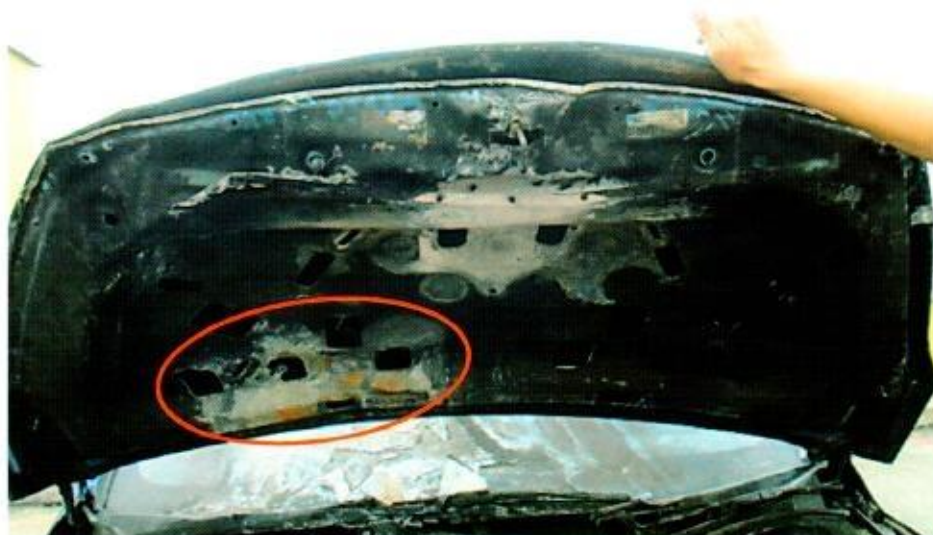
Photo 6 shows the rust that had developed on the underside of the front bonnet, around the bottom right portion (circled). The development of rust is an indication that this area was subjected to prolonged exposure to high heat intensity, which had caused the steel/metal material of the front bonnet to be exposed to natural environmental condition. Hence the fire to the Insured Vehicle can be determined to have originated towards the rear right portion of the engine compartment.

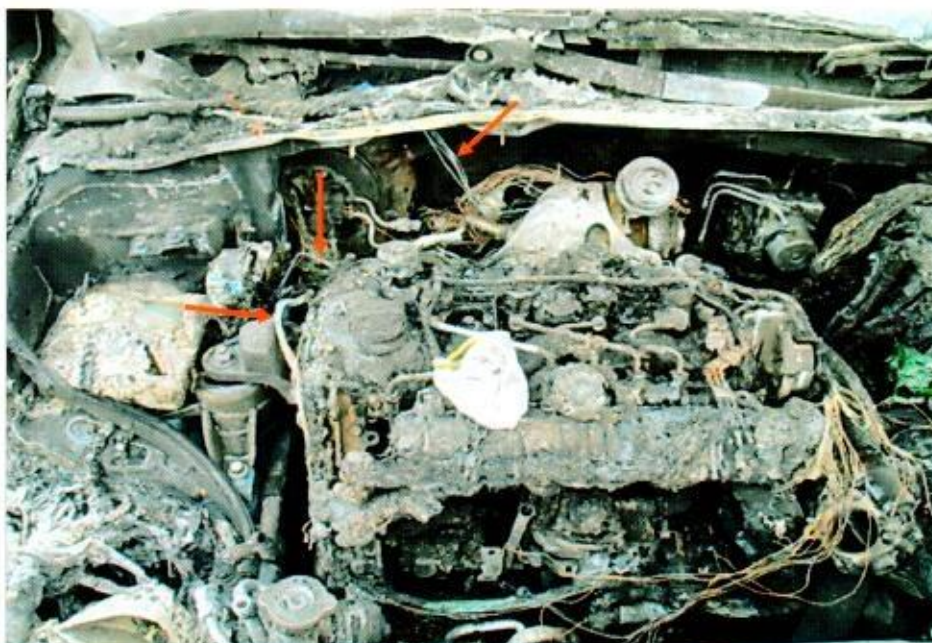
9. Upon closer examination of the rear right portion of the engine compartment, which was where the fire to the Insured Vehicle had likely started, we had found greenish residue on several burnt stretches of original factory fitted wirings around the rear right portion of the engine compartment. The presence of such greenish residue indicates internal heating of copper wires, a sign of an electrical short circuit occurring. The greenish residue is normally left behind from oxidation as a result of chemical reaction involving the copper wires. This physical evidence would then appear to suggest that the cause of fire to the Insured Vehicle could have possibly been due to electrical in nature. See photos 7 - 10 below.

Photo 7 shows the original factory fitted wirings around the rear right portion of the engine compartment, which is in the immediate vicinity where the fire to the Insured Vehicle had likely started. We had found greenish residue on several burnt stretches of these wirings (arrowed). The presence of such greenish residue indicates internal heating of copper wires, a sign of an electrical short circuit occurring. The greenish residue is normally left behind from oxidation as a result of chemical reaction involving the copper wires.

28. Having investigated and technically analysed the damages of burnt nature to the Insured Vehicle, we are of the view that the cause of fire to the Insured Vehicle was of electrical in nature. For this particular case, the fire had originated along the wirings inside the engine compartment, somewhere around the rear right portion of the engine compartment.

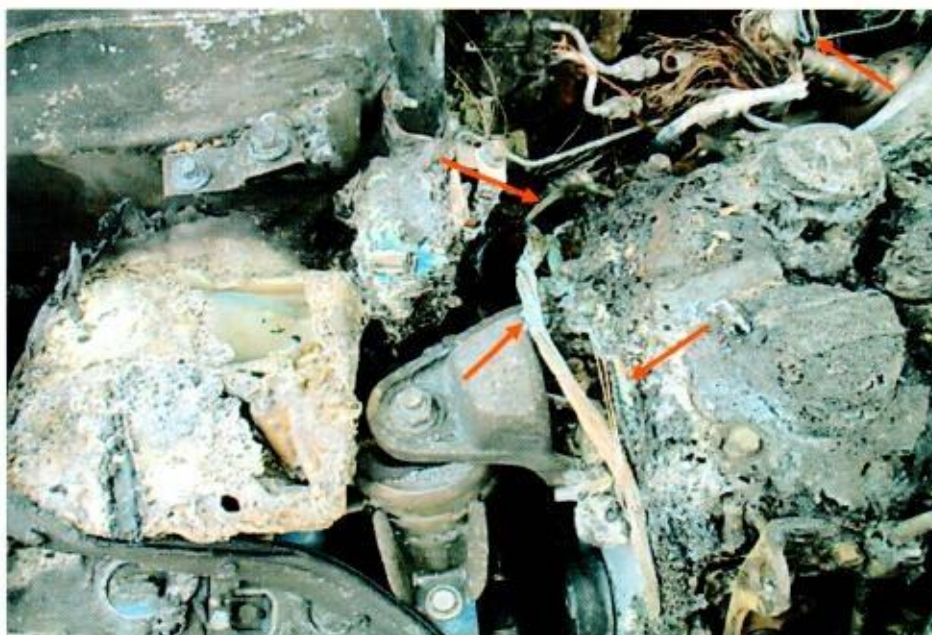
Photo 8 shows a closer view of the greenish residue found on some of the burnt stretches of original factory fitted wirings (circled). The presence of such greenish residue suggests occurrence of an electrical short circuit.

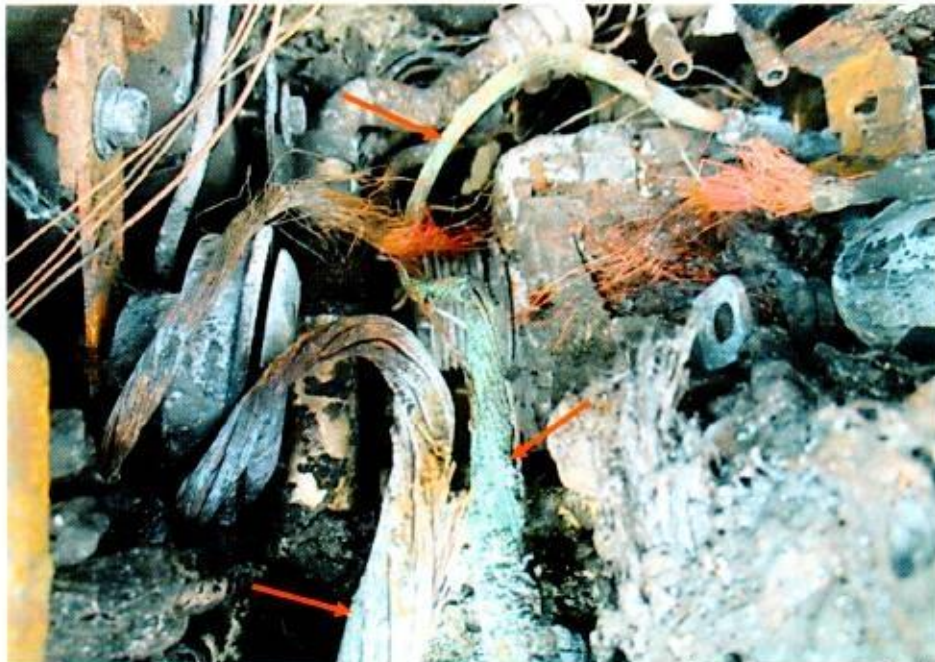
Photo 9 shows a close up view of the greenish residue found on some of the burnt stretches of original factory fitted wirings (arrowed). The presence of such greenish residue suggests occurrence of an electrical short circuit.

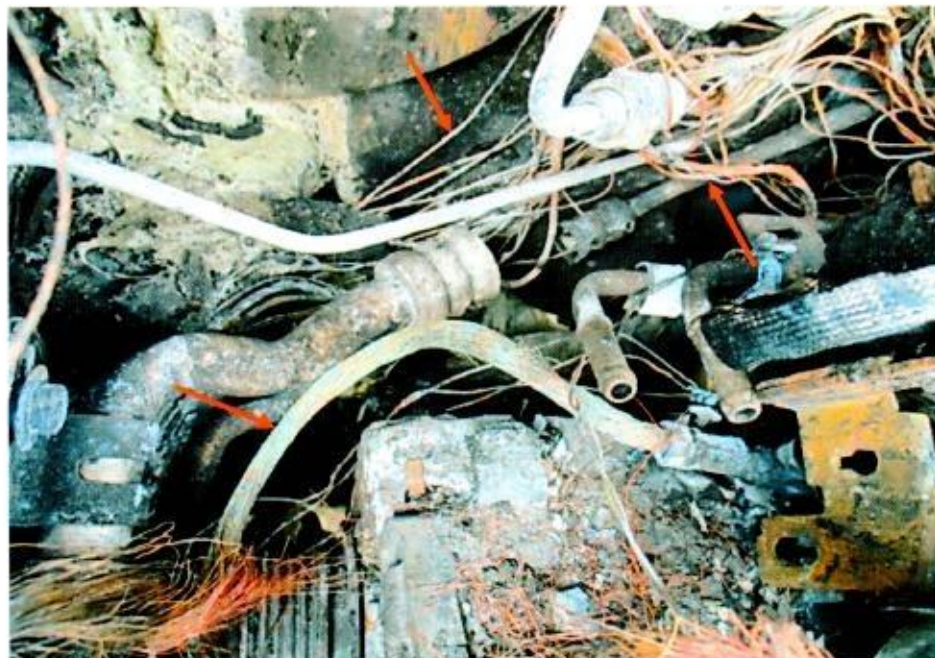
Photo 10 shows a close up view of the greenish residue found on some of the burnt stretches of original factory fitted wirings (circled). The presence of such greenish residue suggests occurrence of an electrical short circuit.

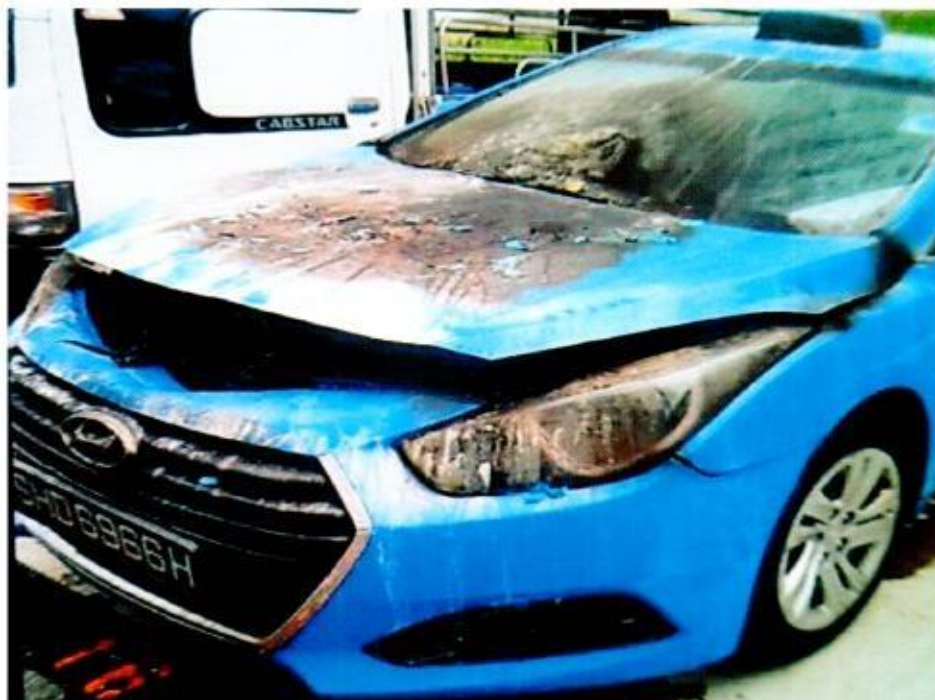
Photo 11 shows the Insured Vehicle after the fire was extinguished. In general, the information that could be gathered from this photograph had corresponded to the events that were related to us by Mr Toh, which is the fire broke out after he had parked the Insured Vehicle at the parking lot.

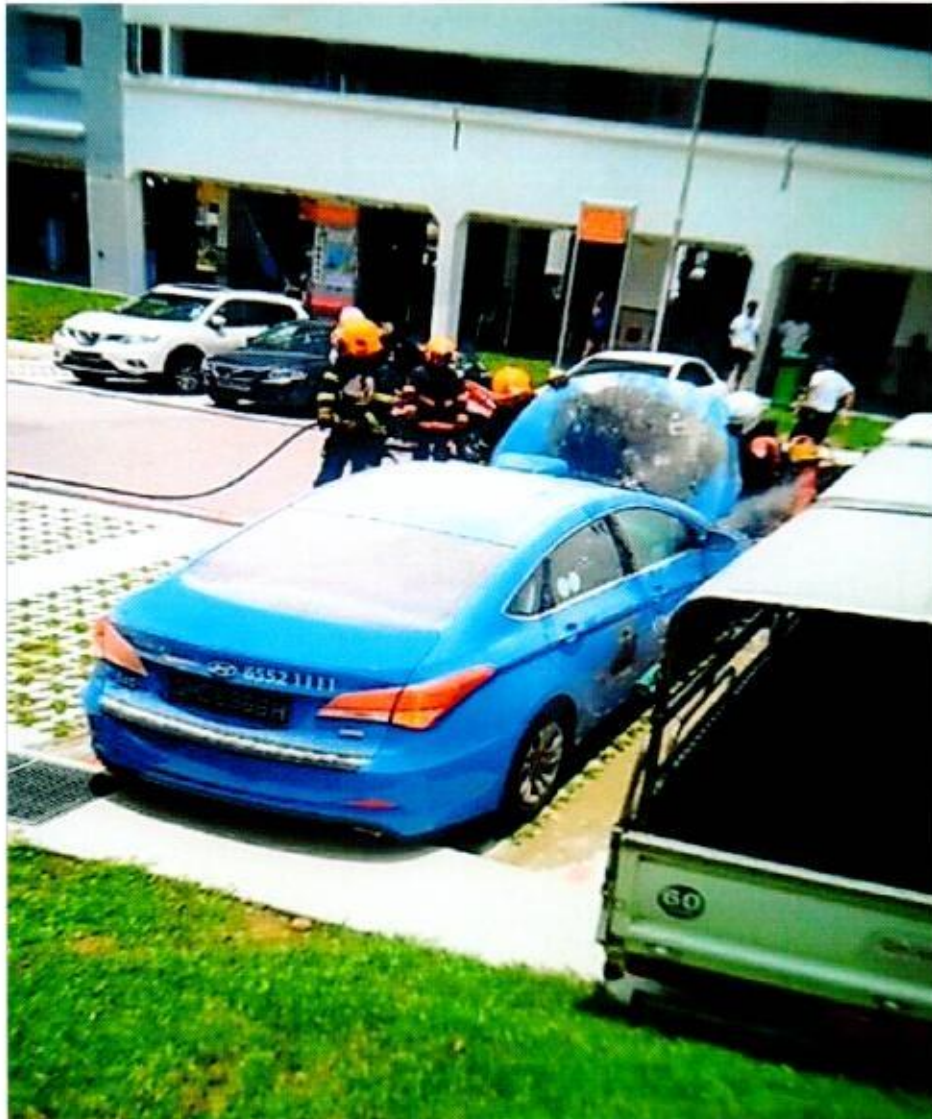
Photo 12 shows firefighters attempting to put out the fire to the Insured Vehicle.

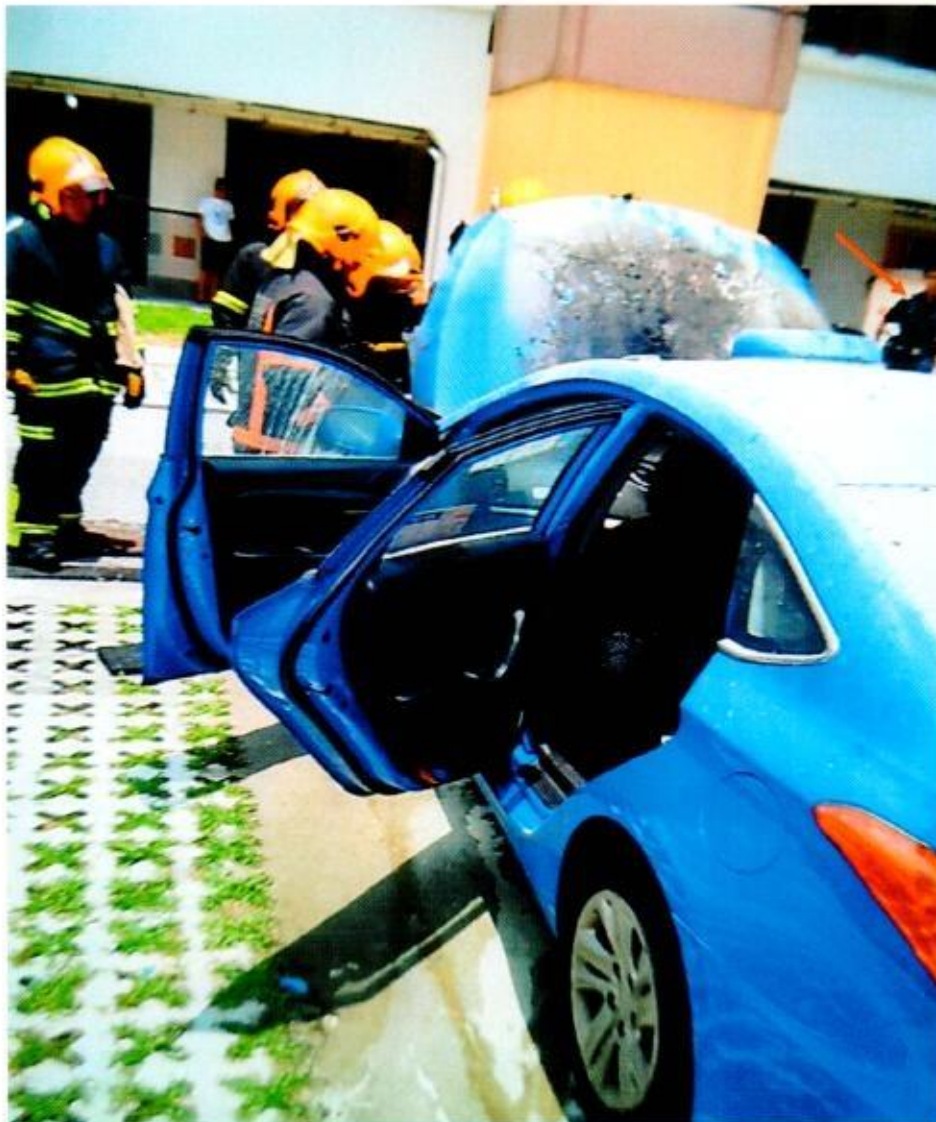
Photo 13 shows firefighters ensuring that the fire had been completely extinguished (arrowed). In general, the information that could be gathered from this photograph had corresponded to Mr Toh's account of the incident, which is the police (arrowed) and SCDF were present at the incident location.

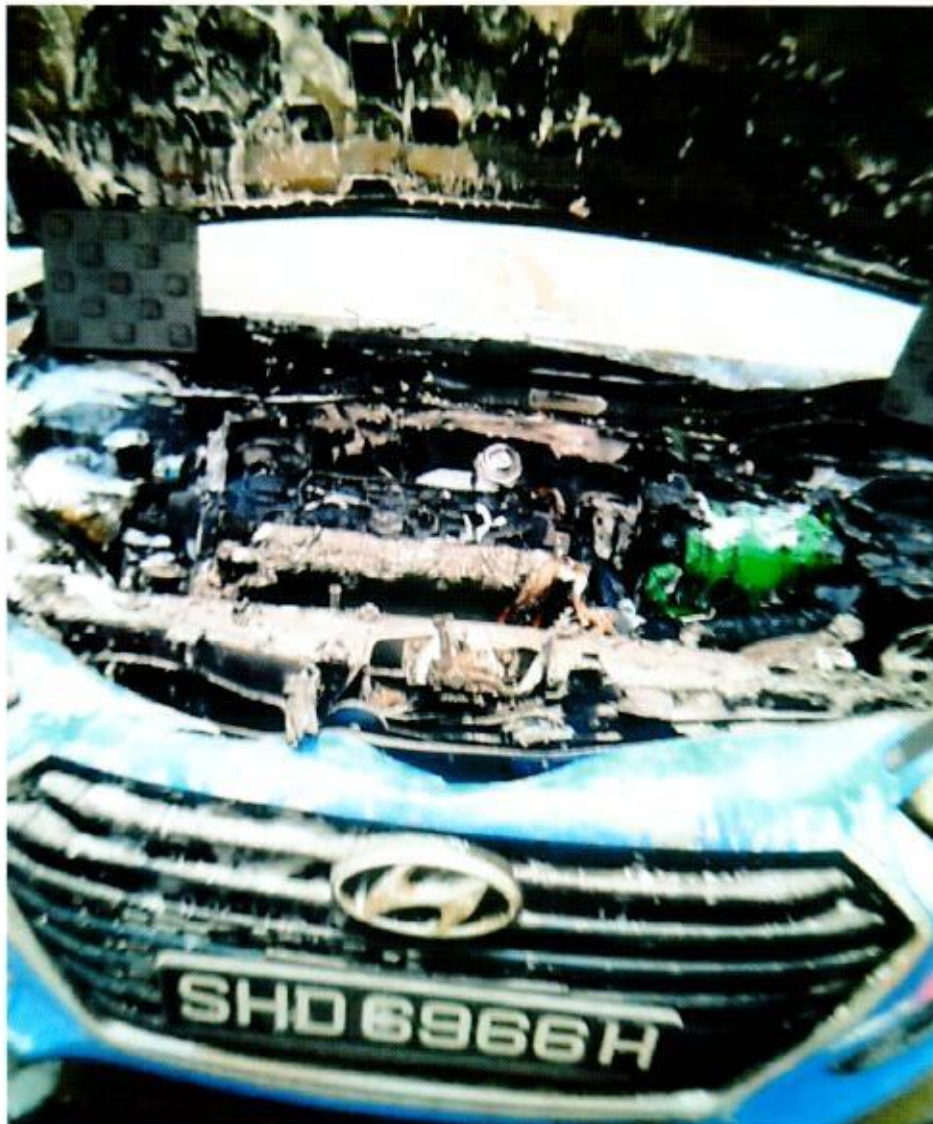
Photo 14 shows the engine compartment of the Insured Vehicle post- incident. In general, the damages sustained to the engine compartment and the fire extinguisher residue found all around the engine compartment had corresponded to the events that were related to us by Mr Toh, which is the fire had started from the engine compartment.

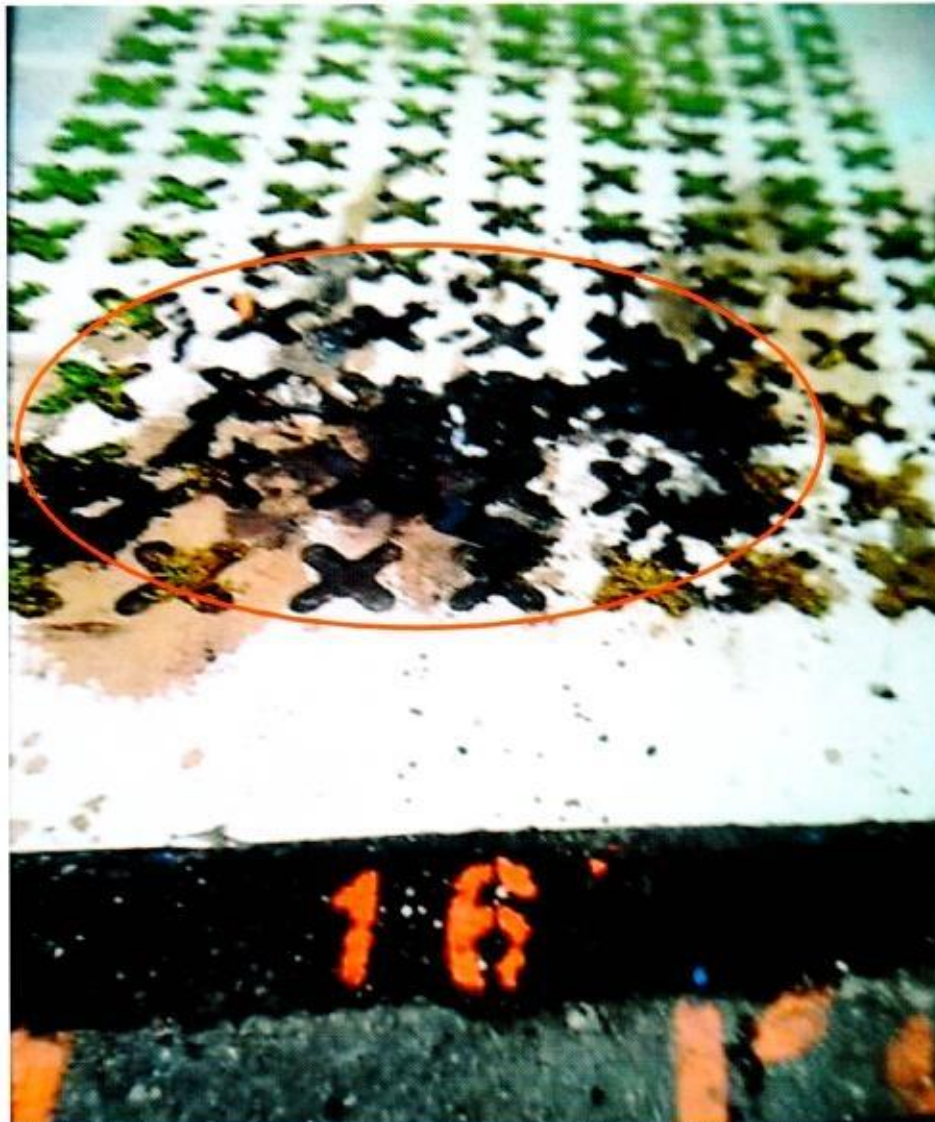
Photo 15 shows the burnt marks and/or burnt residual remains on the ground of the lot where the Insured Vehicle was parked (circled), taken after the Insured Vehicle was towed to CDGE. Our close examination of this photograph showed no unusual foreign material(s) and/or object(s) found on the ground in the lot where the Insured Vehicle was parked at the material time of incident.

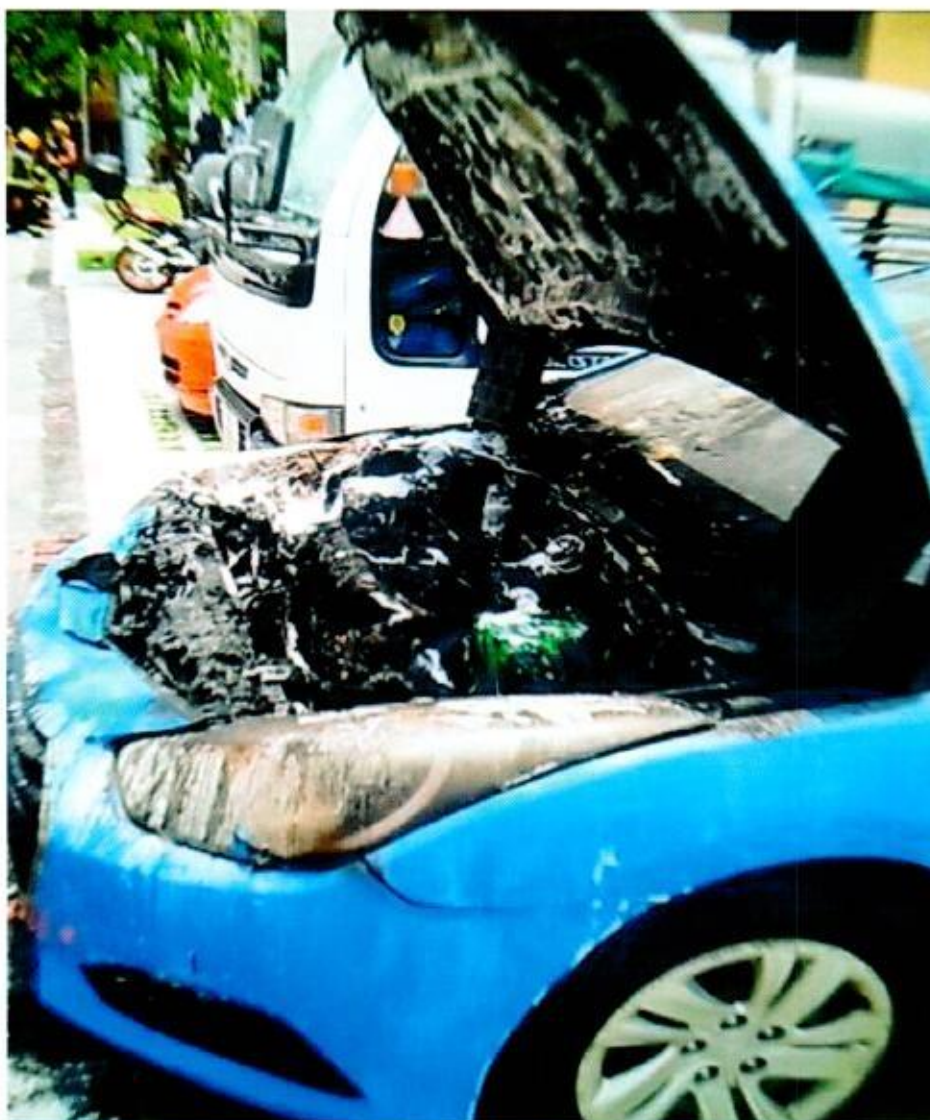
Photo 16 shows the Insured Vehicle in the parking lot after the fire was extinguished. Our close examination of this photograph showed no unusual foreign material(s) and/or object(s) found on the ground in the immediate area of the lot where the Insured Vehicle was parked.
