Our Ref : CS/FCI18006948/N

15 April 2018

M/s First Capital Insurance Limited36 Robinson Road #16-01
City House
Singapore 068877**TECHNICAL INVESTIGATION REPORT OF FIRE INCIDENT INVOLVING THE INSURED VEHICLE SHD 6966H ON 30 MARCH 2018**

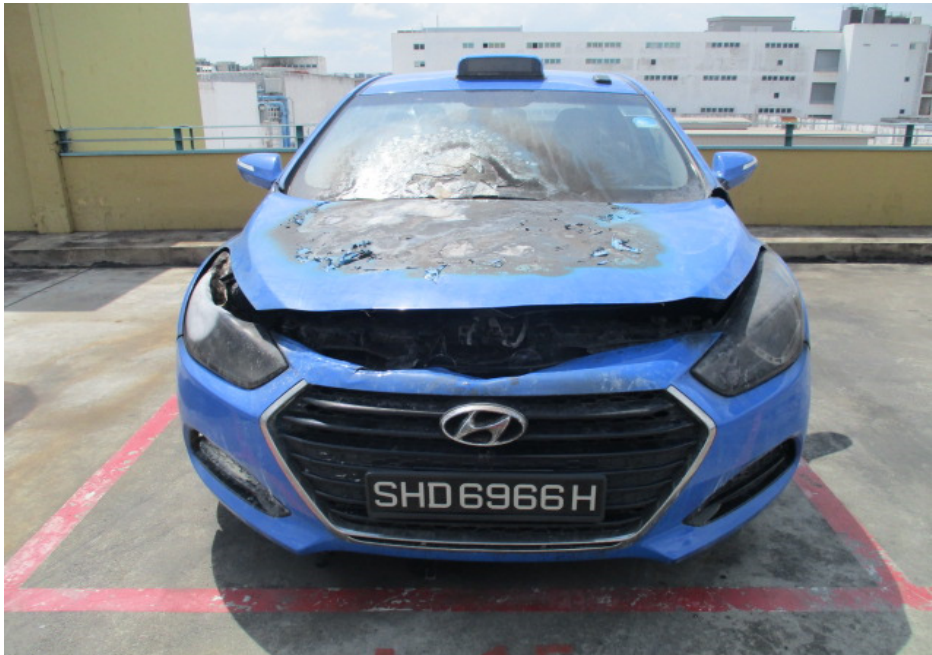
Photo 1 shows the general view of the front portion of the Insured Vehicle at the time of our inspection. The fire damage to the Insured Vehicle was confined to its front portion. Its front bumper, front bonnet, front grille, front windscreen and front headlamps were amongst the body parts that were found to have been affected as a result of the fire.

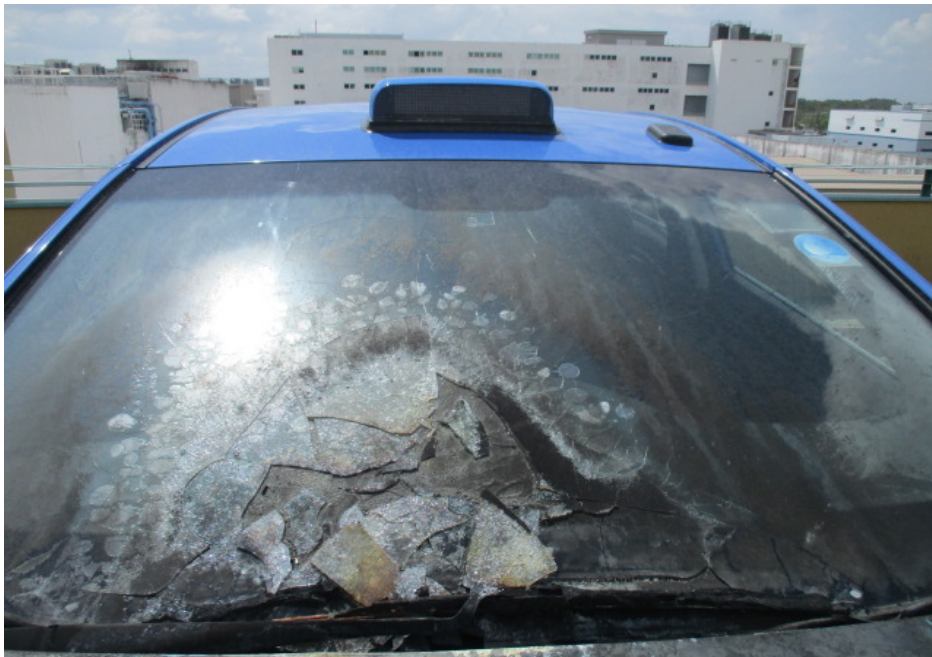
Photo 2 shows the general view of the front windscreen of the Insured Vehicle at the time of our inspection. The fire damage to the Insured Vehicle was confined to its centre portion.

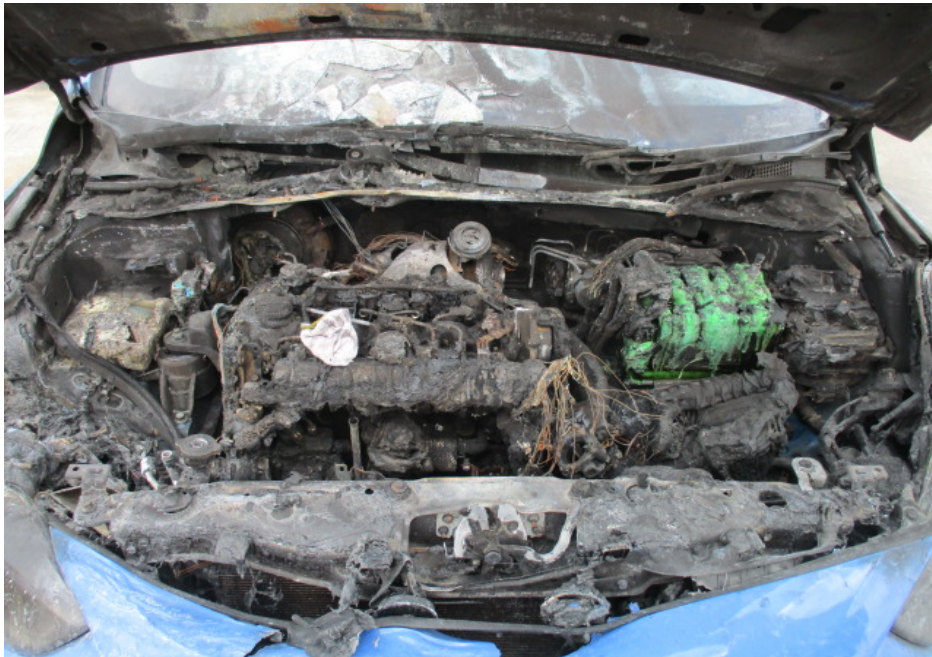
Photo 3 shows the engine compartment of the Insured Vehicle at the time of our inspection. The entire engine compartment of the Insured Vehicle was observed to be severely burnt. Most of the parts inside the engine compartment were found to be burnt and/or melted as a result of the fire.

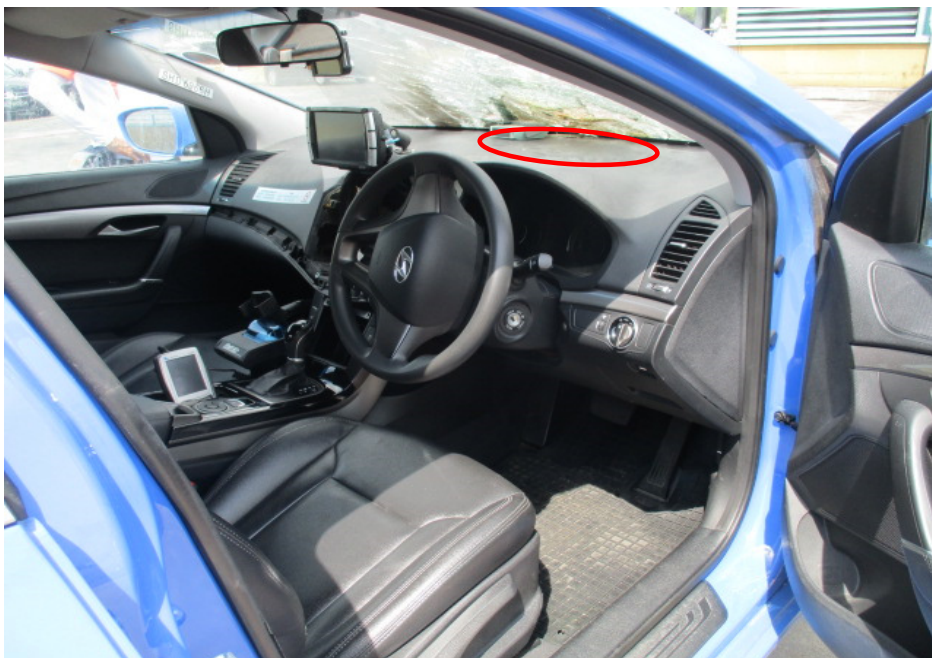
Photo 4 shows the interior compartment of the Insured Vehicle which was relatively unaffected by the fire except for the centre portion of the dashboard panel which was observed to be partially burnt and/or melted (circled).

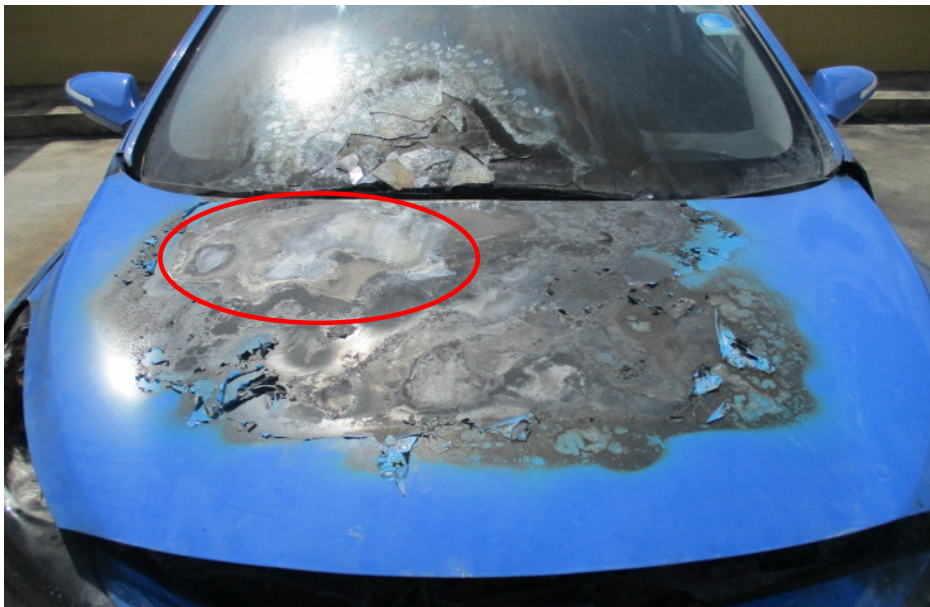
7. For this particular case, the fire appears to have originated within the engine compartment of the Insured Vehicle, somewhere around the rear left portion of the engine compartment. This can be determined from the burn pattern and the high heat intensity burn marks (whitish burn marks) found on the rear right portion of the bonnet of the Insured Vehicle and also the rust that had developed on the underside of the front bonnet, at the bottom right portion.

8. The whitish burn marks are a result of exposure to prolonged heat intensity. Rust would normally start to develop around these areas soon after a fire as prolonged exposure to high heat intensity usually causes steel/metal material body parts to be exposed to natural environmental condition. The rust that had developed on the underside of the front bonnet, around the bottom right portion, is an indication that the rear right portion of the engine compartment had sustained exposure to prolonged high heat intensity. See photos 5 & 6 below.

Photo 5 shows the burn pattern and whitish burn marks that were found on the rear right portion of the front bonnet of the Insured Vehicle (circled). Such whitish burn marks are a result of exposure to prolonged heat intensity, which may indicate where the fire had started. Rust would also begin to develop on these areas soon after the fire.

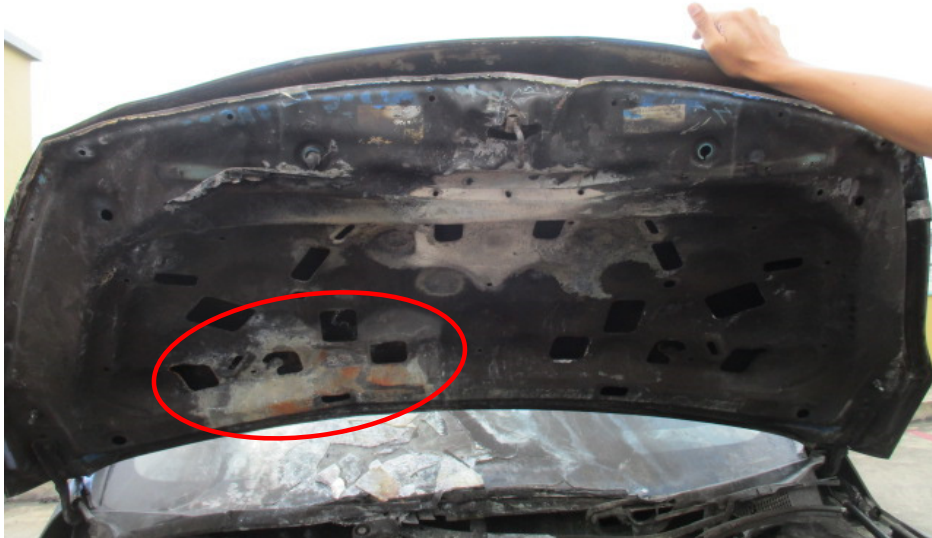
Photo 6 shows the rust that had developed on the underside of the front bonnet, around the bottom right portion (circled). The development of rust is an indication that this area was subjected to prolonged exposure to high heat intensity, which had caused the steel/metal material of the front bonnet to be exposed to natural environmental condition. Hence the fire to the Insured Vehicle can be determined to have originated towards the rear right portion of the engine compartment.

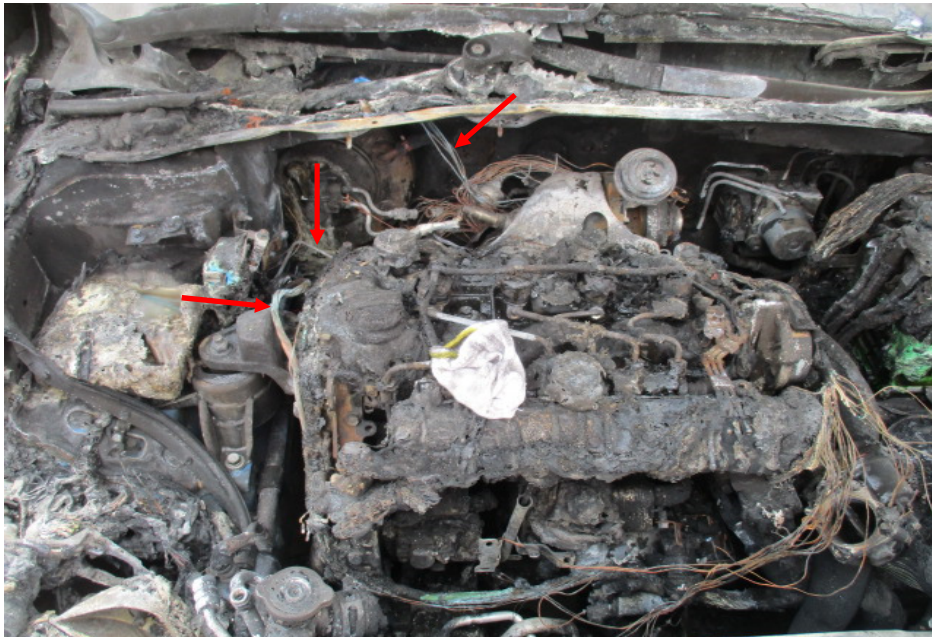
9. Upon closer examination of the rear right portion of the engine compartment, which was where the fire to the Insured Vehicle had likely started, we had found greenish residue on several burnt stretches of original factory fitted wirings around the rear right portion of the engine compartment. The presence of such greenish residue indicates internal heating of copper wires, a sign of an electrical short circuit occurring. The greenish residue is normally left behind from oxidation as a result of chemical reaction involving the copper wires. This physical evidence would then appear to suggest that the cause of fire to the Insured Vehicle could have possibly been due to electrical in nature. See photos 7 - 10 below.

Photo 7 shows the original factory fitted wirings around the rear right portion of the engine compartment, which is in the immediate vicinity where the fire to the Insured Vehicle had likely started. We had found greenish residue on several burnt stretches of these wirings (arrowed). The presence of such greenish residue indicates internal heating of copper wires, a sign of an electrical short circuit occurring. The greenish residue is normally left behind from oxidation as a result of chemical reaction involving the copper wires.

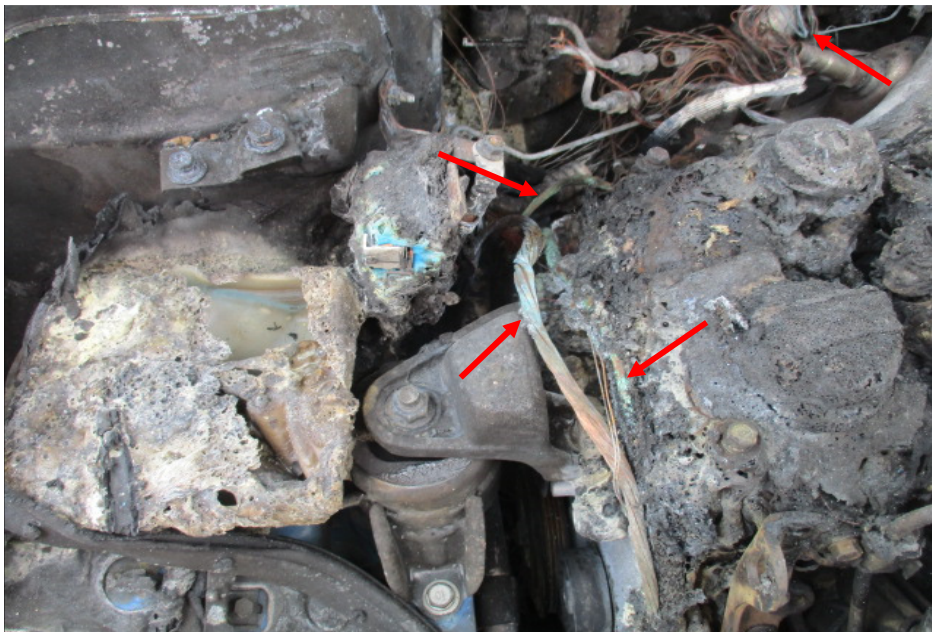
Photo 8 shows a closer view of the greenish residue found on some of the burnt stretches of original factory fitted wirings (circled). The presence of such greenish residue suggests occurrence of an electrical short circuit.

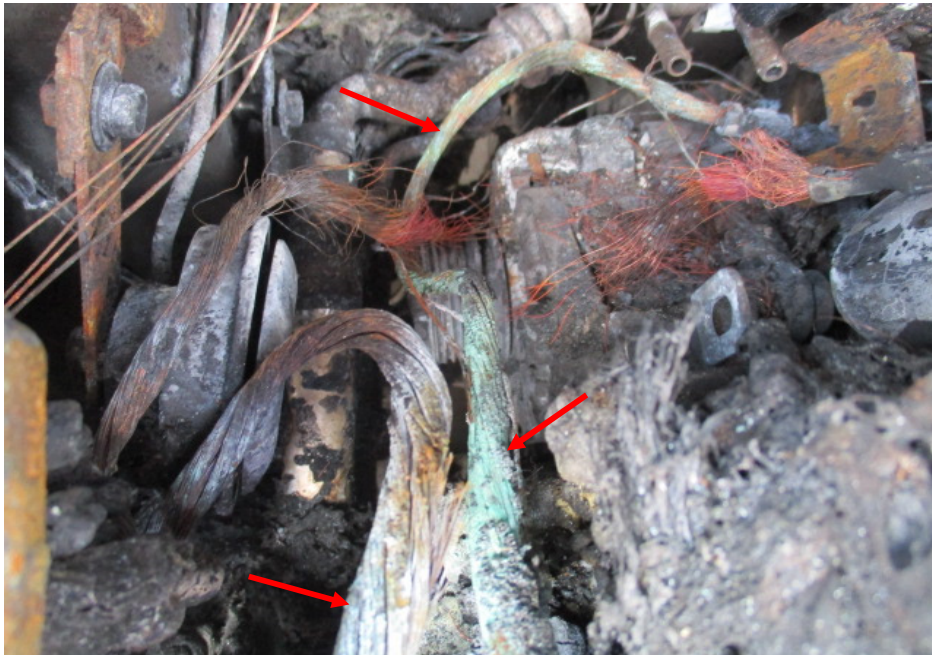
Photo 9 shows a close up view of the greenish residue found on some of the burnt stretches of original factory fitted wirings (arrowed). The presence of such greenish residue suggests occurrence of an electrical short circuit.

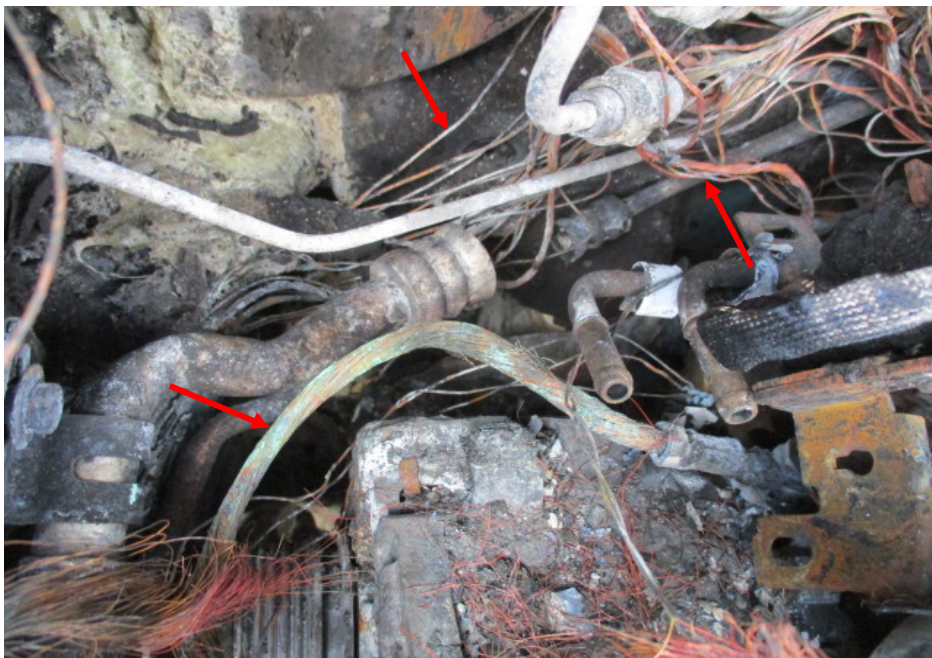
Photo 10 shows a close up view of the greenish residue found on some of the burnt stretches of original factory fitted wirings (circled). The presence of such greenish residue suggests occurrence of an electrical short circuit.

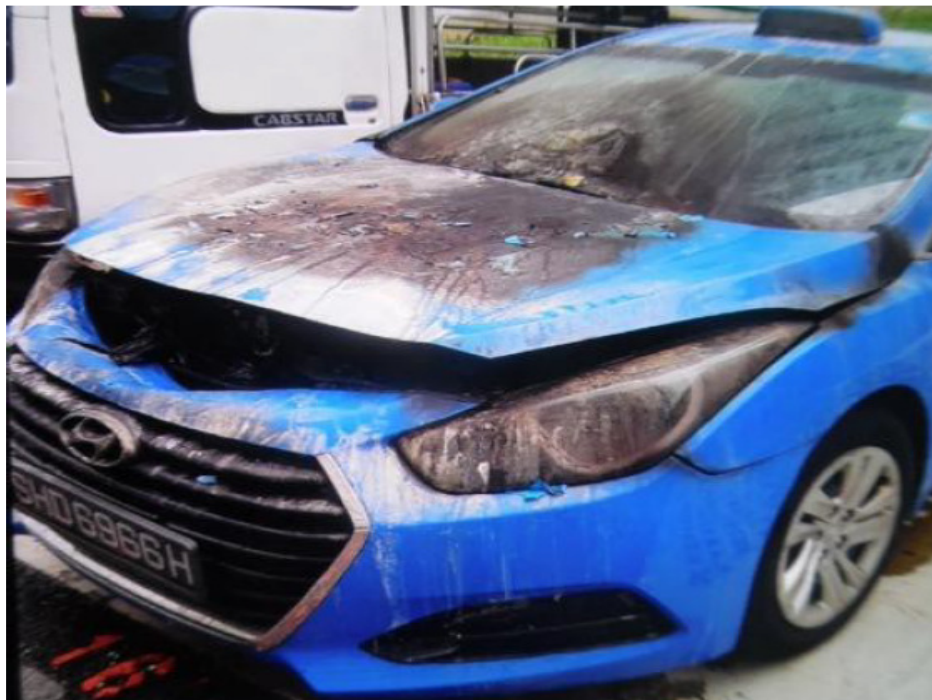
Photo 11 shows the Insured Vehicle after the fire was extinguished. In general, the information that could be gathered from this photograph had corresponded to the events that were related to us by Mr Toh, which is the fire broke out after he had parked the Insured Vehicle at the parking lot.

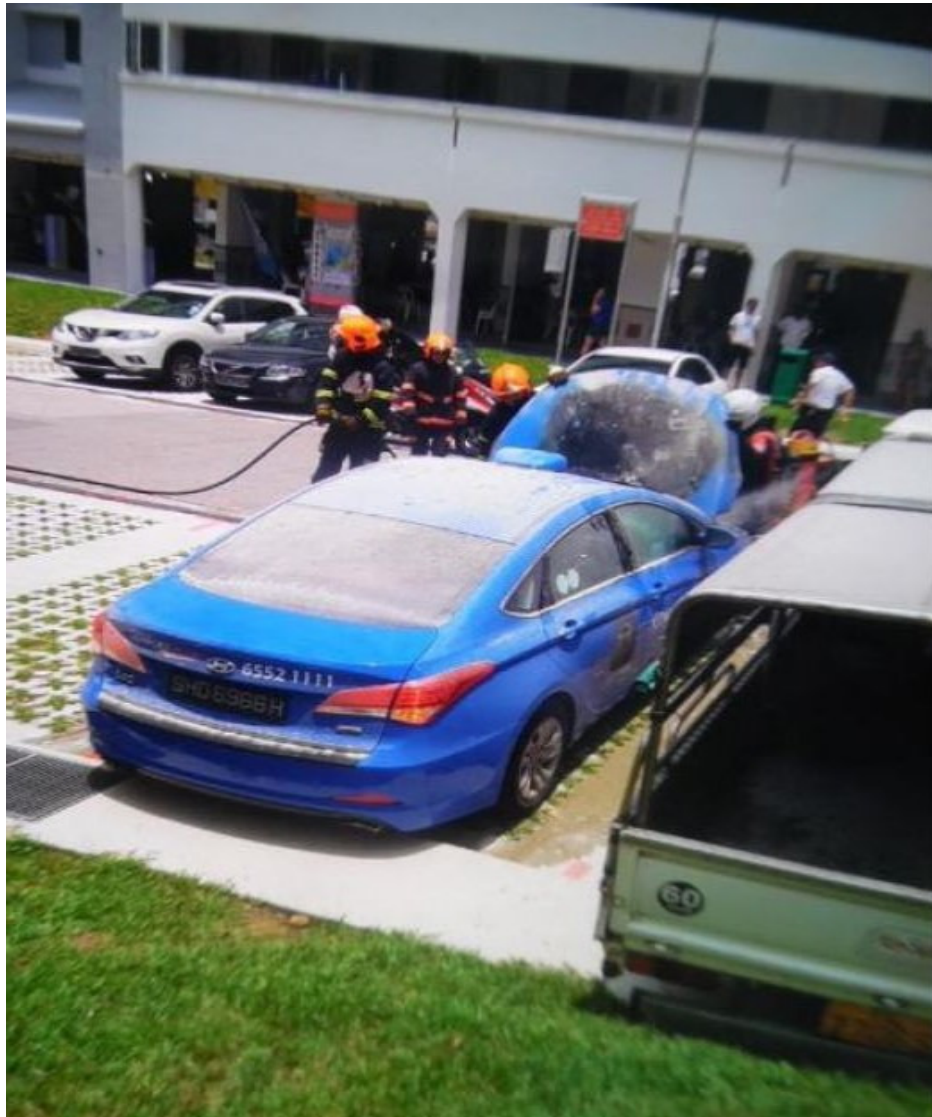
Photo 12 shows firefighters attempting to put out the fire to the Insured Vehicle.

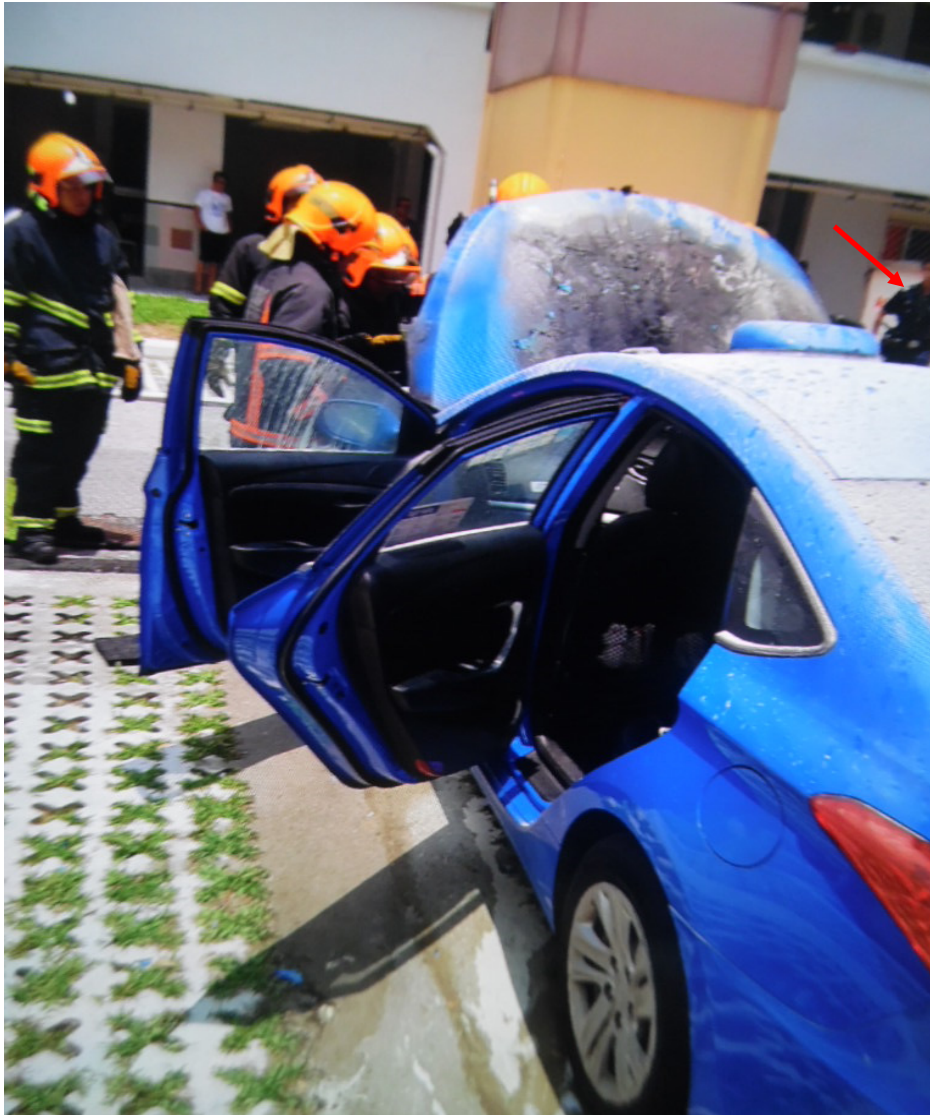
Photo 13 shows firefighters ensuring that the fire had been completely extinguished (arrowed). In general, the information that could be gathered from this photograph had corresponded to Mr Toh's account of the incident, which is the police (arrowed) and SCDF were present at the incident location.

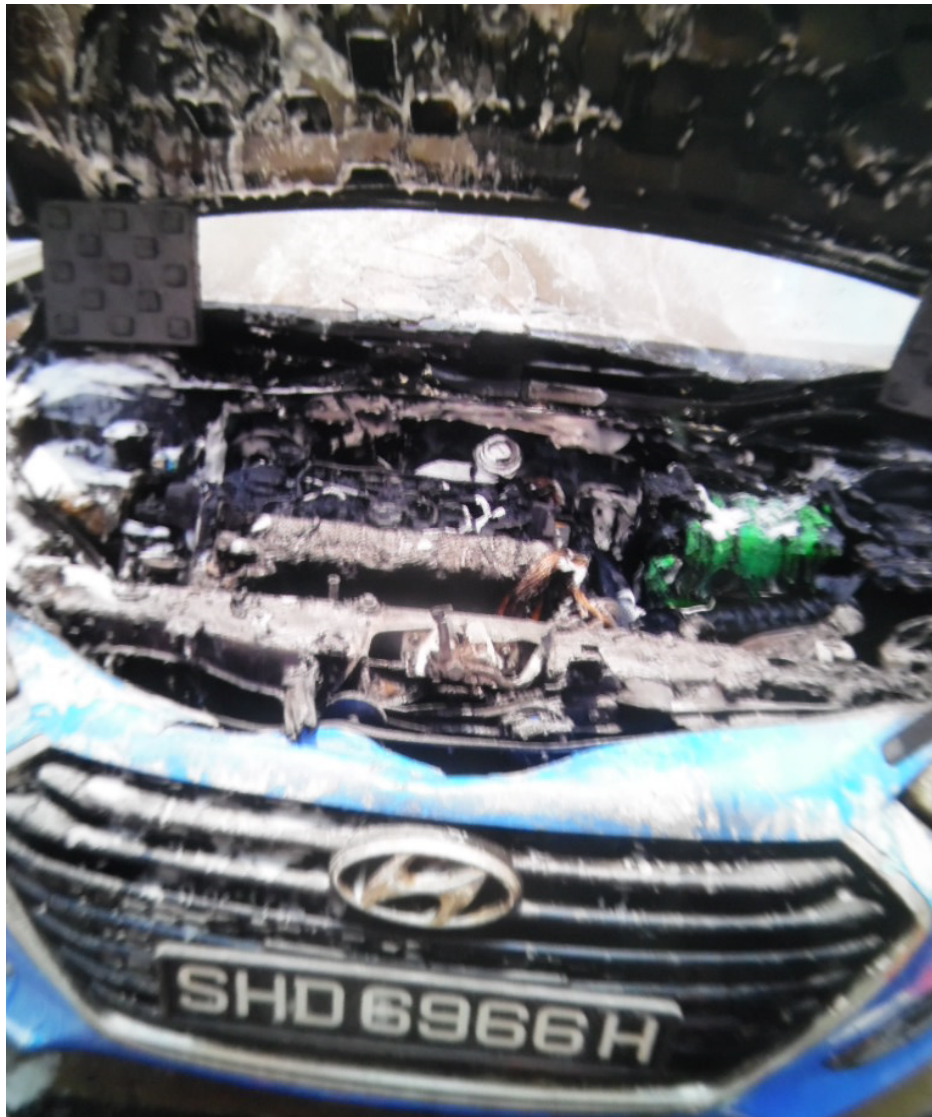
Photo 14 shows the engine compartment of the Insured Vehicle post- incident. In general, the damages sustained to the engine compartment and the fire extinguisher residue found all around the engine compartment had corresponded to the events that were related to us by Mr Toh, which is the fire had started from the engine compartment.

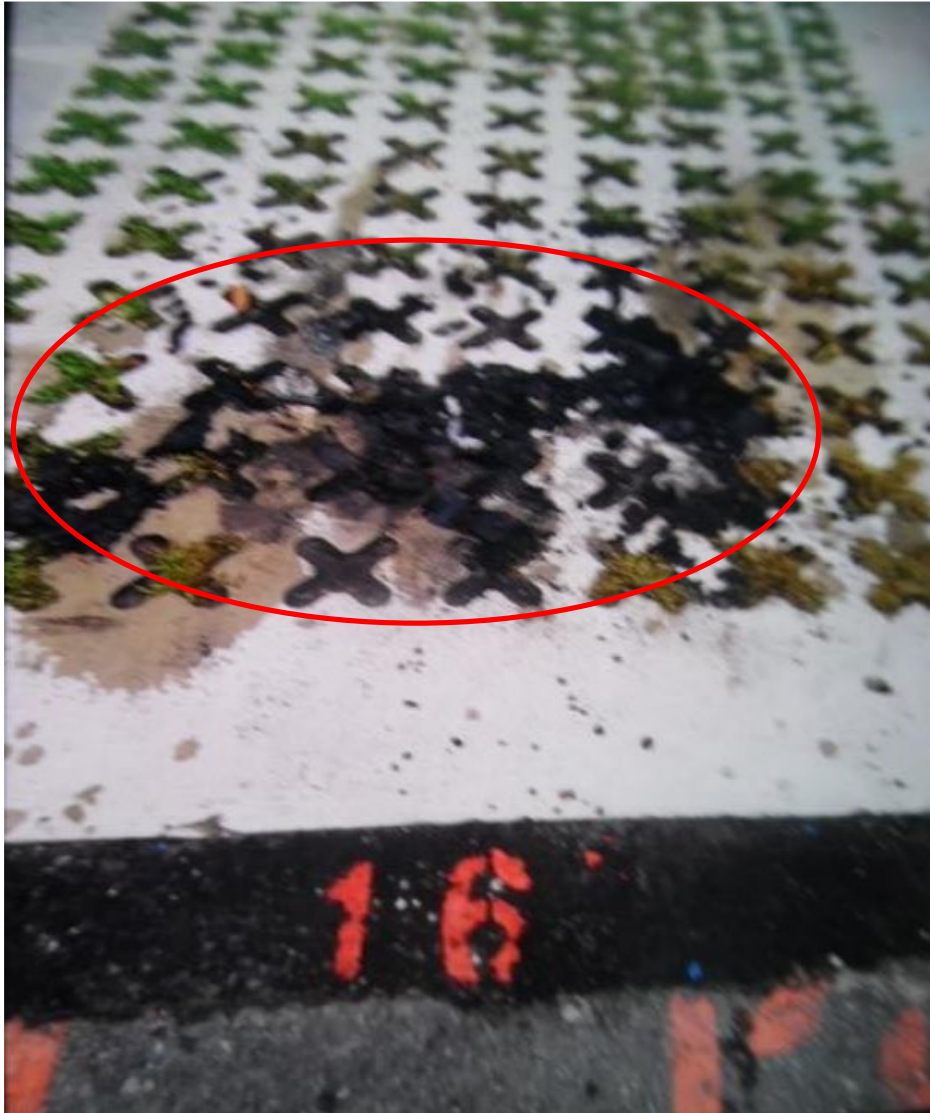
Photo 15 shows the burnt marks and/or burnt residual remains on the ground of the lot where the Insured Vehicle was parked (circled), taken after the Insured Vehicle was towed to CDGE. Our close examination of this photograph showed no unusual foreign material(s) and/or object(s) found on the ground in the lot where the Insured Vehicle was parked at the material time of incident.

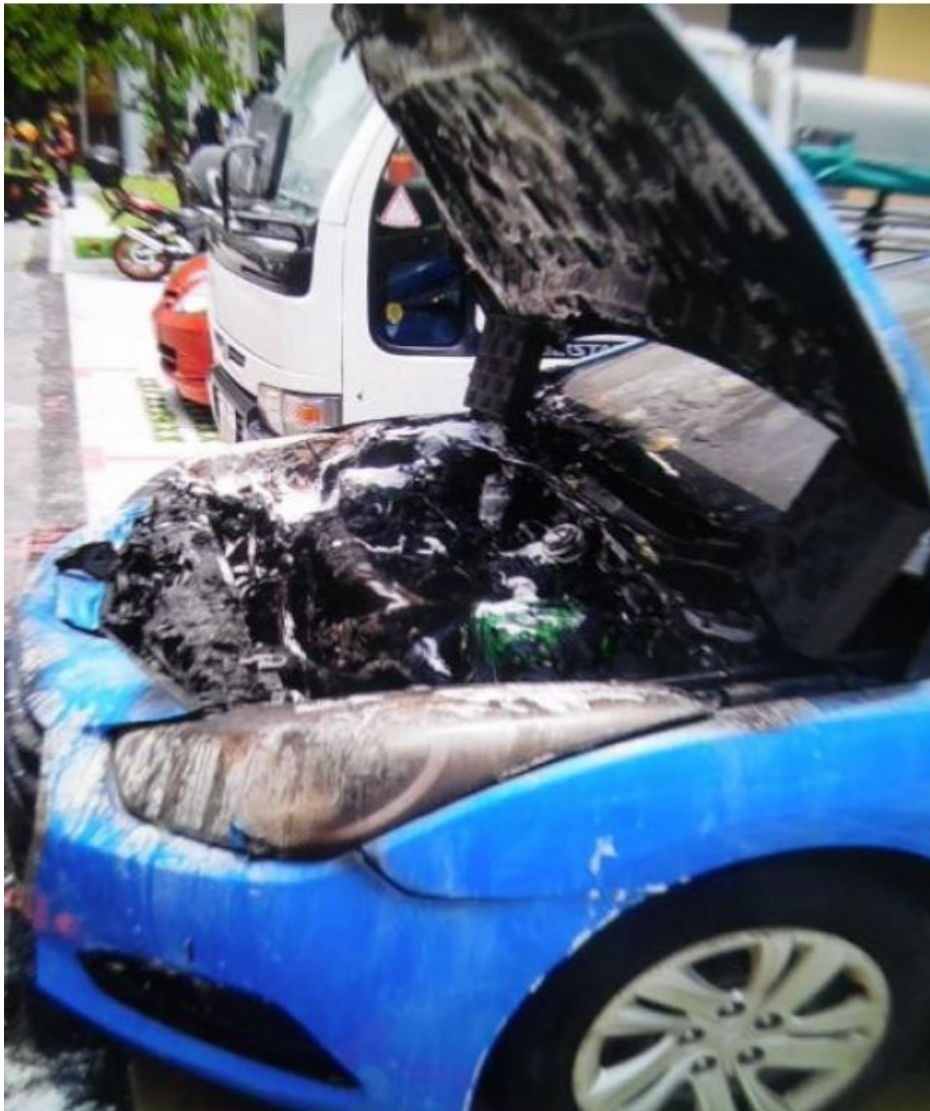
Photo 16 shows the Insured Vehicle in the parking lot after the fire was extinguished. Our close examination of this photograph showed no unusual foreign material(s) and/or object(s) found on the ground in the immediate area of the lot where the Insured Vehicle was parked.
