INVESTIGATION REPORT:

Our Ref : CS/ASM18006969/N

Claim No : S8M00DB8

Insured : SBE 75J

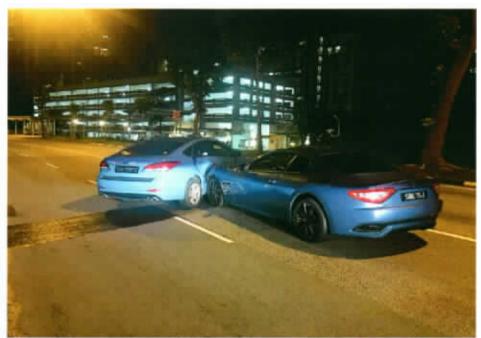
Photo 1 shows the Insured Vehicle at its respective final rest position at the accident scene right after the collision with the Taxi. It seems to correlate with Mr Tan's account of the accident which had occurred when the driver of the Taxi attempted to make an illegal U- turn from the 2nd lane along Tiong Bahru Road.

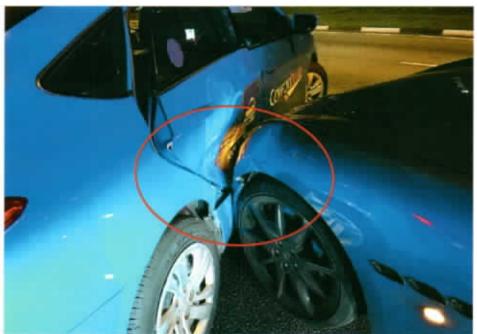
Photo 2 shows a closer view of the damages sustained to both vehicles as a result of the accident. It seems to correlate with Mr Tan's statement in which the right rear portion of the Taxi collided into the left front portion of the Insured Vehicle (circled).

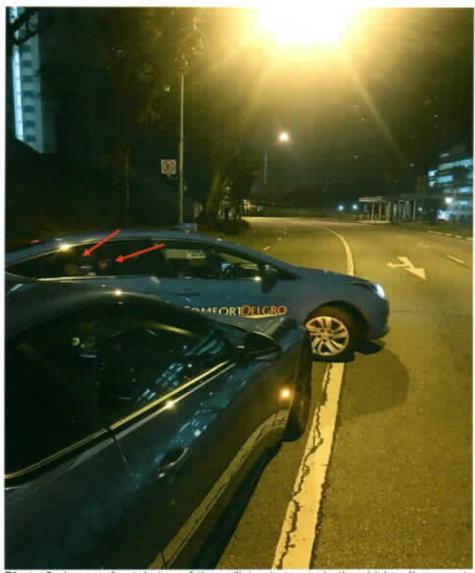
Photo 3 shows a frontal view of the collision between both vehicles. It seems to correlate with Mr Tan's statement in which he mentioned there were 2 female passengers seated at the rear of Taxi at the material time of accident (arrowed).

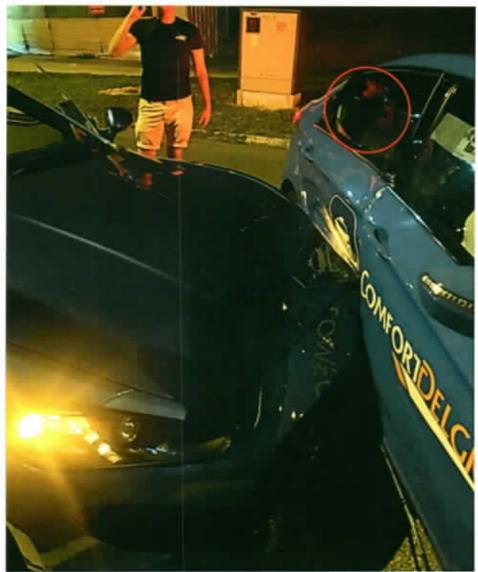
Photo 4 shows the point of impact when both vehicles collided. The reflection of the person in the photograph as viewed from the Taxi's right rear passenger door window seems to correlate with Mr Tan's statement in which he mentioned his friend was sitting beside him when the accident occurred (arrowed).

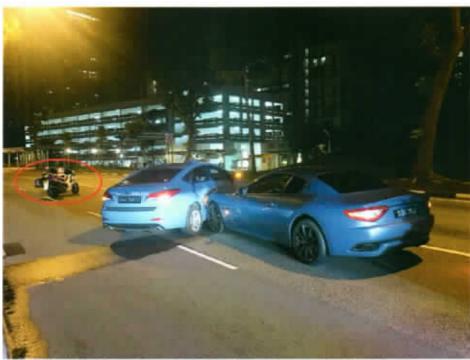
Photo 5 shows the arrival of traffic police at the accident location. It seems to correlate with Mr Tan' account of the accident in particular, the presence of the traffic police (circled) together with the ability of Mr Tan to take clear photographs after the accident would suggest that there was no drink driving involved in this particular accident.

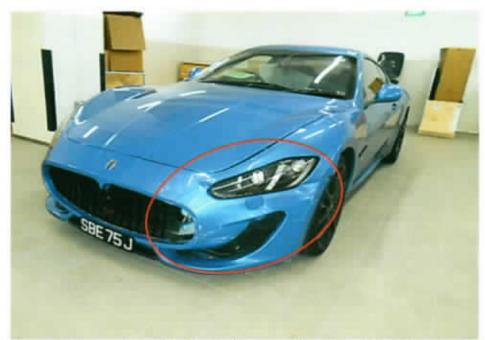
13. Our review of the accident scene photographs provided to us by Mr Tan and subsequent physical inspection of the Insured Vehicle at Tridente revealed that the Insured Vehicle had sustained damages to its front left portion as a result of the accident. The left portion of the front grille had buckled. There were dents, paint cracks and graze marks on the left portion of the front bumper. There was also a slight crack on the left headlight. We observed several bluish paint transfer marks on the left portion of the front bumper which would appear to correspond to the Insured Vehicle being hit by the Taxi. See photos 6 – 9 below.

Photo 6 shows a view of the front left portion of the Insured Vehicle during the physical inspection at Tridente. The Insured Vehicle had sustained damages to its front left portion as a result of the accident (circled).

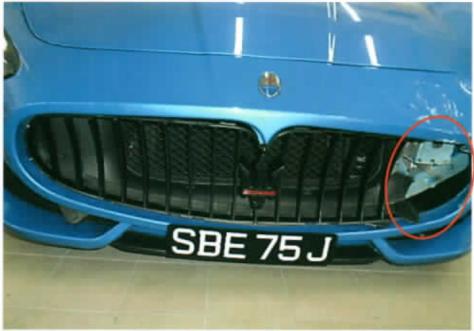
Photo 7 shows a closer view of the Insured Vehicle's buckled front grille (circled).

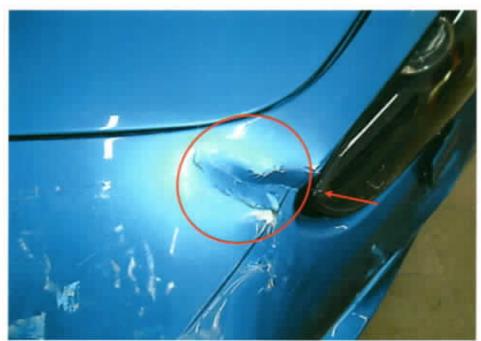
Photo 8 shows a closer view of the dents, paint cracks and graze marks on the left portion of the Insured Vehicle's front bumper (circled). There was also a slight crack on the left headlight (arrowed).

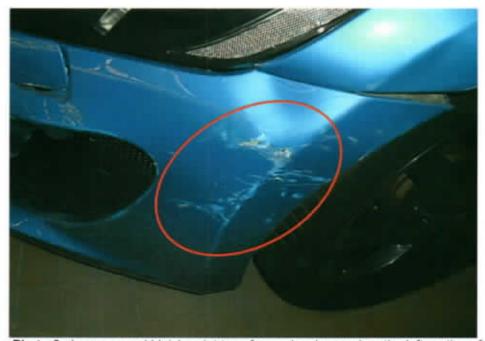
Photo 9 shows several bluish paint transfer marks observed on the left portion of the Insured Vehicle's front bumper (circled) which would appear to correspond to the Insured Vehicle being hit by the Taxi.

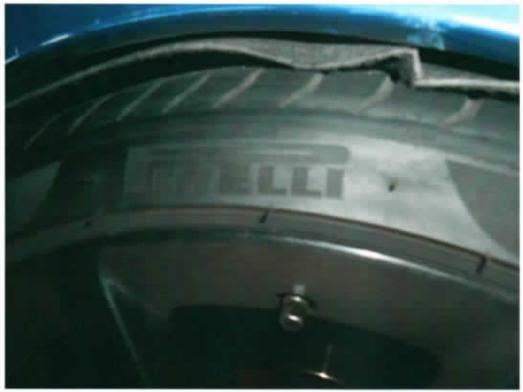
The grazing that Mr Tan felt while driving post-accident could have been caused by the left front tyre mudguard coming into contact with the left front tyre as it had detached from the left side panel as a result of the collision. Please refer to the photo below.

It is unlikely that this will cause further damage to any other part of the vehicle except for the left front tyre mudguard.

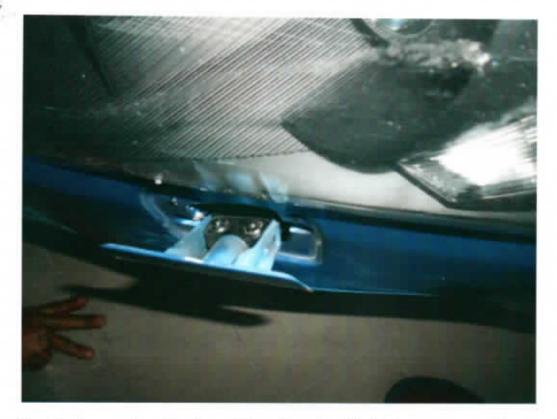
The fluid leakage that Mr Tan mentioned and saw could have been water that came from the left headlight washer system of the Insured Vehicle which may have been damaged due to the collision. Please refer to the photo below.

The leakage of water from this system is unlikely to cause any issues while continuing to drive the Insured Vehicle post-accident.
