Your Ref: S8M00EBB  
Our Ref : CS/ASM18007106/N

24 April 2018

**TECHNICAL INVESTIGATION REPORT OF FIRE INCIDENT INVOLVING THE  
INSURED VEHICLE SKN 9587K ON 15 APRIL 2018**

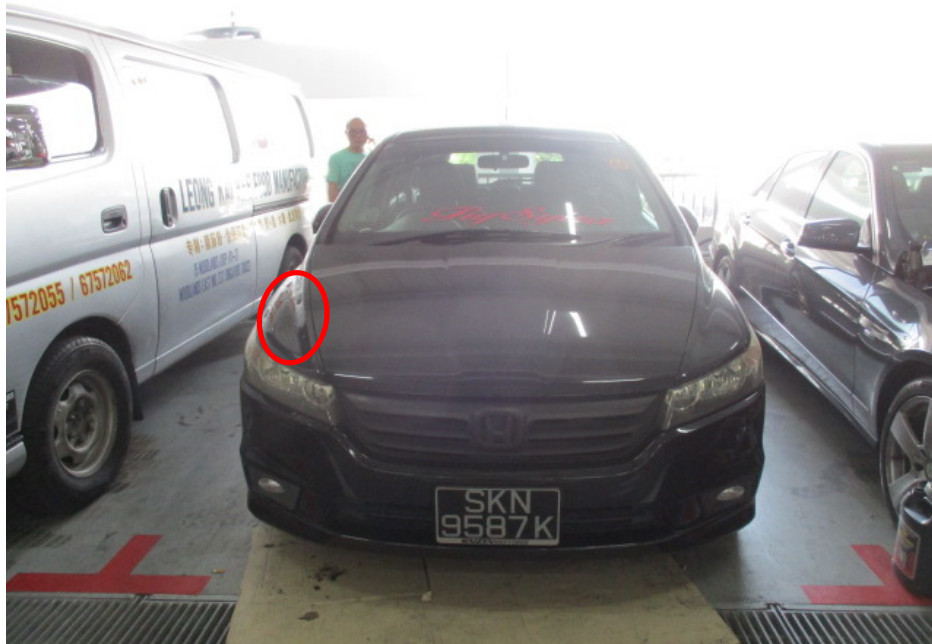
**Photo 1** shows the general view of the front portion of the Insured Vehicle at the time of our inspection. The exterior body of the Insured Vehicle was relatively unaffected by the fire except for the right side panel which was observed to be partially burnt and/or melted (circled).

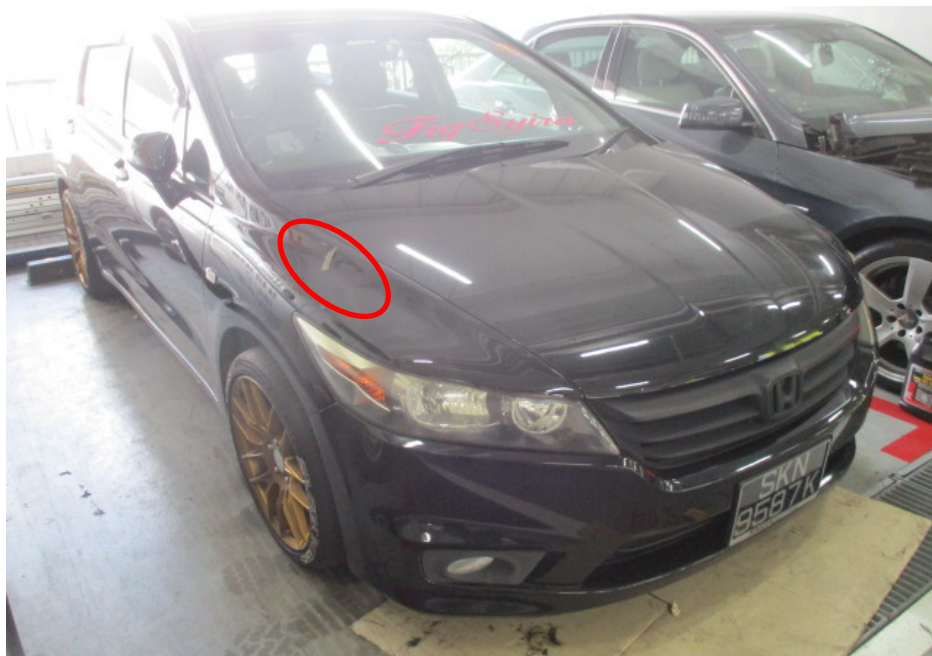
**Photo 2** shows the general view of the right portion of the Insured Vehicle at the time of our inspection. The right portion of the Insured Vehicle was relatively unaffected by the fire except for the right side panel which was observed to be partially burnt and/or melted (circled).

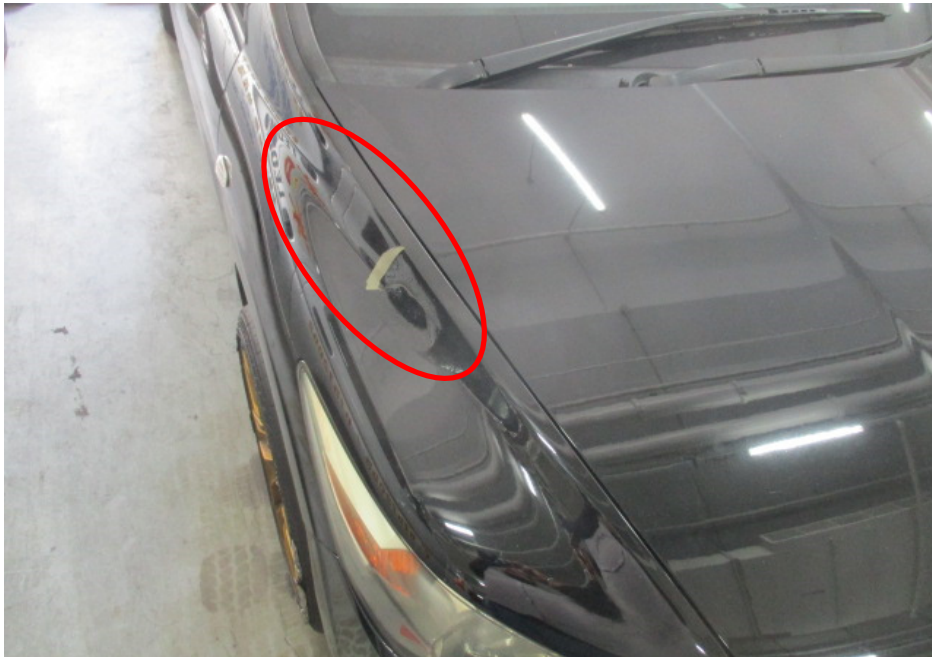
**Photo 3** shows a closer view of the right side panel of the Insured Vehicle which was observed to be partially burnt and/or melted (circled).

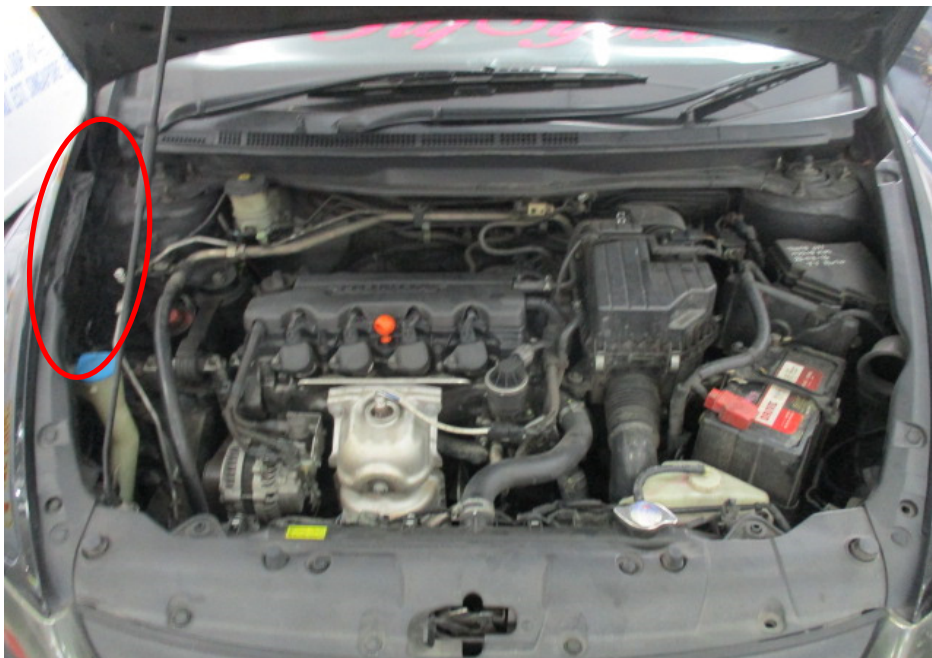
**Photo 4** shows a general view of the engine compartment of the Insured Vehicle at the time of our inspection. The main engine compartment of the Insured Vehicle did not sustain any visible fire damage except for the wiring harness located at the right portion (circled).

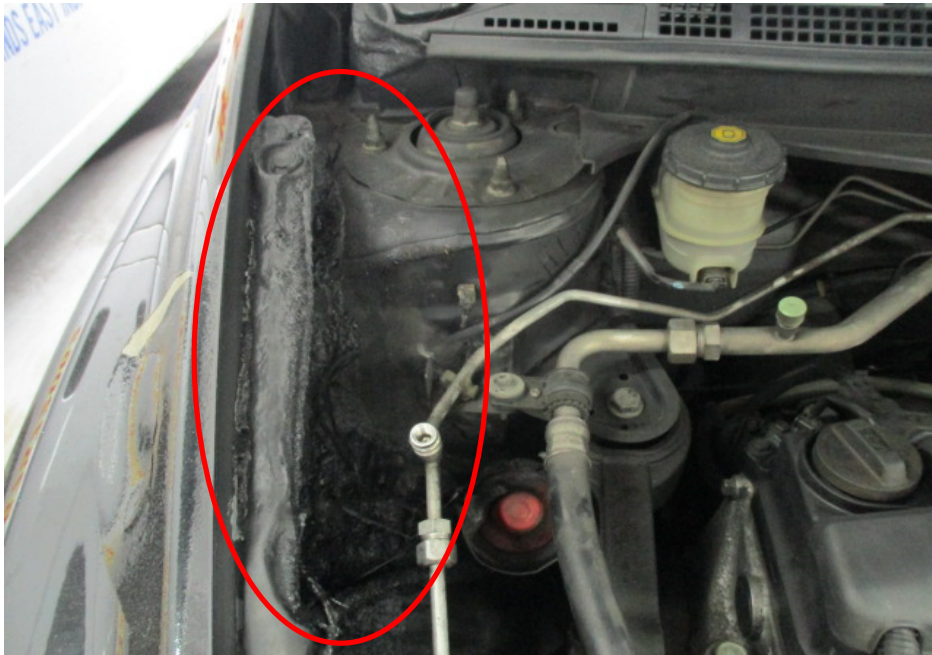
**Photo 5** shows a closer view of the wiring harness located at the right portion of the Insured Vehicle which was observed to be partially burnt and/or melted (circled).

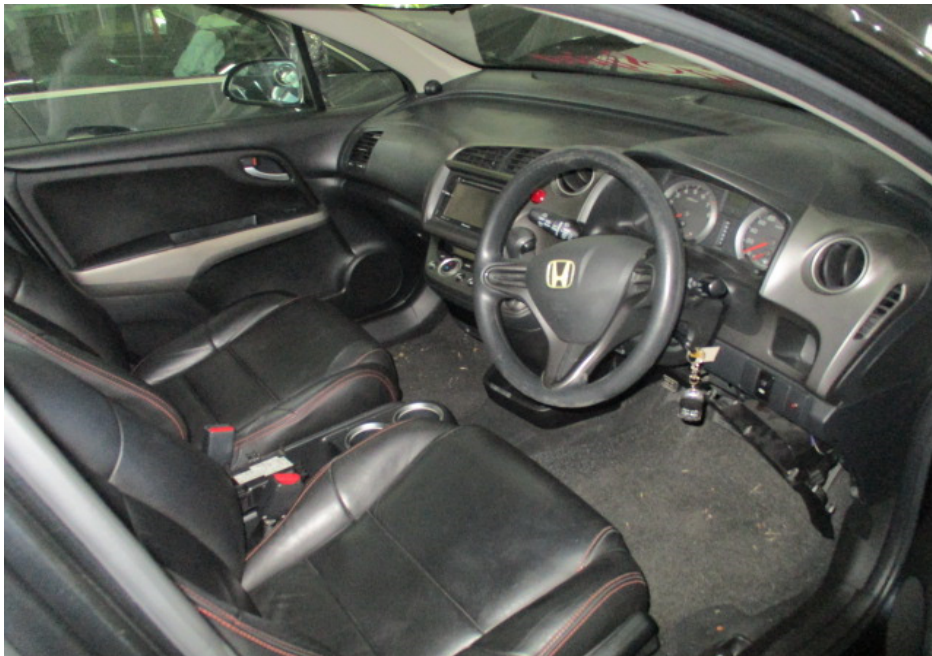
**Photo 6** shows the interior compartment of the Insured Vehicle at the time of our inspection which was relatively unaffected by the fire.

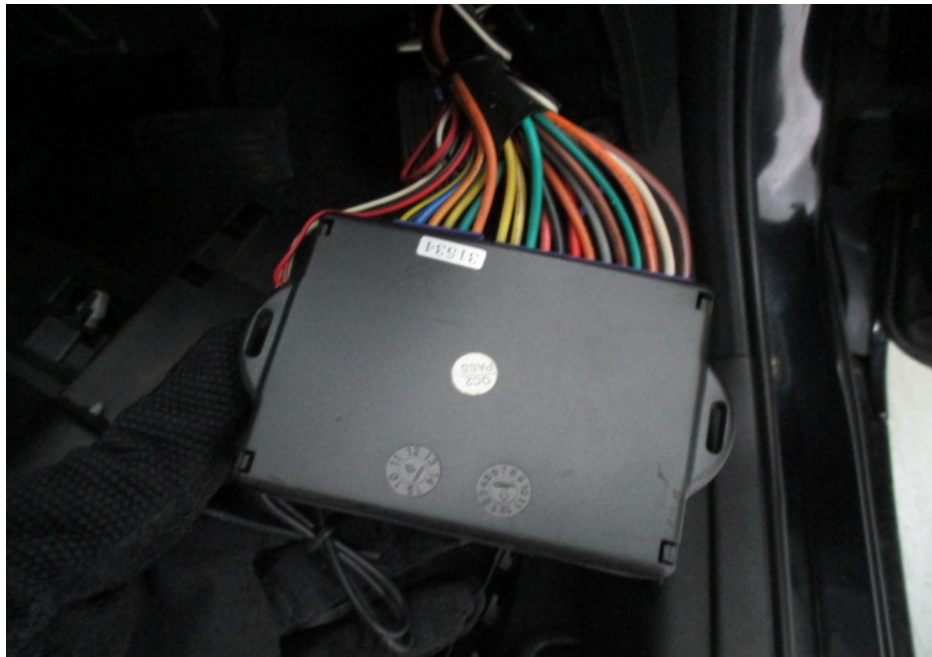
**Photo 7** shows the aftermarket vehicular alarm system which is not the standard type for the Insured Vehicle.

31. We are further of the opinion that the additionally fitted electrical/electronic components found on the Insured Vehicle could have possibly caused overloading to the electrical system of the Insured Vehicle. These components had included an aftermarket vehicular alarm system, 2 twitters, an in-car flip-down monitor and 2 headrest monitors which are all LTA compliant. However considering that the installation was carried out for a considerable period of time prior to the fire incident, the overloading was likely to be minimal.

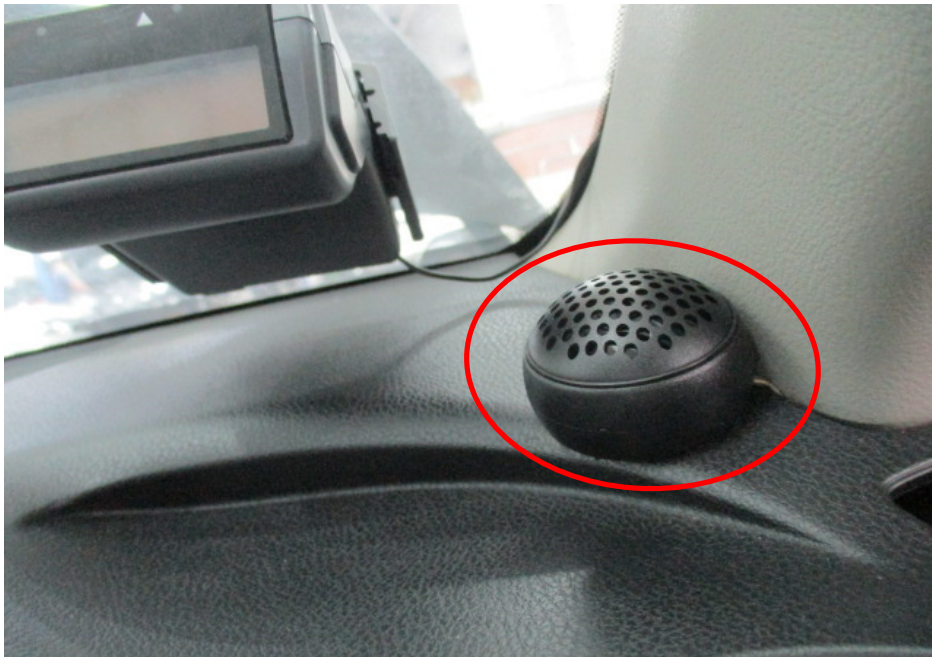
**Photo 8** shows the 1st aftermarket twitter fitted onto the right corner of the dashboard of the Insured Vehicle upon our inspection (circled).

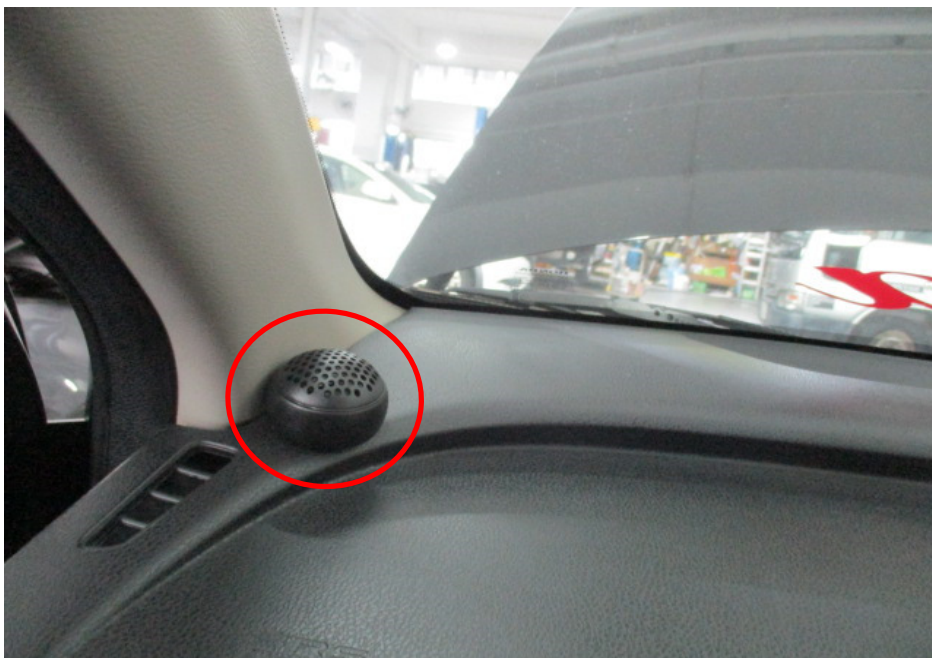
**Photo 9** shows the 2nd aftermarket twitter fitted onto the left corner of the dashboard of the Insured Vehicle upon our inspection (circled).

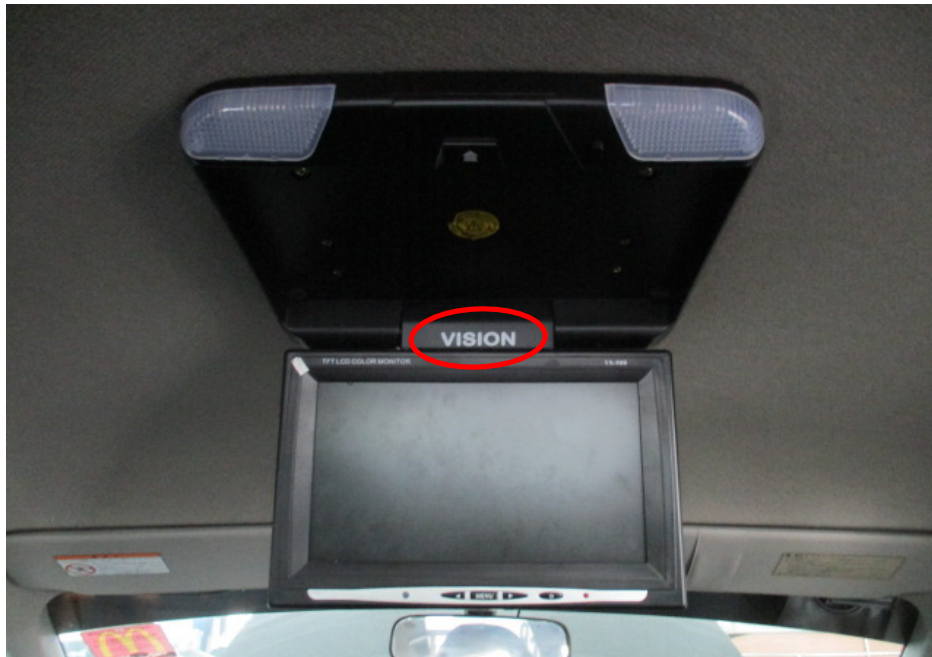
**Photo 10** shows the in-car flip-down monitor fitted onto the Insured Vehicle upon our inspection. The brand of the in-car flip-down monitor was 'VISION' (circled).

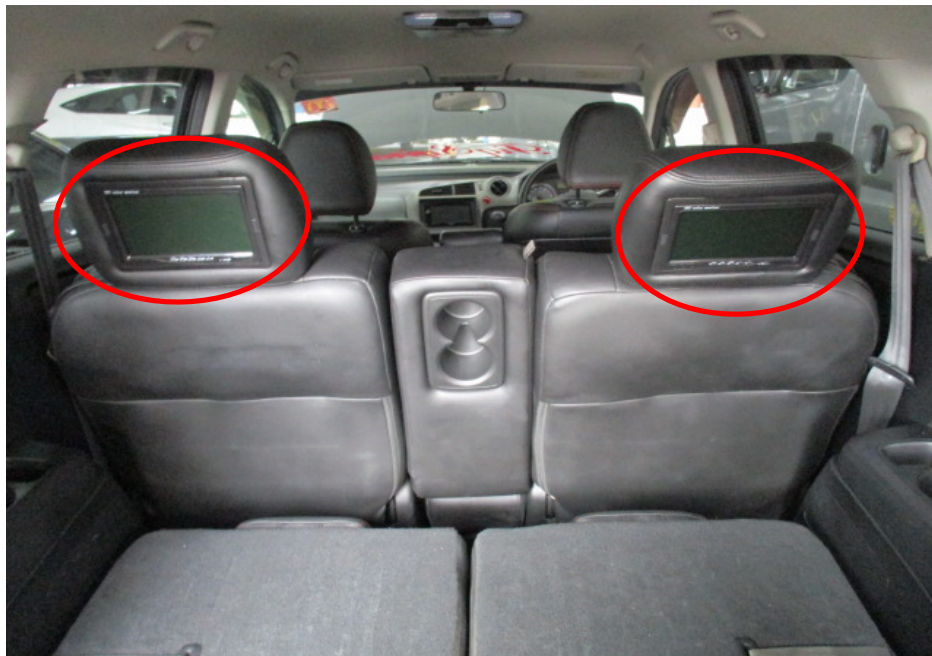
**Photo 11** shows the 2 headrest monitors fitted onto the rear of the passenger seats of the Insured Vehicle upon our inspection (circled).

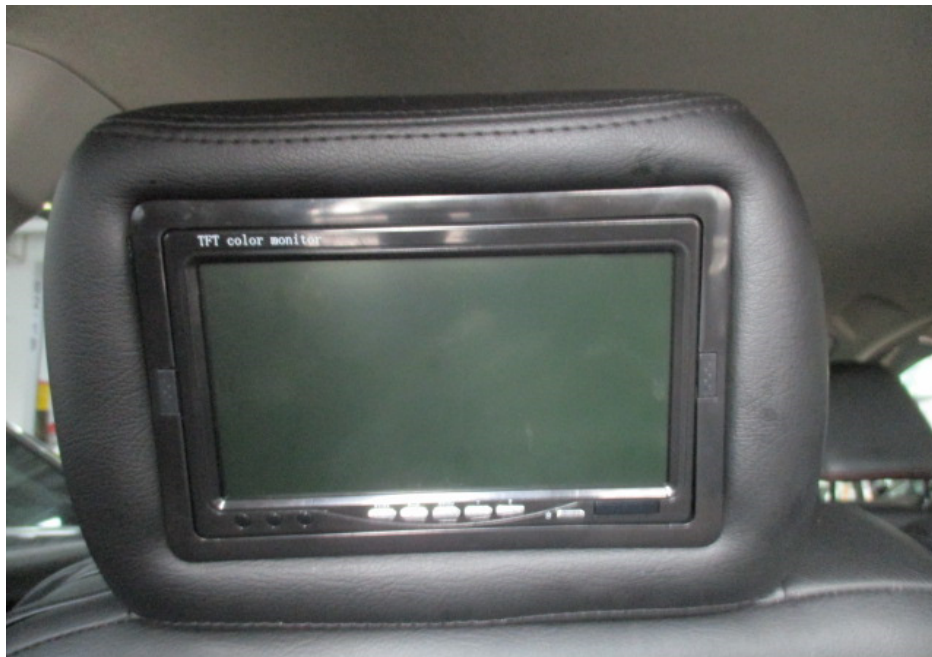
**Photo 12** shows the 1st headrest monitor fitted onto the rear of the left passenger seat of the Insured Vehicle upon our inspection.

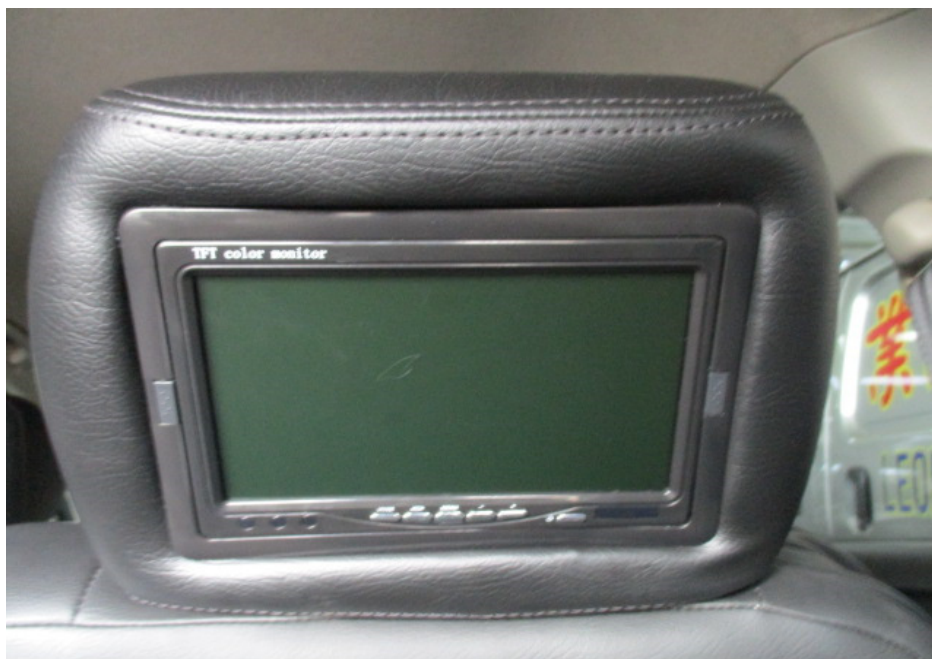
**Photo 13** shows the 2nd headrest monitor fitted onto the rear of the right passenger seat of the Insured Vehicle upon our inspection.

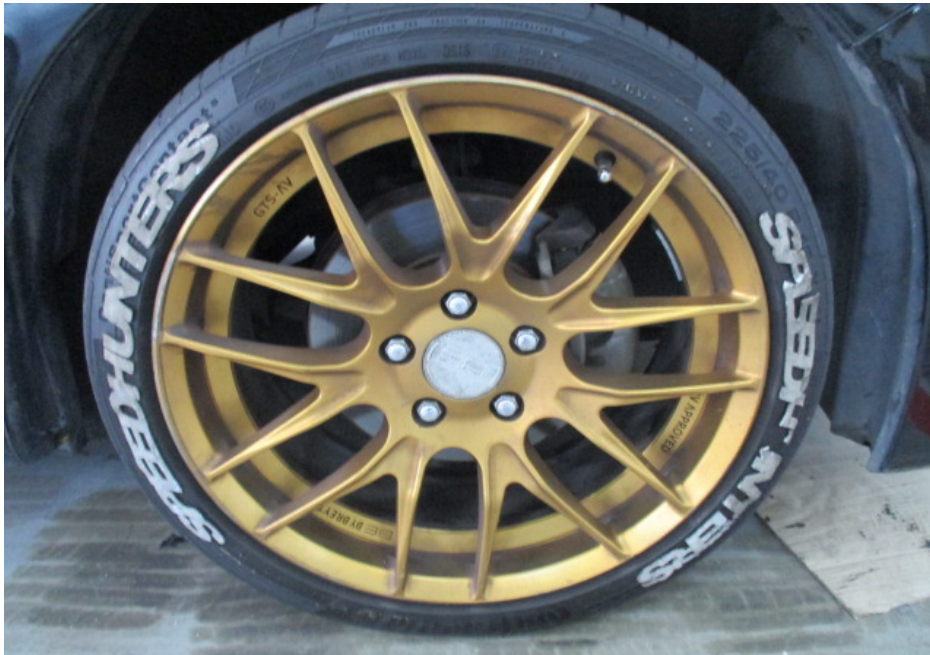
**Photo 14** shows the non-standard rim and tyre found to be fitted on the Insured Vehicle at the time of our inspection. The 18- inch alloy rims fitted on the Insured Vehicle were not the standard type for the Insured Vehicle.

32. Although the aftermarket 18- inch alloy rims and tyres fitted on the Insured Vehicle were not the standard type for the Insured Vehicle, we are of the view that these parts did not cause and/or contribute to the fire incident.
33. Our investigations had also revealed that at the time of writing this report, there is no manufacturer recall of electrical nature to similar make and model vehicle as the Insured Vehicle that may possibly be related to this incident.

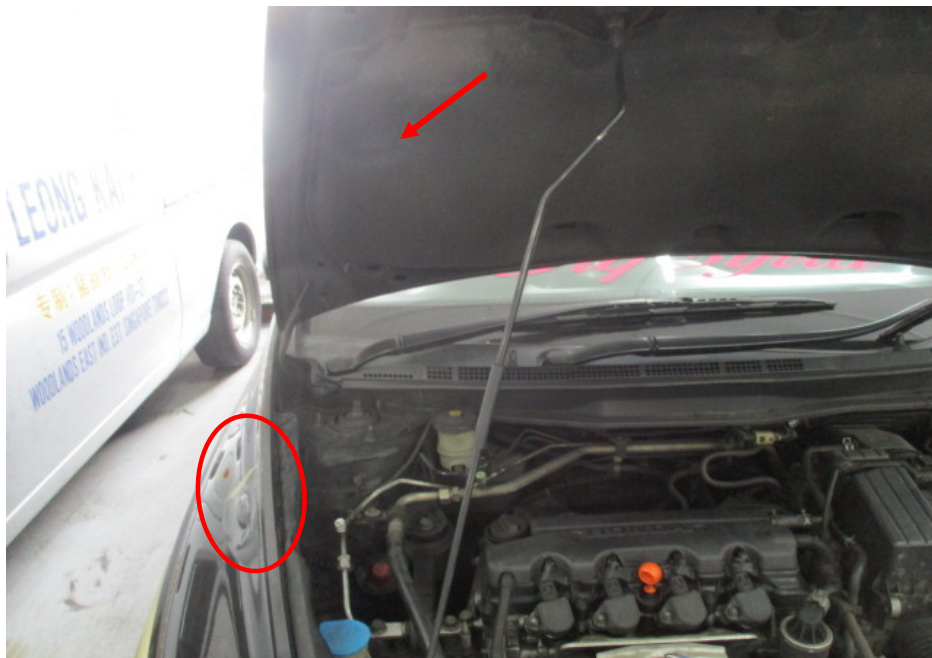
8. For this particular case, the fire appears to have originated within the engine compartment of the Insured Vehicle, somewhere around the right portion of the engine compartment. This can be determined from the cracks as well as discolouration found on the insulating material on the underside of the right portion of the bonnet due to prolonged exposure to high heat intensity. A closer examination revealed faint whitish burn marks on the underside of the right portion of the bonnet due to prolonged exposure to high heat intensity. We also observed paint bubbles on the right side panel. In general the location of the fires' origin was determined given that the damage of fire nature was confined to these particular areas on the Insured Vehicle. See photos 15 - 18 below.

**Photo 15** shows the cracks as well as discolouration found on the insulating material on the underside of the right portion of the bonnet (arrowed) due to prolonged exposure to high heat intensity. We also observed paint bubbles on the right side panel of the Insured Vehicle (circled).

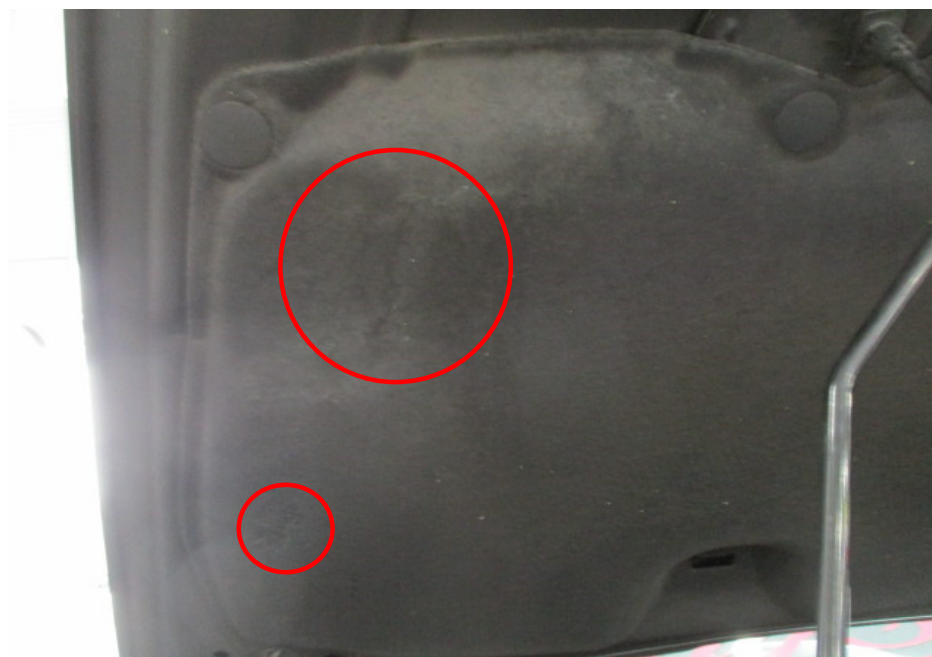
**Photo 16** shows a closer view of the cracks as well as discolouration found on the insulating material on the underside of the right portion of the bonnet of the Insured Vehicle (circled) due to prolonged exposure to high heat intensity.

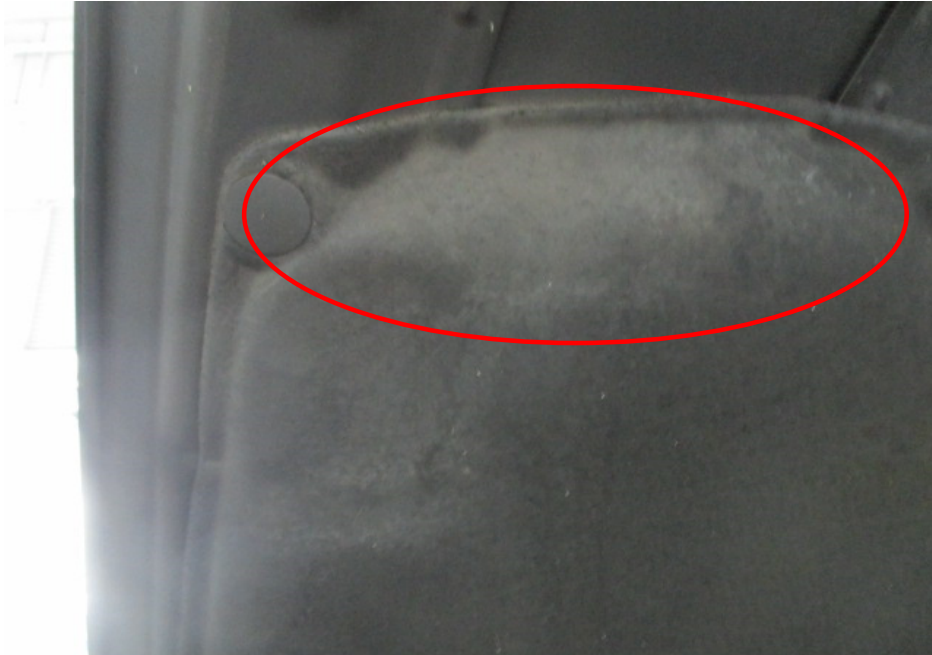
**Photo 17** shows faint whitish burn marks on the underside of the right portion of the bonnet (circled) of the Insured Vehicle due to prolonged exposure to high heat intensity upon our closer examination.

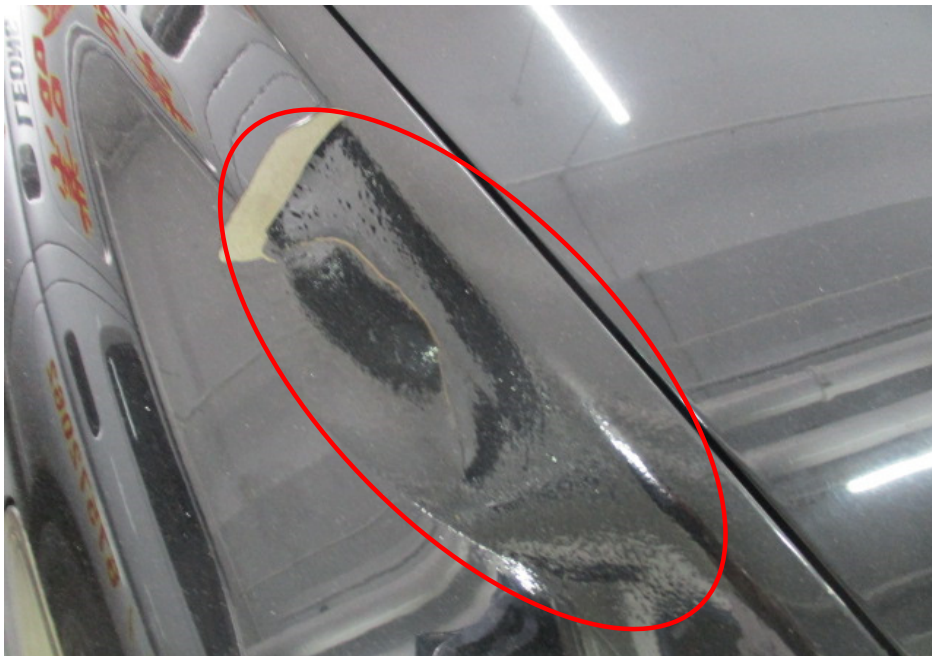
**Photo 18** shows paint bubbles on the right side panel of the Insured Vehicle (circled).

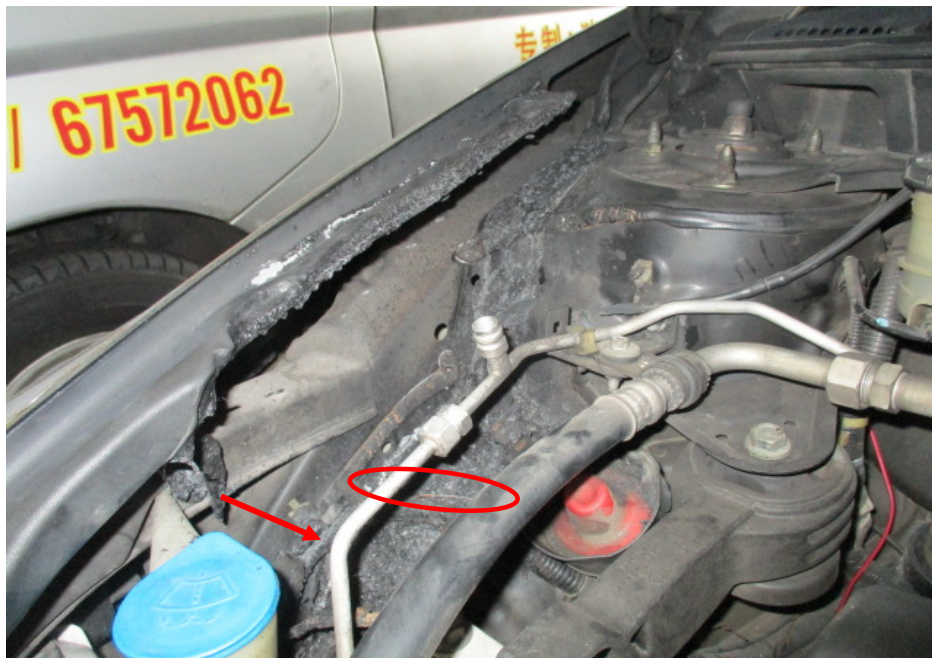
9. Upon closer examination of the right portion of the engine compartment, we found several stretches of burnt wirings from the wiring harness burnt to its bare copper state. We also noticed faint traces of greenish residue on the wirings leading from the vehicular alarm horn. The presence of such greenish residue indicates internal heating of copper wires, a sign of an electrical short circuit occurring. The greenish residue is normally left behind from oxidation as a result of chemical reaction involving the copper wires. These physical evidences would then appear to suggest that the cause of fire to the Insured Vehicle could have possibly been due to electrical in nature. See photos 19 - 21 below.

**Photo 19** shows the stretches of burnt wirings from the wiring harness (arrowed) as well as the wiring leading from the vehicular alarm horn (circled). We noticed faint traces of greenish residue on some of these wirings.

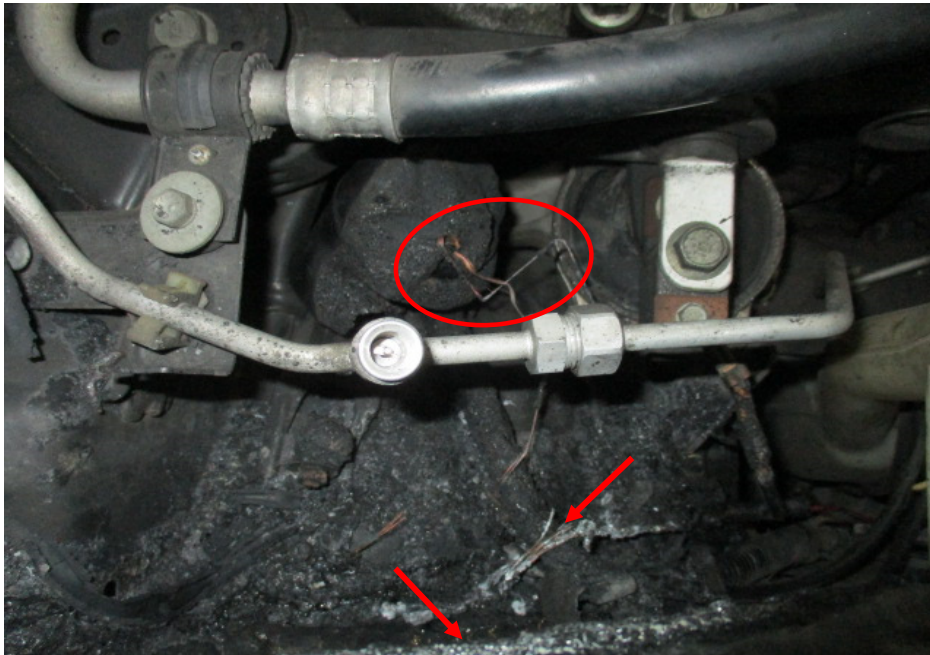
**Photo 20** shows a closer view of the stretches of burnt wirings from the wiring harness (arrowed) as well as the wiring leading from the vehicular alarm horn (circled). We noticed faint traces of greenish residue on some of these wirings. The presence of such greenish residue suggests occurrence of an electrical short circuit.

26. The possibility of the fire being due to electrical in nature would then seem more likely given that engine overheating and external factors would both seem unlikely. The fire being due to electrical nature is also supported by the faint traces of greenish residue that was found on the wirings of the Insured Vehicle, which was earlier discussed in paragraph 9 above.

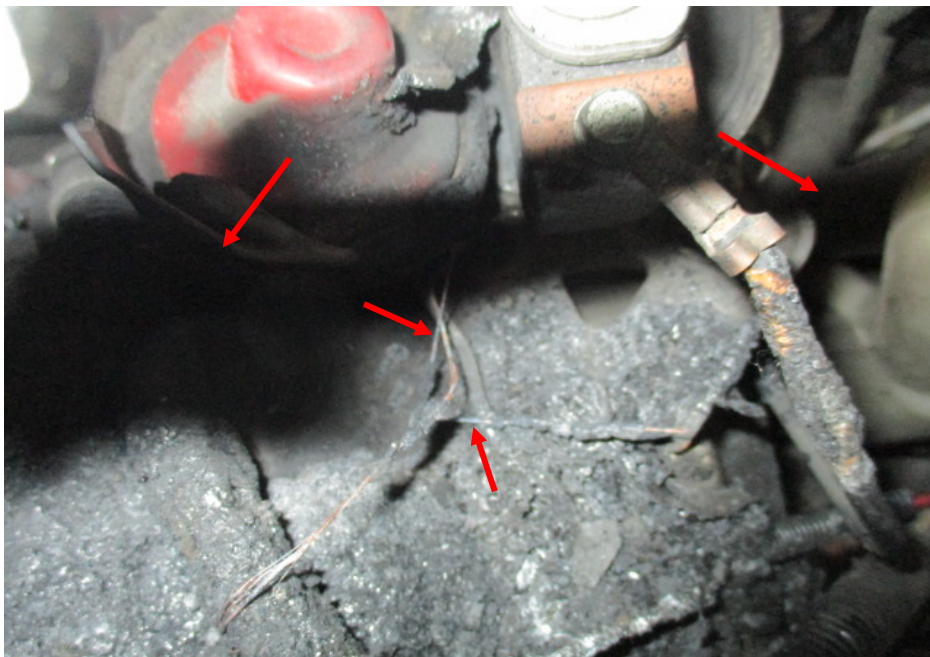
**Photo 21** shows a close up view of the greenish residue on several stretches of wiring leading from the vehicular alarm horn (arrowed). The presence of such greenish residue suggests occurrence of an electrical short circuit.

28. Having investigated and technically analysed the damages of burnt nature to the Insured Vehicle, we are of the view that the cause of fire to the Insured Vehicle was of electrical in nature. For this particular case, the fire had originated along the wirings inside the engine compartment, somewhere underneath the right portion. These wirings were original factory wirings leading from the wiring harness of the Insured Vehicle.

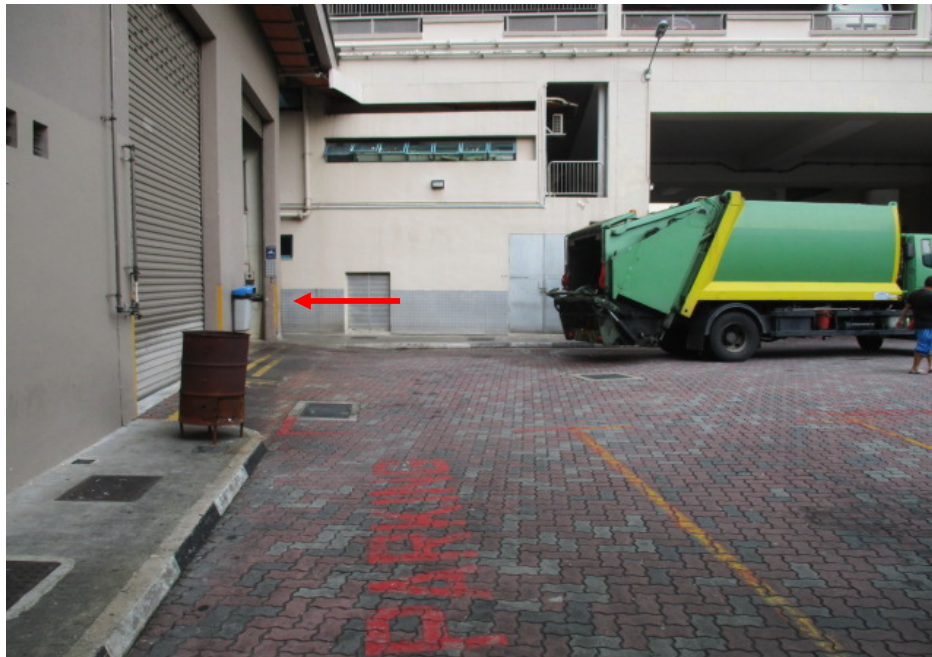
**Photo 22** shows the loading/unloading bay of Vista Point Shopping Centre. The Insured Vehicle was positioned adjacent to the rubbish collection centre (arrowed) when the incident occurred.

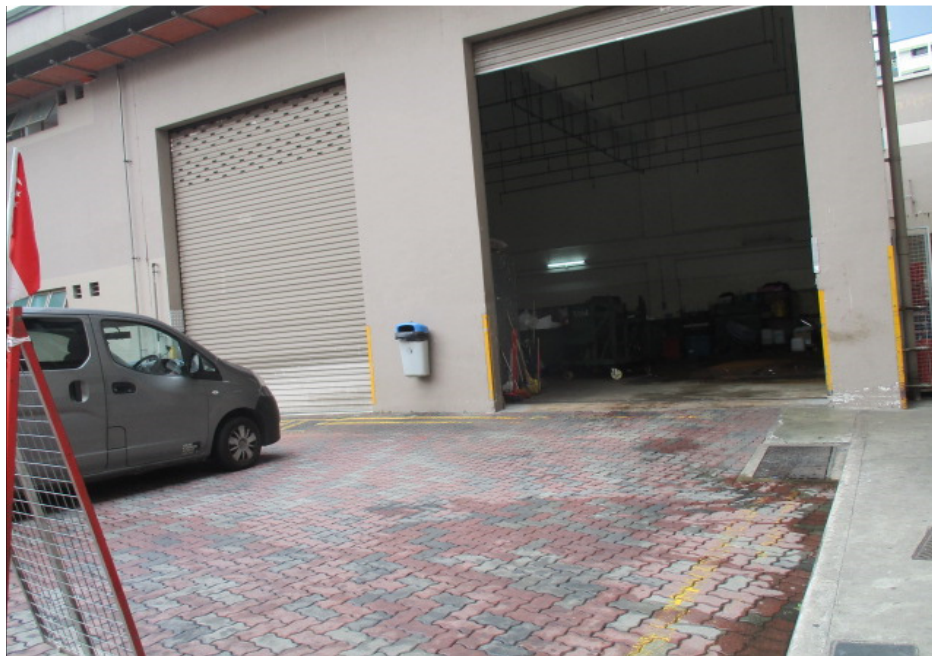
**Photo 23** shows the rubbish collection centre where Mr Kasim's son-in-law grabbed the water hose from. The rubbish collection centre was in operation at the time of our visit but we were not allowed entry into the premises by the staff for security reasons.

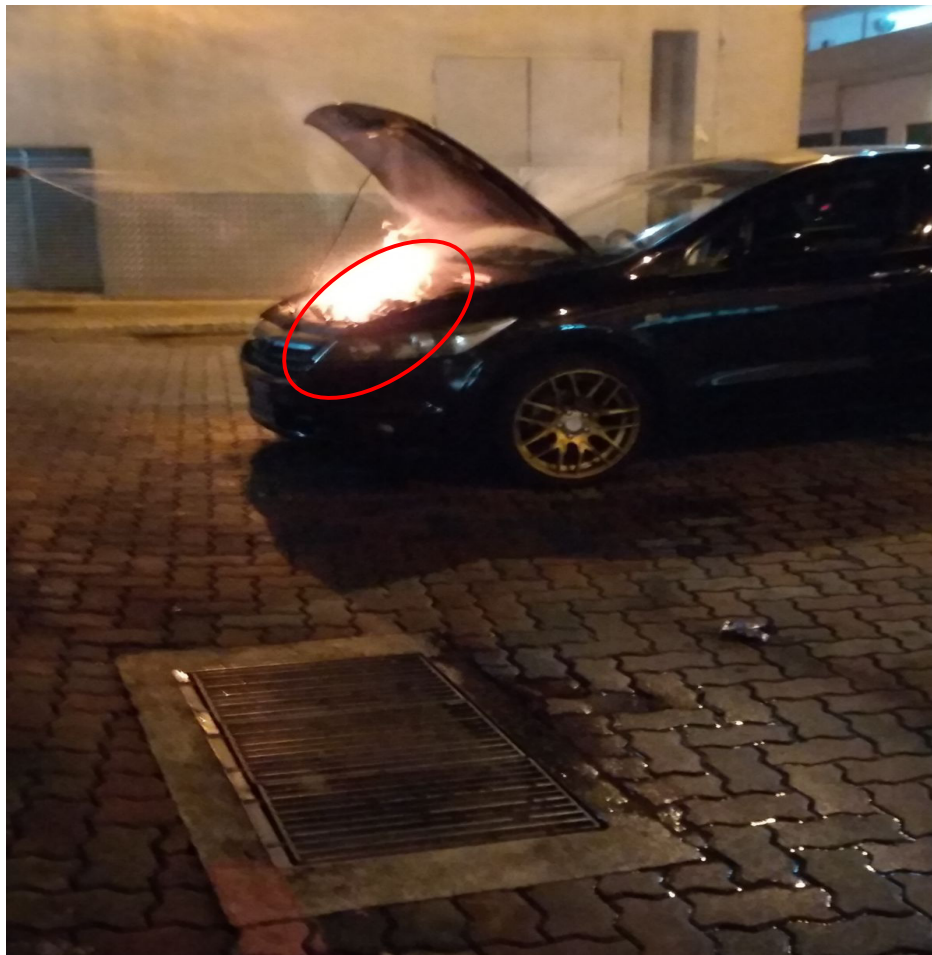
**Photo 24** shows the Insured Vehicle when the fire got bigger after Mr Kasim opened the front bonnet. In general, the information that could be gathered from this photograph had corresponded to the events that were related to us by Mr Kasim, which is he saw flames emitting from the right portion of the Insured Vehicle's front bonnet after he had dropped off his son-in-law and grandchildren near the loading/unloading bay.

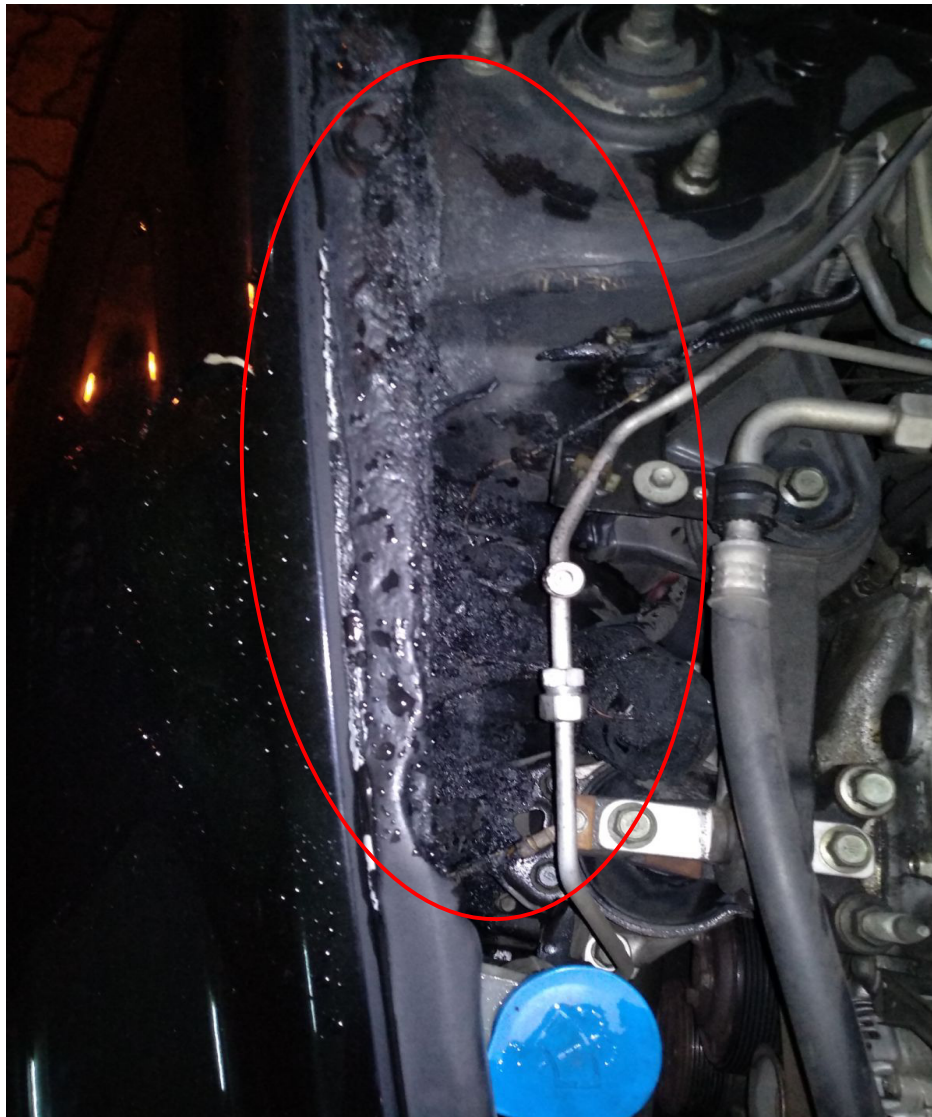
**Photo 25** shows the Insured Vehicle after the fire was put out. In general, the information that could be gathered from this photograph had corresponded to the events that were related to us by Mr Kasim, which is the fire started from the right portion of the engine compartment of the Insured Vehicle (circled).
