Your Ref : GA219427
Our Ref : CS/ASM18007192/Z

19th April 2018

TECHNICAL INVESTIGATION REPORT OF FIRE INCIDENT INVOLVING THE INSURED VEHICLE SGV 4954Y ON 20th March 2018

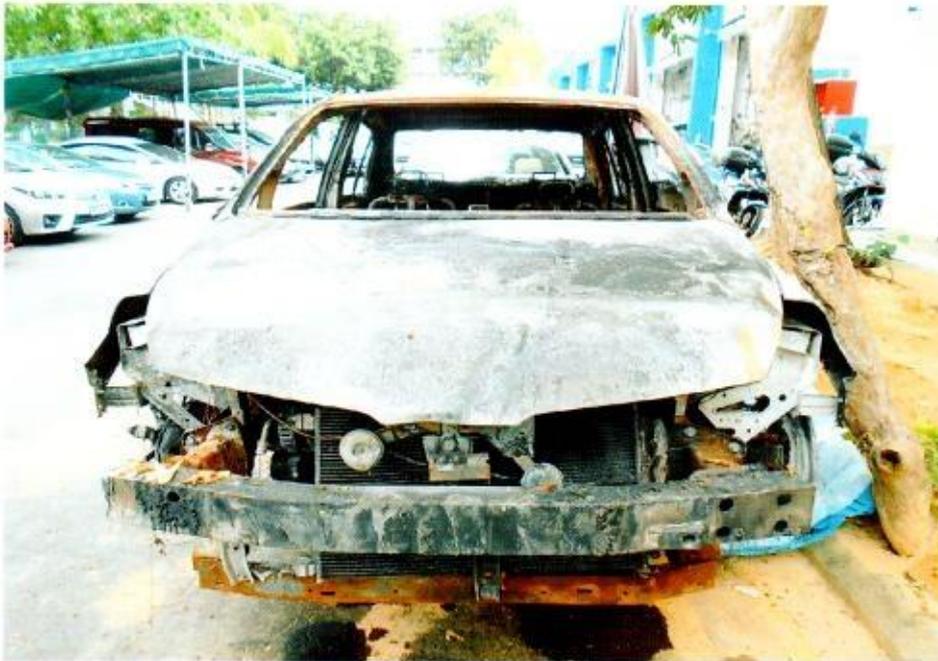
Photo 1 shows the general view of the front right portion of the Insured Vehicle at the time of our inspection. A severe burnt damage to the Insured Vehicle was observed as a result of the fire.

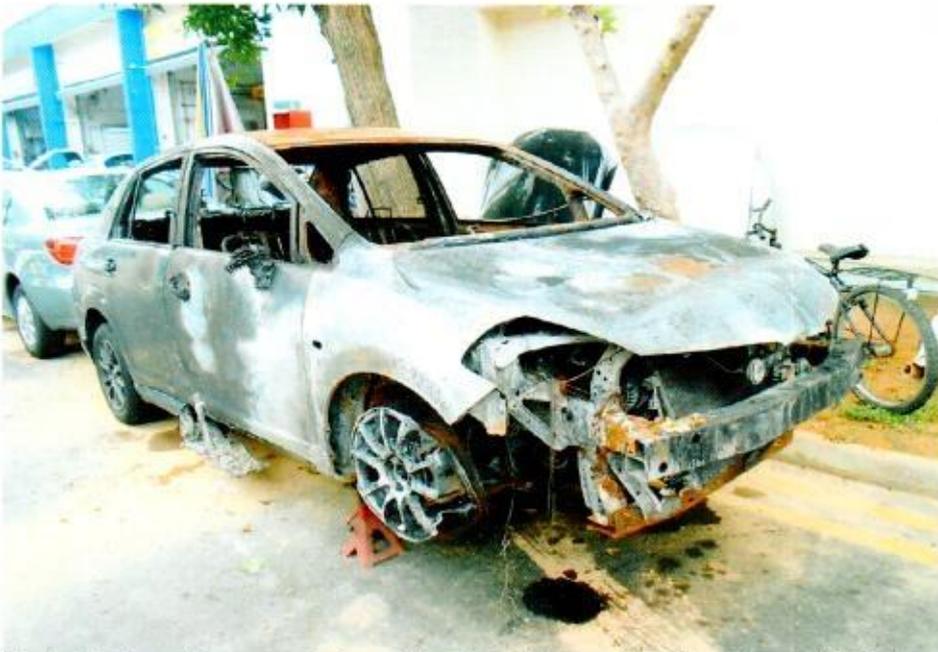
Photo 2 shows the general view of the front right portion of the Insured Vehicle at the time of our inspection. A severe burnt damage to the Insured Vehicle was observed as a result of the fire.

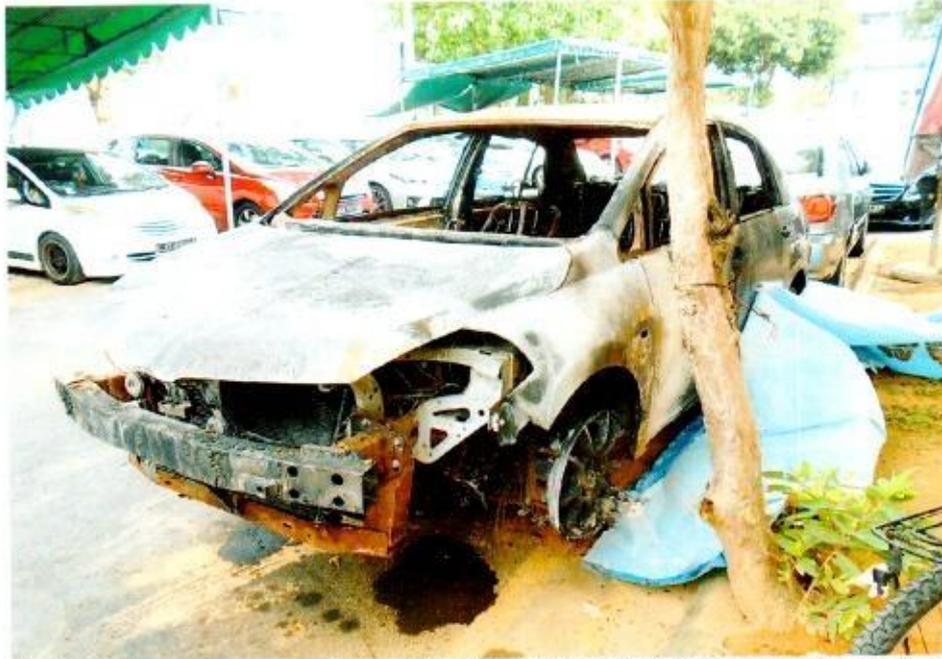
Photo 3 shows the general view of the front left portion of the Insured Vehicle at the time of our inspection. A severe burnt damage to the Insured Vehicle was observed as a result of the fire.

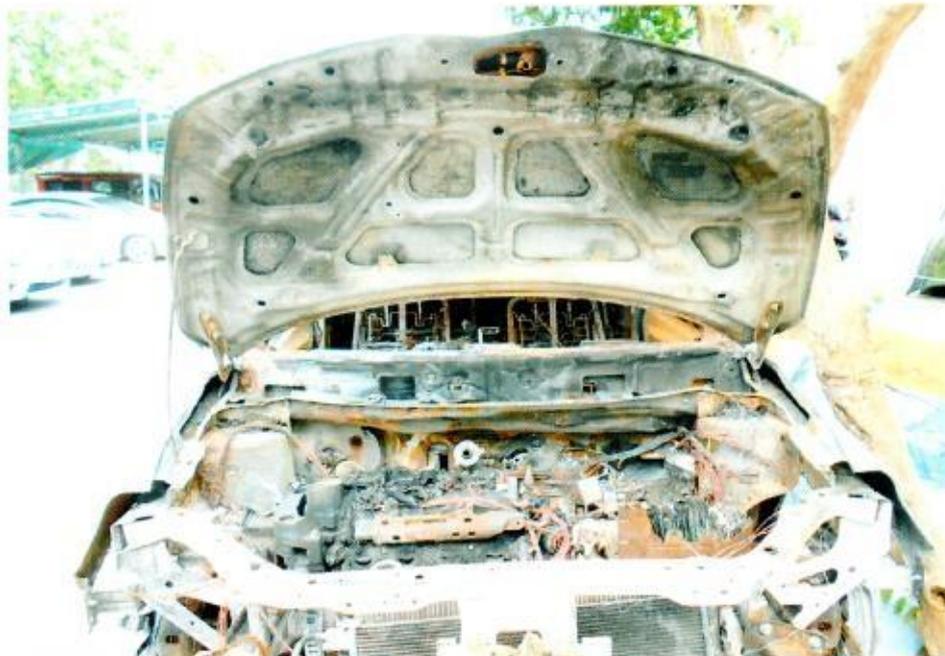
Photo 4 shows the engine compartment of the Insured Vehicle at the time of our inspection. The entire engine compartment of the Insured Vehicle was observed to be severely burnt. Most of the parts inside the engine compartment were found to be burnt and/or melted as a result of the fire.

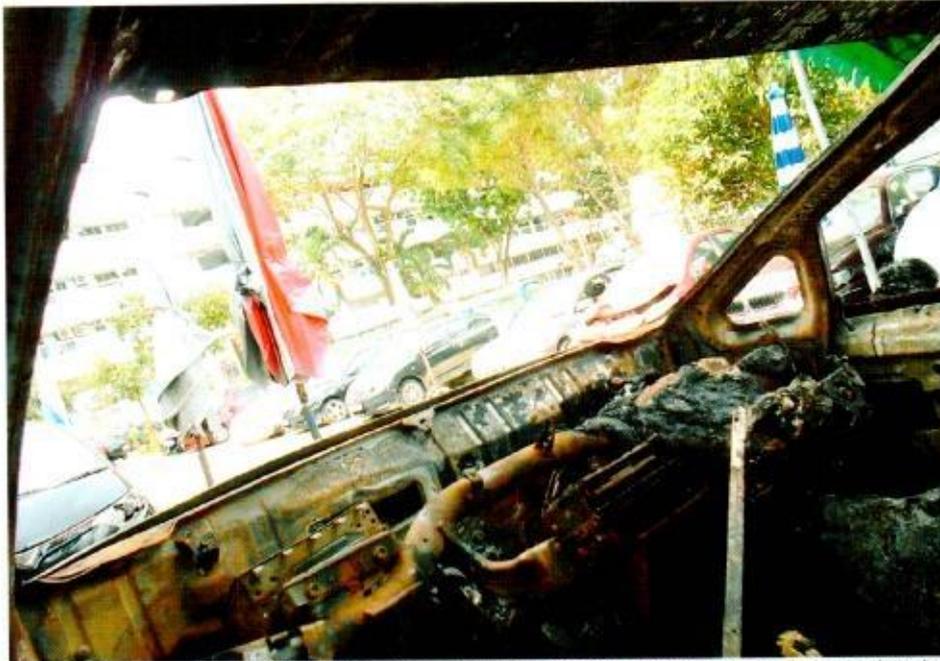
Photo 5 shows the windshield of the Insured Vehicle, which was observed to be shattered were amongst the parts that were found to have been damaged as a result of the fire.

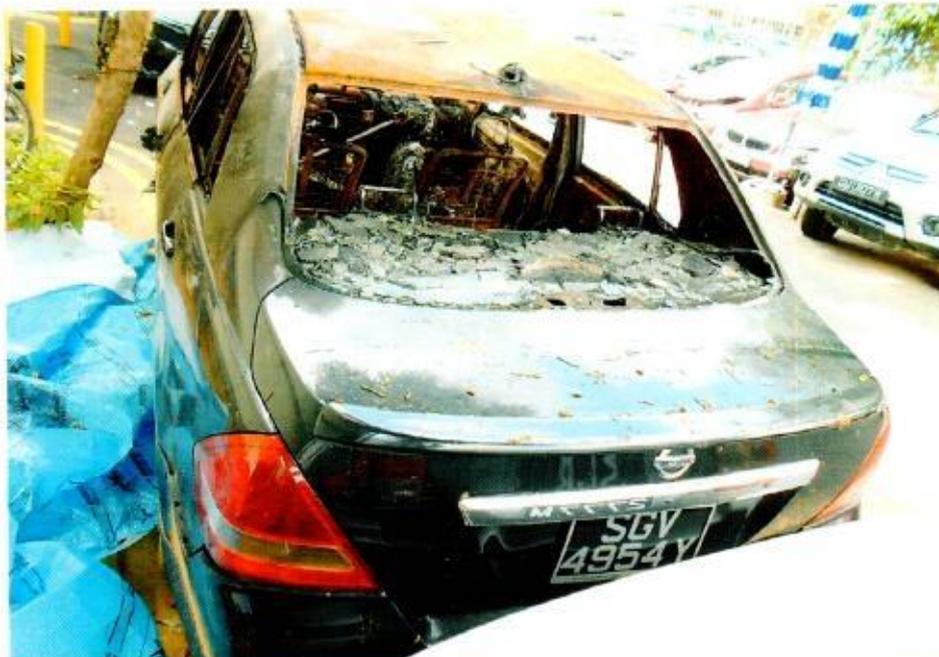
Photo 6 shows the rear windscreen of the Insured Vehicle, which was observed to be shattered were amongst the parts that were found to have been damaged as a result of the fire.

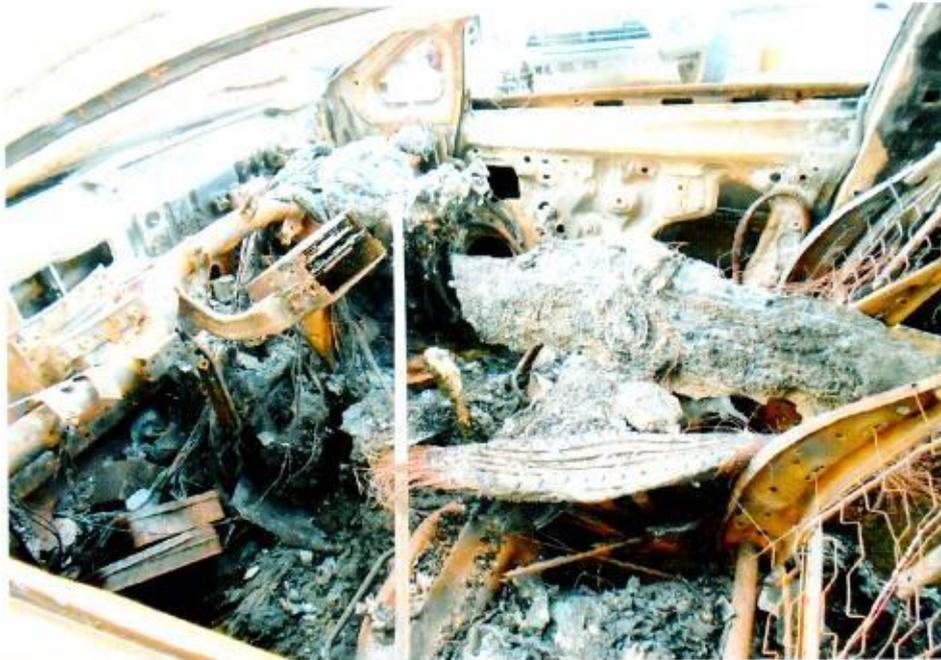
Photo 7 shows the interior of the Insured Vehicle, which was observed to be severely burnt were amongst the parts that were found to have been damaged as a result of the fire.

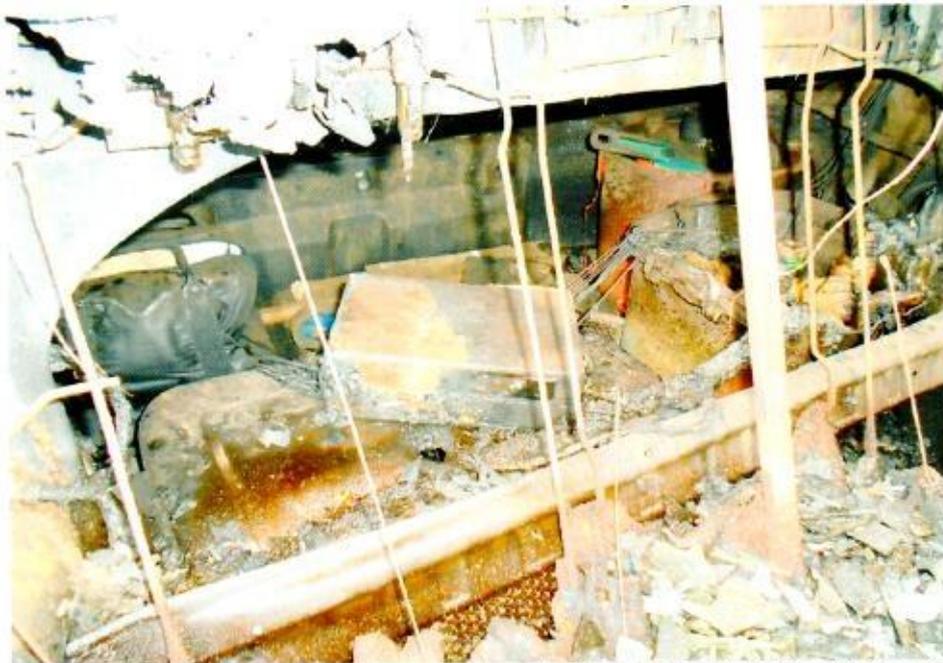
Photo 8 shows the rear bonnet compartment of the Insured Vehicle, which was observed to be severely burnt were amongst the parts that were found to have been damaged as a result of the fire.

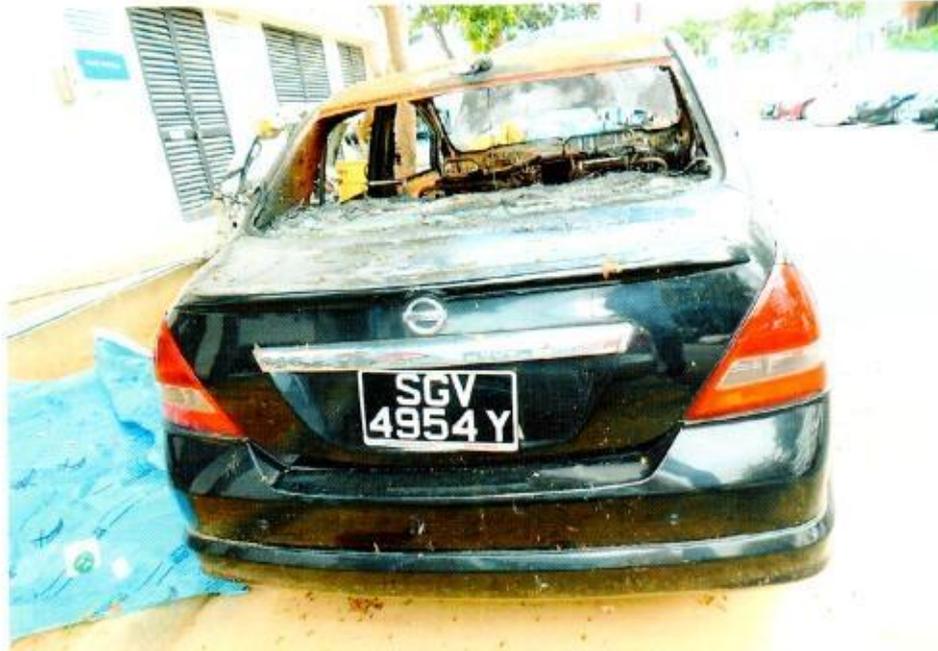
Photo 9 shows the rear portion of the Insured Vehicle, which was observed to be unaffected by the fire.

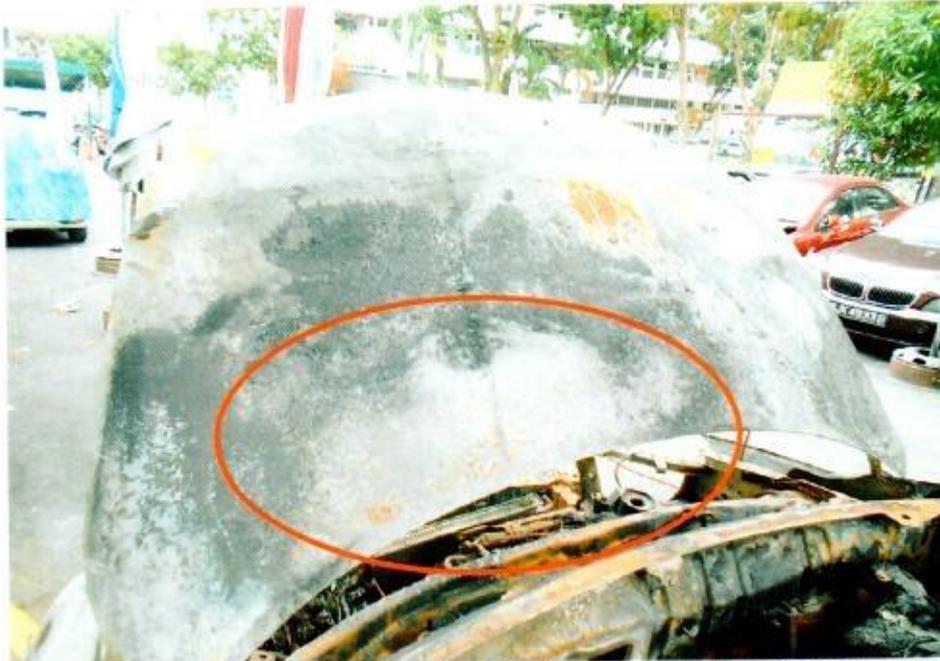
8. For this particular case, the fire appears to have originated within the engine compartment of the Insured Vehicle, somewhere around the centre and towards the rear of the engine compartment. This can be determined from the burn pattern and the high heat intensity burn marks (whitish burn marks) found on the front bonnet of the Insured Vehicle, at both its top and under side.
9. These whitish burn marks are a result of exposure to prolonged heat intensity. Rust would normally start to develop around these areas soon after a fire as prolonged exposure to high heat intensity usually causes steel/metal material body parts to be exposed to natural environmental condition. See photo 10 & 11 below.

Photo 10 shows the burn pattern and whitish burn marks that were found on the top side of the front bonnet of the Insured Vehicle. Such whitish burn marks are a result of exposure to prolong heat intensity, which may indicate where the fire had started. Rust would also begin to develop on these areas soon after the fire.

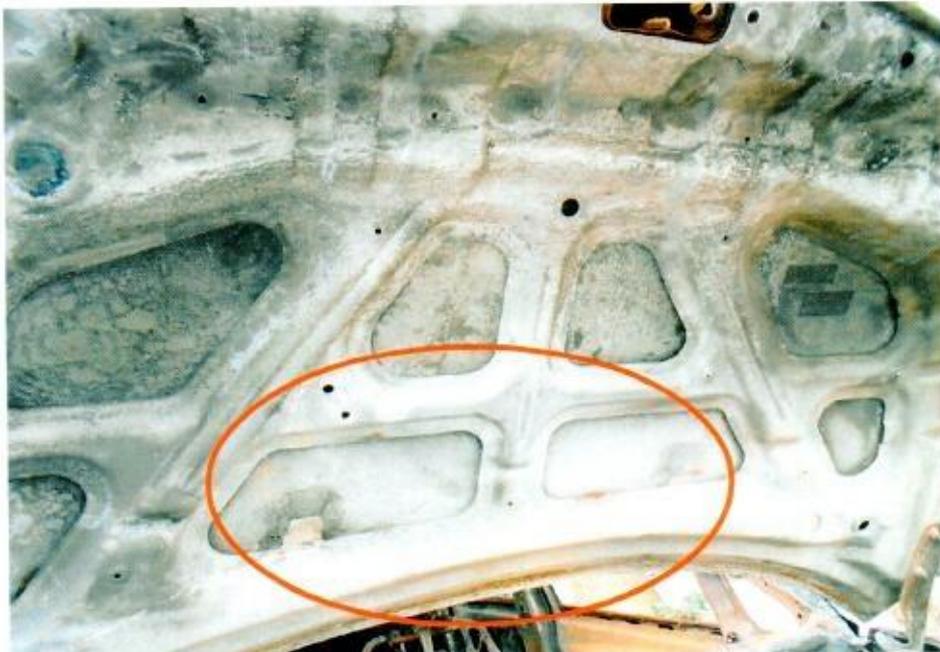
Photo 11 shows the whitish burn marks that were found on the underside of the front bonnet, directly under the area where the same whitish burn marks were found on the top side of the front bonnet.

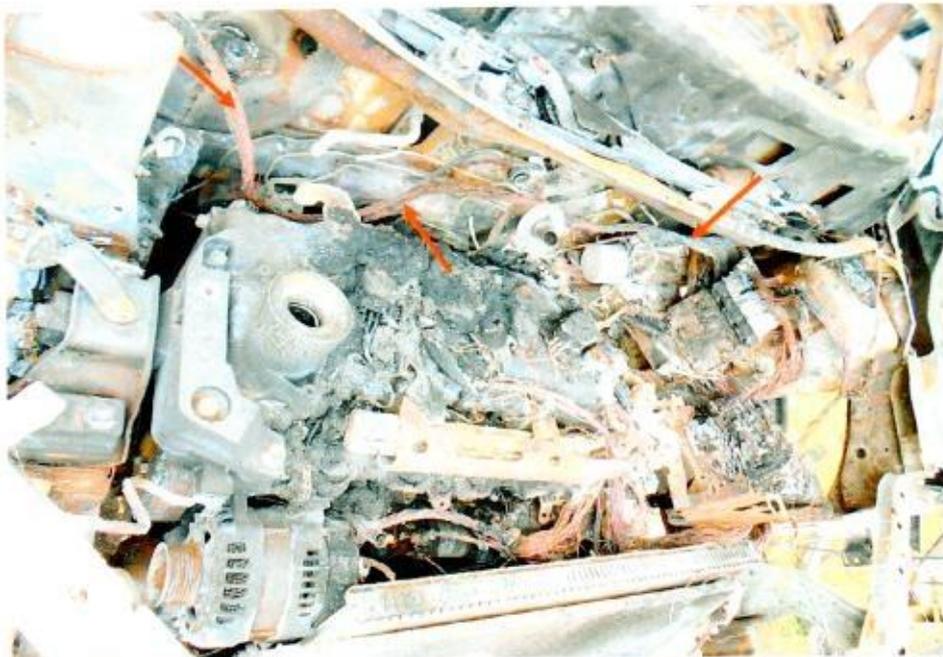
10. Upon closer examination of the area around the rear of the engine compartment, which was in the immediate vicinity of where the fire to the Insured Vehicle had likely started, we had found several stretches of wiring burnt internally to its bare copper state. The wirings of the Insured Vehicle and are likely to be the original engine wire harness. Such condition normally indicate internal heating of copper wires which is a sign of an electrical short circuit occurring. This would then appear to suggest that the cause of fire to the Insured Vehicle could have possibly been due to electrical in nature. See photo 12 - 13 below.

Photo 12 shows the wirings around the rear of the engine compartment, which was in the immediate vicinity where the fire to the Insured Vehicle had likely started. The wirings (red arrow) were found to have been burnt internally, suggesting occurrence of an electrical short circuit. The wirings also appear to be an original engine wire harness of the insured vehicle.

30. Having investigated and technically analysed the damages of burnt nature to the Insured Vehicle, we are of the view that the cause of fire to the Insured Vehicle was of electrical in nature. For this particular case, the fire had originated along the wiring inside the engine compartment, somewhere around the left rear of the engine compartment. The wiring was an original factory fitted on the Insured Vehicle.

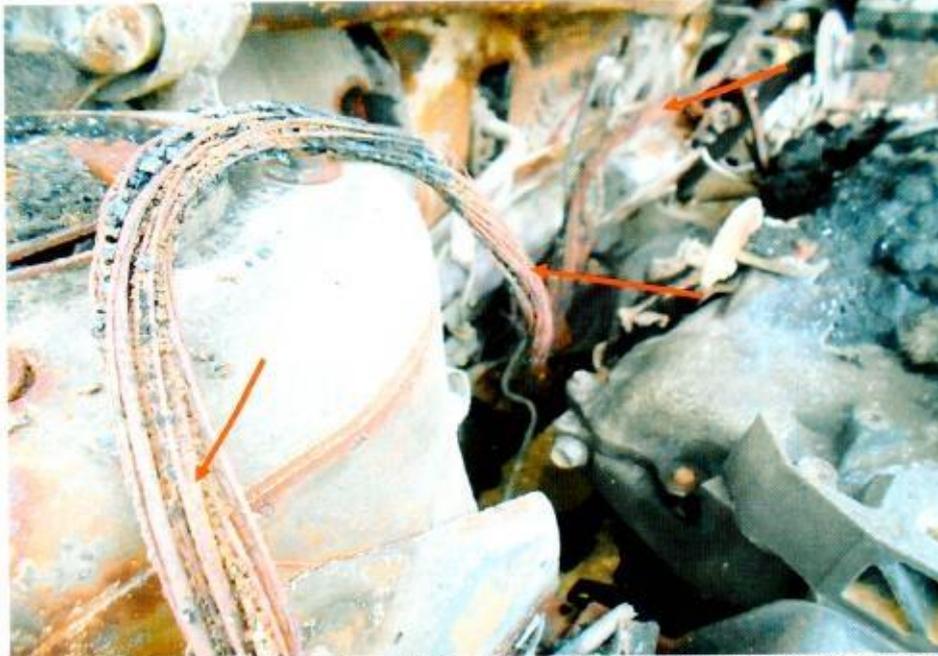
Photo 13 shows a closer view of the wirings (red arrow) which were found to have been burnt internally, suggesting occurrence of an electrical short circuit.

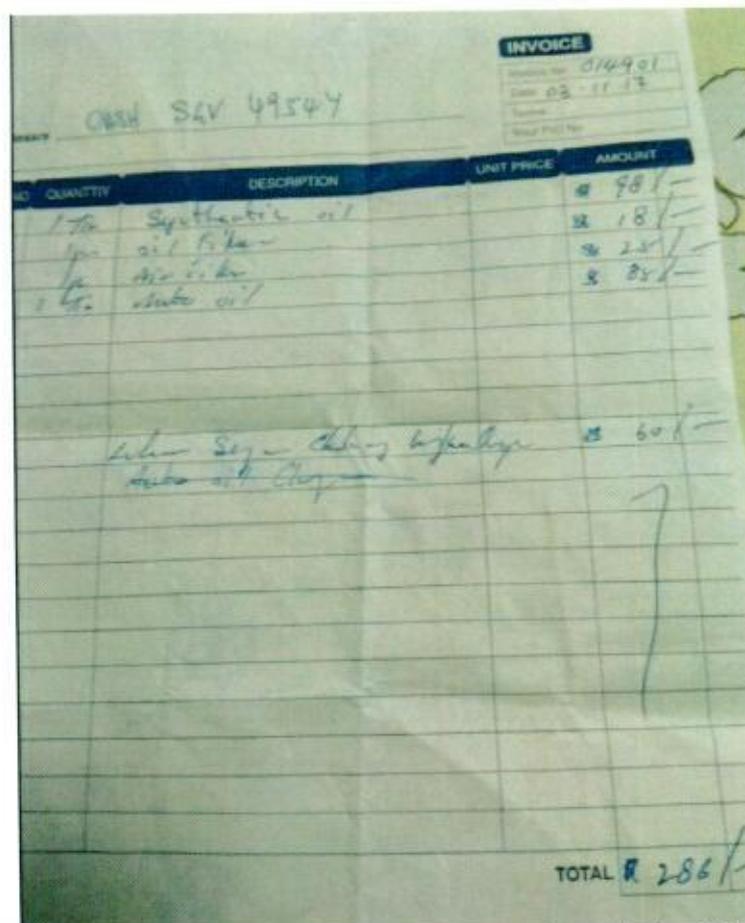
19. Regarding on the maintenance aspect, Mr Leong informed me that the last servicing carried out on the Insured Vehicle was on 03rd November 2017 at his regular workshop. He was able to provide me with a document relating to this servicing. Our review of this document revealed that the engine oil, oil filter, air filter & Auto Transmission Oil were replaced during this servicing. See document photo below relating to this servicing which was provided to me by Mr Leong. See photo 14.

Photo 14 shows a preventive maintenance record provided by Mr Leong.

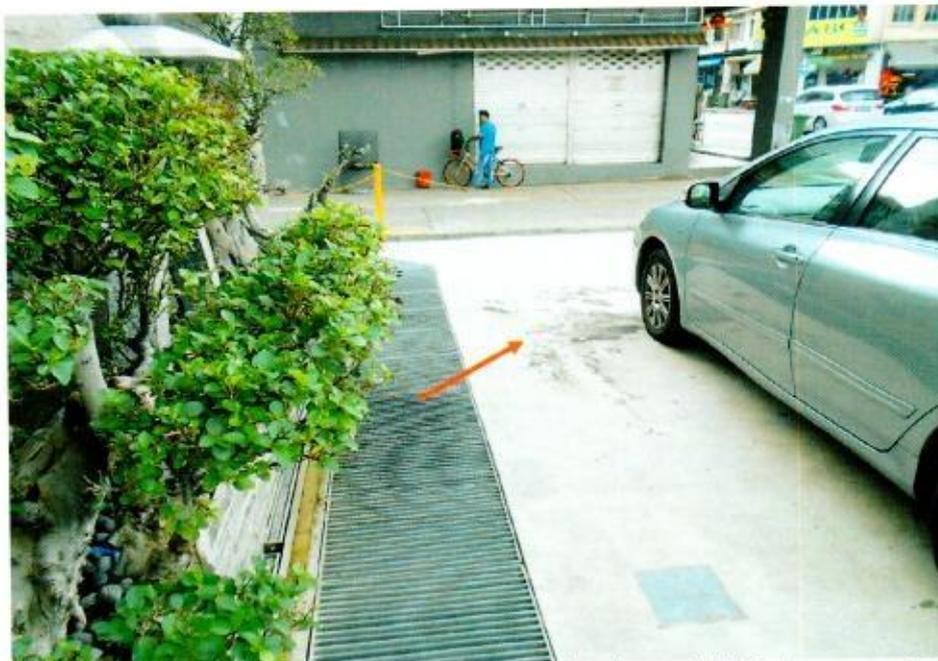
Photo 17 shows the general view of where the Insured Vehicle was parked (arrowed) at the time of incident. This was on the left side upon entering the private open car park.

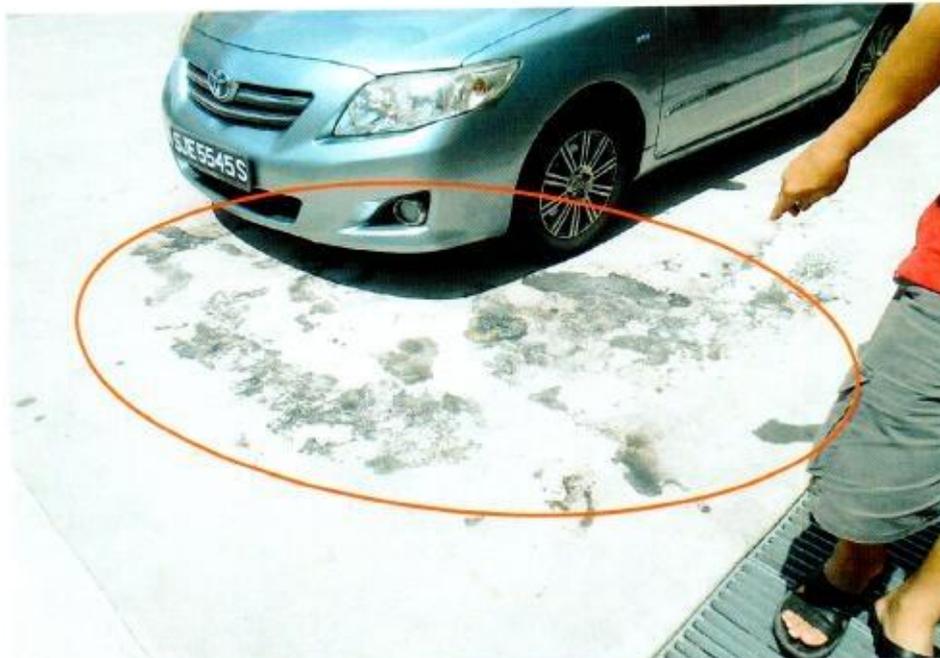
Photo 18 shows the close-up view of where the Insured Vehicle was parked at the time of incident. Further observations on the ground, we found burnt marks/ burnt residual on the cemented parking space. This reveals that there's evidence that fire incident happen at the said spot.

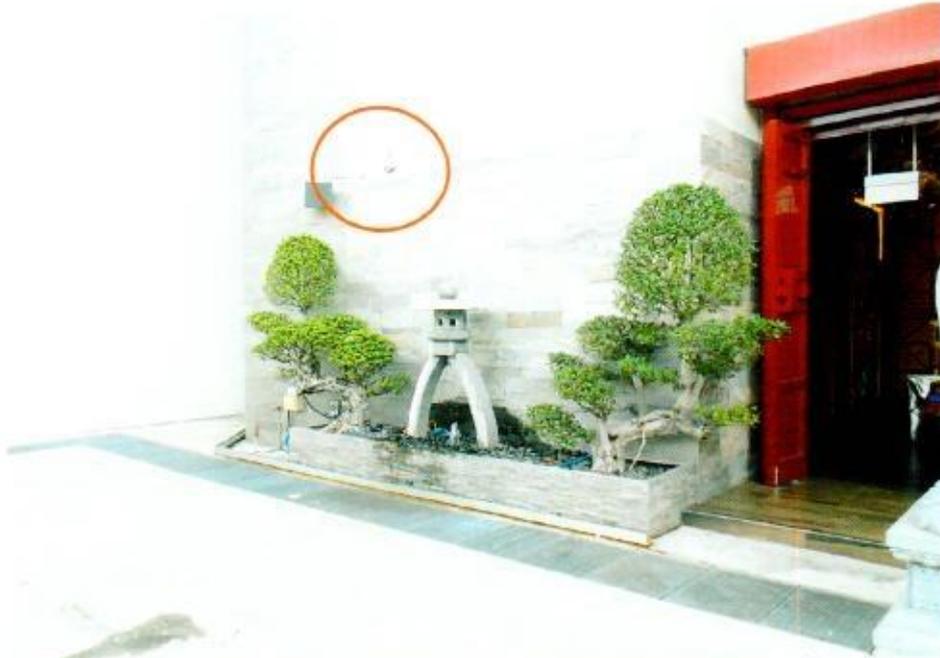
Photo 19 shows the installed CCTV was pointing to the direction of the Insured Vehicle at time of the fire incident.

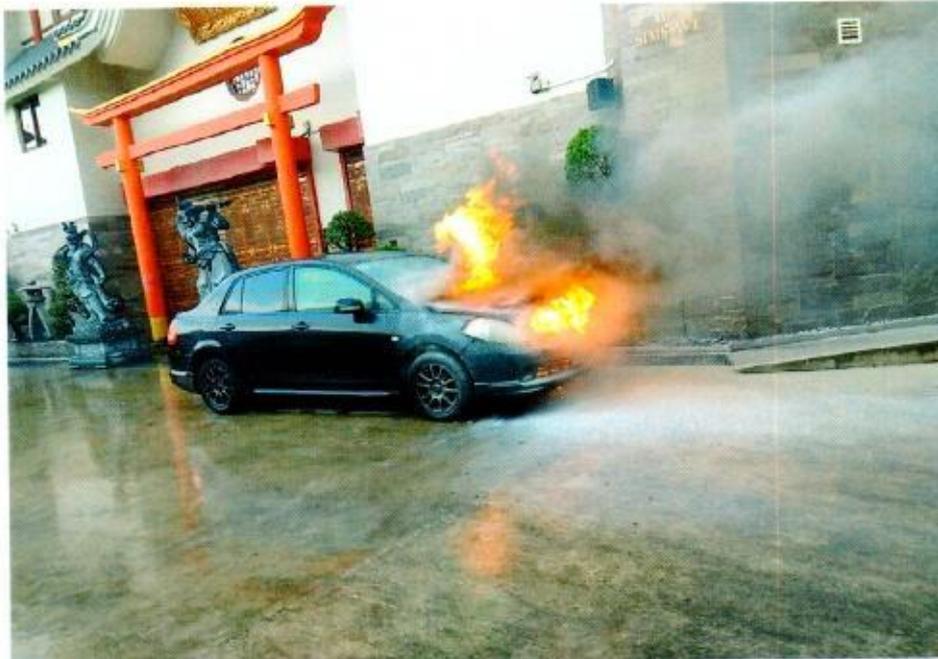
Photo 20 shows the Insured Vehicle at the incident scene. These photograph was taken before the arrival of SCDF fire fighters. Mr Leong tried to extinguish the fire with a fire extinguisher but failed.

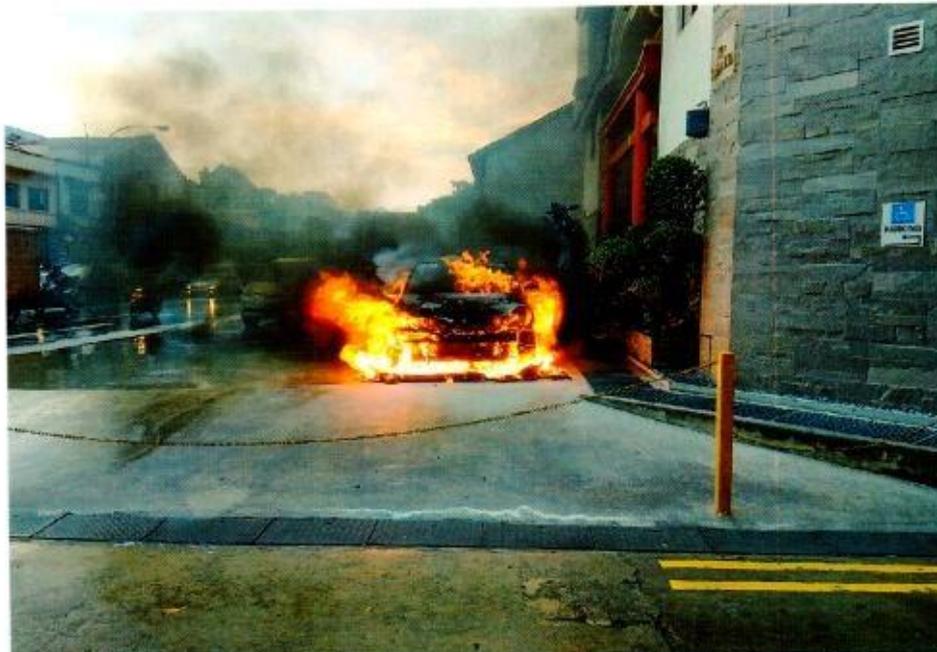
Photo 21 shows the Insured Vehicle at the incident scene. These photograph was taken before the arrival of SCDF fire fighters. Mr Leong tried to extinguish the fire with a fire extinguisher but failed hence it was engulf with fire.

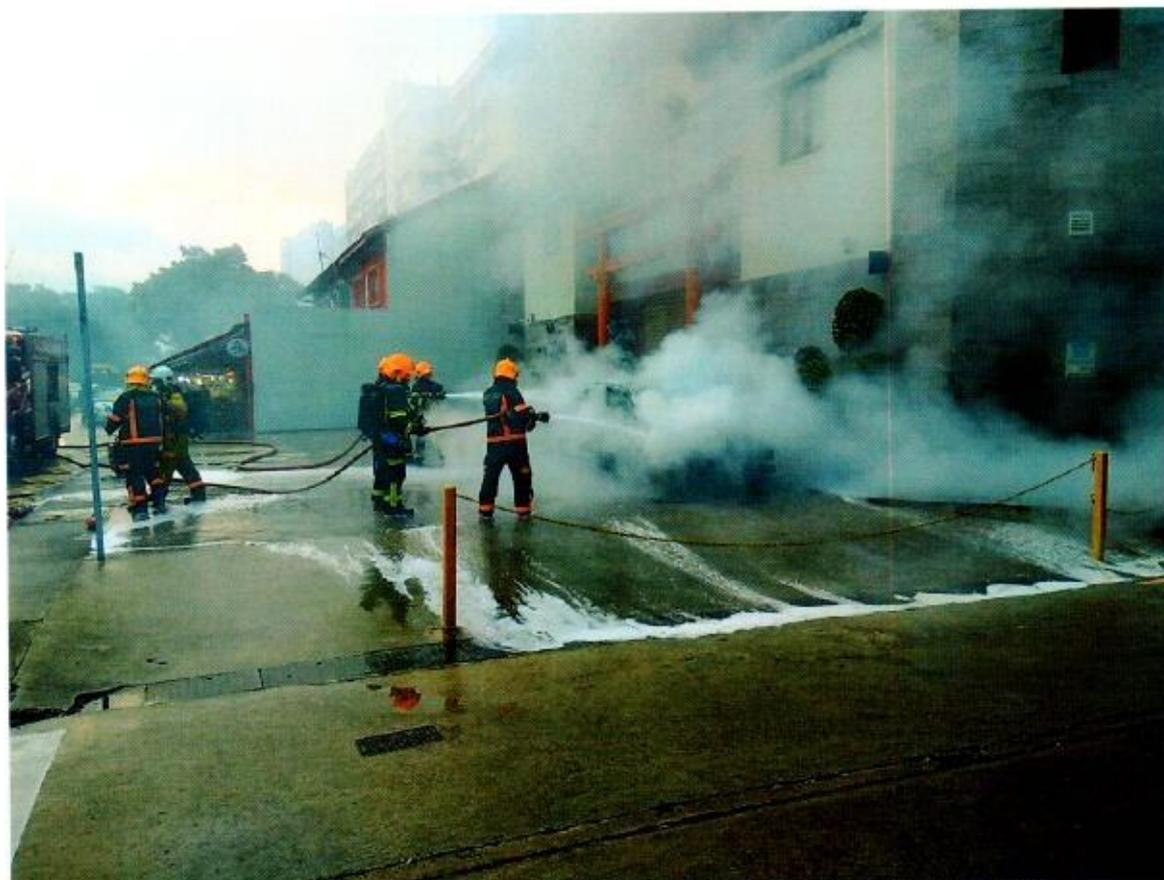
Photo 22 shows the general view of the fire fighter while in the process of extinguishing the fire.
