## **DAMAGED VEHICLE (SJP 2050 P) INSPECTION REPORT (WITHOUT PREJUDICE)**

## ASSESSMENT OF REPAIRS AND SPARE PARTS COSTS FOR VEHICLE NO : SJP 2050 P

Insured Veh.	SJM 9169B	Veh. Inspected	SJP 2050P
Policy No.		Coverage (\$)	0.00
Claim No.	18/18/18/VP05/020496	Excess (\$)	0.00
Assign From	ONG LI LI	Assign Date	19/04/2018

## ADJUSTMENT ON REPAIR COST FOR VEHICLE NO. SJP 2050P

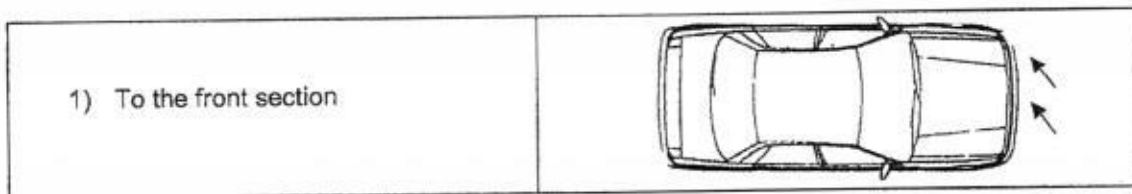
**(E) Point of Impact**

The impact of the collision has damaged/affected the front bumper, front bumper reinforcement, front grille and etc.

Our adjusted cost of lump sum repair is \$3,400.00 and an estimated 4 days is required to repair the vehicle. Please refer to the Annex for a detailed account of the cost estimates.
