SUPPLEMENTARY COST OF REPAIRS TO AUDI A4 SLF1227H

## VEHICLE DAMAGE INSPECTION REPORT

Our File No: CS/MSG18007365/KRBE2

Handling Insurer: MSIG Insurance (Singapore) Pte. Ltd.	Policy No: A80310530QMY
Claimant Vehicle No: SLF1227H	Insured Vehicle No: SCJ8685H
Date of Loss: 19/04/2018	Nature of Claim: TP Claim No: 556123

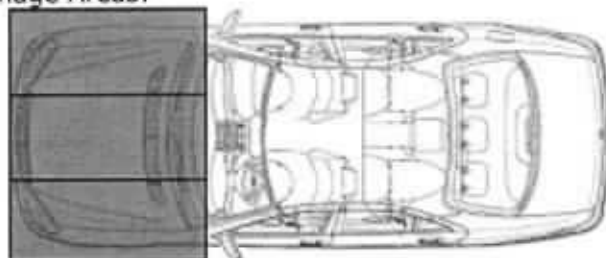
## Damage Areas:

Veh No: SLF 1227H Yr Regn: 04 / 11  
 Type: C M.Cycle / Bus / Van / Lorry / Taxi / Prime Mover /  
 Truck / Trailer or  
 Make: Audi A4 C.C. 1798  
 Colour: M. Gray A/C. Insured / Std / NI / NA  
 Sp. Reading: 105810 T/Radio: Insured / Std / NI / NA  
 Eng/No:  
 C/No: WAUZZZ8K 2BA076157  
 Gen. Cond: Good / Fair / Poor / Burnt  
 Steering: In order / Jammed / Leaked / Burnt or  
 Brake: In order / Jammed / Leaked / Burnt or  
 Modi: Nil / S/Rim / STD A/Rim or  
 Tyre Size F: 245/35ZR19  
 R:  
 BS / DUN / EXNOVA / GY / FS / LIZA / MIC / OHTSU / PIR / SUMI /  
 TOYO / YOKO or Falken  
 Front: 7 mm R/Bal. 8 mm  
 L/Bal. 7 mm L/Bal. 8 mm  
 D.O.A. 19/4/18 D.O.I. 20/4/18  
 Survey held at ✓  
 Des. of Damages: Frt / Rear / O/S / N/S / U/C / Rooftop or  
o/s A & U/C  
 The U/C / Chassis frame / Body Structure affected due to collision

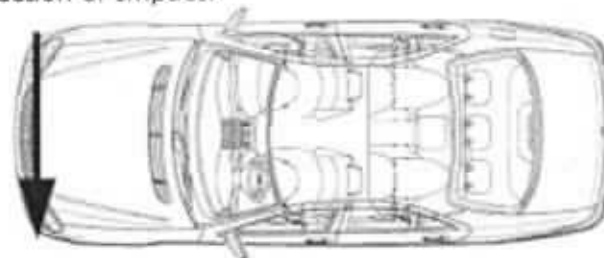
## Direction of Impact:

Primary Impact  
Secondary Impact
