Your Ref: G0047390
Our Ref :CS/AVI18007515/D

30 April 2018

**TECHNICAL INVESTIGATION REPORT OF FIRE INCIDENT INVOLVING THE
INSURED VEHICLE SJY 7990X ON 15 MARCH 2018**

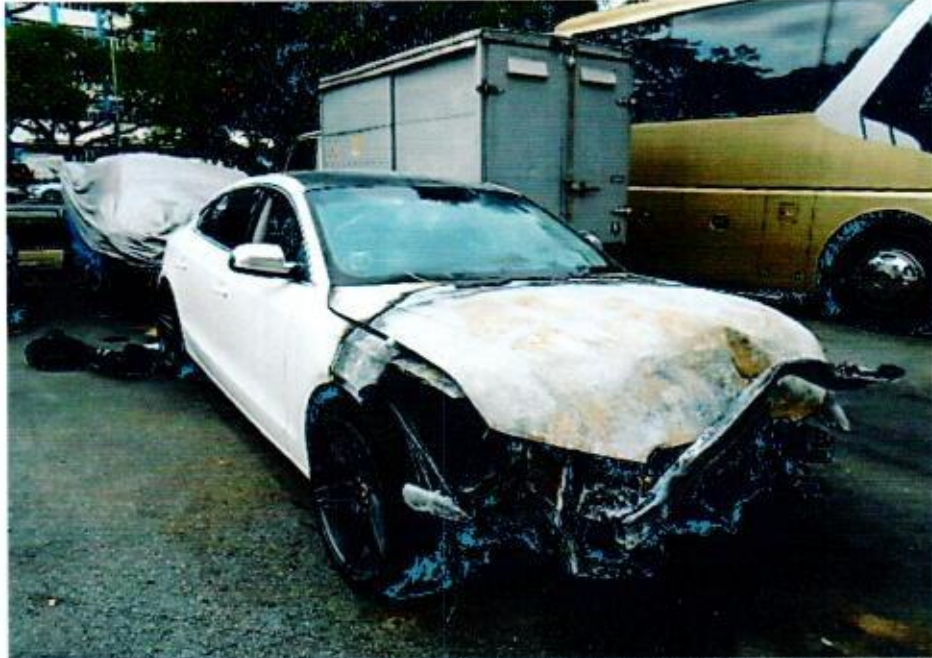
4. The Insured Vehicle was observed to have sustained extensive fire damage that was confined to its frontal portion. Its front bumper, front bonnet, front headlamps, front fenders and front windscreen were amongst the body parts that were severely burnt.

Photo 1 shows a general view of the front right body of the Insured Vehicle at the time of my inspection. The Insured Vehicle was observed to have sustained extensive fire damage at its frontal portion. Its front bumper, front bonnet, front right headlamp and front right fender were amongst the body parts that were observed to have been burnt.

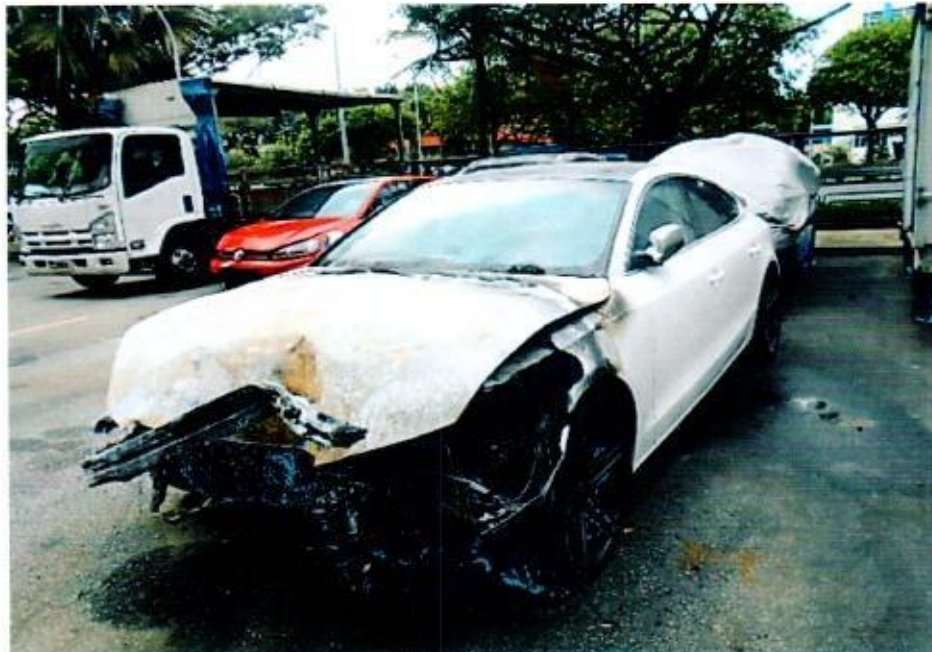
Photo 2 shows a general view of the front left body of the Insured Vehicle. The damage of fire nature was confined to the frontal portion of the Insured Vehicle. Its front bumper, front bonnet, front left headlamp, front left fender and front windscreen were amongst the body parts that were observed to have been burnt.

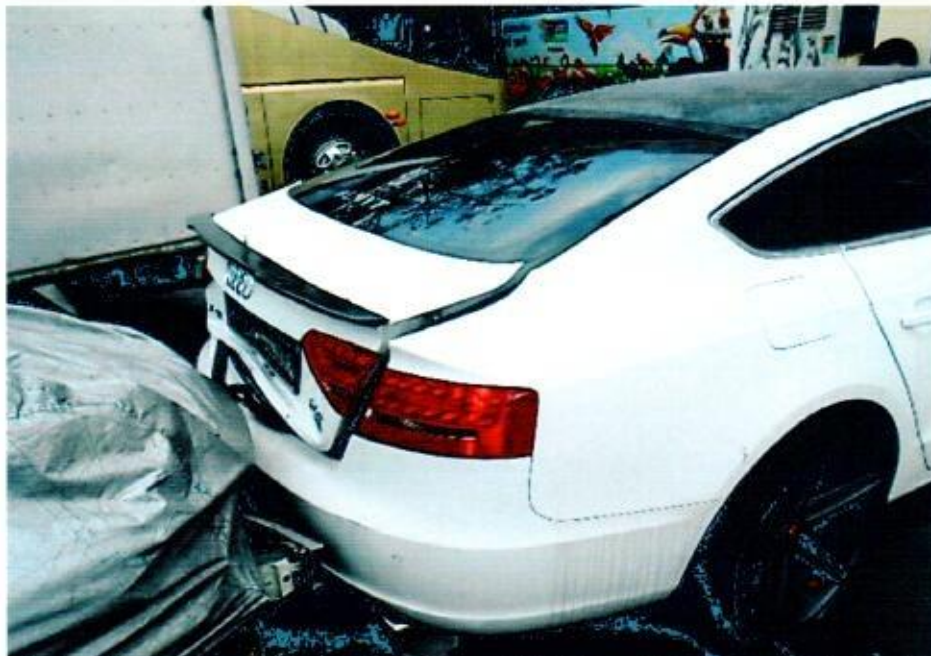
Photo 3 shows the rear body of the Insured Vehicle, which was unaffected by the fire. Its rear tailgate was however observed to be dented due to rescue operation.

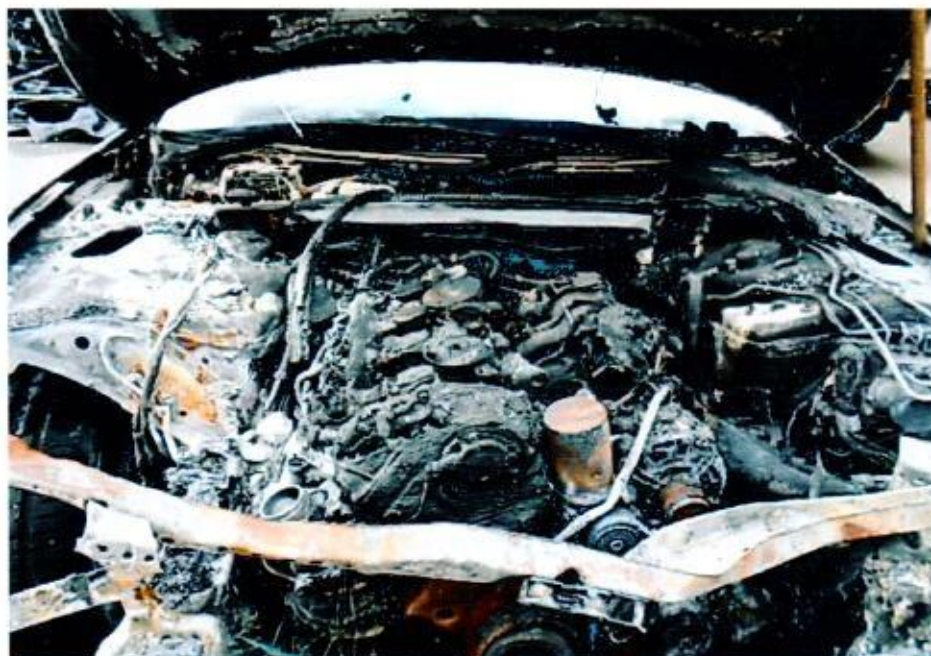
5. The engine compartment was also severely affected by the fire. Almost all the parts and components within the engine compartment were found to be badly burnt. This had included the air intake manifold, fuel rail, exhaust manifold and various hoses/pipes.

Photo 4 shows the engine compartment of the Insured Vehicle at the time of my inspection. The various parts and components inside the engine compartment were observed to have been severely burnt. This had included the intake manifold, fuel rail, belting, exhaust manifold and various hoses/pipes.

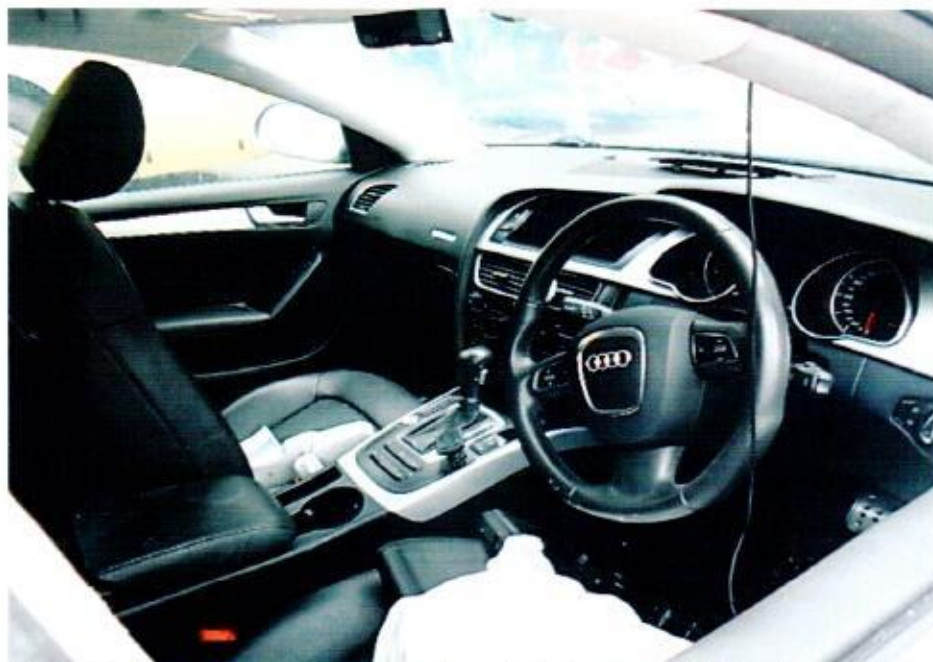
Photo 5 shows the interior compartment of the Insured Vehicle, which was unaffected by the fire.

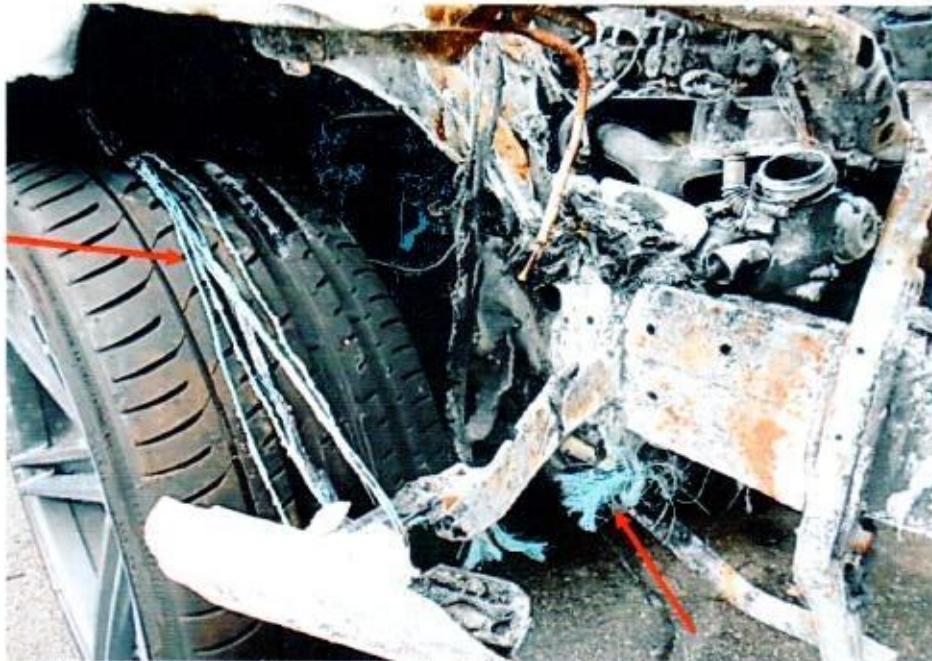
23. Given that fluid leak was not the primary cause of fire, the most probable cause would then be electrical in nature. This is supported by my observations during inspection of the Insured Vehicle, where I had found greenish residue on several stretches of wirings within the engine compartment. The presence of greenish residue indicates internal heating of copper wires, a sign of an electrical short circuit occurring. The greenish residue is normally left behind from oxidation as a result of chemical reaction involving the copper wires. This physical evidence would then appear to indicate that the cause of fire to the Insured Vehicle was of electrical in nature.

Photo 6 shows the wirings at the front right side of the engine compartment. I had found greenish residue on several stretches of wirings (arrowed) around this area of the engine compartment. Such greenish residue indicates internal heating of copper wires, a sign of an electrical short circuit occurring.

28. The cause of fire was likely to be of electrical in nature, where live wires may have become exposed/torn as a result of the impact force and come into contact with each other and/or the metal body of the Insured Vehicle, creating sparks that had ignited the fire.
29. At the time of inspection, I did not find any modification(s) and/or additionally fitted electronic and/or electrical component(s) on the Insured Vehicle.
30. My investigations also revealed that at the time of writing this report, there is no manufacturer recall of similar make and model vehicle as the Insured Vehicle.

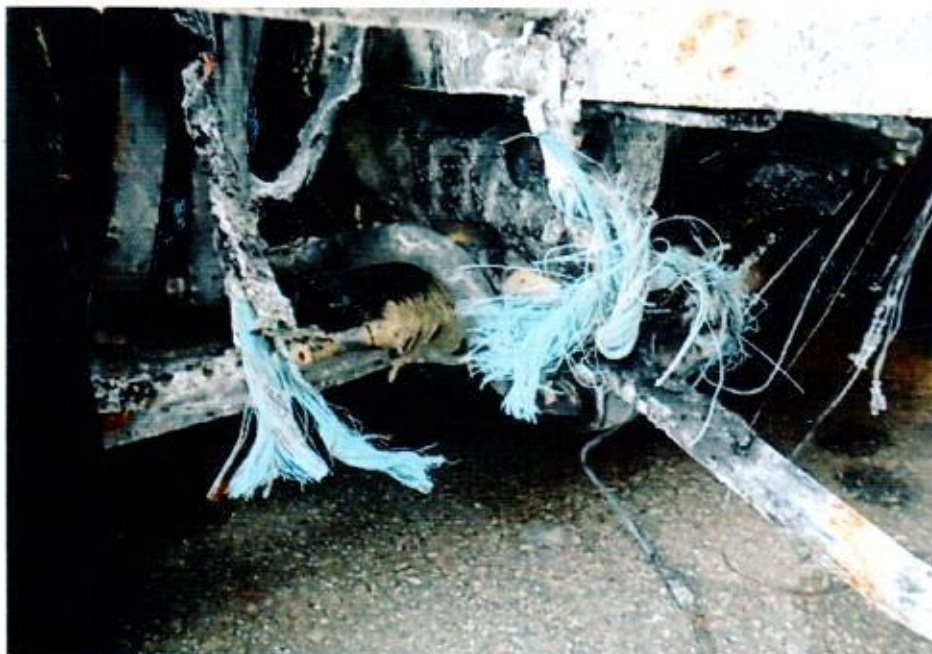
Photo 7 shows a closer view of the wirings of the Insured Vehicle, which were found with greenish residue. The presence of such greenish residue indicates internal heating of copper wires, a sign of an electrical short circuit occurring. This would then indicate that the fire to the Insured Vehicle was due to electrical nature.

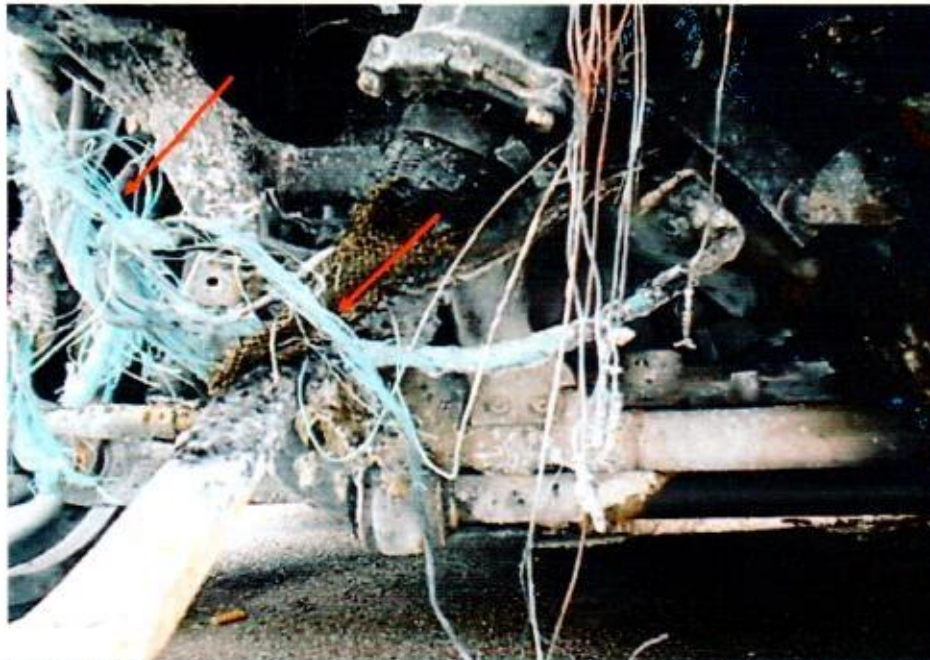
Photo 8 shows another stretch of wirings, at the front of the engine compartment, where greenish residue was found. Such greenish residue indicates internal heating of copper wires, a sign of an electrical short circuit occurring.
