Accident involving GBB7553R and SCU9881T on 10/11/2017

VEHICLE DAMAGE INSPECTION REPORT

Our Ref: 677/TP/2017

ADJUSTMENT ON REPAIR COST FOR VEHICLE NO. SCU 9881T

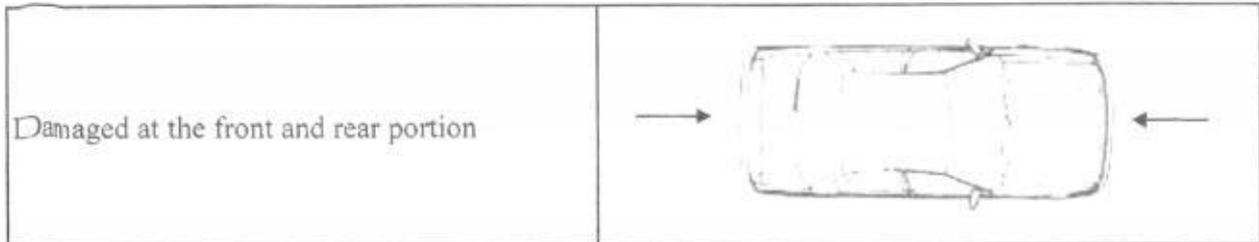
POINT OF IMPACT

Our visual inspection of the vehicle revealed that the damages noted are at the front and rear portion.
