Your Ref : 556994
Our Ref : CS/MSG18007877/N

29 May 2018

**AUTOMOBILE TECHNICAL INVESTIGATION REPORT OF ACCIDENT
INVOLVING SJU 1138B AND SGQ 8709P ON 25 APRIL 2018**

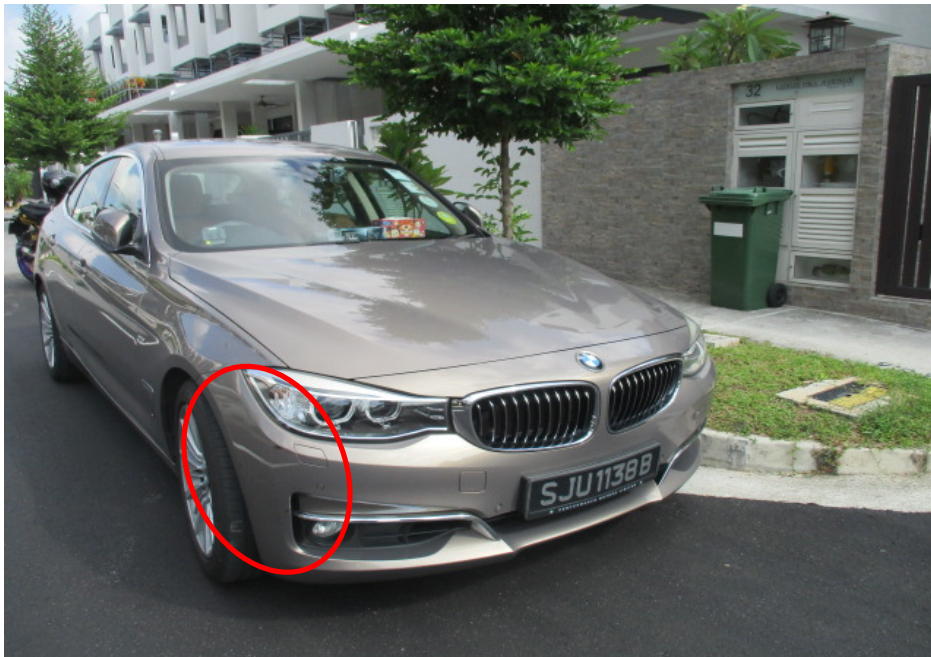
7. The BMW was physically inspected at the home premises of Ms Tan located at 32 Luxus Hill Avenue, Singapore 804890. The mileage of the BMW recorded at the time of our inspection was 46,682km.
8. At the time of our inspection, the BMW was observed to have sustained relatively minor impact damage at its right frontal portion. The right front portion of the front bumper was observed to be grazed.

9. In general, the physical condition found on the BMW indicates that it had sustained an impact directly onto its right frontal portion. This impact was relatively light as we did not observe any obvious misalignment at the corner edges of the front bumper, adjacent to the front fenders. See photos 1 – 5 below.

Photo 1 shows the general right view of the front of the BMW at the time of our inspection. Its right frontal portion was observed to have sustained relatively minor impact damage, which had affected its front bumper (circled).

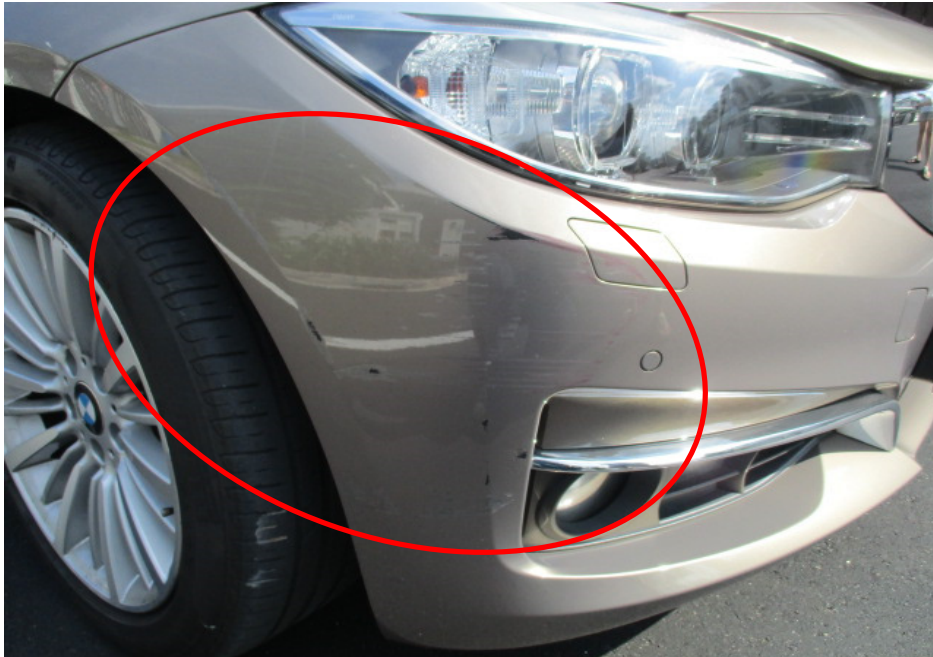
Photo 2 shows the paint graze marks found on the right portion of the BMW's front bumper (circled).

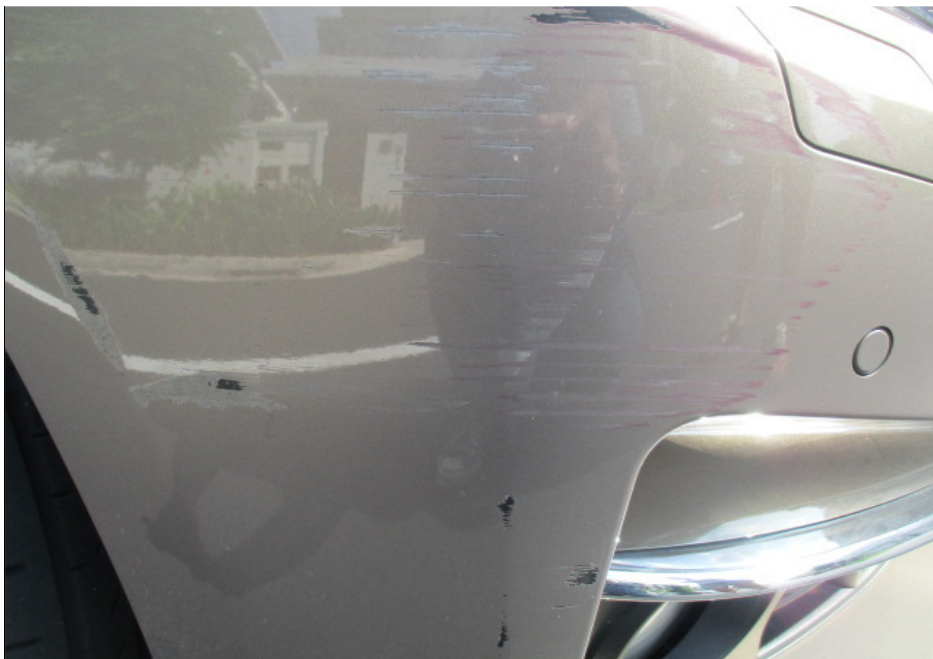
Photo 3 shows a closer view of the paint graze marks found on the right portion of the BMW's front bumper.

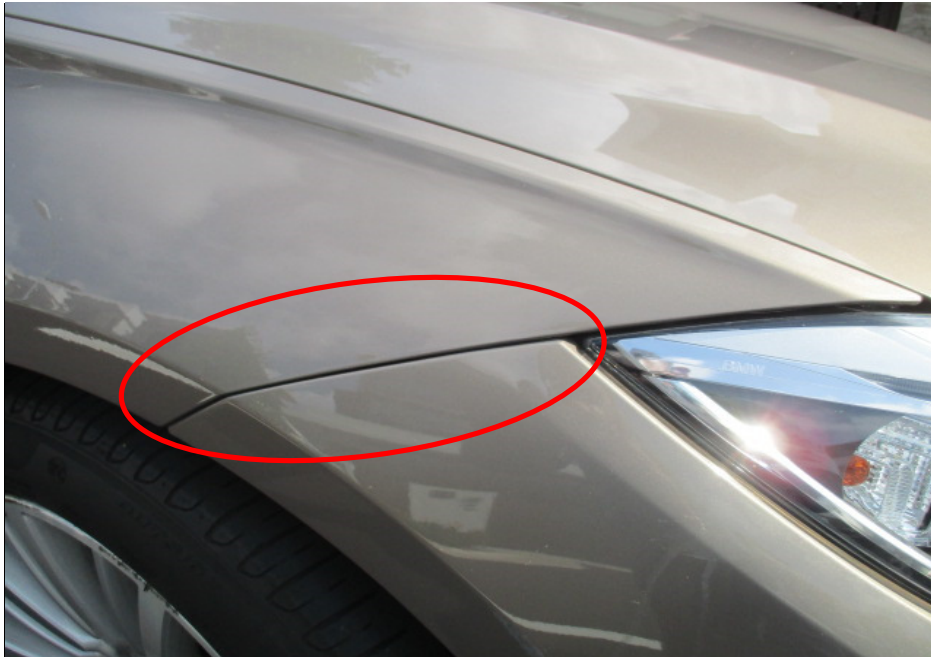
Photo 4 shows no obvious misalignment at the corner edges of the BMW's front bumper, adjacent to its front right fender (circled). This would indicate that the impact onto the frontal portion of the BMW was relatively light.

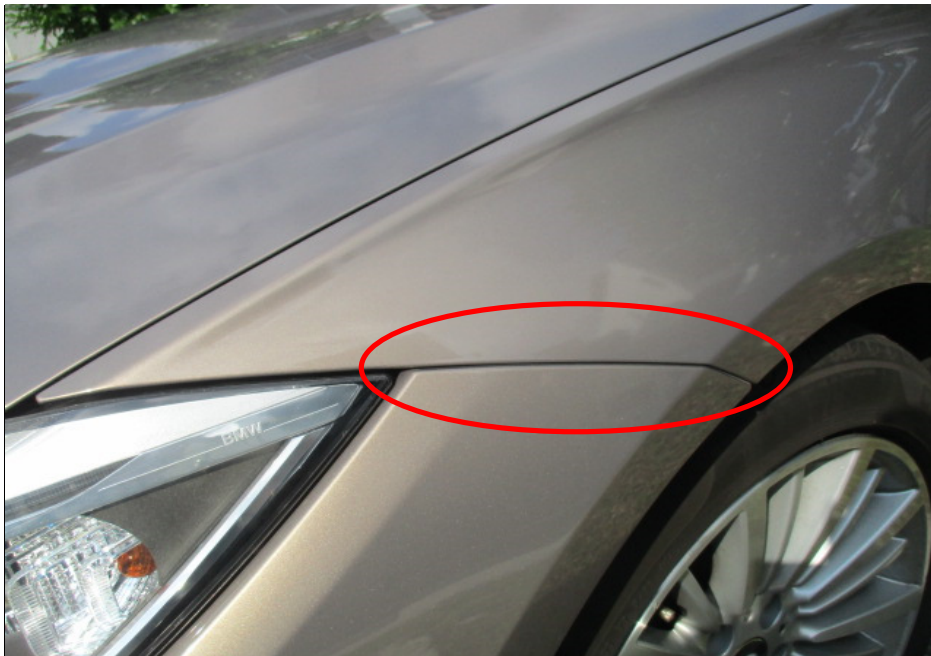
Photo 5 shows no obvious misalignment at the corner edges of the BMW's front bumper, adjacent to its front left fender (circled). This would indicate that the impact onto the frontal portion of the BMW was relatively light.

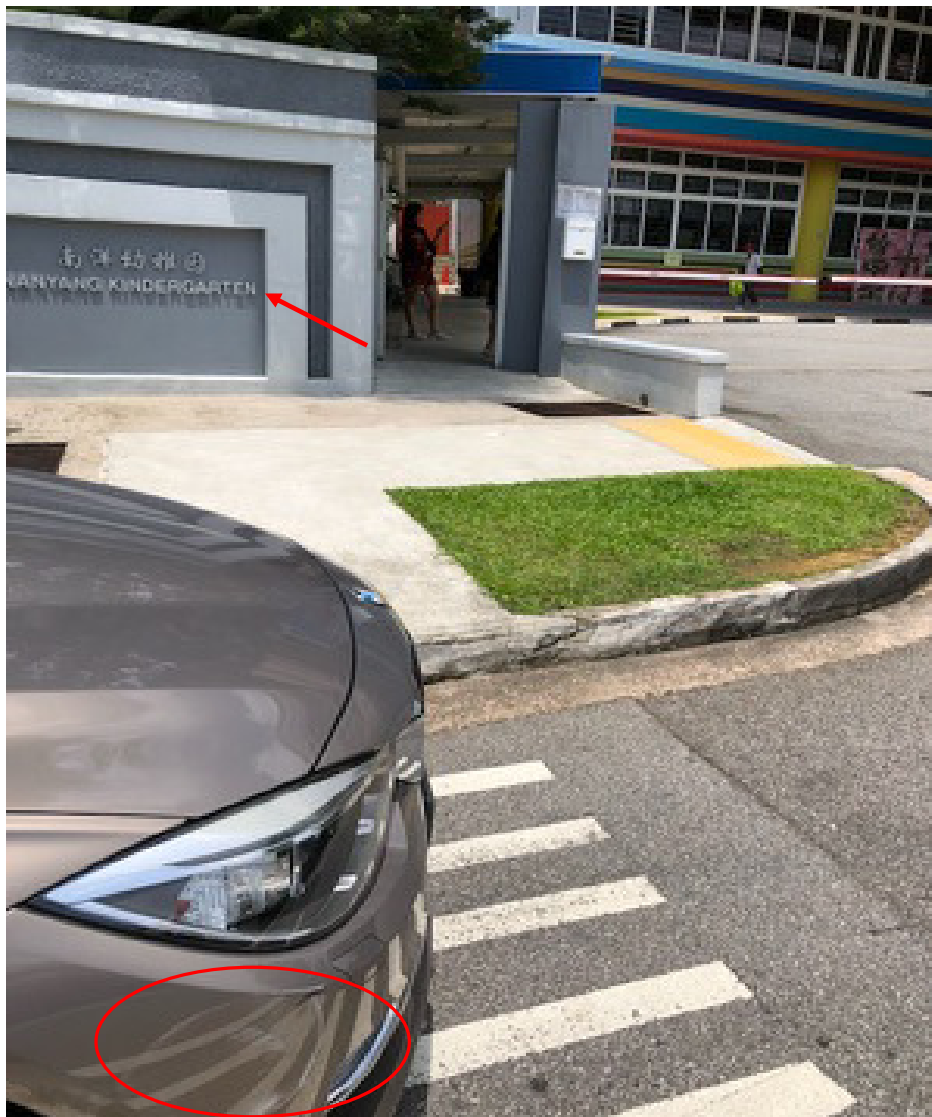
10. Our comparison of the condition of the BMW at the time of our inspection with the photographs of the BMW that were taken by Ms Tan post- accident had showed similar condition, which was discussed earlier in paragraph 8 & 9, on the frontal portion of the BMW immediately post- accident. See photos 6 & 7 below of the BMW taken by Ms Tan at the accident scene.

Photo 6 shows the condition of the Toyota's front bumper as depicted in the photographs that were taken by Ms Tan post- accident outside Nanyang Kindergarten (arrowed). The same paint graze marks towards the right front portion of the BMW were observed (circled).

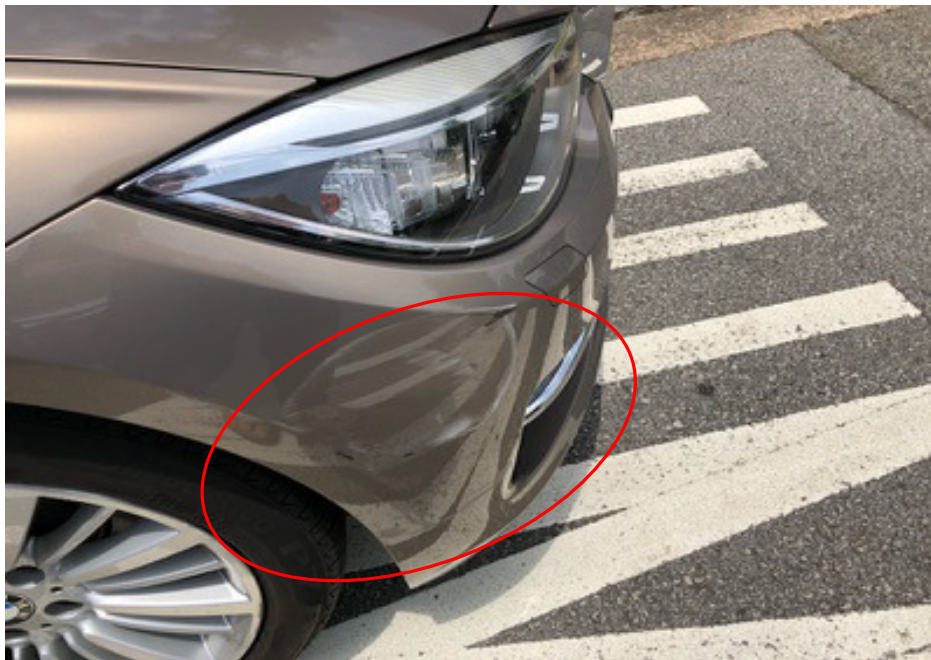
Photo 7 shows a closer view of the condition of the BMW's front bumper as depicted in the photographs that were taken by Ms Tan post- accident. The same paint graze marks on the right front portion of the BMW were observed (circled).

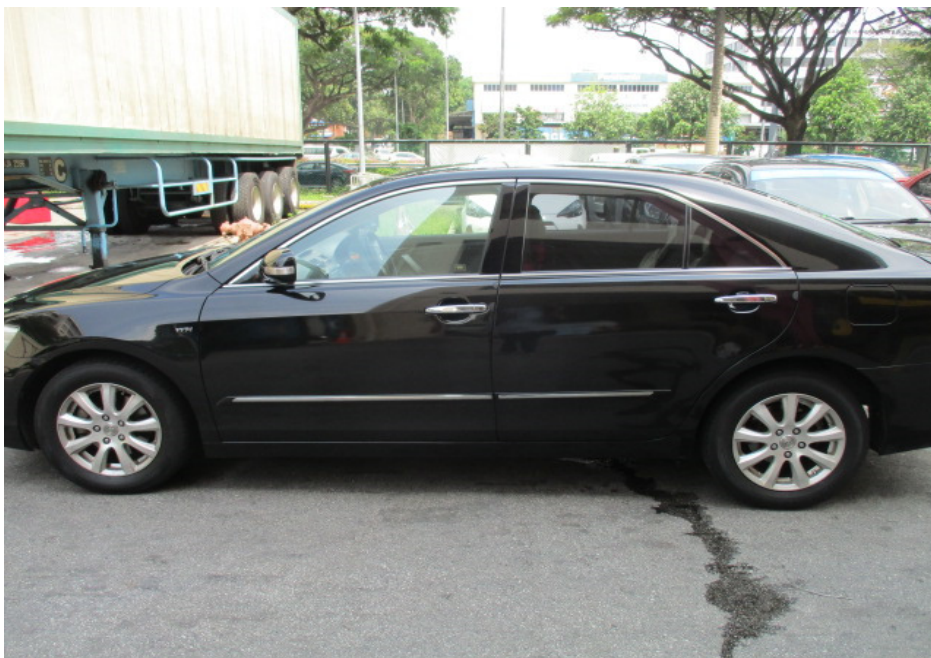
Photo 9 shows the general view of the Toyota's left portion at the time of inspection. Its left portion was observed to have sustained relatively minor impact damage, which had affected its left passenger door and rear bumper only.

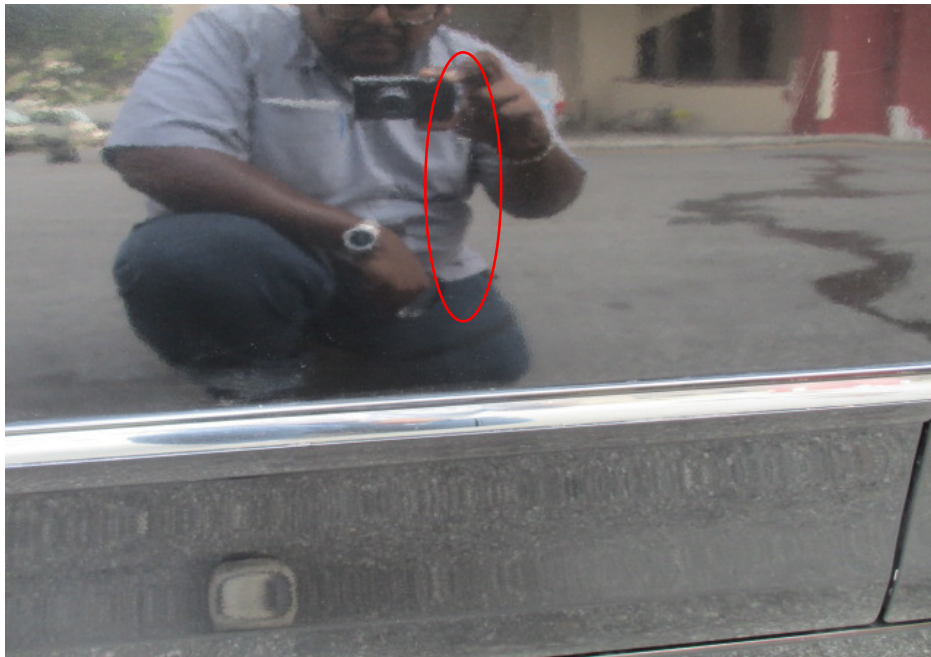
Photo 10 shows upon closer inspection, we note that there were paint scratch marks on the left front passenger door of the Toyota (circled).

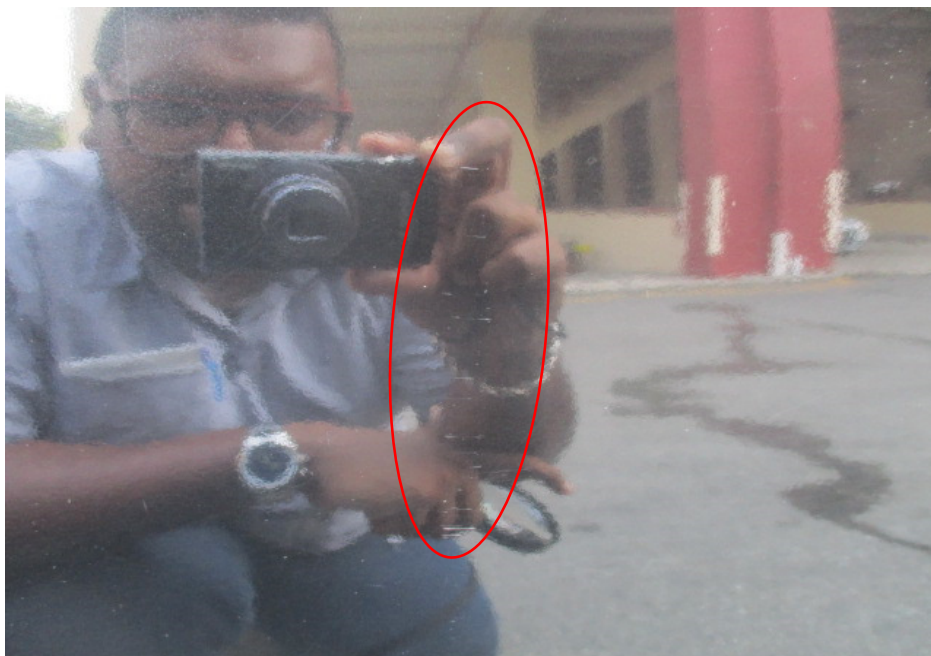
Photo 11 shows a close up view of the paint scratch marks found on the left front passenger door of the Toyota (circled).

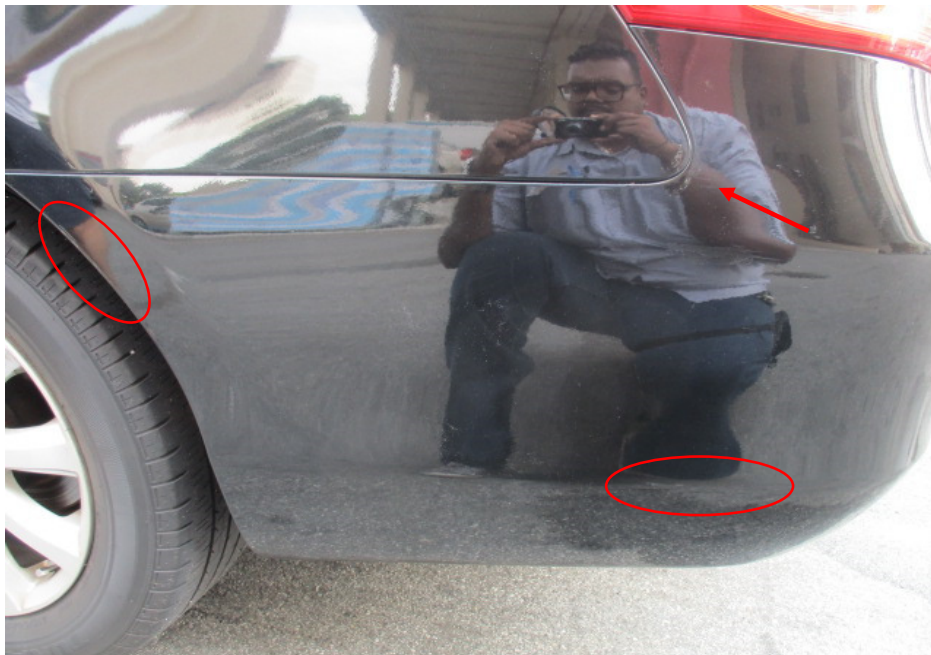
Photo 12 shows the paint scratch marks (arrowed) and paint graze marks (circled) found on the left rear portion of the Toyota, on the rear bumper.

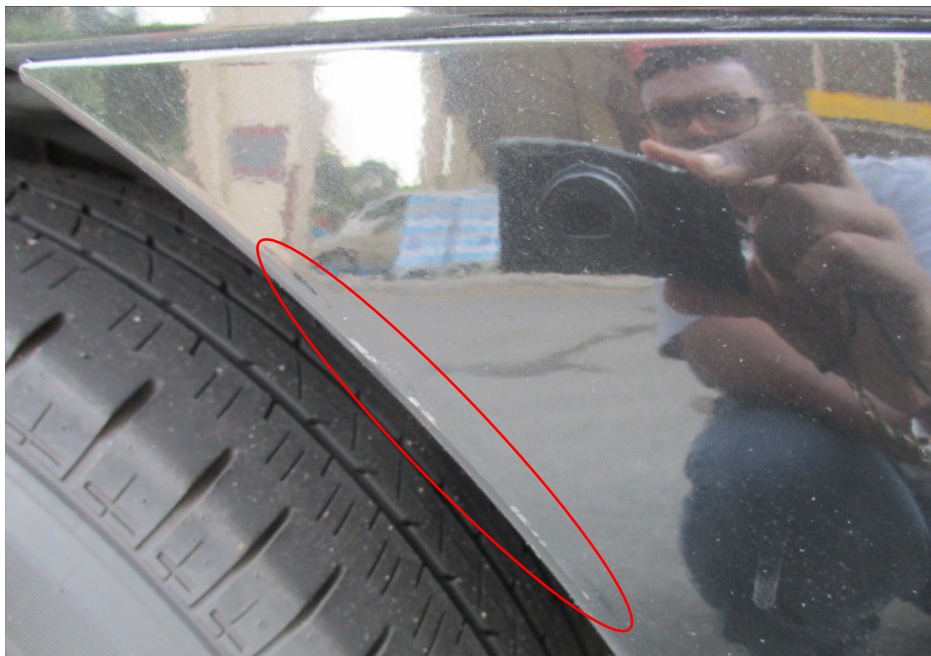
Photo 13 shows a close up view of the paint graze marks (circled) found on the left rear portion of the Toyota, on the rear bumper.

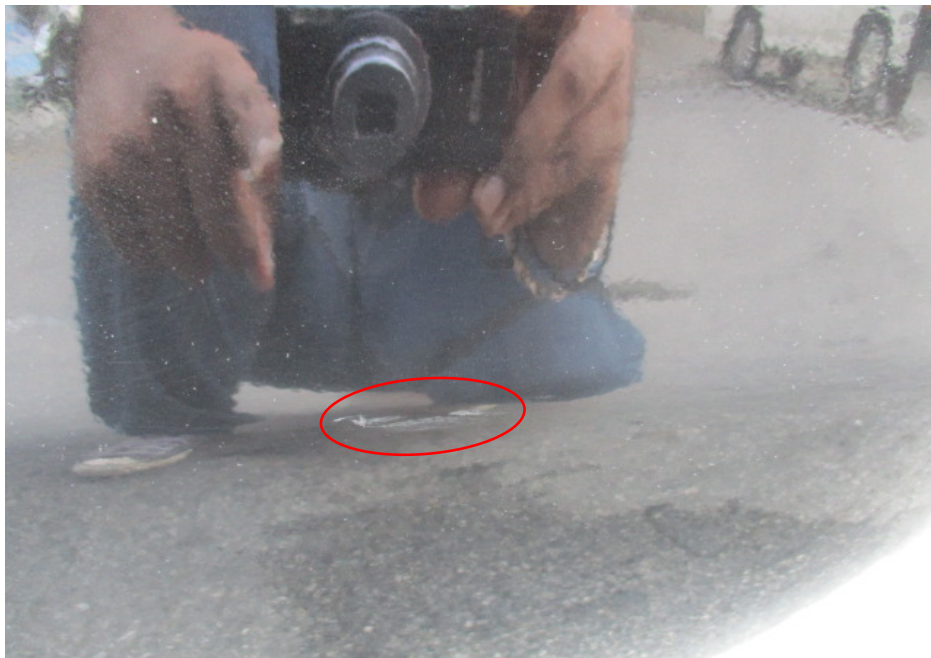
Photo 14 shows a close up view of the paint graze marks (circled) found on the lower left rear portion of the Toyota, on the rear bumper.

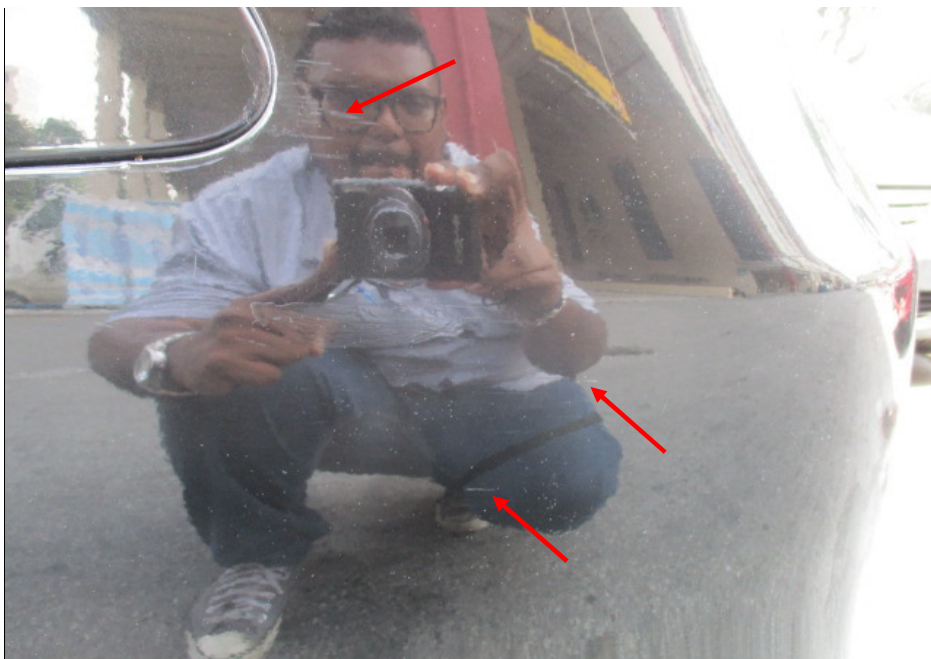
Photo 15 shows a closer view of the paint scratch marks found on the left rear portion of the Toyota, on the rear bumper (arrowed).

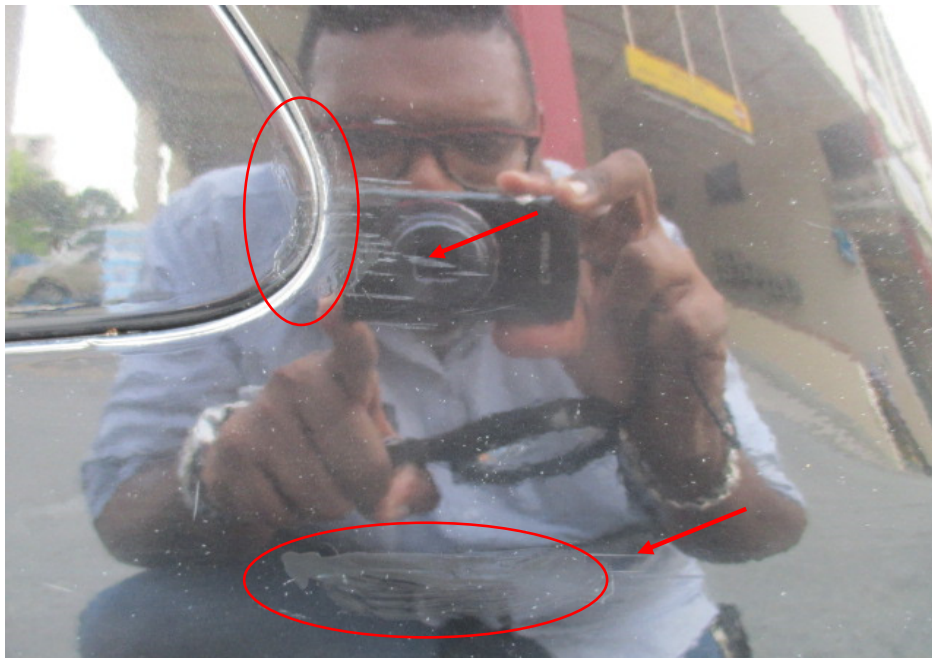
Photo 16 shows upon closer examination, we observed that several areas around the paint scratch marks (arrowed) had been painted over (circled).

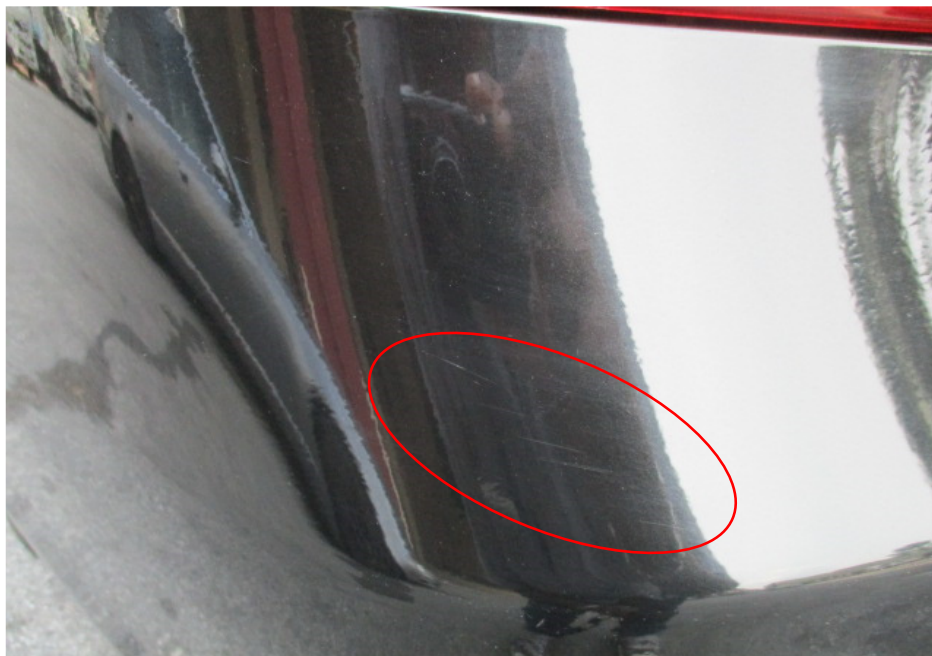
Photo 17 shows a closer view of the paint scratch marks found on the left portion of the Toyota's rear bumper (circled).

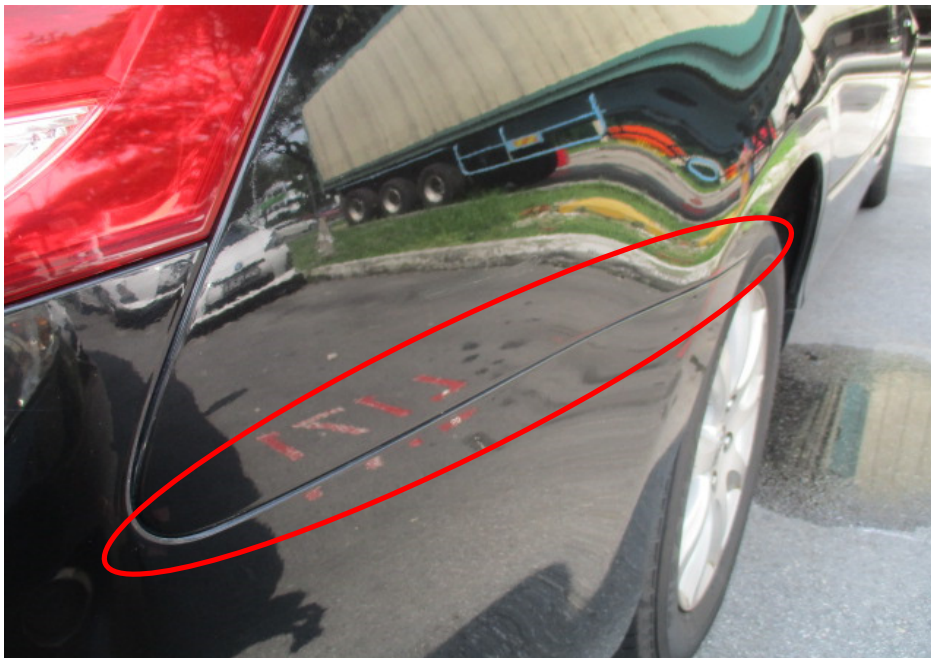
Photo 18 shows no obvious misalignment at the corner edges of the Toyota's rear bumper, adjacent to its rear right fender (circled). This would indicate that the impact onto the rear portion of the Toyota was relatively light.

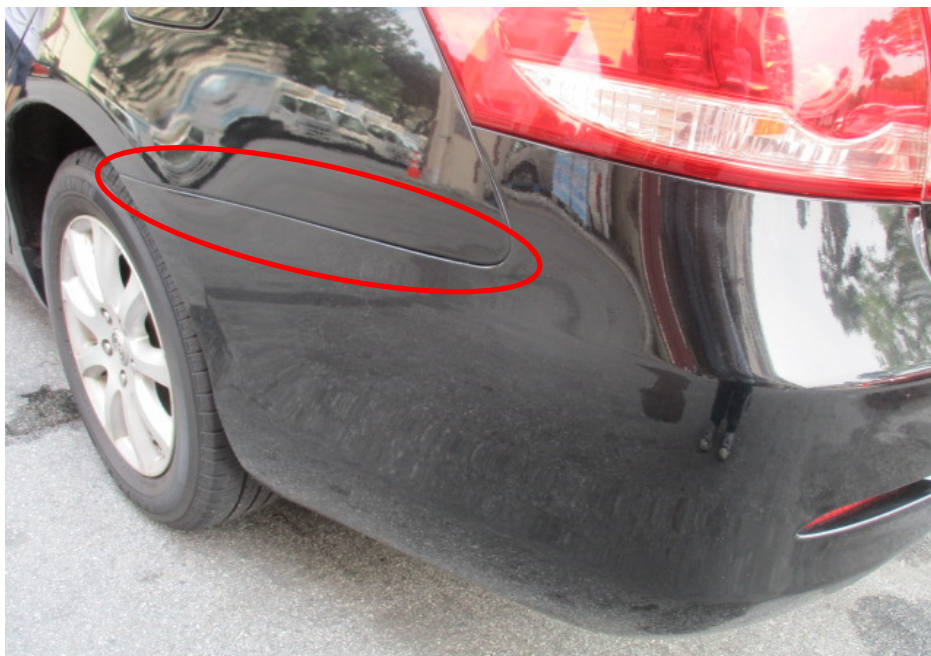
Photo 19 shows no obvious misalignment at the corner edges of the Toyota's rear bumper, adjacent to its rear left fender (circled). This would indicate that the impact onto the rear portion of the Toyota was relatively light.

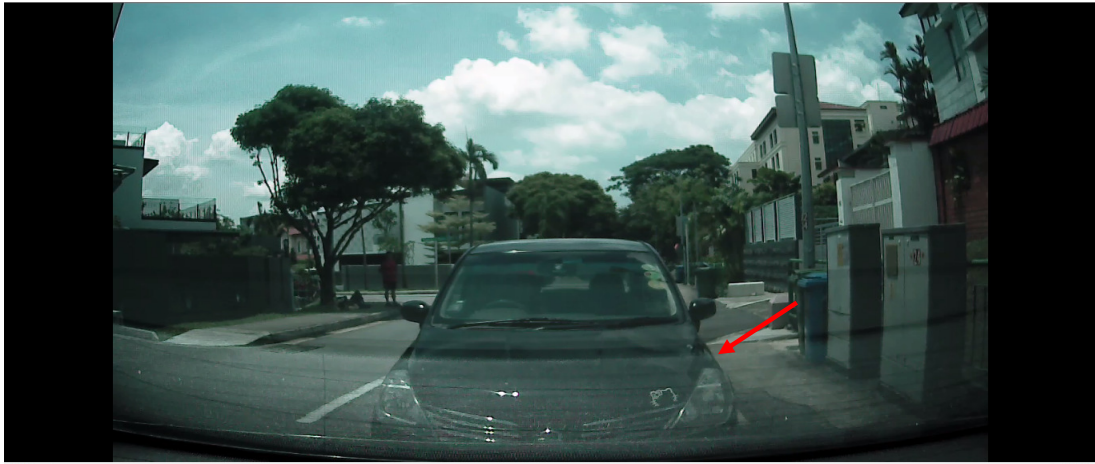
16. At the 11 second mark of the rear video, we had noted a slight movement (jerk-like movement) to the parked vehicle behind the BMW. Impact sound could also be heard at the 11 second mark. When viewing the front video at the 11 second mark where the slight jerk- like movement was noted to the parked vehicle behind the BMW, it could be seen that the left rear portion of the Toyota had just passed the right front portion of the BMW, indicating possible contact between the left rear portion of the Toyota and the right front portion of the BMW.

17. The capturing of this slight jerk- like movement of the parked vehicle behind the BMW by the rear video is a sign that there was jerk- like movement to the BMW itself. Ultimately, indicating possible contact between the left rear portion of the Toyota and the right front portion of the BMW. However one would have to view the recordings to see this movement. See screenshots 1 – 4 below.

Screenshot 3 shows at the 11 second mark of the rear video, slight jerk- like movement was noted to the parked vehicle behind the BMW (arrowed). The capturing of this slight jerk- like movement of the parked vehicle behind the BMW by the rear video is a sign that there was jerk- like movement to the BMW itself. Impact sound could also be heard at the 11 second mark.

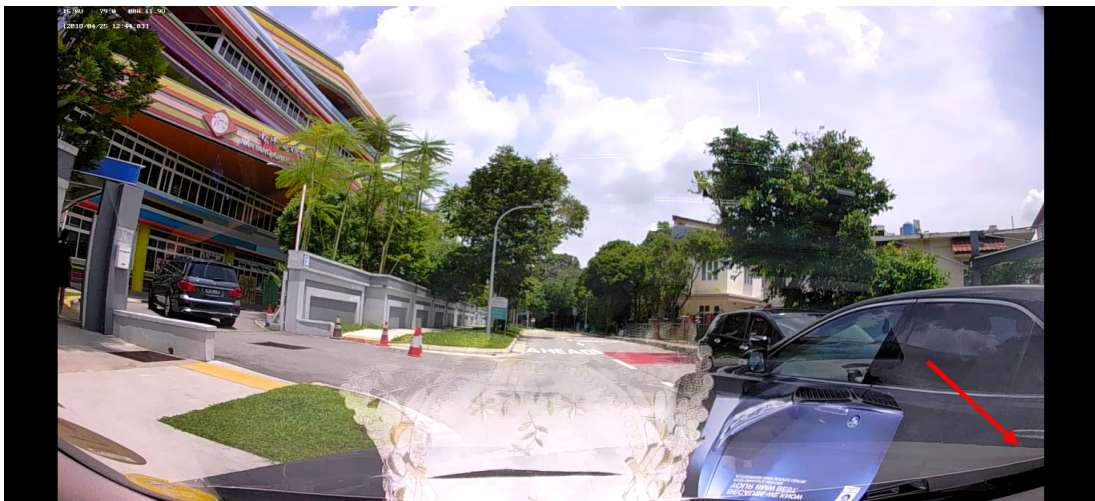
Screenshot 4 of the front video shows at the 11 second mark where the slight jerk- like movement was noted to the parked vehicle behind the BMW, the left rear portion of the Toyota had just passed the right front portion of the BMW (arrowed), indicating possible contact between the left rear portion of the Toyota and the right front portion of the BMW.

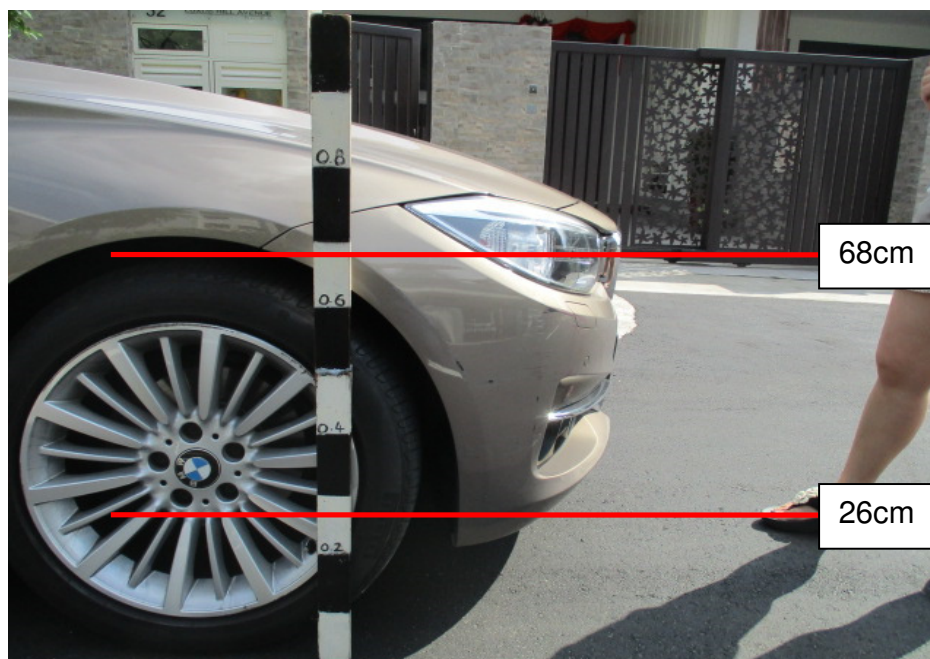
Photo 20 shows the height measurement being conducted on the right front portion of the BMW. The paint graze marks on the right front portion of the BMW were between the height ranges of 26cm to 68cm above ground level.

- a) the paint graze marks on the right front portion of the BMW were between the height ranges of 26cm to 68cm above ground level;
- b) the paint graze marks and paint scratch marks on the left rear portion of the Toyota are within the 26cm to 68cm range;
- a) the height measurements appear to support the findings of possible contact between the left rear portion of the Toyota and the right front portion of the BMW.

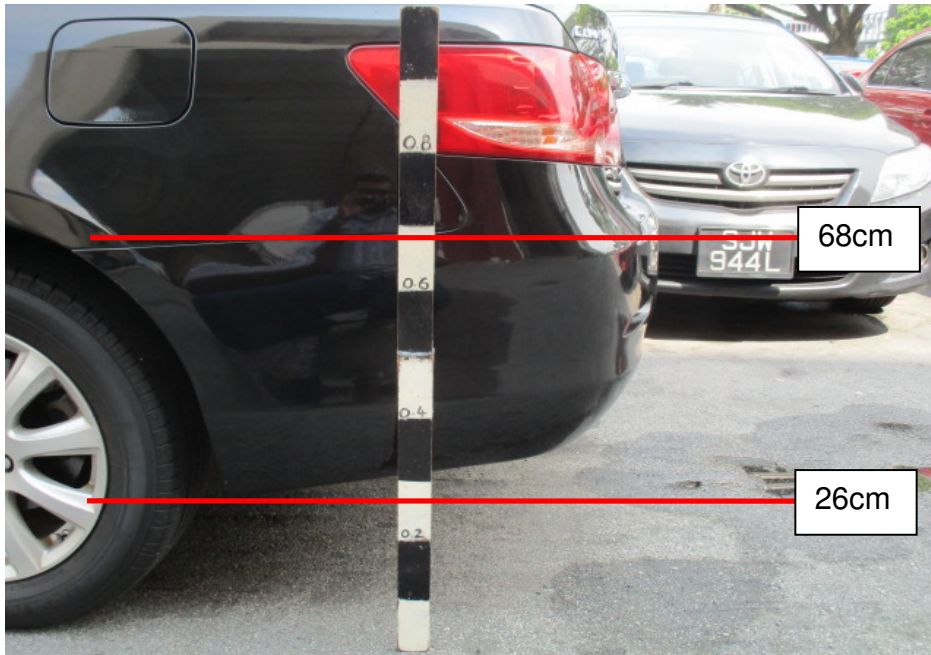
Photo 21 shows the height measurement being conducted on the left rear portion of the Toyota. The paint graze marks and paint scratch marks on the left rear portion of the Toyota are within the 26cm to 68cm range.

23. Both damages are corresponding to their respective heights and are consistent to their nature of contact. Furthermore the pattern of the graze marks observed on the left rear portion of the Toyota corresponds to the pattern of the paint graze marks observed on the right front portion of the BMW.
